CRITICAL EVALUATION OF CORN SILO BURST FAILURE ANALYSIS

MTRL 585 Case Study 3

Prepared By:
GROUP 7

Submitted 16 October 2012

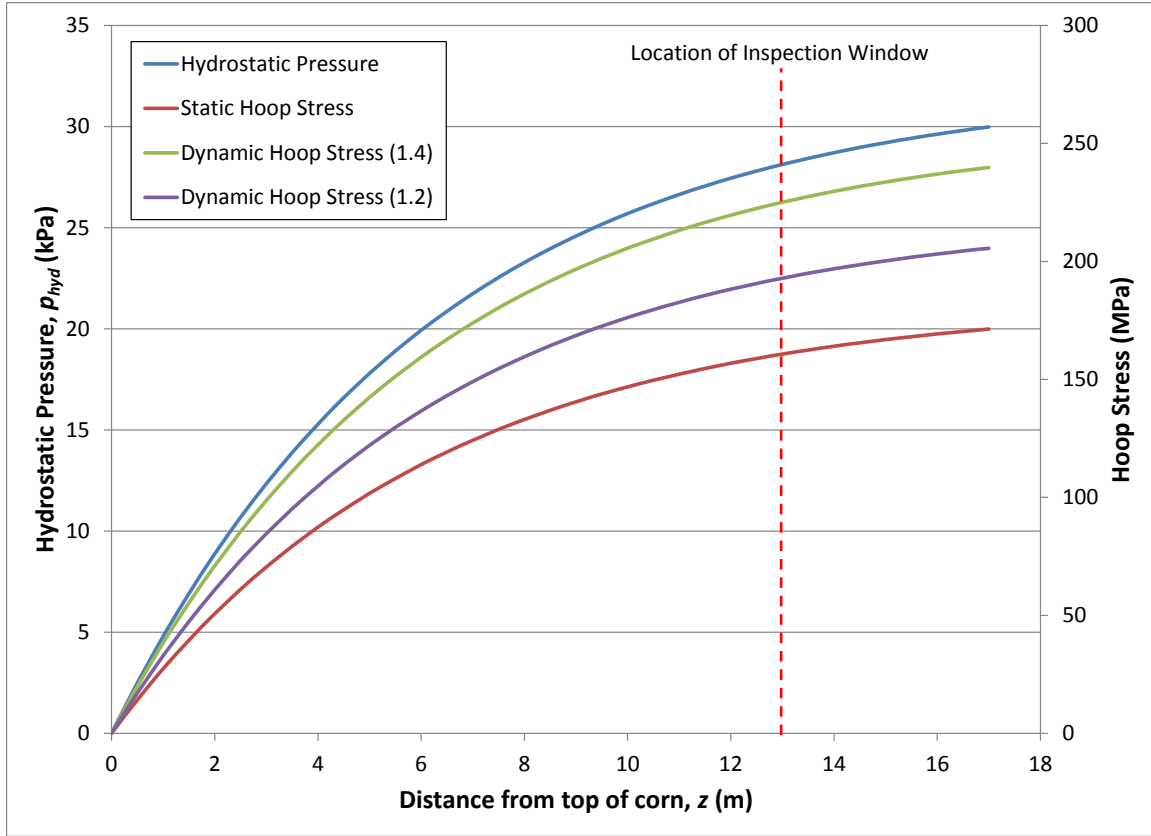
Figure 1: Variation in hydrostatic pressure through height of silo

To gain an appreciation for the variation across the height of the silo, hydrostatic pressure and hoop stresses in an un-corroded sheet were calculated as a function of distance from the top of the corn (Figure 1). Considering only hydrostatic pressure, the silo walls would be able to withstand hoop stresses in the un-corroded condition.
