Geohazards in the South Okanagan

Dr. Dwayne D. Tannant University of British Columbia

A version of this document was prepared for the technical field trip conducted as part of the 5th Canadian Geohazards Conference held at the Okanagan campus of the University of British Columbia - May 15 to 17, 2011

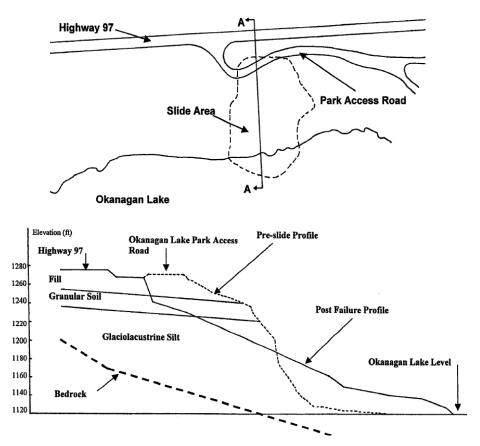
The Okanagan Lake Provincial Park landslide damaged a park access road and entered the lake.

Figure 1. Plan view and vertical section of the Okanagan Lake Provincial Park landslide (Iravani 1999).

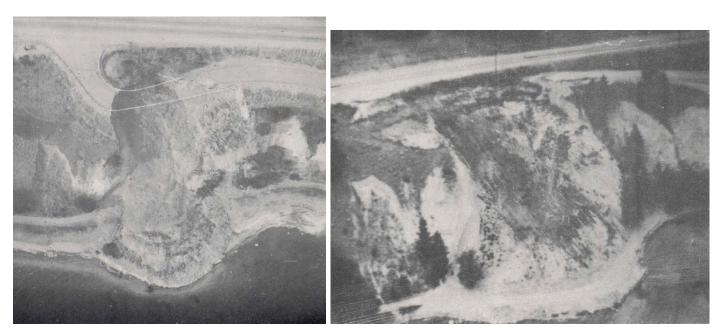
Figure 2. Okanagan Lake Provincial Park landslide (a) a few weeks after failure and (b) after slide mass was re-shaped and seeded (Nyland & Miller 1975).

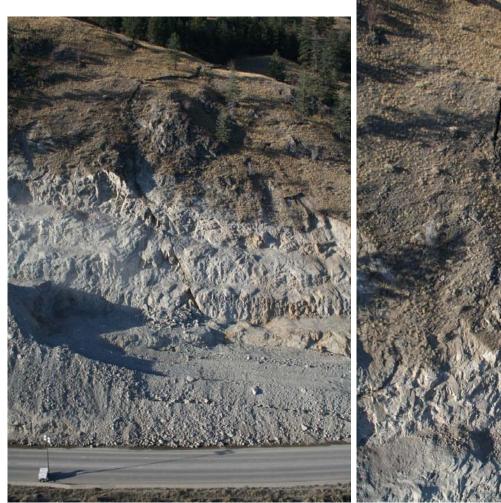
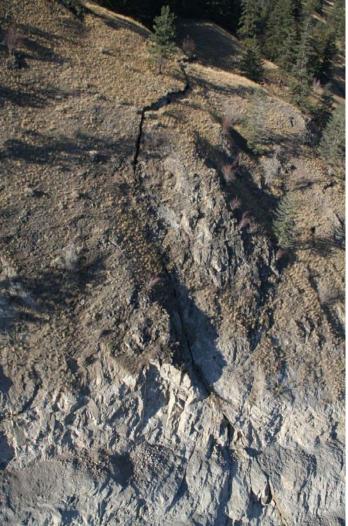
October 25, 2008: Geotechnical engineers were flown in to inspect the wide and deep tensile fracture in the slope.

Figure 3. Tensile fracture and slip surface (Arthon Construction, Oct. 2008).

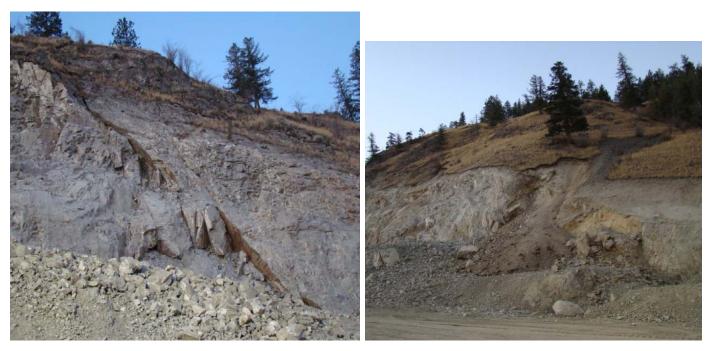
Figure 4. Slope movement along slip surface (day-lighted portion - left, buried under colluvium - right).

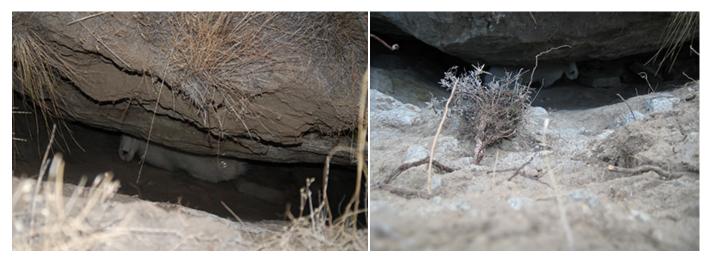
October 29, 2008: Test blast prepared however first they had to clear the area. Workers found a mountain goat trapped 6 to 10 m deep in a back-scarp fracture. The goat was tranquilized and lifted to surface. 15 homes on North Beach Ave. were evacuated as a precautionary measure, and the contractor loaded a crevice with 125 kg of explosives. The small explosive charge was used to assess stability of the slide mass.

Figure 6. Mountain goat trapped in the fracture (Arthon Construction, Oct. 2008).

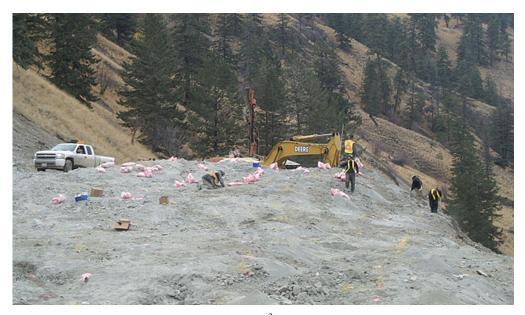
Figure 7. Preparation for removing 17,700 m³ of rock (Arthon Construction, Oct. 2008).

October 30 to November 11, 2008: Rock was blasted for 12 days working downward from the top of bluff, reducing the sliding mass, and placing loose rock at a toe berm to increase movement resistance. Blasting gradually slowed the fracture creep from 10 -20 mm/day to 1 mm/day

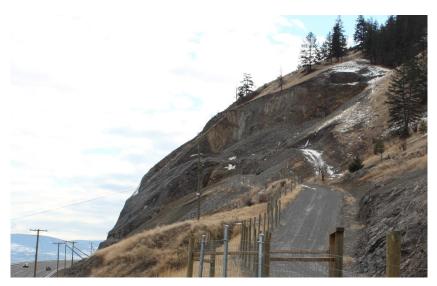
Figure 8. Completed construction with upper part of slope above the slip surface removed.

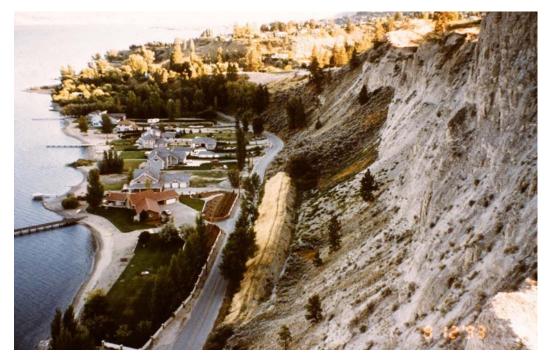
A steep silt bluff above North Lakeshore Drive in Summerland collapsed at 5:15 pm on Sept. 15, 1992. The silt debris travelled across the road and engulfed a garage and the vehicles and boats inside (Schuster house). Lakeshore Drive was blocked by up to 5 m of silt. Fortunately no people were injured in this event.

Figure 10. Schuster slide area showing toe berm built after the landslide (N. Skermer).

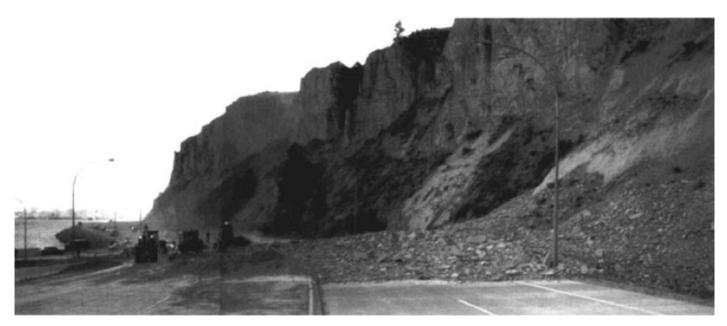
Figure 12. Dry silt flow triggered by block fall from a scarp in glacio-lacustrine silt (Hungr et al. 2001)

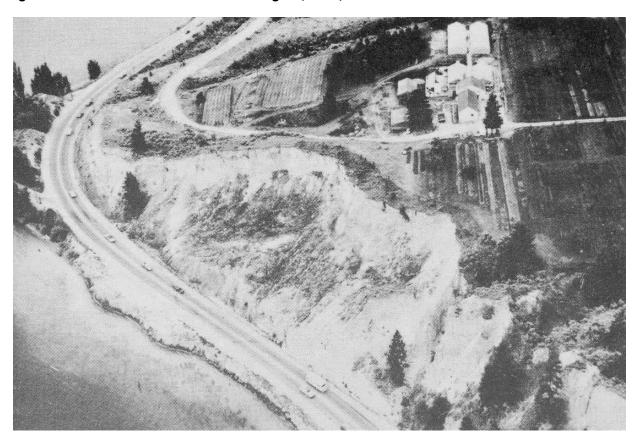
Figure 13. Agricultural Research Station landslides (Nyland & Miller 1975).

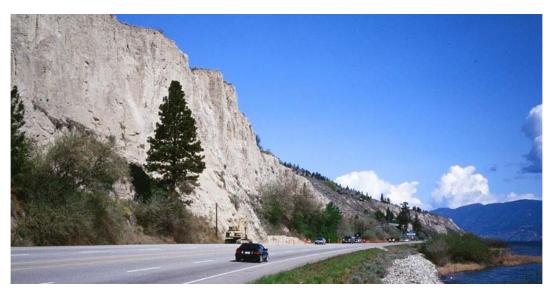
Figure 14. Example of a silt bluff block failure (N. Skermer).

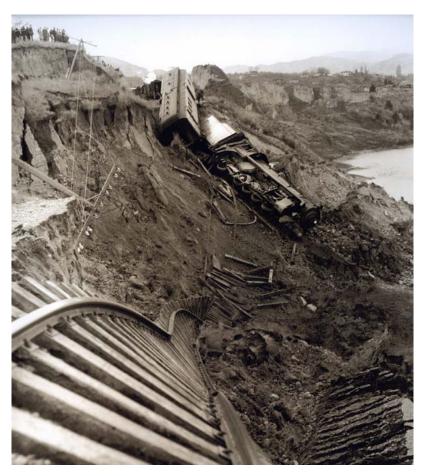
Amazingly no one was killed when a Kettle Valley Railway train entered the slide depression and turned on its side. The slide is named after the conductor of the train - Joe Raymond.

Figure 15. Joe Raymond landslide on the Kettle Valley Railway just north of Penticton (N. Skermer).

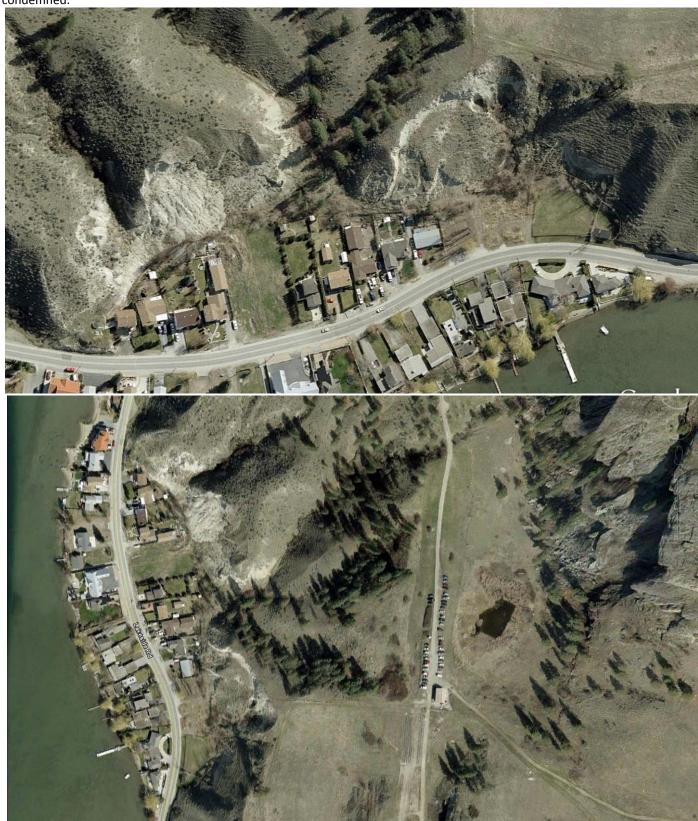
Mud flows and landslide movements occurred over a 3-year period. Six property owners affected, 3 or 4 houses were condemned.

Figure 18. Aerial views of Lakeside Road landslides.

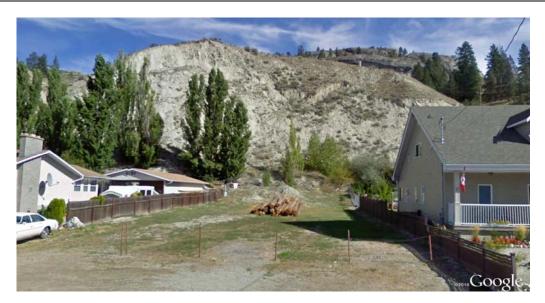
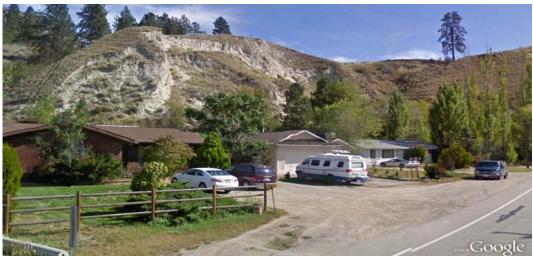
Figure 19. Google Streetview images of Lakeside Road landslides.

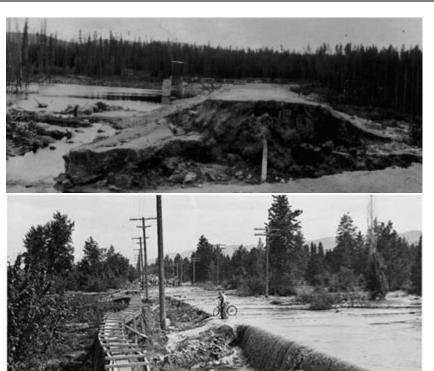
1941: The 10 m high, 560 m long, No. 4 Ellis Creek dam failed. The storage capacity of the reservoir had been tripled from the previous year by raising the height of the dam by 1.8 m. The dam was inspected just before the failure and no signs of seepage were noted. The failure released approximately 740,000 m³ of water.

Figure 20. Dam failure in 1941 and resulting debris flood in Penticton (1941).

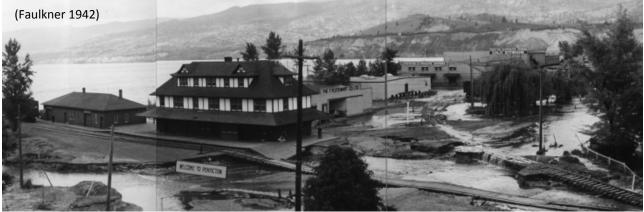
1942: Heavy precipitation and snowmelt resulted in partial failure of the Ellis Creek dam No. 4, releasing 150,000 m³ of water, which was added to the already overflowing Ellis Creek. Extensive flood damage occurred in Penticton.

Figure 21. Dam failure at wooden spillway in 1942 and flood in Penticton.

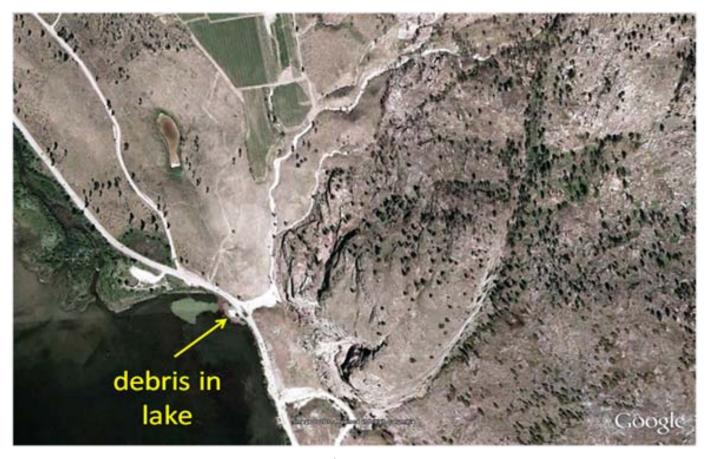
An intense rainstorm near Vaseux Lake on June 30, 2004 created severe run-off and triggered numerous small debris flows. Debris crossed Highway 97, temporarily closing the highway, and entered the north end of Vaseux Lake. Private property was also damaged. The Vaseux Lake forest fire (3,300 ha) the year before is believed to have been a contributing factor (Forest Practices Board 2005) by changing the water infiltration and run-off characteristics in the watershed.

Figure 22. Small debris flows that blocked Highway 97.

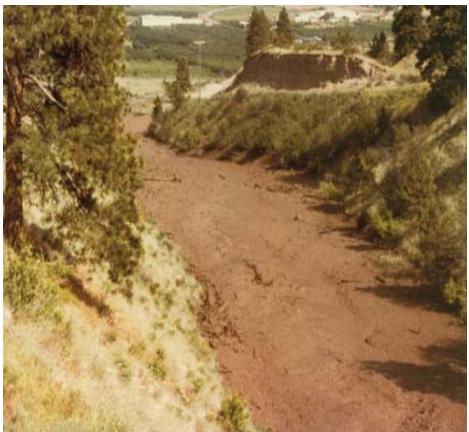
On May 28, 1983, a mud flow came down Tinhorn Creek and crossed and blocked Highway 97. This event occurred after a week of increasingly hotter temperatures in the south Okanagan. It also occurred in the middle of the driest four-week period recorded at Oliver in the first six months of 1983. It is likely that late spring snowmelt was the main factor in causing the mud flow.

Figure 23. Tinhorn Creek mud flow May 28, 1983 (Osoyoos Times).

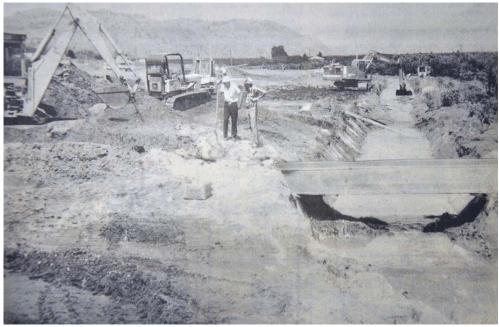
Figure 24. Tinhorn Creek mudflow triggered by rainfall on Aug. 9, 1989 (Oliver Chronicle).

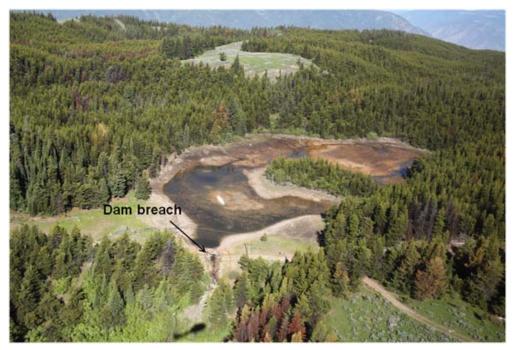
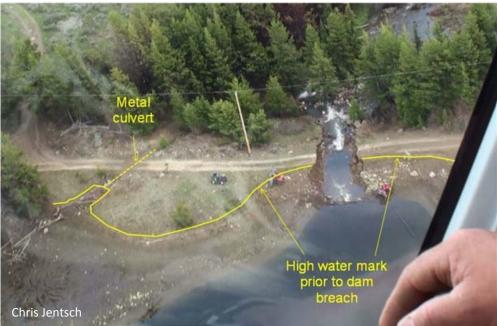
A large mud flow descended Testalinden Creek on the afternoon of Sunday, June 13, 2010. It caused extensive property damage on the fan of Testalinden Creek and destroyed five houses. Fortunately there was no loss of life. A breach occurred in a small dam constructed in the 1930's for the purpose of water storage and irrigation at Testalinden Lake at the headwaters of the creek, approximately 1500 m above the fan. The dam failure coincided with the first period of sustained hot weather for the year. The hot weather accelerated the melting of the lingering late season snowpack at the top of Mount Kobau. The small reservoir had already been filled and the dam was overtopping. The last surge of snowmelt, which was occurring at the time of the breach, created enough overflow velocity and resulting erosive energy to scour through a harder, grass covered, outer surface crust on the dam, and expose a softer, more easily eroded core. The breach released approximately 20,000 m³ of water that descended the creek to the Okanagan Valley, entraining materials from the creek and growing to more than 200,000 m³ in volume by the time it reached the alluvial fan (Tannant & Skermer 2011).

Figure 25. Testalinden lake dam breach.

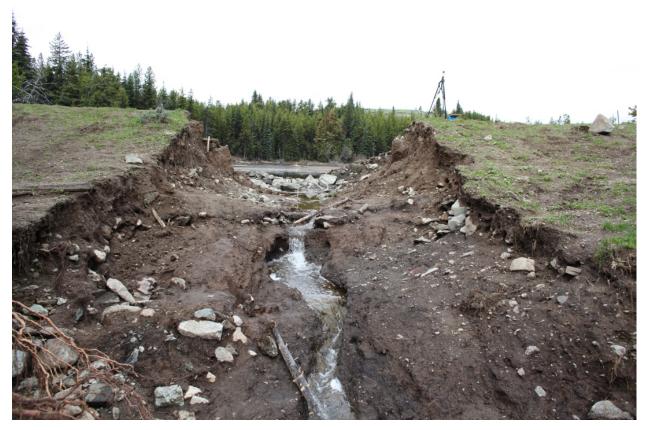
Figure 26. Testalinden lake dam breach.

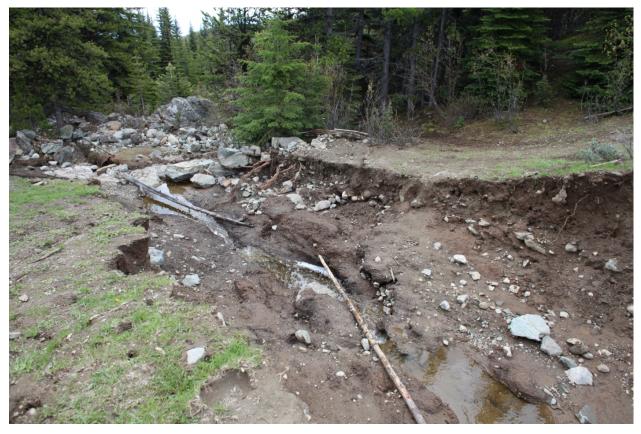
Figure 27. Downstream face of dam breach.

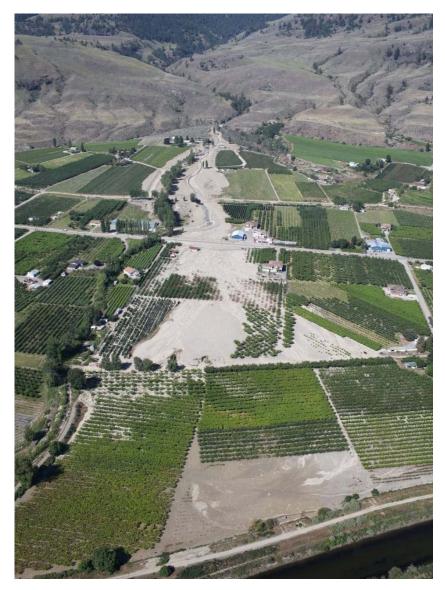
Figure 28. Deposition area on the fan.

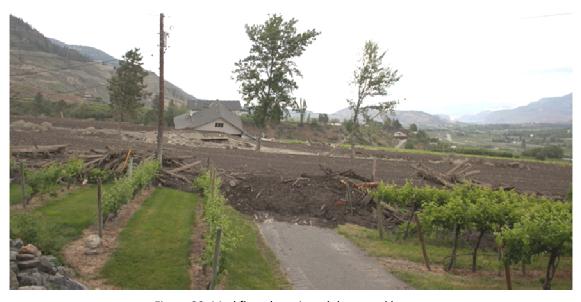
Figure 29. Mud flow deposit and destroyed house.
