Proceedings of the 25th Annual British Columbia Mine Reclamation Symposium in Campbell River, BC, 2001. The Technical and Research Committee on Reclamation IDENTIFICATION AND MITIGATION OF HIGH ZINC DISCHARGES TO THE ENVIRONMENT FROM THE WATER DIVERSION SYSTEM AT THE KEMESS SOUTH MINE

Harold Bent, BSc, Scott Frostad, M.A.Sc., P.Geo. and Scott Davidson, M.Sc., P.Geo.,

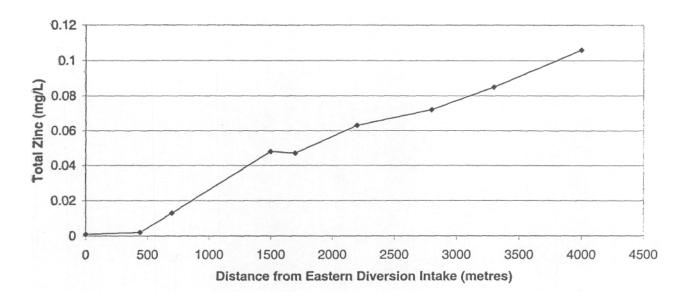
On July 24th, 1999, environmental staff sampled all WDS inflow locations and a number of sites along the EDC and NDDC to determine the source(s) of zinc. The results of the sampling showed that the water inflow locations returned zinc concentrations below the laboratory detection limit while the concentration of zinc increased with distance along the EDC (Figure 2) and NDDC diversion conduits. The maximum zinc concentrations returned from the EDC and NDDC were 0.106 and 0.049 mg/1, respectively. Based on the sampling program, the galvanized steel conduit was determined to be the source of the elevated zinc levels.

Proceedings of the 25th Annual British Columbia Mine Reclamation Symposium in Campbell River, BC, 2001. The Technical and Research Committee on Reclamation Proceedings of the 25th Annual British Columbia Mine Reclamation Symposium in Campbell River, BC, 2001. The Technical and Research Committee on Reclamation Figure 2. Zinc Concentrations in Eastern Diversion Conduit (July 24,1999)

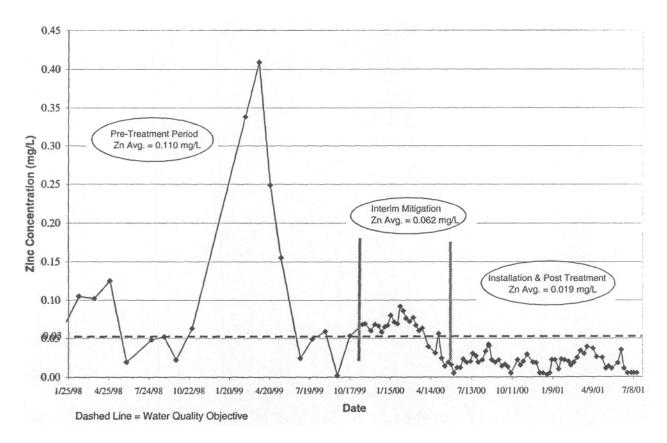
The Water Diversion System was commissioned in January 1998 and monitoring of the diverted waters commenced on February 18, 1998. The water quality objective site for this portion of the mining property is located in South Kemess Creek, 150 metres downstream of the WDS outlet and is designated as WQ-25. The water quality objective for zinc at WQ-25 is 0.03 mg/1 (30ppm). The recorded zinc concentrations at WQ-25 from February 1998 to July 2001 are presented in Figure 3.

The data presented in Figure 3 represents the zinc concentrations in South Kemess Creek during 3 distinct operating phases of the Water Diversion System: (1) Pre-Treatment Period, (2) Interim Mitigation Period and (3) Post Treatment Period (including the pipe installation period).

Monitoring during the pre-treatment period showed the zinc levels at WQ-25 to exceed the 0.03 mg/1 Zn WQO, primarily during the winter low flow periods. The recorded zinc values during spring freshet, and throughout the summer and fall seasons, drop substantially due to dilution, however, there were still zinc exceedences at WQ-25 during this time. The average zinc concentration during the pre-treatment period was 0.11 mg/1 and the recorded high value was 0.409 mg/1.

Redirecting EDC waters into the Tailings Storage Facility from November 1999 to May 2000 resulted in a significant lowering of zinc concentrations at WQ-25. Although, the SDD reservoir still contained elevated concentrations greater than Zn 0.03 mg/1, the average zinc concentration at WQ-25 was reduced by approximately 50% as compared to the pretreatment period. The average zinc concentration at WQ-25 during the interim mitigation period was 0.062 mg/1 and the recorded high value was 0.092 mg/1.

The water quality monitoring continued during the pipe installation project. The flow of water through the EDC was intermittent during this time and sampling reflects various stages of completion of the project. Upon completion of the pipe installation, the water quality monitoring continued on a weekly basis. The data shows that there has been a significant decrease in zinc concentrations. The average zinc concentration since initiation of the pipe insertion program has been 0.019 mg/1 and the recorded high value was 0.042 mg/1.

Figure 3. Zinc Concentrations at WQ-25

Kemess Mines Ltd. has achieved its objective of identifying and implementing a mitigation solution that provided the greatest security of effectiveness and long-term operational success. The Boss 2000 "Big O" HDPE Pipe was identified as that solution after considering of a variety of diverse options and has been inserted into the Eastern Diversion Conduit.
