TROUT LAKE MOLYBDENUM PROPERTY RECLAMATION CASE STUDY

Clem Pelletier

Rescan Environmental Services Ltd.
Sixth Floor – 1111 West Hastings Street
Vancouver, B.C. V6E 2JE

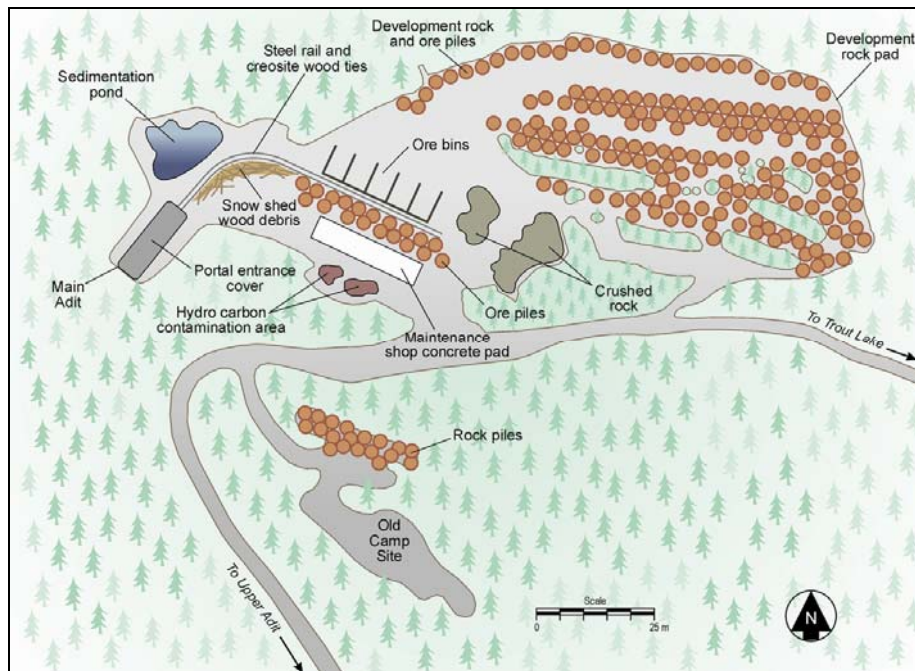
Figure 2. Trout Lake Exploration Site – Main Portal Area prior to Reclamation

A site plan showing pre-reclamation structures and conditions is presented in Figure 2. In addition to the aforementioned metal and wood debris, there was a collapsed steel snow shed and steel cover at the main portal, concrete pads at the maintenance shop and core storage areas as well as concrete pylons which remained from the old camp infrastructure. Rail steel supported by creosote preserved rail ties was located between the main adit and the concrete ore bins and the maintenance area.

The hydrocarbon staining was visible on the overburden adjacent to the former maintenance building area. Core storage racks near the old camp area had collapsed and were a tangled mess. The roof of the core shack at the upper adit had caved in, creating a safety hazard to hikers and wildlife.
