SNIP MINE: SEVEN YEARS AFTER CLOSURE

S.J. Sibbick, P.Geo. AMEC Earth & Environmental
R. MacGillivray, P.Geo, Barrick Gold Inc.

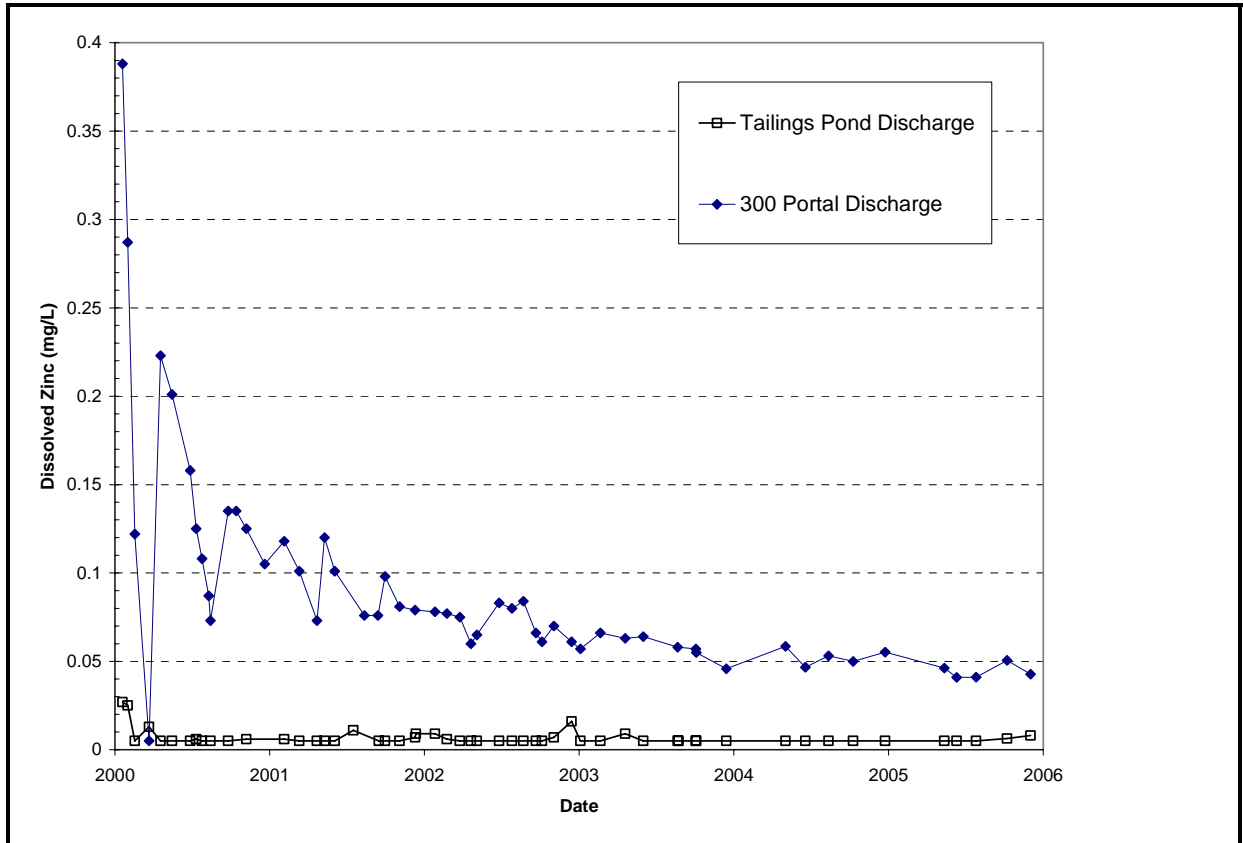
Figure 1 - Dissolved zinc concentrations, 300 Portal and Tailings Pond discharges, 2000 to 2005

Initial discharges from the 300 Portal reported elevated levels of metals, most notably zinc (Figure 1). A peak concentration of 0.388 mg/L was measured in January 2000 from the 300 Portal discharge. Since that time, zinc concentrations have shown a pattern of near-continuous decrease. Concentrations measured in 2005 were approximately 0.05 mg/L or less, representing an almost ten-fold decrease since mine water began to discharge from the mine. Conversely, zinc concentrations measured at the TPD have remained very low, generally at or below the detection limit of 0.005 mg/L.

A notable distinction between zinc and sulphate are the differences in the concentrations found between the 300 Portal and the tailings pond discharge (TPD). As noted, sulphate concentrations at the TPD are as little as one-half the 300 Portal discharge concentration. However, zinc concentrations in the TPD have remained near or below detection limit (0.005 mg/L) since closure. Zinc concentrations of the 300 Portal water have been reduced by at least an order of magnitude during flow through the tailings impoundment. Based on the available flow monitoring data, the estimated monthly flows from the TPD are twice that of the 300 Portal (Table 3), suggesting that dilution can account for approximately a 50% reduction in concentrations at the TPD. Therefore the zinc concentration reduction appears to be the result of both dilution and the attenuation of zinc within the impoundment, possibly by the absorption onto organic materials.

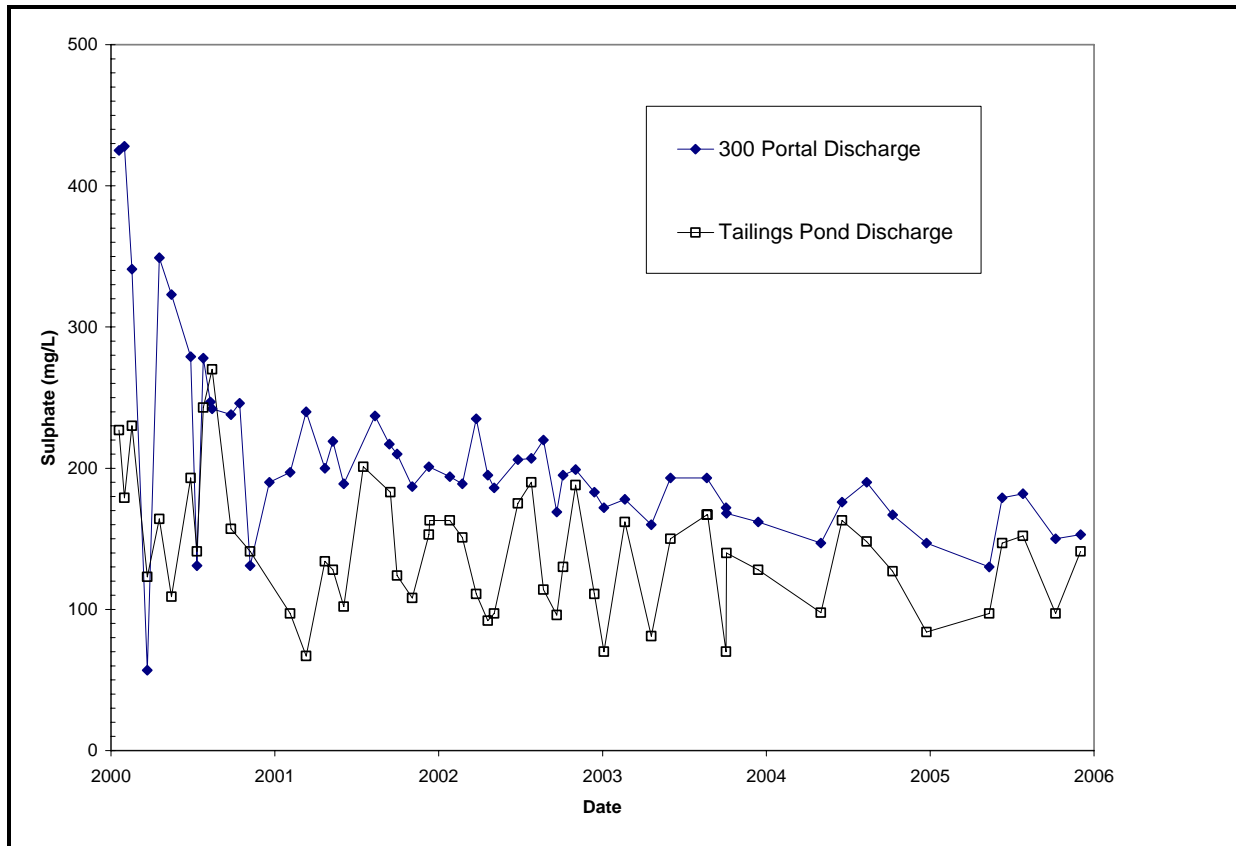
Figure 2 – Sulphate concentrations, 300 Portal and Tailings Pond discharges, 2000 to 2005

Sulphate concentrations in mine drainage are an indicator of sulphide oxidation and/or the dissolution of secondary sulphate minerals produced from the oxidation of sulphides. Sulphate tends to be a conservative parameter; unless saturated, sulphate concentrations will be unaffected by interactions with other metals or compounds. Therefore, sulphate concentrations in mine water discharges can be used to gauge the ongoing oxidation of sulphides and the release of oxidation products that have accumulated within the mine. Initial sulphate concentrations discharging from the mine had elevated concentrations (~425 mg/L) in the 300 Portal drainage (Figure 2). Sulphate concentrations have gradually decreased in the portal flow since mine flooding. Flows from the TPD have reported lower sulphate concentrations than the portal discharge (Figure 2) that show a pattern of variable, but gradually decreasing

concentrations over time. In general, the TPD flows have sulphate concentrations that range from equivalent to approximately one-half of the 300 Portal concentrations.

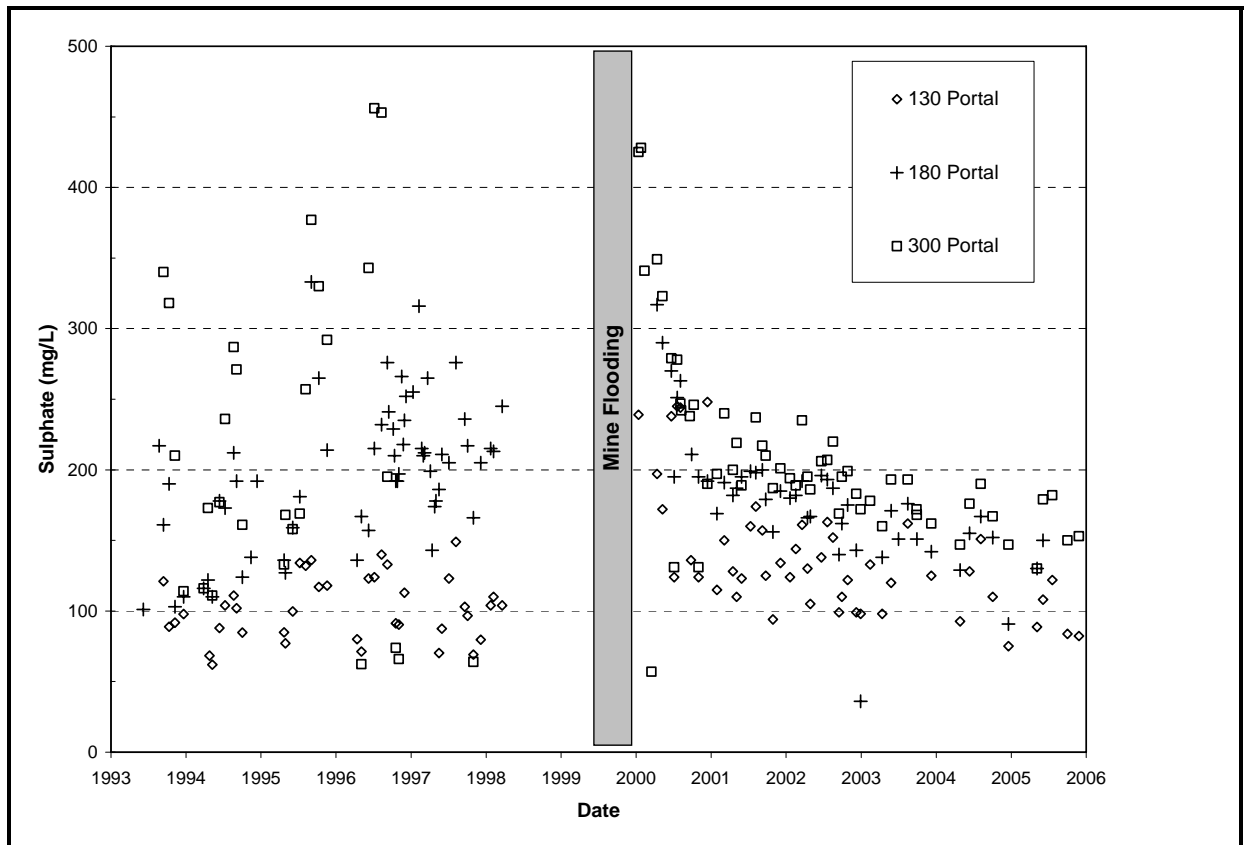
Figure 3 – Mine water sulphate concentrations, Pre and Post flooding

Figure 3 presents concentration data for sulphate collected from mine water discharge at the 130, 180 and 300 portals before and after closure of the mine. Mine water discharge at these portals was regularly collected between 1993 and 1998 and from 2000 to 2005. Mine water quality during operations showed an overall wide range of concentrations but similar concentration ranges for each of the three portals. The mine water represented a combination of groundwater, surface infiltration from areas such as the Crown Pillar, and mine process water. Process water primarily constituted water used in the placement of hydraulic backfill in stopes; other lesser sources included water used in the operation of machinery such as drills.

The 130 Portal discharges generally had the lowest concentrations, followed by the 180 Portal and finally the 300 Portal with the highest overall concentrations. This likely reflects the use of the 180 and 300 portals for active discharge of mine water to the tailings pond. Lower concentrations in the 130 Portal discharges may also represent dilution by groundwater seepage along the longer flowpath from the mine workings to the portal entrance.

During the operation of the mine prior to flooding, mine water from all three portals showed a similar overall pattern of increasing concentration with time. Concentrations of the discharges were commonly in the range of 50 to 300 mg/L sulphate, with some values in the 300 to 450 mg/L range. These concentration increases over time likely reflect both the increasing volume of backfill placed in the mine during operations, and oxidation of sulphides within the backfill and possibly on mine surfaces.

Following flooding of the mine to the 300 Portal level, discharge concentrations showed initial maximum concentrations (up to 425 mg/L) which decreased rapidly over a few months. By early 2003, sulphate concentrations in the mine water discharges were below 200 mg/L. Like the water quality data during mine operations, sulphate levels in the 130 Portal discharges had lower concentrations than the 180 and 300 Portal flows. Discharges from the 180 and 130 portals have been relatively insignificant since closure; these flows consist of minor seepage flows that emanate from bedrock downgradient of the plugs. Inspections during 2005 observed no flows from these two locations. It is not clear what the source of the post-closure flows from the 130 and 180 portals; however, the similarity in the concentrations and patterns of decrease suggest that these waters are at least partially derived from mine water.

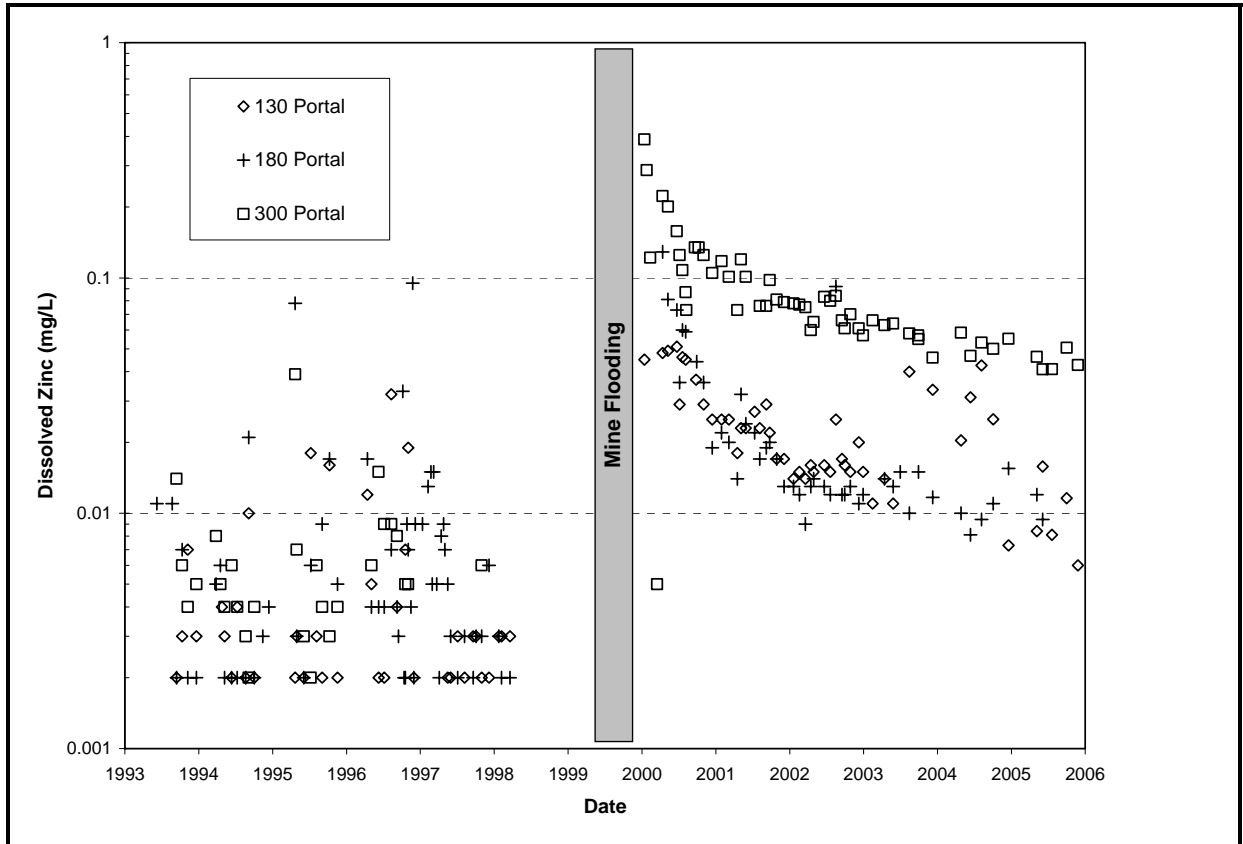
Figure 4 – Mine water zinc concentrations, Pre and Post flooding

Dissolved zinc concentrations for pre- and post-closure water quality are shown in Figure 4. Concentrations during mine operations generally ranged from at or below detection limit (0.005 mg/L) to

0.01 mg/L, with infrequent concentrations between 0.01 and 0.1 mg/L. No relationship appears to exist between dissolved zinc concentrations and discharge location in the mine.

Following flooding, zinc discharge concentrations from all three portals increased significantly over their pre-closure concentrations; values greater than 0.1 mg/L were measured in flows from the 300 and 180 portals. Concentrations in the 130 portal discharges reached 0.05 mg/L. Since mine flooding, dissolved zinc levels in flows from the 300 Portal have decreased steadily to concentrations below 0.05 mg/L. Concentrations from the 130 and 180 portals have also decreased steadily, reaching concentrations of approximately 0.01 mg/L. Dissolved zinc concentrations in the 300 Portal flows have been significantly higher than those measured for the 130 and 180 portals. The patterns of decrease followed a very similar pattern to that observed for the 300 Portal concentrations. As well, these patterns of decrease are also very similar to that observed for sulphate (Figure 3). However, like sulphate, the dissolved zinc concentrations decreased rapidly from their peak concentrations immediately following onset of discharge from the 300 Portal. The pattern of mine water concentrations suggest that steady-state concentrations may be reached in the near future.

The observed increases in the sulphate and dissolved zinc concentrations in mine water immediately following closure of the mine indicate that a mass of soluble metals were released into the mine water during flooding. These metals accumulated on the mine surfaces during the operational phase of the mine due to the oxidation of sulphides on surfaces such as mine walls and backfill. During the mine operation these soluble metals remained in place as there was no mechanism to remove them in significant quantities from the mine surfaces. However, as the mine flooded these accumulated oxidation products were released into the mine water.

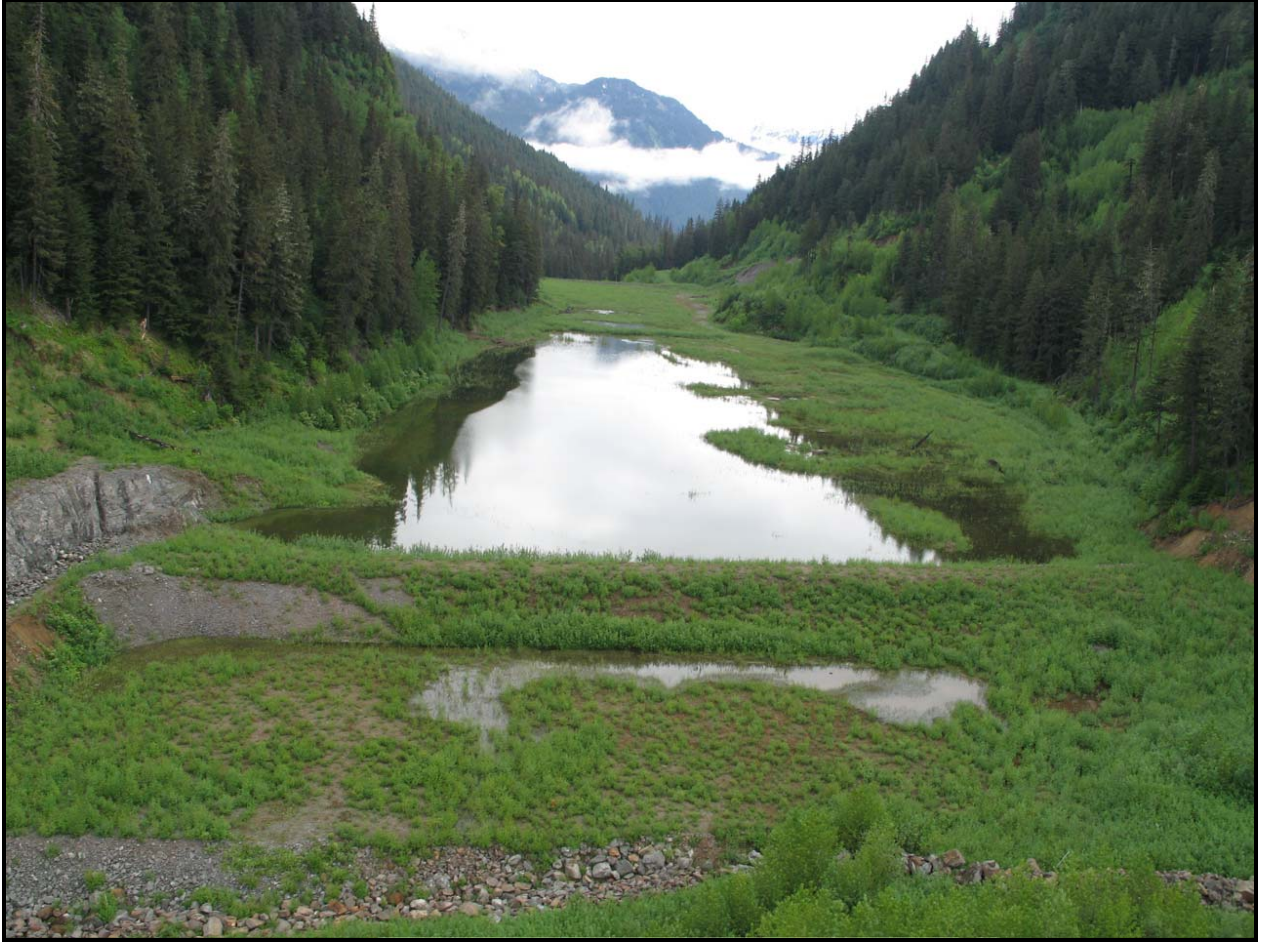
Tailings were identified as potentially acid generating, requiring an oxygen-limiting cover to ensure that ARD/ML conditions could not occur. Construction of a suitable dry cover was ruled out as it would have required a volume of material greater than the volume of the entire mine. The final design resulted in the construction of a saturated cover that would maintain water-saturated conditions within the tailings. To achieve this, the tailings were regraded to promote drainage towards Sky Creek, and then capped with a layer of non-acid generating waste rock from the 150 dump and 180 dump. A spillway was built at the south end of the impoundment to allow discharge into Sky Creek. The spillway elevation was constructed to maintain the water level within the waste rock layer capping the tailings. A coarse rock blanket was placed in the spillway to prevent potential damming as a result of beaver dam construction. Subsequent settlement of the tailings has resulted in the formation of shallow ponding behind the embankment which ensures saturation during drier periods. Consolidation of the tailings and the migration of vegetation onto the cap have resulted in the development of a naturally formed wetland as shown in Photo 1.

Photo 1 - Snip tailings pond, looking north, May 2005
