# **SAFETY AND SUSTAINABLE HABITAT CONSIDERATIONS FOR THE LAKEVIEW DIVIDEND MINE CLOSURE - BATS IN THE ADIT**

Bill Steller, B.Sc.  
Lara Reggin, P.Geo  
Tara Schmidt, MCIP  
Scott Sylte, P. Eng.

## **ABSTRACT**

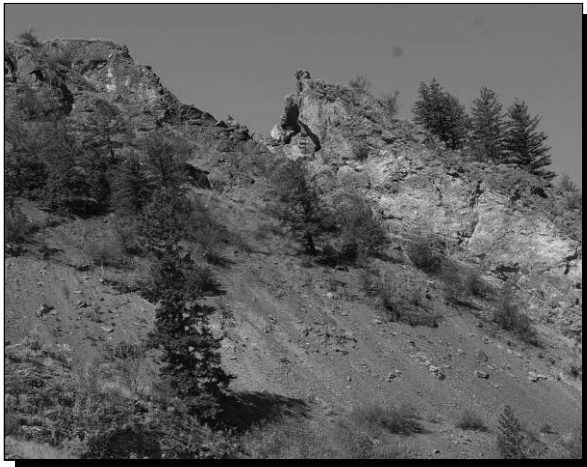
The site contained extensive underground workings, including a 120 m long by 50 m wide "glory hole" where the stope had partially collapsed to surface. On the north side of the stope, a precarious 20 m+ wide overhanging portion of the hanging wall remained, supported by slender, 10 m tall pillars of weak ore. The higher south side of the open stope was near vertical, but also had large overhangs associated with mined out areas of the ore body. Numerous open passageways leading to the underground development workings existed around the perimeter and floor of the glory hole. Three main access adits exposed in the hillside below the mine provided ready access into the glory hole.

There were several public safety issues at this site. The glory hole was encircled by a fence to prevent access, however access routes through adits and development drifts were not secured. Within the glory hole, there were extensive areas of overhanging, potentially unstable rock as well as partially blocked ore passes to haulage drifts below. The underground workings contained caved areas, ore passes and

Photo 1: Before Remediation

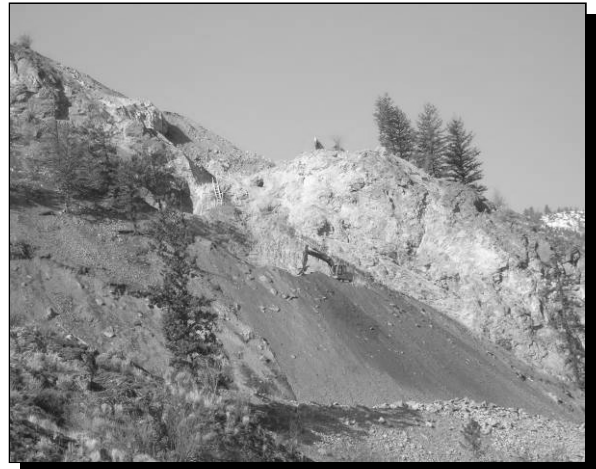
Photo 2: After Remediation

The glory hole was filled from the west end progressing towards the east end. The volume of fill consisted of approximately 30,000 cubic meters of imported rock fill and approximately 12,000 cubic meters of broken rock from the edges of the glory hole.

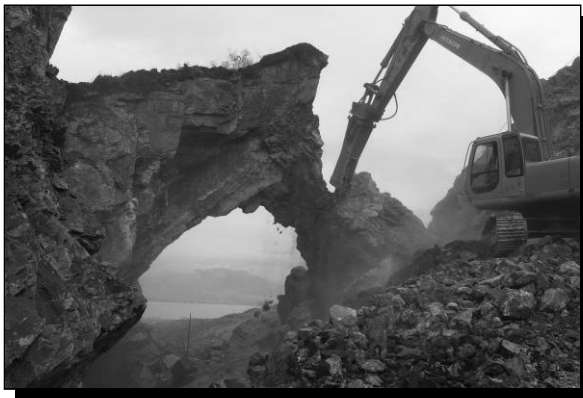
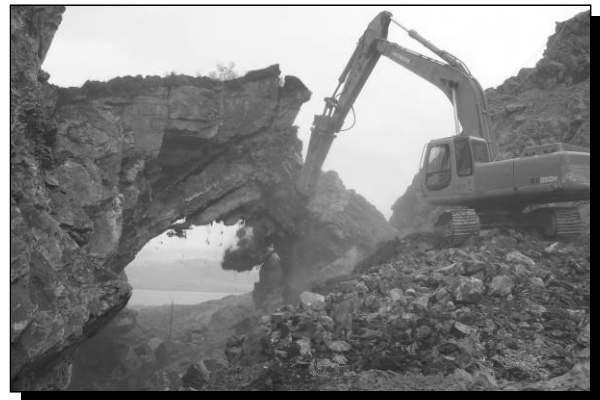
Stabilization of a large cracked rock pinnacle at the northeast corner of the glory hole where it intersected a high rock cliff above the adjacent subdivision, as well as stabilizing adjacent areas of the cliff, was addressed using several methods. At the base of the cliff there was an existing rock fall catchment to protect the subdivision; this was formed by an excavated 2-m wide ditch with adjacent 2-m high berm. Prior to rock stabilization work, the catchment was deepened, and widened to more than 8 m to greatly increase its effectiveness and capacity. Towards the north end, below the highest section of the cliff face, an existing gravel stockpile (for construction of a new subdivision road) also provided added protection against rock fall. Once most of the glory hole was filled, rock breakers safely removed the cracked pinnacle of rock.

Photos 3 & 4: Rock Breakers working in glory hole.

The success of the rock breakers in removing the cracked pinnacle led to the adoption of similar methodology for scaling and stabilizing adjacent areas of the cliff face above the subdivision north and south of the glory hole. The breakers were also used to establish a construction access ramp down to one of the adit portals exposed in the hillside approximately 20 m below the glory hole. Alternative options for access to this adit were either costly (requiring the use of helicopters or large cranes) or had environmental and aesthetic concerns (slash a 300 m access road across a steep slope in an area visible to the town). During removal of the rock pinnacle and stabilization of the adjacent areas, approximately 7,000 cubic meters of rock was removed, and the catchment ditch had to be cleaned out regularly to maintain its effectiveness.

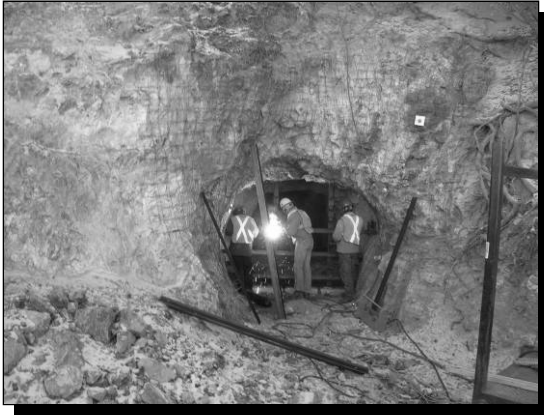
Photo 5: Adit #1, Bat Gate Installation.

The bat gate for this adit was partially prefabricated in WEB Manufacturing's (WEB) facility in Osoyoos. The vertical posts and horizontal bars were field cut to fit the portal. The gate was secured to the concrete sill and rock using 25-mm diameter threaded dowels grouted into the rock. The dowels were located on the inside of the gate, and nuts were threaded onto the dowels and welded to secure the gate in place and to prevent removal.

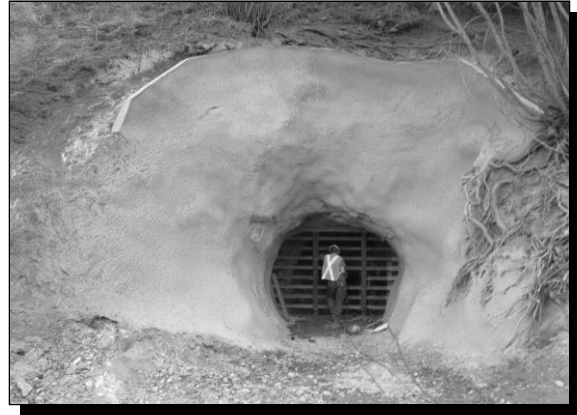
Photo 6: Adit #1 Shotcrete.

Initially sloughed rock and soil debris partially blocked the portal, and excavation to expose the adit invert was completed using a small back hoe. The approximate portal dimensions are 3 m wide (reducing to 2 m wide about 1 m into the adit) and 2 m high. After exposing the rock invert, a low concrete sill secured with dowels grouted into the rock was poured to form a level base for installation at the bat gate. A perimeter of rock dowels was installed to secure the gate to the rock. After intensive machine and hand scaling of the portal area, rock bolts and dowels were installed, followed by a heavy 100-mm square welded wire mesh. Shotcrete was pumped 200 m from adit 2 eliminating the need to further upgrade the existing road to handle concrete trucks. Eight cubic meters of shotcrete was applied in thicknesses varying from 50 to 75 mm.

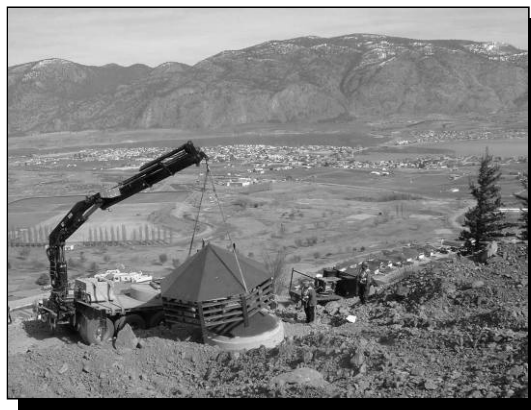
Photo 7: Installation of ventilation cap.

A vent cap was designed to allow bats to escape and minimize tampering from the public. The design utilized the basic bat gate forms with features to obstruct attempts to throw rocks in the vent or set fires on top of it.
