## **CLOSURE OF THE LUMBY QUINTO MINE SITE**

S.E. Ames, Ph.D., M.Sc., P.Ag.

Rescan Environmental Services Ltd.  
Sixth Floor, 1111 West Hastings Street  
Vancouver, B.C. V6E 2J3

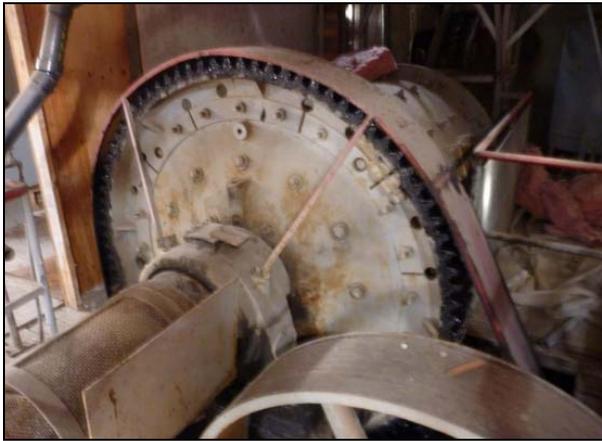
*Plate 1. Mill equipment removed by the salvage company.*

A local mining equipment salvage company removed all of the mining equipment from the site, which included a ball mill, flotation cells, jaw crusher, cyclone, cone crusher, a screen feed conveyor, and

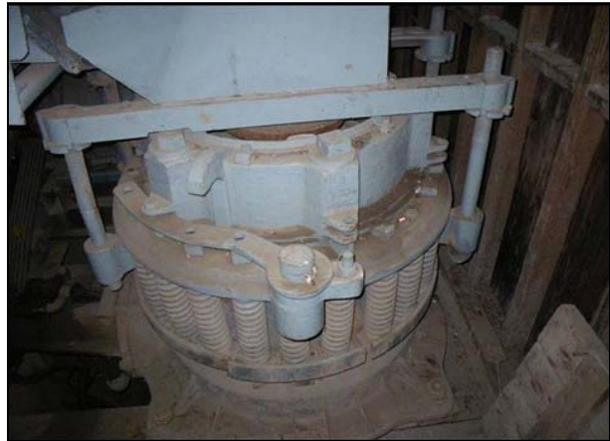
*Plate 2. Cone crusher in the mill building.*

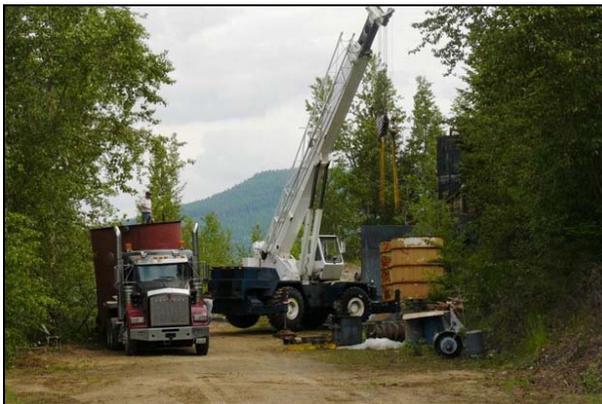
*Plate 3. Loading the salvaged equipment for removal from the site.*

various tanks (Plates 1 and 2). The grizzly and its housing were dismantled. Cranes were used to load the equipment on flat beds and the equipment was removed from site (Plate 3).

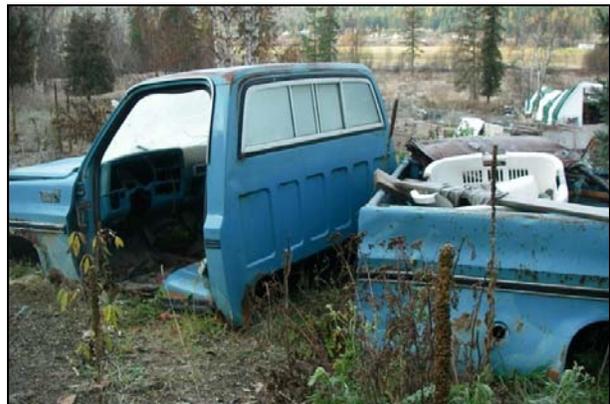
*Plate 4. One of the old vehicles that was removed from the site.*

A local demolition company removed all refuse, vehicles, the four ATCO trailers, a vandalized camper, the core and core shack, and any other debris found on site including refuse left in the mine building (Plates 4 to 10). All of the trailers had been vandalized and one of the trailers had been demolished. Cranes were used to load the trailers onto flat beds and these were removed from site. Much of the refuse was household waste including discarded computer equipment, fencing, insulation, tires, and furniture. Most of it had been dumped over slopes and had to be removed by hand. The material was recycled, as much as possible, and non-recyclables were taken to a designated landfill off-site. Several old cars and trucks had been dumped in various locations, some near the top of Saddle Mountain. These were removed using a crane and a flat bed.

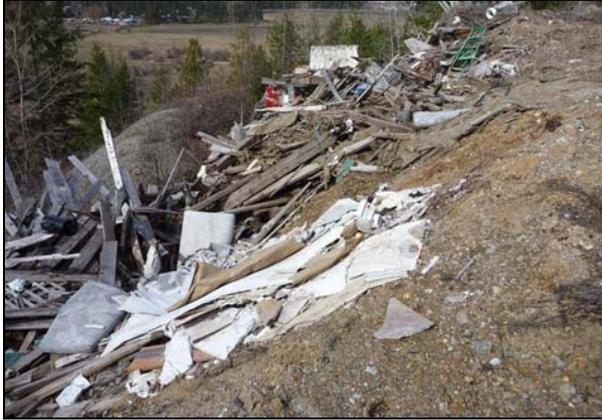
*Plate 5. Piles of debris (before).*

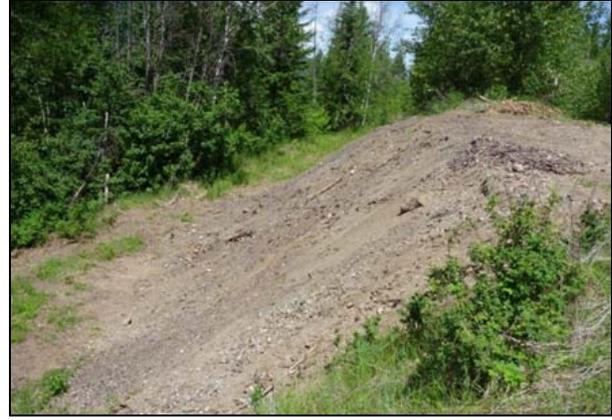
*Plate 6. Cleaned up former debris site.*

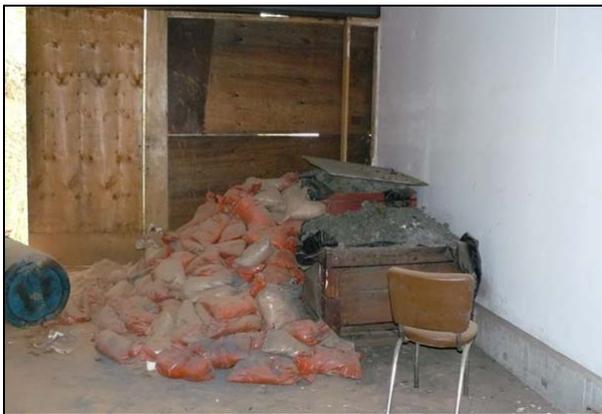
*Plate 7. Graphite samples and other refuse in the mine building.*

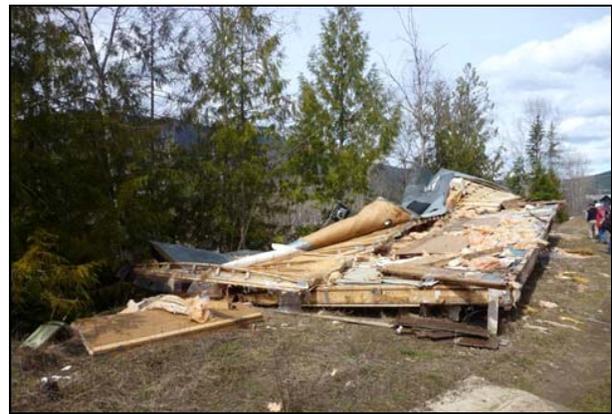
*Plate 8. Demolished ATCO trailer that was removed.*

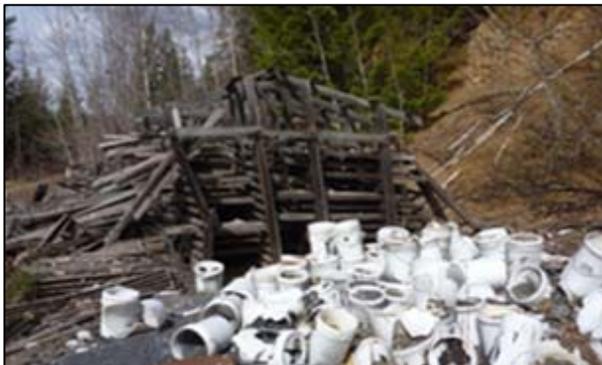
*Plate 9. Core shack and pails (before).*

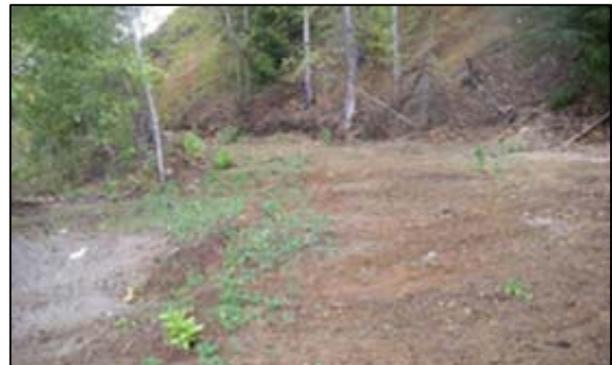
*Plate 10. Core shack after reclamation and cleanup.*

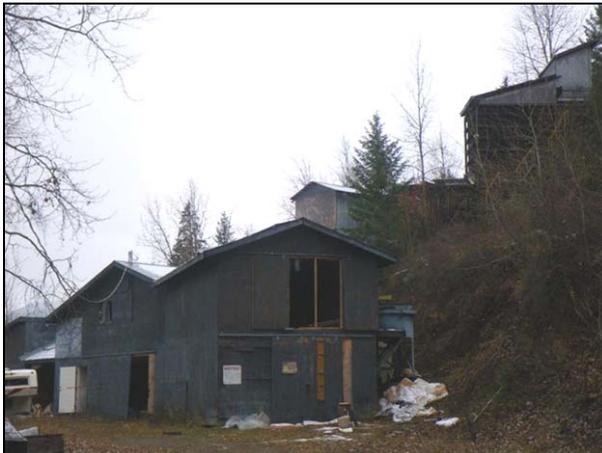
*Plate 11. Mine site buildings.*

Once the buildings were emptied of equipment and refuse, they were demolished (Plates 11 and 13). The metal roofs were separated and the metal was recycled. Beams, trusses, and wood in good condition were separated and recycled. The foundations were broken up and transported by truck to the tailings pond to be used as backfill. A concrete pad near the core shack was also broken up and included with the rest of the broken concrete. The former building area was then re-sloped and contoured. The cut-slope adjacent to the buildings was pulled back and re-sloped. The disturbed areas were seeded (Plates 15 and 16).

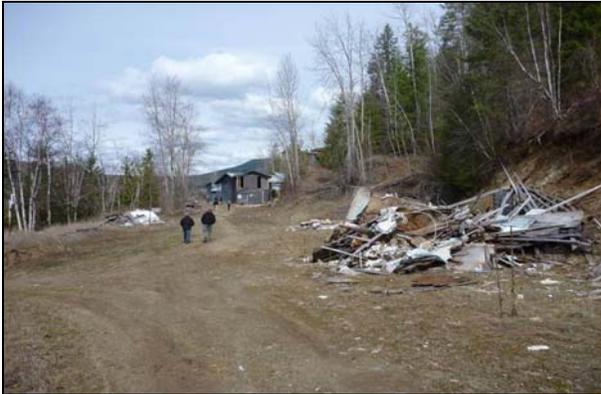
*Plate 15. Mine site before demolition and cleanup.*

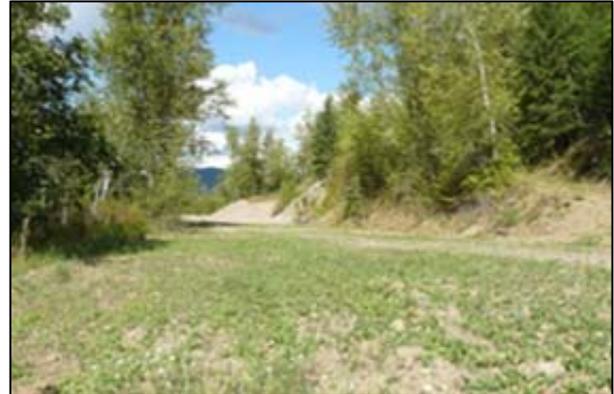
*Plate 16. Reclaimed mine site.*

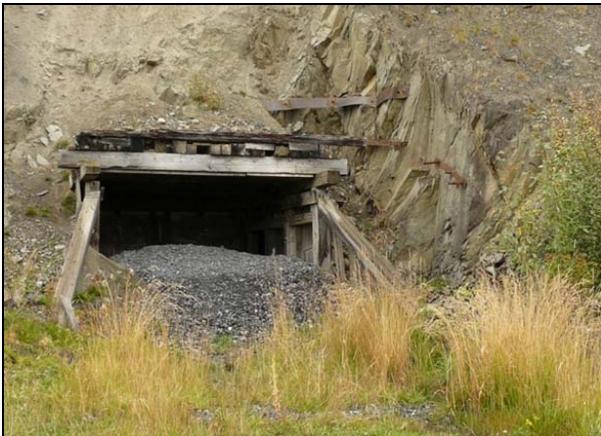
No bats were found to permanently inhabit the adits but bats did use them periodically so the plan was to close the adits but allow for access for them. The upper adit was approximately 3 m by 3 m in size with a timber portal at the adit entrance. The adit has been sealed with a steel plate and a pile of waste rock had been placed in front, to cover the lower two thirds of the entrance. A small opening had left room for human access. The concern was that the timbers would decay with time and result in an unstable area. Therefore, the plan was to remove the timbers and steel door and to backfill it with ore to prevent any future access, except by bats. Two of the adits had been previously backfilled to an acceptable standard. The middle adit was located in the side of the mountain so access was difficult. It had been roughly sealed with boards which had been partially removed allowing access by humans. The plan was to backfill it with ore.

*Plate 17. Upper adit.*

The upper and middle adits were closed (Plate 17). The steel doors were removed from the upper adit and taken off-site for recycling. The timbers were then removed and were also taken off-site for recycling. The adit was backfilled with waste rock (Plate 18). A culvert was partially inserted into the backfilled adit to allow for bat use (Plate 19). The slope below the adit was regraded to reduce the steepness. The area was then seeded. The middle adit had been previously boarded up (Plate 20). Access to the middle adit was steep so a ramp was constructed to allow for large equipment access. For closure, the planks were removed from the entrance. A culvert was inserted to accommodate bats and the adit was backfilled (Plate 21). The slope was regraded and the area was revegetated (Plates 22 and 23).

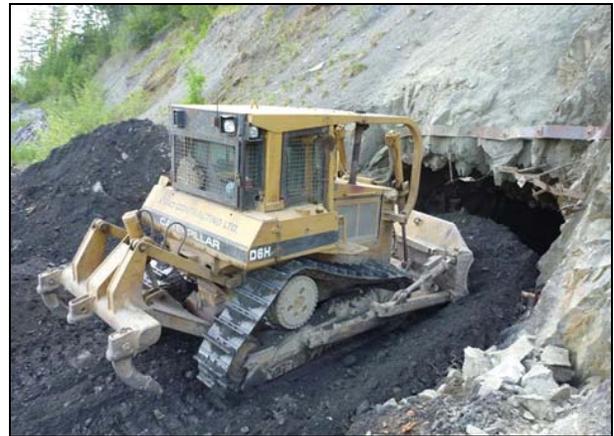
*Plate 18. Backfilling of upper adit.*

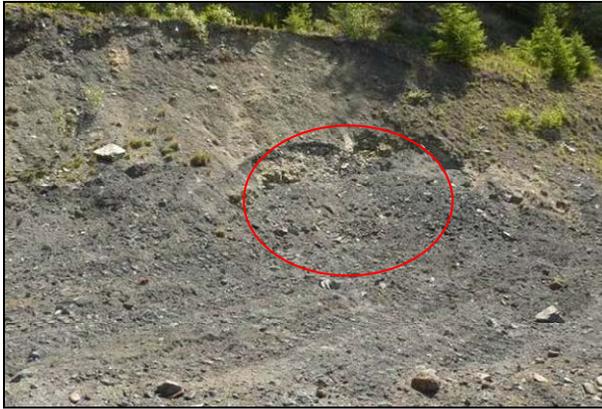
*Plate 19. Upper adit after closure.*

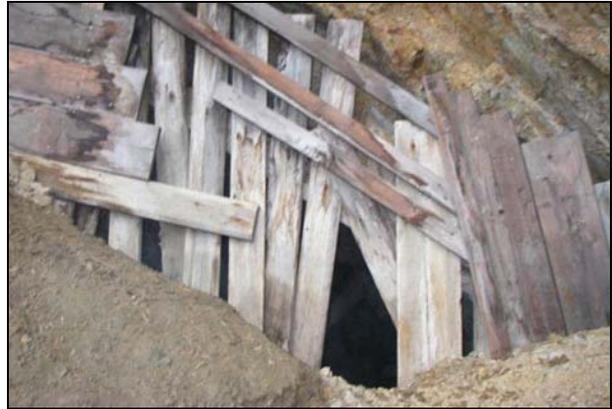
*Plate 20. Middle adit.*

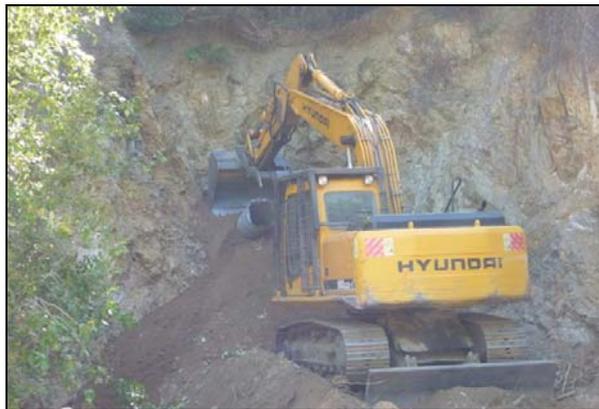
*Plate 21. Backfilling of middle adit.*

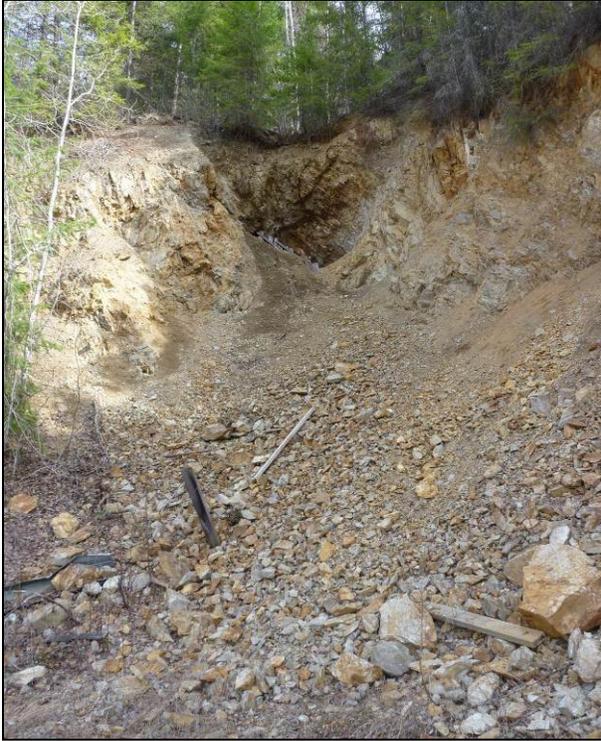
*Plate 22. Steep access to middle adit (before).*

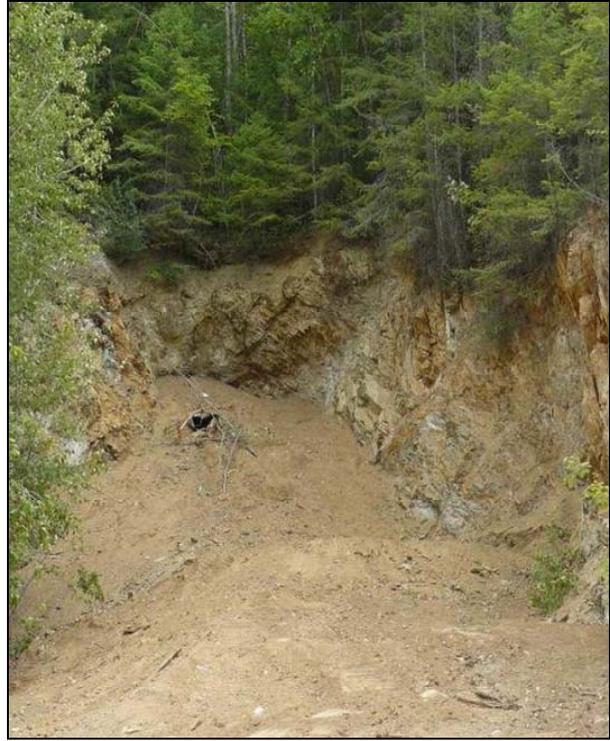
*Plate 23. Regraded and backfilled middle adit.*

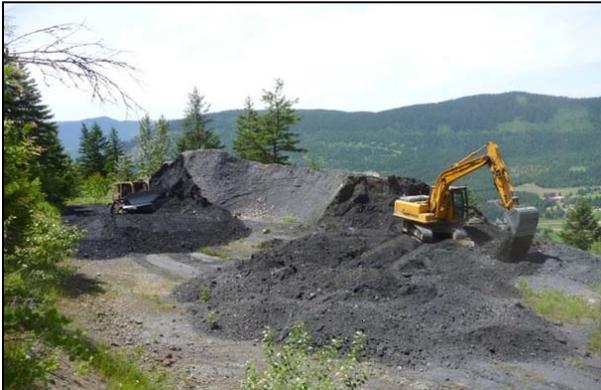
*Plate 24. Spreading waste rock piles.*

The waste rock had occurred in piles. The waste rock that was not used as backfill was flattened and spread out (Plate 24). Twenty loads of topsoil were brought in and spread over the waste rock (Plate 25). The areas were then revegetated (Plate 26). Ore piles were located in the vicinity of the grizzly. Originally the plan was to backfill the adits with the ore. However, a private individual who expressed interest in the ore contacted Rescan just before closure was to be carried out. An agreement was made with Quinto Mining and eighty-seven loads of ore were removed from the site. The ore had occurred in piles and had been spread on the existing road. Care was taken to remove all of the ore from the piles and the road base. The area was then regraded and seeded except for the road which will remain open according to the wishes of the property owner.

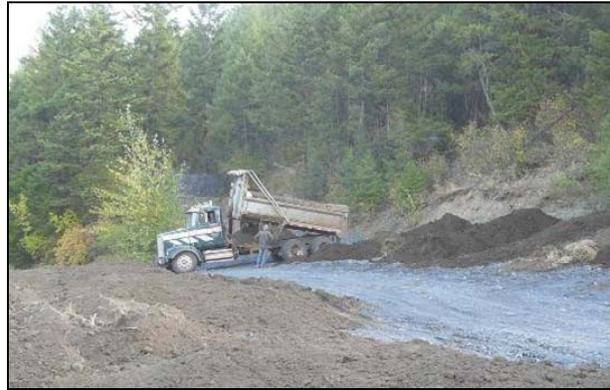
*Plate 25. Spreading topsoil over waste rock.*

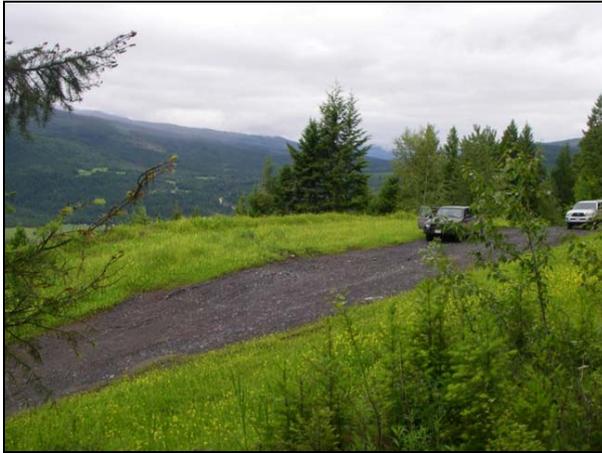
*Plate 26. Revegetated topsoil area (over waste rock).*

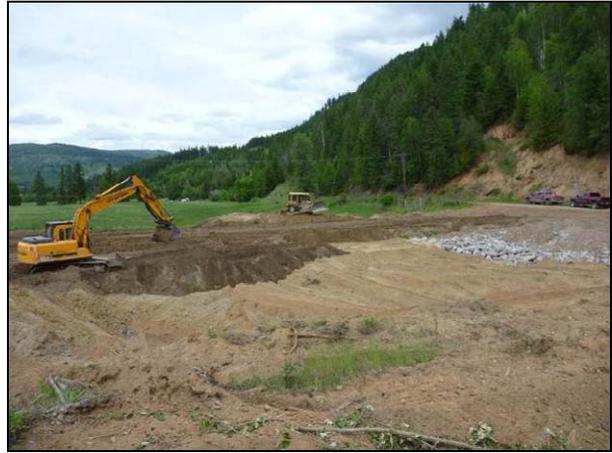
*Plate 27. Backfilling tailings pond.*

The two tailings ponds and the water storage pond were closed according to the closure plan. The northern tailings pond had an HDPE liner that had been previously removed and set aside. The liner was disposed of off-site. The upper part of the berm of the northern tailings pond consisted of tailings. These tailings were pushed back into the pond. The broken concrete from the building foundations was then placed in the pond bottom. The rest of the berm was used to backfill the pond (Plate 27). The area was regraded to match the adjacent landform. The area was then seeded. The berms around the middle pond and the water storage pond were also used to backfill the ponds (Plate 28). These were re-graded to match the surrounding landform and were vegetated (Plate 29).

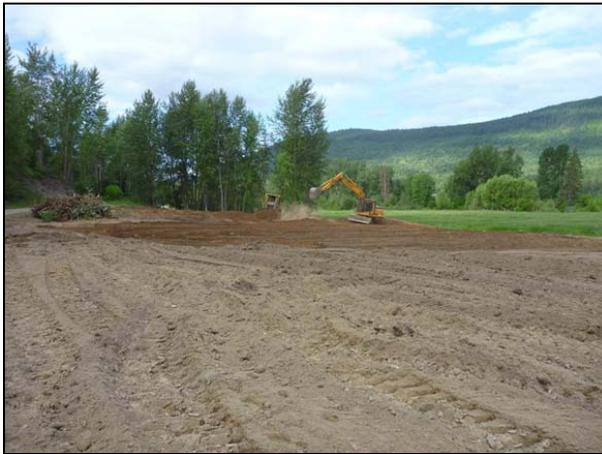
*Plate 28. Backfilling tailings pond.*

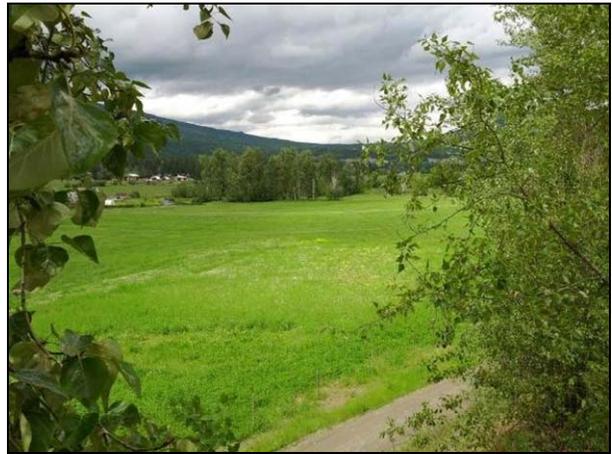
*Plate 29. Revegetated tailings pond.*
