THE FLOODED TAILINGS IMPOUNDMENT AT THE EQUITY SILVER MINE

W.A. Price¹ and M. Aziz²

ABSTRACT

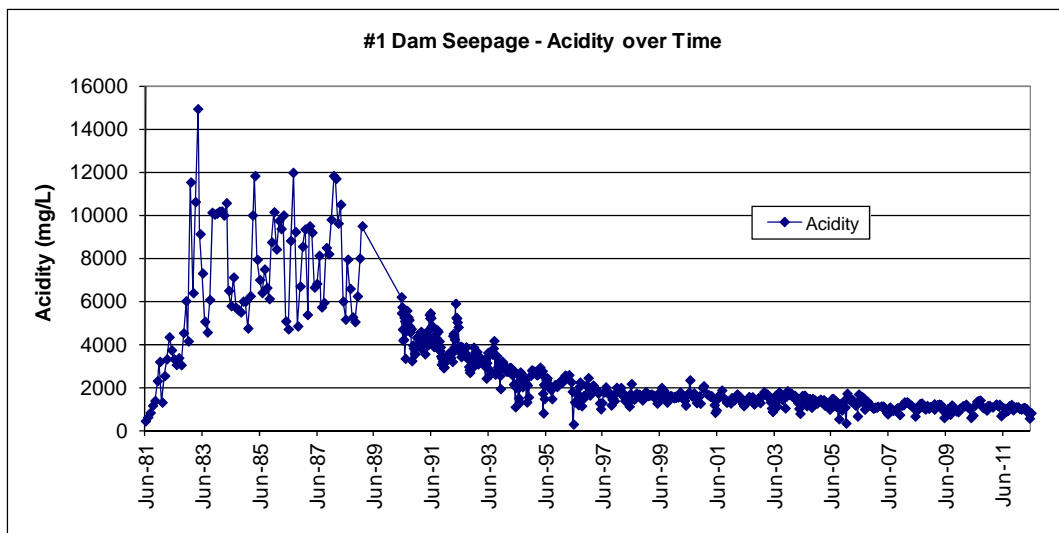
Figure 2. Concentration of acidity in drainage from #1 Dam

Seepage through the #1 Dam contacts acidic waste rock in the toe of the dam, becomes acidic, and is collected in a seepage pond named #1 Dam Seepage (Figure 2). During mining, ARD from #1 Dam Seepage was pumped into the tailings impoundment to increase cyanide degradation and lower the pH of the water sufficiently for re-use in the mill. Since mine closure, drainage from #1 Dam Seepage has been pumped to a holding pond and treated using lime along with drainage from the waste rock dumps and plantsite. Other smaller seepages from the tailings impoundment occur through the Diversion Dam into the Diversion Pond and through #2 Dam into the ARD collection system. These smaller seepages are much lower in volume and are not acidic since the rockfill for those dams was NPAG.

Acidity from the #1 Dam Seepage Pond increased rapidly from 1981 to 1982 and exceeded 10,000 mg CaCO₃eq /L from 1983 to 1989. Since 1989, acidity has steadily decreased and is now less than 1500 mg CaCO₃eq /L. It is theorized that the decrease in acidity is due to the depletion of finer, more reactive sulphides and a higher ratio of drainage to exposed rock than large waste rock dumps. The average volume of seepage from the #1 Dam is 68,076 m³/yr, approximately 20% of the volume, but only 4% of the acidity load that the site needs to treat. Improvements to the collection of acid water below the #1 Dam have included diversion ditches to reduce the volume of uncontaminated drainage that is collected and purchase of a diesel generator to provide power for the pumps in the event of a power failure.

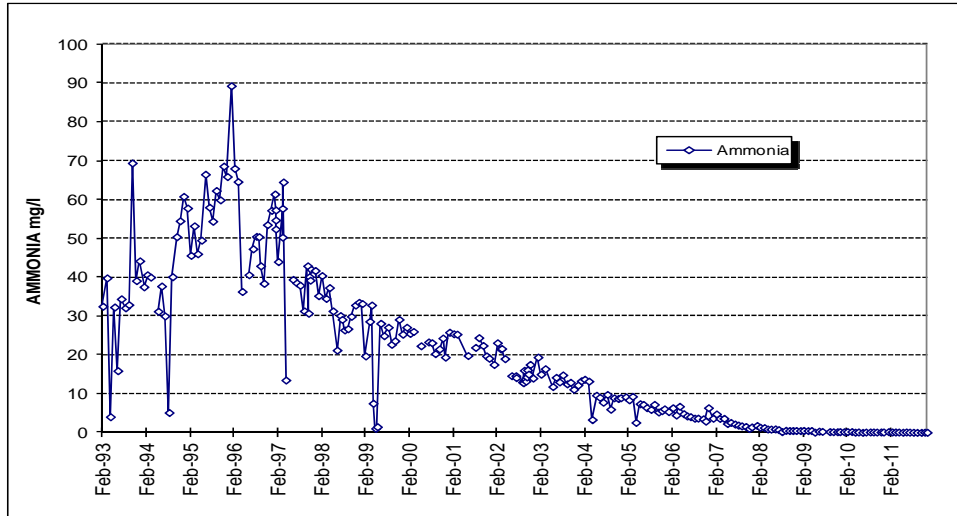
Figure 3. Concentration of ammonium in tailings pond (Aziz and Meints, 2012)

After the mill closed, CN continued to be reduced by natural degradation. By 2003, natural degradation had decreased CN levels from 4.5 mg/L to 0.007 mg/L and thiocyanate was below detection (0.5 mg/L). Total cyanide levels in 2009 were below the detection limit (< 0.005 mg/L). CN decomposition produced ammonium (NH₄⁺) levels which reached values as high as 90 mg/L

in 1996 (Figure 3). Phosphorous fertilization was considered as a means to accelerate NH_4^+ decomposition but rejected due to concerns about remobilization of treatment sludge and other secondary wastes. Since 1997, NH_4^+ has steadily decreased and since 2009 has averaged less than 0.3 mg/L.

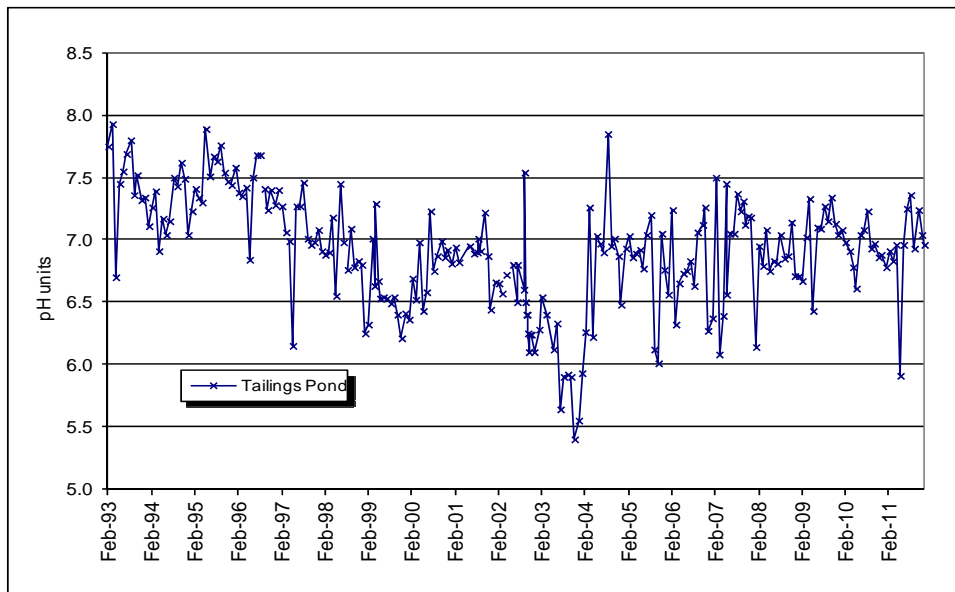
Figure 4. pH of tailings pond (Aziz and Meints, 2012)

Sampling of the water cover is done around the sides of the impoundment or from the discharge during decant/pumping periods. Anomalously low Cu and pH values (Figures 4 and 5) often occur in the spring (e.g., in 1997, 1999 and 2000) when the ice is melting and the water cover is stratified with cold melt water on surface. Low Cu and pH values at these times reflect the chemistry of on land runoff and snow melt rather than changes to the chemistry of water cover.

At the time the mine closed (1994), the pH of the water cover was 7 to 8 (Figure 4) and there was a large, more than two orders of magnitude decrease in dissolved Cu (Figure 5). In 1997, dissolved Cu was less than 0.01 mg/L.

In 1997, the pH of the impoundment started to decrease (Figure 4) and dissolved Cu and Zn started to rise (Figure 5). By 2000, the pH had decreased to less than 6.5 and Cu(d) and Zn(d) had increased to 0.2 mg/L. The decline in pH was attributed to depletion of lime added with process water and treatment sludge when the mine was operating and acidity inputs from 866,000 m³/yr of pH 5.5 incident precipitation.

Starting in 2002, the pond pH again decreased reaching a low of pH 5.4 and Cu concentrations increased. Based on advice from a helpful regulator that some consider a lucky guess confirmed by rigorous limnological results, it was concluded that the primary cause of the decline in pH was acid produced by nitrification of ammonium produced from the degradation of CN rather than the original hypothesis that the main acid source was incident precipitation (Equation 1).

Approximately 51 and 23 tonnes of lime slurry were added to the impoundment from tanker trucks during the second and third quarters in 2000 and 2001 to raise the pH (Table 1). The pH was monitored and lime was added incrementally in small doses to ensure the pH did not get too high and dissolve other contaminants. The amount of lime added was calculated to neutralize acidity added from 5 years of rain and snow. The addition of lime caused the pH to increase from an average of 6.2 in 1999 to above 6.8 in 2001 . Copper values decreased from a high of 0.2 mg/L to a less than 0.06 mg/L.

A modeling exercise was used to predict how much lime was required to neutralize acid from oxidation of NH_4^+ (Lorax, 2003) Again using a cautious, incremental additions approach to ensure the pH was not raised too high, 88 and 35 tonnes of slaked lime slurry were added to the tailings pond in 2003 and 2004. The addition of lime caused the pH to increase from an average of 6.0 in 2003 to an average 6.8 in 2004 . Copper values in 2004 decreased from a high of 0.092 mg/L in January to lows of 0.005 mg/L in September and October.

In 2005/2006, the pH again decreased to below 6.5 and Cu increased to above 0.1 mg/L. To counteract this, 7.92 tonnes of lime slurry was added in 2006 and 32.0 tonnes of lime slurry was added during the summer of 2007. Since the last lime addition in 2007, the pH has remained above 6.5, with an average pH between of 6.83 and 7.02 for the years 2007 to 2011. Average dissolved Cu decreased from 0.038 mg/L in 2008 to 0.025 mg/L in 2009 and was below 0.010 mg/L for 2010 and 2011. Average dissolved zinc decreased to 0.128 mg/L in 2008, 0.109 mg/L in 2009 and was less than 0.08 mg/L for 2010 and 2011.

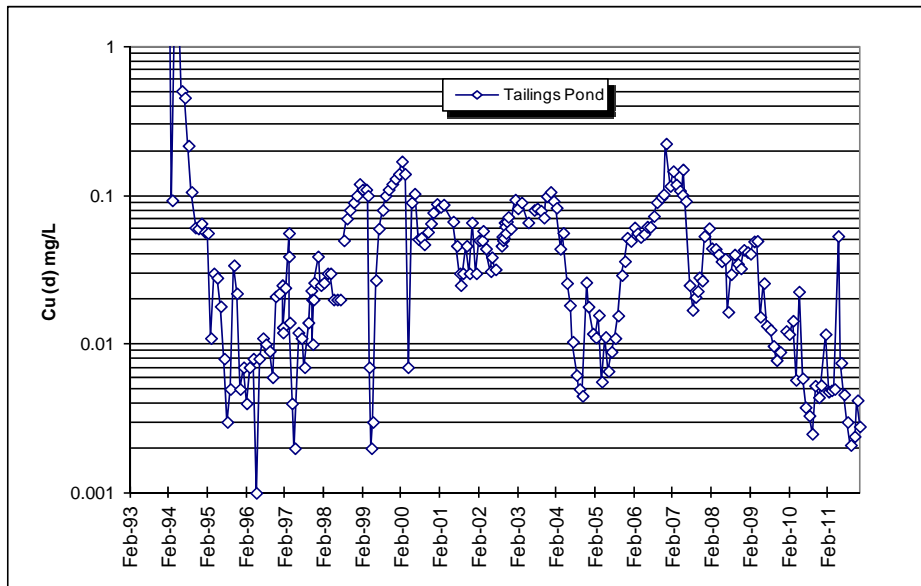
Figure 5. Concentration of copper in tailings pond (Aziz and Meints, 2012)

Three peepers were inserted in tailings to locate the source of increasing Cu. The peeper in the southern corner, the location of sludge inputs, fell over ("became dislodged and was not processed for fear of compromised sample integrity"). Based on results from the peeper near to the #1 Dam, it was postulated that the source of Cu and Zn was remobilization of pH sensitive hydroxides (Cu(OH)₂ and Zn(OH)₂) created (precipitated) when ARD from #1 Dam was pumped into and neutralized in the impoundment (Lorax, 1999). Other potential Cu sources were lime treatment sludge and 738 kg/d of CuSO₄ added in the process water.

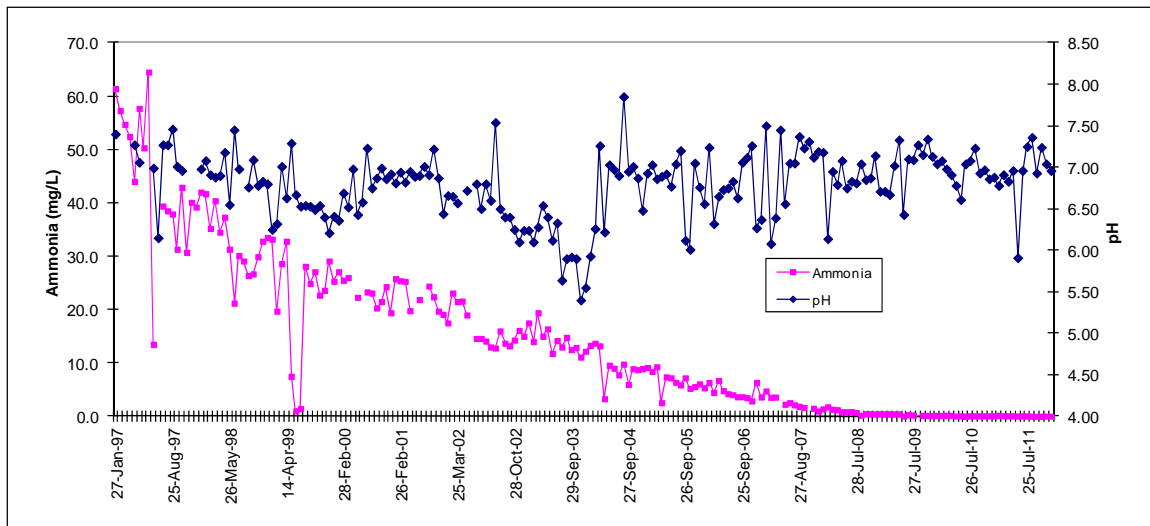
Figure 6. Changes in ammonia and pH over time

The stable pH since 2007 is correlated with the depletion of NH_4^+ and supports the hypothesis that the main source of acid was ammonium oxidation rather than incident precipitation (Figure 6). The low ammonium concentration indicates relatively little acidity will be generated in the future by the nitrification of ammonium. Future lime slurry additions are only planned if the pH needs to be raised to suppress Cu solubility. The steady decline in dissolved Cu since 2007 (Figure 5) suggests that the soluble Cu precipitates near the surface of the flooded tailings have been depleted.

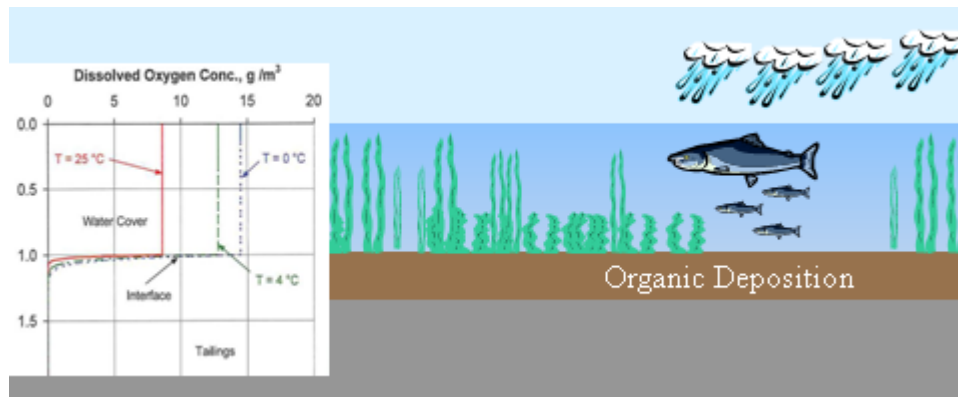
Figure 7. Schematic depiction of the impact of increasing biological activity in the tailings impoundment

Presently the shallow tailings pond contains relatively little aquatic vegetation. Eventually there is likely to be more extensive plant invasion increasing the organic content of the upper layer over the mine wastes (Figure 7). A question regarding the long-term performance of the impoundment is whether accumulation of organics and more reducing conditions in the flooded mine wastes will release trace elements such as arsenic and antimony co-precipitated within lime treatment sludge. Released elements may re-precipitate in situ as sulphides or be released into the water
