# **REGULATORY CONSIDERATIONS FOR HISTORIC MINE REMEDIATION IN BC: ATLIN RUFFNER MILL AND TAILINGS CASE STUDY**

Joanna Runnells, M.Env.Sc., P.Geo., EP  
Gregg Stewart, P.Geo.

Crown Contaminated Sites Program, BC Ministry of Forests, Lands and Natural Resource Operations,  
Victoria, BC

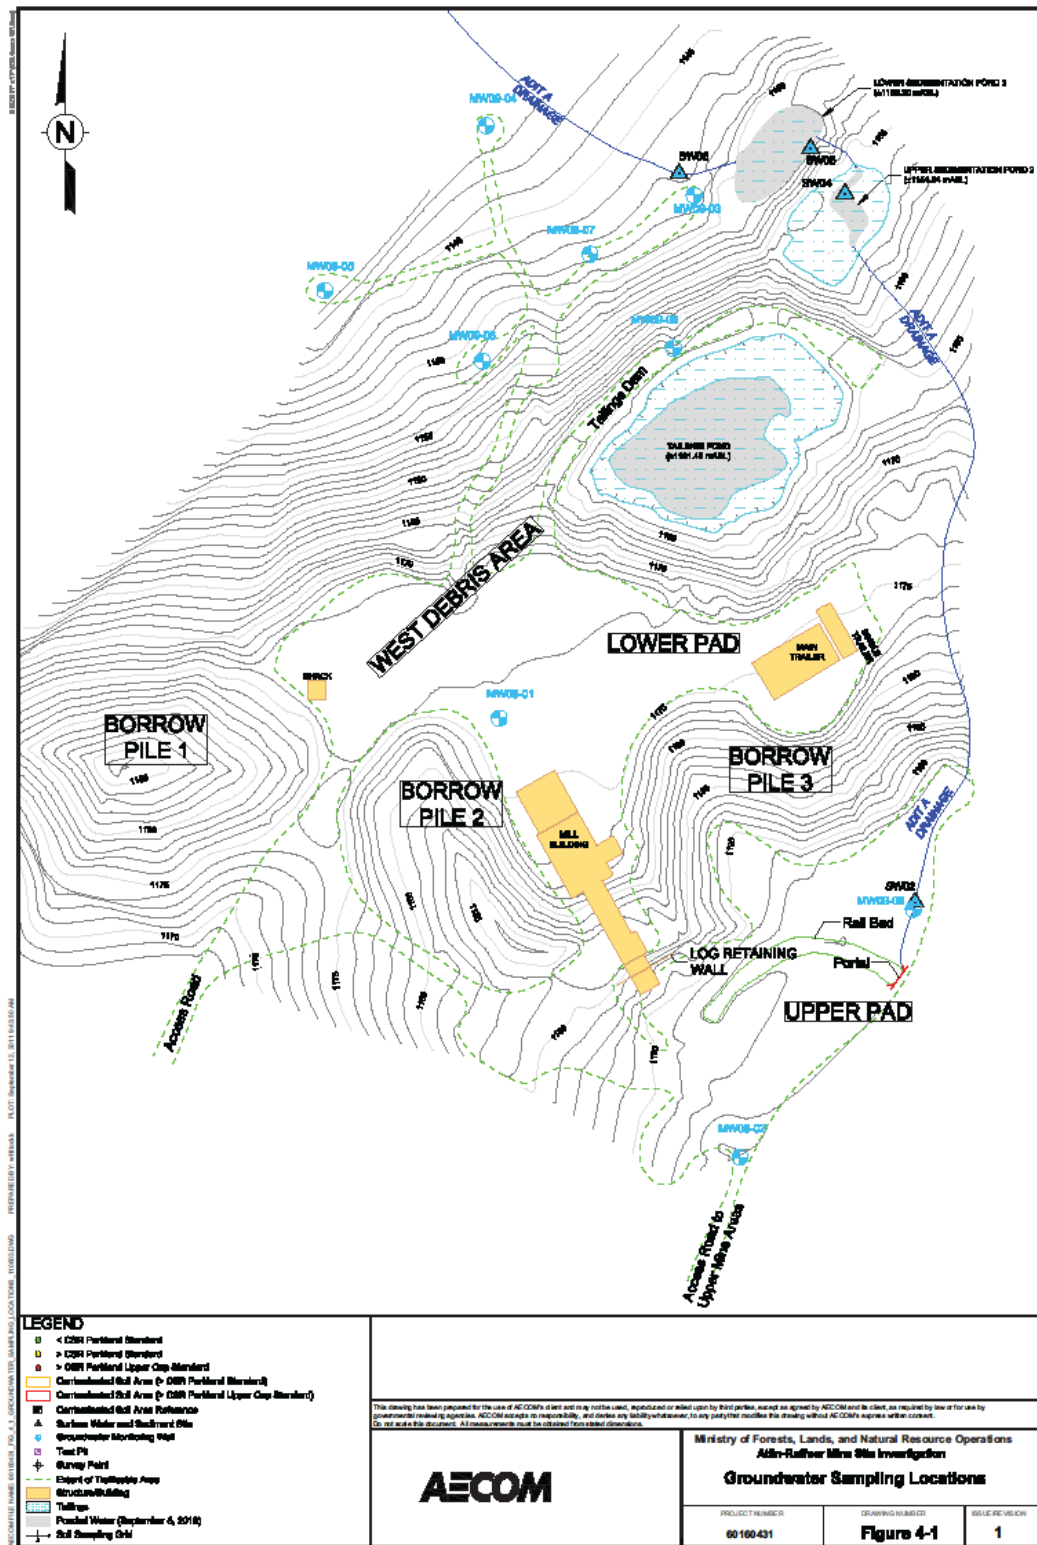
Figure 1: Site Plan Prior to Remediation of Atlin Ruffner Mill and Tailings

The mill and tailings area was developed by cutting into an esker formation on the side of Mt Vaughn. At least 3,535 tonnes of ore were milled at the site. Prior to remediation, the mill and tailings site included a mill building with machinery and ore storage bins, two leveled areas (upper and lower mill pads), two trailers, a shack, an explosives shed, a tailings pond, two settling ponds, and an adit with flowing drainage (Figure 1, Photos 1 through 3).

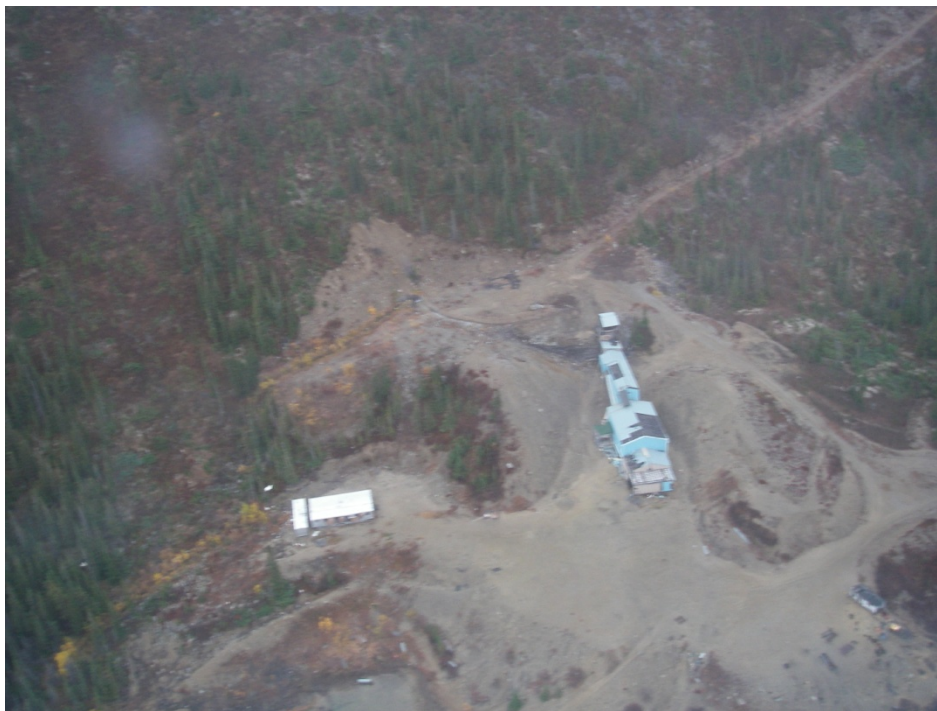
Photo 1: Adit, mill building, trailers, upper and lower mill pads, and portion of tailings pond prior to remediation (October 2008).

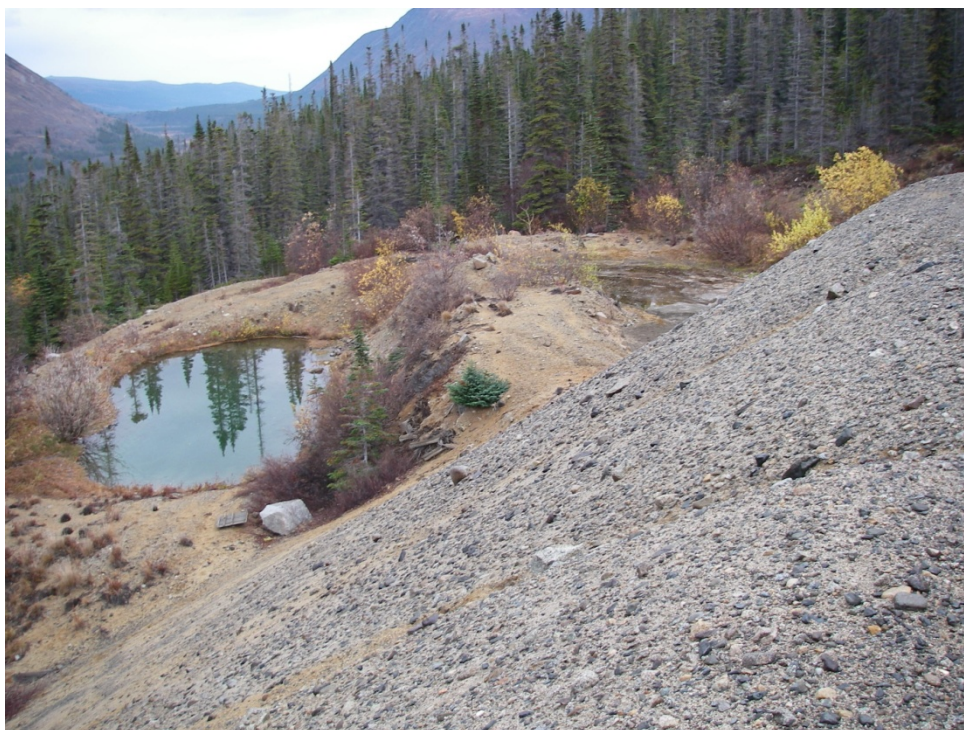
Photo 2: The settling ponds seen from the top of the tailings dam, prior to remediation (October 2008).

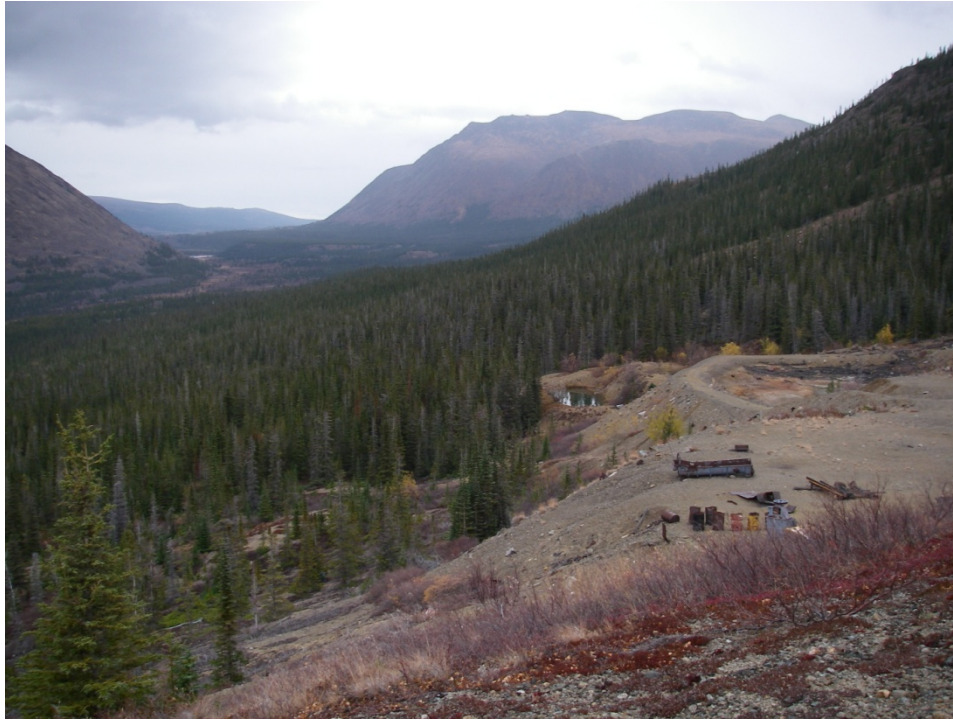
Photo 3: The lower mill pad, with the tailings and lower settling pond in distance prior to remediation (October 2008).

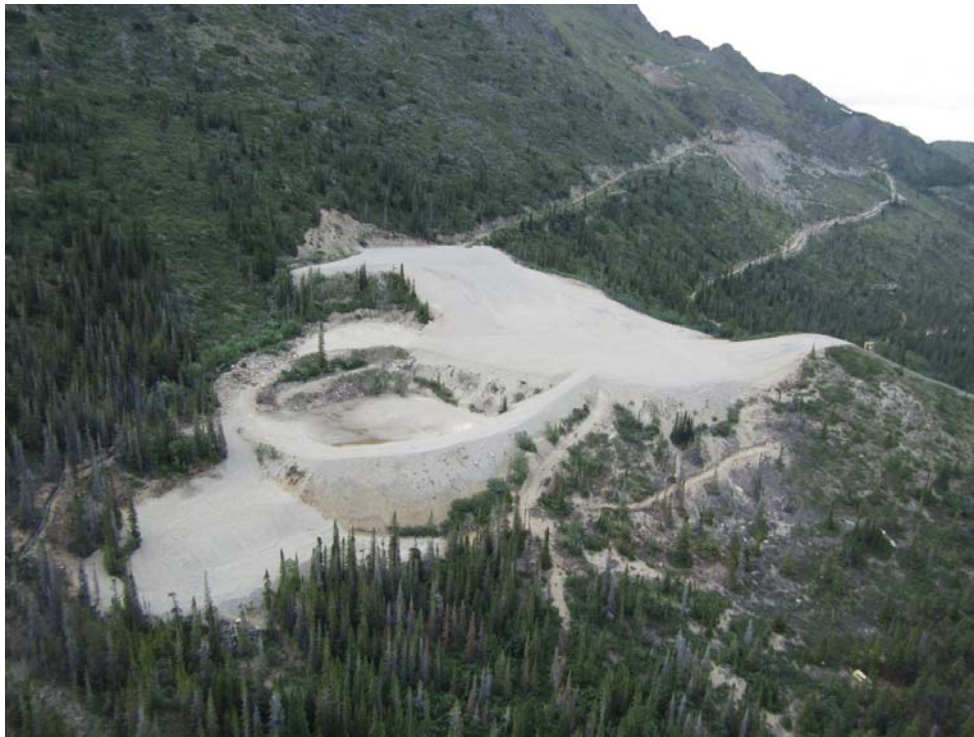
Photo 4: The site post-remediation, with the tailings area in the centre. (June 2013)

Salvage was looked as an option for the mill equipment remaining on site but was not economic. The mill building was demolished, compacted, and capped in its original footprint. The remedial plan made use of the existing topography of the site. Removal of a waste rock retaining adjacent to the former mill and natural, uncontaminated hills used as borrow sources on either side of the mill allowed the area to be reformed into a continuous slope over the demolished mill building (Figure 2, Photos 4 and 5).

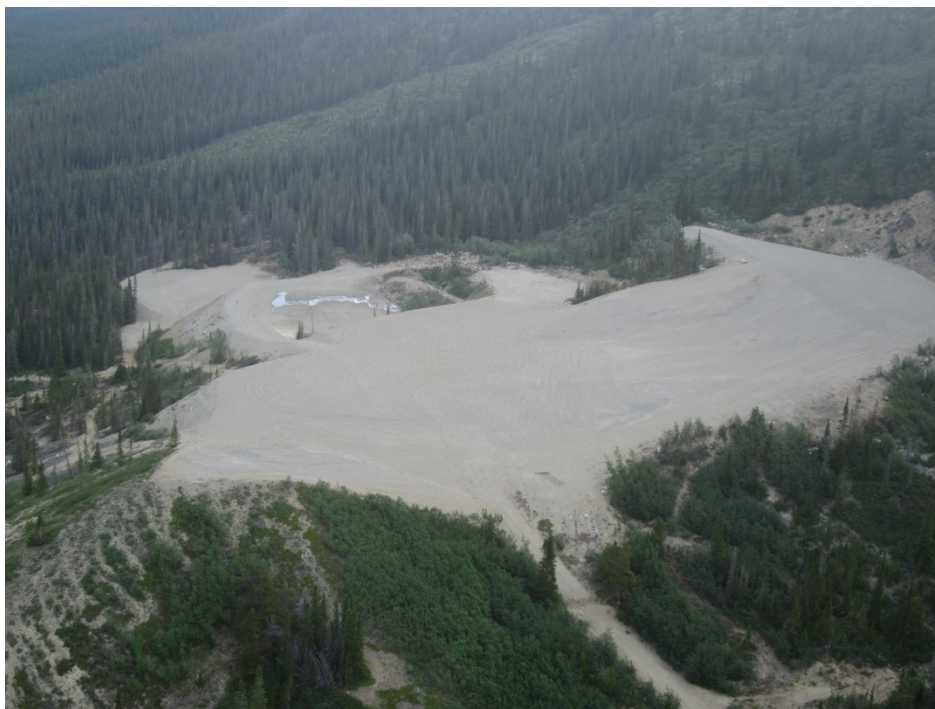
Photo 5: The site post-remediation, with the former mill area and access road in the foreground. (June 2013)
