# **MOUNT POLLEY MINE AUGUST 2014 TAILINGS DAM EMBANKMENT BREACH RESPONSE AND APPROACH TO REMEDIATION**

## **ABSTRACT**

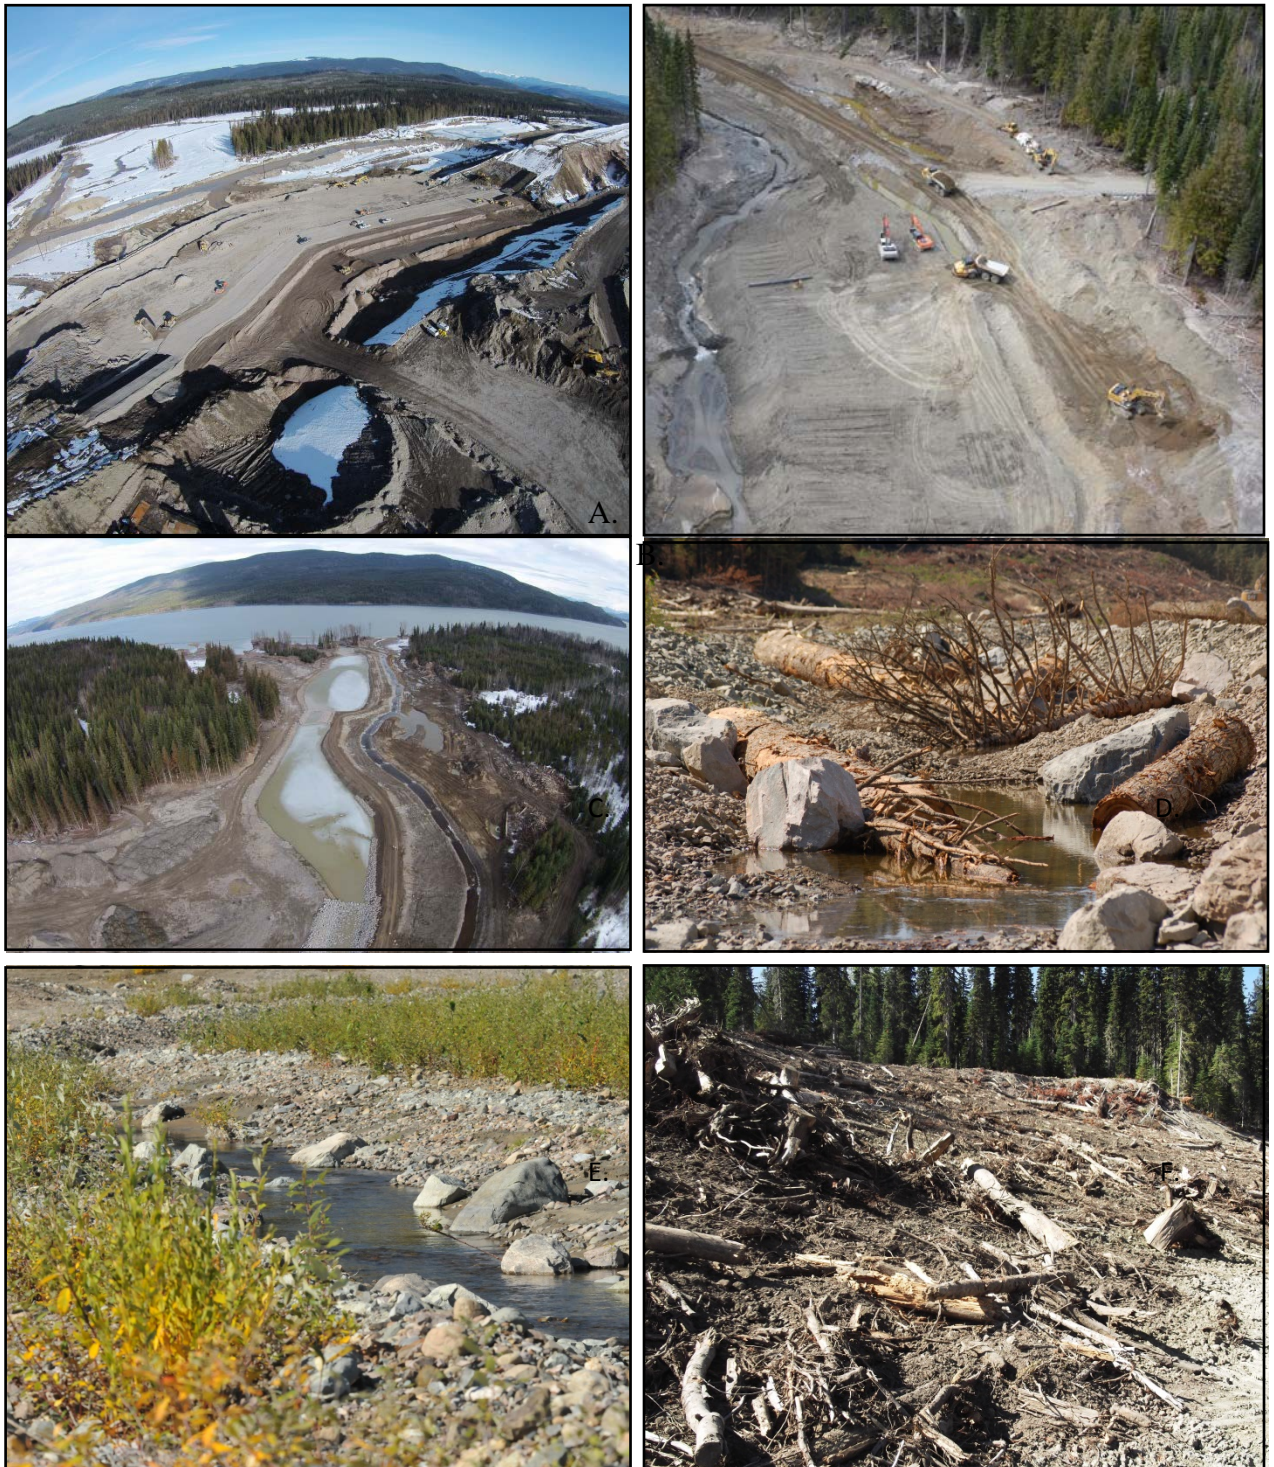
Figure 5 Rehabilitation works photos: A. TSF Perimeter Embankment breach repair cut-off wall and buttress; B. Hazeltine Creek channel reconstruction; C. Lower Hazeltine Creek sedimentation ponds; D. Edney Creek fish habitat features; E. Hazeltine Creek floodplain revegetation; F. Terrestrial reclamation site preparation and woody debris application

**Scour Zone (Middle Hazeltine Creek corridor):** In areas where scouring was the primary impact, most of the exposed cutbanks have been recontoured, often requiring push back of the undisturbed forest to achieve an appropriate slope angle for safety and erosion control. Where that pushback has occurred, the forest soil was placed over the recontoured area to provide additional organic matter, seed sources, and active soil biota to enhance rehabilitation. Site preparation (mounding) and application of woody debris recovered from the debris flow is

ongoing to reduce erosion, as well as to create wildlife habitat and improved plant microsites (Figure 3). The woody debris also acts as a source of seed and long-term soil carbon. Revegetation to date has focused on the floodplain areas to reduce potential erosion into the channel. Willow (*Salix* spp.) wattles and live stakes and black cottonwood (*Populus trichocarpa*) wattles collected from site have been installed using bioengineering techniques (Figure 3). Black twinberry (*Lonicera involucrata*), red-osier dogwood (*Cornus stolonifera*), and prickly rose (*Rosa acicularis*) nursery seedlings have also been planted along one side of the floodplain, maintaining the other side for access to construct fish habitat features in the future. Planting of Sitka alder (*Alnus viridis*) seedlings grown from seed collected on site is planned for fall 2016 in areas between the floodplain and forest edge. Future revegetation of upland areas is anticipated to include additional early successional species, with seeds collected from Mine site where possible. These native species have been selected based on their role in primary succession in the region and projected ability to survive in the available habitats. The selected species are anticipated to be fast growing (and shade out invasive species), easily propagated, and produce leaf litter (and in the case of alder, fix nitrogen) to begin building soil. While primary succession in the region is typically dominated by shrubs, a light application (30 kg/ha) of a native blend of grasses and forbes is being applied to provide additional erosion control and organic matter inputs. Figure 3 presents photos of rehabilitation work in this area.

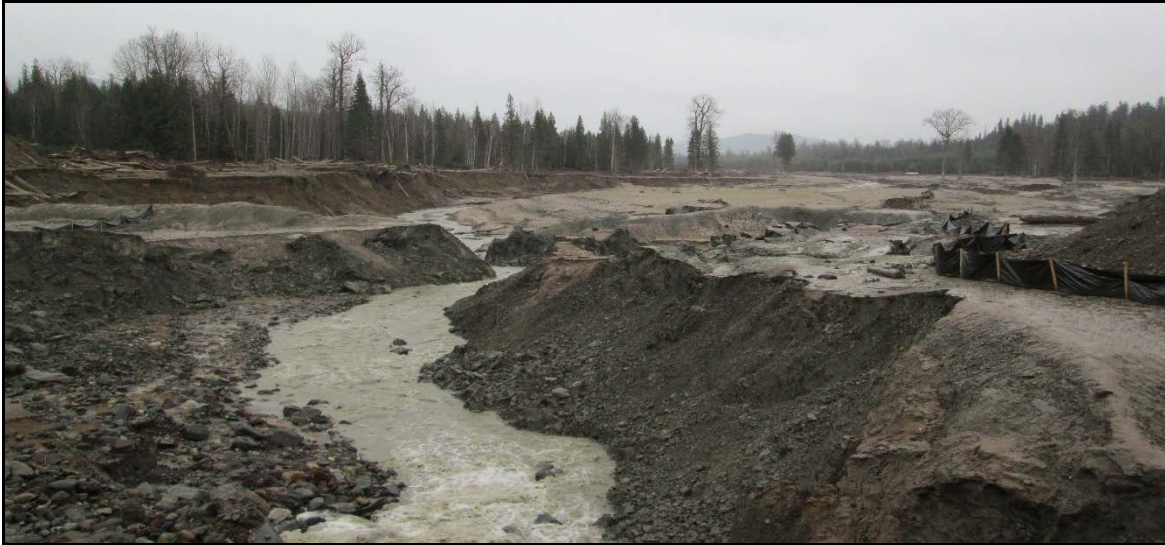
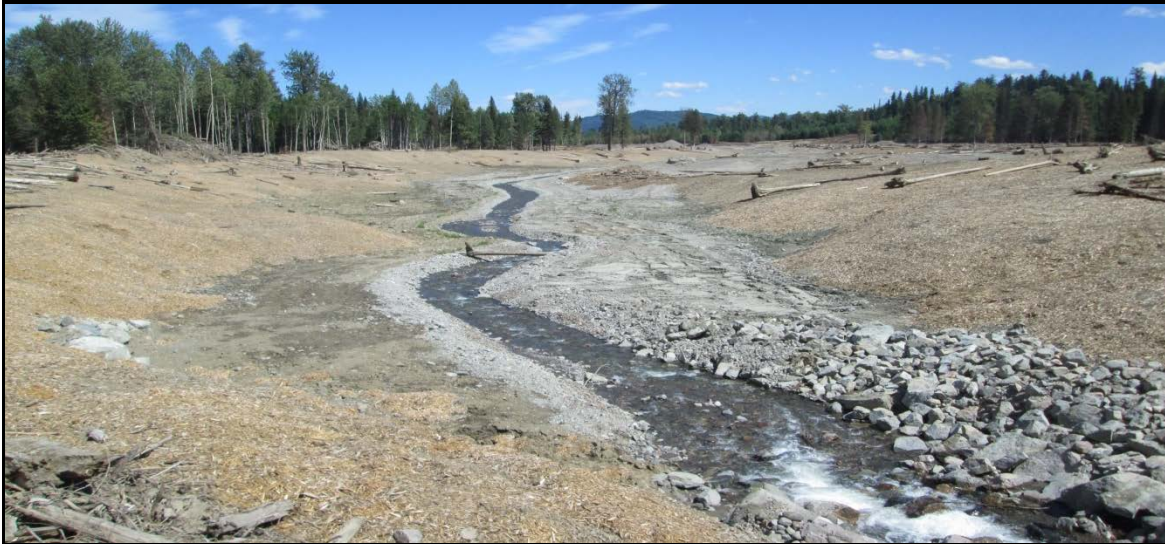
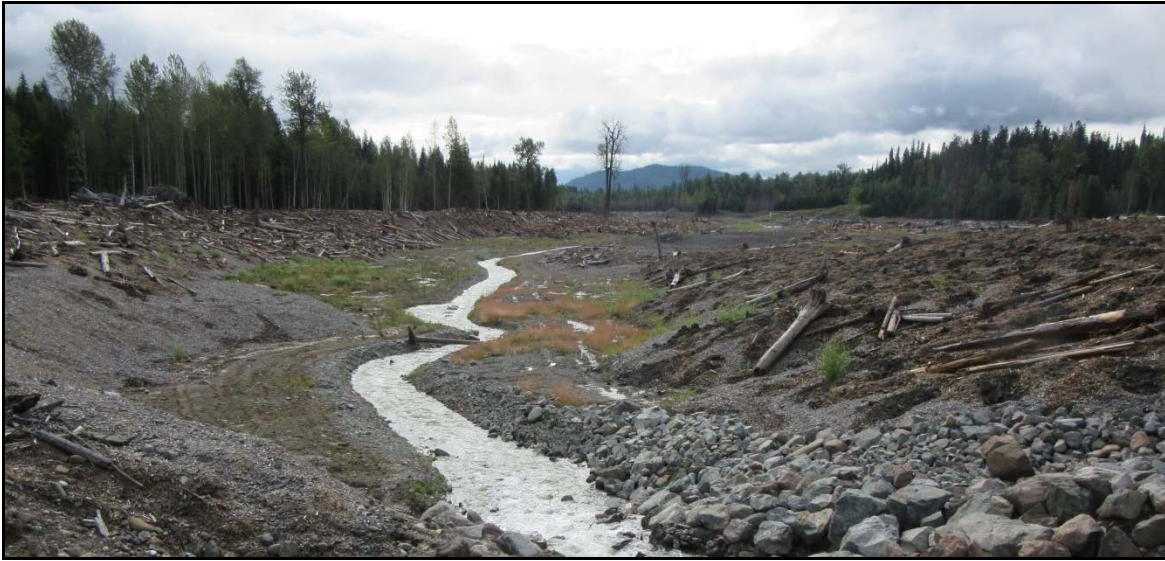
Figure 6 Lower Hazeltine Creek rehabilitation timeline; top to bottom: November 2014, June 2015, August 2016

**Depositional Zone (lower Hazeltine Creek corridor):** The deposited tailings and eroded native materials at the mouth of the Hazeltine Creek channel were not as deep as in the “Polley Lake Plug” near upper Hazeltine Creek (0.15 to 1.5 m). Tailings were, for the most part, removed, in particular from the channel and floodplain areas. Wood chips produced from trees recovered from Quesnel Lake were available and applied in spring 2015 to reduce erosion, hold moisture and eventually to provide organic carbon as they decompose. These chips were mixed and mounded in 2016, along with larger site preparation work across the area to expose mineral soil for planting and natural plant ingress. This site preparation work included mounding and application of woody debris as described for the Scour Zone above. Planting of the floodplain and revegetation of upland areas is ongoing as described in Scour Zone section above. The time series photographs in Figure 4 shows progression of reclamation in this area.
