AN INNOVATIVE APPROACH TO MONITORING THE PHYSICAL STABILITY OF CONSTRUCTED FISH HABITAT USING DRONES

Golder Associates Ltd.,
Suite 200 - 2920 Virtual Way
Vancouver, BC, V5M 0C4

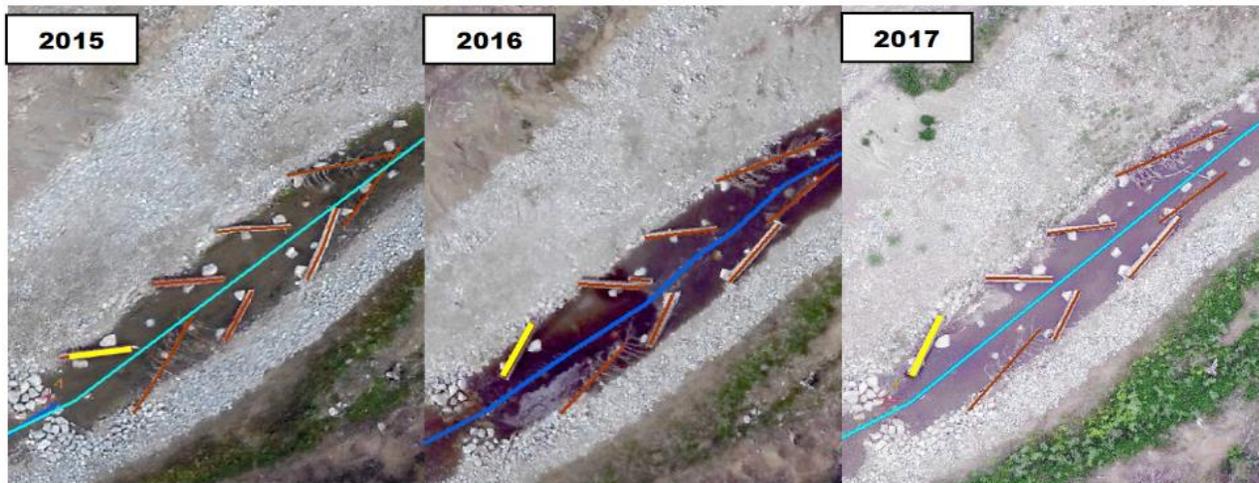
As an example of movement captured, the detected LWD non-stability occurrences in Edney Creek included both shifts in alignment and complete detachment from the anchoring (Figure 3 and Figure 4). Follow up field surveys were able to determine that these failures came from a failure of the anchoring hardware, and in response, these features were replaced and re-attached to their original locations.

Figure 3: Stability failure leading to the change in orientation of a piece of large woody debris.

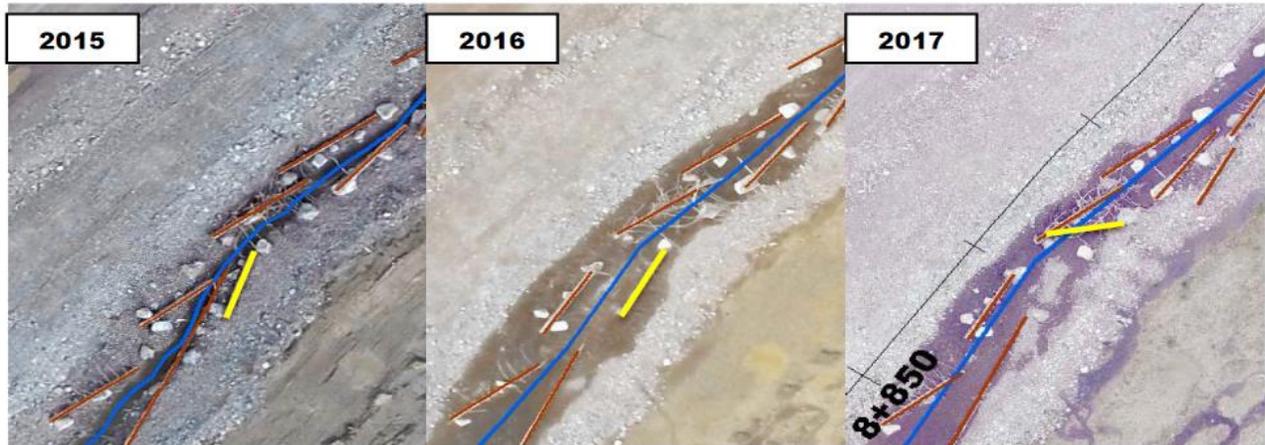
Figure 4: Stability failure leading to the complete detachment of a piece of large woody debris.
