# **Burlington Mine VCUP Case History: an Ecological Approach to Mine Site Remediation**

This paper discusses the ecological approach and long-term results of remediation of the Burlington Mine, Boulder County, Colorado under a Voluntary Clean Up (VCUP) action.

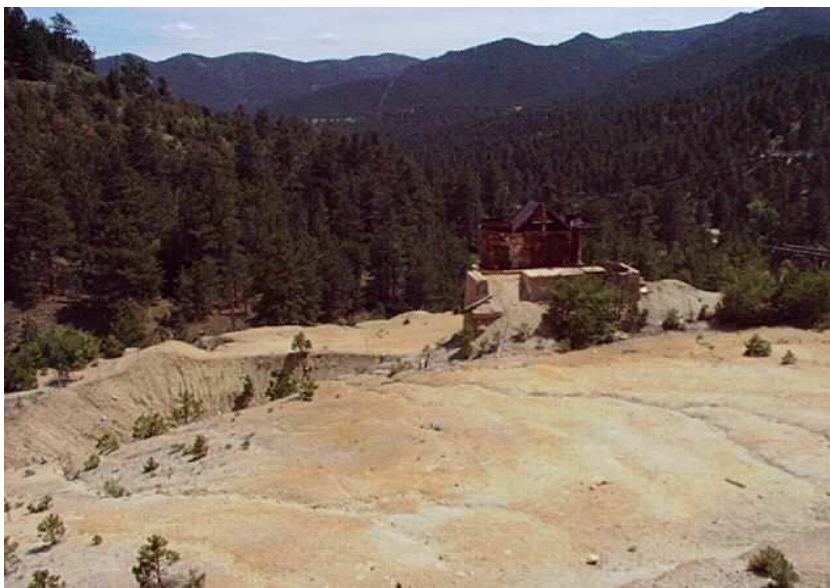
Extensive development began in the early 1940s when General Chemical Company purchased the mine (Photo 1). Between 1943 and 1973, the mine was enlarged from a single 150 foot (46 meter) shaft with

**Photo 1. View of the Burlington fluor spar mine complex, around 1940, including the mine adit, waste rock pile, residences, and a hoisting tower.**

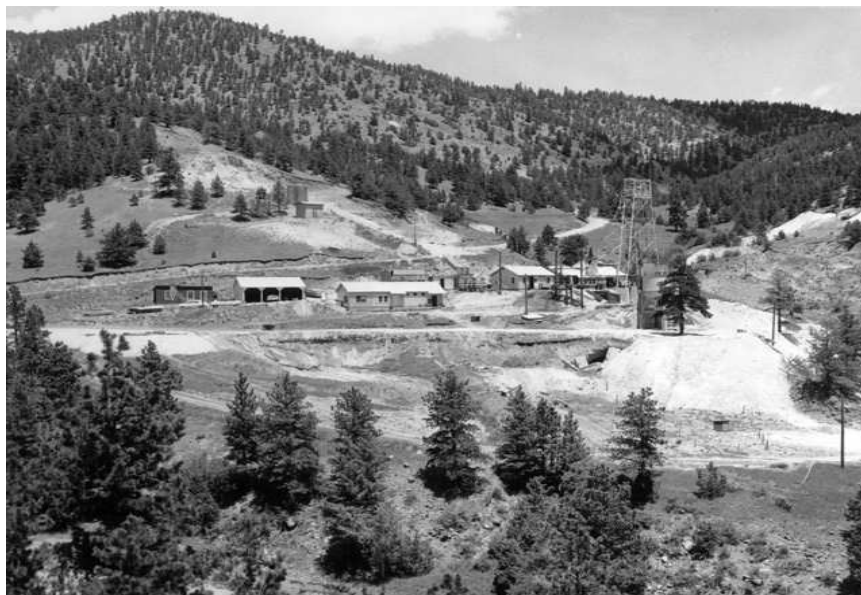
At the time of the VCUP, the site was a vacant mining property, dominated by an unvegetated waste rock feature (Photo 2). Two subsidence pits and a large mine shaft opening presented significant hazards and impacts to water quality. A concrete and steel ore bin and loading structure and several building foundations remained on the property. The Balarat Hill Road (County Road 82) crossed the site on the north, between the main mine site and the secondary open cut mine to the north (Photo 3). The largest subsidence pit was intercepting flows in Balarat Gulch and creating direct flow path into mine workings. Interaction with mine workings and waste rock resulted in potential water quality

**Photo 2. Ore bin and loading structure amidst waste unvegetated waste rock pile.**

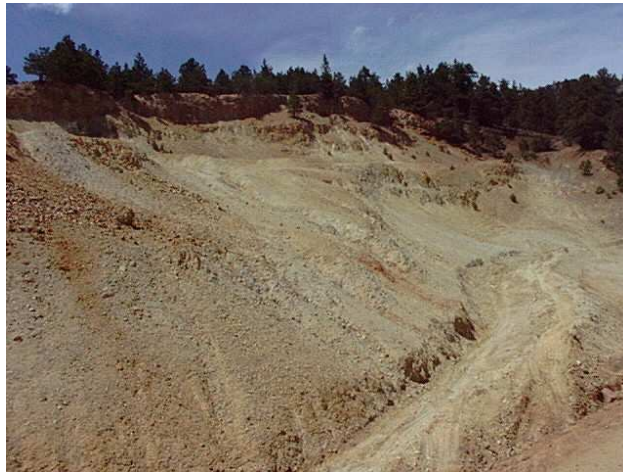
**Photo 3. Secondary open cut mine.**

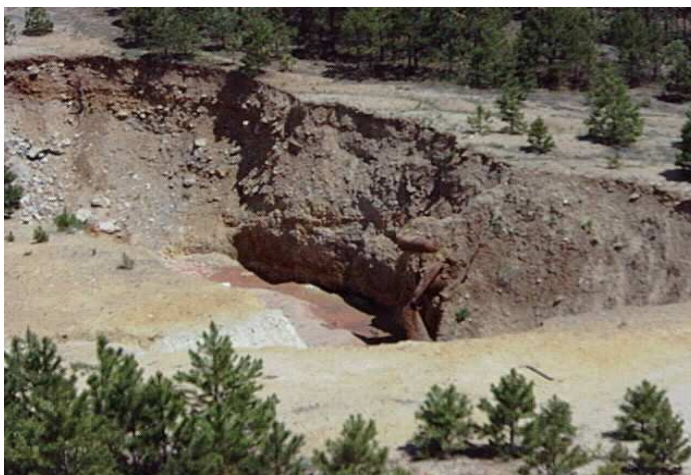
**Photo 4. Interception of Balarat Gulch by largest subsidence pit.**

Under existing conditions, the subsidence pits were providing direct flow paths into the mine workings. Of particular concern was the pit that intercepted Balarat Gulch, an intermittent drainage that drains to Little James Creek and ultimately to Left Hand Creek. Backfilling this pit was the first step in eliminating the direct flow path for the gulch into the mine workings. Final grading included substantial mounding over the backfilled pits to create a minimum two percent slope. The positive slope created by the mounding discourages infiltration – and potential contact with mine workings – by promoting runoff. In anticipation of backfill settling, the area was overmounded by a minimum of 4 feet (1.2 meters).

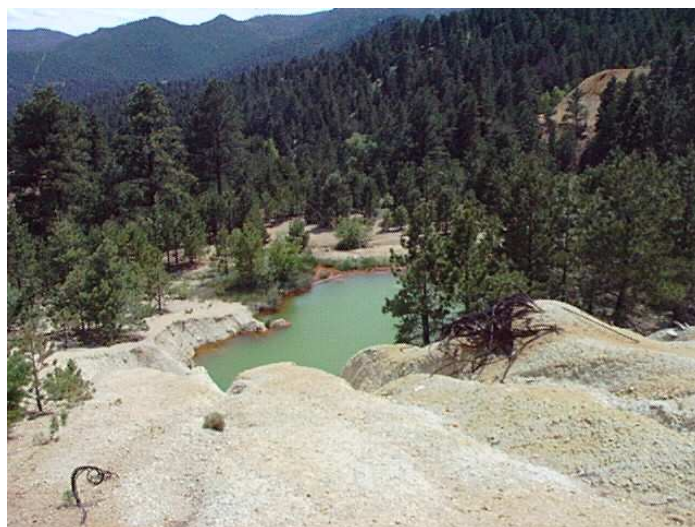
**Photo 5. Mine pond at toe of waste rock pile.**

An old mine tunnel at the southern end of the site has become permanently flooded and causes a constant discharge from the overlying pond. The flooded area is known as the “mine pond”. Water in the pond has a low pH and heavy iron staining exists along the discharge path from the pond.

While the pond and its discharge had to be excluded from this VCUP project due to point source discharge issues, concerns for the health of waterfowl that would be tempted to land in the pond were addressed. Bird Balls<sup>TM</sup>, which were recommended by the U.S. Fish and Wildlife Service, were used to cover the pond surface, preventing waterfowl from landing or residing in the pond, and removing potential contamination pathways.

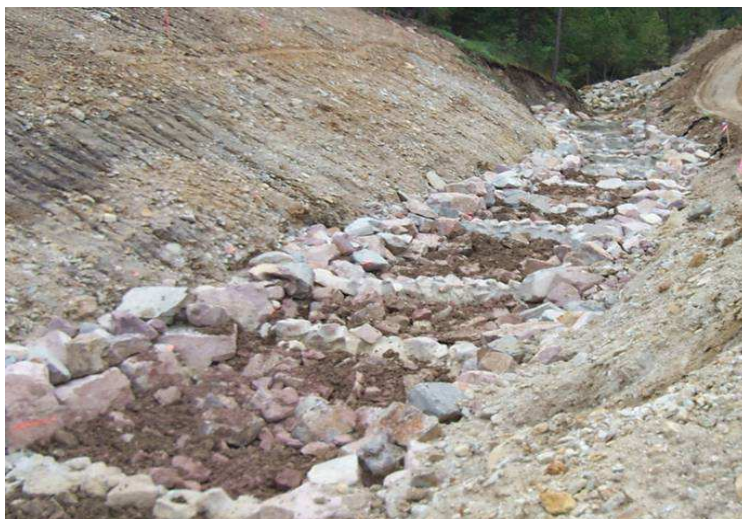
**Photo 6. Balarat Gulch Diversion Channel, 2004.**

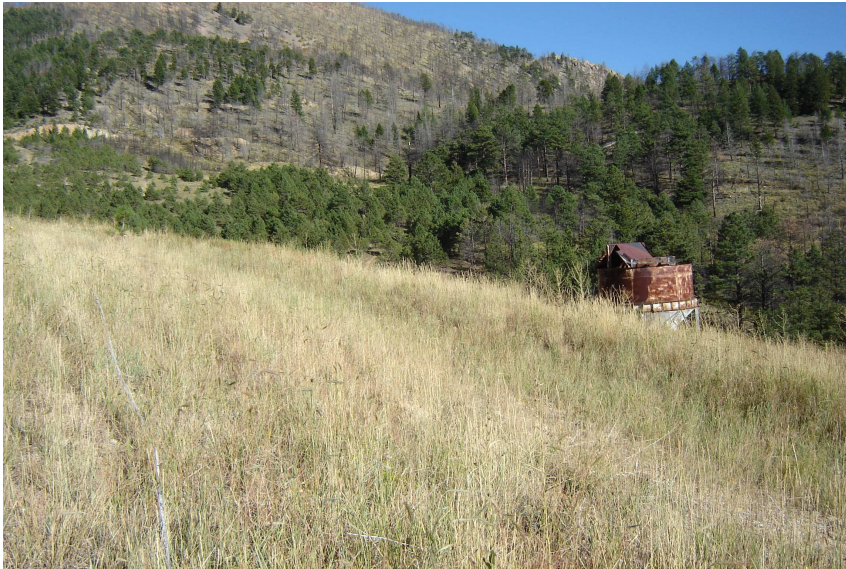
**Photo 7. Ore bin and revegetated waste rock pile, three full growing seasons following VCUP completion (comparison to Photo 1).**

Revegetation progressed as expected over the first three full growing seasons following completion. Quantitative monitoring results are summarized in Table 5. Average foliar cover was approximately 61 percent across the upland portions of the site by the end of the first growing season. By the end of the third full growing season, this value had increased to almost 65 percent (Photo 7).
