**LARGE WOODY DEBRIS FISH HABITAT STRUCTURE
PERFORMANCE AND BALLASTING REQUIREMENTS**

A THESIS SUBMITTED IN PARTIAL FULFILLMENT OF
THE REQUIREMENTS FOR THE DEGREE OF
MASTER OF APPLIED SCIENCE
in
THE FACULTY OF GRADUATE STUDIES
(Department of Civil Engineering)

THE UNIVERSITY OF BRITISH COLUMBIA

August 1998

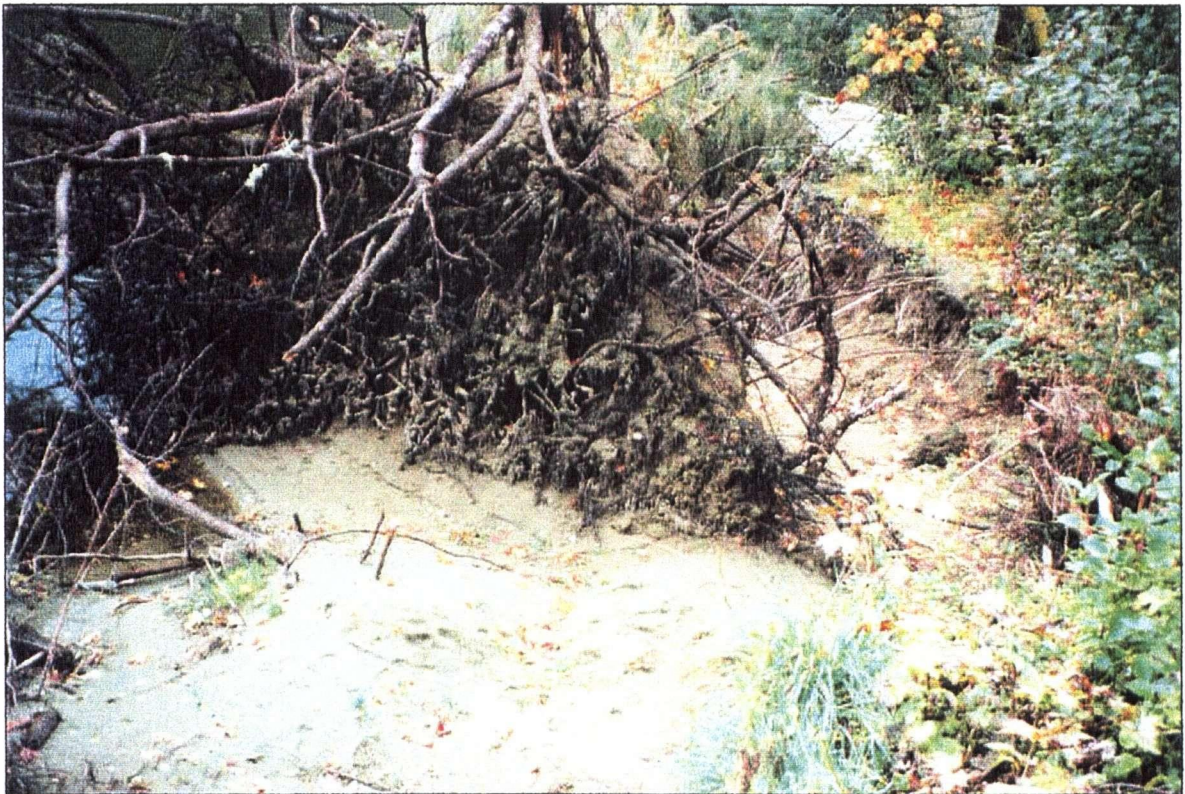
Figure 4-3: Looking downstream at SJ-108 root wad and fine sand (Sept. '97)

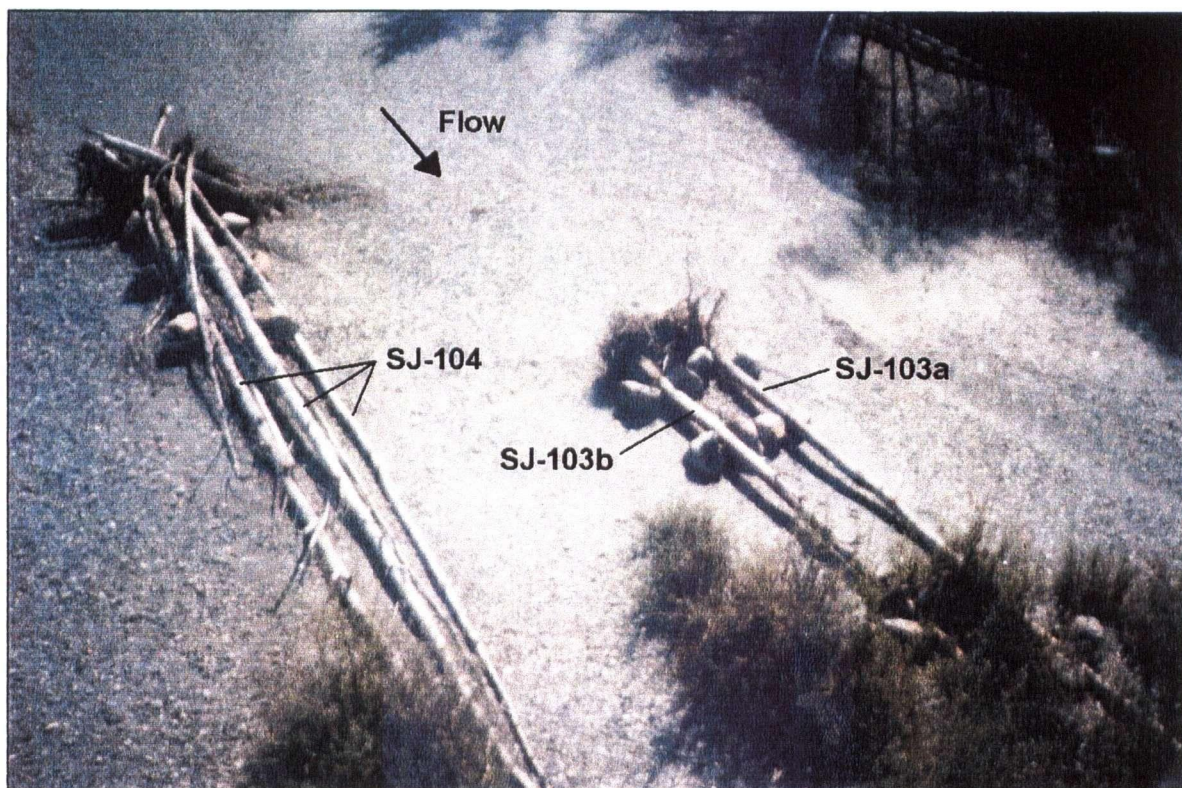
Structure SJ-104 was completely washed away (Figures 6-3 and 6-4) while both structures W80-15 and SJ-106 shifted only slightly. Some small movement of structures SJ-103a and SJ-103b was observed, however the distance travelled by the “settling in” of the anchor boulders was less than 0.7 m. The FS_b of these 2 structures are well above 2.0. The factors of safety were also determined for the bankfull and design (50 year return) flows (Table 6-3).

In terms of functionality, all structures but SJ-104 were essentially in place and performing as intended. SJ-104 could not be found downstream and is assumed to be non-functional. Figures 6-3 and 6-4 show the pre and post flood photos of structures SJ-103a, SJ-103b and SJ-104. Note that structure SJ-104 was displaced following a first flood in early November of 1997 while the peak instantaneous discharge was recorded in mid December 1997.

Figure 6-3: Aerial Photo of SJ-104, SJ-103b and SJ-103a (Sept. '97)

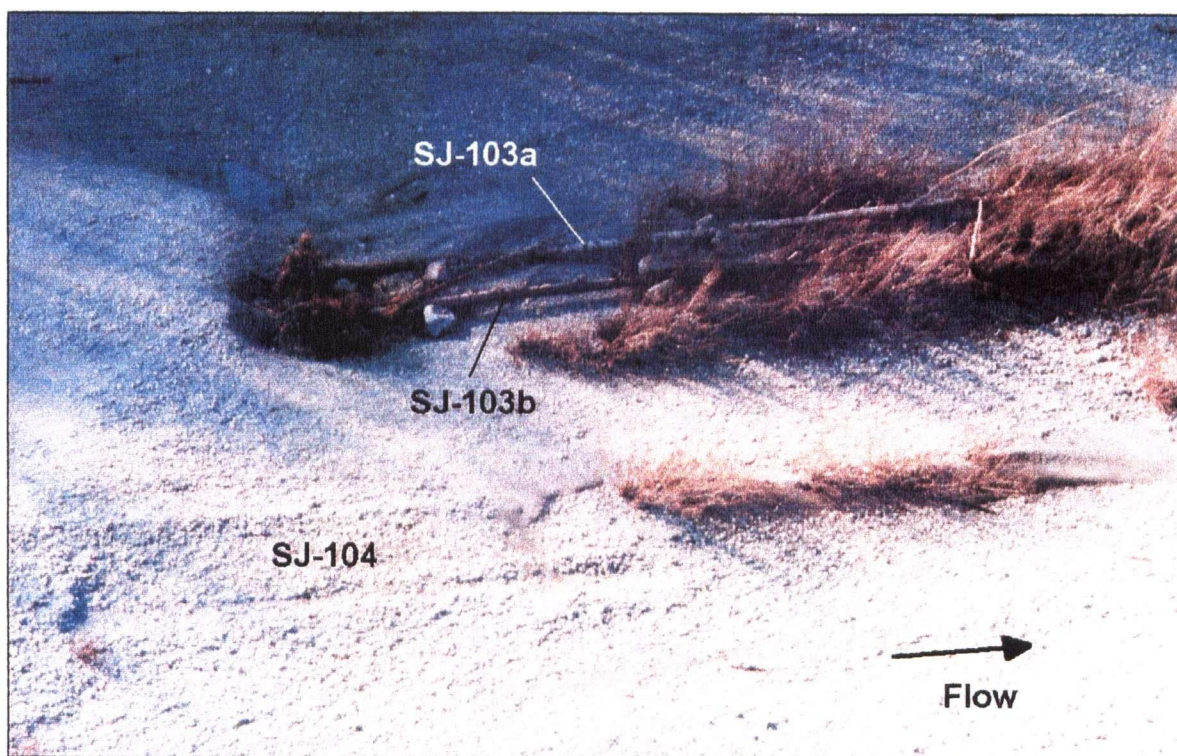
Figure 6-4: Aerial Photo of SJ-103a, SJ-103b and print of SJ-104 (Nov. '97)

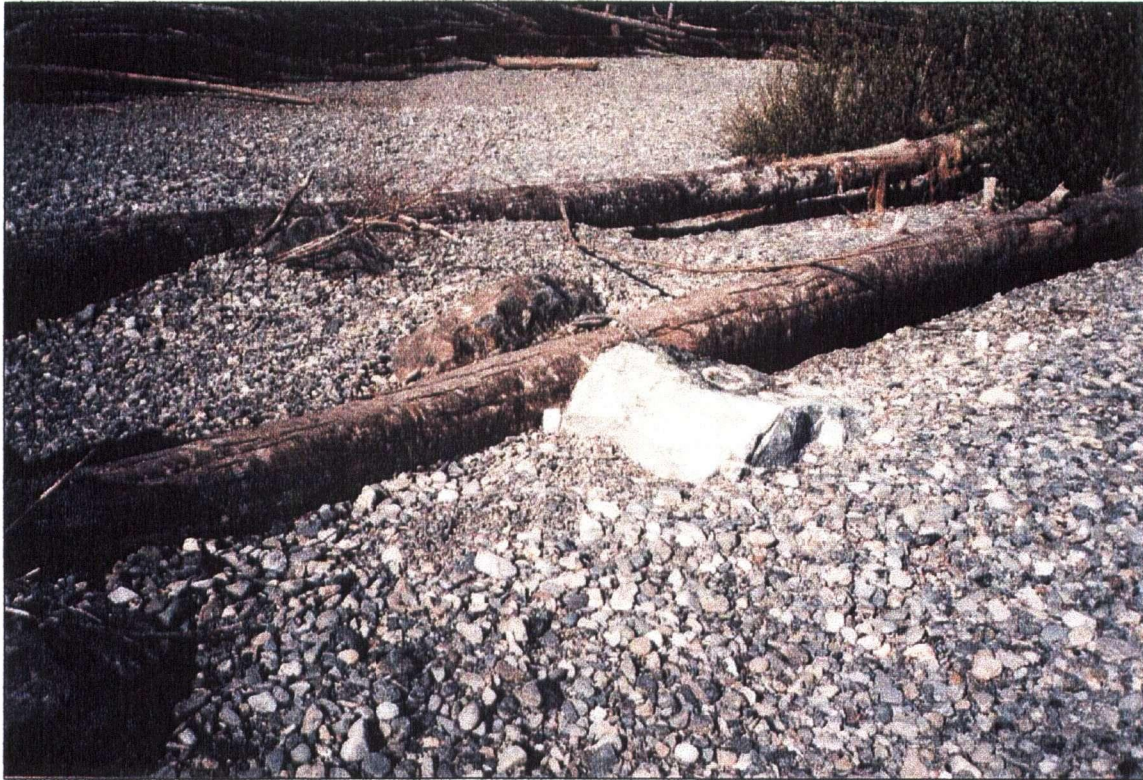
Although most of the single-LWD structures were not subjected to large floods, they (with the exception of SJ-104) appear to be providing an acceptable level of bank and bar protection.

Figure 6-5: Smothering of anchor boulders on SJ-103a and SJ-103b (April '98)

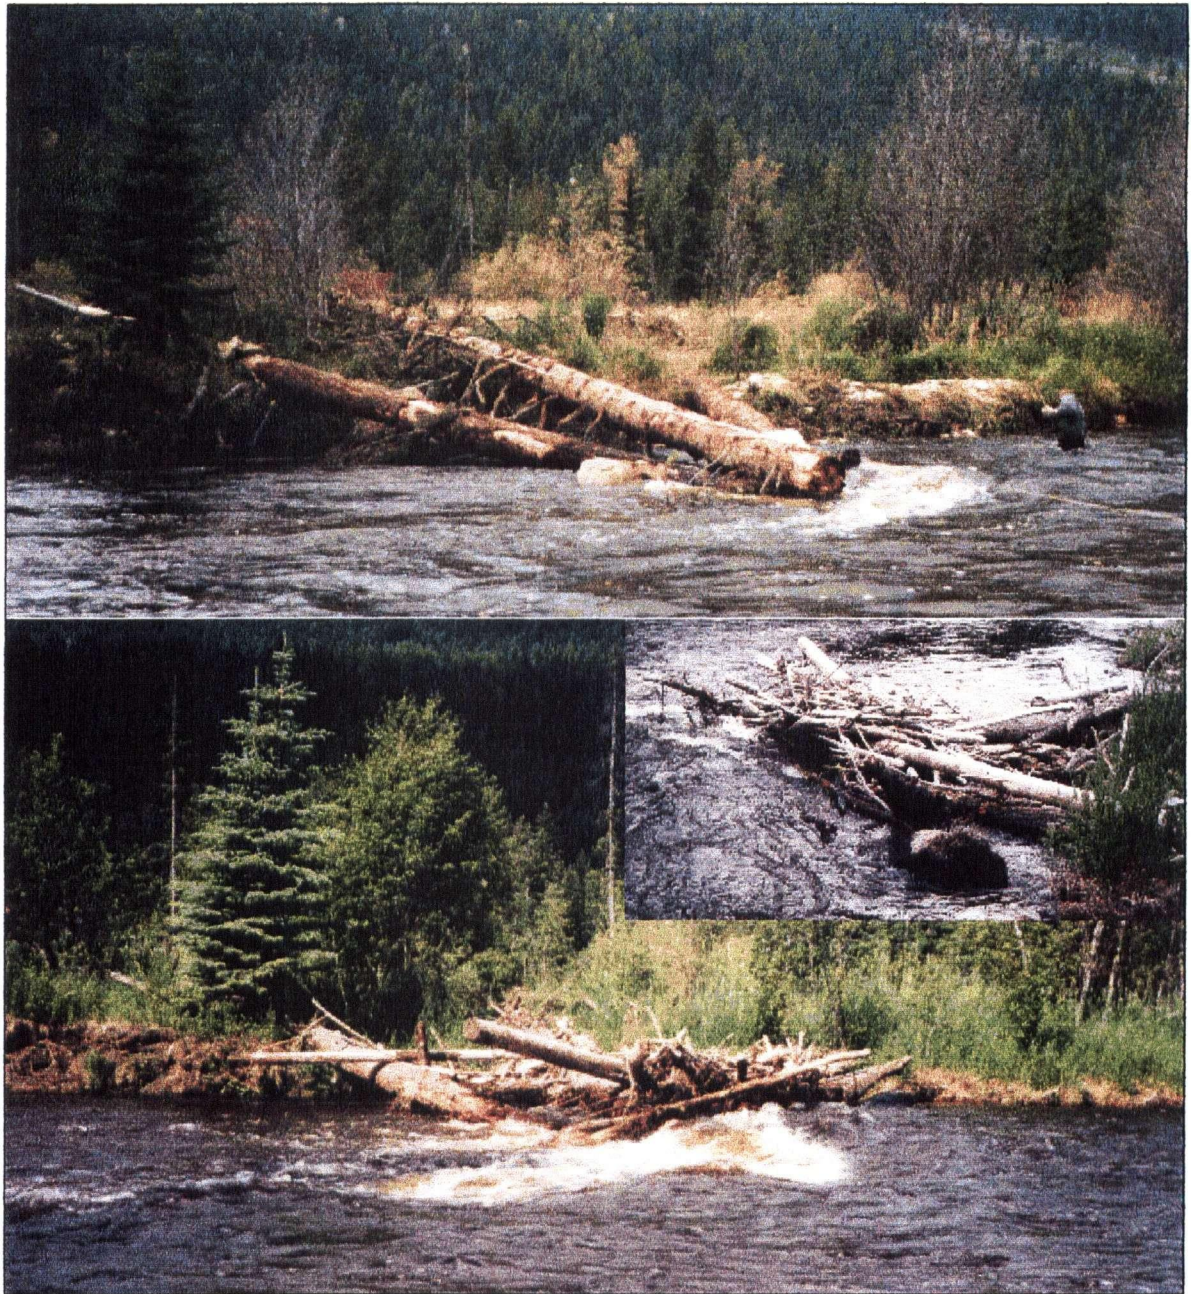
Figure 6-7: Debris accumulation on face of WK-1 structure. As built - Oct. 1997 (top, note human figure at right for scale), post freshet - June 1998 (bottom) and looking downstream from bank (inset).

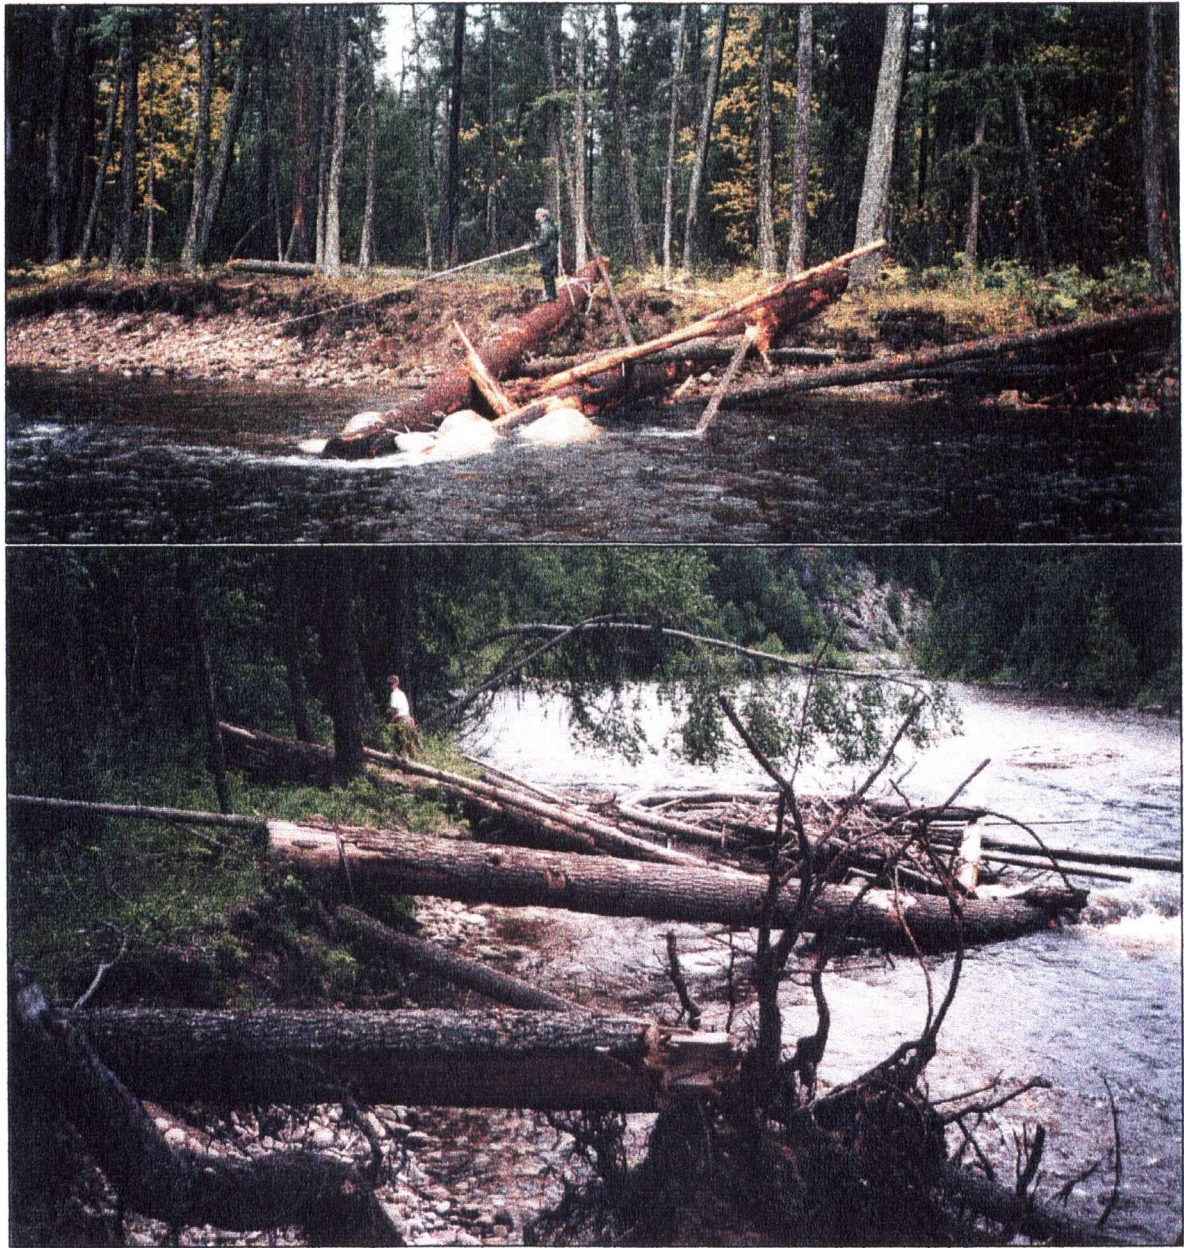
Figure 6-8: WK-8 as built Oct. 1997 (top) and post freshet looking upstream June 1998 (bottom). Note (bottom photo) debris on upstream face, fallen bank anchor tree (centre left) and eroded bank downstream.

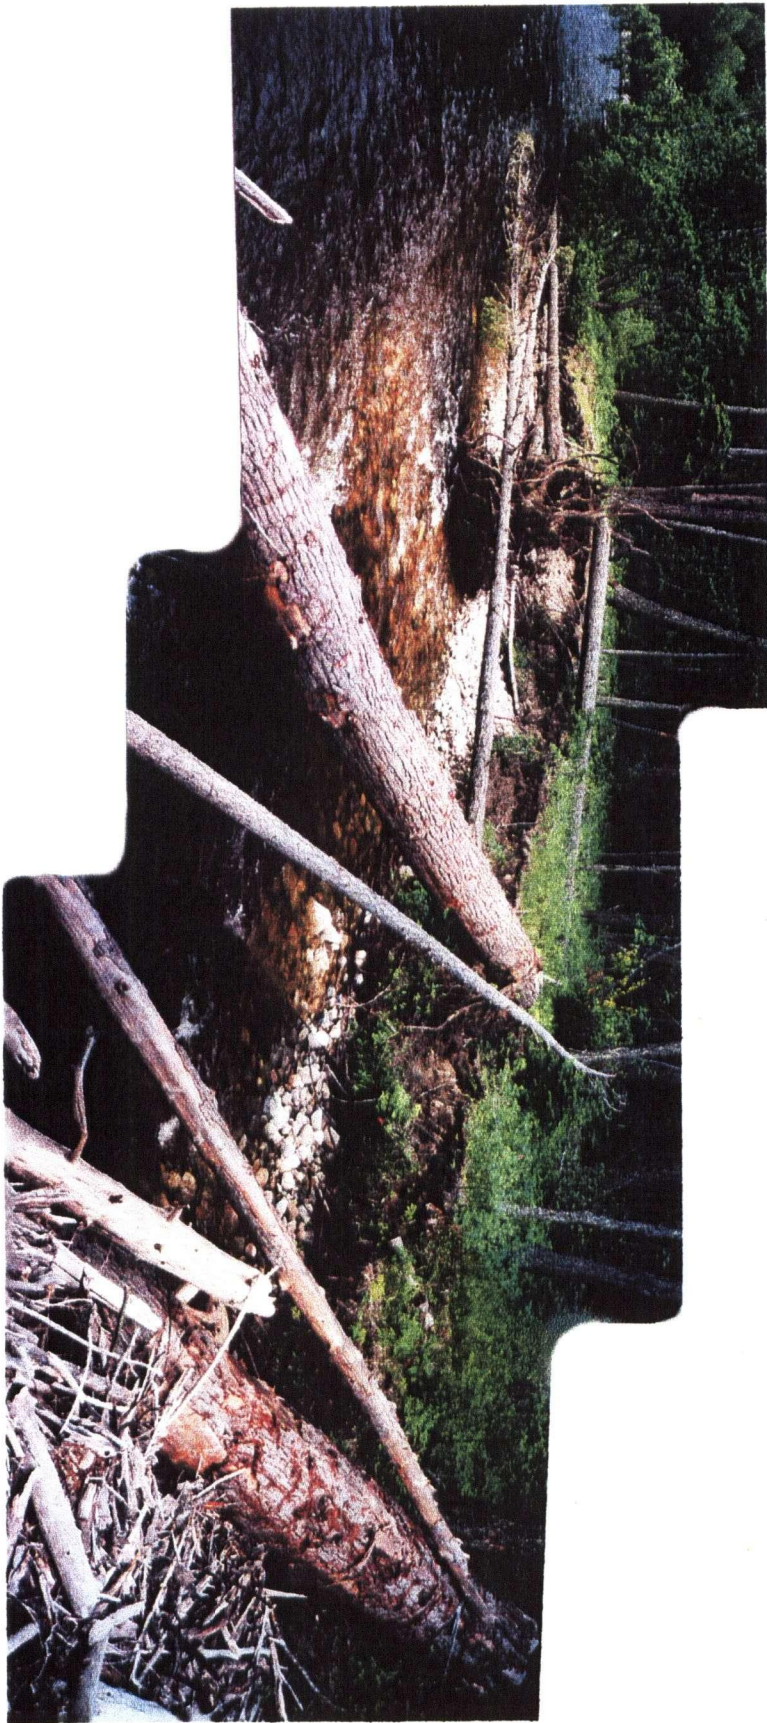
Figure 6-9: Eroded bank looking downstream from top of structure WK-8 (June 1998)

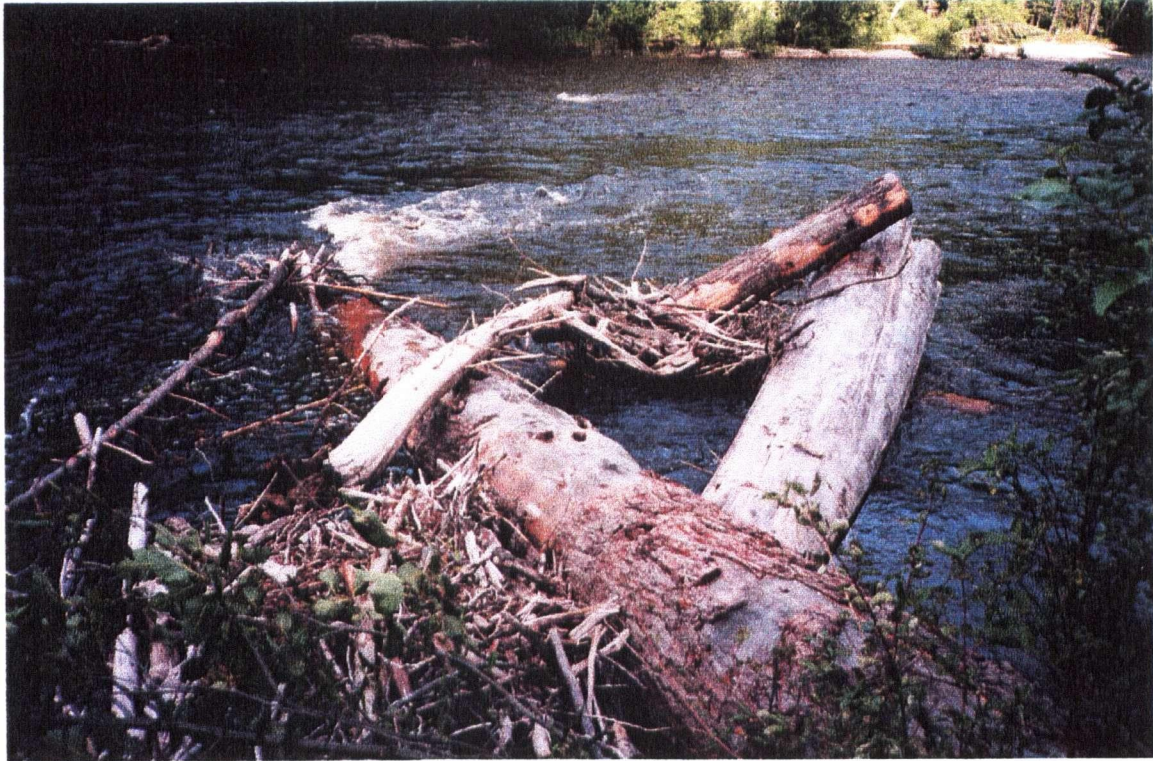
Keeping in mind that the field observations are based on slightly less than a year of operation, it appears that the debris capture efficiency of the multiple-LWD structure ranges from good to poor. Approximately 20% of the structures were found to have accumulated some small and LWD. Factors which seem to influence the capture efficiency of structures is the size of the system (affects ease of transport), quantity of structures/obstacles in place, presence of debris and structure characteristics. The provision of secondary LWD pieces, cabled above and/or below the primary LWD members, at an orientation parallel to the flow appears to increase the “snagging” capability of structures. Structure WK-9 is a good example (Figure 6-11) where such secondary members increase debris capture.

Figure 6-11: Structure WK-9 (looking downstream from bank, flow is left to right). Both LWD pieces oriented roughly parallel to flow (centre right) increase the structure debris capture efficiency.
