LANDSLIDES IN THE CHARLIE LAKE MAP SHEET,
FORT ST. JOHN

A THESIS SUBMITTED IN PARTIAL FULFILMENT OF
THE REQUIREMENTS FOR THE DEGREE OF

MASTER OF SCIENCE

(Department of Earth and Ocean Sciences)

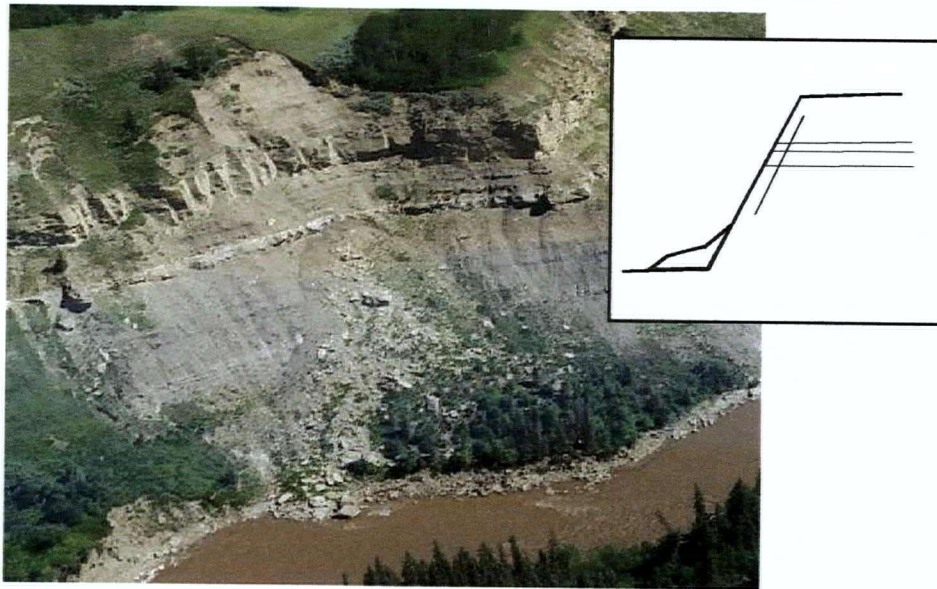
Figure 6.1 Slide Type 1: Raveling - Photo and Schematic Diagram (inset)

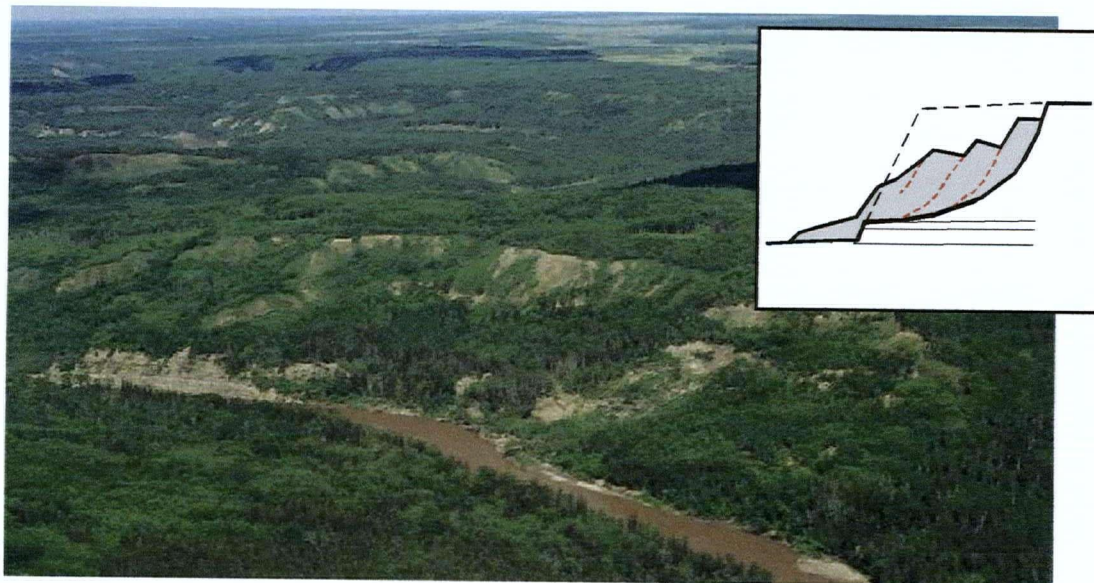
Figure 6.2 Slide Type 2: Retrogressive Rotational Failure - Photo and Schematic Diagram (inset)

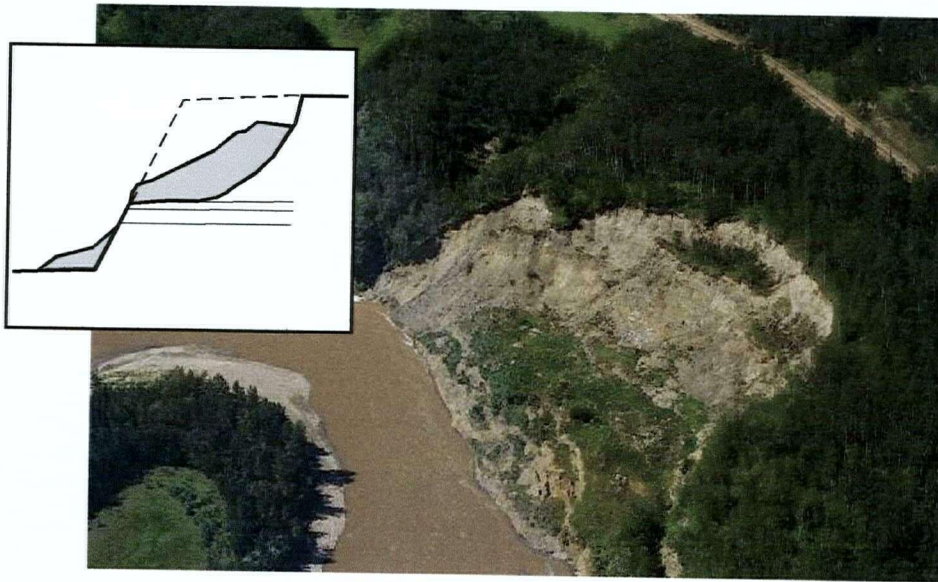
Figure 6.3 Slide Type 3: Rotational Failure - Photo and Schematic Diagram (inset)

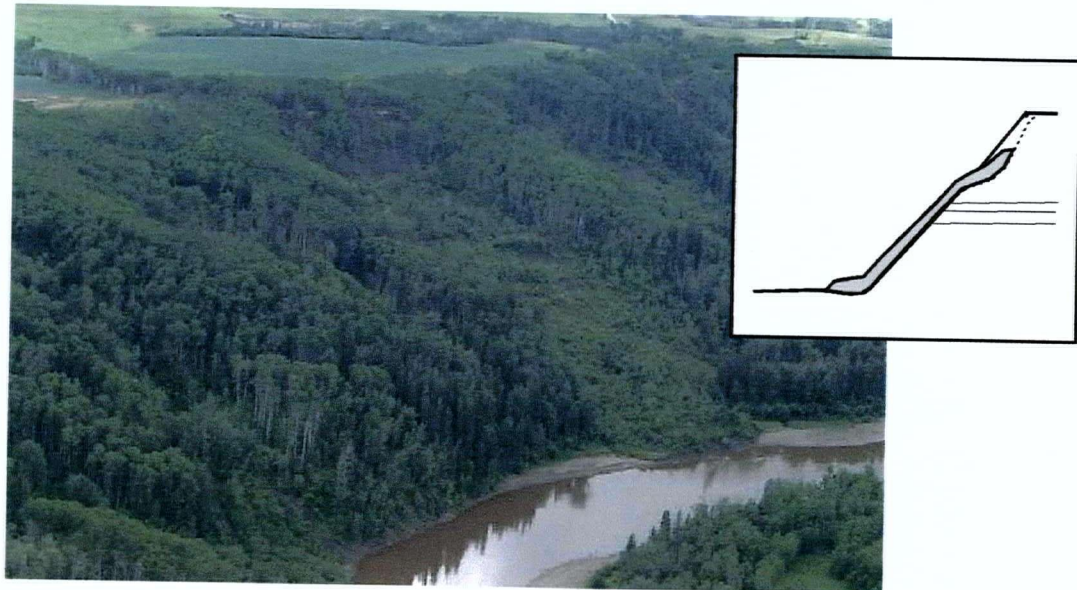
Figure 6.5 Slide Type 5: Earth Flow - Photo and Schematic Diagram (inset)

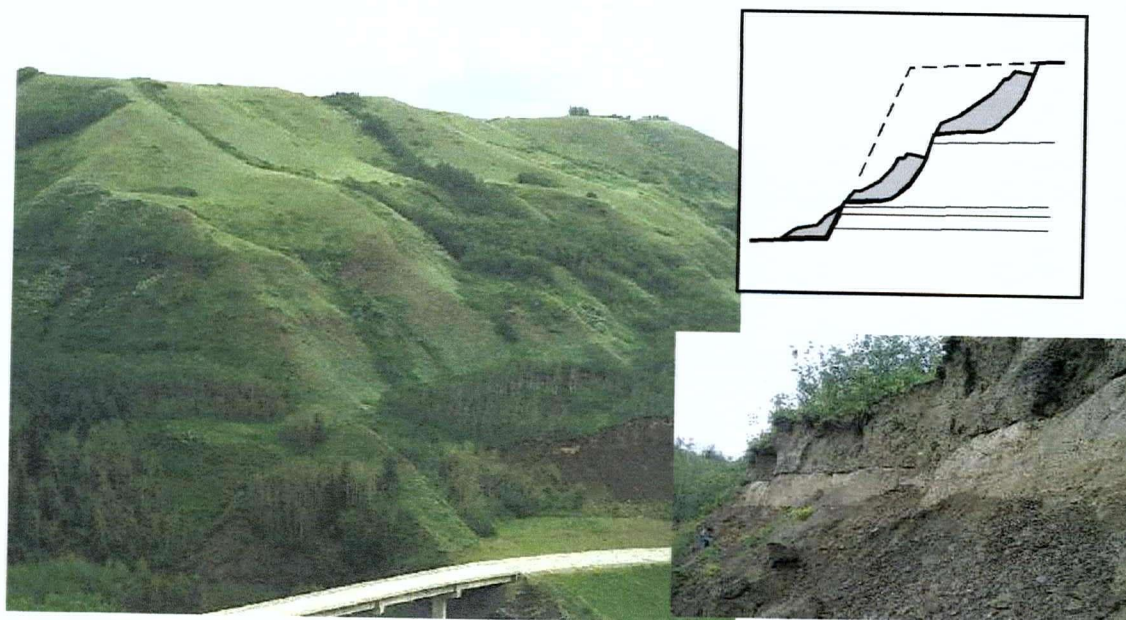
Figure 6.6 Slide Type 6: Multi-level Failure - Photo and Schematic Diagram (inset 1) and shear plane (inset 2)

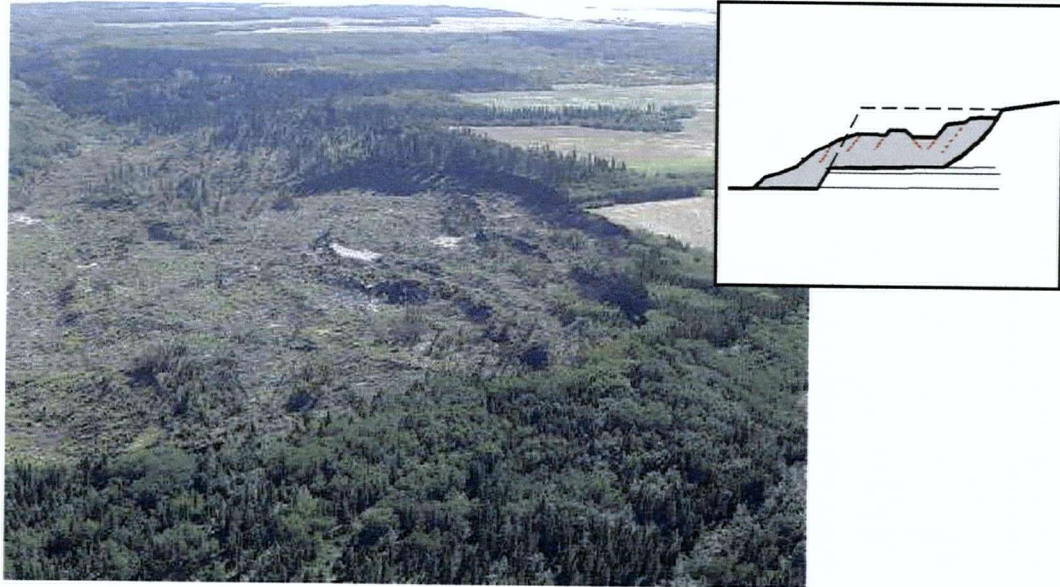
Figure 6.7 Slide Type 7: Compound Failure - Photo and Schematic Diagram (inset)

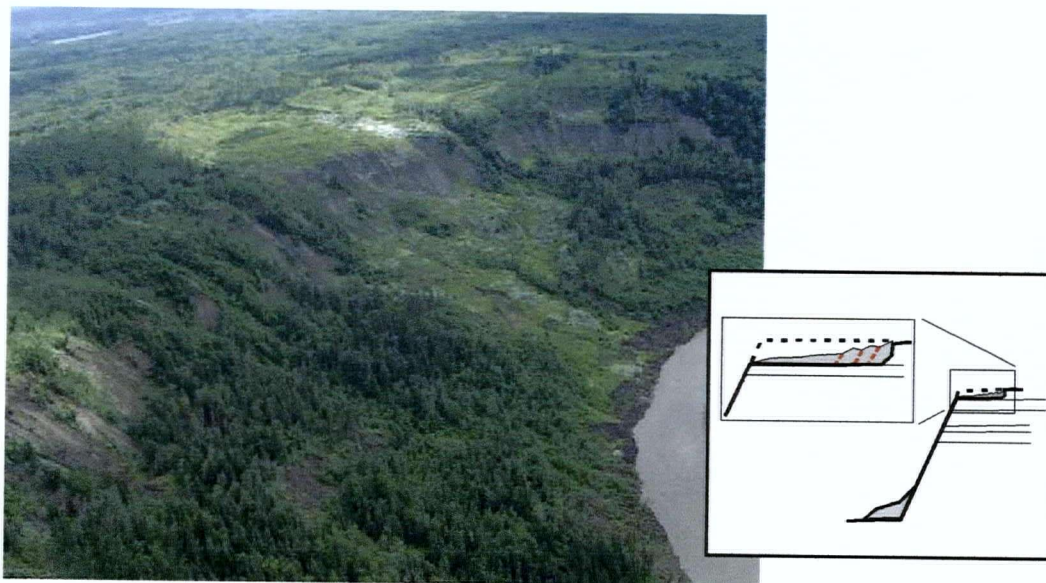
Figure 6.8 Slide Type 8: Shallow Retrogressive Failure - Photo and Schematic Diagram (inset)

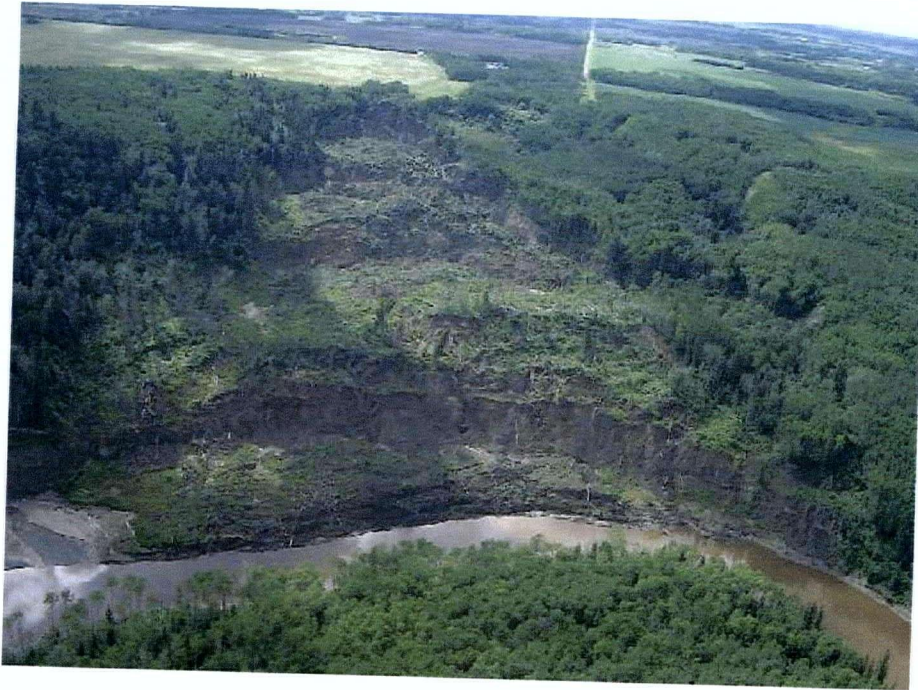
Figure 6.9 Very Active Landslide (Photo)

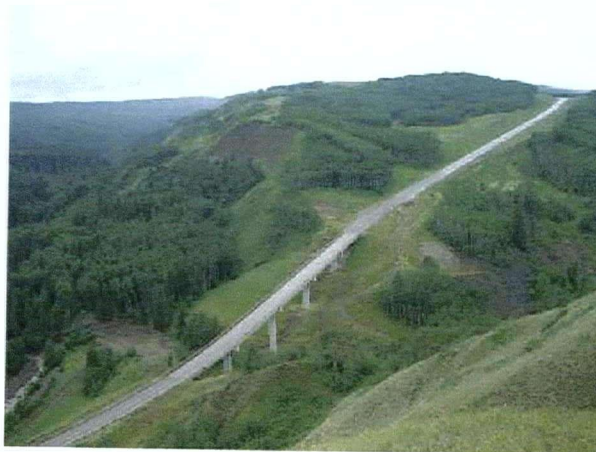
Figure 6.13 Modified Slide (Photo)

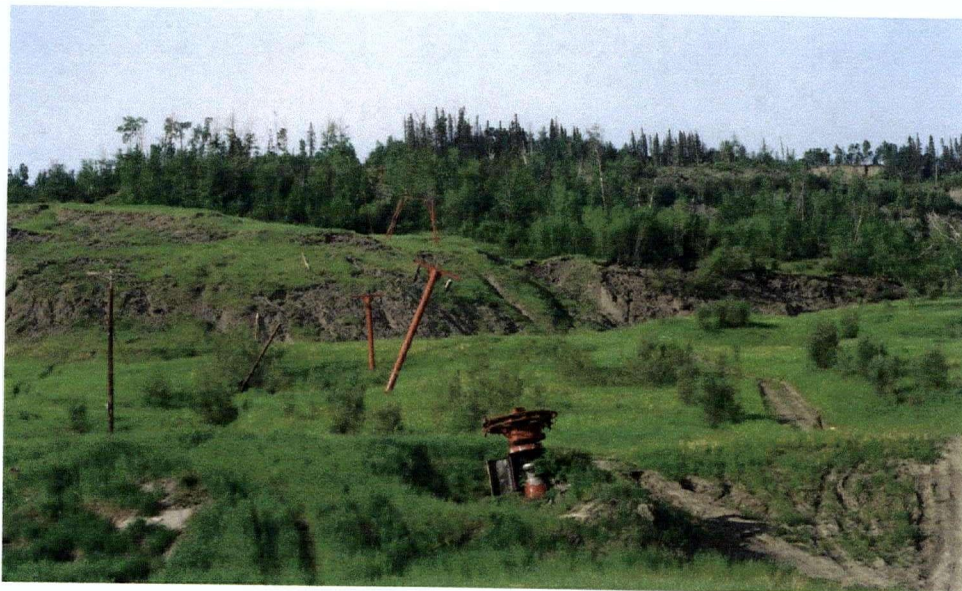
Figure 8.5 Former Big Bam Ski Hill Tower Line (Slide 1-2)

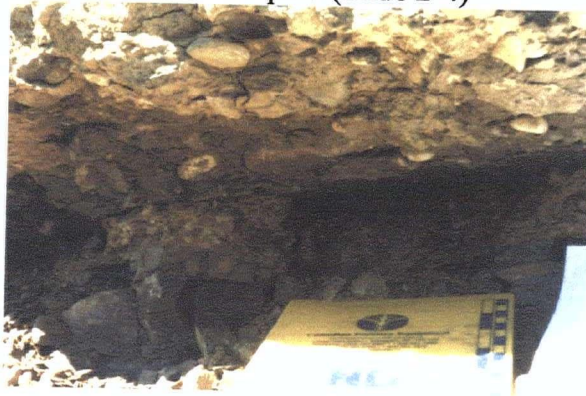
Figure 8.16 Shear Plane found and sampled (Slide 2-4)

of 53% and a low plasticity index of 23%. Below the gouge, a sheared surface in the shale was observed and found to consist mostly of silt, 85%, with a liquid limit of 41% and a plasticity index of 22%. Another intact section was beneath the upper failure made of weather shale. The rest of the slope is made of 2 inferred failure planes, both showing small, muted compound features (Figure 8.20). This slide shows 2 interesting features not seen elsewhere. The first is a large amount of cobbles near the base of a gully at the top

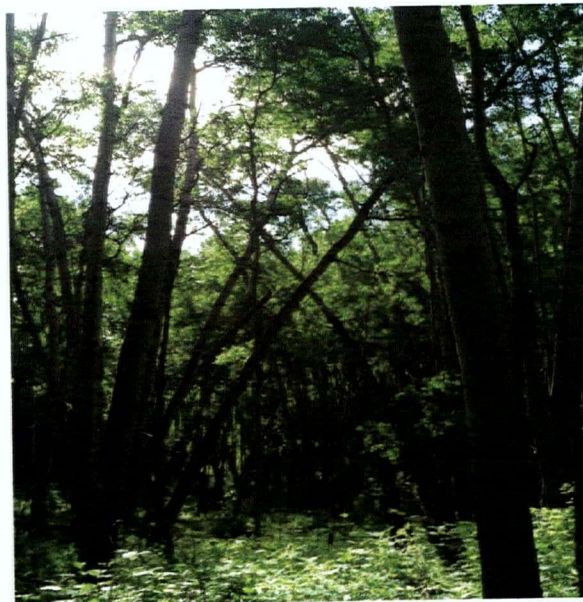
Figure 8.33 Cross-Tilting of trees on Landslide Profile 3-4

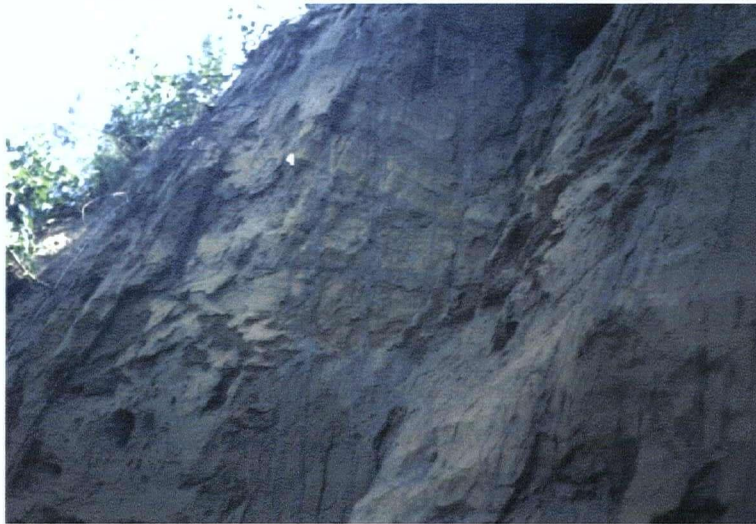
Figure 8.53 Intact Section Photo (Slide 4-1)

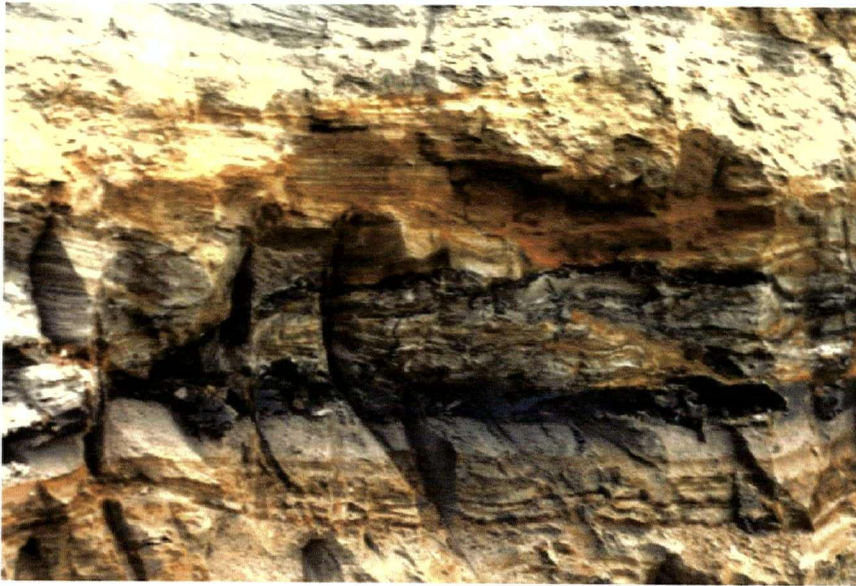
Figure 8.54 Complex Stratigraphy (Slide 4-4)
