BC CROWN CONTAMINATED SITES PROGRAM REMEDIATION OF THE HISTORIC MINE TAILINGS AT TWO MILE CREEK, NEAR HAZELTON, BC

Joanna Runnells, M.Env.Sc. Gregg Stewart, P. Geo.

ABSTRACT

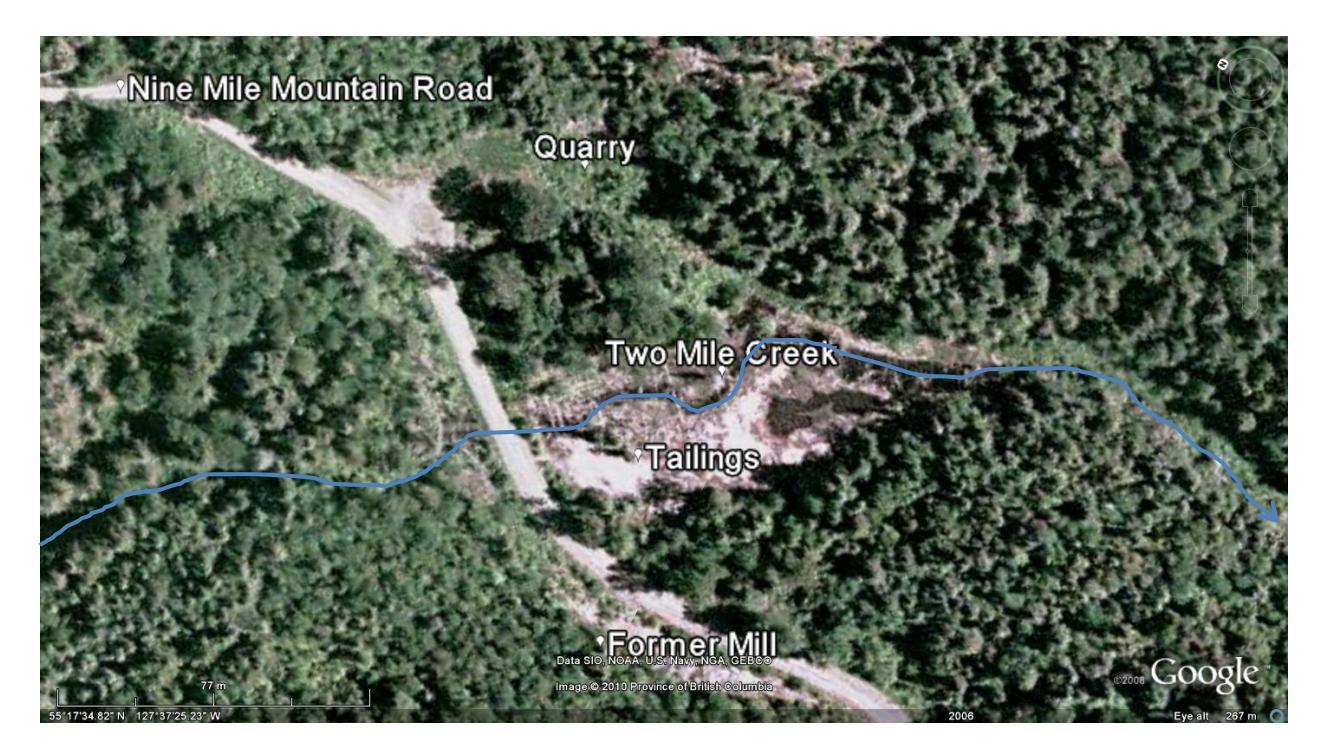
Figure 1: The tailing in Two Mile Creek, adjacent to Nine Mile Mountain Road. Two Mile Creek flows from left to right across the photo.

During the 2006 program, Two Mile Creek was observed to be flowing over areas of exposed tailings and eroding these materials into the creek. Downstream of the site, Two Mile Creek is used as a source of drinking water and irrigation water for the Village of Hazelton and Gitanmaax Band communities. A water treatment plant is located about 800 metres downstream of the tailings and treats water through slow sand filtration and chlorination.

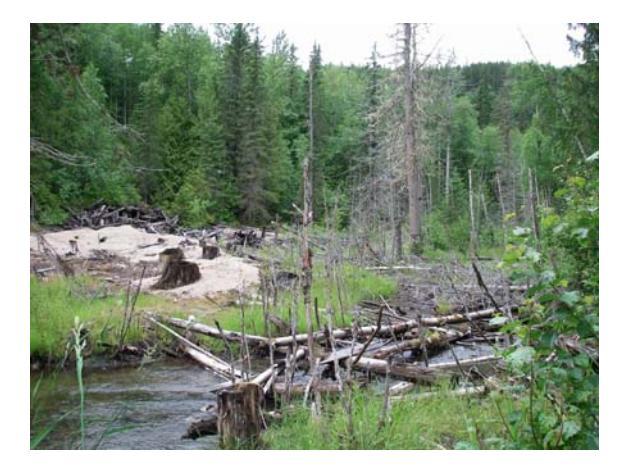
Photo 1: Looking upstream towards Nine Mile Mountain Road, Two Mile Creek on right, tailings on left.

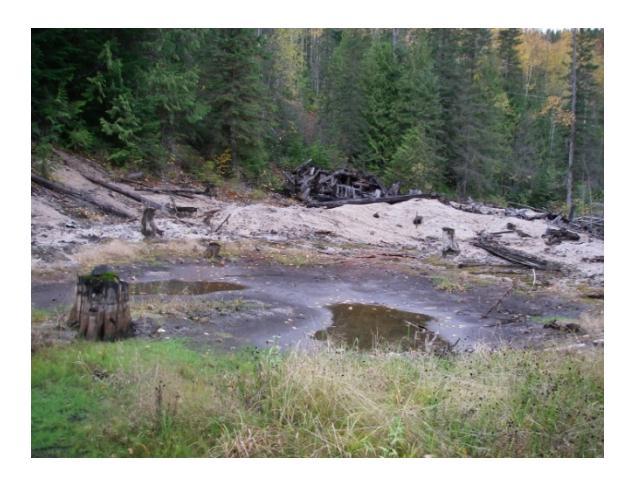
Photo 2: Ponded water with high metals concentrations at south end of tailings area.

Water sampling adjacent to the water treatment plant intake indicated that dissolved metals concentrations met the Health Canada drinking water quality objectives for all parameters analyzed. Two samples from ponded water on the tailings deposit had concentrations of dissolved iron and manganese greater than the drinking water standards. The sand filter removes suspended solids and thereby addressed concerns around elevated total concentrations for aluminum, arsenic, cadmium, iron, lead, and manganese found in creek samples.

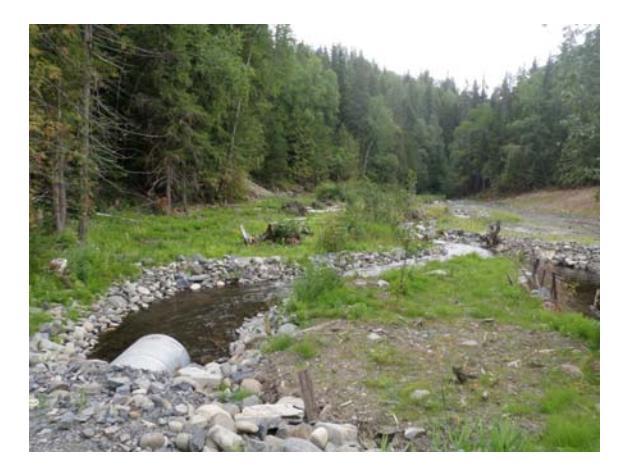
Photo 3: Looking downstream from Nine Mile Mountain Road post remediation and 2 months after reseeding August 2009.

Reclamation also involved realignment of Two Mile Creek. The creek bed was rebuilt and raised to establish a proper gradient. Boulders, fallen trees and root wads that had been saved during the excavation process were places along the creek as enhancement features. Flow was gradually re-established on October 25, 2008 and the creek was subsequently monitored closely to ensure banks and structures were stable. This met the Section 9 Approval deadline of October 31, 2008 for the completion of in stream works.

As the construction work was completed late in the year, re-vegetation occurred in the following spring. Spruce, hemlock, and alder seedlings were planted along the banks of the creek in June 2009. Topsoil was placed as needed and a local seed mixture was applied to the impoundment, the creek banks, and the excavated area. Water was applied numerous times during plantings and again a few weeks later. Photo 3 shows the creek and excavated area in August 2009, about two months after planting. Photo 4

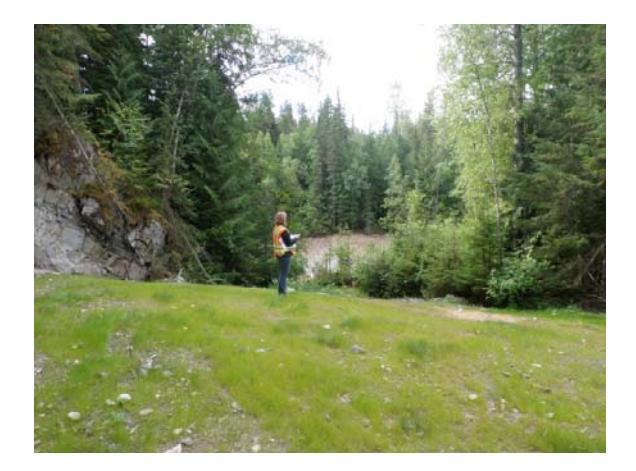
Photo 4: View from the top of the tailings impoundment, August 2009.

Based on the increased volume of tailings, the shape and size of the impoundment were altered. Instead of a large mound that drained in all directions at a 3:1 slope, the impoundment was piled highest closest to the quarry wall and was sloped downwards towards the northwest. The slope was lower (approximately 12.5 degrees) than the designed 3:1 angle due to the friction angle of the interface between the unbounded geonet and geotextile of the stockpile cap. Originally, non-woven geotextile bonded to geonet in factory was specified, but the approved alternative was Armtec 250 and Layfield Geo-Net (not bonded). Covering the impoundment involved placing a geomembrane (EnviroLine 404 (40 mil LLDPE) instead of 40 mil HDPE) over the stockpile and installation of a drainage trench along the quarry wall. A 100 mm Ø perforated HPDE drainpipe was installed to facilitate drainage. The geonet was placed over the geomembrane using zip ties to keep the net in place and then the geotextile was fit over the net. A layer of subsoil was placed on the geotextile. The same geotextile was used to cover the excavated area, and was covered with approximately 30 cm deep pit run material.
