**OUT-OF-PLANE STABILITY OF REINFORCED MASONRY SHEAR WALLS  
UNDER SEISMIC LOADING: CYCLIC UNIAXIAL TESTS**

**A THESIS SUBMITTED IN PARTIAL FULFILLMENT OF  
THE REQUIREMENTS FOR THE DEGREE OF**

**MASTER OF APPLIED SCIENCE**

**THE UNIVERSITY OF BRITISH COLUMBIA**

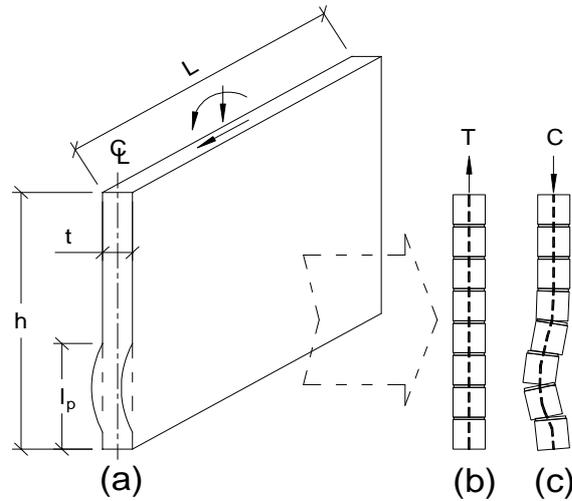
**Figure 1-1 Out-of-plane instability mechanism in a RM shear wall:**

a) buckled zone within plastic hinge region under axial and in-plane lateral loads, b) residual tensile cracks form following the application of tensile stress, and c) out-of-plane buckling of wall in compression.

Out-of-plane instability of shear walls, illustrated in Figure 1-1-a, is associated with their flexural response to in-plane seismic loads. A rational explanation for lateral instability of reinforced masonry shear walls was initially presented by Paulay (1986) and Paulay and Priestley (1993). When the wall experiences large curvature ductility, the vertical bars at one end of the wall experience large inelastic tensile strains. As a result, uniformly spaced horizontal cracks of considerable width develop over the plastic hinge length as illustrated in Figure 1-1-b.

Upon reversal of the loading direction, the tensile stresses in these bars will first drop to zero and then turn into compression stresses. At this stage, unless the cracks close, all compression stresses imposed on the wall section must be resisted by the vertical reinforcement, which offers very small stiffness against lateral deformation. This increases the likelihood of rapid out-of-plane displacements leading to out-of-plane instability as shown in Figure 1-1-c.

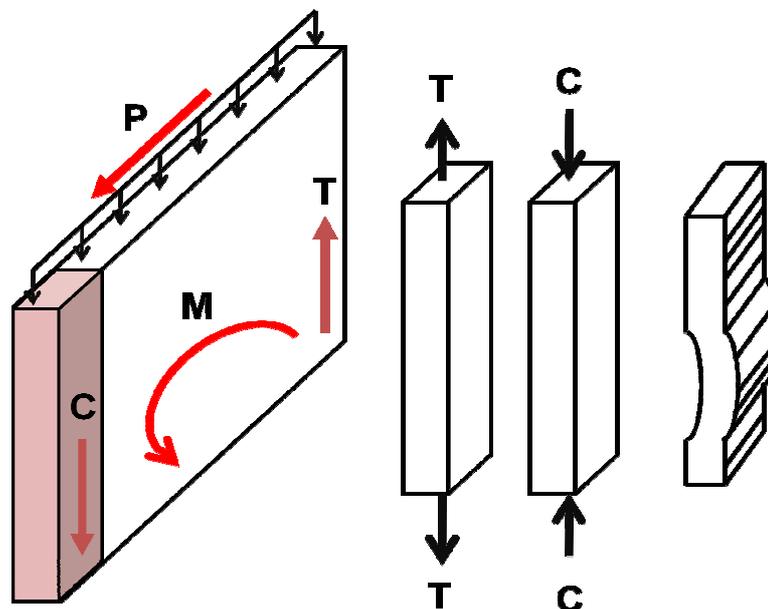
**Figure 3-1** End zone of shear walls subjected to axial loads during reversed lateral loading

Figure 3-1 shows a reinforced masonry shear wall subjected to gravity loads and in-plane lateral loads due to earthquake motions. An overturning moment is developed along the base of the wall, thereby putting end regions of the wall into alternating cycles of axial tension and compression. Based on the review of previous research studies, it is expected that the reinforcement in the end region of the wall is going to experience large tensile strains causing uniformly spaced horizontal cracks to develop in the plastic hinge zone at the wall end regions. When the wall is subjected to subsequent compression load cycles, it may experience out-of-plane displacements and possible out-of-plane instability, as illustrated in the figure.

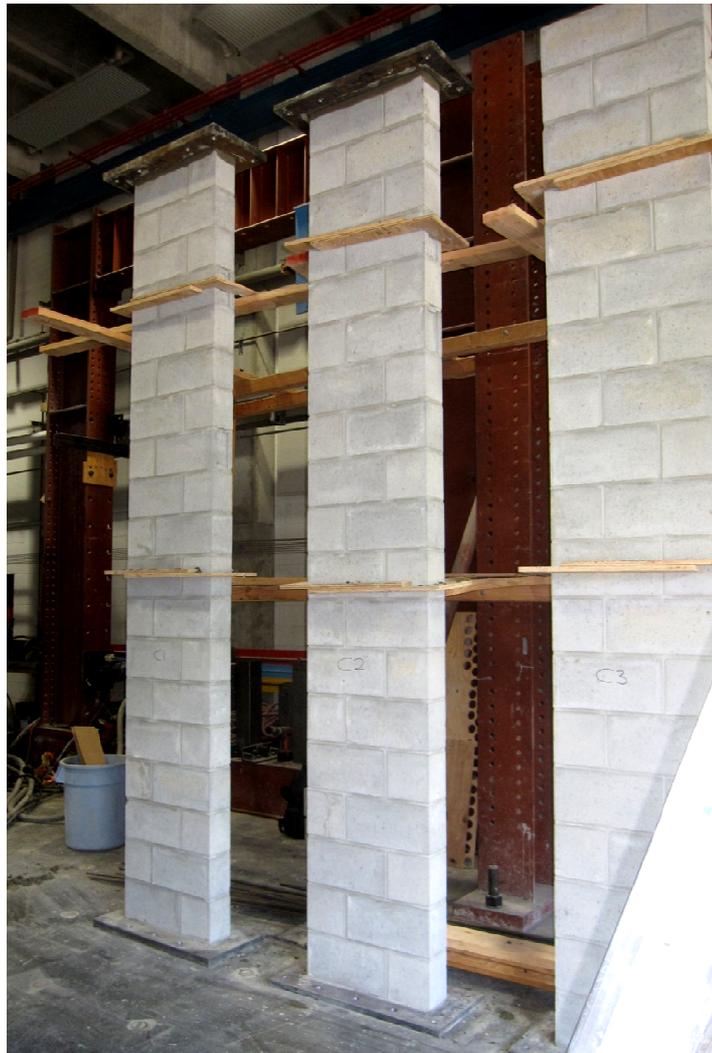
**Figure 3-2 Test specimens after the construction**

Five reinforced masonry uniaxial (column) specimens with nominal dimensions of 140 mm x 600 mm x 3800 mm (length x thickness x height) were designed for this study. All specimens had steel plates welded to the reinforcement at top and bottom. Figure 3-2 shows specimens after the construction.

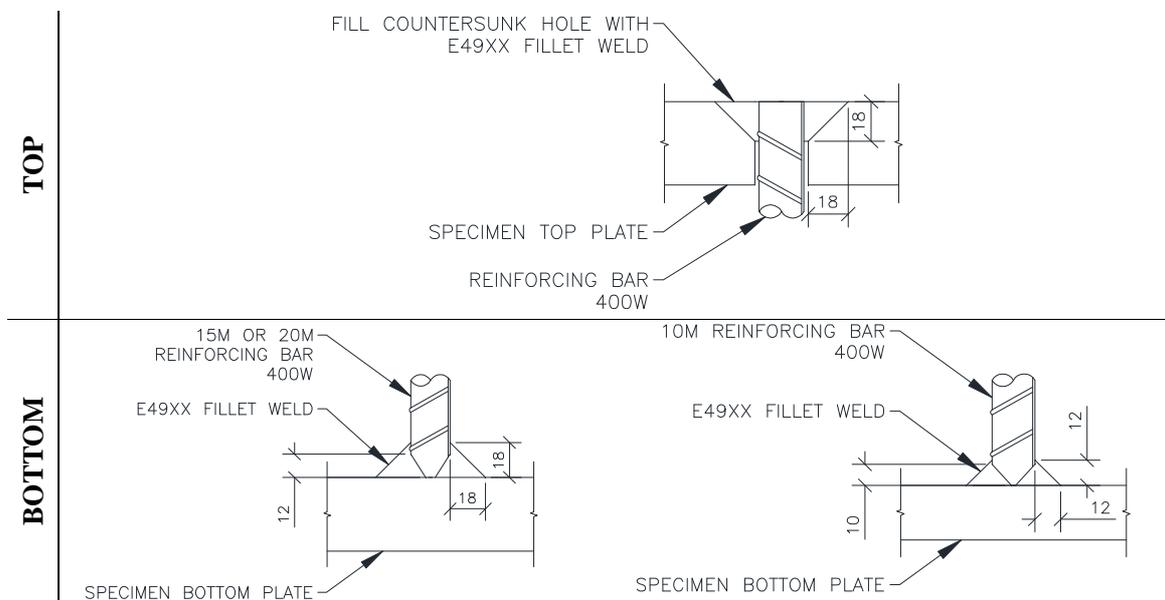
To this end, several welding details were designed and tested at BCIT (Lim, 2011). Figure 3-3 shows the welding details chosen as the most effective for the connection of reinforcement to the top and bottom specimen plates.

Note: the reinforcing bars were grinded to a pencil-tip shape at the bottom with a tip diameter of 5mm for 15M and 20M bars and 2 mm for 10M bars

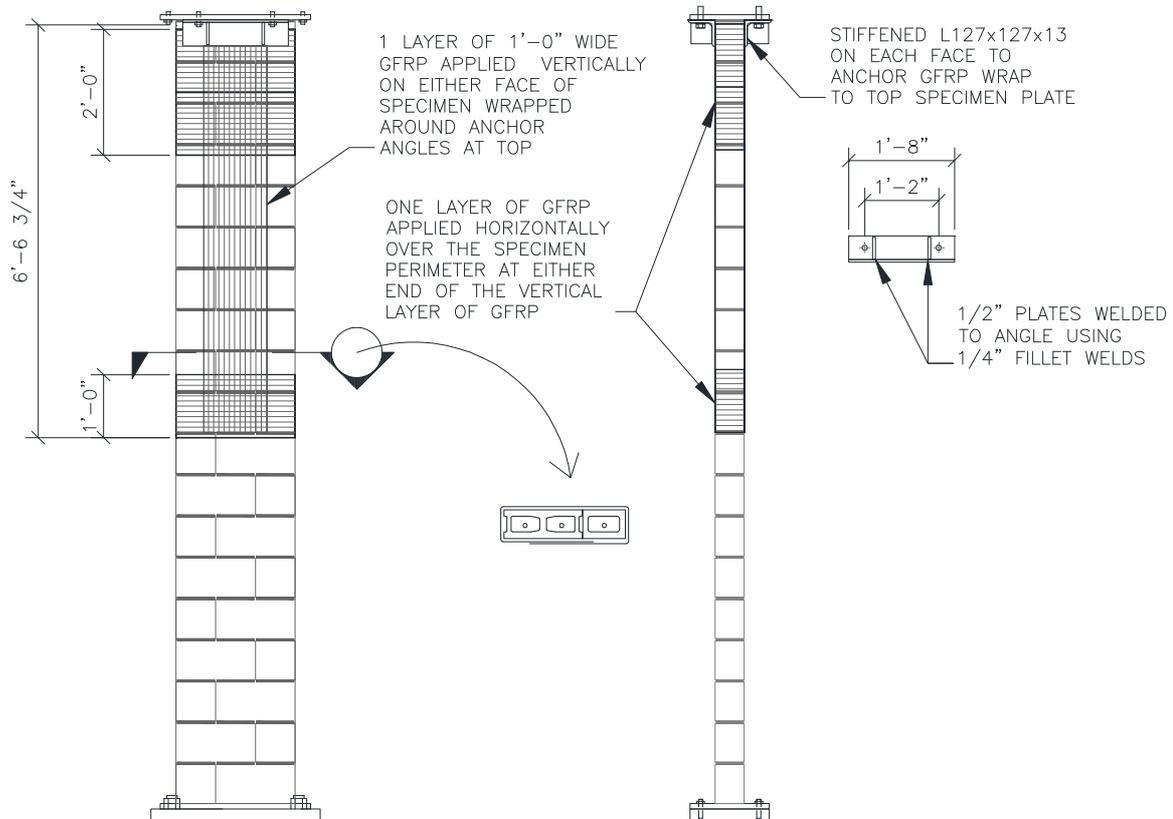
**Figure 3-4 Layout of SikaWrap 100G GFRP to the top half of specimens C3, C4 and C5**

As noted in Table 3-1, specimens C3, C4 and C5 were retrofitted with Glass Fiber Reinforced Polymer (GFRP) over the top half to limit their effective height over which tensile cracking occurs. For this purpose, SikaWrap 100G product was applied in horizontal and vertical direction, as shown in Figure 3-4.

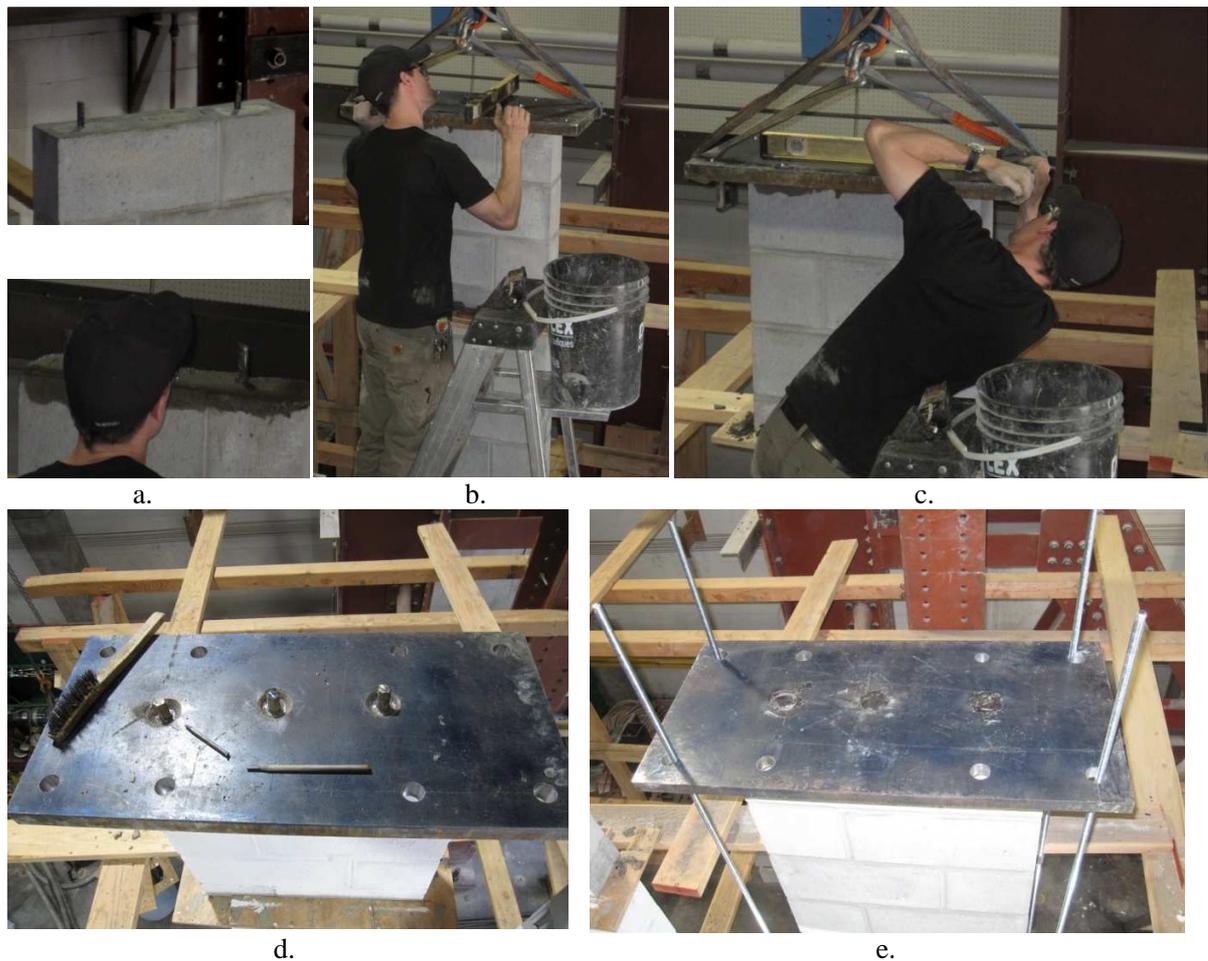
**Figure 3-7** Welding of reinforcing bars to the top specimen plate

In a similar approach to the development process of the weld detail for the bottom steel plates, the weld detail for the steel cap plates was chosen from amongst a set of proposed weld details that were tested earlier to ensure that the steel would yield and fracture without damaging the weld connection. Figure 3-7 shows photographs of the welding of the top plate.

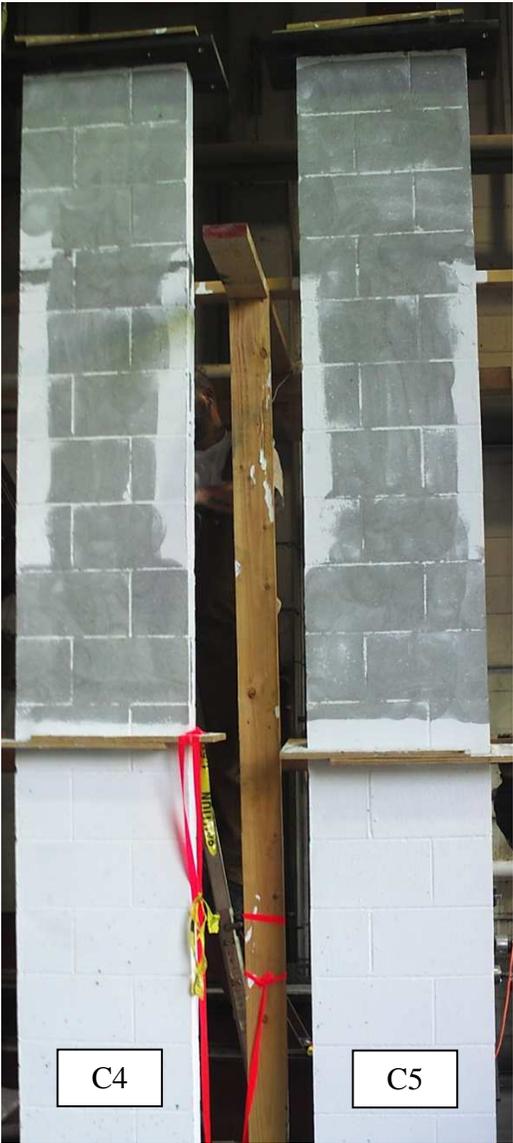
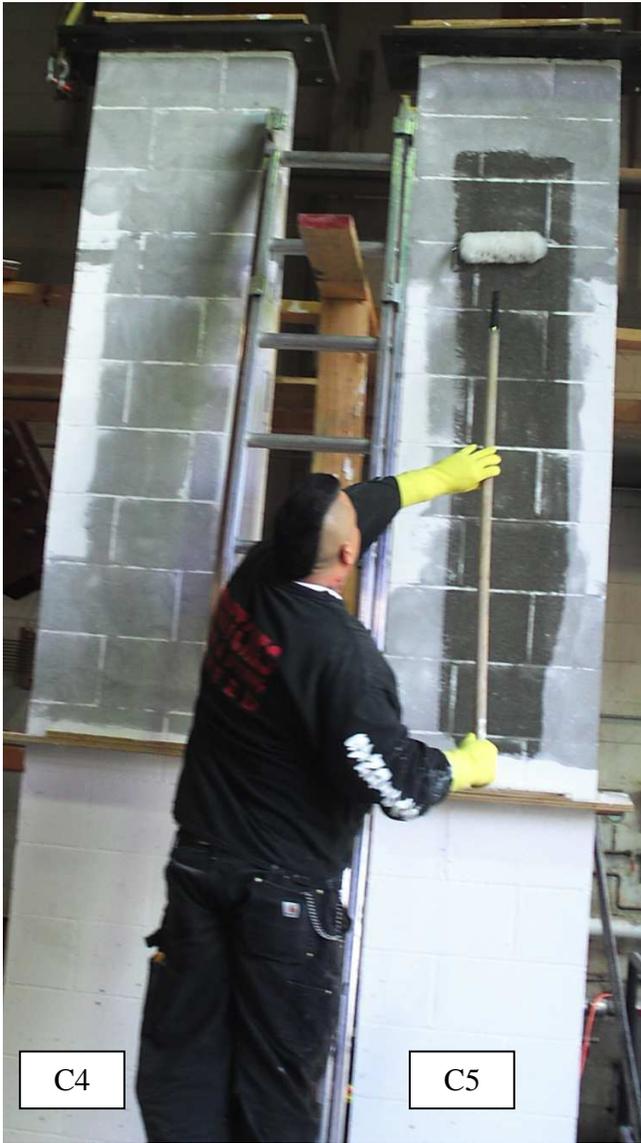
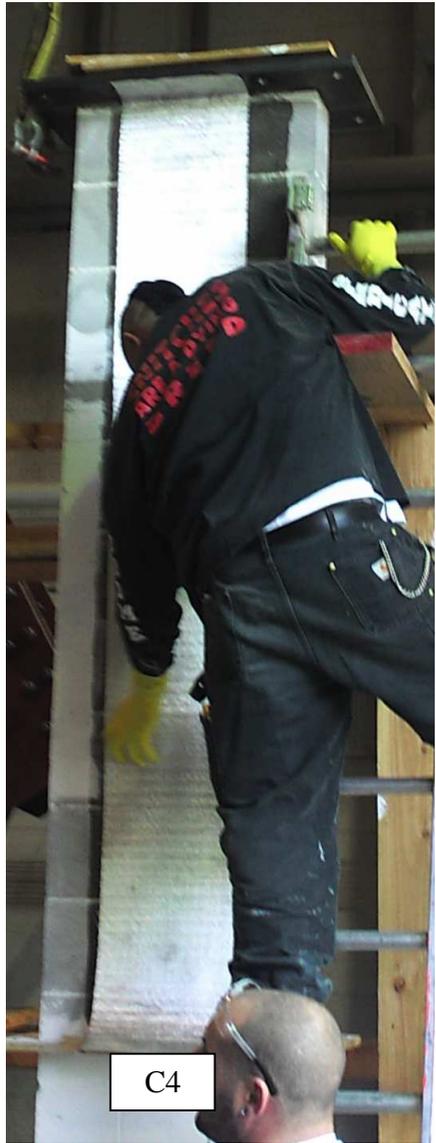
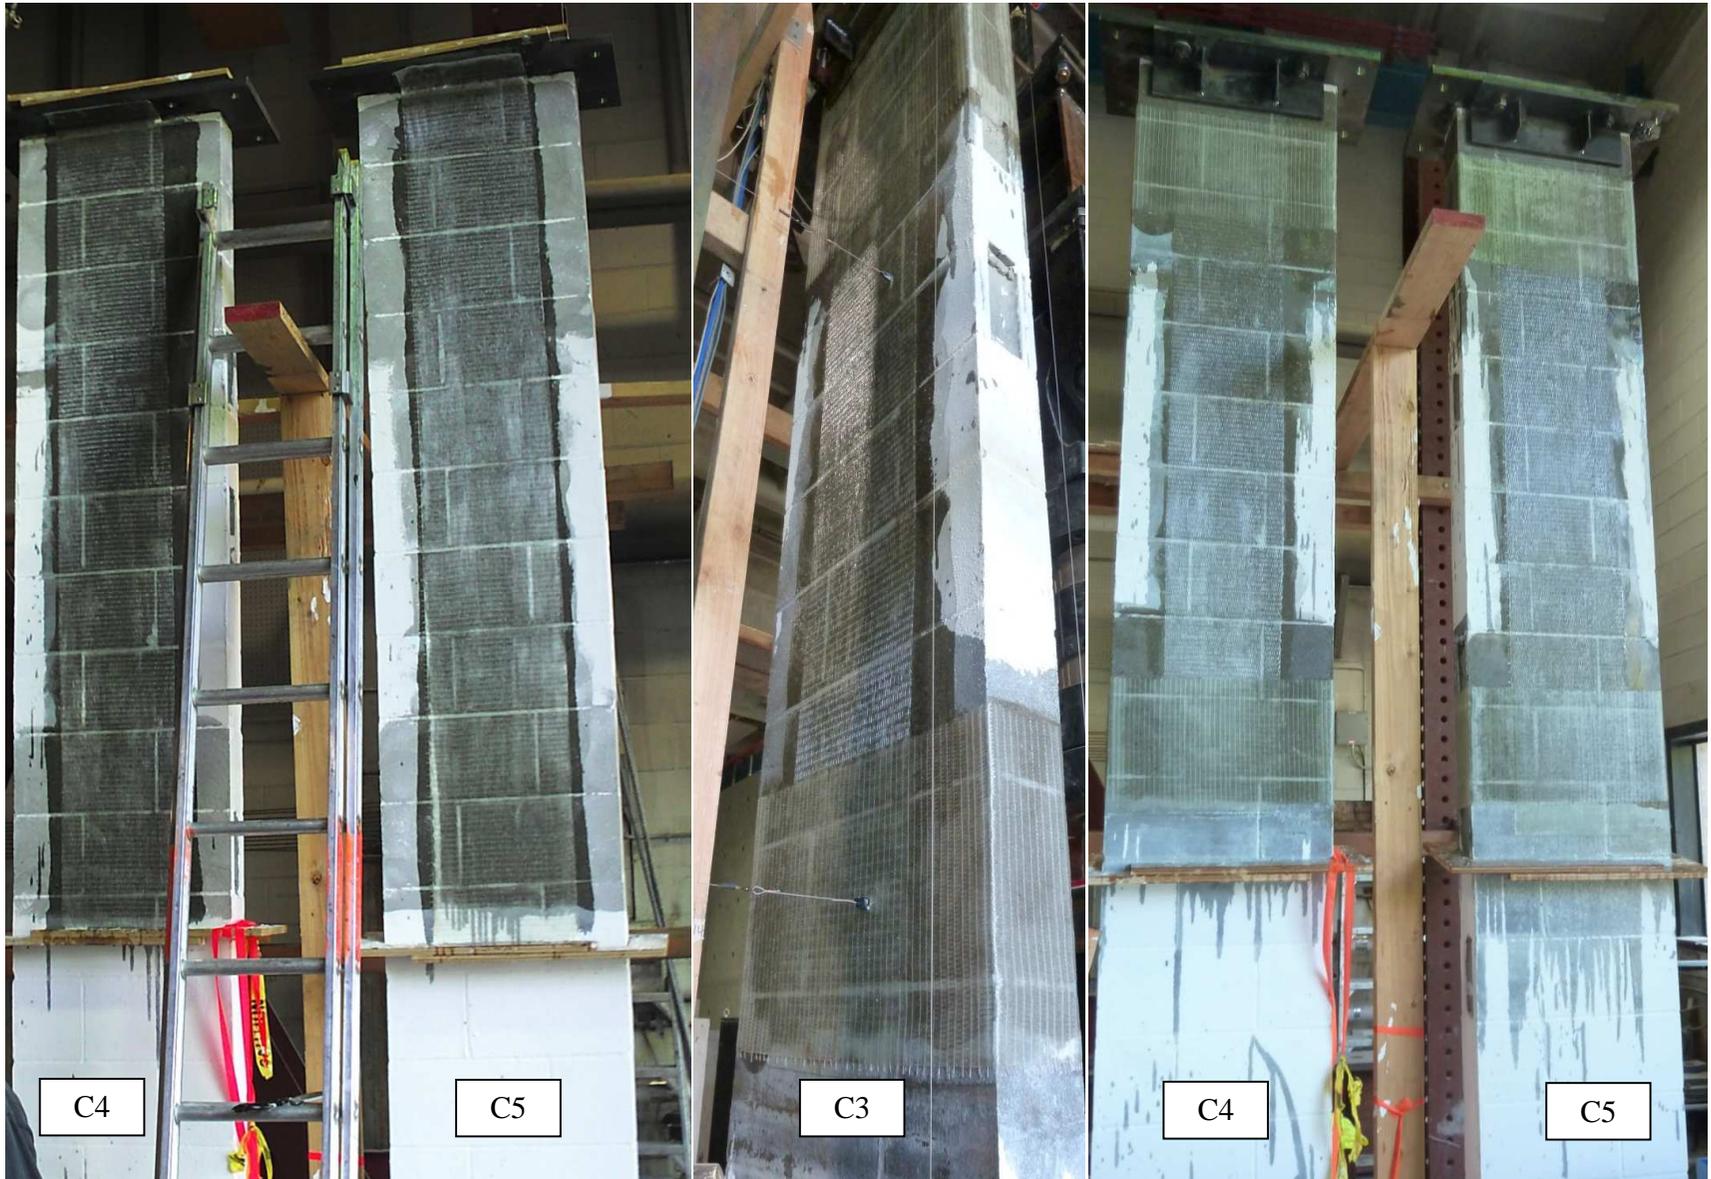
Figure 3-8 Application of GFRP over the top half of specimens C3 through C5

Specimens C3, C4 and C5 were reinforced with GFRP, as discussed in section 3.2.1. The surface over which the GFRP were to be applied was first cleaned and then grinded smooth. The SikaWrap-100G GFRP fabric was applied onto specimens using a two-part resin, Sikadur 300, as recommended by the manufacturer. Experienced contractors and authorized installers of Sika products carried out the surface preparation and installation of the GFRP. Figure 3-8 illustrates application of the GFRP.

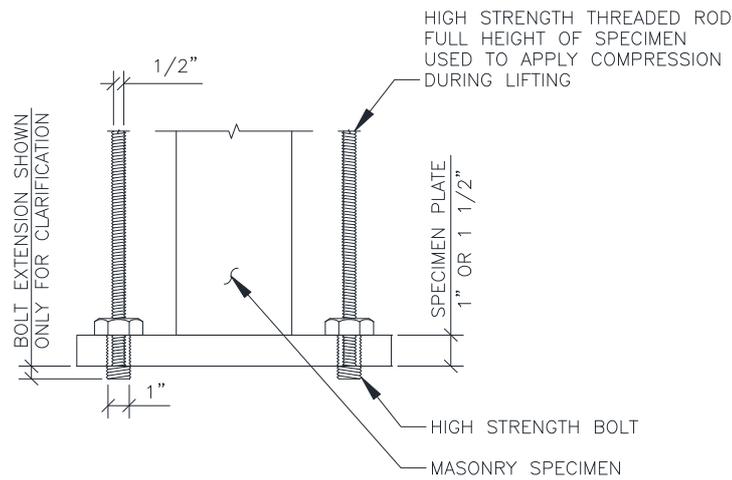
**Figure 3-9 Mechanism to connect threaded rods to bottom specimen plate**

Prestressing of the specimens during lifting was made possible by providing bolt holes in the top steel plates; the holes were drilled in line with those of the bottom plate. Four threaded rods extending the height of the specimens were used to prestress the specimen while it was being lifted and moved from the location of construction into the test rig. These rods were threaded into the bottom steel plate at each corner, via the connection detail shown in Figure 3-9.

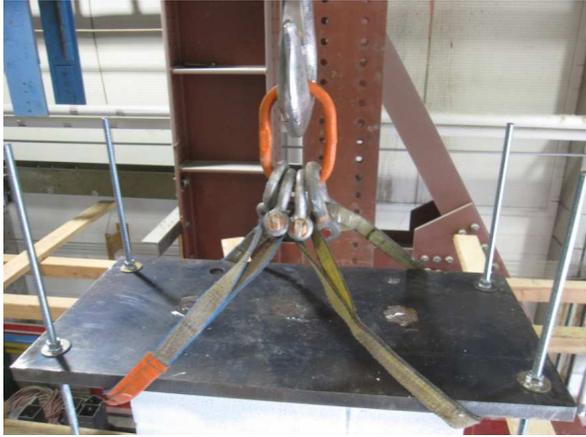
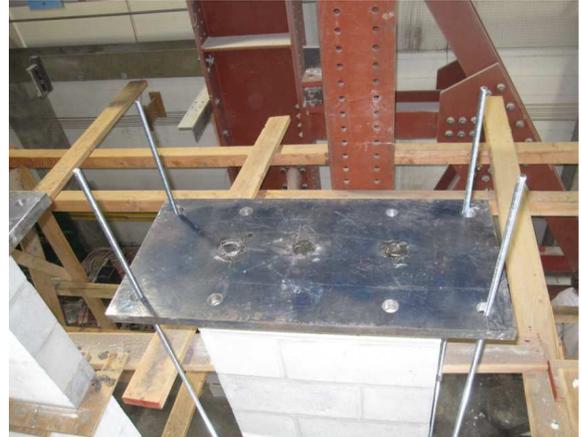
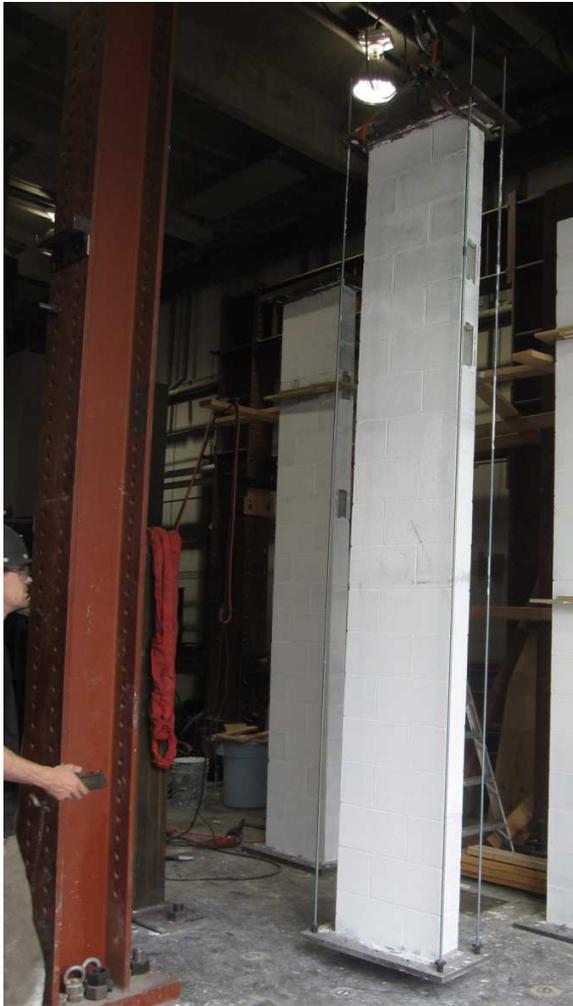
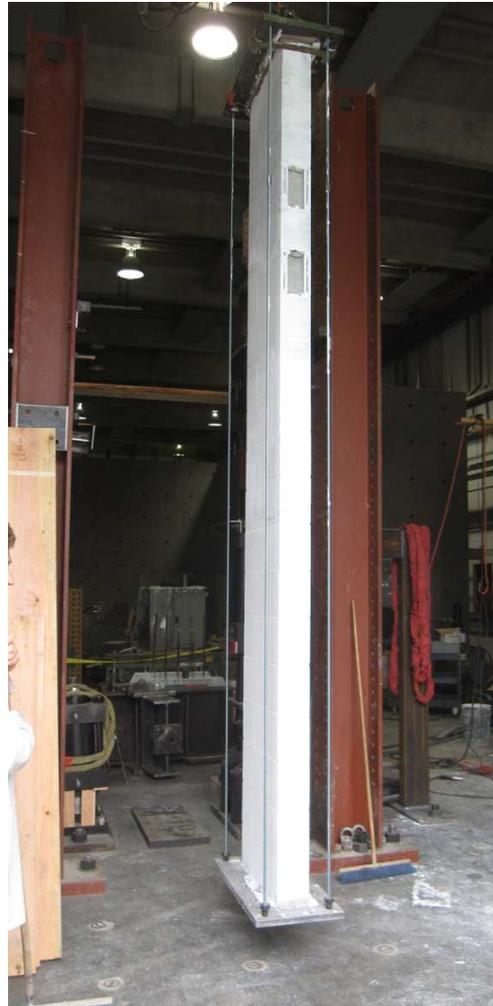
**Figure 3-10** Prestressing and lifting of the specimen into the test rig

The threaded rods extended over the entire specimen height and through the bolt holes in the top steel plate. The rods were fastened by nuts from above of the top steel plate and torqued to ensure no cracking would occur during the transport of specimens. Figure 3-10 illustrates prestressing of the specimen and moving it into the test rig using the ceiling crane.

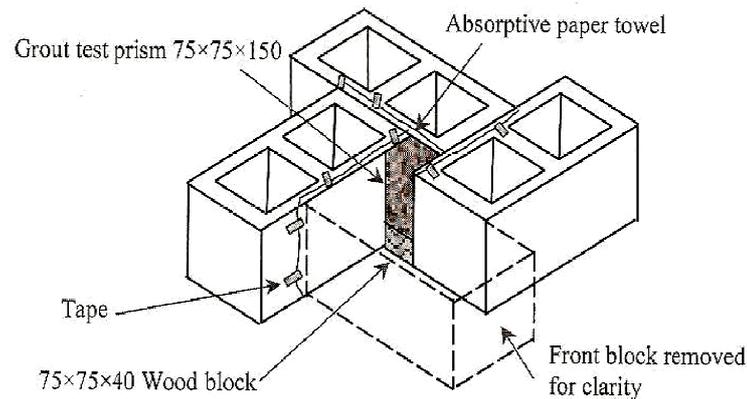
**Figure 3-11 Pinwheel method of preparation of grout prisms**

Grout prisms were prepared using the pinwheel method. This is done by placing four concrete masonry units perpendicular to one another, such that a square cylindrical shaft is formed in the center, as shown in Figure 3-11.

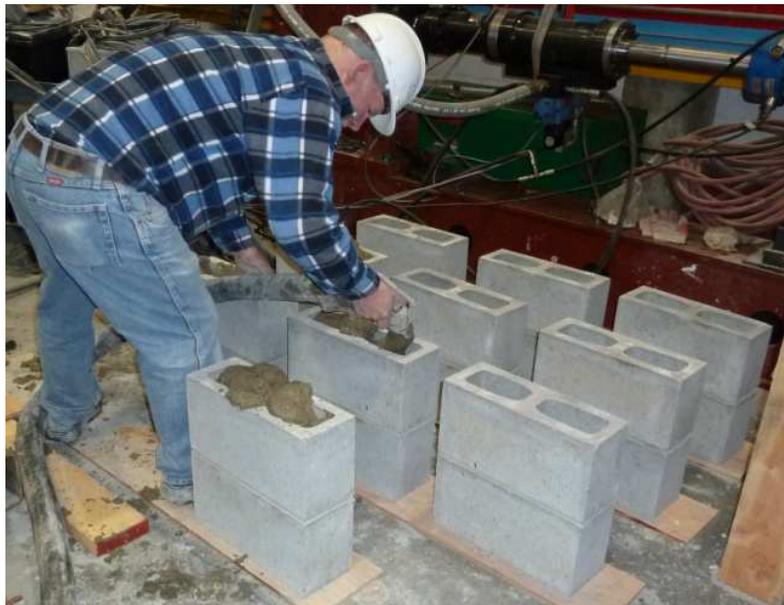
**Figure 3-12 Construction of masonry prisms**

To determine the compressive strength of grouted and hollow masonry, ten two-course high, stack bond, masonry prisms were prepared by an experienced mason using concrete masonry units from the same batch that was used to build the specimens. The mortar used was also from one of the mortar batches used in the construction. To reflect the same environment as the specimens, the masonry prisms were built adjacent to the specimens, while construction of the specimens was taking place. Five of the masonry prisms were fully grouted three days later, at the same time that the specimens' grout was poured. The remaining five prisms remained ungrouted.

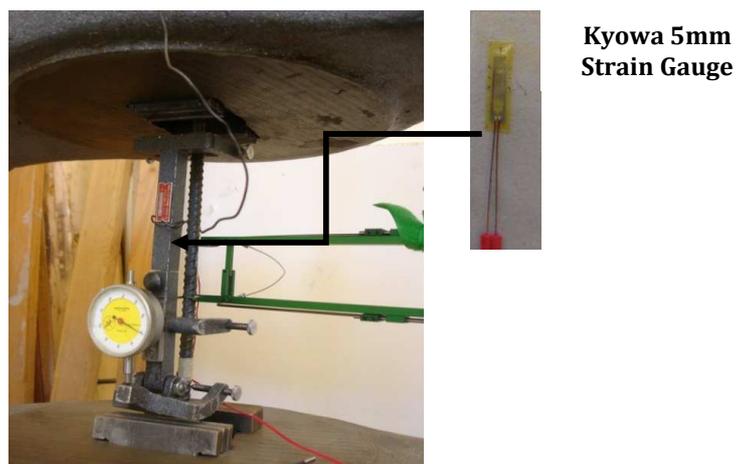
**Figure 3-13 Testing reinforcement bars in the Baldwin universal testing machine**

Each steel rebar sample was prepared according to CSA-G30.18-M92 (R2002) and ASTM A370 standard, Section A9.3. The loading rate was applied according to the ASTM A370 standard, Section 7.4. Tensile strength of reinforcing bars was determined by testing bar specimens in a Baldwin Wiedemann BTE-120 universal testing machine at BCIT. A 200 mm manual dial gauge and Kyowa electronic strain gauge were used to measure strains during the test. The Kyowa electronic strain gauge was glued to the specimen and fed strain deformation data directly into the DAQ6 data acquisition program. The loading information was fed directly from the test machine. Table 3-6 summarizes the test results.

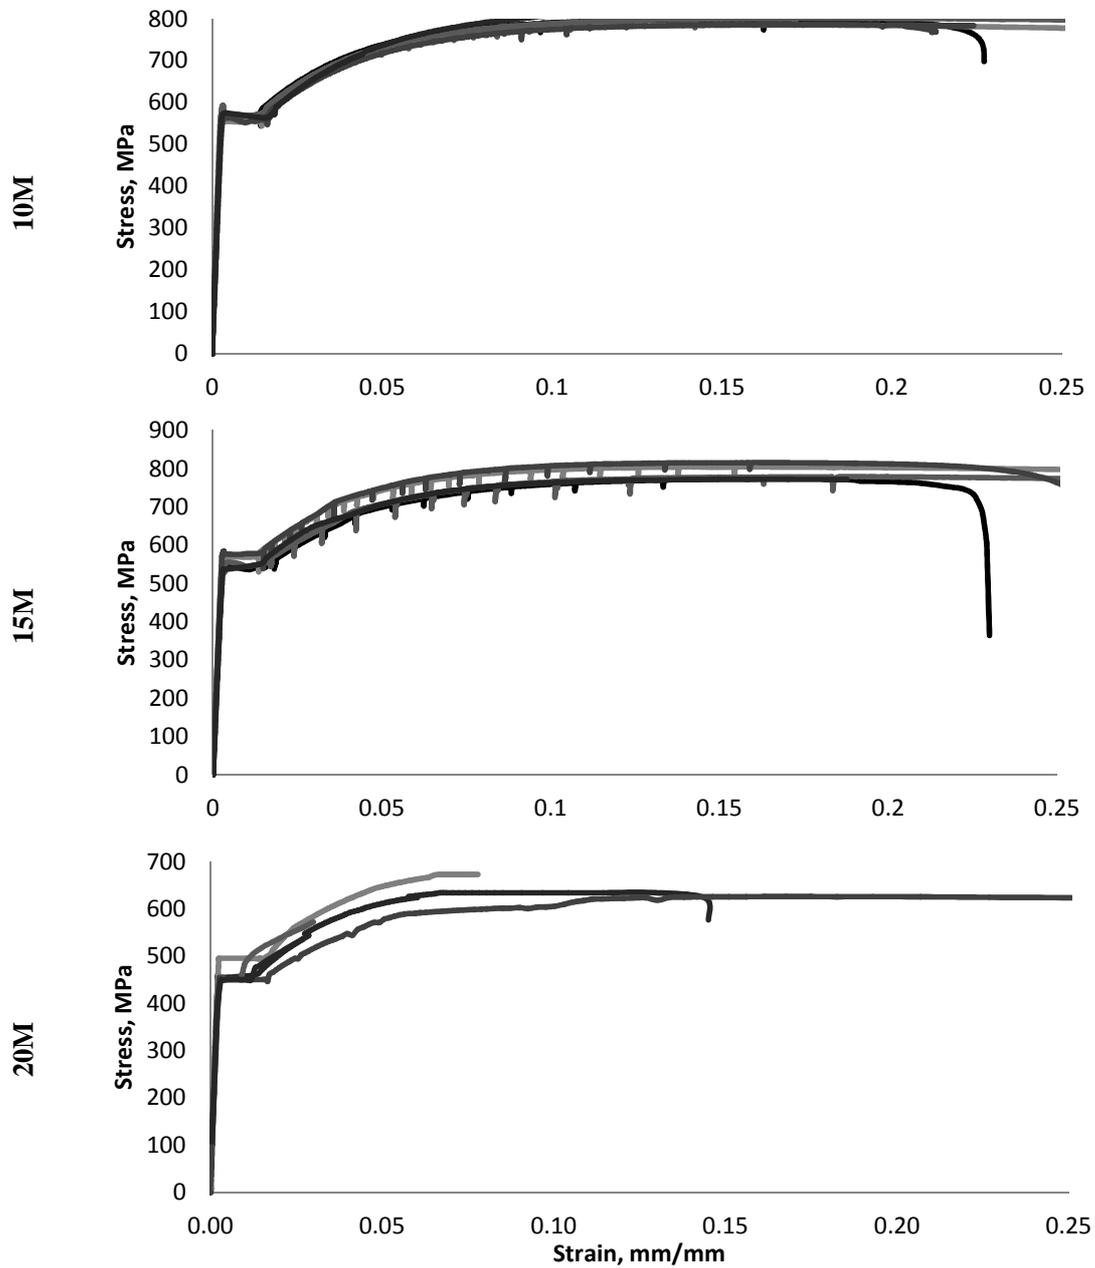
**Figure 3-14 Stress-strain relationship for reinforcing bars**

The reinforcing steel satisfied the minimum requirements outlined by CSA G30.18-M92<sup>1</sup> with respect to minimum yield strength and elongation of 400 MPa and 13% elongation at rupture respectively. Figure 3-14 illustrates average stress-strain relationships for each size of bar based on strain-gauge measurements.

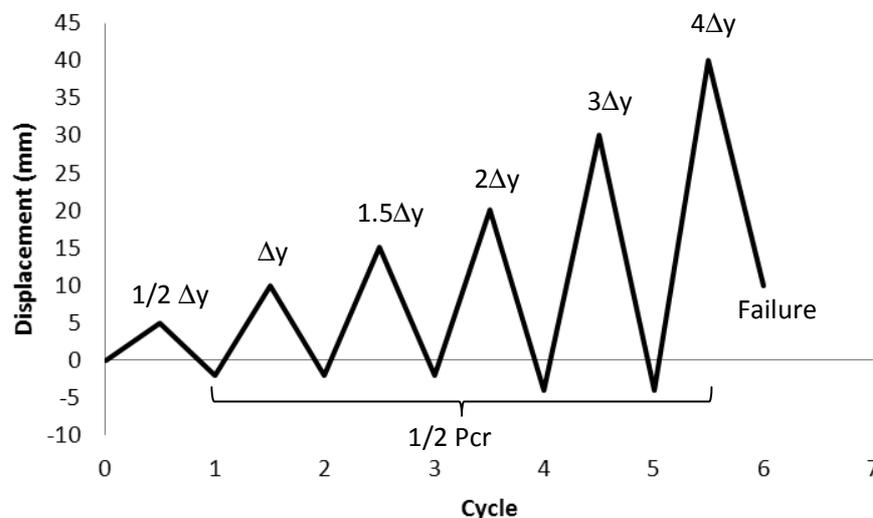
**Figure 3-19 Loading protocol for specimen C2**

In the tension cycles, the specimen was subjected to displacements equal to increasing multipliers of the yield displacement. The yield strain for steel reinforcement of 0.0026 used in the test was obtained from the tensile testing of bar samples. For example, the tensile displacement corresponding to yield,  $\Delta_y$ , was approximately equal to 10 mm for specimen C2. Compressive displacements were incrementally increased until a load approximately close to one-half of the crushing load for the specimen C1, ( $P_{cr}/2=700$  kN) was reached. Figure 3-19 shows the loading protocol for specimen C2.

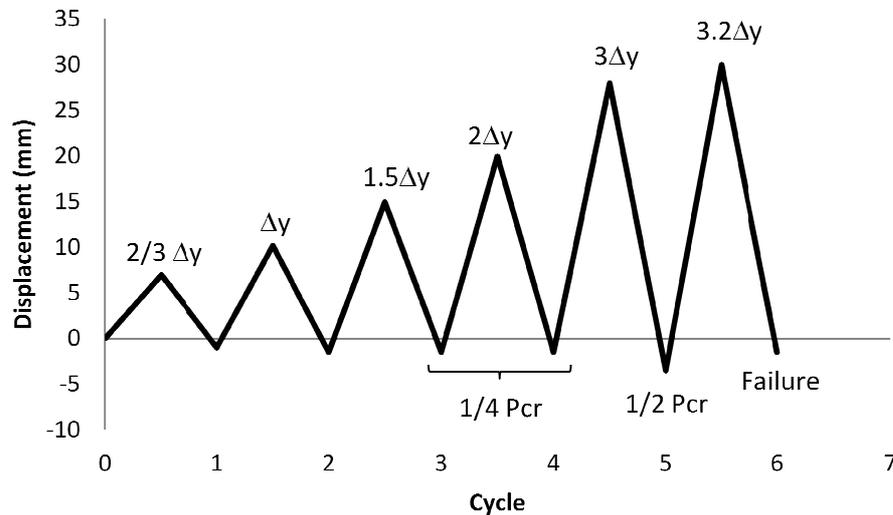
**Figure 3-20 Loading protocol for Specimen C3 after the retrofit**

crushing strength. Out-of-plane displacements were closely monitored after the tensile displacements reached  $2\Delta_y$ . This was done in an effort to close in on the actual tensile strain level past which the specimen becomes susceptible to out-of-plane instability. Figure 3-20 shows the loading protocol for specimen C3.

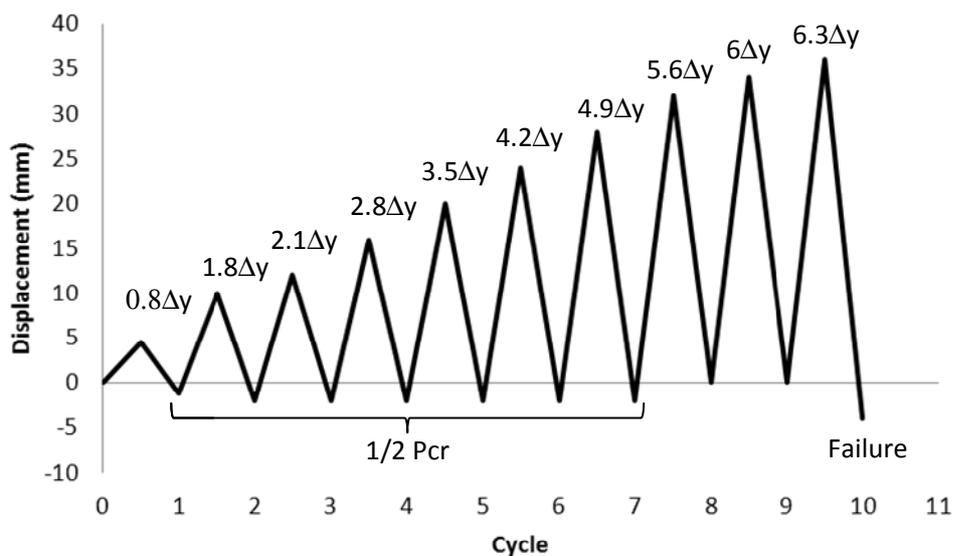
**Figure 3-22 Loading protocol for specimen C5**

The specimen was subjected to a similar loading protocol to that used for the testing of specimens C2, C3 and C4. The estimated yield displacement ( $\Delta_y$ ) was 5.7 mm. In compression, maximum displacements corresponded to half the crushing strength of the specimen ( $P_{cr}/2$ ). However, near the end of the experiment, the specimen was only subjected to compression until the cracks closed, since there were concerns that it would fail prematurely in local crushing. Figure 3-22 shows the loading protocol for specimen C5.

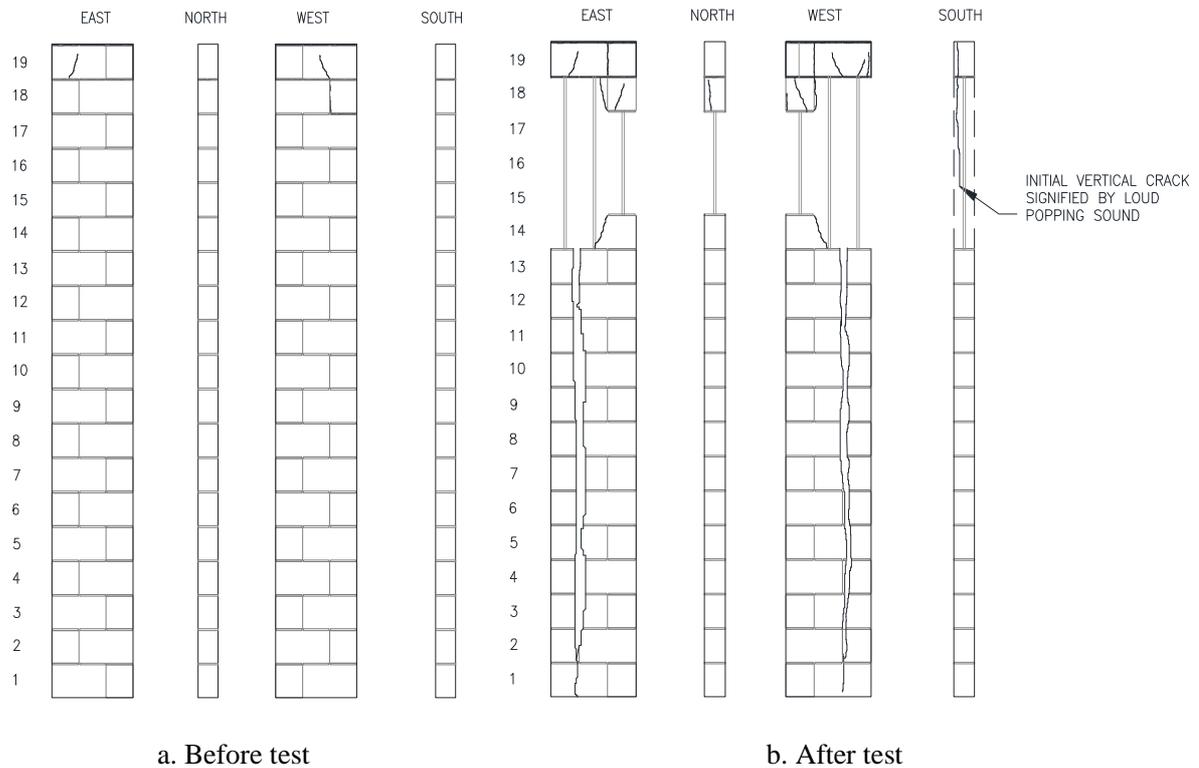
**Figure 4-1 Crack pattern for Specimen C1**

the top six courses and the propagation of the vertical crack. Face shell spalling occurred on the east face; this is typical of a crushing failure as shown in Figure 4-1b. Also shown in Figure 4-1b is the full-height continuous vertical splitting crack which was observed on the south face. The location of this large splitting crack coincided with the head joint between half-block and full-size (stretcher) block.

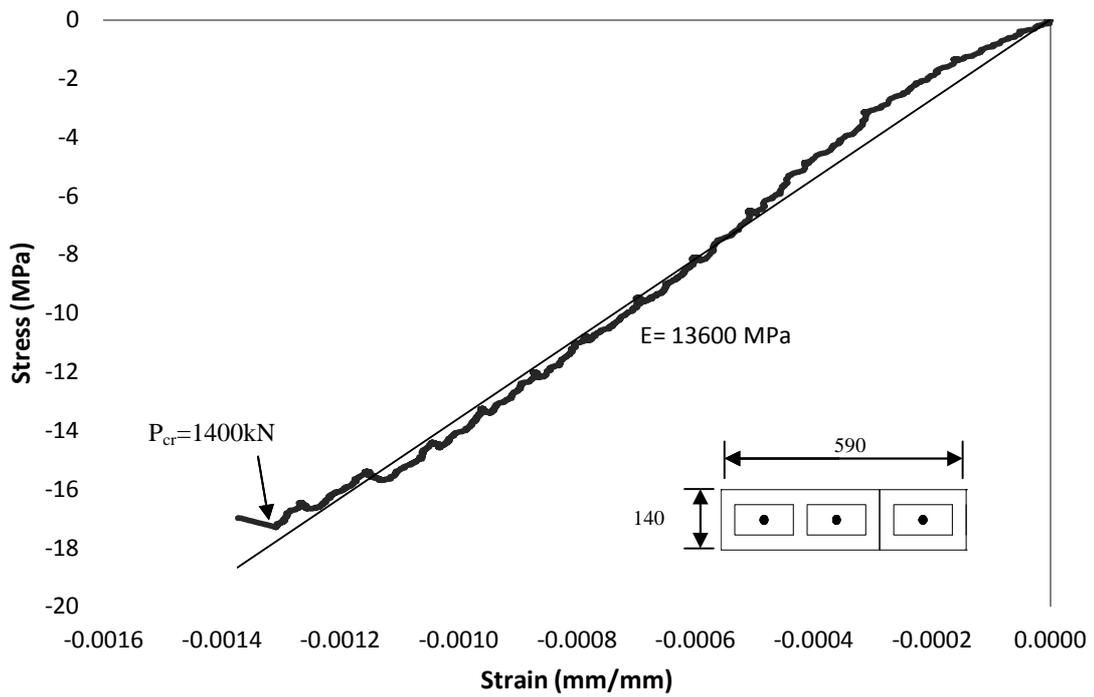
Figure 4-3 and Figure 4-4 illustrate the axial load vs. total axial deformation and axial load vs. lateral deformation at midheight for specimen C1 respectively. As indicated on Figure 4-3, specimen C1 failed at a compressive load of about 1400 kN (corresponding to compressive stress of 17 MPa). This stress is significantly less than the masonry compressive strength ( $f'_m$ ) value of 23.2 MPa obtained through material testing (see Section 3.2.3.4). The maximum capacity of the specimen was achieved at a compressive strain level of 0.13%. Based on the compressive response of the specimen, elastic modulus for masonry ( $E$ ) of 13.6 GPa was calculated.

**Figure 4-3** Axial stress vs. axial compressive strain response for specimen C1

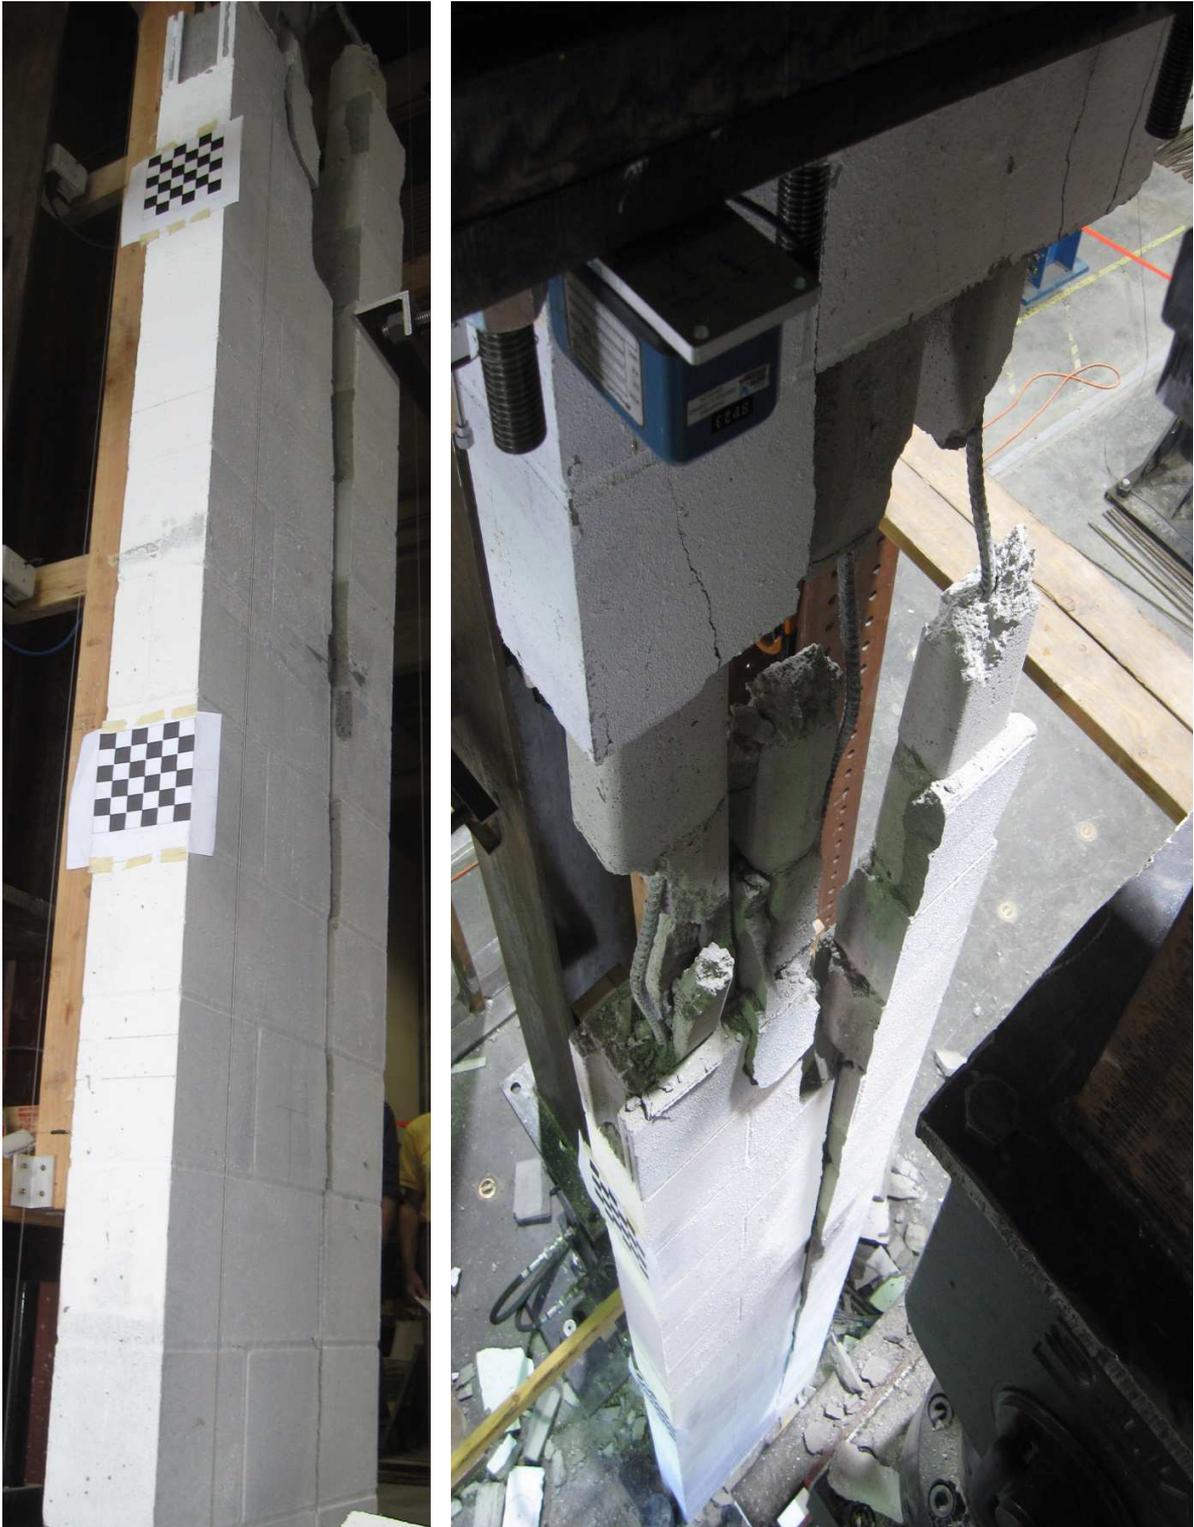
It is noteworthy that two reinforcing bars were bent westwards (in the direction of the lateral deformation of the specimen) as shown in Figure 4-5 (right). After the grout hardened, it was noticed that these reinforcing bars were slightly offset with regards to the centerline towards west, as shown in Figure 4-2. The third reinforcing bar (located closer to the centerline of the specimen) was bent in the plane of the specimen.

**Figure 4-5** Specimen C1 at failure: note a continuous vertical splitting crack along the end block core (left) and disintegration of masonry in the crushed portion of the specimen (right)

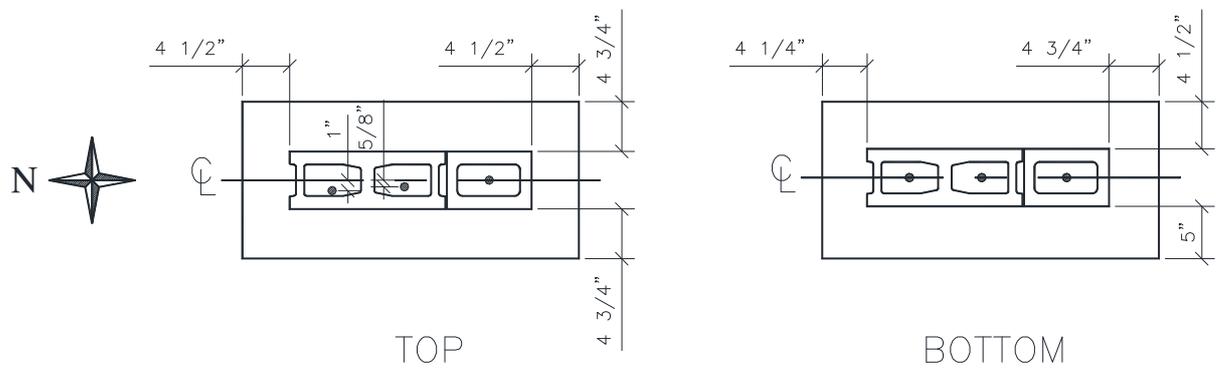
**Figure 4-6 Specimen C2 cross-section and reinforcement layout relative to top and bottom specimen plates**

As mentioned previously, reinforcing bars in all specimens were welded to top and bottom steel plates, which were subsequently attached to the strong floor at the bottom and to the floating loading beam at the top through bolted connections. During the construction of specimen C2, the reinforcing bars were welded to the bottom specimen plate exactly along the centerline of the bottom specimen plate. However, it was noted that masonry blocks were not perfectly centered on the specimen plate. Figure 4-6 shows the plan view of the specimen in relation to the top and bottom specimen plates.

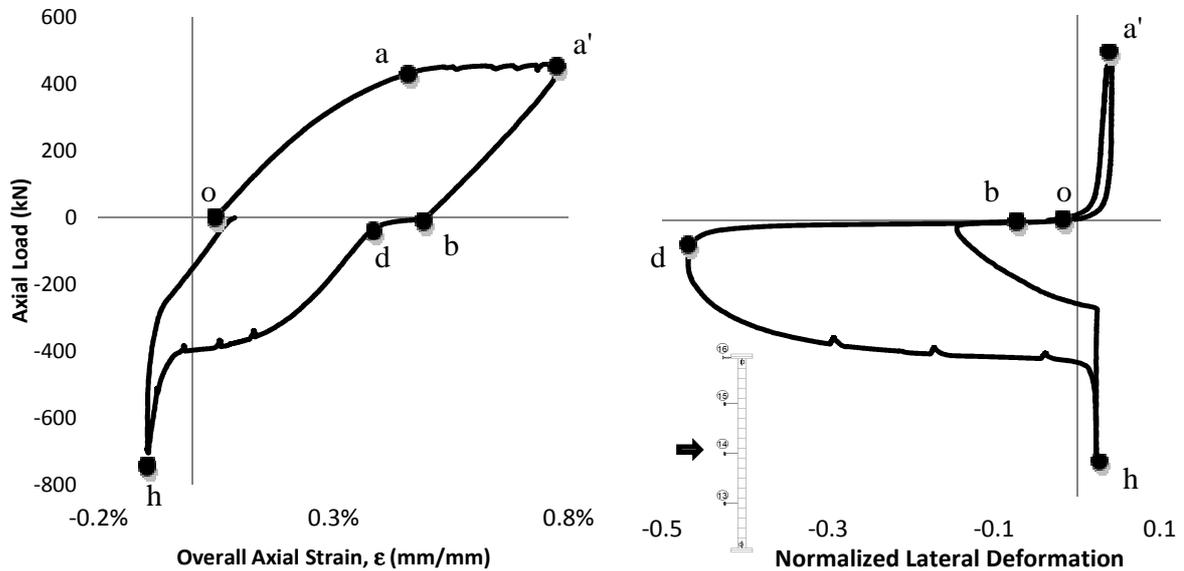
normalized by specimen thickness. The points **o** through **h** identified on these two plots indicate the important events that were observed during a typical loading cycle.

**a.** Applied axial load vs. axial strain over the plastic hinge region

In general, horizontal cracks developed along bed joints during the tension portion of each loading cycle, shown in Figure 4-7 as the path along points **o** through **b**. Examples of such horizontal cracks are shown in Figure 4-8. Point **a** on the plot of axial load vs. axial strain corresponds to the yielding of reinforcement. Although there were no strain gauges attached to the reinforcement, the yielding of reinforcement was easily identifiable by the onset of a plateau in the loading. At the peak of the tension half cycle, identified by point **a'**, the horizontal cracks reached their maximum size. The crack pattern at the peak of each loading cycle is shown in Figure 4-9.
