**OUT-OF-PLANE STABILITY OF REINFORCED MASONRY SHEAR WALLS  
UNDER SEISMIC LOADING: CYCLIC UNIAXIAL TESTS**

**A THESIS SUBMITTED IN PARTIAL FULFILLMENT OF  
THE REQUIREMENTS FOR THE DEGREE OF**

**MASTER OF APPLIED SCIENCE**

**THE UNIVERSITY OF BRITISH COLUMBIA**

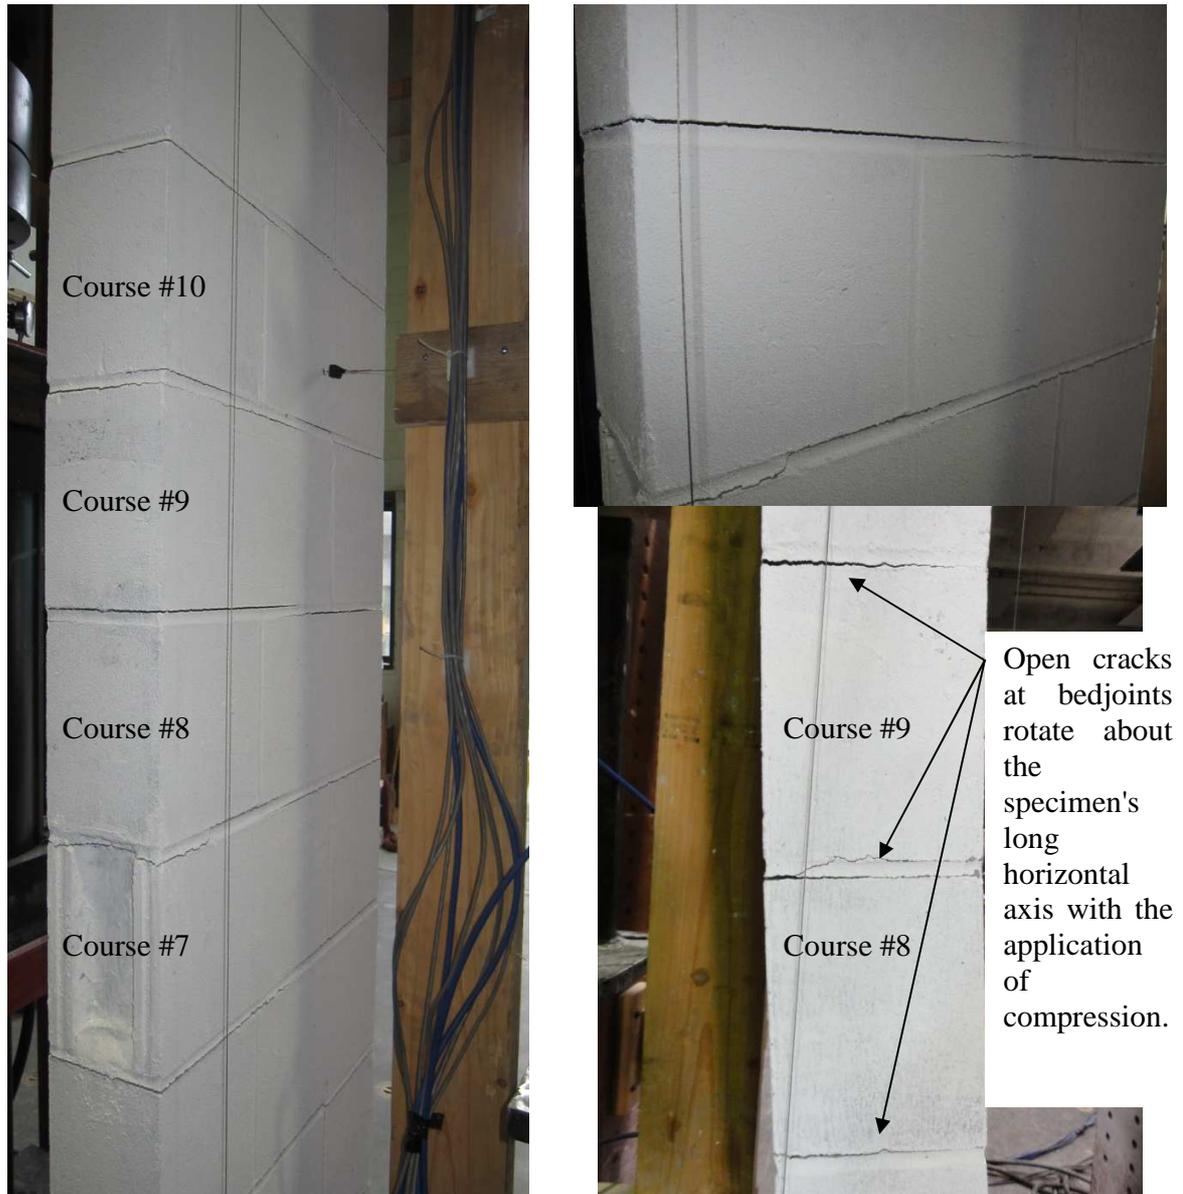
**Figure 4-8 Uniformly distributed horizontal cracks developed in specimen C2 along mortar bed joints during a tension loading cycle**

In general, horizontal cracks developed along bed joints during the tension portion of each loading cycle, shown in Figure 4-7 as the path along points **o** through **b**. Examples of such horizontal cracks are shown in Figure 4-8. Point **a** on the plot of axial load vs. axial strain corresponds to the yielding of reinforcement. Although there were no strain gauges attached to the reinforcement, the yielding of reinforcement was easily identifiable by the onset of a plateau in the loading. At the peak of the tension half cycle, identified by point **a'**, the horizontal cracks reached their maximum size. The crack pattern at the peak of each loading cycle is shown in Figure 4-9.

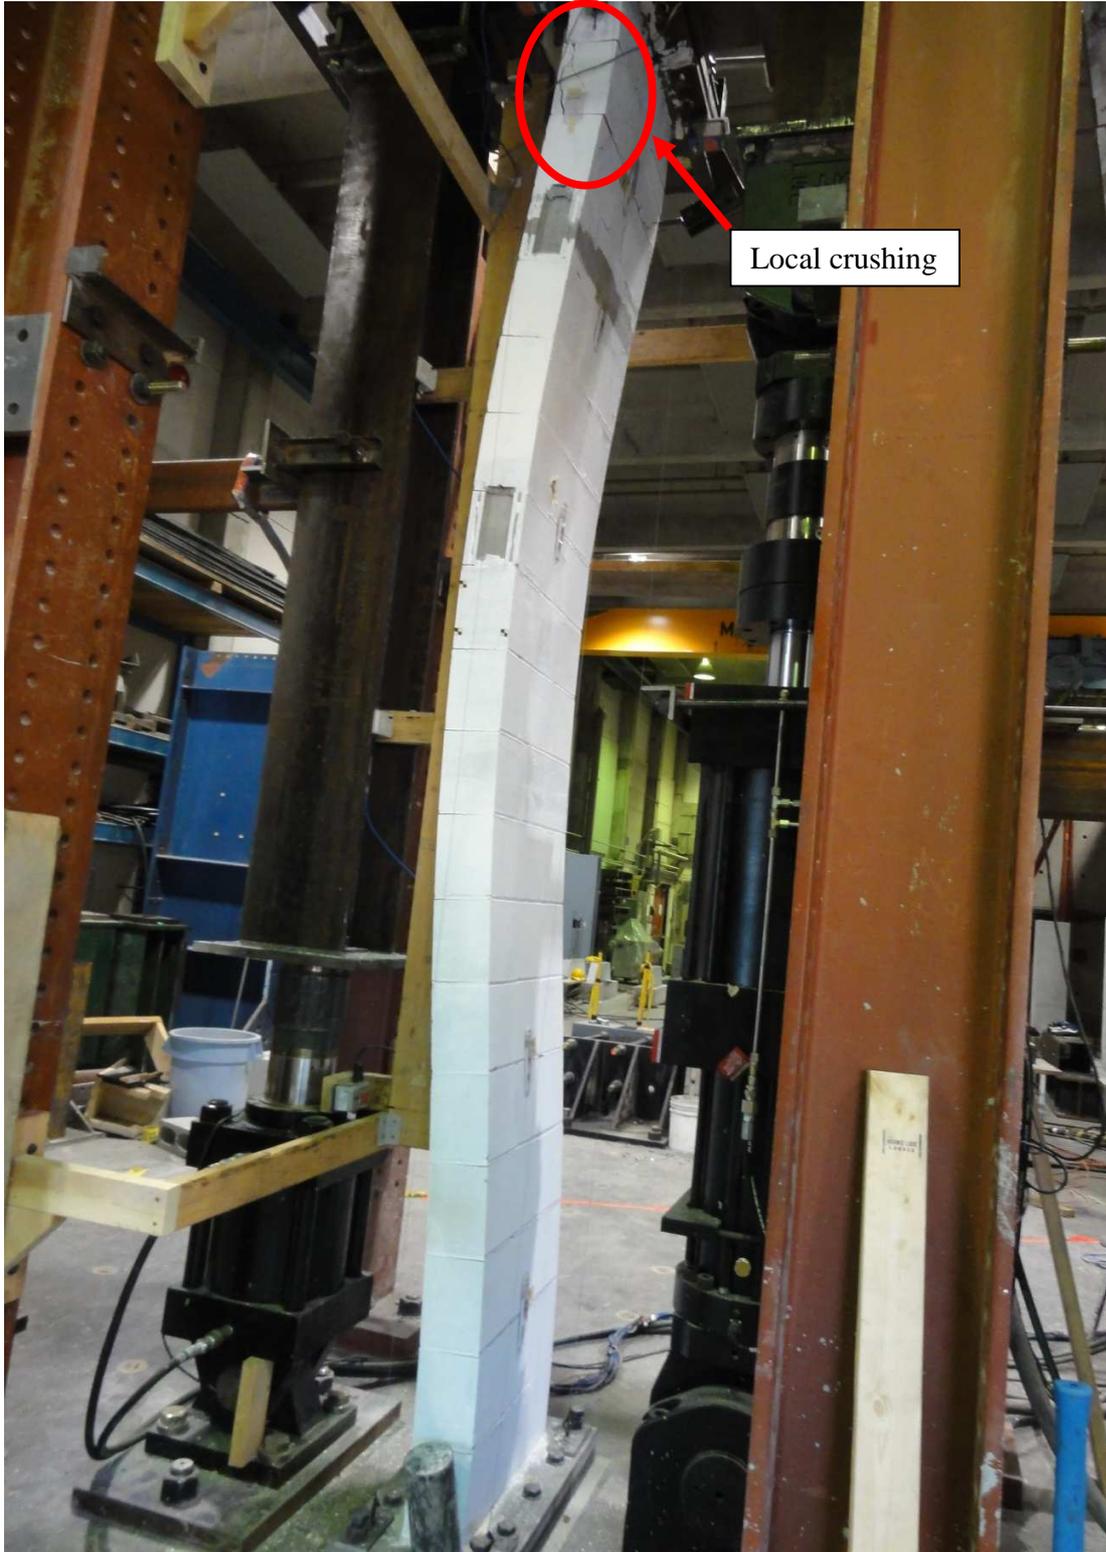
**Figure 4-11 Specimen C2 at the end of the test, after experiencing out-of-plane instability**

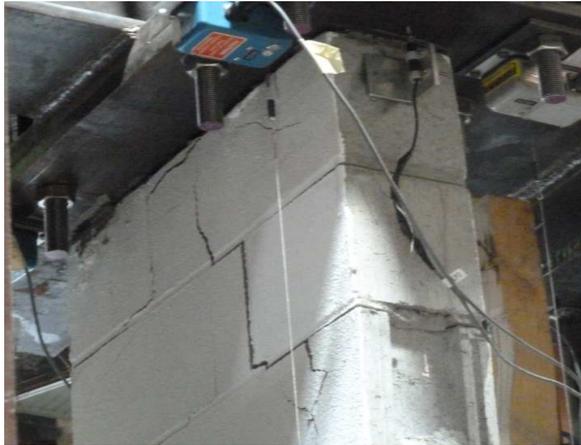
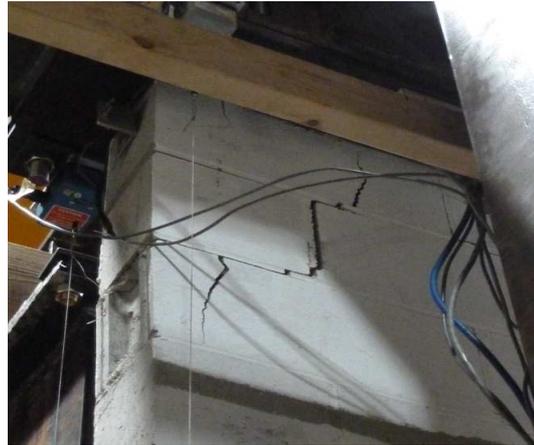
**Figure 4-17 The splitting cracks at the top three courses of specimen C3 before retrofitting**

Originally, it was intended that the only difference between specimens C2 and C3 and be their reinforcement ratios. However, this was not possible due to problems with the welding connection of reinforcement at the top of the specimen. During the first test run, the reinforcing bars disconnected from the top specimen plate at relatively low tensile strain levels. This transpired through the development of significant vertical splitting cracks in the top three masonry courses, as shown in Figure 4-17. This occurred before the specimen even reached the expected yield tensile capacity of reinforcement. These vertical cracks indicated that the reinforcement had detached from the top specimen plate at different times and had caused rotation about the specimen's weak axis at the top. The testing had to be discontinued at early tension cycles.

Subsequently, the top half of the specimen was stiffened using Glass Fiber-Reinforced Polymer (GFRP) overlay. The reinforcing bars at the top were grinded smooth and re-welded to ensure an effective connection to the top plate according to the original design. The retrofit design and construction were discussed in Sections 3.2.1 and 3.2.2 respectively.

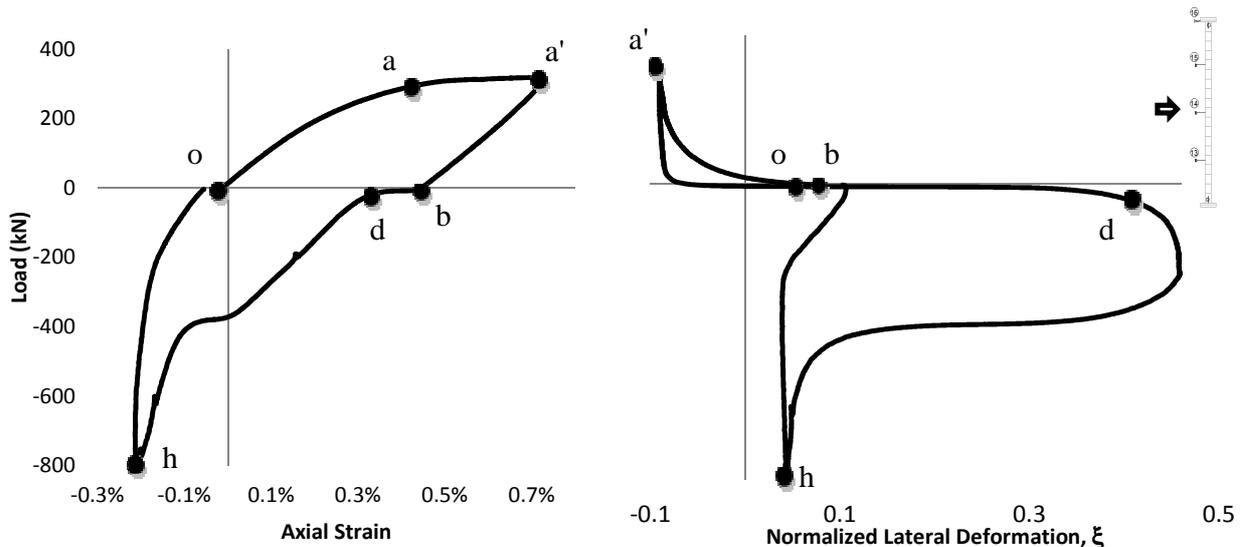
**a.** Applied axial load vs. axial strain over the plastic hinge region

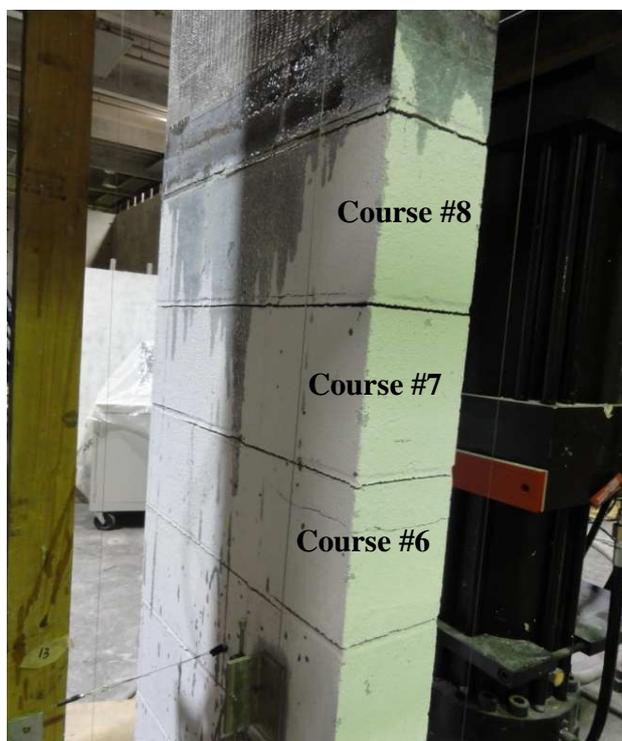
**Figure 4-19** Horizontal cracks developed along all bed joints in the last tension cycle in specimen C3

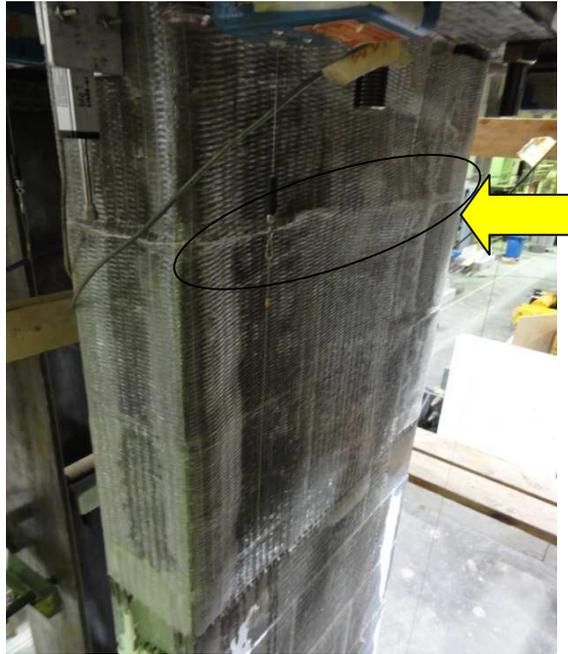
**Figure 4-20** Open cracks underneath the GFRP overlay led to crushing of the overlay under compression loads (specimen C3)

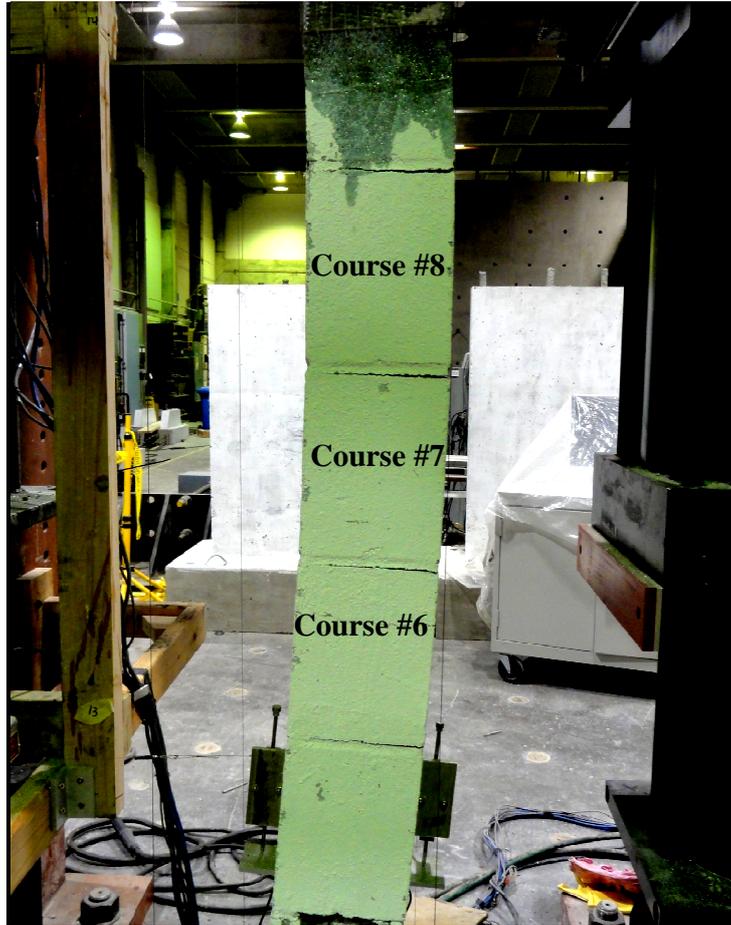
**Figure 4-21** Rotation of the open cracks at bed joints at low compression loads during the compression half-cycle (specimen C3)

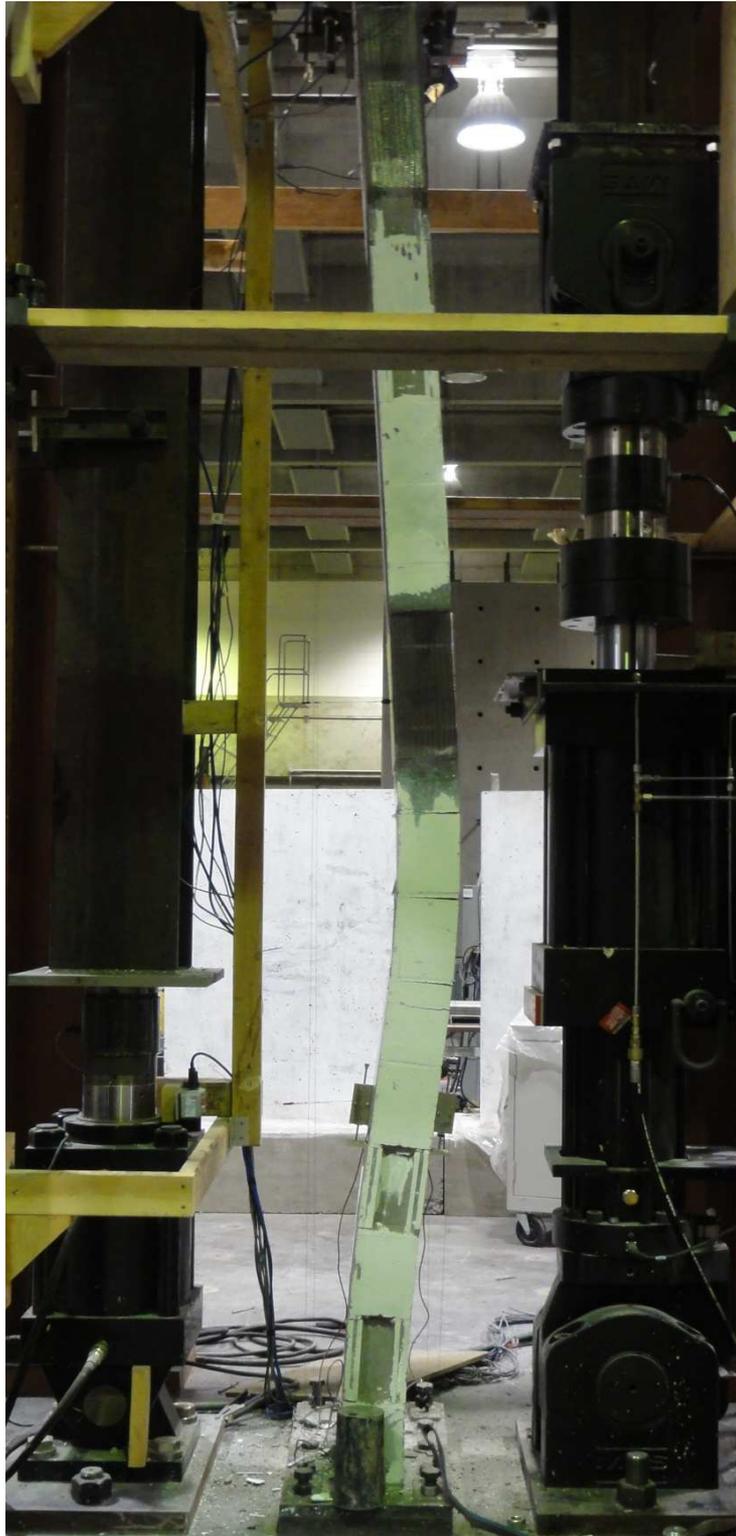
**Figure 4-22 Specimen C3 at the end of the test, after experiencing out-of-plane instability**

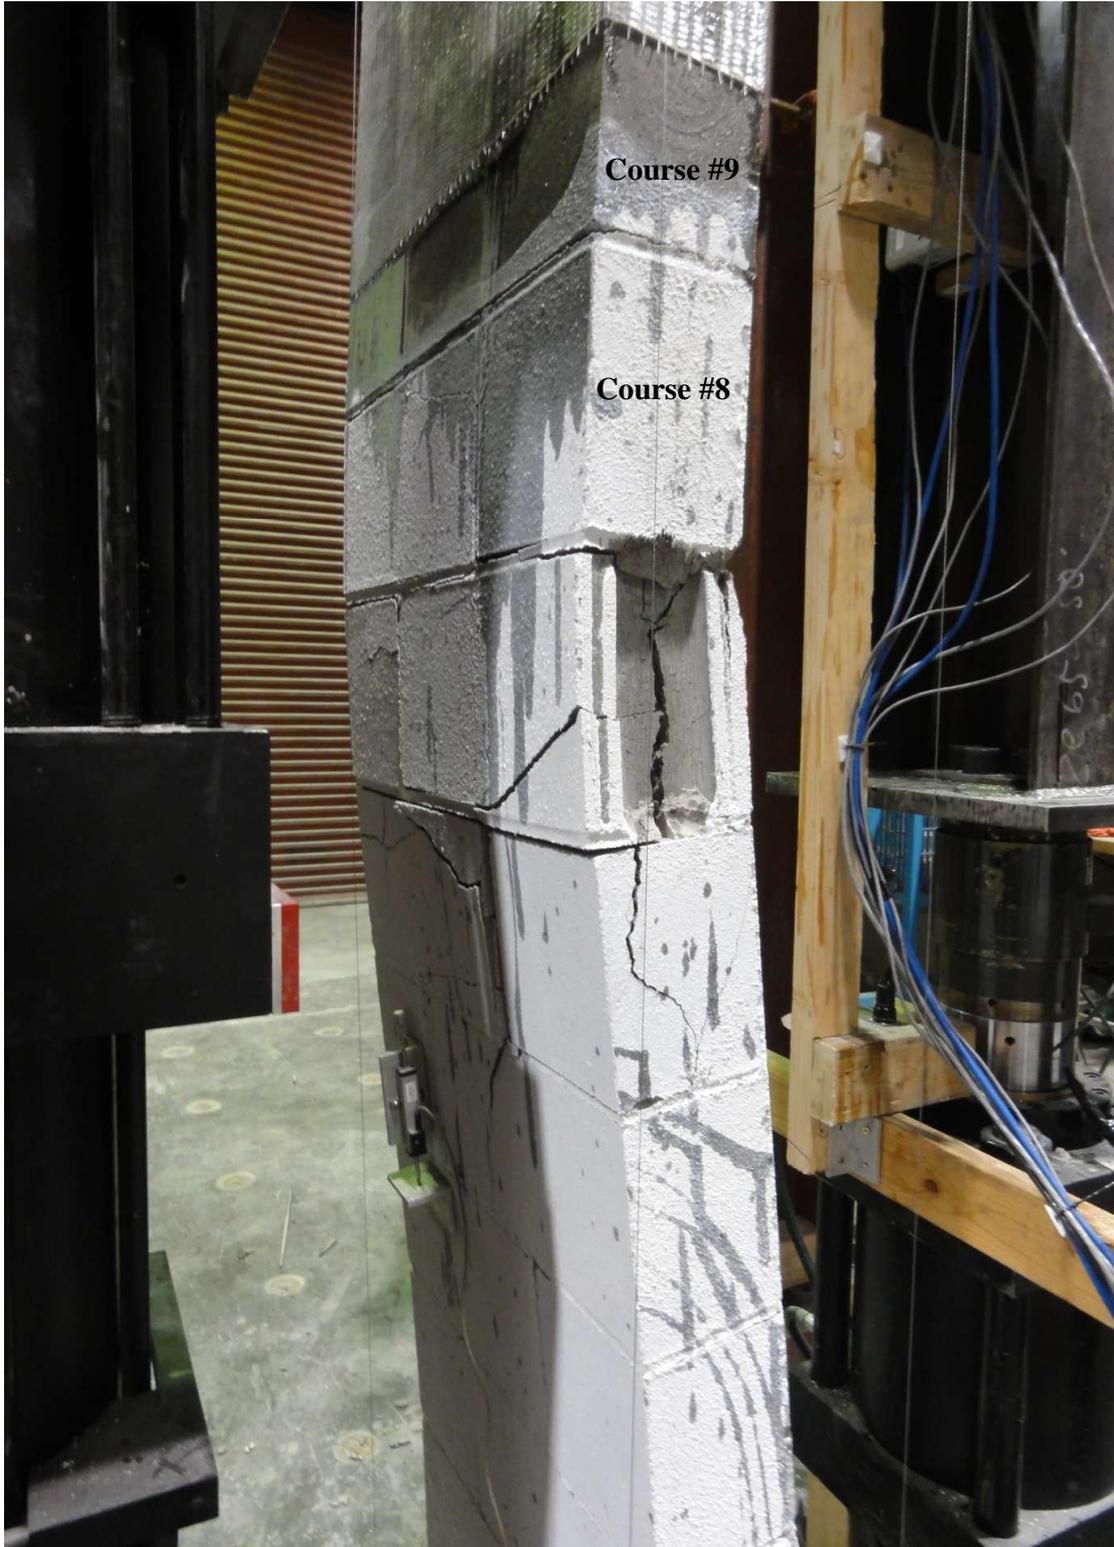
**Figure 4-23** Local crushing of specimen C3 at the compression face where crack closed after the specimen had become laterally unstable

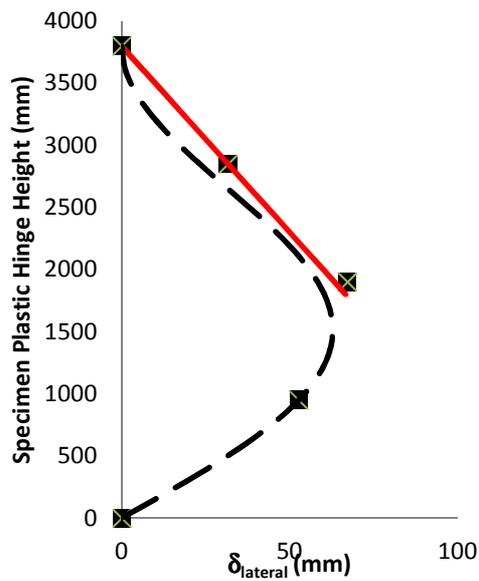
**Figure 4-24** Buckled shape of specimen C3, during load cycle  $\epsilon_t=0.8\%$

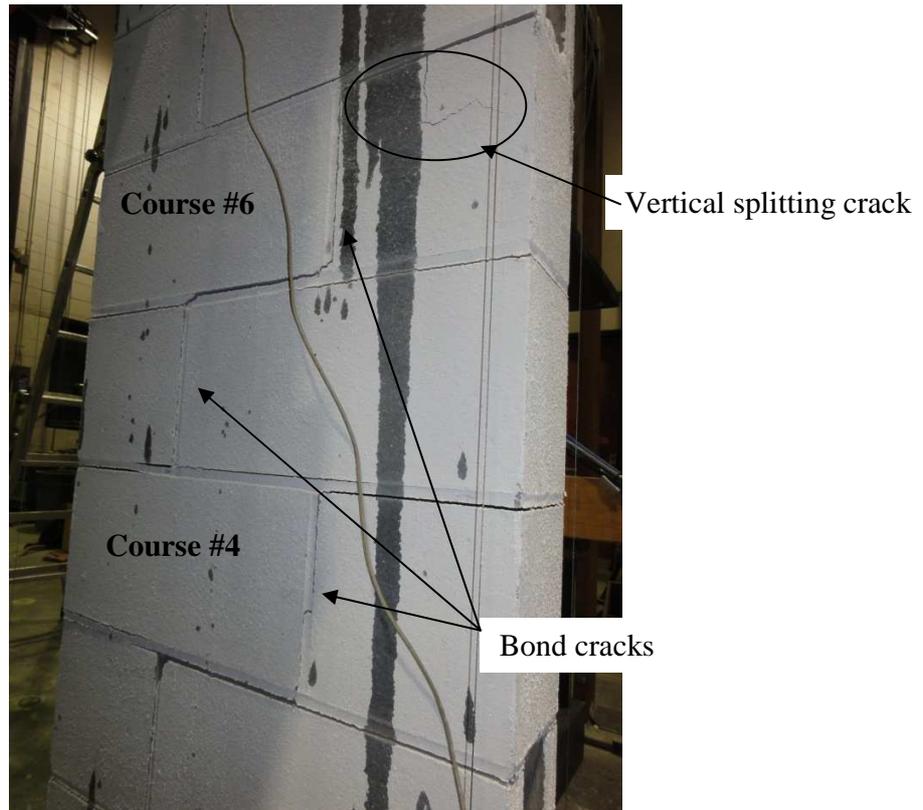
**Figure 4-30 Uniformly distributed horizontal cracks over as well as vertical splitting cracks at tensile strain level equal to 1.3% (specimen C4)**

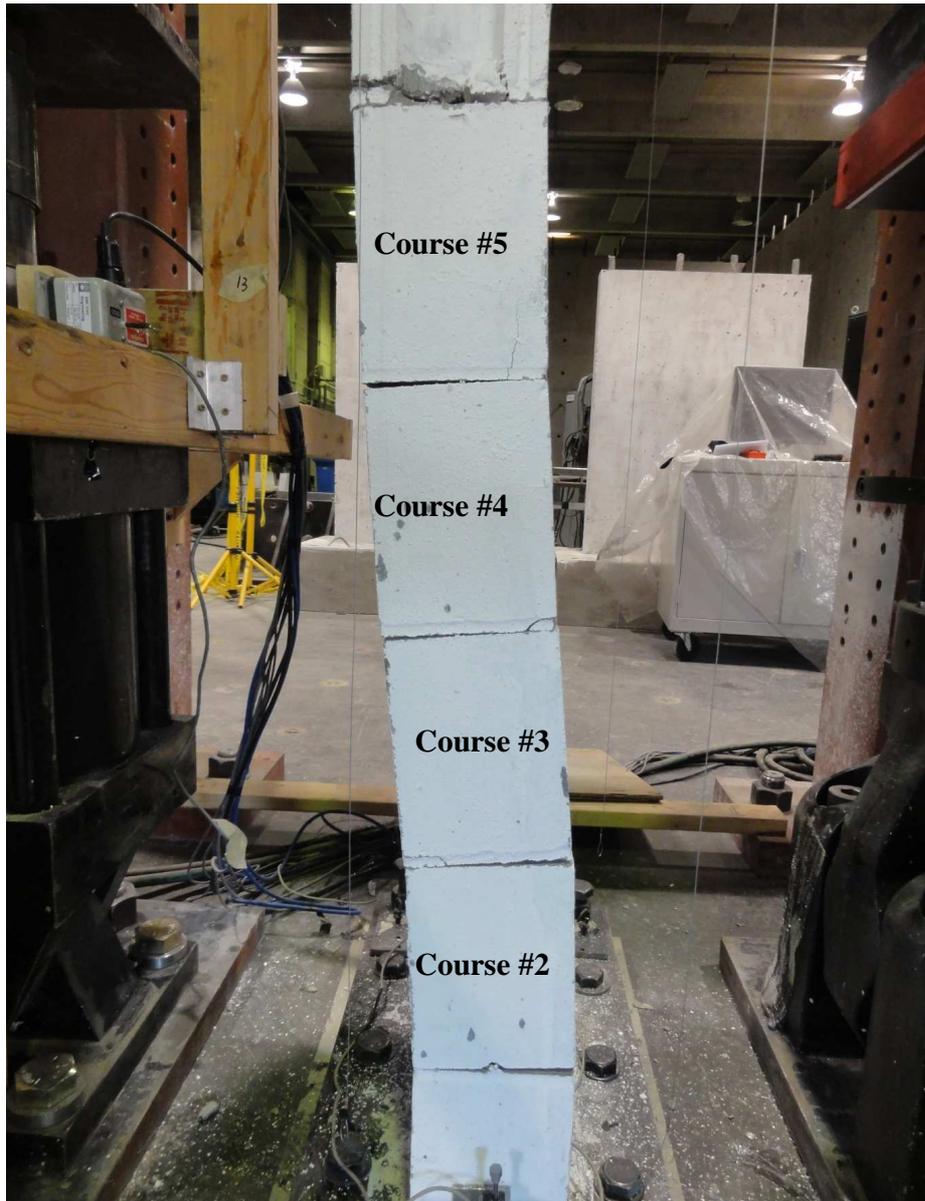
**Figure 4-31** Rotation at the location of open horizontal cracks when specimen C4 experienced lateral displacements (Loading cycle #5)

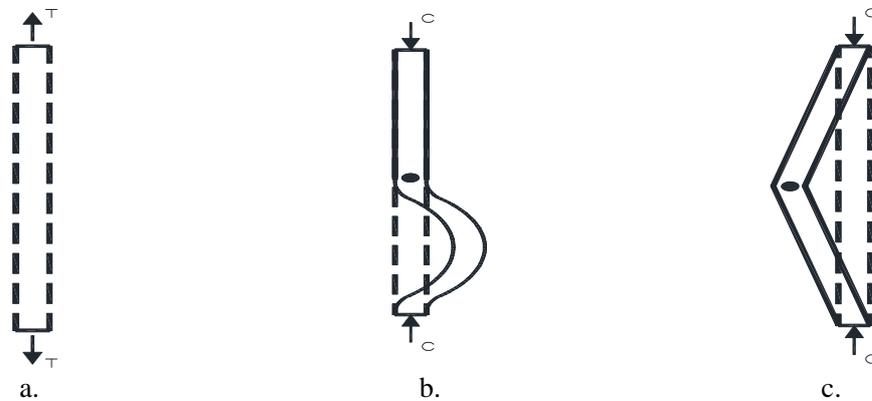
**Figure 4-32 a. Specimen in tension, b. first mode of buckling, c. second mode of buckling**

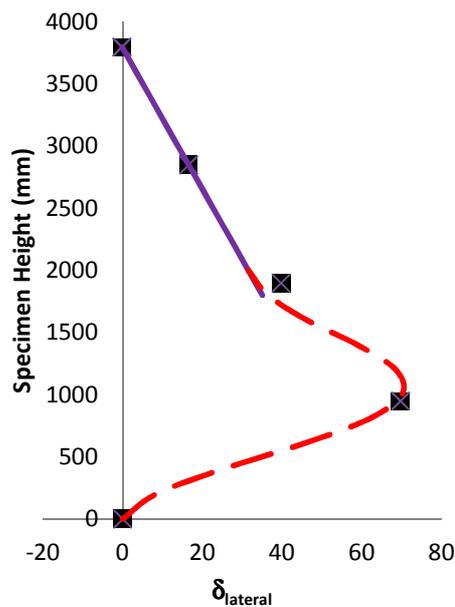
**Figure 4-33 Buckled shape of specimen C4 during the load cycle  $\epsilon_t=1.7\%$**

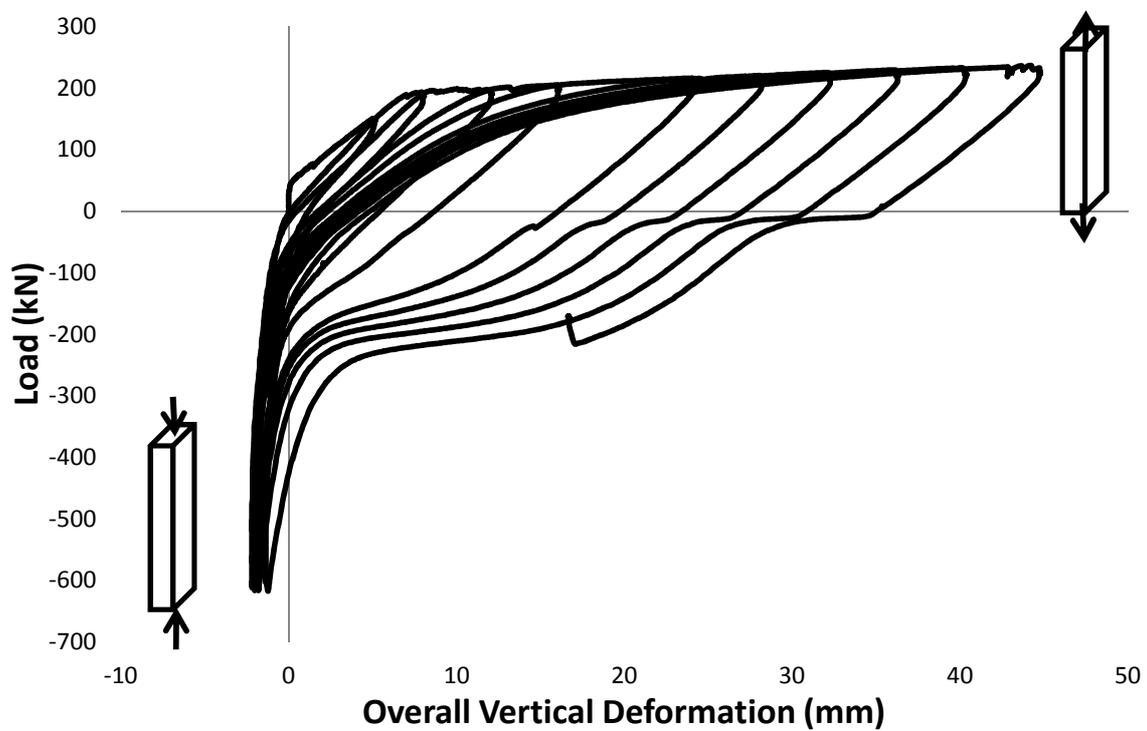
**Figure 4-34** Axial load versus overall axial deformation for specimen C4

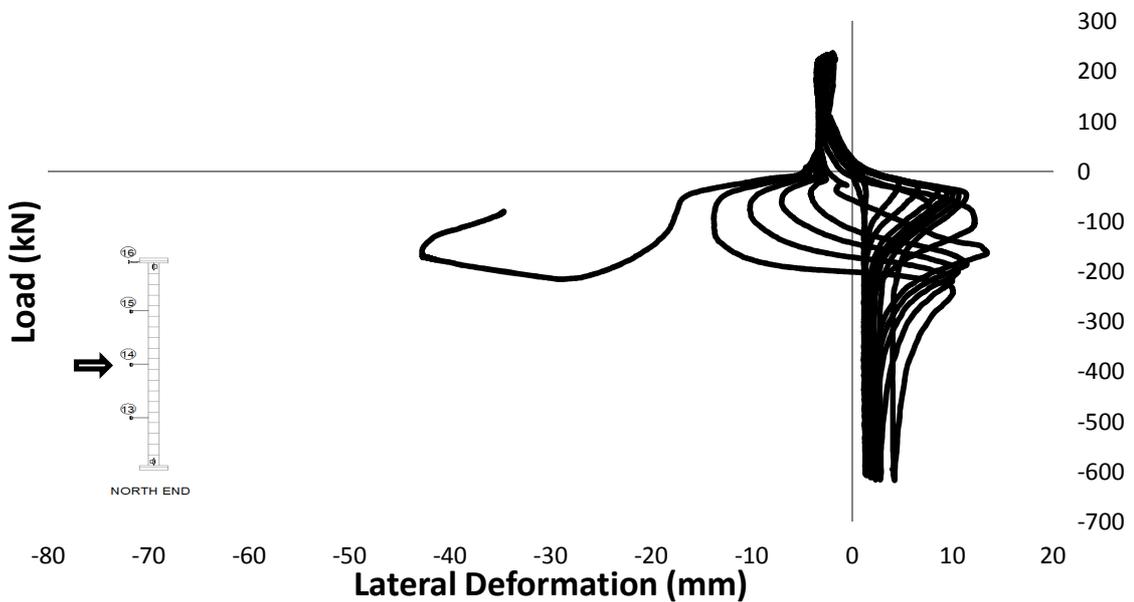
**Figure 4-36** Axial load versus lateral deformation at midheight for specimen C4

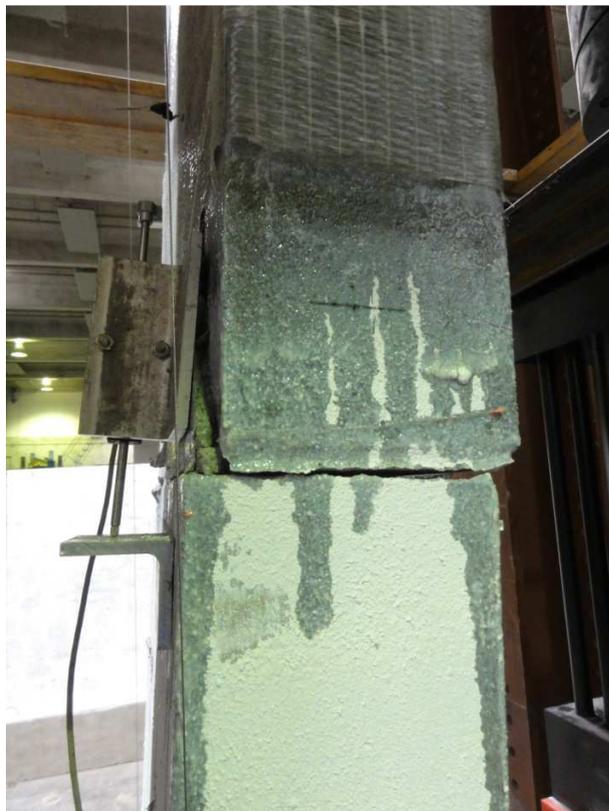
**Figure 4-37 Sliding at the bed joint on the north face of specimen C4 at the ultimate stage**

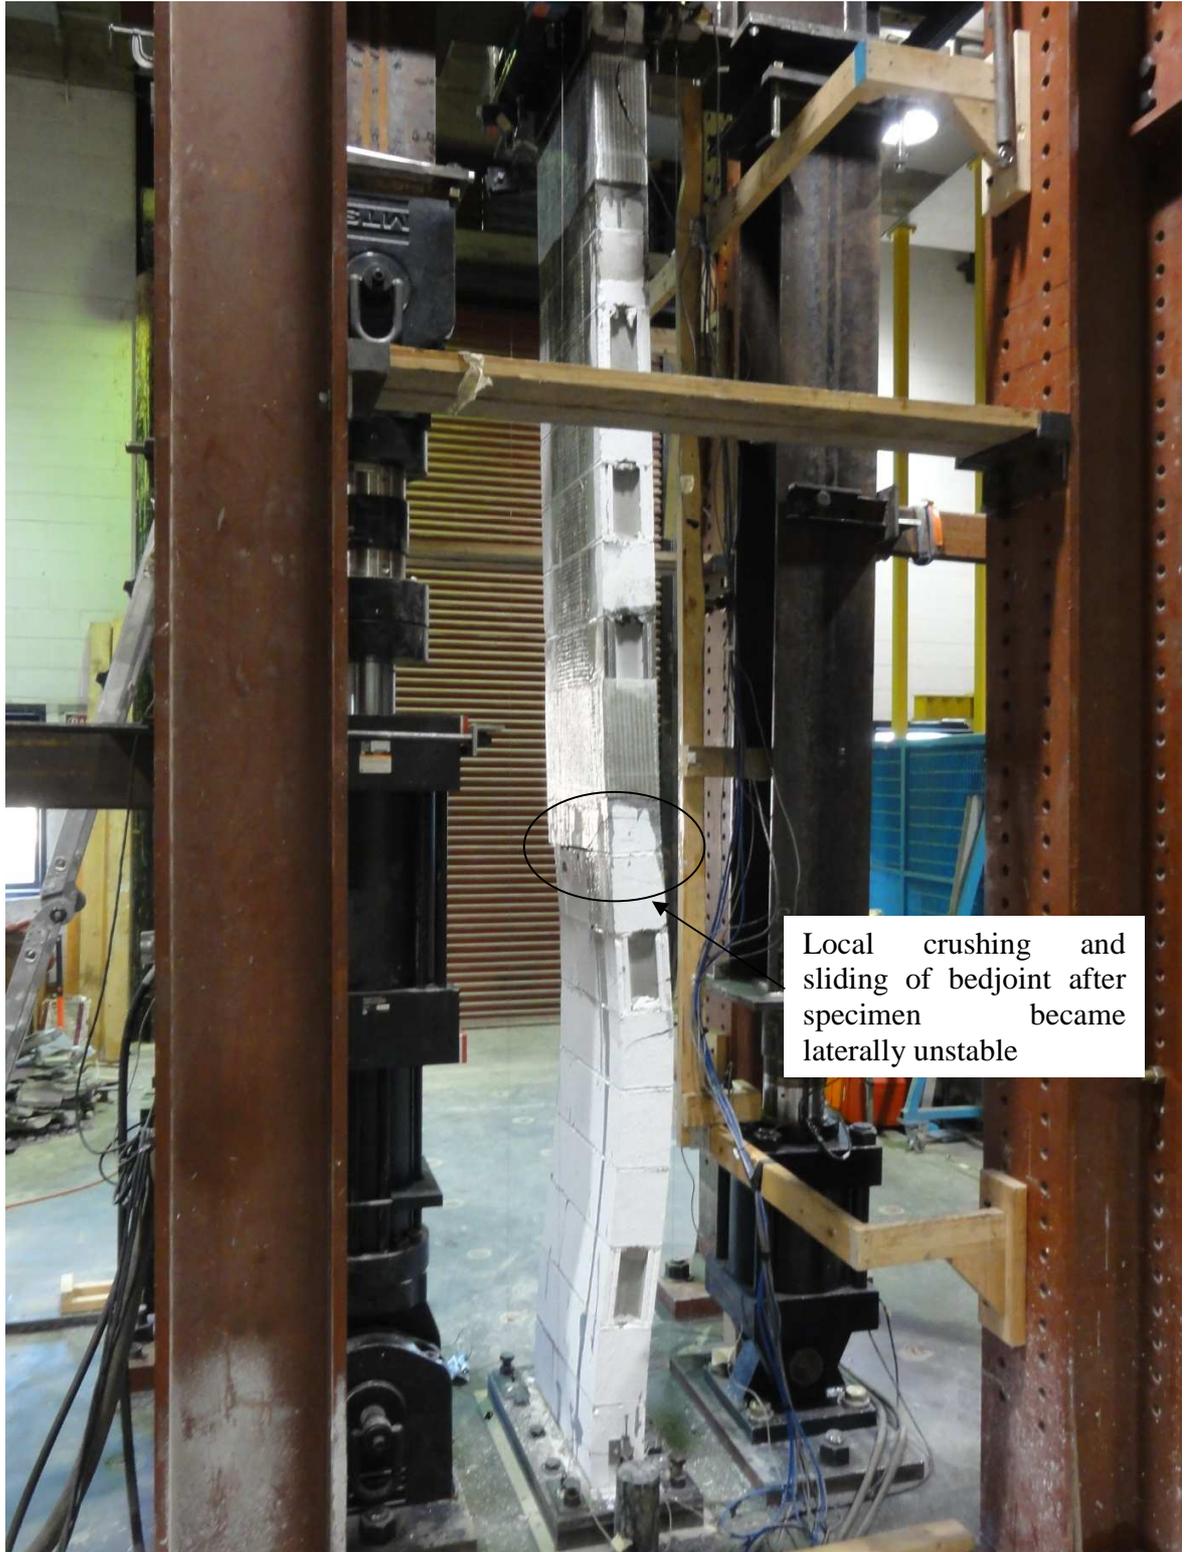
**Figure 4-38 Specimen C4 at the end of the test after experiencing lateral instability**

Figure 4-38 illustrates the overall buckled shape of specimen C4 and the location of the horizontal sliding after instability had occurred while Figure 4-39 shows a photo of the buckled shape over the lower half of the specimen only.

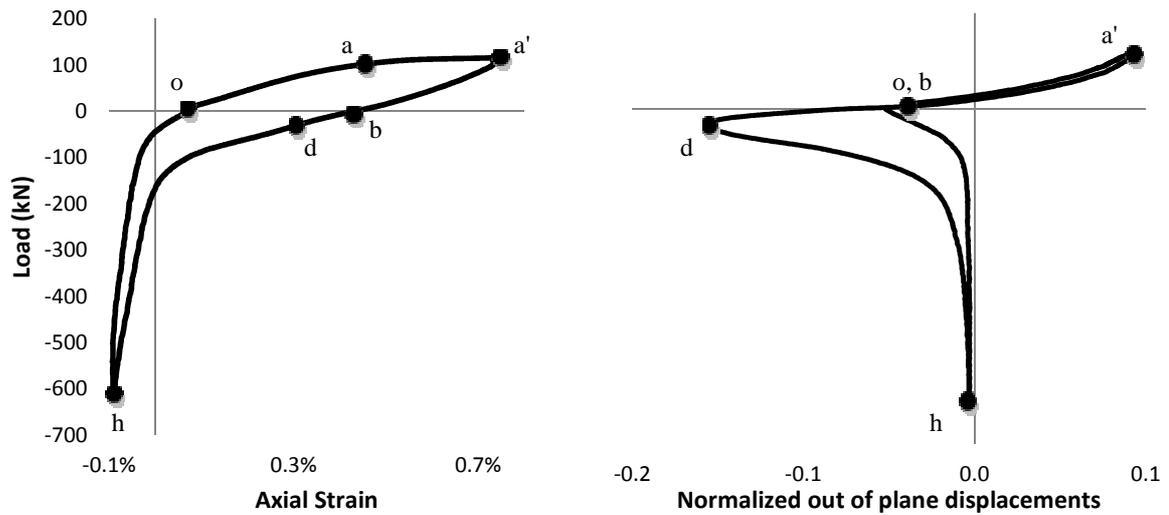
**a.** Applied axial load vs. axial strain over the plastic hinge region      **b.** Applied axial load vs. maximum lateral deformation at midheight normalized with respect to thickness

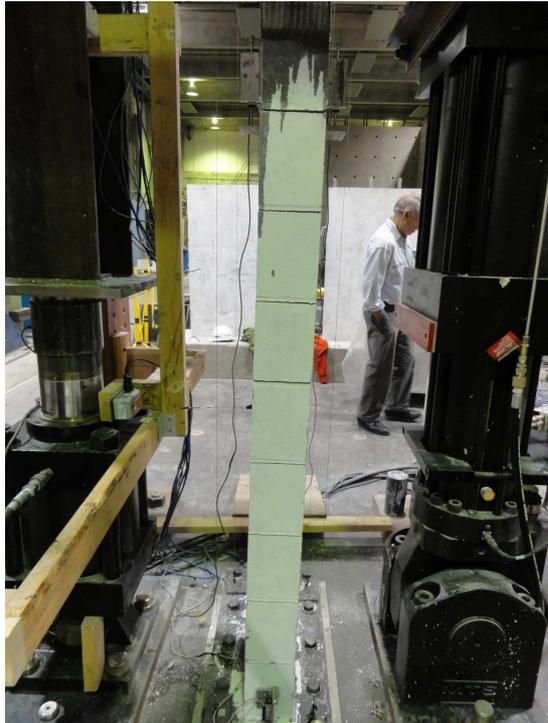
**Figure 4-43 Horizontal cracks at bed joints uniformly distributed over the bottom half of specimen C5**

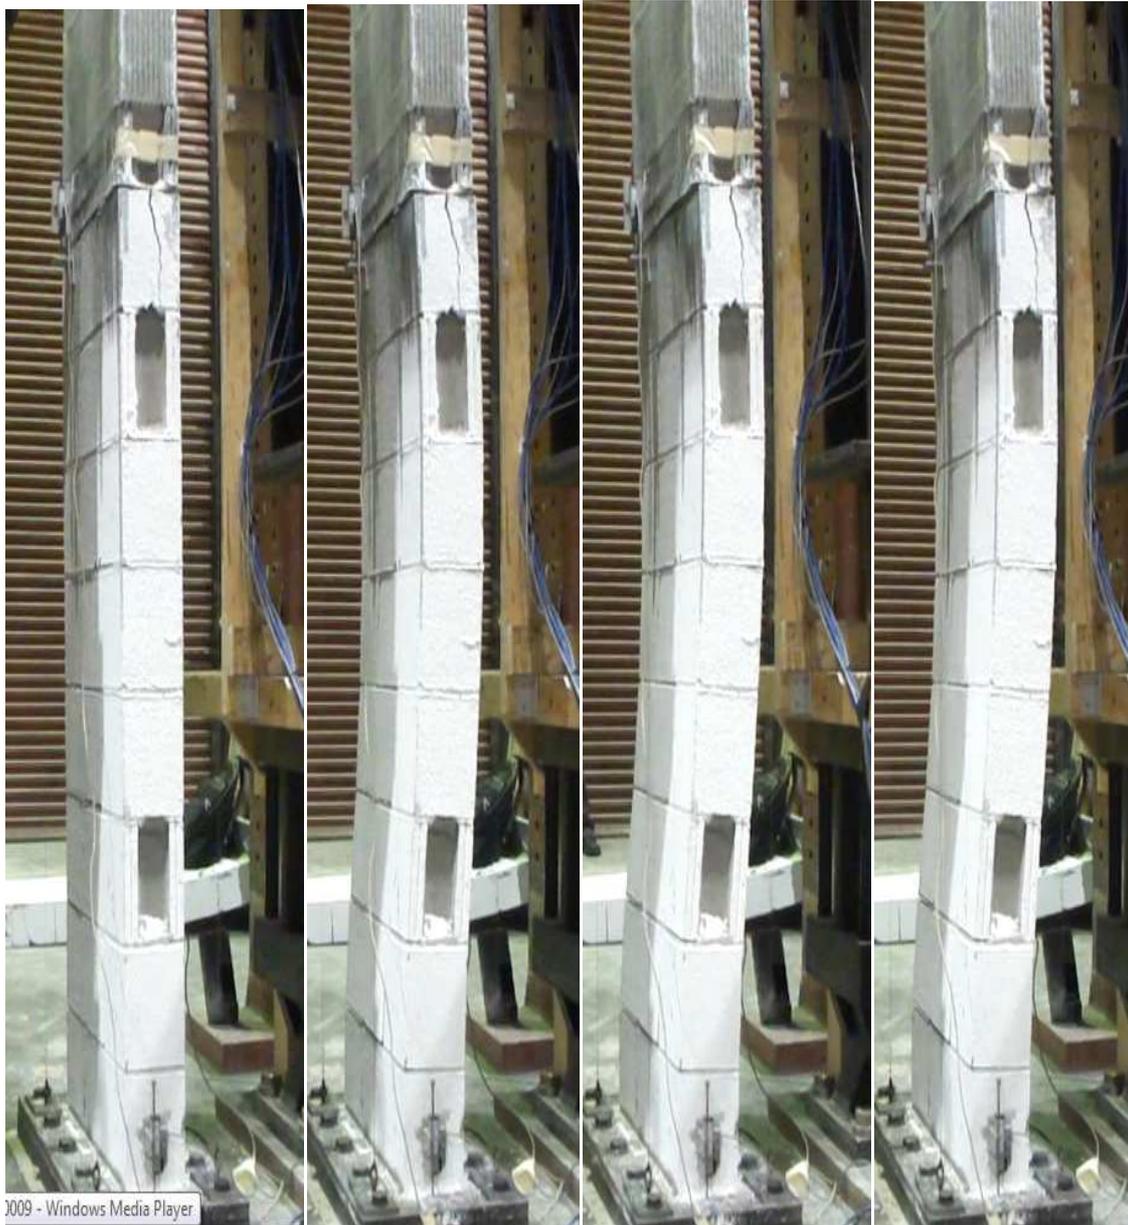
**Figure 4-44 Specimen C5 experienced eastward out-of-plane displacements after tensile half-cycle with the maximum axial displacement of  $4.9\Delta_y$**

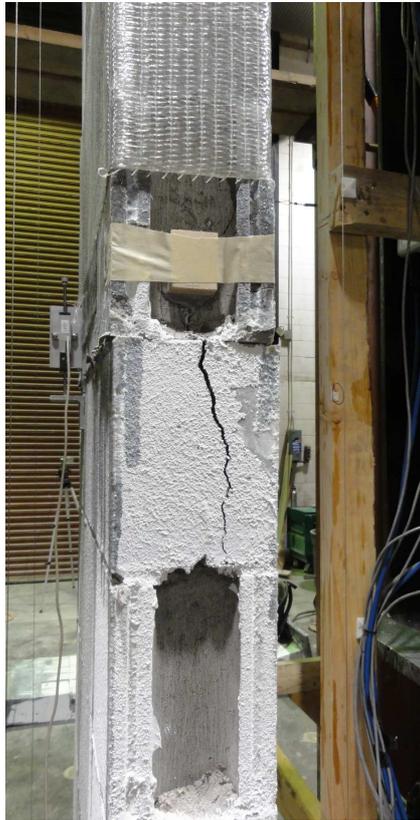
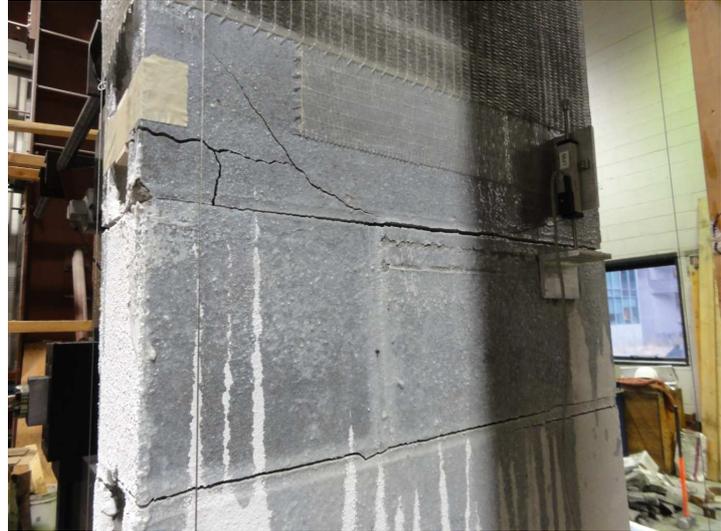
**Figure 4-45 Large horizontal and vertical crack developed at the masonry course below the stiffened portion (above the 8th masonry course from base of the wall) of specimen C5 during load cycle #6 ( $\Delta = 4.3\Delta_y$ )**

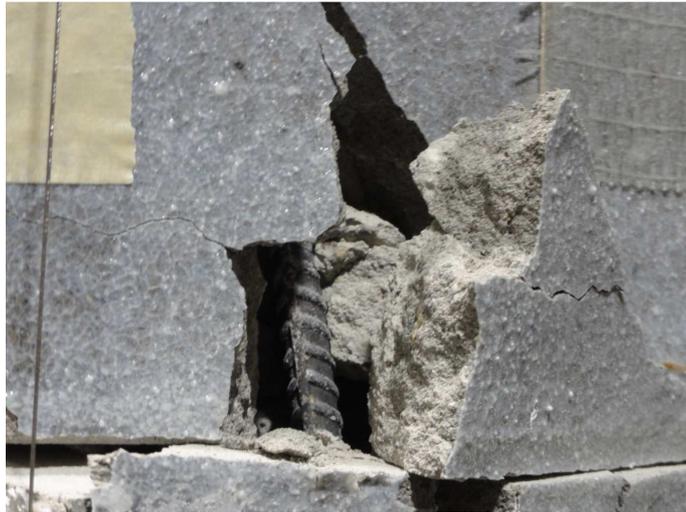
**Figure 4-46 Reinforcing bar protruding through the block face shell during the compression half-cycle after the tensile axial displacement of  $5.9\Delta_y$**

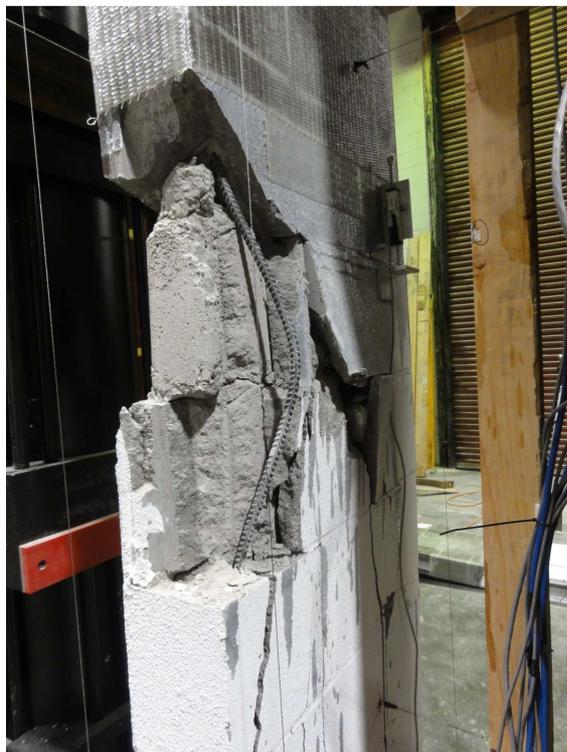
**Figure 4-47 Localized buckling of the reinforcing bar, caused spalling of block face-shells and crumbling of the grout.**

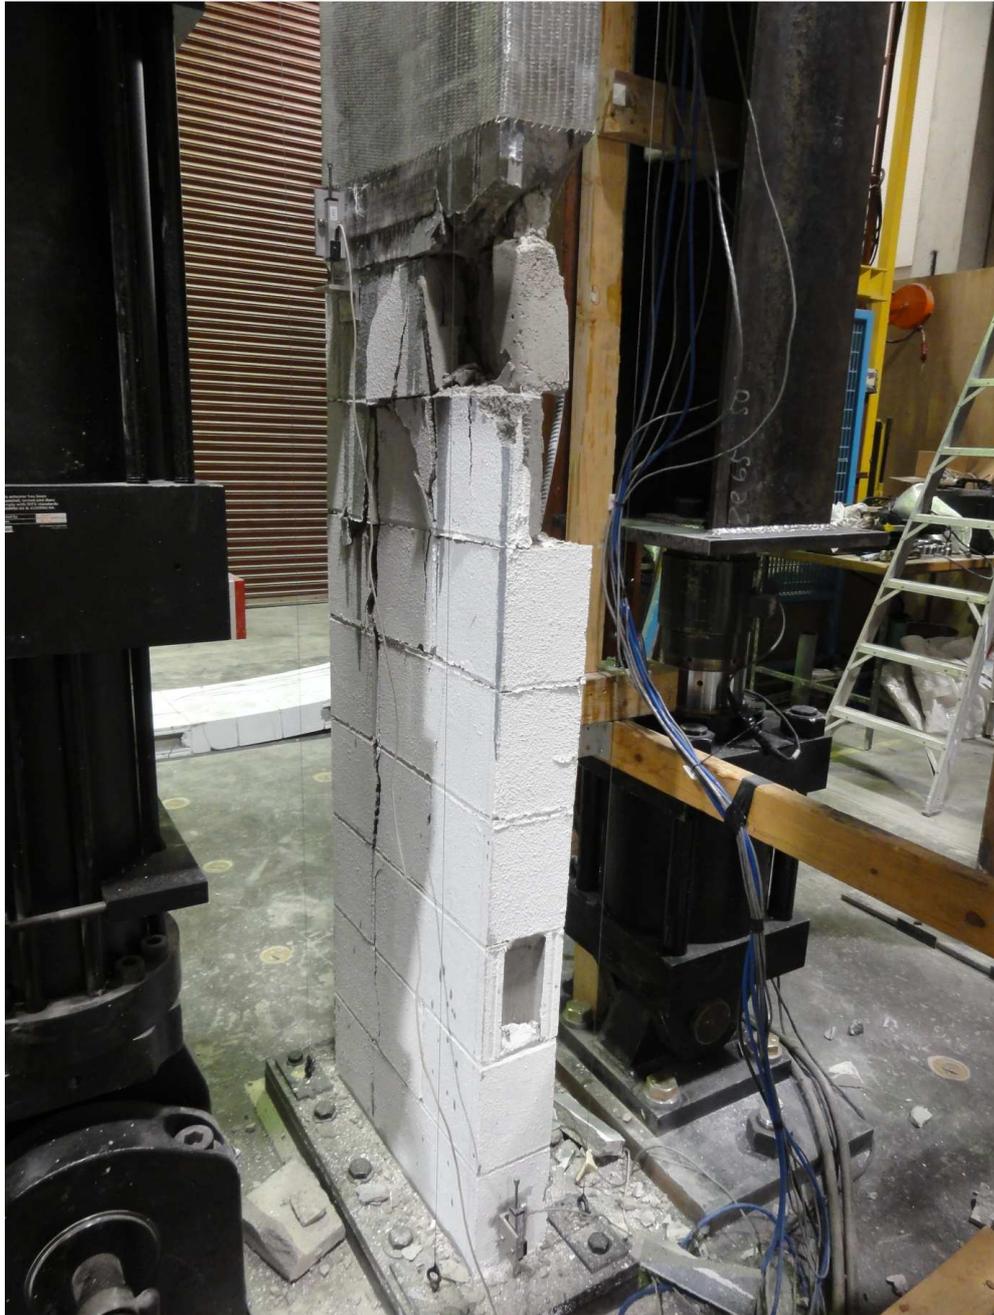
**Figure 4-48 Specimen C5 after experienced the failure characterized by localized buckling of the reinforcement and crushing of the masonry**

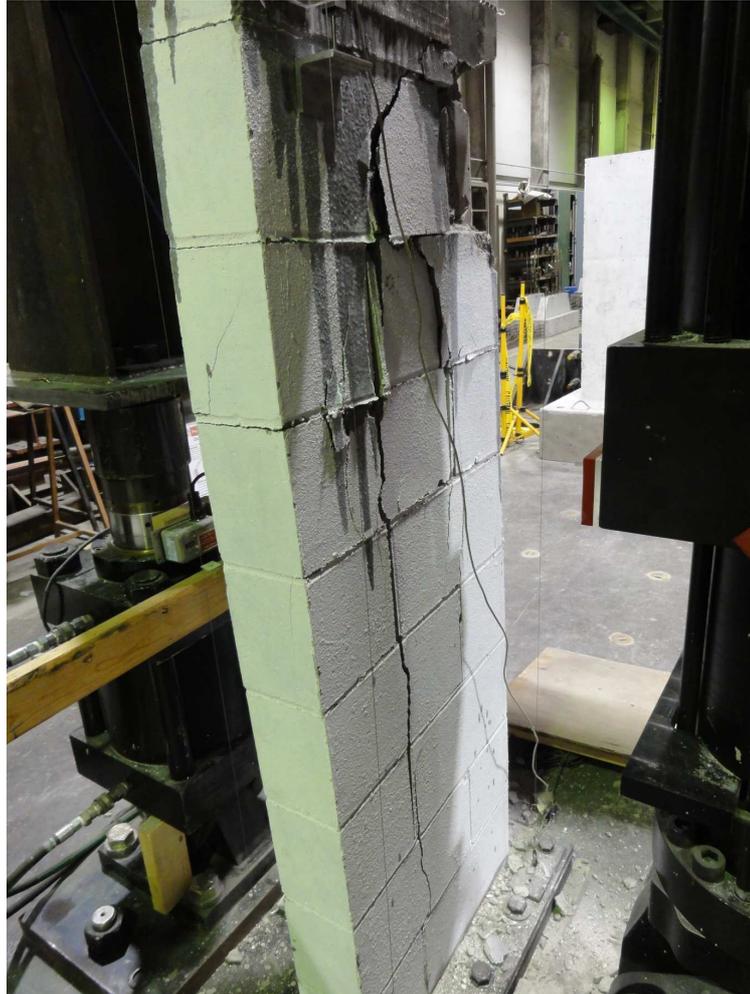
**Figure 4-49** Continuous vertical splitting crack in specimen C5 at the end of the test

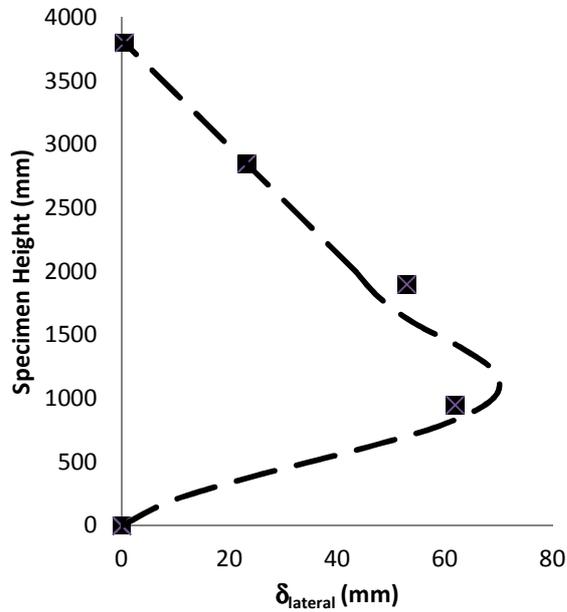
**Figure 4-50** Buckled shape of specimen C5 during load cycle  $\epsilon_t=1.6\%$
