**OUT-OF-PLANE STABILITY OF REINFORCED MASONRY SHEAR WALLS  
UNDER SEISMIC LOADING: CYCLIC UNIAXIAL TESTS**

**A THESIS SUBMITTED IN PARTIAL FULFILLMENT OF  
THE REQUIREMENTS FOR THE DEGREE OF**

**MASTER OF APPLIED SCIENCE**

**THE UNIVERSITY OF BRITISH COLUMBIA**

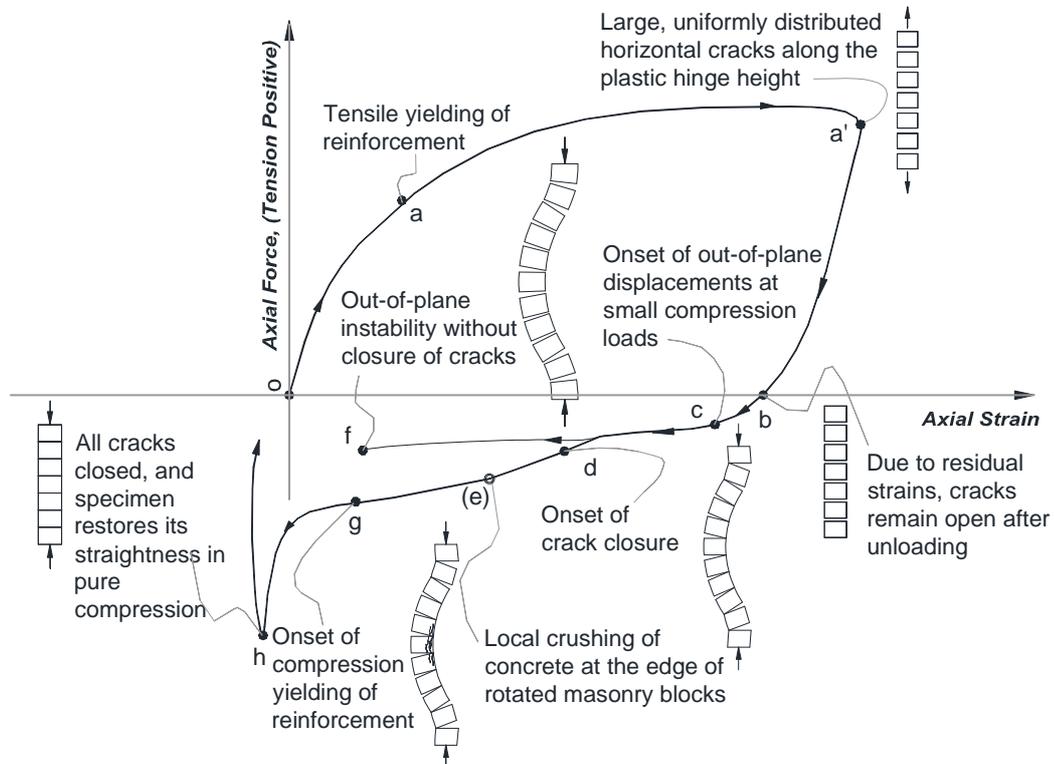
**Figure 5-1** Axial reversed cyclic response of a reinforced masonry column with point (e) only occurring during the loading cycle corresponding to lateral instability

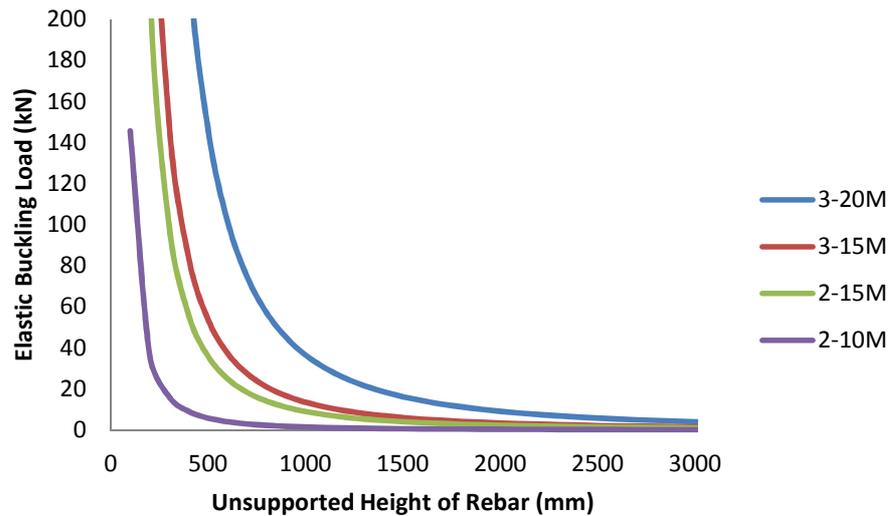
**Figure 5-3 Elastic buckling load of rebar for the different reinforcement schemes**

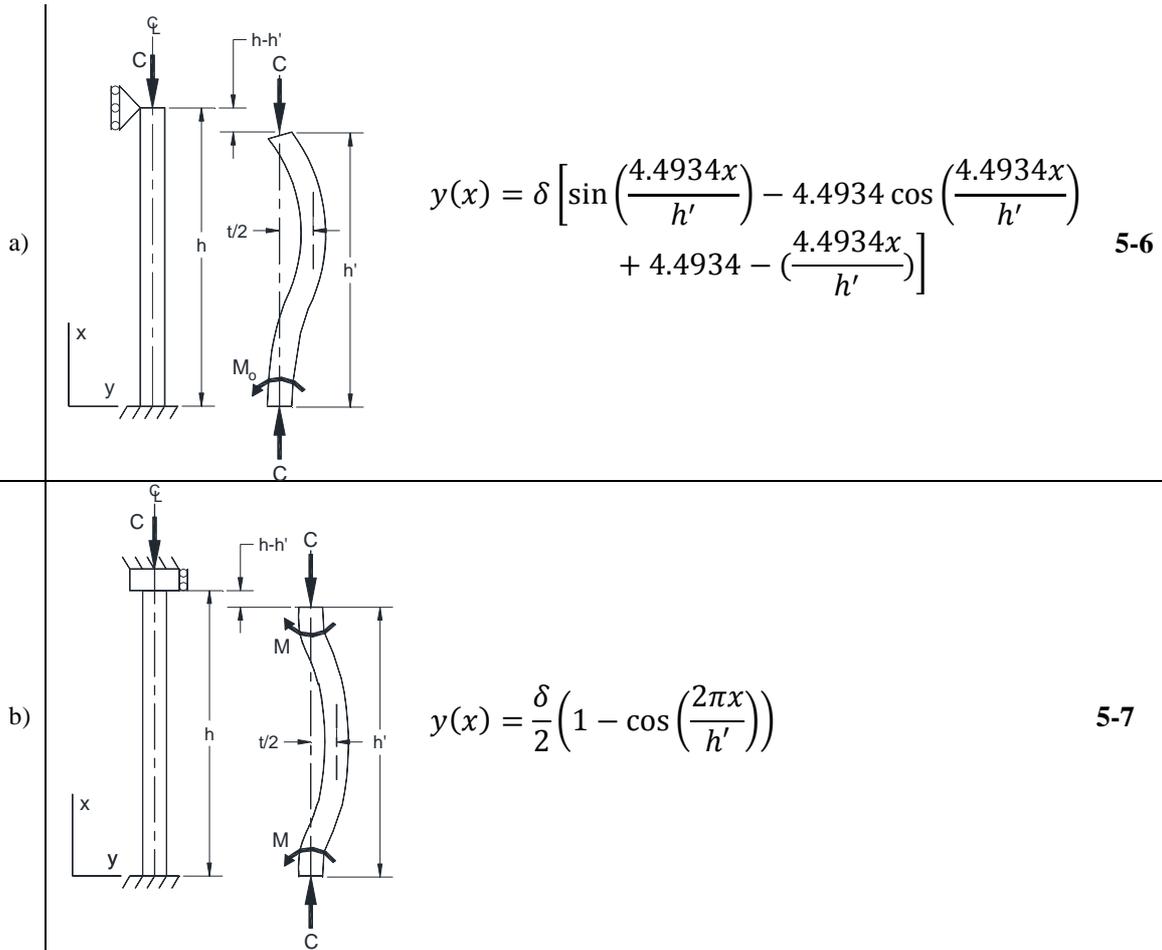
**Figure 5-5 The assumed deformed shape of the wall end zone under pinned-fixed and fixed-fixed boundary conditions**

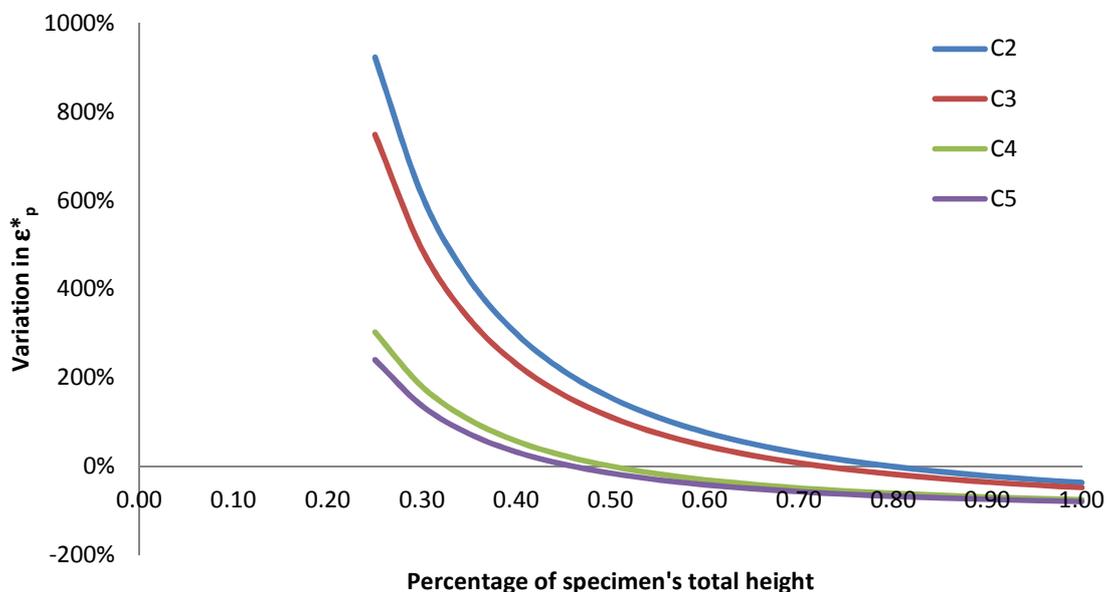
**Figure 5-7** Variation of the residual plastic strain vs. assumed length of plastic hinge

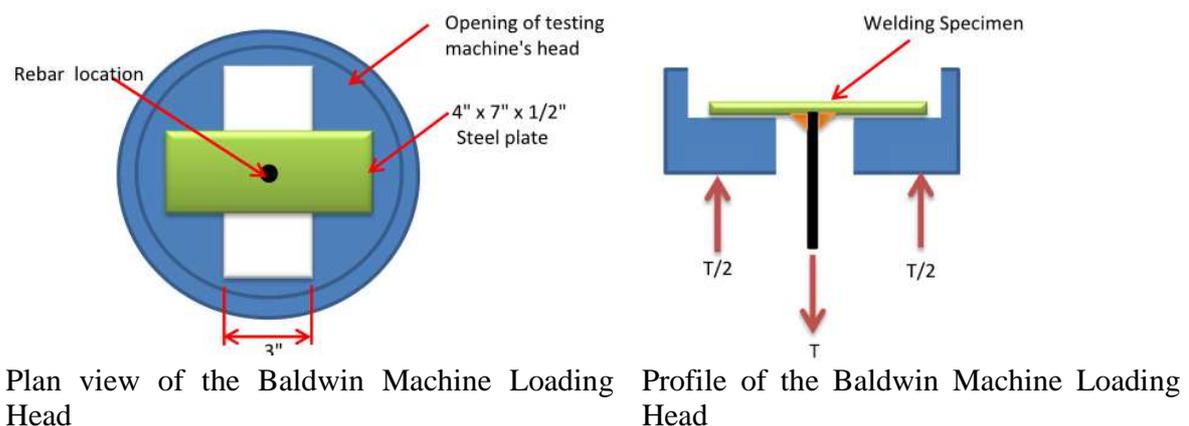
**Figure B- 1 Loading of the weld connection sample in the Baldwin Machine**
