**IN-PLANE SHAKE TABLE TESTING OF GRAVITY LOAD
DESIGNED REINFORCED CONCRETE FRAMES WITH
UNREINFORCED MASONRY INFILL WALLS**

A THESIS SUBMITTED IN PARTIAL FULFILMENT OF
THE REQUIREMENTS FOR THE DEGREE OF

MASTER OF APPLIED SCIENCE

THE UNIVERSITY OF BRITISH COLUMBIA
(Vancouver)

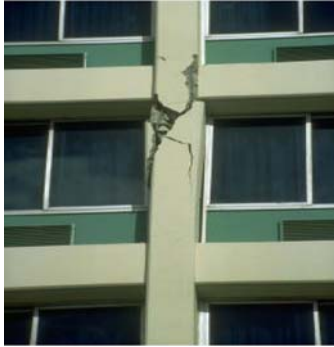
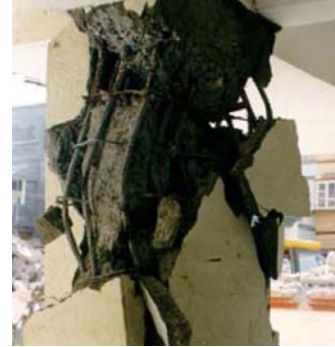
Figure 1.2. Observed behavior of RC columns with inadequate transverse reinforcement during earthquakes

Northridge, 1994
(reproduced from EERI Photo Collection)

Kocaeli, 1999
(reproduced from Sezen, Whittaker, Elwood, Mosalam, 2003)

Bhuj, 2001
(reproduced from Jaiswal, K., Sinha, R., Goyal, A. 2003)

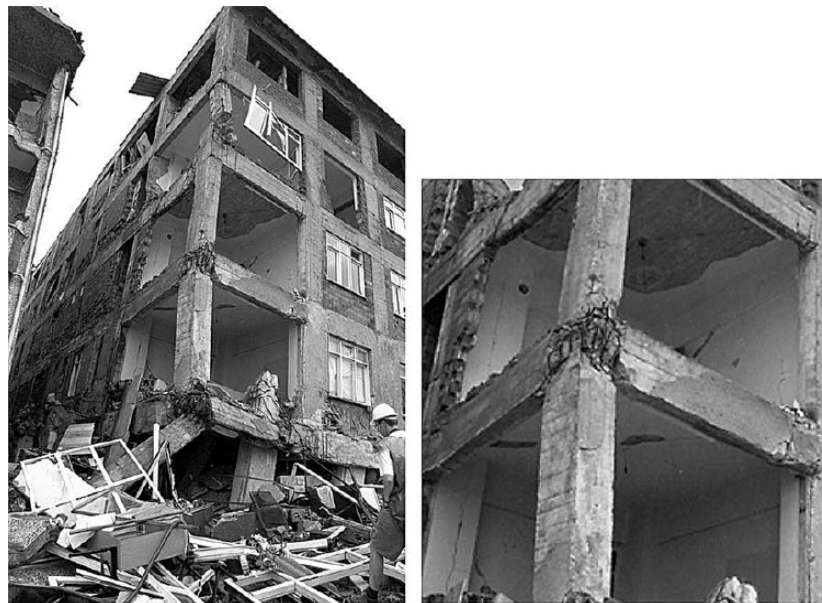
Figure 1.4. Building collapse due to failure of beam-column joints. (reproduced from Sezen, Whittaker, Elwood, Mosalam, 2003)

The role of the beam-column joint is to transfer the forces developed in the columns and beams, therefore adequate strength of the joint is essential for the development of the full capacity of the framing members. Joint provisions for seismic loading in which transverse reinforcement is required throughout the connection were first introduced in the 1971 edition of the ACI code [ACI 318-1963]. As a result, most structures built prior to this time are likely to have beam-column joints without any transverse reinforcement. Damage to beam-column joints is shown in Figure. 1.4.

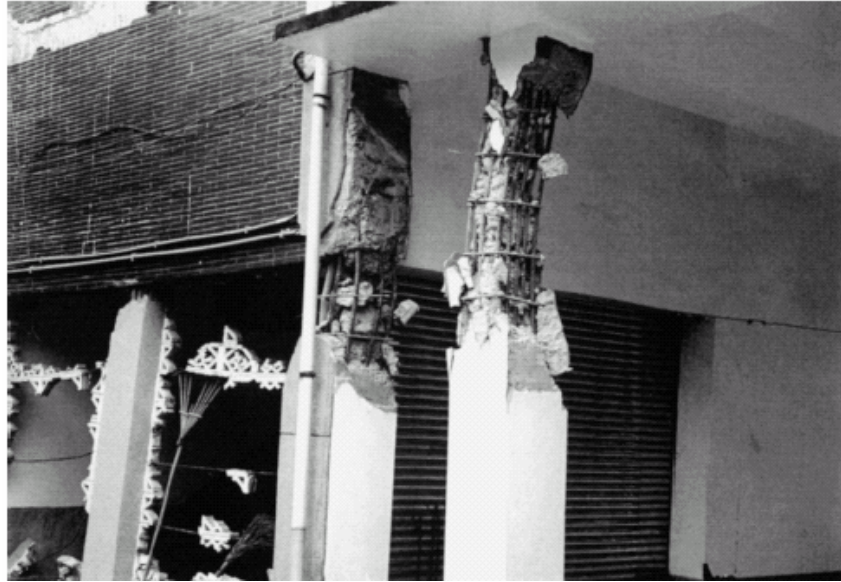
Figure 1.5. Weak-Column Strong Beam failure observed for Chi Chi Earthquake 1999.
(reproduced from Nan, Su 2002)

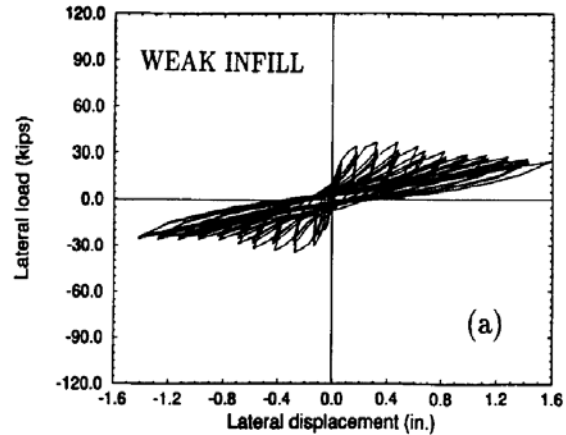
Figure 2.2. Specimens with weak frames and h/L ratio of 0.67 (reproduced Mehrabi, A. and Shing, P. Benson, 1996)

a) Weak infill weak frame failure mode (Sliding of Bed Joints)

b) Weak infill weak frame Force vs Displacement Plot

c) Strong infill weak frame failure mode (Shear Failure of Columns)

d) Strong infill weak frame Force vs Displacement Plot

The authors showed that the failure mechanism of an infilled frame depends very much on the relative strengths of the frame and the infill. In general, lateral resistance for a frame with a weak (hollow) panel was governed by the sliding of the panel along its bed joints. In the case of a strong (solid) infill and a weak frame, the ultimate resistance and failure were dominated by the diagonal sliding crack and the shear failure of the columns. Figure 2.2 shows of the tested specimen after the failure and the force vs displacement

hysteresis curves for the cyclic tests. It can be observed that the specimen with the weak infill shows less energy dissipation capacity than that with the strong infill.

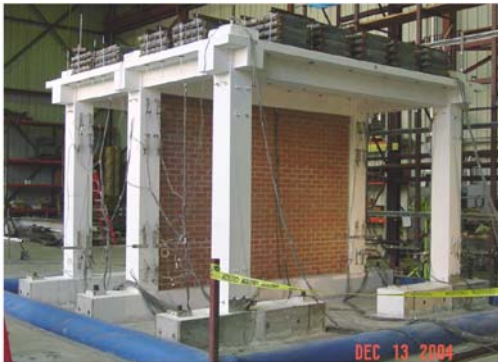
a) Reduced scale one storey high test structure

Hashemi and Mosalam [2007], performed a comprehensive study to evaluate the seismic performance of RC buildings with URM infill walls. A reduced scale, one storey high test structure was constructed to represent a substructure of the prototype building, as shown in Figure 2.4a, and subjected to shake table testing simulating a sequence of ground motions. The test structure was based on a hypothetical five story three bay by two bay RC building containing URM infill wall. The masonry walls were made of clay bricks and mortar type N. In this study the test structure is only subjected to the ground motion in the longitudinal direction (parallel to the URM infill wall).

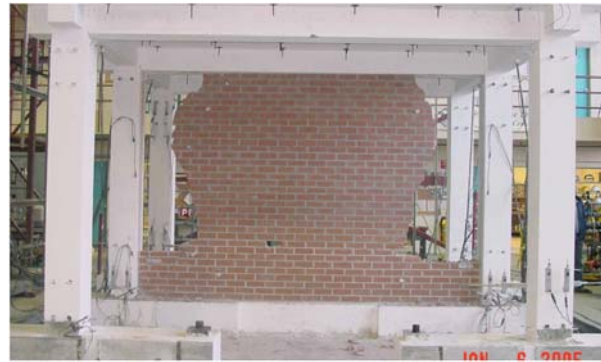
b) Failed URM infill after dynamic testing

Failure mode of the URM infill wall is characterized by 45° cracks at the bottom corners of each of the wall diagonals and 60° cracks at the top corners. Early signs of corner crushing were observed at the top corners, as shown in Figure 2.4b. The authors concluded that the URM infills have a significant role in the strength and ductility of RC frame structures and increasing global stiffness and damping level.

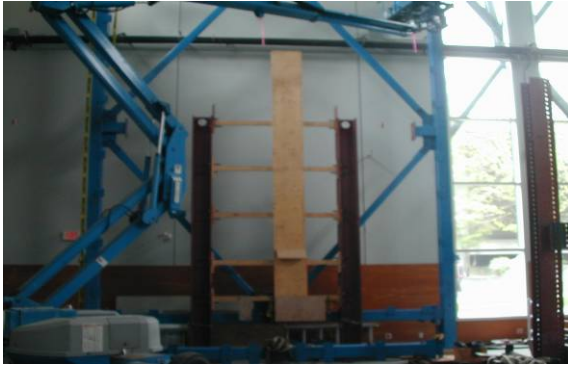
Figure 3.3. Construction process of the reinforced concrete frames.

a) The shake table frame was secured to two adjacent steel frames.

b) Formwork and rebar for foundation

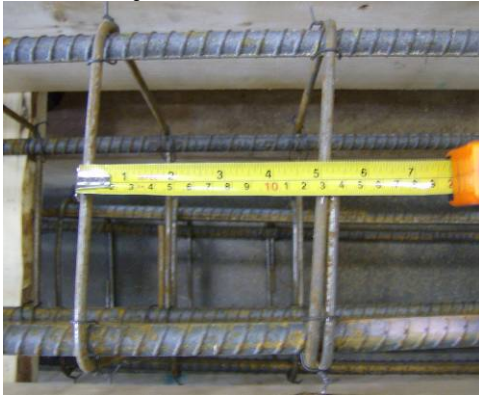
c) Beam stirrups $\phi_s=6.35$ mm using smooth wire with 90-degree hooks

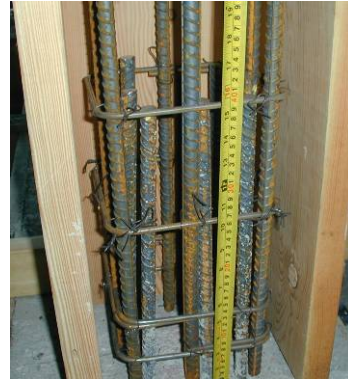
d) Column lap splice $26 d_b$ length column using smooth wire

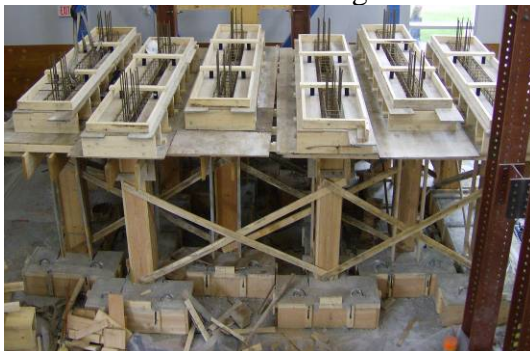
e) Formwork and rebar for frame

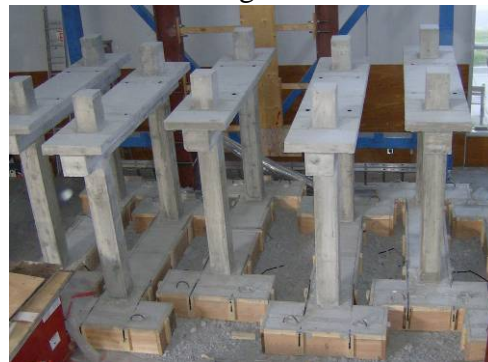
f) Finished RC frame and foundation

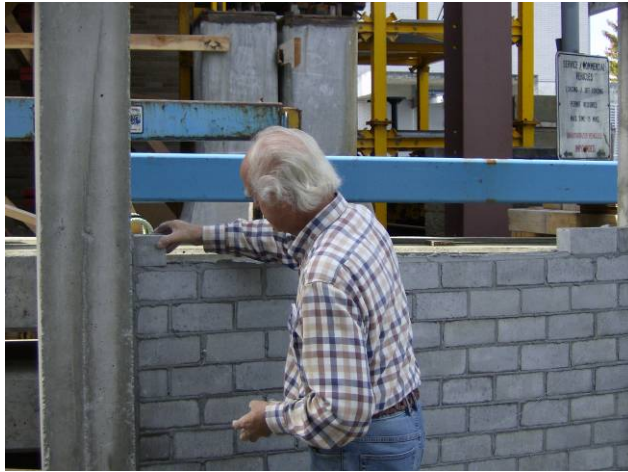
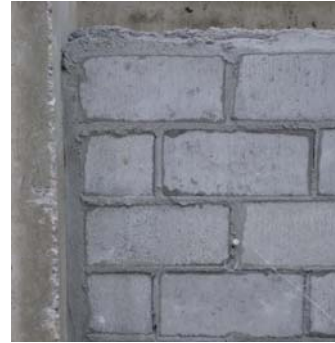
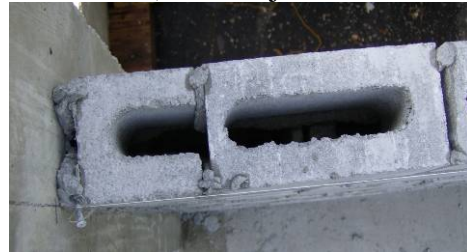
Figure 3.4. Construction of URM infill walls

No anchors were used to connect the infill walls to the frame. Nine infill walls were built to have a mortar joint thickness of 19mm (3/4") around the perimeter of the GLDRC frame, and only one infill wall was built with an air gap around the perimeter. The mortar head and bed joints had an average thickness of 9mm (3/8").

a) Wall Construction

b) Mortar joints

c) Mortar applied only on face shells

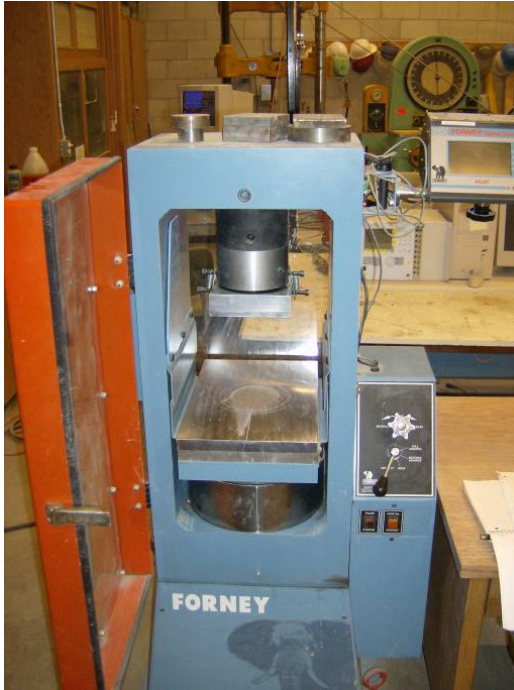
a) Compression testing machine

The dimensions of test cylinders dimensions were 100 mm diameter and 200mm length. The testing equipment used was the Forney Concrete Testing Machine FX500, at the UBC Civil Engineering Materials Lab (see Figure 3.5a). The loading rate was 0.24 MPa/sec. Test cylinders were tested at 7 days and 28 days after construction. The compression strengths and average values are summarized in Table 3.1.

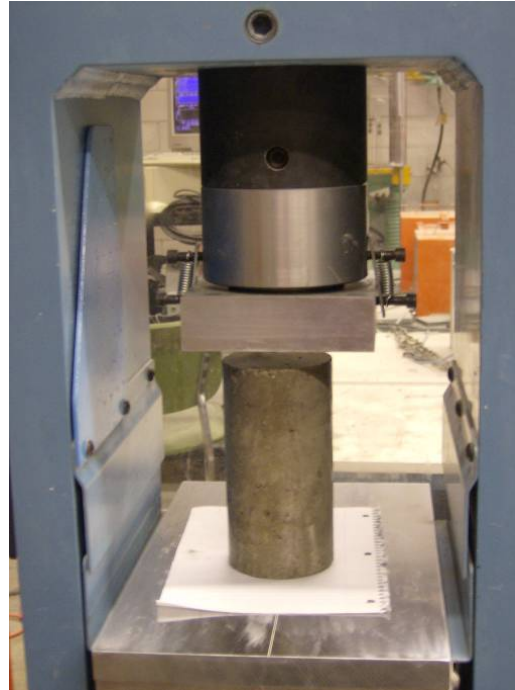
b) A concrete cylinder prior to compression test

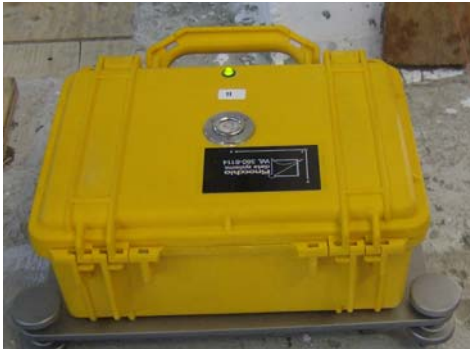
a) Pinocchio WL 380 geophone sensor

The equipment used included three Pinocchio WL 380 geophone sensors (Figure 3.8a). The sensors are tri-axial and each contains six geophone sensor elements used in a dual coordinate configuration. WL 380 sensors have two modes of data collection: sensitive mode and dynamic range mode. The sensitive mode is used at a site where the vibration noise level is low. The dynamic range mode is used when the noise level is higher and the full dynamic range of the instrument is needed. The SC sensors also use GPS technology for time synchronization (Brincker, R., Ventura, C.E., and Larsen, J.A., 2007; Brincker, R., and Larsen, J.A., 2007).

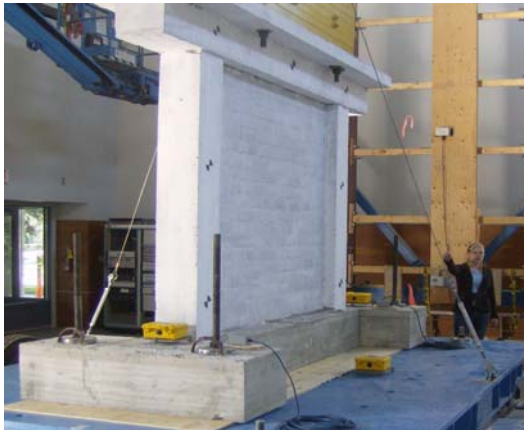
c) Setup for ambient vibration measurements test# 2

Two ambient vibration tests were performed. Test#1 was performed to measure the vibrations of the test specimen itself, and test#2 recorded the vibrations of the test specimen and the unidirectional shake table. Figure 3.8b presents a diagram of sensor location for tests #1 and #2. For test #1, the sensors were placed on the foundation (Figure 3.8b point 5) and at the top of the test specimen (Figure 3.8b point 7 & point 8). For test 2, sensors were placed on the four corners and center of the unidirectional shake table as well as the top of the specimen and the foundation, Figures 3.8c and 3.8d show a diagram and an illustration of the location of the sensor. Measurements were taken for 10 minutes at sampling rate of 100Hz.

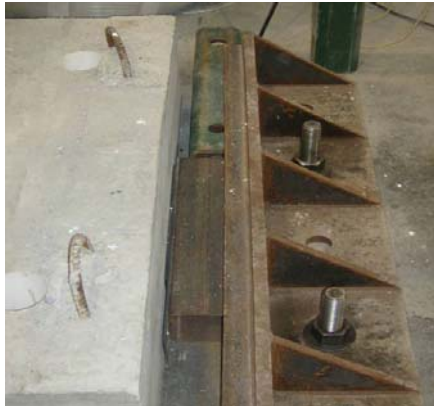
a) Sliding Restraint

The test specimen's connection holes located in the foundation did not coincide with the ones existing in the strong floor of the Structures Laboratory. The support conditions required for this testing were obtained by using two structures to restrain the foundation movement. Figures 3.9 a and b illustrate the sliding restraint and vertical supports, respectively.

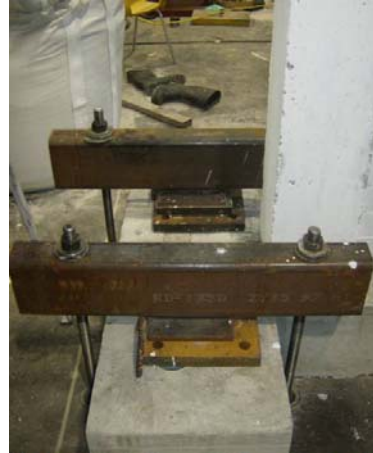
b) Vertical support

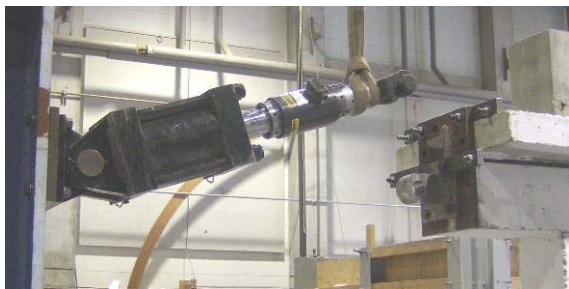
b) Actuator and load cell

loading plate to the top beam of the infilled frame to apply the horizontal load. The connection to the loading plate allowed for free rotations. Figure 3.10b shows the connection of the actuator to specimen 1.

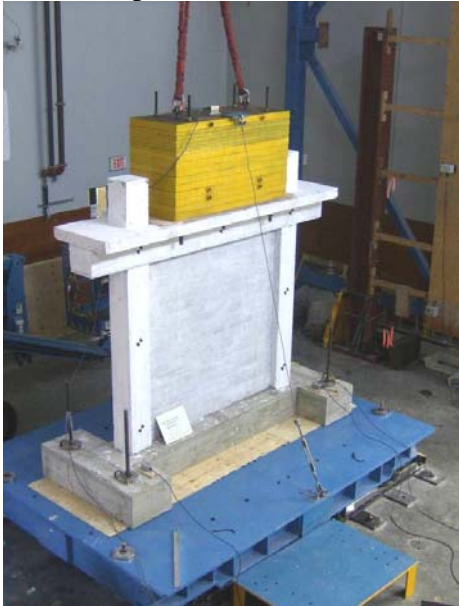
a) Specimen #2 prior to shake table test #01

The primary focus of the research program was to document experimental data on the dynamic interaction of an unreinforced hollow concrete block masonry infill wall and the bounding GLDRC frame. For this objective, two GLDRC frames were tested, one bounded by an infill URM wall (specimen #2), as shown in Figure 3.11a, and one with a gap between the frame and the infill wall (specimen #3), shown in Figure 3.11b. Both specimens were tested under the same dynamic loading protocol described below.

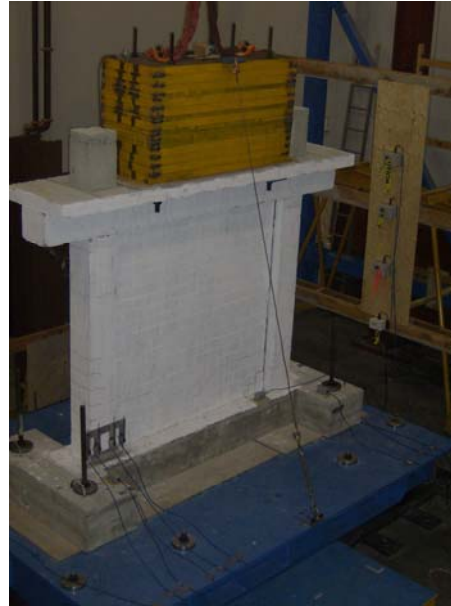
b) Specimen #3 prior to shake table test #07

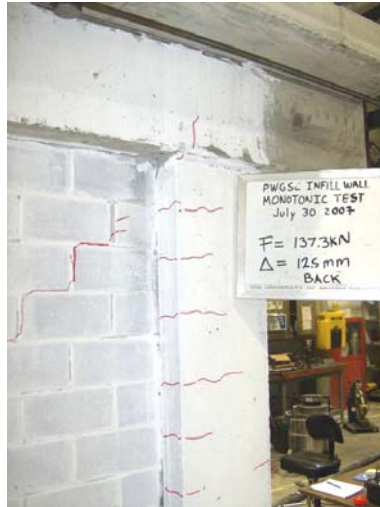
Figure 4.3 Hairline cracks in GLDRC frame

a) Drift 0.625%
Tension Column

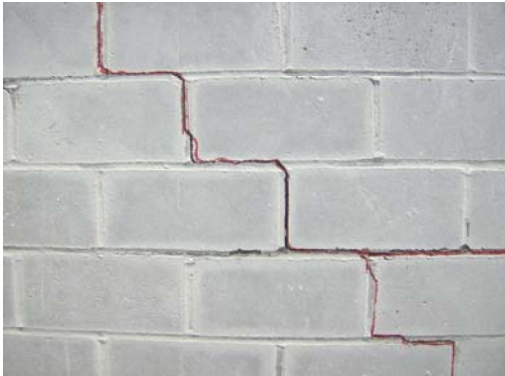
a) Opening of head joints

At 1.00% drift, the sliding mode was observed confirmed by relative displacement of the blocks with respect to the cracked header joints, as shown in Figure 4.4a. In addition, the end of the beam connected to the tension column showed an increase in length top of the previously observed hairline flexural crack. This flexural crack ran all across the top of

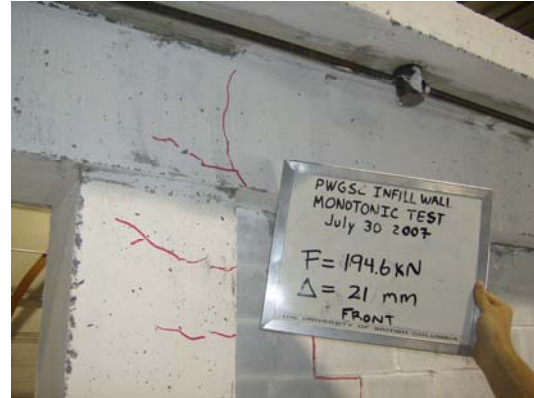
b) Flexural crack at the end of the beam connected to tension column

the beam; this indicates that the positive cracking moment was exceeded for this location, and represents a loss in rotational stiffness of the beam.

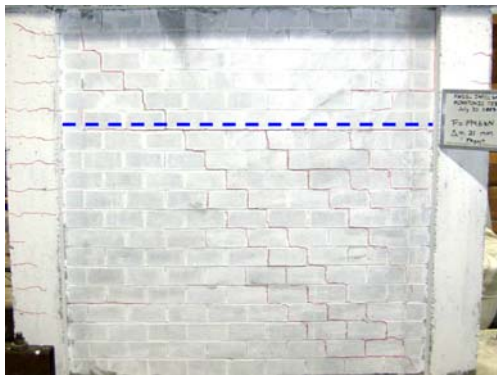
a) Drift 1.00%

At 1.00% drift, several horizontal cracks formed along the bed joints of the URM wall due to bed-joint sliding mechanism. One horizontal crack extended along the full length of the wall was formed at the sixth course from the top of the URM wall as shown in Figure 4.5a. Additional smaller horizontal cracks were formed at higher drift levels, located at the bottom two courses. Also, new diagonal cracks were observed located closest to the compression column and ending at the intersection with the longer horizontal crack.

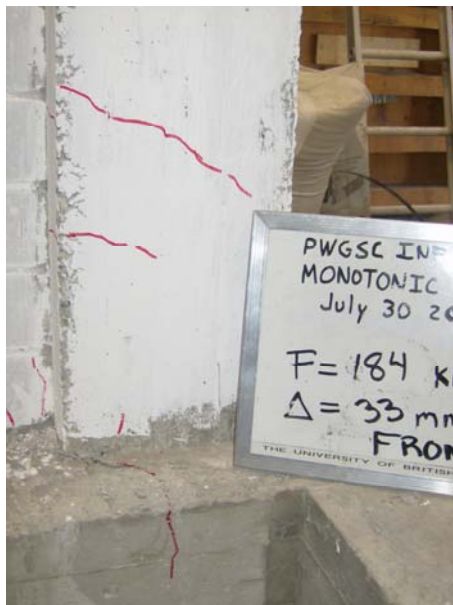
Figure 4.7 Rotations at the base of the compression column

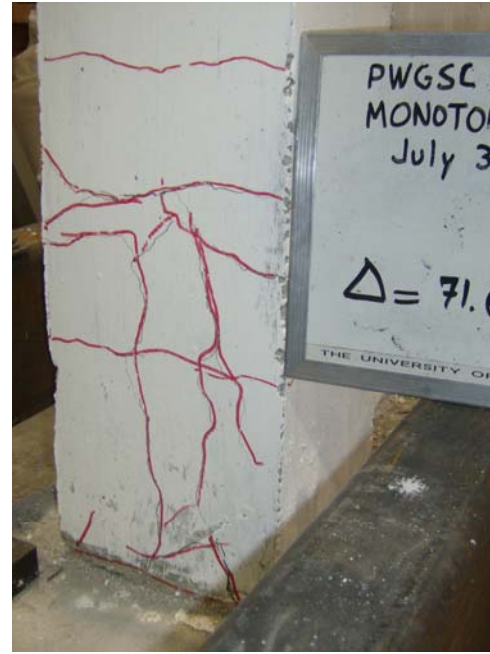
b) Drift 3.55%

the 90 degree hooks of the column ties opened up losing confinement and allowing the rebar to bend outwards, see Figure 4.8b.

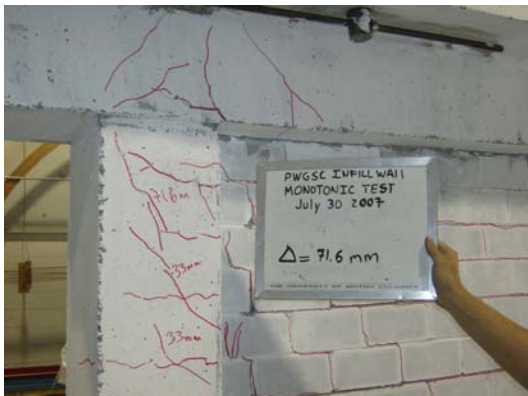
Figure 4.9 Additional damage in GLDRC frame

a) Drift 1.65 - 3.55%

shear cracks developed
top the tension column and the
beam-column joint

b) Drift 1.65%

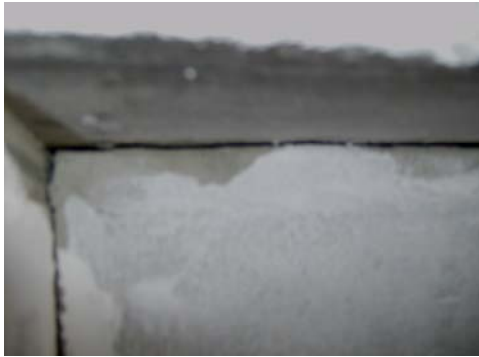
a) After test #03
Mortar interface cracked

This was observed as a cracked mortar joint that left a 2 mm gap between the infill wall and frame, as shown in Figure 4.10a. This gap allowed for out-of-plane flexibility; however it did not allow for sufficient rotation of the top masonry blocks under the GLDRC beam to result in out-of-plane collapse of the URM wall.

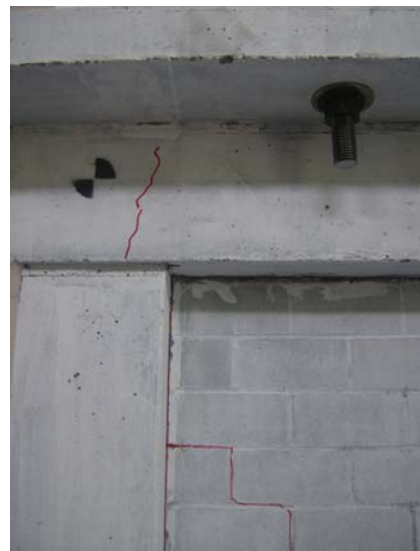
Figure 4.12 Observed damage of specimen 2 after test#08

a) After test #08
More mortar cracks due to sliding
(URM wall back view)

b) First flexural crack formed at
left end of GLDRC beam

During test #08, the shake table tests began to show sporadic vertical displacements resulting in the rocking motion at the foundation level of the specimen. At this stage of testing the steel plates showed significant sliding between plates.

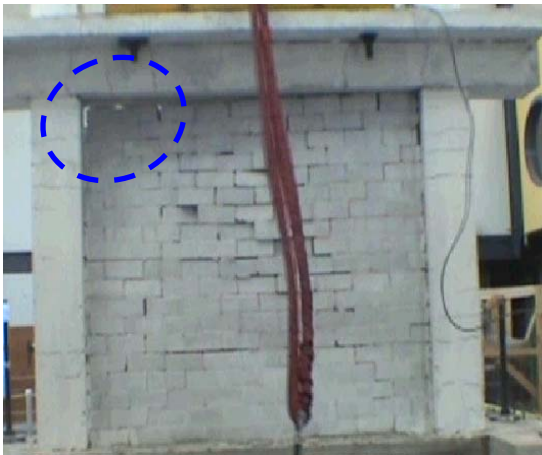
Figure 4.15 Observed damage of specimen #2 for test #30

a) top corner concrete block
sliding out of plane
(back view of URM wall)

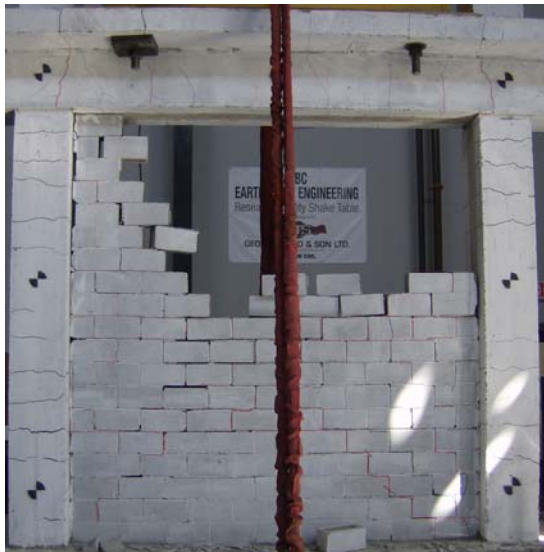
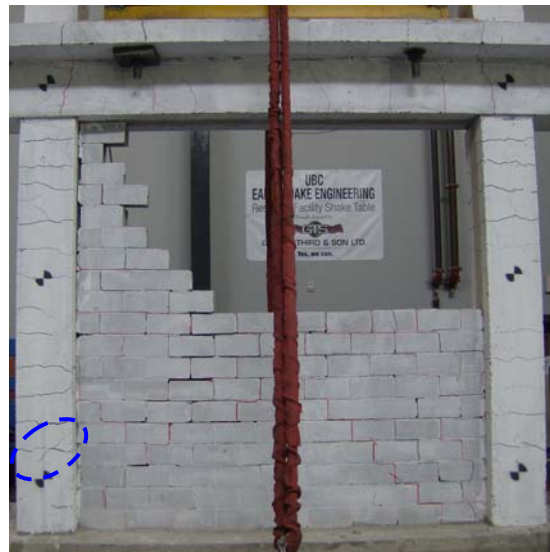
Figure 4.16 Observed damage of specimen 2 for tests #30 and #33

a) After test #30
(URM wall front view)

b) After test #33
(URM wall front view)

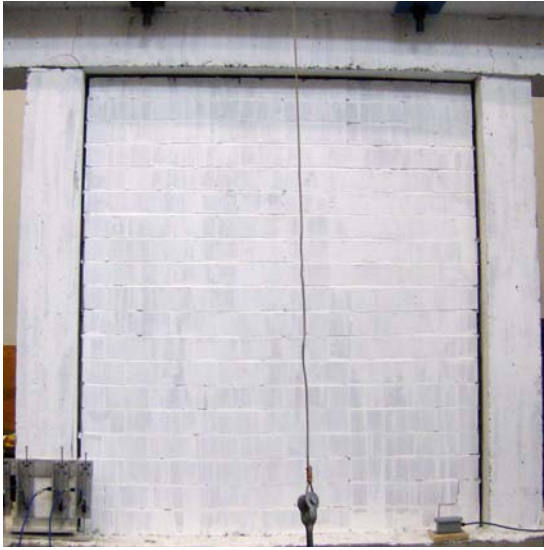
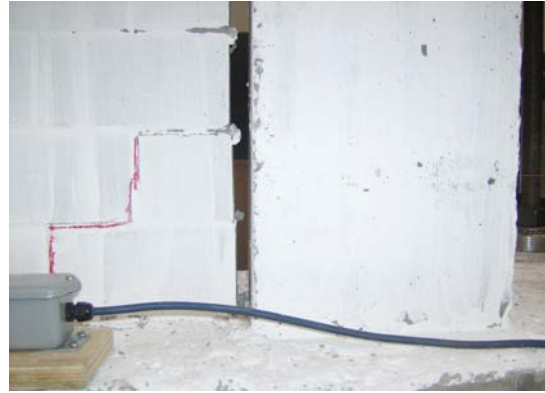
Figure 4.18 Observed damage of specimen 3 after test# F

a) After test F
Flexural cracks in beam ends
(URM wall front view)

b) After test F
Mortar cracks at lower right corner
of URM wall
(URM wall front view)

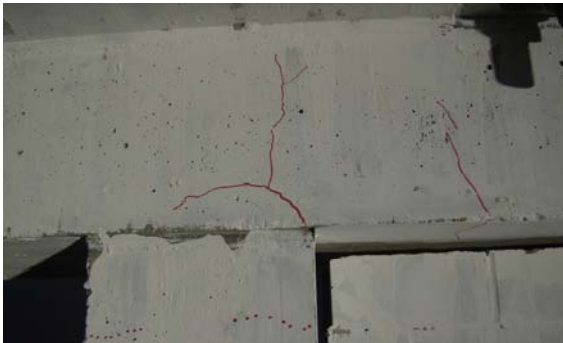
Figure 4.19 Observed damage of specimen 3 after test#01

a) After test #01
Flexural cracks formed in
GLDRC columns
(URM wall front view)

b) After test #01
Flexural cracks formed at top fibers of
foundation beam
(URM wall front view)

c) After test #01
Flexural crack left end of beam
(URM wall front view)

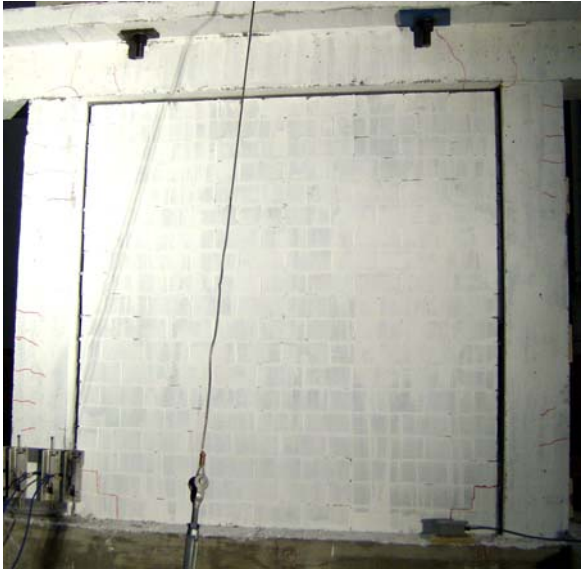
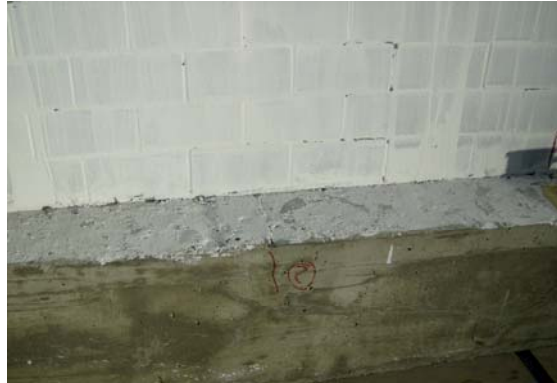
Figure 4.20 Observed damage of specimen 3 after test#02

a) Test specimen after test #02
No additional cracks found in frame
(URM wall front view)

b) After test #02
Flexural crack at foundation beam
at midspan
(URM wall front view)

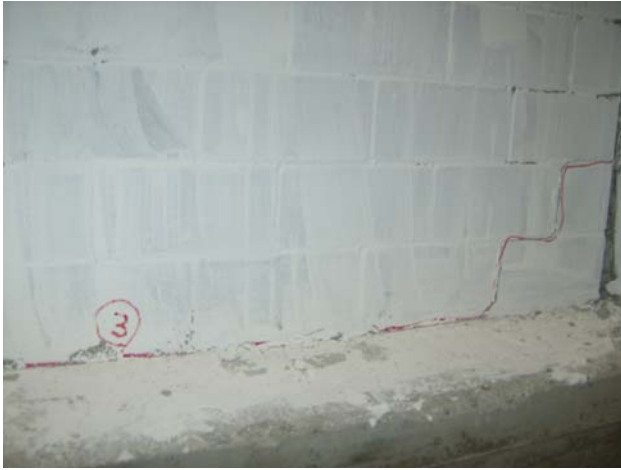
Figure 4.21 Observed damage of specimen 3 after test#03 and test#04

a) After test #03
Mortar cracking at bed joint
of bottom course of URM wall
(URM wall front view)

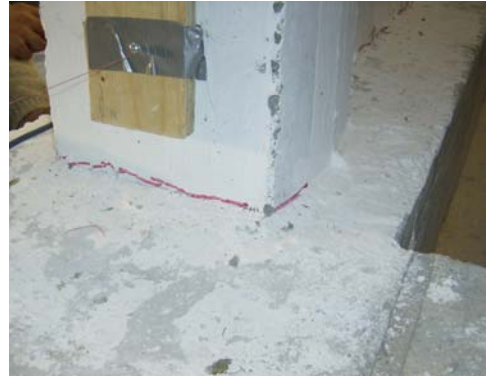
b) After test #04
Concrete cracking at interface of right
column and foundation beam
(Specimen side view)

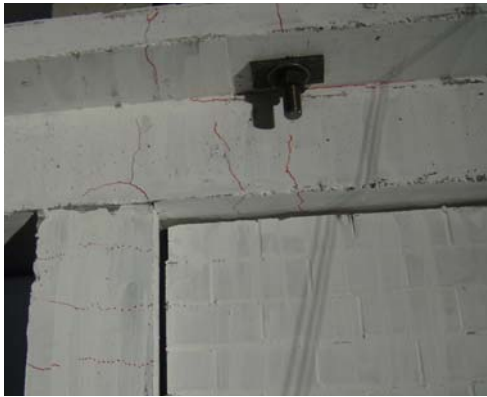
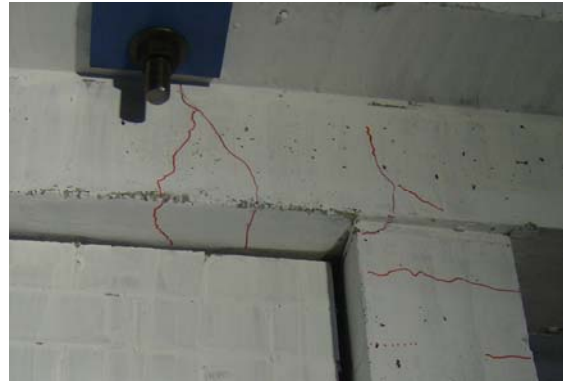
Figure 4.22 Observed damage of specimen 3 after test#05

a) After test #05
Flexural cracks left end of beam
(URM wall front view)

b) After test #05
Flexural cracks right end of beam
(URM wall front view)

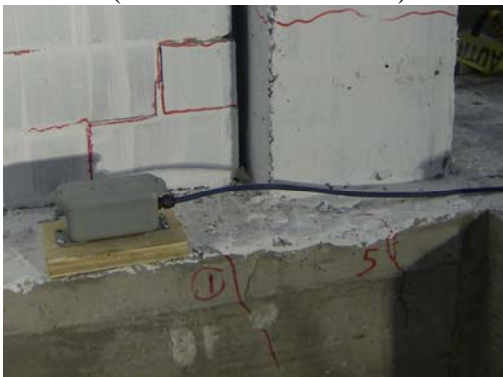
c) After test #05
Flexural crack in foundation beam
under base of right column

After test #05, an additional flexural crack was found on the right end of the foundation beam. This flexural crack was located under the right column of the bare frame, as can be seen in Figure 4.22c. In addition, some concrete spalling was observed at midspan of the foundation beam, as shown in Figure 4.22d.

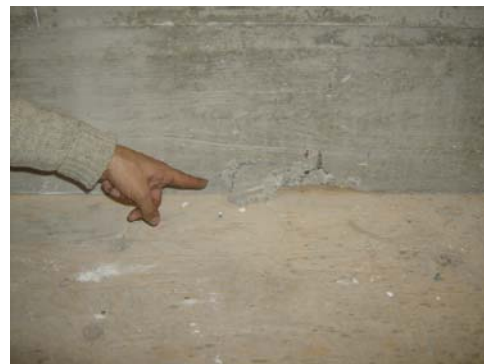
d) After test #05
Concrete spalling of foundation beam
at midspan

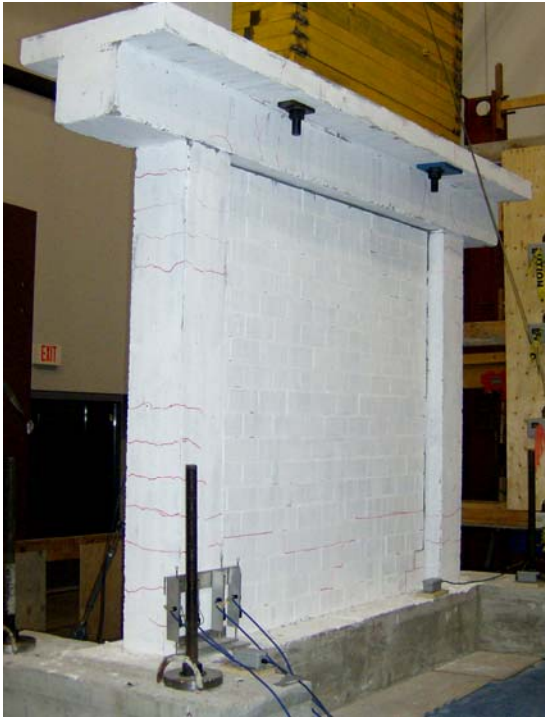
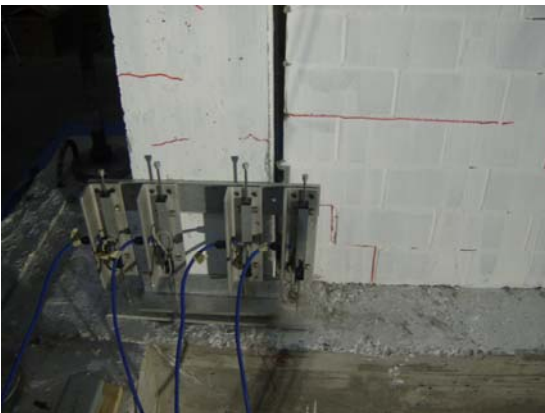
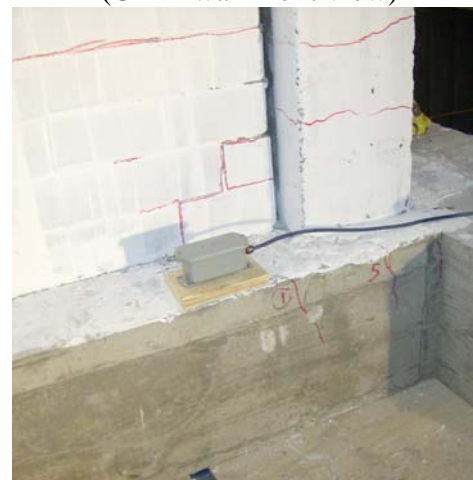
Figure 4.23 Observed damage of specimen 3 after test#06

a) After test #06
Additional crack patterns
in the URM wall
(URM wall front view)

b) After test #06
Mortar crack pattern
bending failure of URM wall
(URM wall front view)

c) After test #06
Mortar crack pattern at the left side
of URM wall (URM wall front view)

d) After test #06
Mortar crack pattern right side
of URM wall (URM wall back view)
