**A COLLAPSE STUDY OF A LIGHTLY REINFORCED CONCRETE SHEAR WALL  
BUILDING DURING THE FEBRUARY 22, 2011 CHRISTCHURCH EARTHQUAKE**

A THESIS SUBMITTED IN PARTIAL FULFILLMENT OF  
THE REQUIREMENTS FOR THE DEGREE OF

(Civil Engineering)

THE UNIVERSITY OF BRITISH COLUMBIA

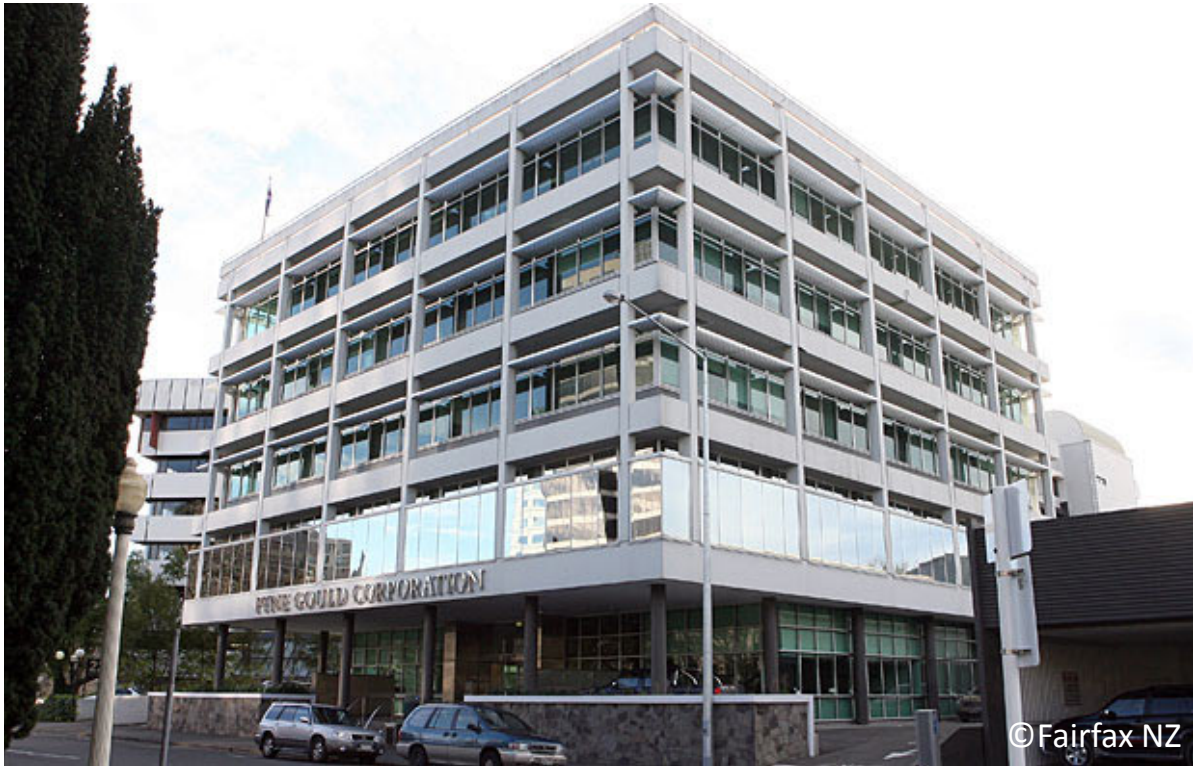
**Figure 1: Pyne Gould Corporation Building (South East Face) (Stuff.co.nz 2012)**

The Pyne Gould Corporation building was a 5-story reinforced concrete (RC) structure built in 1964 (Figure 1). The occupancy of the building was mixed use office space, with partition walls distributed throughout each level. The main lateral-force-resisting system was a set of 8-inch walls offset to the north end of the plan (Figure 2 and Figure 3). The core walls extend from the ground story to the roof, at an elevation of 68.7 feet above the ground level. The ground level columns and walls extend 5 feet below grade to typical RC shallow pad and strip footings, connected by a grid of grade beams (see structural drawings in Appendix A.1).

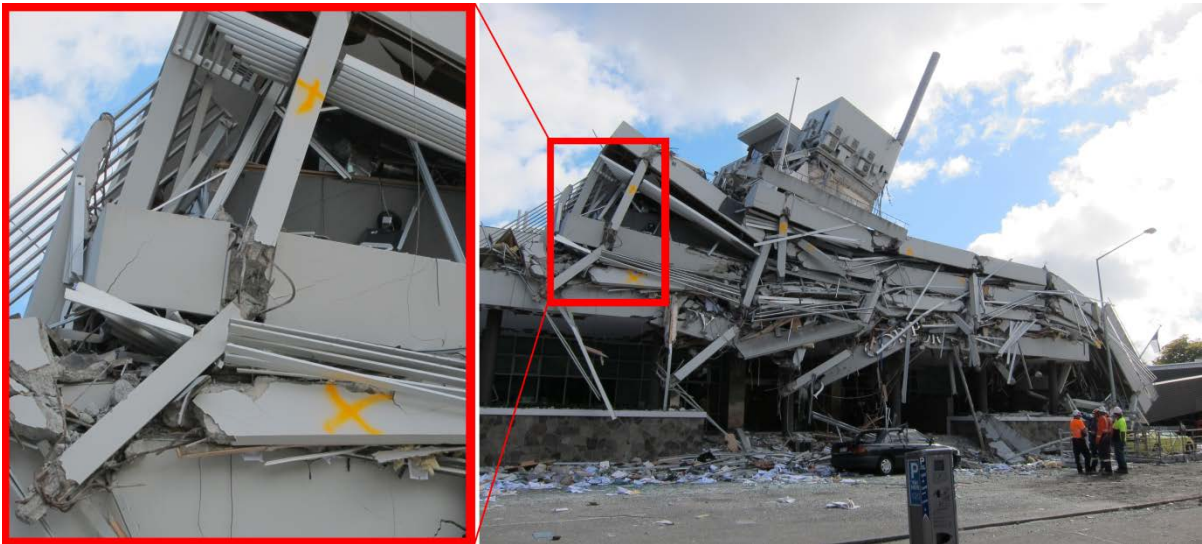
**Figure 10: Typical joint damage (left) South elevation showing the collapse of exterior gravity frame (right) (photos courtesy of Ken Elwood)**

Shear-critical columns (Critical Deficiency A), based on the photos following the collapse, very little damage can be seen in the columns (Figure 10). Majority of the damage is

concentrated in the beam-column joints (Figure 10), refer to section 4.3.2 for more detailed information regarding the expected performance of the beam-column joints. It is unclear based on the observed damage if the columns were shear critical, since majority of the damage is sustained within the joints. The non-ductile exterior frame of PGC was constructed with minimal transverse reinforcement through the beam-column joints (critical deficiency B), resulting in very little deformation capacity. The lack of continuous transverse reinforcement in the joints is common practice for buildings built at this time. The exterior gravity frame failed in a sidesway mechanism, following the increase in displacement demand from the shear core, as it collapsed to the southeast, see Figure 10. The props installed from the 1997 assessment provided little assistance for this type of failure mechanism.

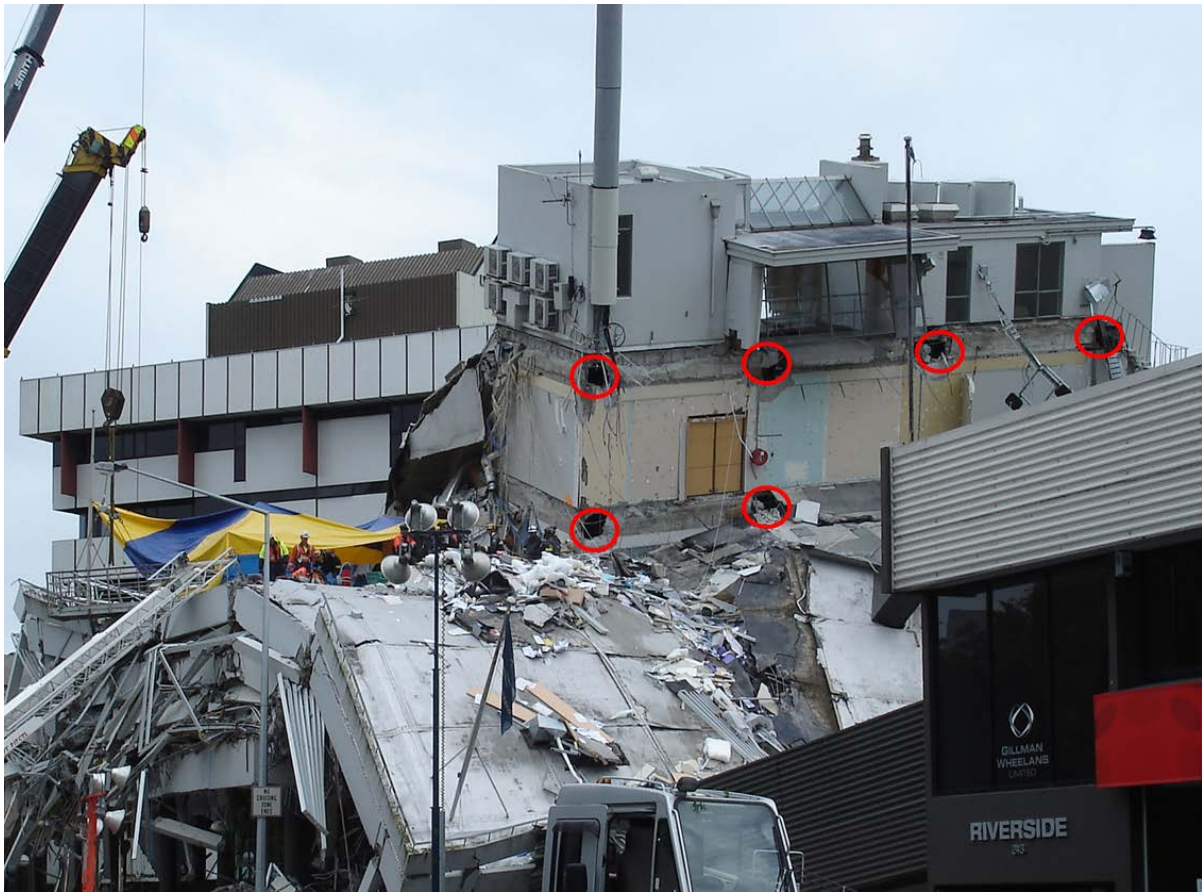
**Figure 11: Detached floor systems from shear core shown by large holes where the girder slab connection pulled away from the wall due to lack of continuous reinforcement (photo courtesy of Ken Elwood)**

Poor connectivity between elements, critical deficiency D, is a significant factor when considering the separation of the floor system (girders and slabs) from the shear core. From Figure 11, the red circles show the large openings where the floor beams used to be connected to the core. Minimal to no continuous reinforcement or hooks of any kind are shown in the drawings at the connection between the beam and the shear core, requiring the minimal slab reinforcement, which were spliced at this location to transfer majority of the load to the shear core.

Only 2-#8 bars, embedded 4 inches into the core at the top and 4-#10 bars, embedded 4 inches at the bottom (with respect to the attached beam) are used at the connection. A quick calculation of bond strength for these two types of bars is shown in A.3, the 2-#8 bars govern the bond slip ultimate capacity estimated at 5.3 kips. Looking closer at the picture in Figure 11, the embedded beam reinforcement had removed a portion of the wall during collapse (a concrete pull-out failure). Beyond the critical deficiencies that have been observed from existing buildings that may have caused collapse in past earthquakes, PGC is unique and more specific deficiencies can still be observed.

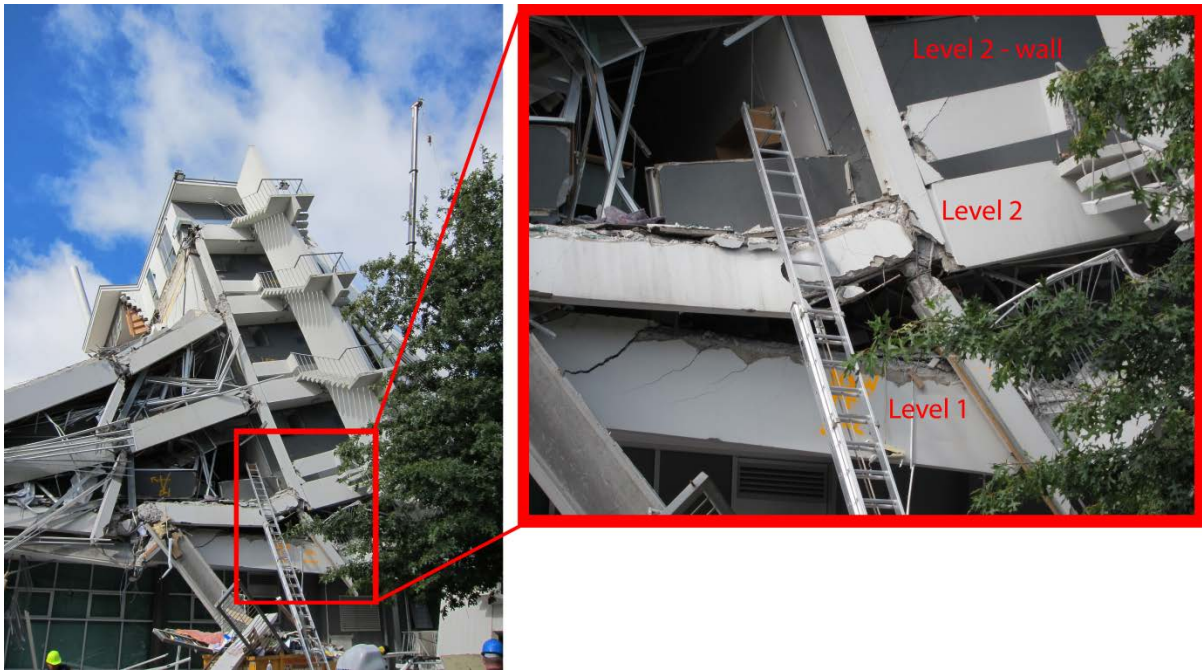
**Figure 12: North Elevation indicating loss of the level 1 wall along gridline E (photos courtesy of Ken Elwood)**

crushing from high demand in the east-west direction. Also, the door openings in the core walls on gridlines D and E increase this critical vulnerability in the wall at this location. It is assumed the location of failure is just above level one, due to the previously described vertical discontinuity at this location and by inspection of Figure 12, where the wall at level 1 cannot be seen between the floor slabs of level 1 and 2.

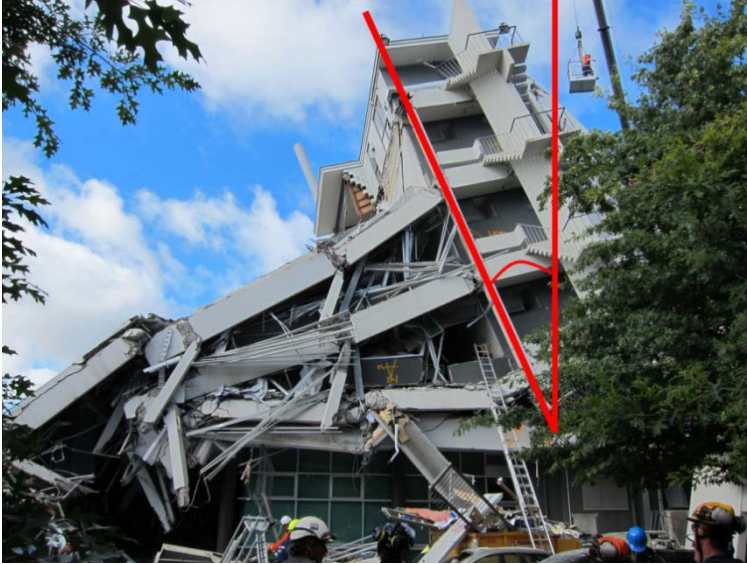
**Figure 13: North Elevation of the collapsed structure showing the end location of the core relative to its starting position (photo courtesy of Ken Elwood)**

By further observation of the post-earthquake photos, it appears that the failure of the walls at level 1 caused the entire shear core to lean towards the southeast (see Figure 13), which would be consistent to a crushing and buckling type failure at the wall opening along gridline E. Figure 13 indicates the core rotation based on the final positions of column at grid E-b.

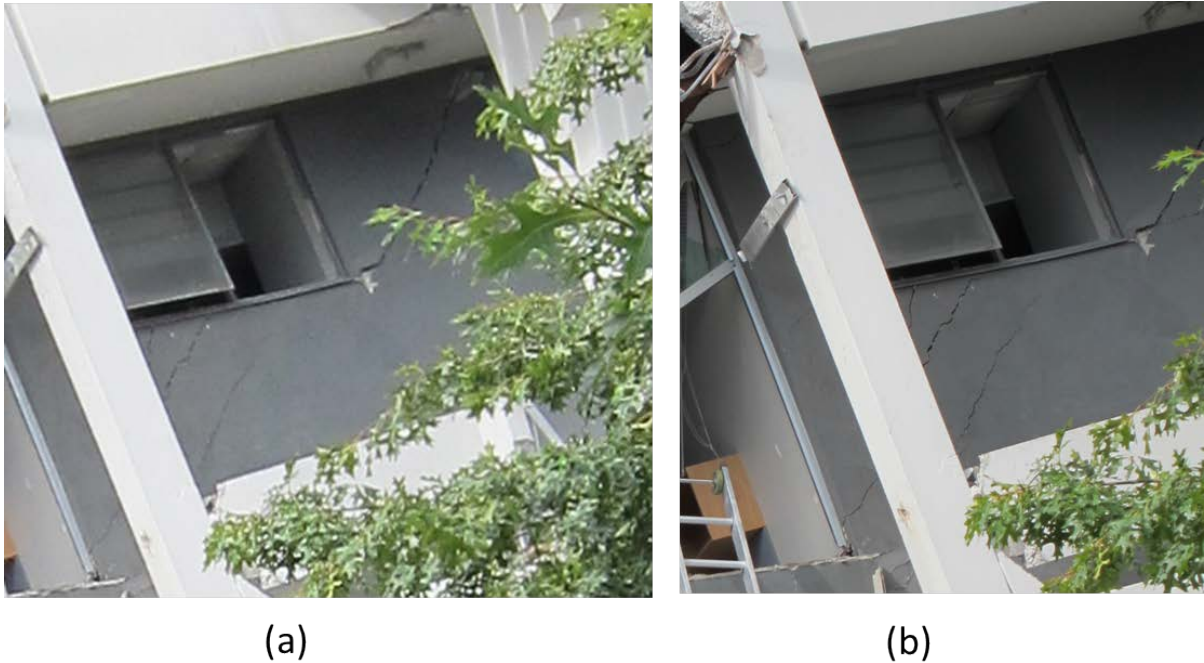
**Figure 14: Diagonal shear cracks at the window openings of the north wall at level 2 (a) and (b) (photos courtesy of Ken Elwood)**

A final observation regarding the failure of the wall is the large diagonal cracks shown in Figure 14, located around the window opening of the north wall of the core at level 2. Considering the severity of the cracks shown at level 2 and the expected increase in demand from level 2 to level 1, it is possible a shear type failure mechanism controlled the failure of the wall at level 1. This type of perforated shear wall is susceptible to shear failures and considering the lack of confinement and thin wall sections of the core walls, this would only increase this susceptibility. These cracks do not definitively indicate shear failure occurred, but they do lead to the possibility that it could have influenced the collapse. The cracks, shown in Figure 14 span from the top right to the bottom left, which is consistent with a loading demand from the west to the east, which is the direction the entire structure failed. Shear failure of a concrete wall is essentially a compression or tension failure along a diagonally cracked plane. Following a shear failure of the north wall at level 1, the east flange of the core, considering the increase in demand could have still failed in compression, which would explain the previously stated observations regarding the final position of the shear core.

Shear failure at this location has been speculated by numerous academics and practicing engineers as summarized by the Royal Commission (2012a), but no analytical evidence has been shown. The 1997 structural assessment identified the walls as being vulnerable, stating that:

“The wall shear strains are also relatively high although cracking is confined to specific portions of the walls, mainly the coupling beams and around openings. The main effect of this cracking is to reduce the stiffness of the wall but as the cracks do not close there are potential serviceability problems. For walls which have been strained to the degrading portion of the curve there will be some loss of gravity load carrying capability. However, the consequences of this are not likely to be as severe as for columns as each wall portion supports a relatively small tributary area of floor” (Beca 2011b).

Since the expected damage to the walls around openings was expected to be minimal and not life threatening, no retrofit procedures were undertaken. Further supporting the possible shear failure, an engineer’s site report following the December earthquake stated:

“General diagonal cracking to all shear walls (Beca 2011a).”
