Quantifying Unreinforced Masonry Seismic Risk and Mitigation Options in Victoria, BC

A THESIS SUBMITTED IN PARTIAL FULFILLMENT OF
THE REQUIREMENTS FOR THE DEGREE OF

MASTER OF APPLIED SCIENCE

THE FACULTY OF GRADUATE AND POSTDOCTORAL STUDIES
(Civil Engineering)

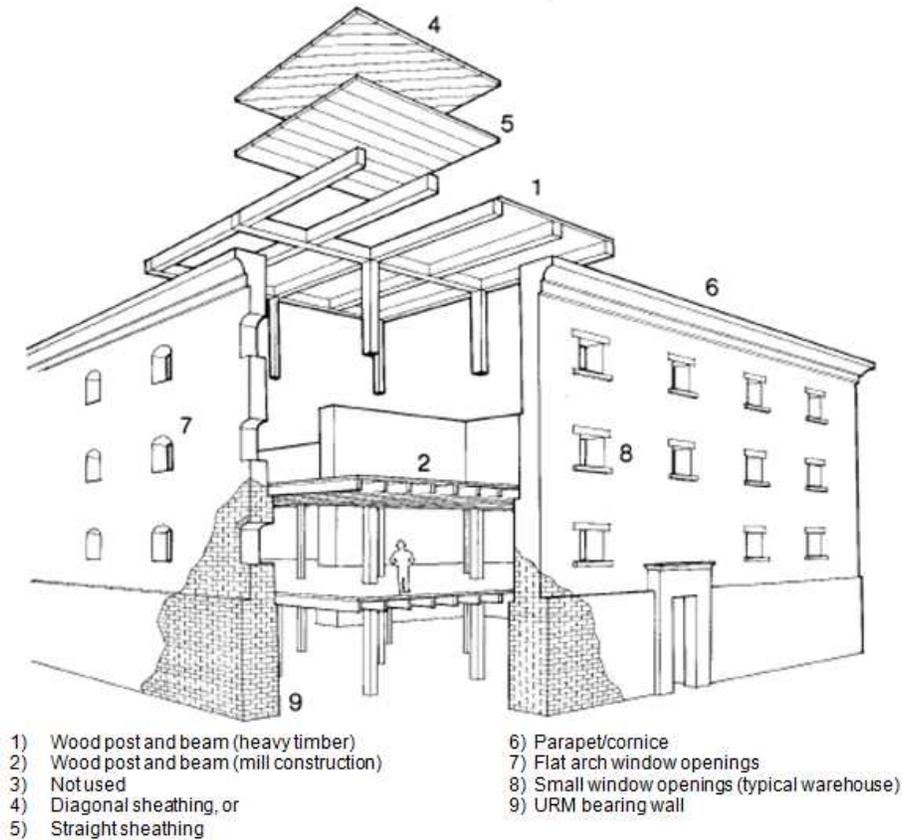
Figure 2.1 – Typical URM Building and Components

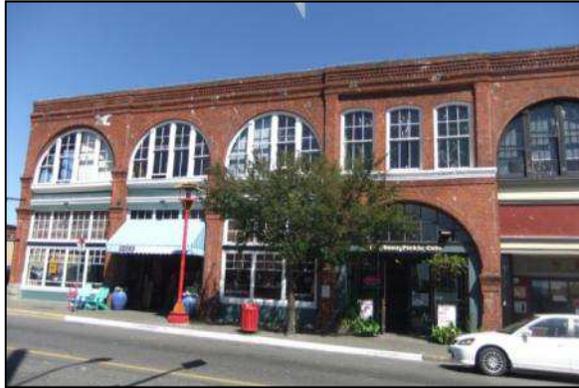
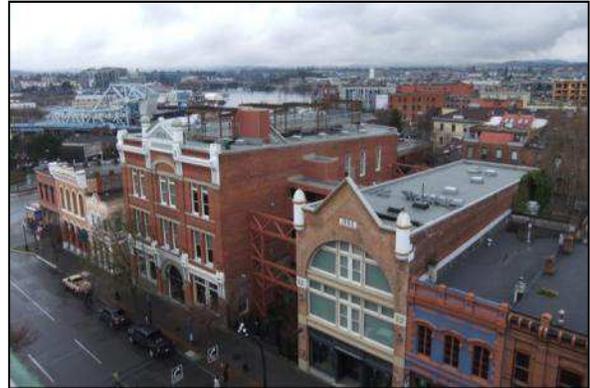
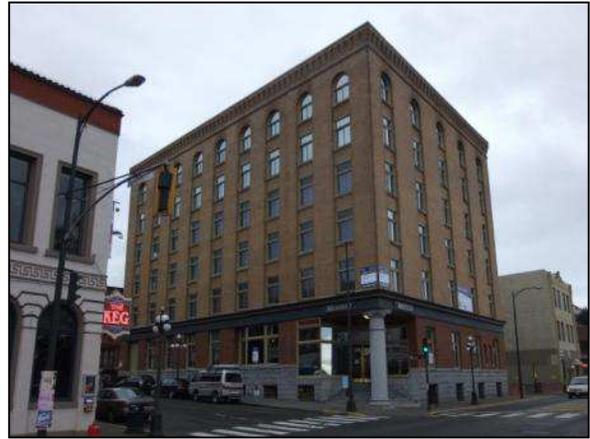
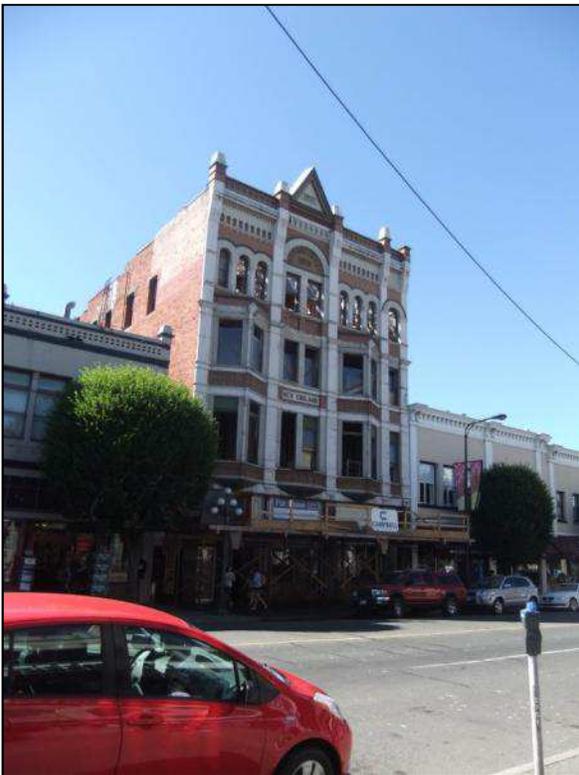
Figure 2.3 – Examples of URM Buildings in Victoria, BC

Based on the literature (ABK 1981, Lizundia, Dong and Holmes 1993, Rutherford & Chekene 1997) and discussion with practicing engineers and researchers, it is understood that this type of URM construction is common throughout western North America. Of course, there are many variations in structural form fitting this broad description and the structural form of a URM building is often quite indicative of its original use. Rutherford and Chekene (1990) defined 15 prototype URM buildings for San Francisco, U.S.A. based largely on original use. The illustration from the document is reproduced here, as Figure 2.2. This essentially shows the variety of URM buildings that is commonly encountered on the west coast of North America, including Victoria. All would fit the aforementioned broad description. Figure 2.3 shows photos of a few example buildings in Victoria.

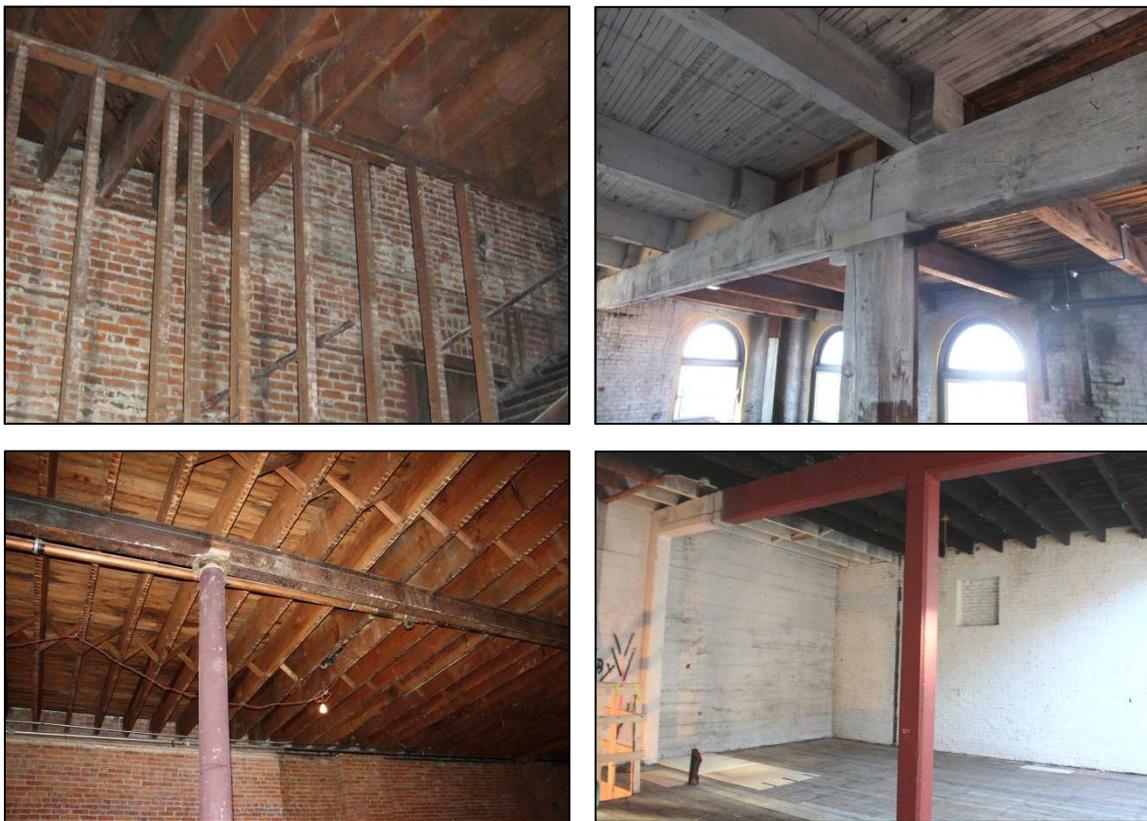
Figure 2.10 – Light Wood (Top Left), Heavy Timber (Top Right), Structural Steel (Bottom Left), and Reinforced Concrete (Bottom Right) Framing

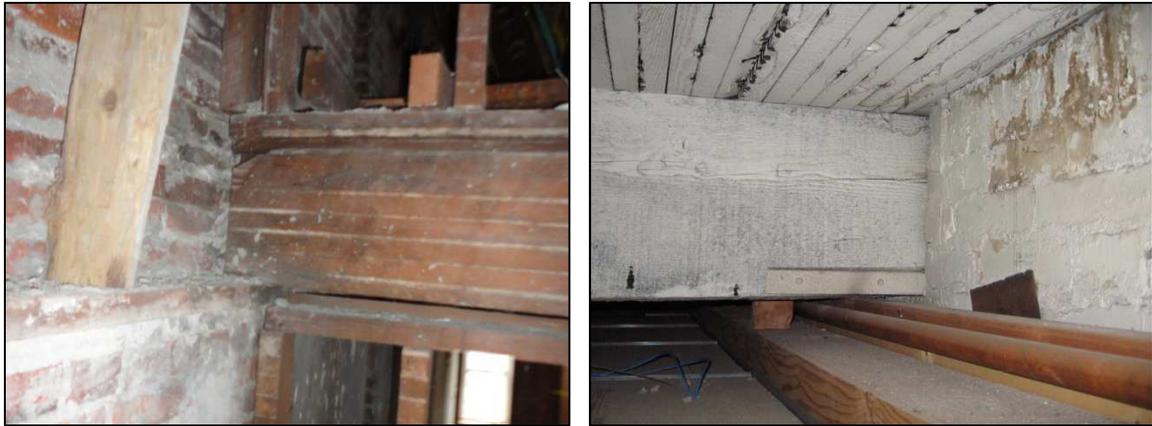
Figure 2.12a – Floor Framing at a Ledge (Left) and a Pocket (Right)

Another key component of diaphragms is their connection to the URM walls. The two most common conditions are for joists/beams to sit on ledges (created by reducing the wall thickness by one wythe) or in pockets formed into the wall lay-up. In both cases, the floor framing may or may not be anchored to the wall to resist lateral loading (eg. from wind and earthquake) as part of the original construction; the frequency of anchorage varies by region, presumably due to local construction practices of the day. In any case, the anchorage (if present at all) is generally not capable of resisting the loads imposed by any modern seismic codes. Figures 2.12a shows ledge and pocket details and Figure 2.12b shows ties from original construction.

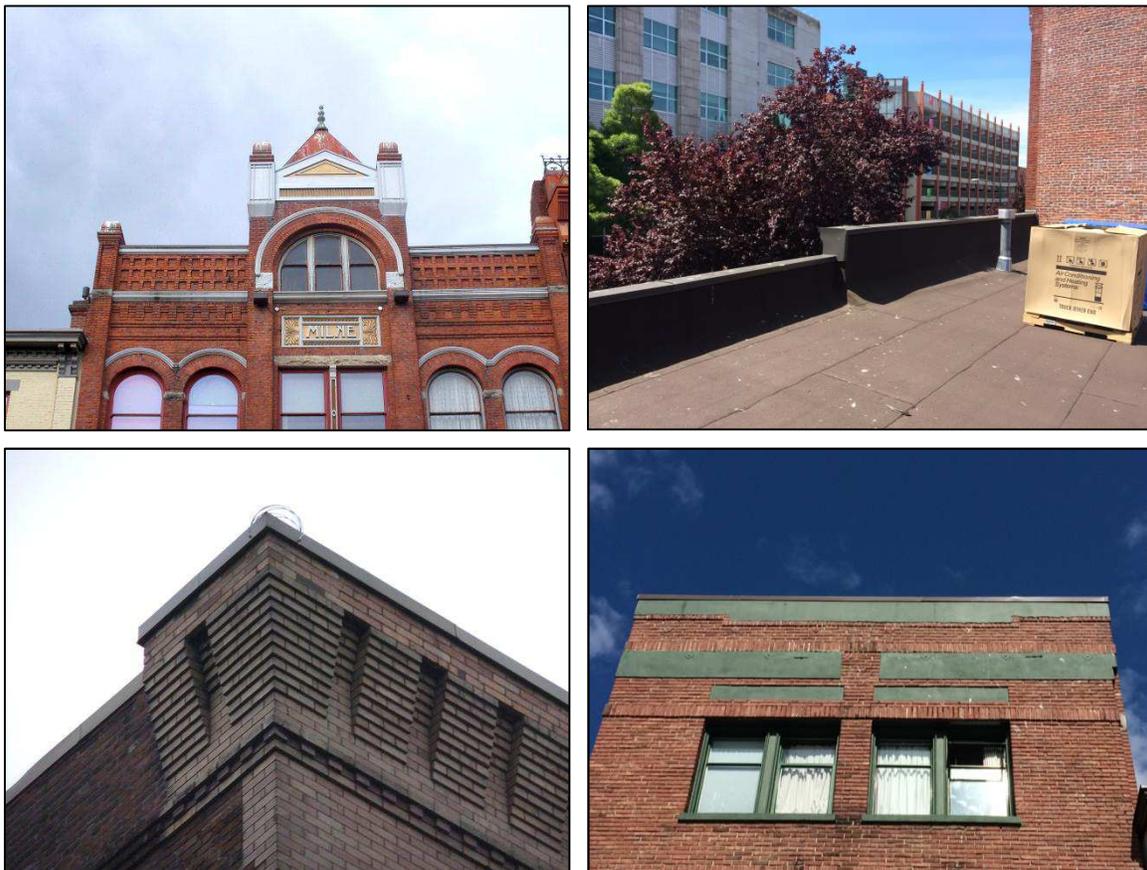
Figure 2.13 – Masonry Parapets Viewed From Street (Top Left) and Rooftop (Top Right); Corbelled Parapet (Bottom Left); Concrete Parapet (Bottom Right)

Parapets are the portions of URM exterior walls that extend above the roof. They serve many functions, but were originally provided to prevent fire from spreading from rooftop to rooftop (Rutherford & Chekene 1997). As URM construction became more popular in the early 1900's, parapets became an important architectural feature and character defining element of a building, and often were often large and ornately decorated, particularly on the main facades. Height varies from just a few inches above the roof surface to several feet and the parapet may project straight up from the wall below or be corbelled outwards in a decorative fashion. Occasionally, concrete parapets will be found on URM buildings. Figure 2.13 shows examples photos of parapets.

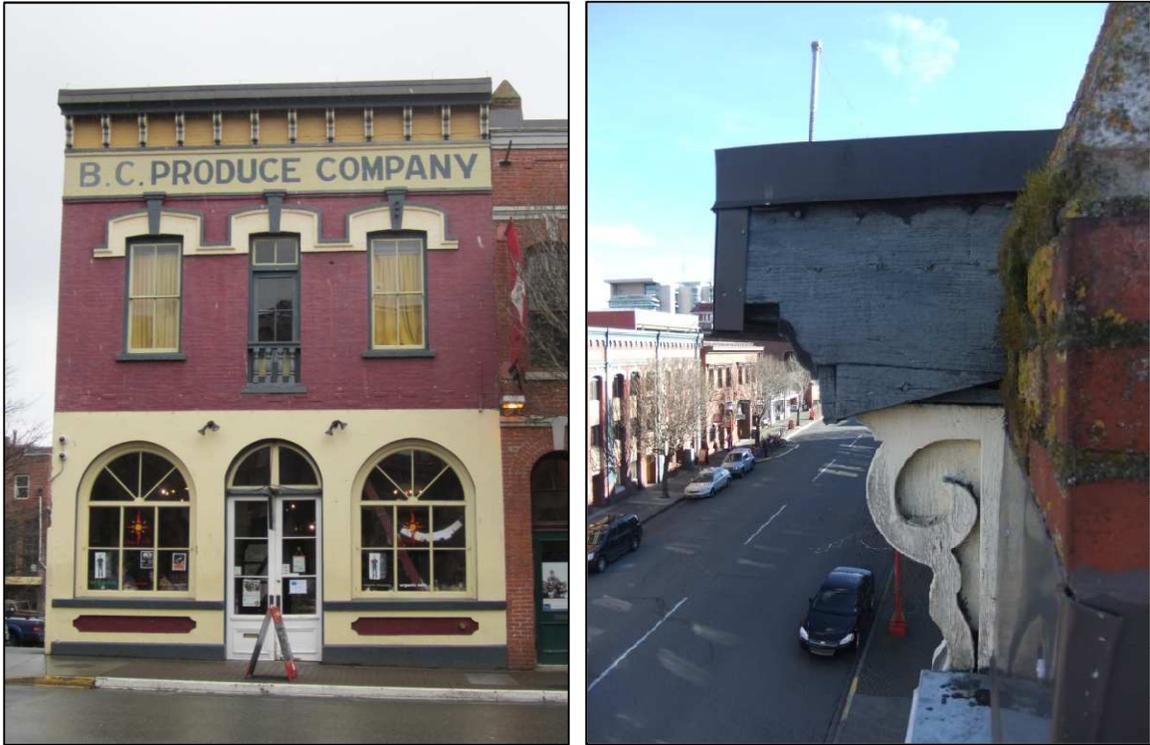
Figure 2.14 – Example Photos of a Typical Lightweight Cornice

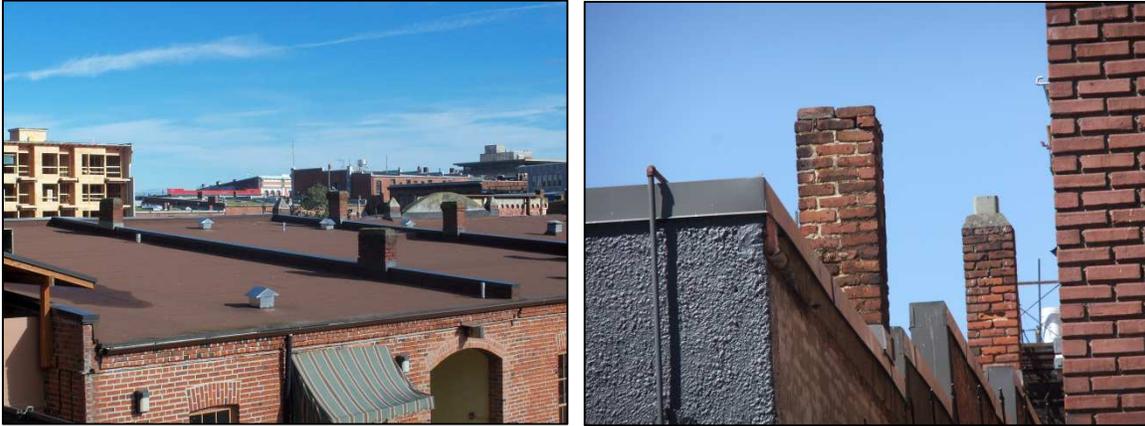
Figure 2.15 – Example Photos of Chimneys & Pilasters

Chimneys and pilasters are common elements on URM buildings that are constructed of URM and pose significant fall hazards to life-safety. Because all four sides are exposed to weather, there is often a greater fraction of the mortar in a deteriorated condition. For chimneys, the portion projecting from the roof may be just one wythe thick and the result is that they are highly vulnerable to earthquakes. Pilasters may appear similar to chimneys, but are generally solid sections. It should also be noted that these elements are not always located at the perimeter of a building and, thus, may not be readily visible from street level. Figure 2.15 provides example photos of chimneys and pilasters.

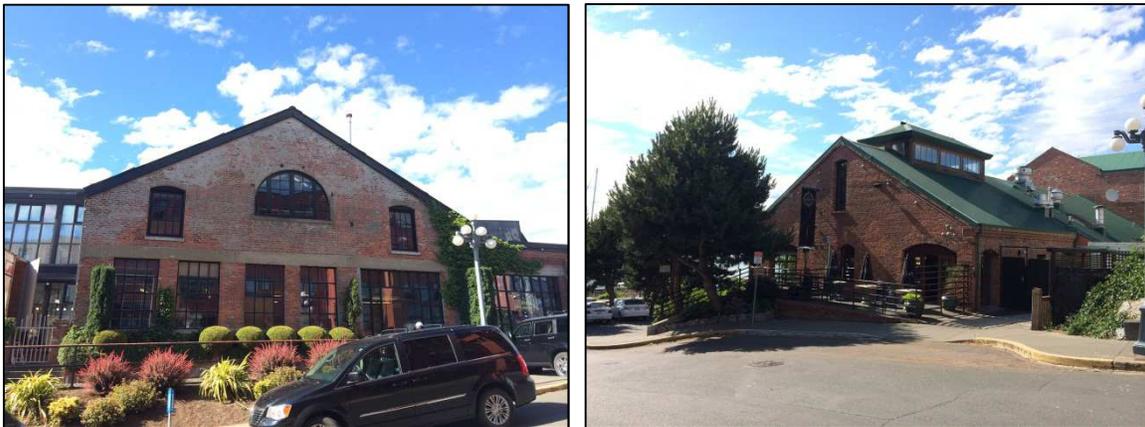
Figure 2.16 – Example Photos of Gables

Buildings with pitched roofs often employ gable ends, resulting in an increased wall height. There is also typically little dead load or restraint from the roof, as the roof framing spans parallel to the gable. As a result, gables are also highly vulnerable elements. Although considered part of the structural wall (and thus not a true appurtenance), it is identified in this section because it poses a fall hazard similar to the other elements herein. Figure 2.16 shows examples photos of gable ends.

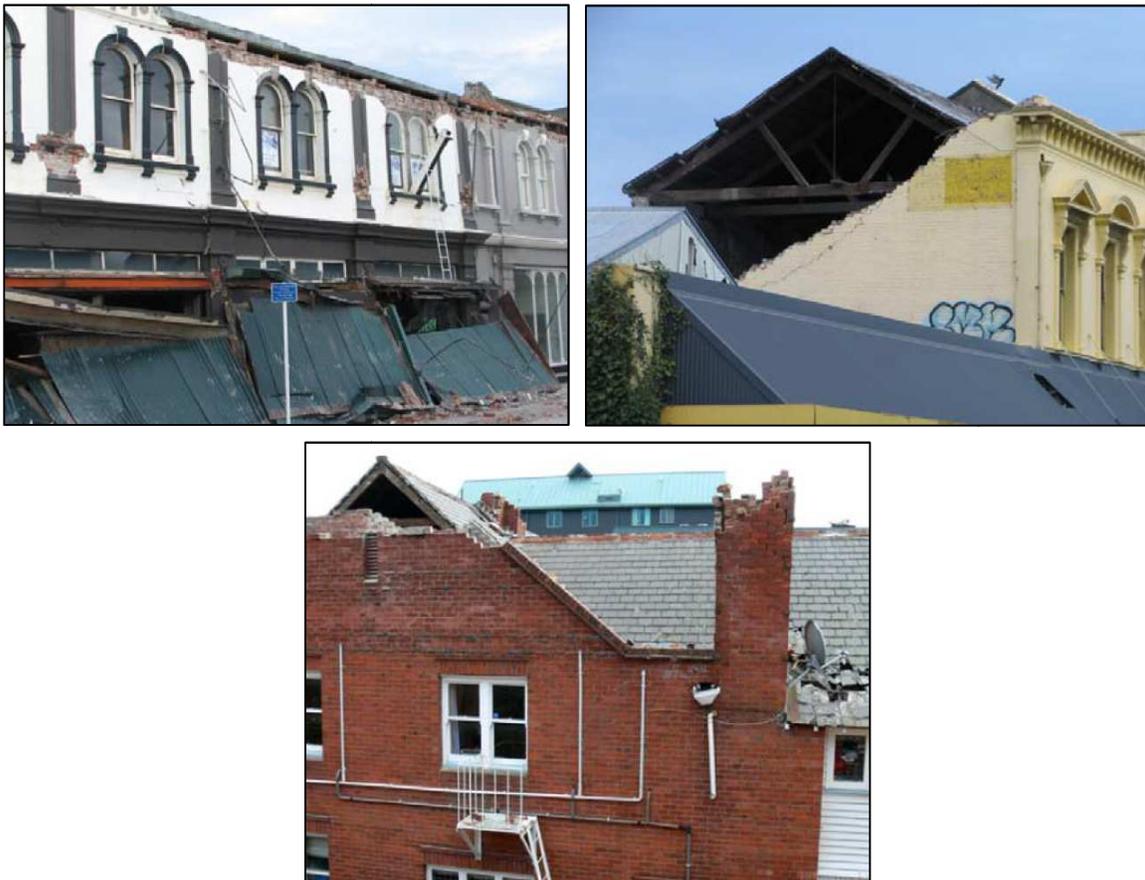
Figure 2.17 – Failure of Parapets (Left), Gables (Right) and Chimneys (Bottom)

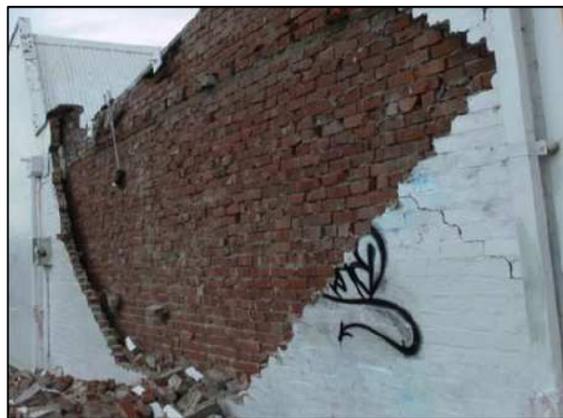
Figure 2.19 – Veneer Failure

As mentioned in Section 2.4.1, anchorage of veneers to the structural backing wythes in URM buildings often consists of either corrugated metal ties, long nails, or other miscellaneous steel ties. The seismic resistance of the ties is further reduced due to low strength, high-lime content mortar typically used in URM buildings. Figure 2.19 provides a photo of a veneer failure.

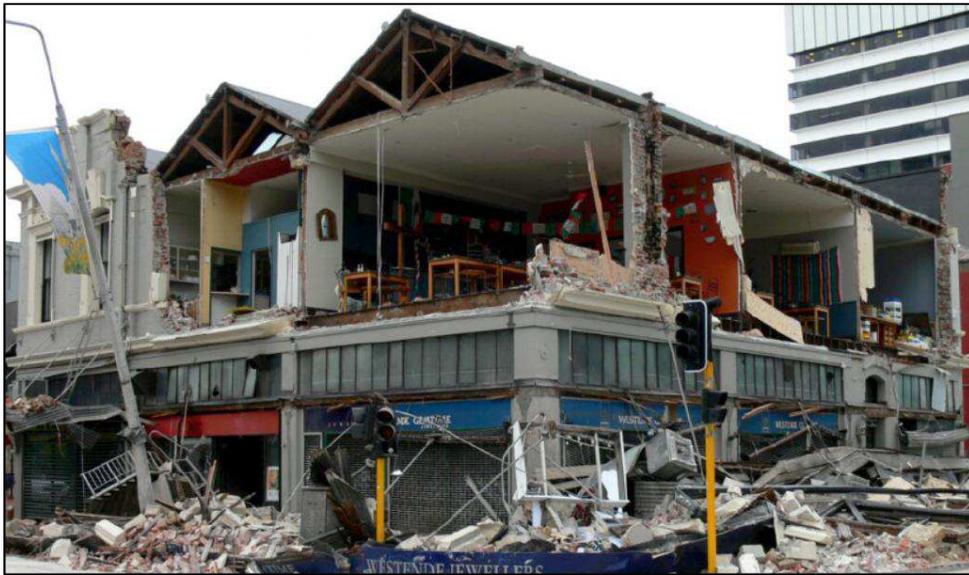
Figure 2.21 – Photo of Out-of-Plane Wall Failure

Under shaking of increased intensity or duration, entire walls may topple outwards. This is due to either a lack of anchorage or an excessive flexural stress in the wall as it bends between floors. The life-safety hazard to pedestrians is increased due to the increased volume of debris falling outwards. Often, the interior walls and columns are sufficient to support the floors and the remainder of the structure is left standing, while the wall lies on the ground in ruins. As pointed out by Ingham and Griffith (2011b), the hazard is greater to the public on the street than the occupants of building. Figures 2.20 and 2.21 provide an illustration and a photo of an out-of-plane (OoP) failure.

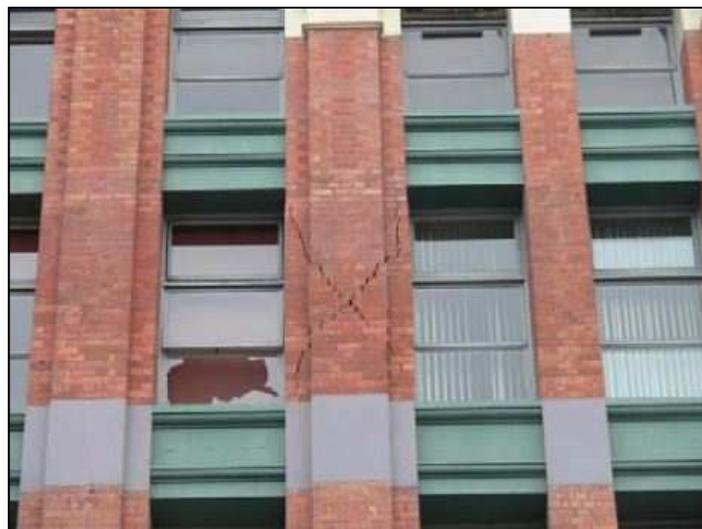
Figure 2.23 – Photo of In-Plane Shear Failure

Significant damage can also result from in-plane seismic actions. The most commonly observed in-plane failure is an ‘X’ crack shear failure; other in-plane failures include bed joint sliding shear and toe crushing. In general, in-plane failures pose less of a life safety threat. Figures 2.22 and 2.23 provide an illustration and a photo, respectively. Note that although the life-safety threat is considered lower for such failures, it is still significant, especially if the damage is widespread. The building shown in the photo below was ultimately demolished due to safety concerns.

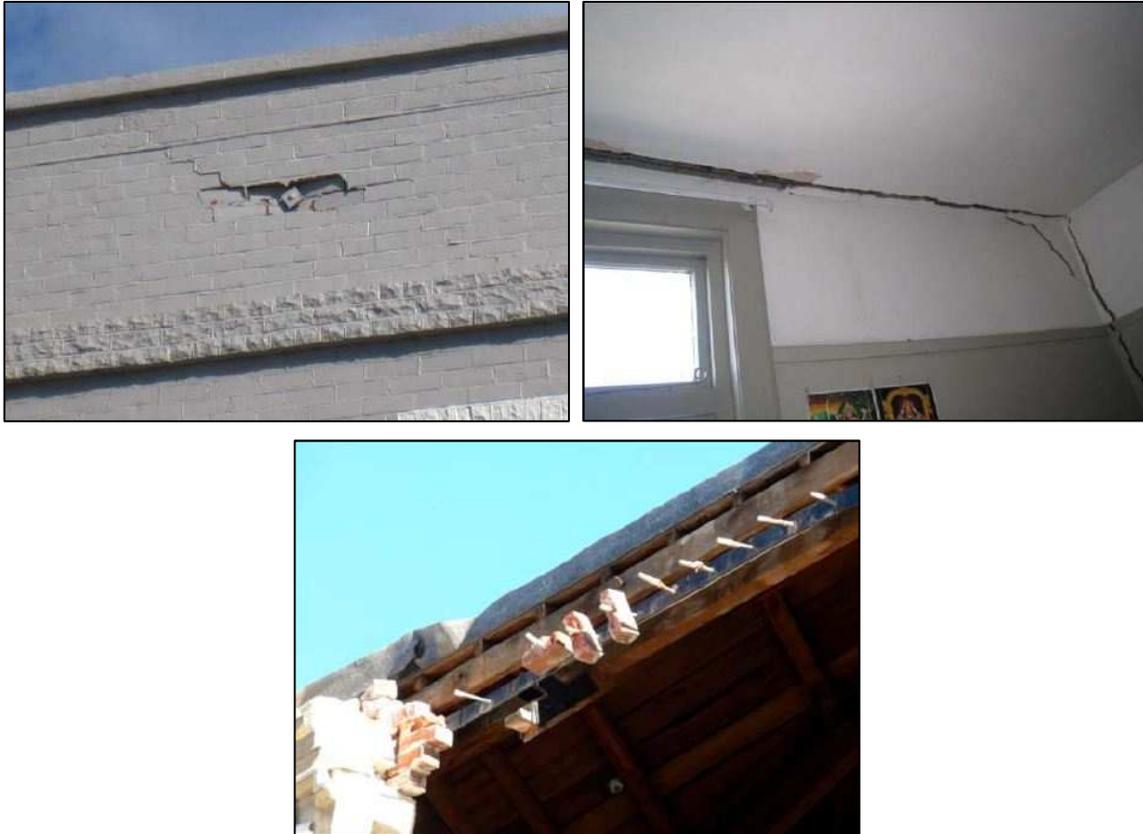
A variety of anchorage failures are possible, depending on the details of the connection. For through-bolted anchors, this could include yielding/rupture of the steel components, punching shear failure of the masonry wall around the plate, or failure of the wood joist/blocking to which the anchor is attached. For adhesive-type anchors, there is the additional potential failure mode of pullout/breakout of the anchor and the surrounding masonry. Figure 2.24 provides photos of anchorage failures.

Figure 2.24 – Photo of Anchorage Failures

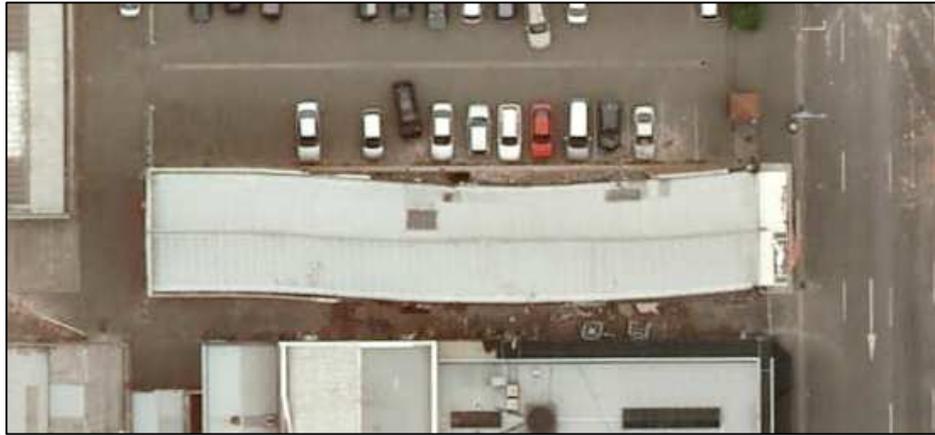
Figure 2.25 – Photo of Excessive Diaphragm Deflections

Recall that URM floor and roof diaphragms are typically constructed of board sheathing (straight or diagonal) which is even more flexible than modern wood diaphragms. Given the low stiffness of the diaphragms, diaphragm “failure” is most commonly associated with excessive deflections, which can lead to collapse of the out-of-plane walls (as the walls lean in/outwards with the deflection). Figure 2.25 shows an aerial view of a building that suffered excessive diaphragm deflections. Observe that the majority of the debris has fallen in the direction of the diaphragm deflection (i.e. into the building on

one side and away from the building on the other). Note that seismic assessment standards typically limit the aspect ratio of diaphragm to 3 or 4 to 1.

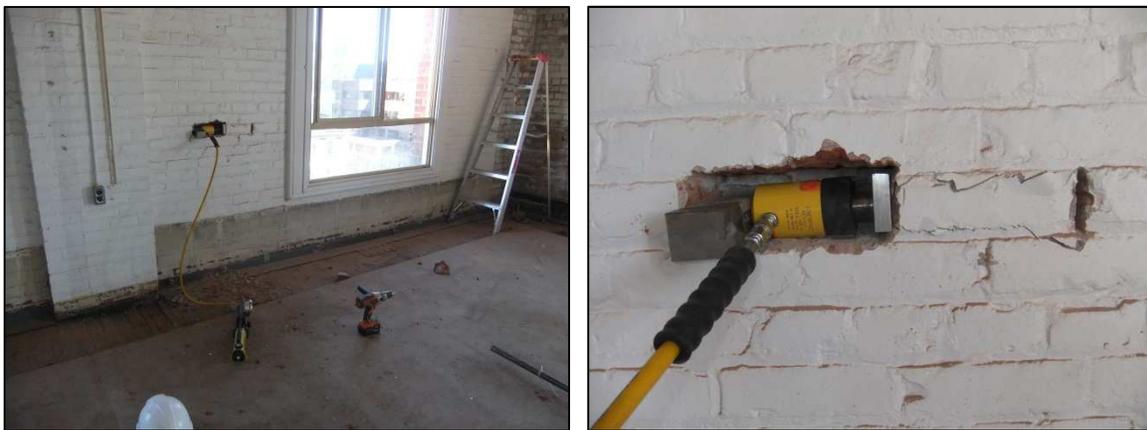
Figure 2.28 – In-Place Shear Testing

Another key issue sometimes overlooked is the condition of the masonry. In most post-earthquake reconnaissance reports, deteriorated/poor quality mortar is correlated with parapet (and other URM) collapses. There are several methods of assessing the condition of the mortar, from a simple scratch test to (destructive) in-place shear testing. Such testing may represent a slightly or modestly increased cost (say a few hundred to a thousand dollars), but is vital to ensuring the strengthening meets its intended objective. Figure 2.28 provides photos of in-place shear testing, which involves determining the lateral load necessary to initiate shear failure in the bed joints. The process and interpretation of results is commonly discussed in the aforementioned retrofit standards for URM.

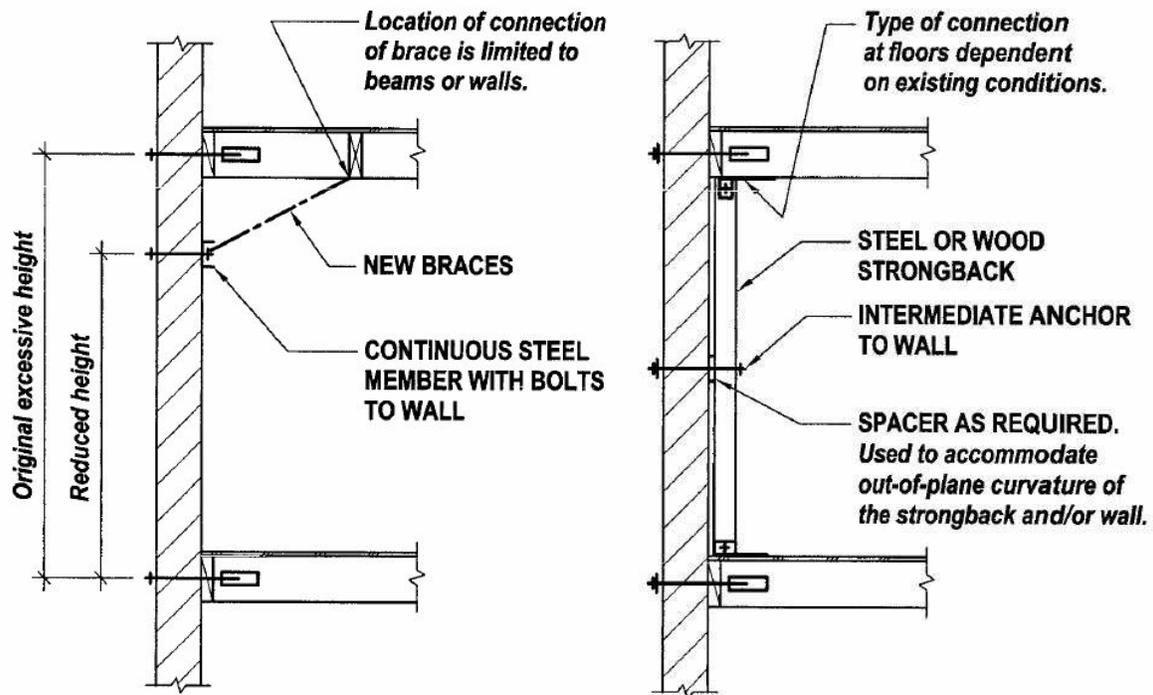
With tension and shear anchors in place, the walls span vertically between the floors under seismic loading. However, they can crack, rock, and subsequently collapse if the shaking is of sufficient intensity and duration. Out-of-plane strengthening addresses this failure mode. The most common solution is structural steel “strongbacks” installed at regular spacing along the wall, which act as a splint to help prevent the out-of-plane cracking and rocking. Another common solution is an “intermediate brace” which helps to reduce the unsupported height of the wall. Figure 2.34 provides a detail for each of these solutions and Figure 2.35 provides photos. Other solutions could include shotcrete overlays and reinforced/post-tensioned centercores (see FEMA 2006).

Figure 2.34 – OoP Bracing, Intermediate Brace (left) and Strongback (right)

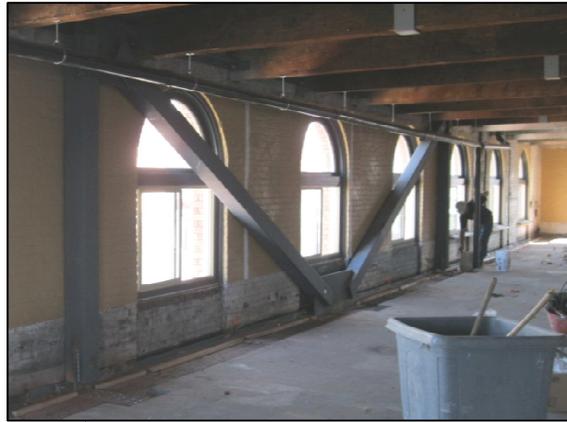
Figure 2.38 – Example Photo of URM Retrofitted with Steel CBF

In Victoria, steel concentrically braced frames are by far the most common design solution and so we focus on those herein. Many other elements such as reinforced concrete/masonry shear walls or steel/concrete moment frames are possible. Rutherford and Chekene (1990) provides a summary of all the common elements. Figure 2.37 shows an example illustration of steel braced frames in a URM retrofit applications and Figure 2.38 provides an example photo.

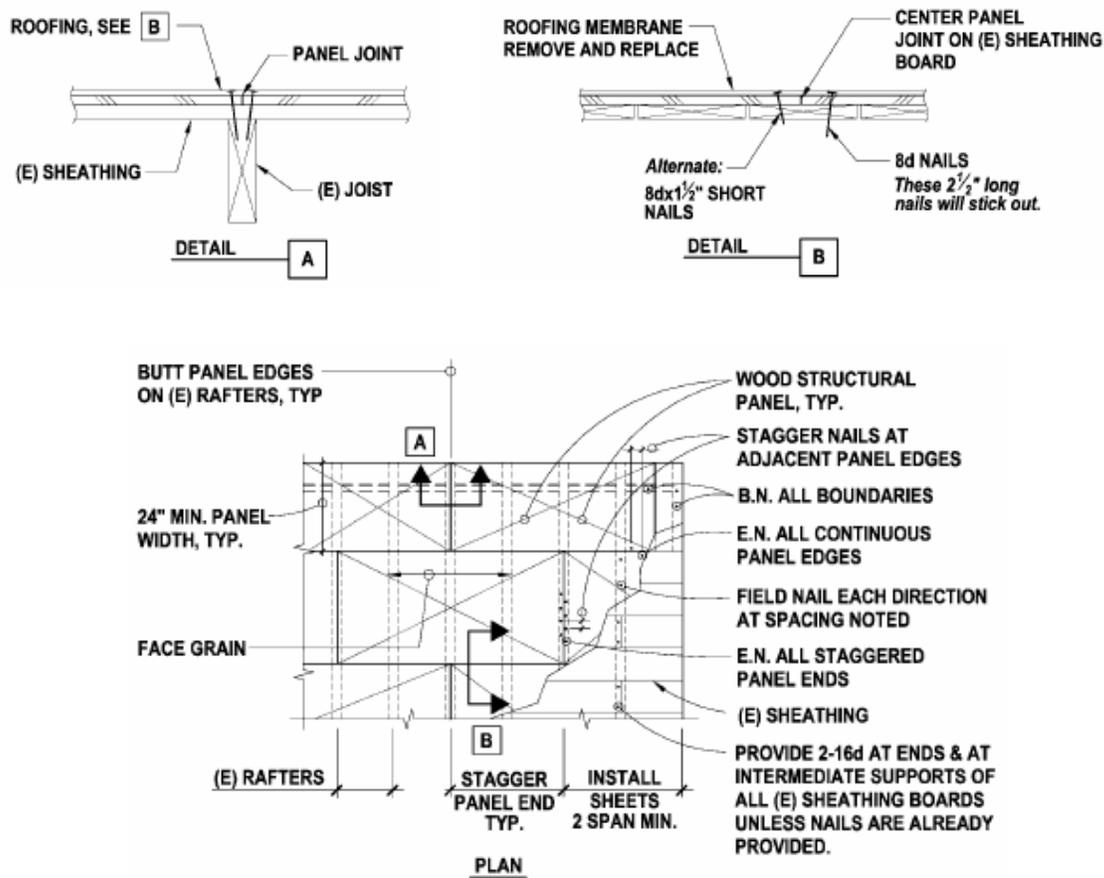
Figure 2.39 – Illustration of Plywood Overlay Retrofit

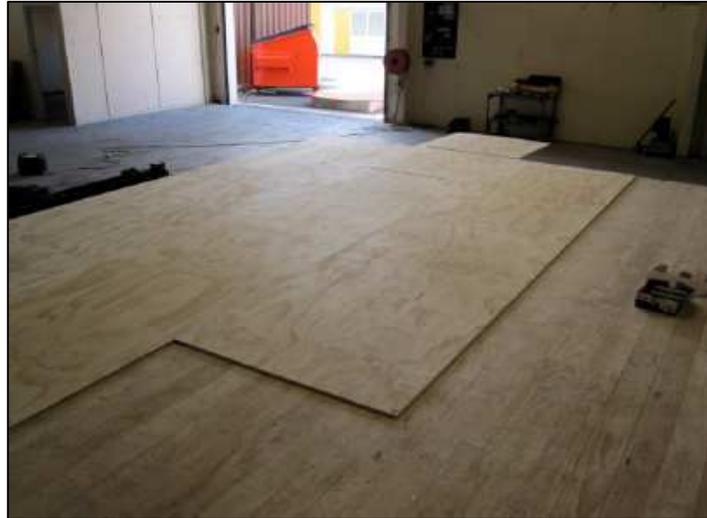
Figure 2.40 – Diaphragm Strengthening

be replaced by installing new structural steel horizontal bracing. Finally, a concrete overlay can be applied. Wilson (2012) discusses in detail the seismic behavior and the strengthening of wood diaphragms in URM buildings. Figures 2.39 and 2.40 show design details and provide an example photo, respectively, for board sheathing retrofitted with a plywood overlay. An unblocked retrofit solution is shown, but blocking can be provided in cases where additional strength and stiffness are required.

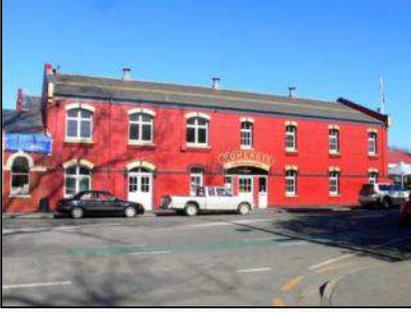
Damage State	Description
A	Undamaged or small cracks only (from Ingham & Griffith, 2011)

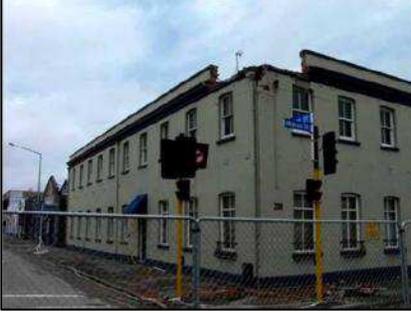
B	Parapets fell, separation of veneer from backing (from Ingham & Griffith, 2011)

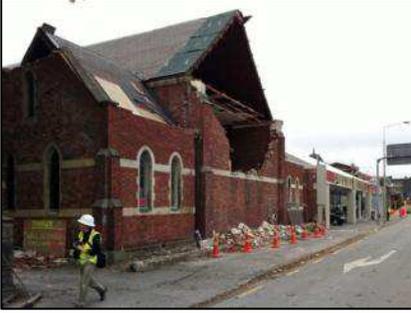
C	Major damage to less than 50% of bearing walls (http://reidmiddleton.wordpress.com)

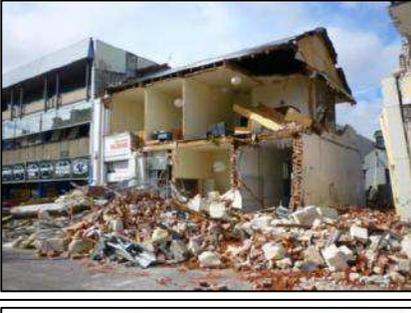
D	Major damage to more than 50% of bearing walls (from Ingham & Griffith, 2011)

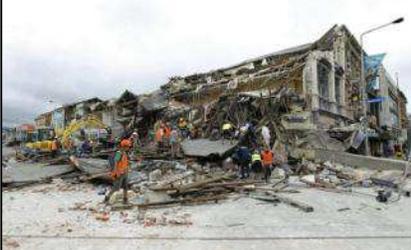
E	Total loss; collapse or severe damage requiring demolition (http://www.newswire.co.nz/2011/02/day-4-the-search-for-survivors-continues/)

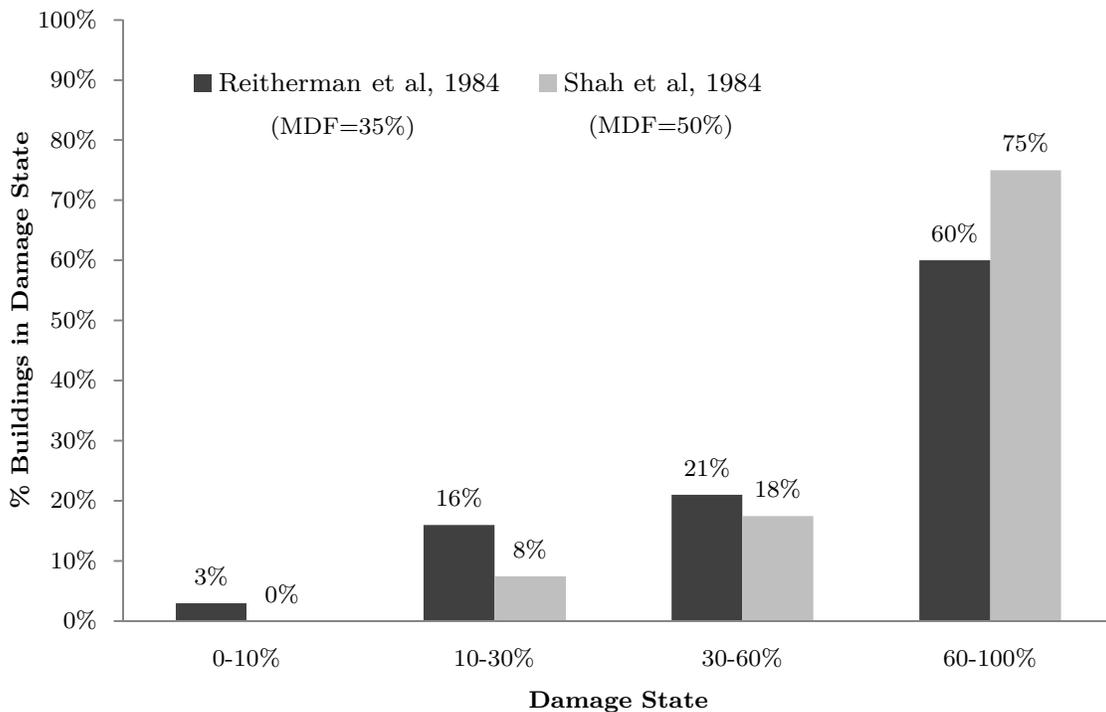
Academics, building officials, and practicing engineers may perform damage surveys specifically for the purpose of compiling damage statistics and quantifying seismic performance/losses. These studies often are more detailed, but may not cover as large a fraction of the total building population as resources can be more limited and the assessments are more in-depth. A related merit is that there is less chance of inconsistencies between assessors, as there are often fewer individuals and greater communication between them. The level of detail in these studies can also vary, yielding significantly different results. Figure 4.2 compares damage ratios for two different surveys from the 1983 Coalinga earthquake: as noted by Lizundia (1993), the study by Shah et al. (1984) consisted of a one-day walk-through by a team of engineering students, while a study by Reitherman et al. (1984) was sponsored by the National Science Foundation and included a walk-through, materials testing, a photo review process, and discussion between at least two engineers before a damage level was assigned. As shown in the figure, the mean damage ratio of the former was 50%, compared to 35% for the latter.

Figure 4.2 – Damage Ratio Comparison from Coalinga Earthquake
(Reproduced From Lizundia, 1993)

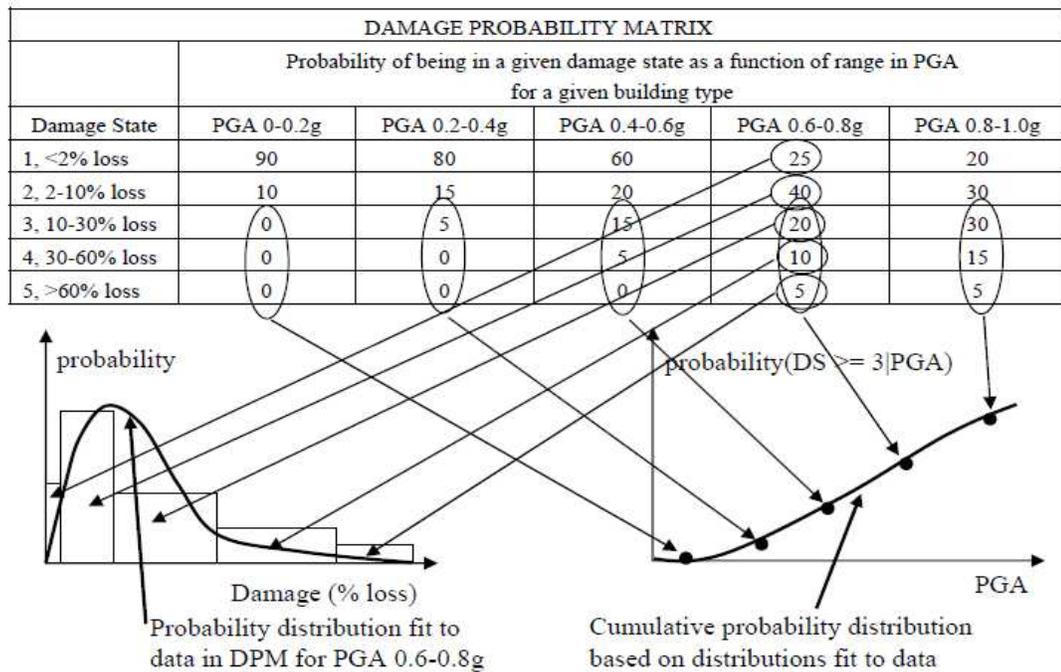
- 1) For the given damage state, the fraction (or percent) of buildings equaling or exceeding the DS is calculated for each intensity level (in this case, PGA); the calculated values represent the conditional probability of being in this DS or greater, given the intensity level
- 2) The process is repeated for each damage state and results are plotted on a graph of PGA versus Probability of Reaching/Exceeding the given DS; note: the PGA to be plotted is the mean for the bin (eg. for the bin of $.3g < \text{PGA} < .4g$, the results are plotted at $.35g$)
- 3) The data is then fitted with an appropriate cumulative probability distribution. This may be accomplished in several ways and is discussed next

Figure 4.8 – Example Construction of Fragility Curve

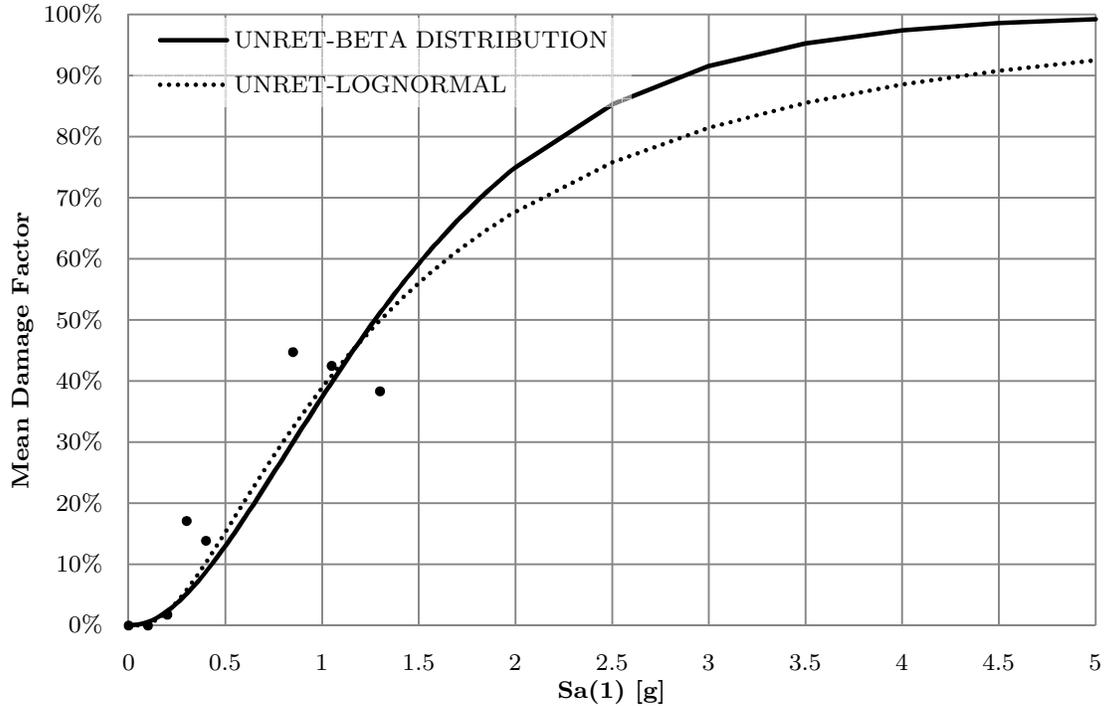
practical purposes, however, the choice between the Beta and Lognormal distribution is of minor consequence because the probability of occurrence of such extreme shaking is low enough so as to not affect the resulting loss estimates.

Figure 4.9 – Beta vs. Lognormal Distribution for MDF of Canterbury Buildings

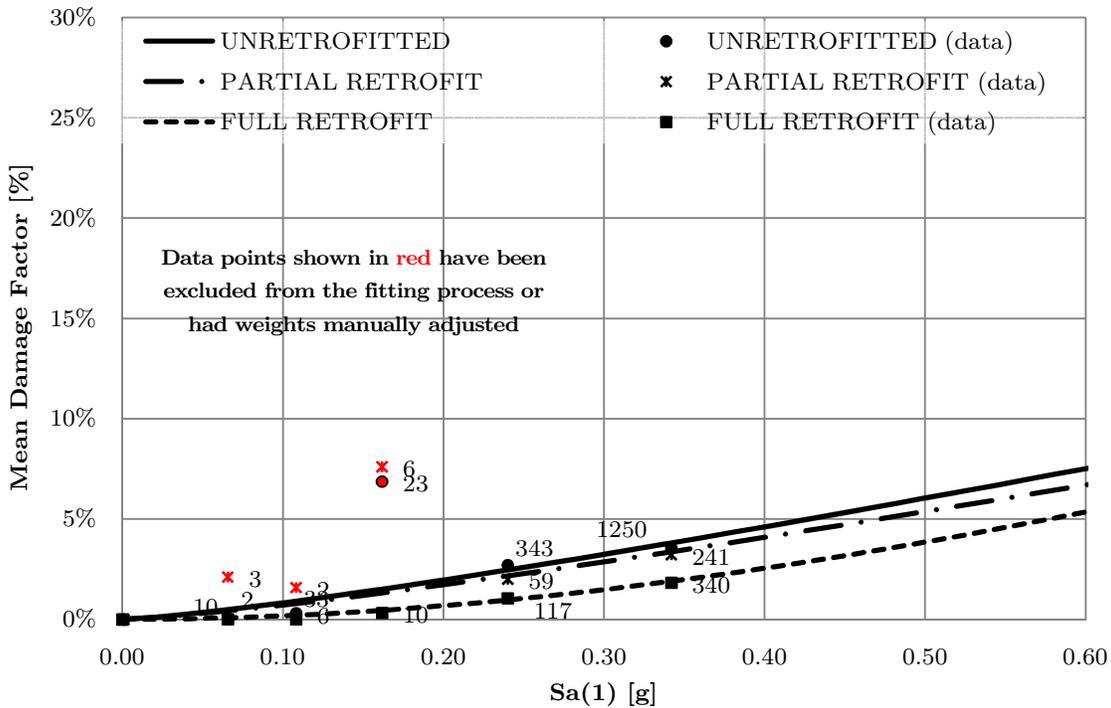
Since we are ultimately interested in the damage at any point, rather than just the measured intensities, the resulting MDFs were plotted as a function of $S_a(1)$ and a probability distribution was fit to the data. The beta distribution was fitted to the data using nonlinear regression with a weighted least squares criterion, as discussed in Section 4.6. This exercise was performed for each of the three subsets of buildings: unretrofitted, partially retrofitted, and fully retrofitted. Figure 4.23 provides a plot of the results.

Figure 4.23 – MDF vs. $S_a(1)$ For Whittier Earthquake

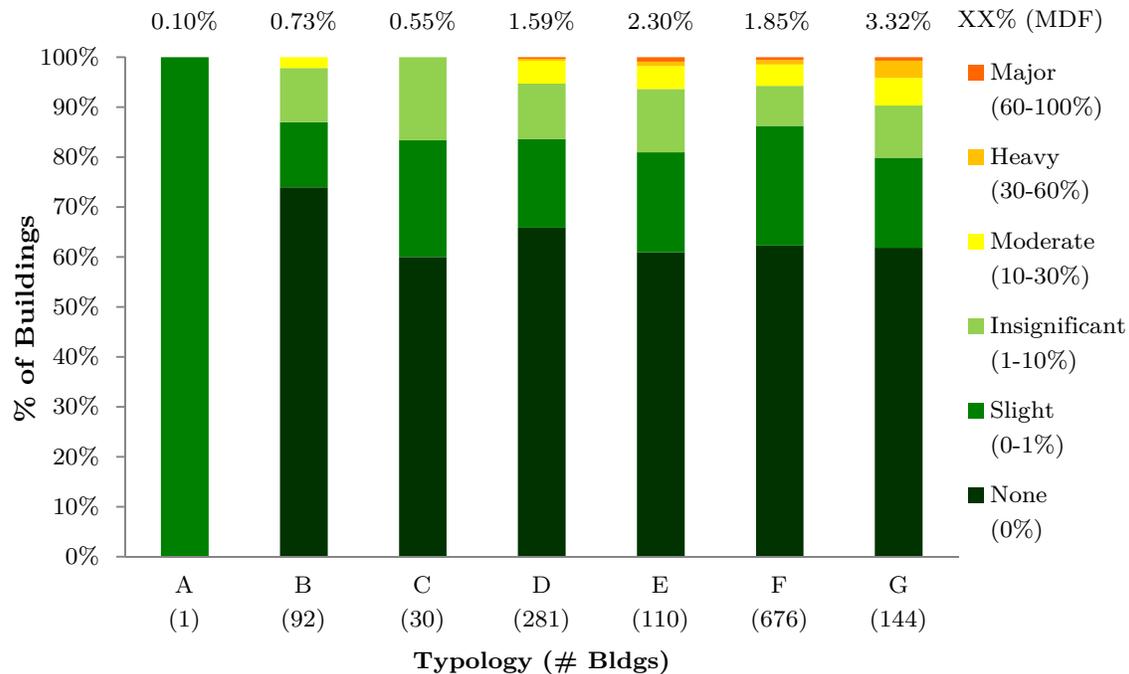
With regards to damageability, a somewhat different trend was observed for the San Francisco buildings than that found by Ingham and Griffith for the Christchurch buildings: Figure 4.29 shows the ATC-13 damage distribution to San Francisco buildings. Note that for each typology, the MDF is shown at the top and the number of buildings in the sample is shown at the bottom. Only buildings in the $S_a(1)=0.35g$ bin ($\pm 0.05g$) were used, to provide a fair comparison amongst the buildings.

Figure 4.29 – Damage to San Francisco Buildings by Typology

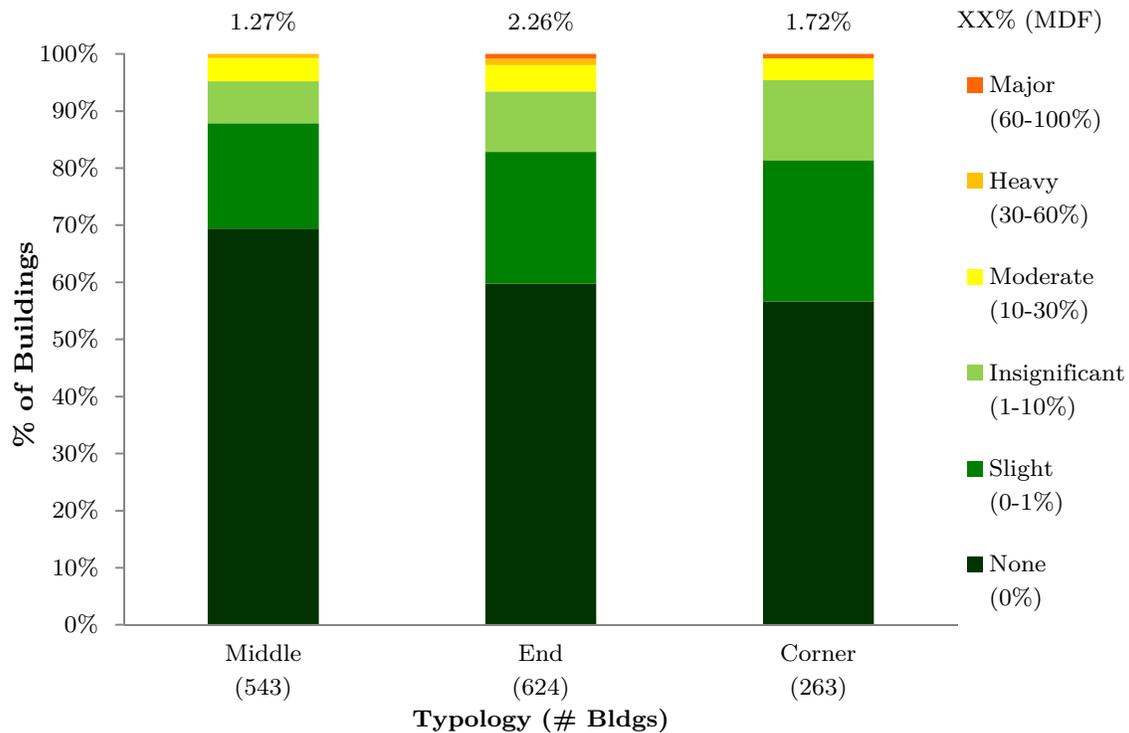
With regards to damageability, a similar trend to that for the Canterbury buildings is observed in that end buildings suffered more damage than middle buildings, as shown in Figure 4.31. Interestingly, corner buildings (i.e. buildings on two perpendicular sides) appear to suffer less damage than end buildings (i.e. only one adjacent building). Engineering intuition suggests that corner buildings could be even worse than end buildings due to the eccentricity of the seismic force resisting walls in corner buildings, as the two streetfront walls tend to be highly perforated and therefore much softer and weaker. One possible explanation is perhaps the fact that these buildings have solid walls in two directions more than makes up for the eccentricity effects in terms of global damageability.

Figure 4.31 – Damage to San Francisco Buildings by End/Middle/Corner
