Quantifying Unreinforced Masonry Seismic Risk and Mitigation Options in Victoria, BC

A THESIS SUBMITTED IN PARTIAL FULFILLMENT OF
THE REQUIREMENTS FOR THE DEGREE OF

MASTER OF APPLIED SCIENCE

THE FACULTY OF GRADUATE AND POSTDOCTORAL STUDIES
(Civil Engineering)

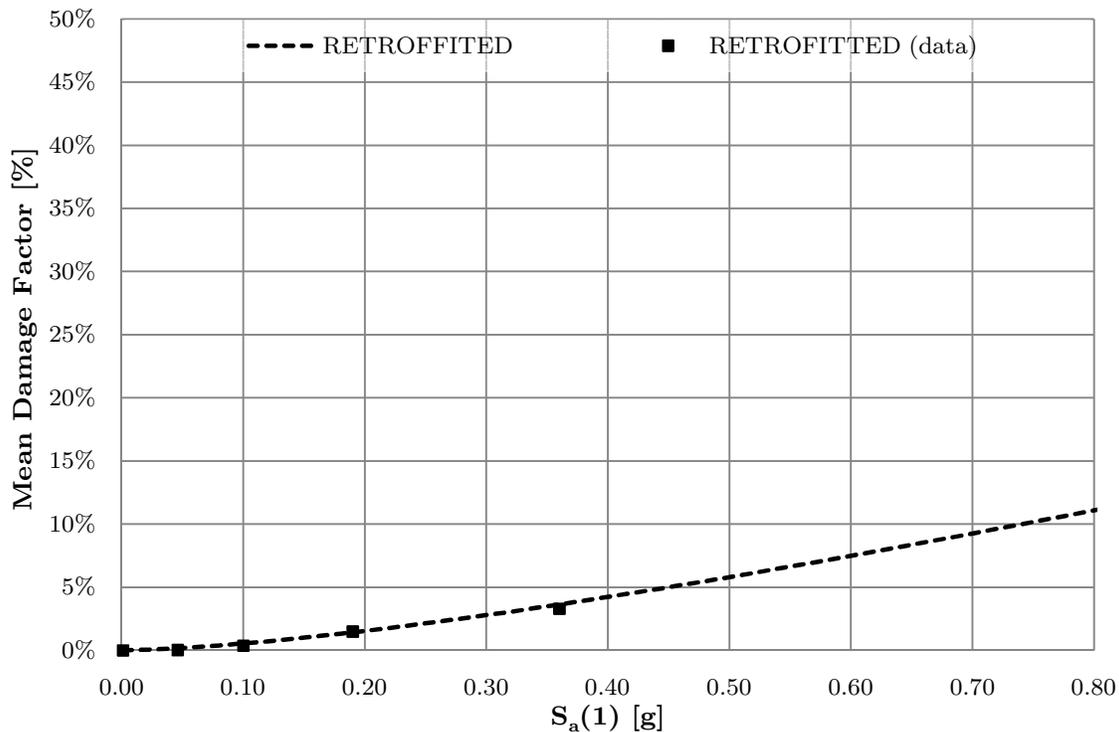
Again, a beta distribution was fit to the data. Figure 4.32 provides a plot of the results. The results appear reasonable, in that damage is lower than both the unretrofitted and braced parapet buildings from the Loma Prieta database.

Figure 4.32 – MDF vs. $S_a(1)$ For Northridge Earthquake

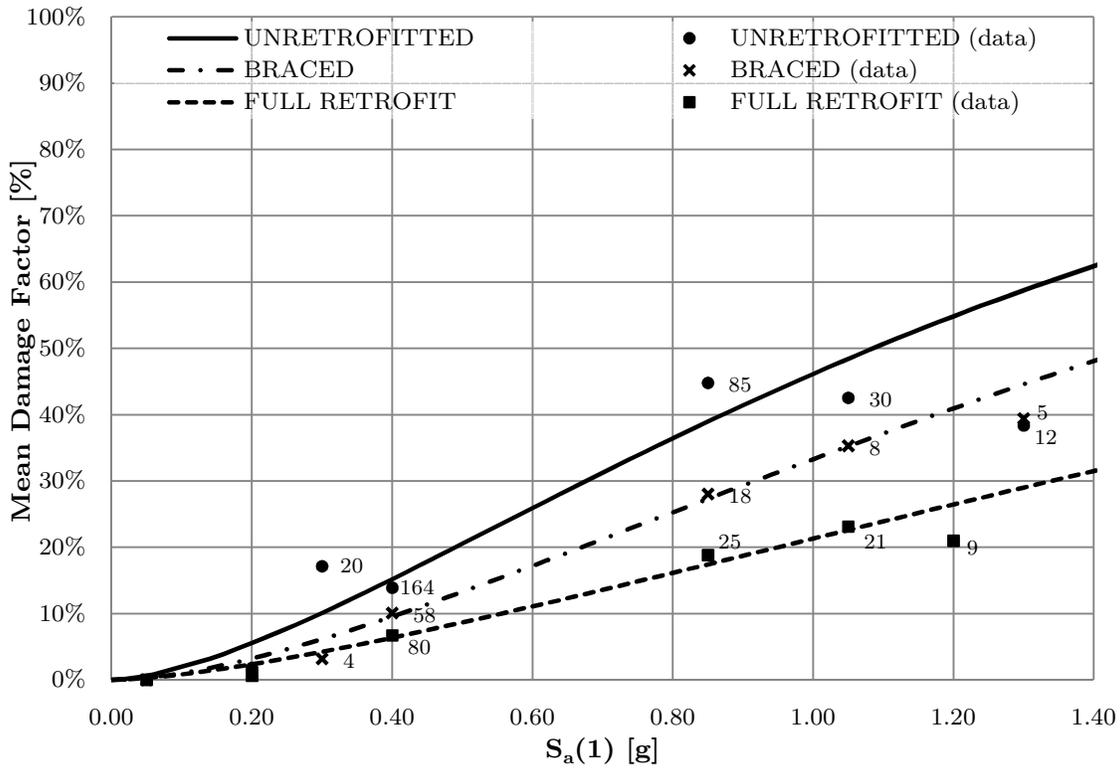
The DPM was then constructed in the typical manner, the MDF was calculated for each bin, and a beta distribution was fitted to the data. Figure 4.33 provides the resulting curves of MDF versus $S_a(1)$.

Figure 4.33 – MDF vs. $S_a(1)$ For Canterbury Earthquakes

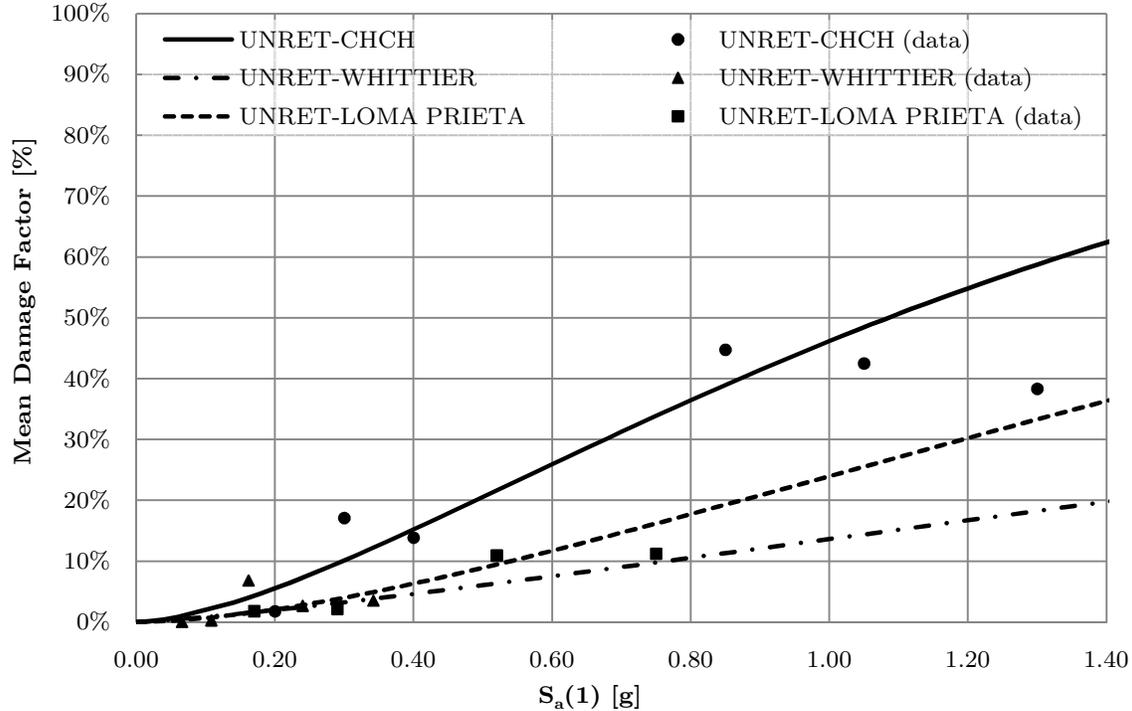
As would be expected, the unretrofitted buildings suffered the most damage in each set. Figure 4.34 shows a plot comparing the MDF vs. $S_a(1)$ relationship for each data set.

Figure 4.34 – Comparison of Unretrofitted Buildings

ATC-13 and HAZUS were both found to contain appropriate motion-damage relationships for unretrofitted buildings. Both sources contained multiple URM types; “Facility Class 75” from ATC-13 and “URMLR (pre-code)” were selected for comparison. Figure 4.38 shows the two relationships along with the relationships from the observed statistics (reproduced from Figure 4.34).

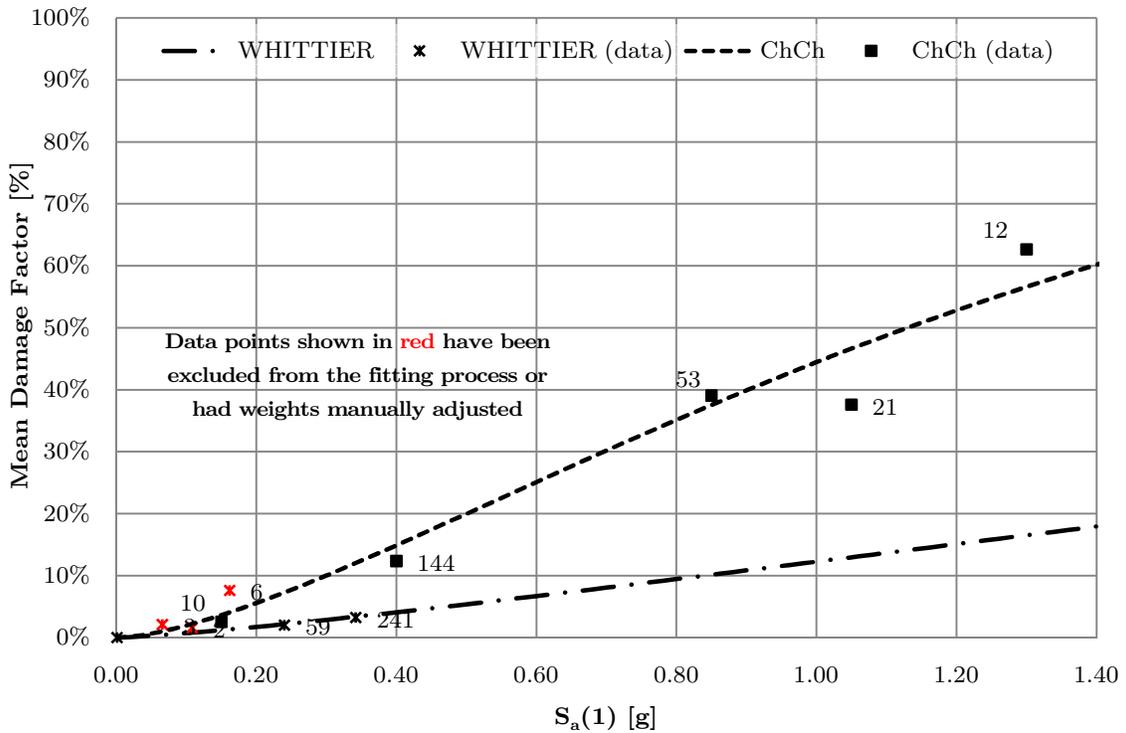
Samples for partially retrofitted buildings were available for the Whittier and Canterbury databases. Note that partial retrofitting is somewhat loosely defined, but the intent is to include tension ties at all floors as a minimum. Figure 4.36 shows the results for these two data sets.

Figure 4.36 – Comparison of Partially Retrofitted Buildings

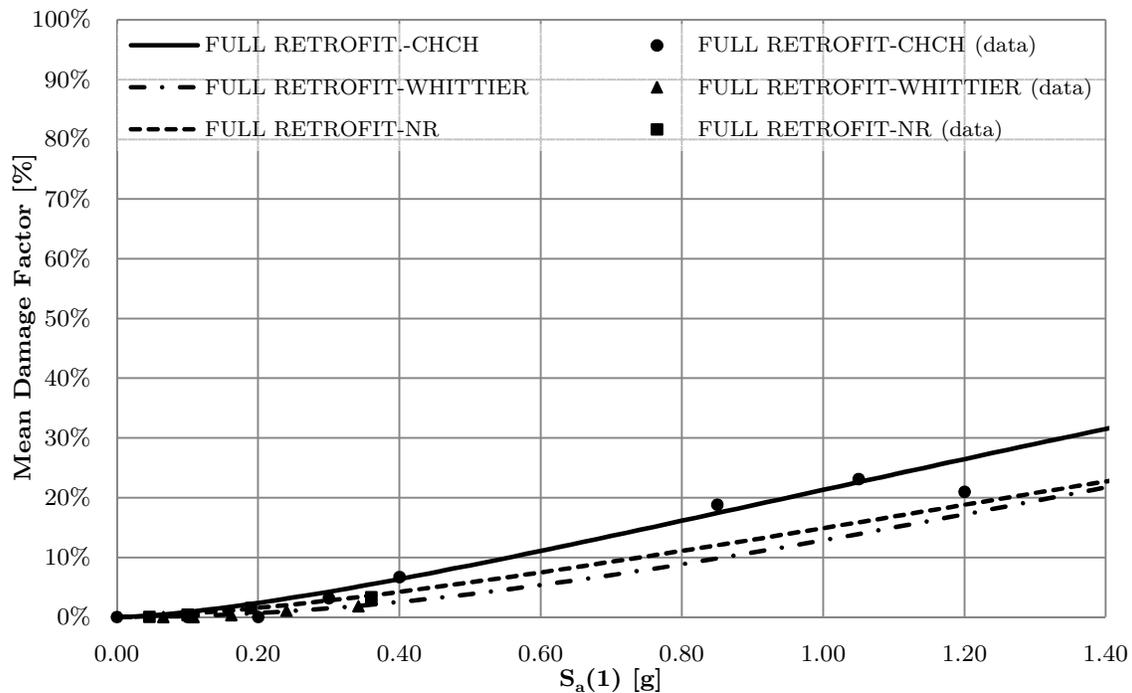
Samples for fully retrofitted buildings were available for the Whittier, Northridge, and Canterbury databases (see Figure 4.37). Note that fully retrofitted buildings can be taken to include strengthening measures for out-of-plane (eg. tension/shear ties, strongbacks) and in-plane demands (eg. steel frames, concrete shear walls).

Figure 4.37 – Comparison of Fully Retrofitted Buildings

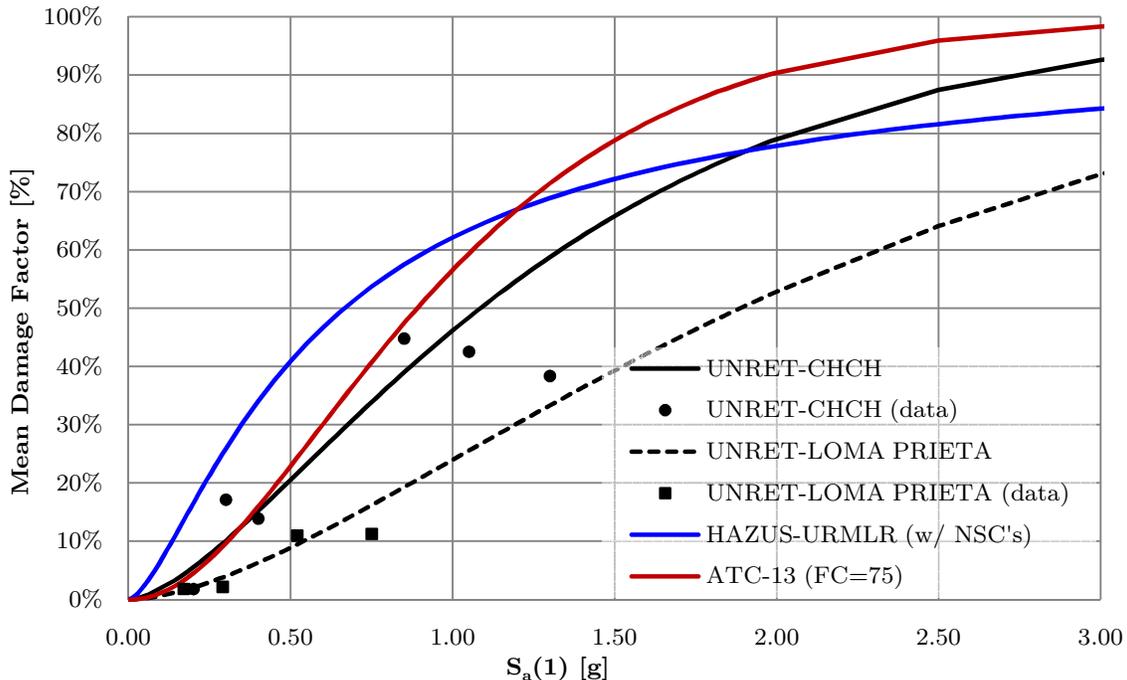
Figure 4.38 – Published vs. Observed Damage for Unretrofitted Buildings

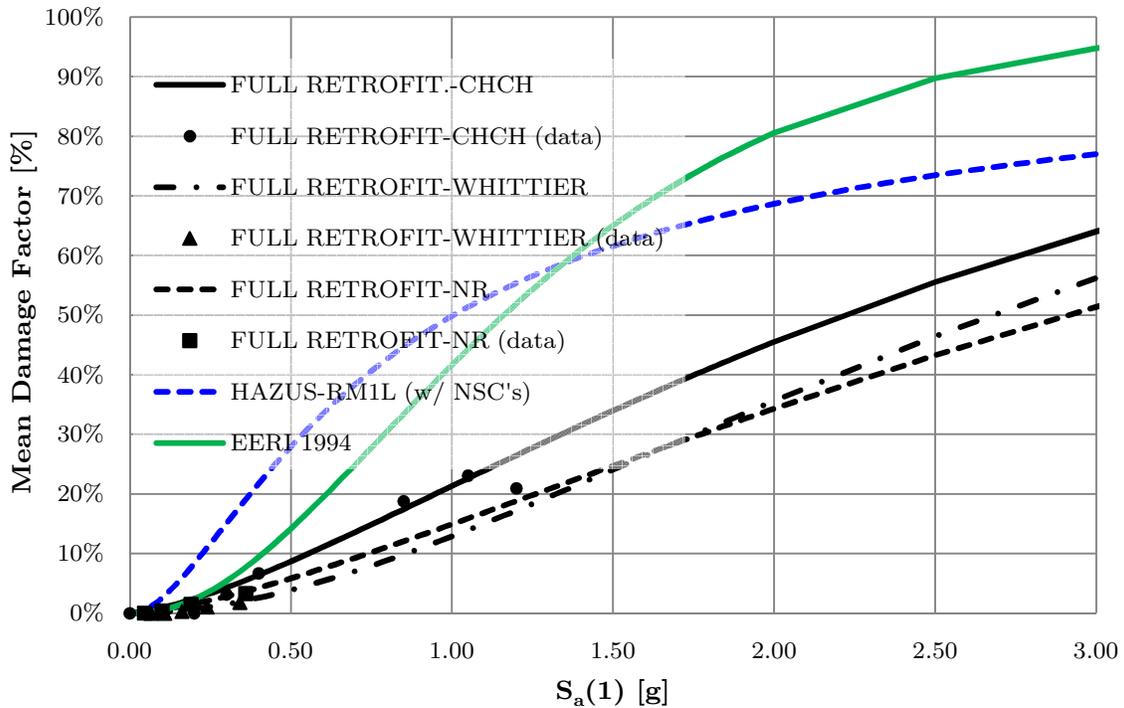
EERI (1994) and HAZUS were both found to contain appropriate motion-damage relationships for retrofitted buildings. As aforementioned, the EERI relationship was specifically developed for rehabilitated URM buildings, while HAZUS simply recommends the relationship for Low Code Reinforced Masonry. Figure 4.39 shows the two published relationships along with the relationships from observed statistics.

Figure 4.39 – Published vs. Observed Damage for Fully Retrofitted Buildings

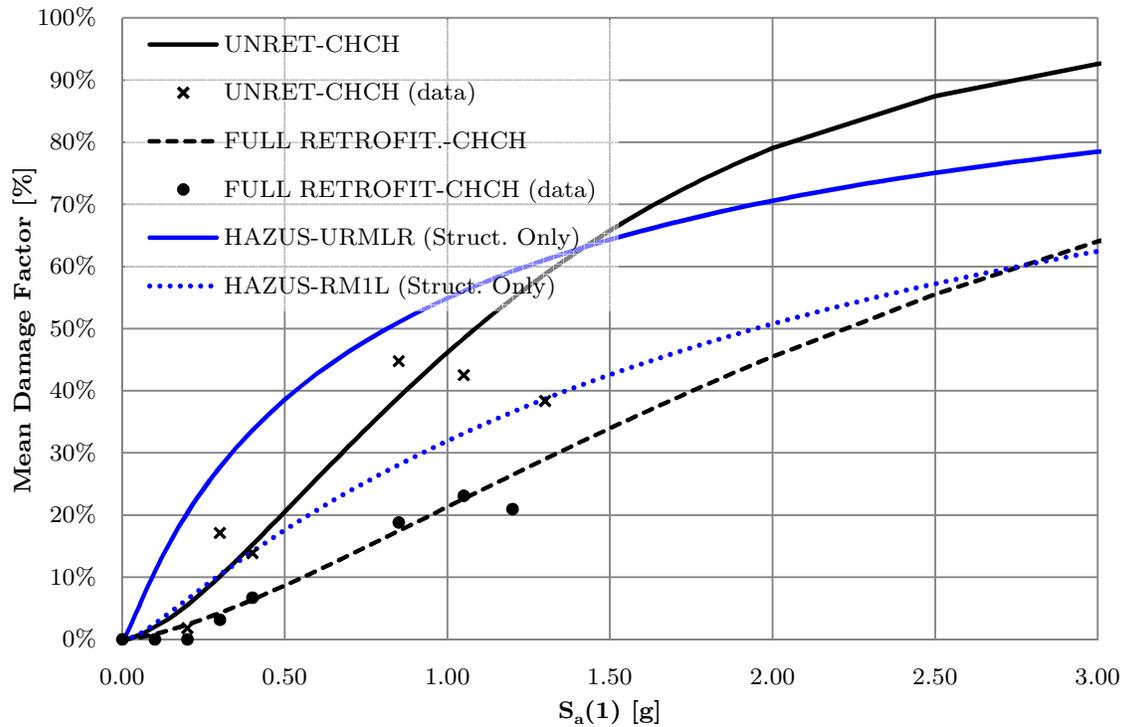
The significance of the foregoing discussion is appreciated when considering the meaning of the observed damage statistics. In Figure 4.40, the structural-only damage relationships from HAZUS are plotted, along with the relationships developed from the Canterbury data. Both unretrofitted and fully retrofitted curves are presented.

Figure 4.40 – Published vs. Observed Damage for Unretrofitted Buildings

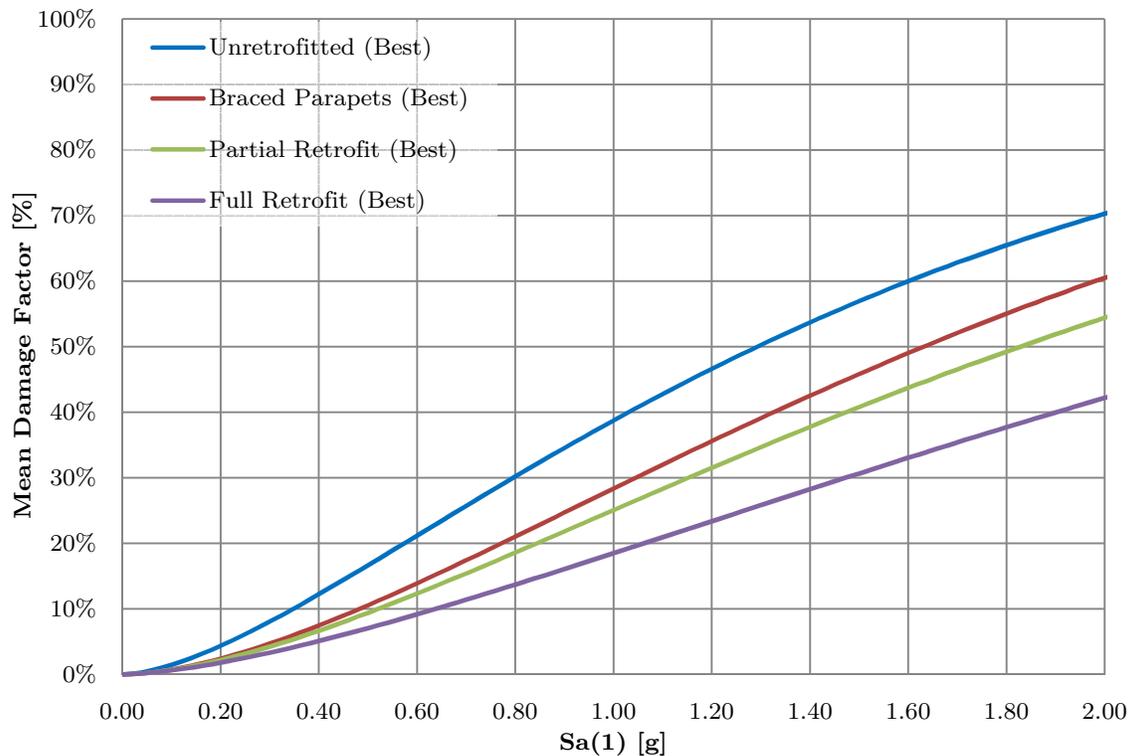
Note that these curves do not yet account for the damageability effects of specific characteristics as discussed in Sections 4.7 and 4.8. Also, only the mean damage factor is addressed for the time being. The distribution of damage into the various damage states (in the form of fragility curves) is also of interest, but was of secondary importance to the study at hand.

Figure 4.41 – Basic Structural MDF vs. $S_a(1)$ Curves (Best Estimate)

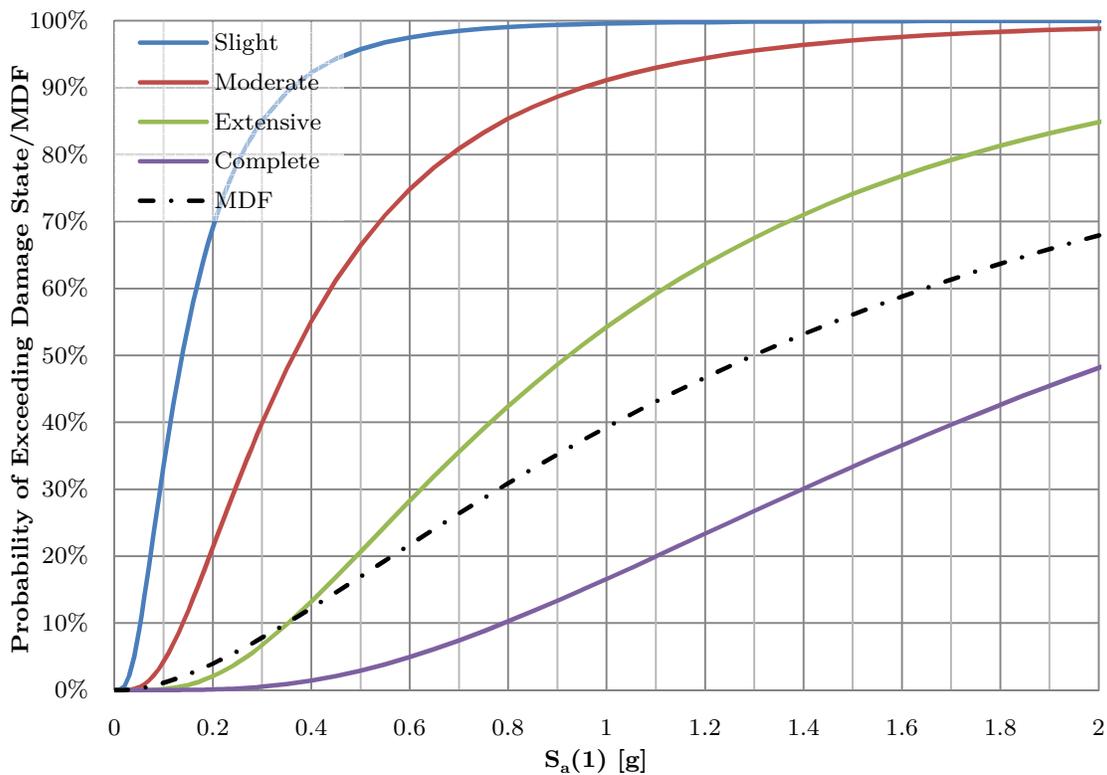
Instead of generating individual damage state fragilities from the observed data, it was decided to generate the fragilities by matching the MDF from our observed results to the MDF associated with the fragilities, while still maintaining a distribution among the damage states that was reasonably similar to the observed data. Figure 4.44 shows an example result for Unretrofitted buildings.

Figure 4.44 – HAZUS Struct. Fragility for Unretrofitted Type D/F Victoria

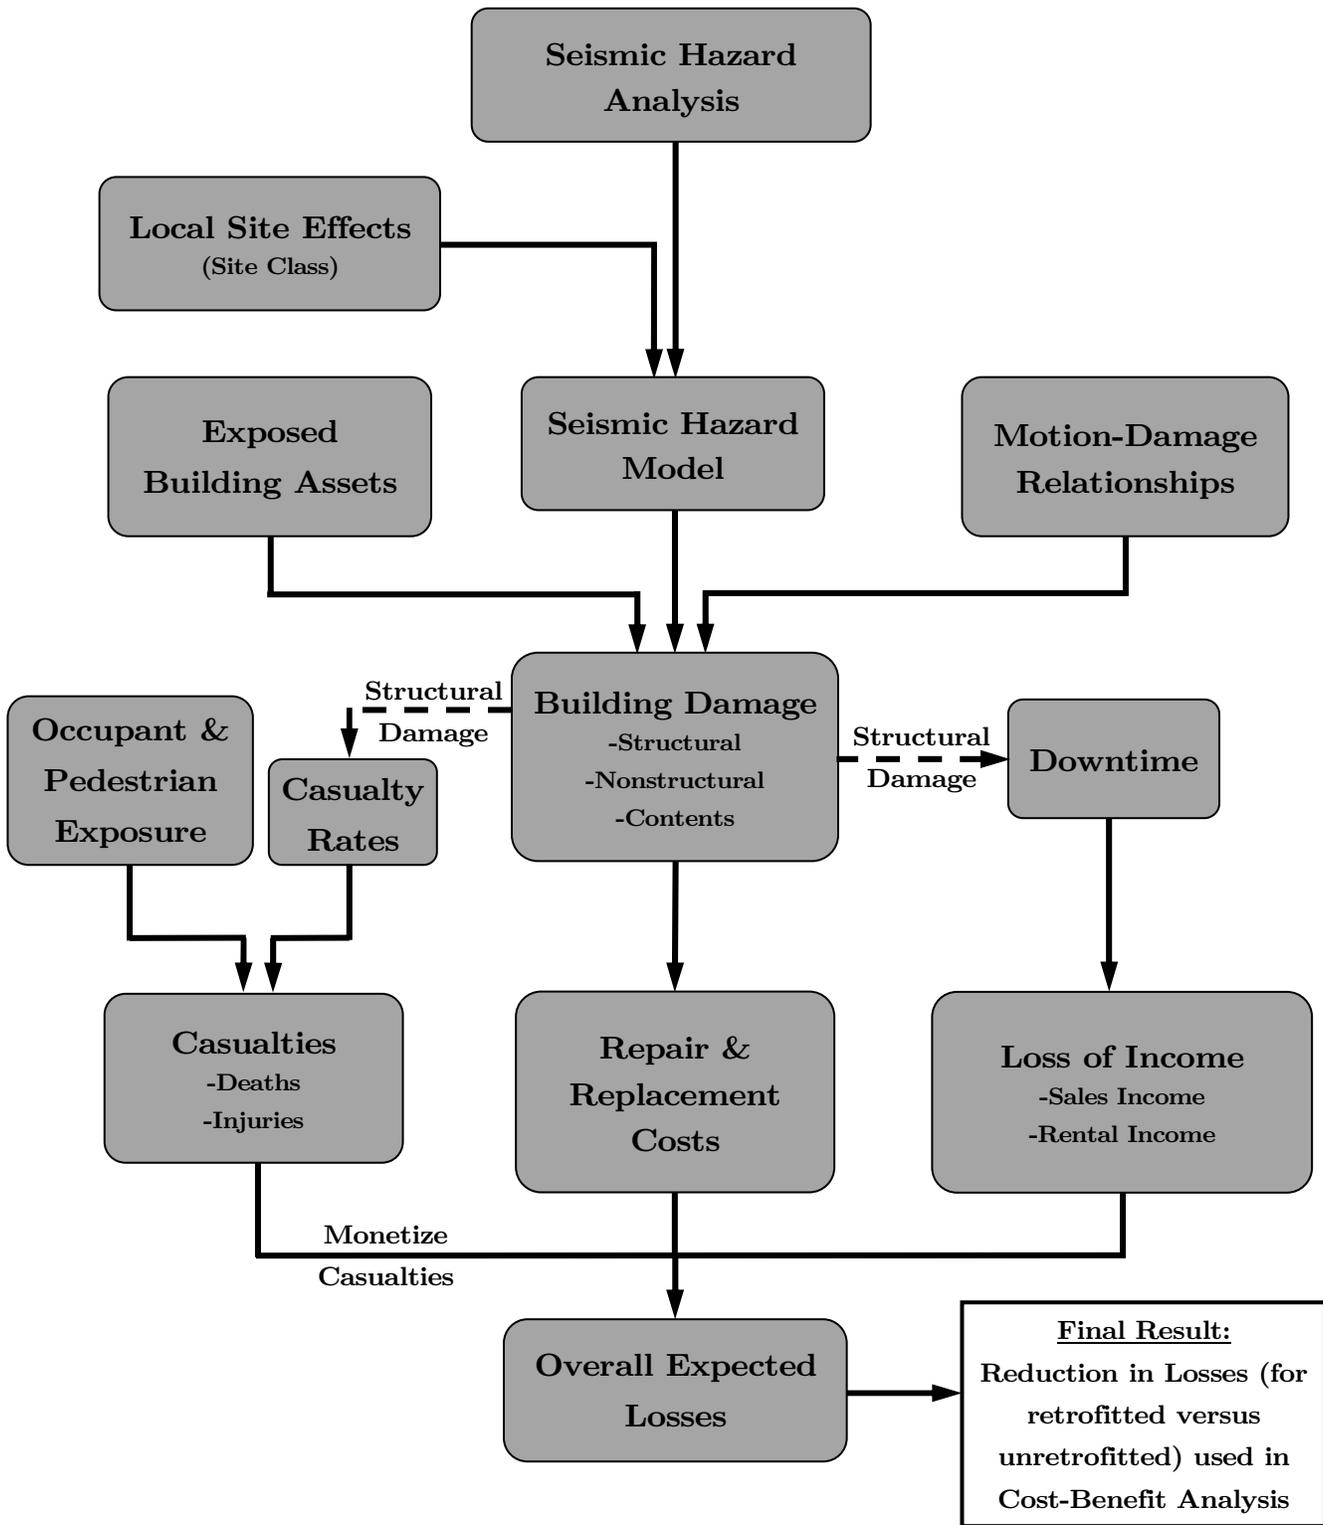
Figure 5.4 – Flow Chart of Loss Estimation Process used in this Study

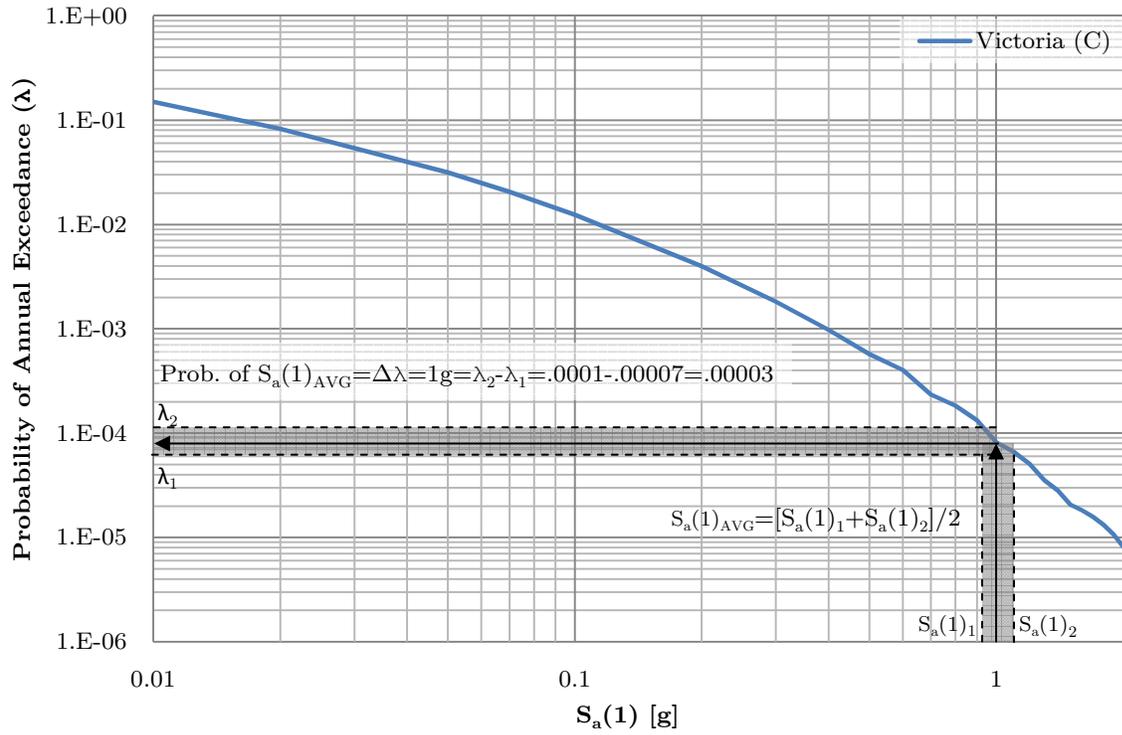
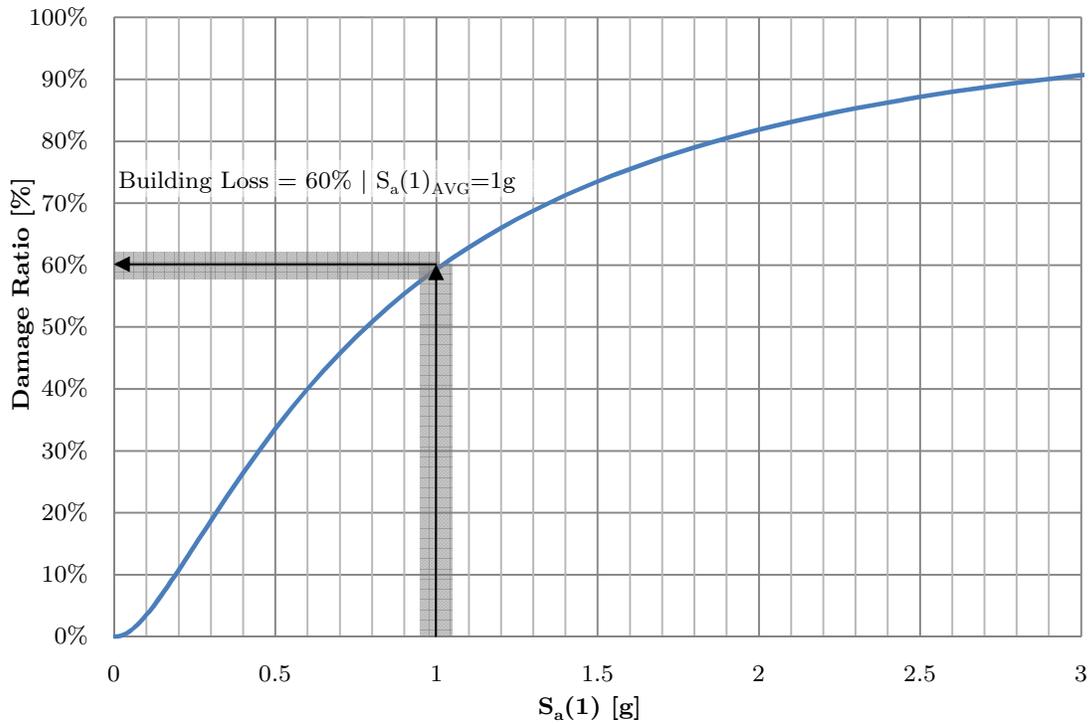
Figure 5.20 – Hazard Curve Discretization (Top) and Damage Curve (Bottom)
