**REPAIRING AND RETROFITTING OF NON-SEISMICALLY DESIGNED
REINFORCED CONCRETE CIRCULAR BRIDGE PIERS WITH LOW GRADE
GLASS FIBRE REINFORCED POLYMER**

A THESIS SUBMITTED IN PARTIAL FULFILLMENT OF
THE REQUIREMENTS FOR THE DEGREE OF

THE UNIVERSITY OF BRITISH COLUMBIA
(Okanagan)

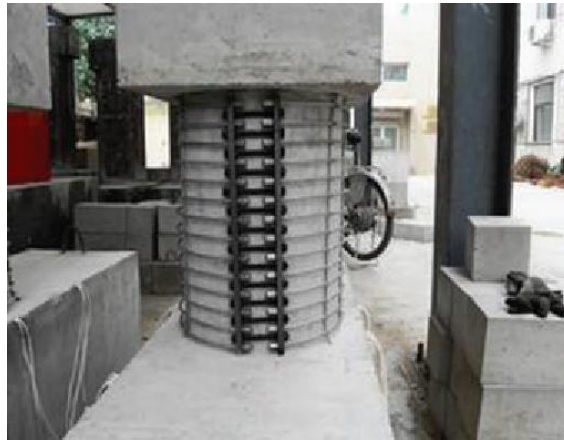
Figure 2.1: Circular reinforced concrete piers prestressed with steel wires (Zong-Cai et al. 2014)

External prestressing can be an effective method of confining concrete and improve its compressive and ductile behavior. This is done by wrapping prestressing wire under tension around a column. Reliable anchorage of the wire ends is essential for this method to be effective in field application. This helps to increase the flexural ductility of circular columns with lap splices at the critical region, though its effect on shear strength has not yet been investigated. Figure 2.1 shows the active confinement technique using prestressing wire.

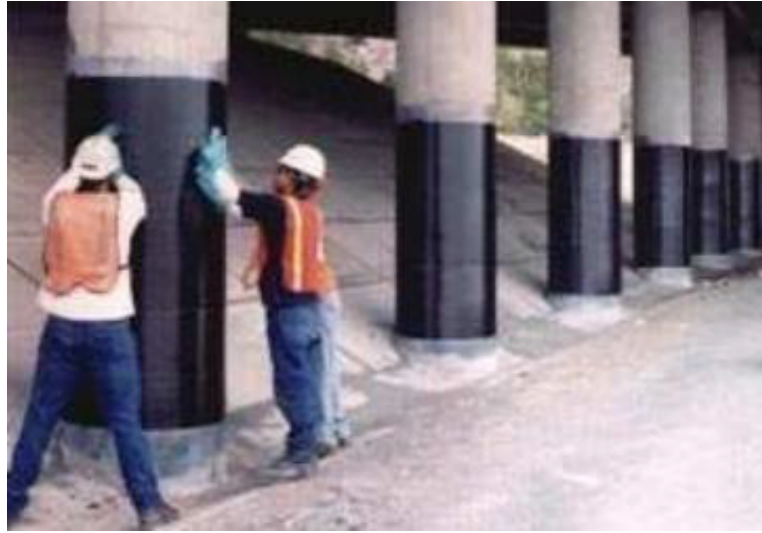
Figure 2.4: Retrofitting of RC circular bridge piers using CFRP (Priestley et al. 1996)

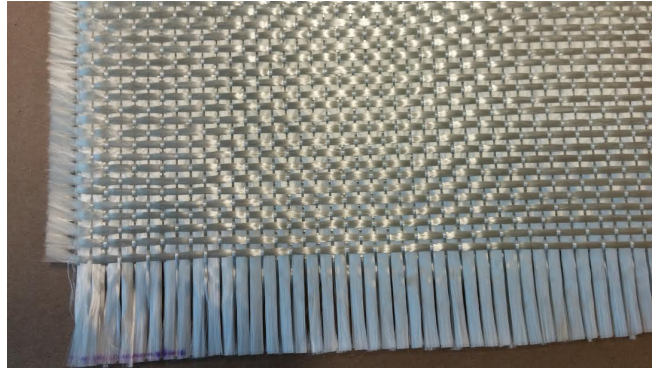
Figure 3.3: Bi-directional woven roving fibres used to prepare GFRP

Aropol K 1951-22 polyester resin and CSM 1.5 OC woven fabric glass fibre (Fig. 3.3) was used as a binder and reinforcing material respectively, to form the GFRP matrix. Luperox DDM-9 from Arkema Inc., a Methyl Ethyl Ketone Peroxide, is used as a catalyst for the resin for curing where 1:1 ratio (w/w) is used for fabric and resin. The amount of catalyst used was 1.5% of the resin (w/w) which lies between 1.5-2% as specified by the producer. The smaller

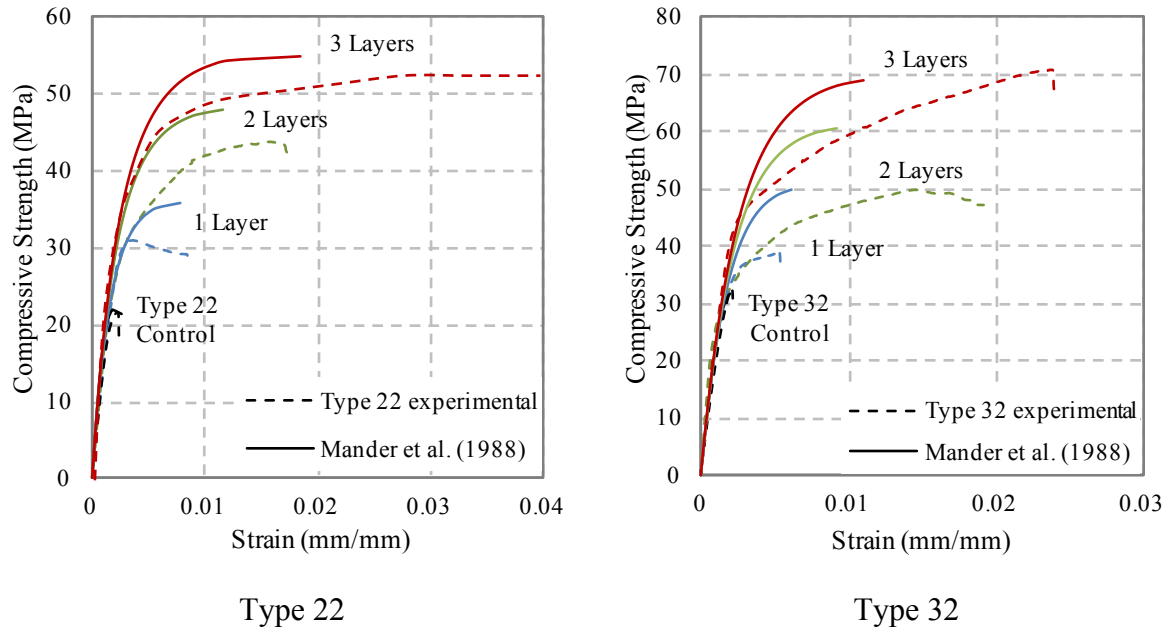
Figure 3.11: Comparison of stress-strain behavior of confined concrete between experimental result and Mander's confined model (1988)

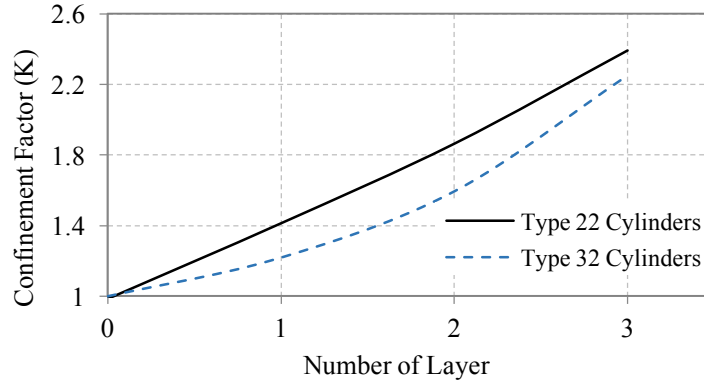
Figure 3.12: Confinement Factors for different number of layers

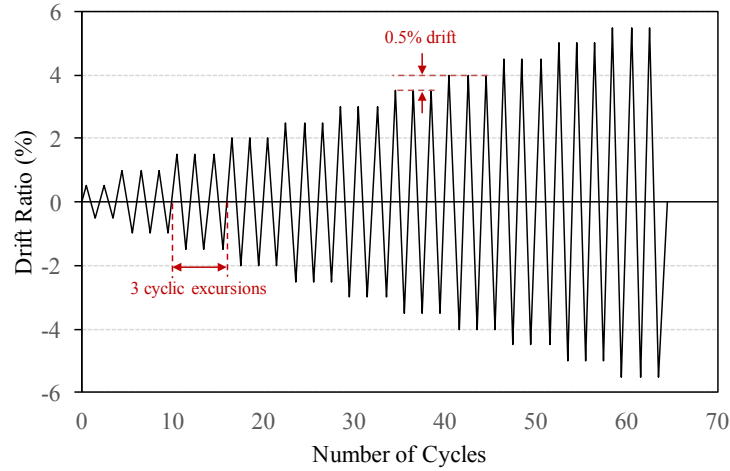
Figure 3.15: Cyclic loading protocol applied on the pier from Kawashima et al. (2000).

The seismic performance of the adopted pier is analysed using a displacement controlled quasi-static cyclic loading with an increment of 0.5% drift until reaching a maximum drift of 5.5%. The displacement loading at each drift level is applied for 3 cycles. Fig. 3.15 shows the loading protocol used in the cyclic test of Kawashima et al. (2000) which is used for lateral loading in the later part of this study.

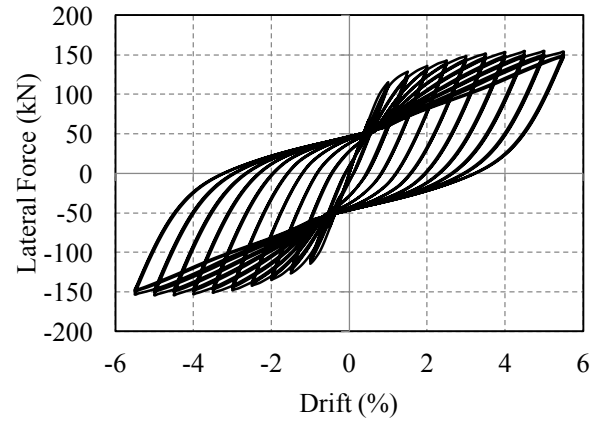
Pier retrofitted with 1 layer (0.85 mm) of GFRP

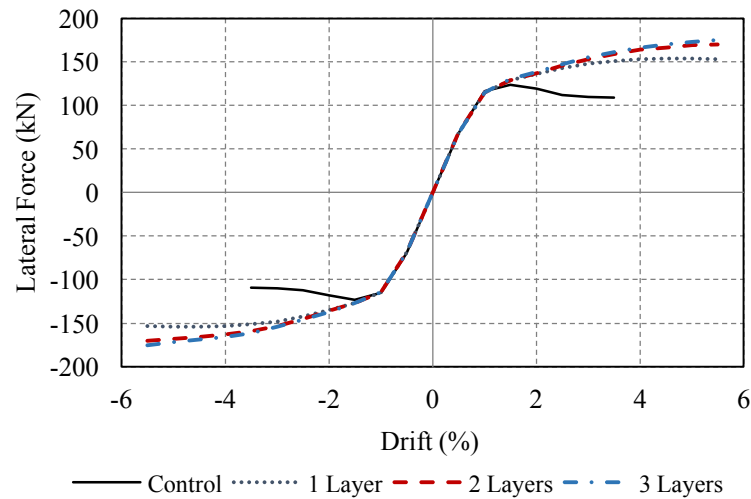
Skeleton curve

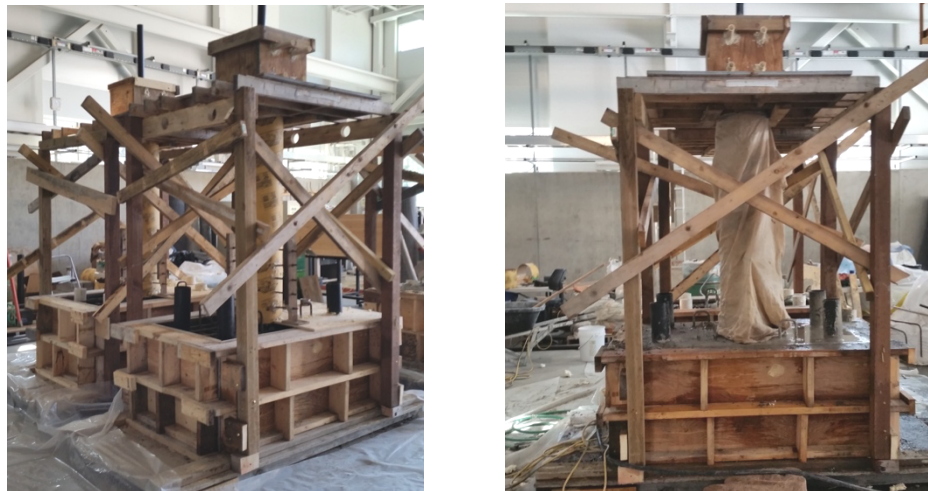
Figure 4.5: Formworks for specimen casting and their curing process

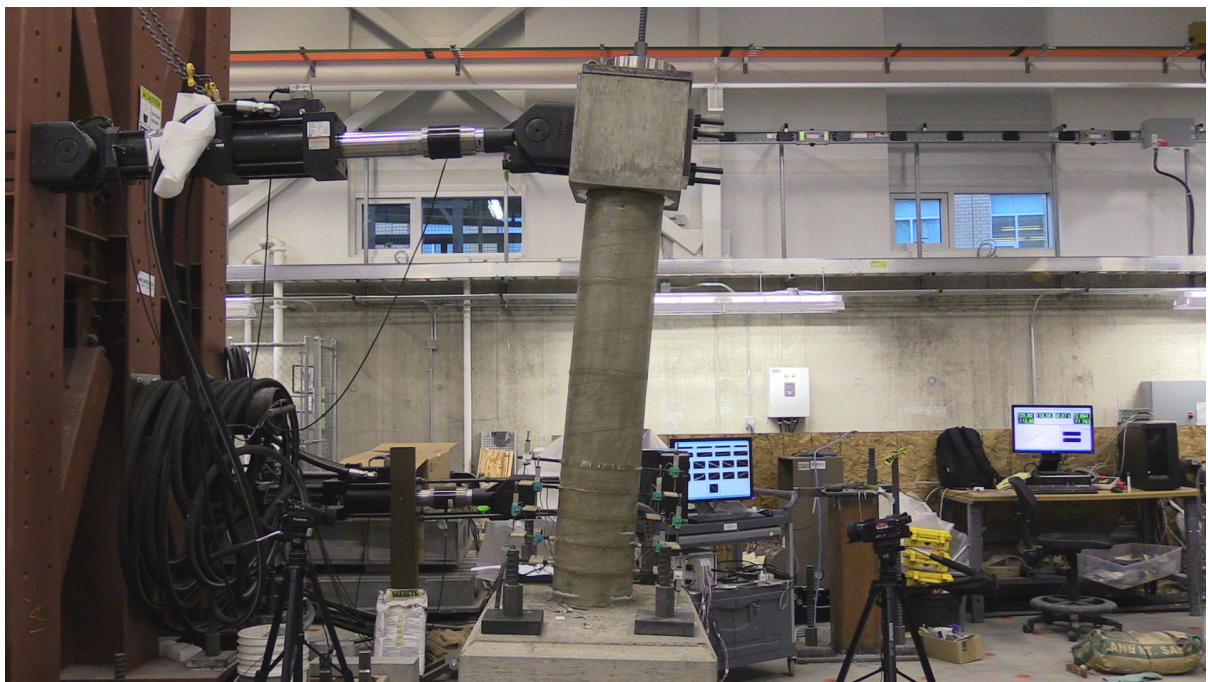
Figure 4.7: Retrofitted pier under significant lateral drift during the test.

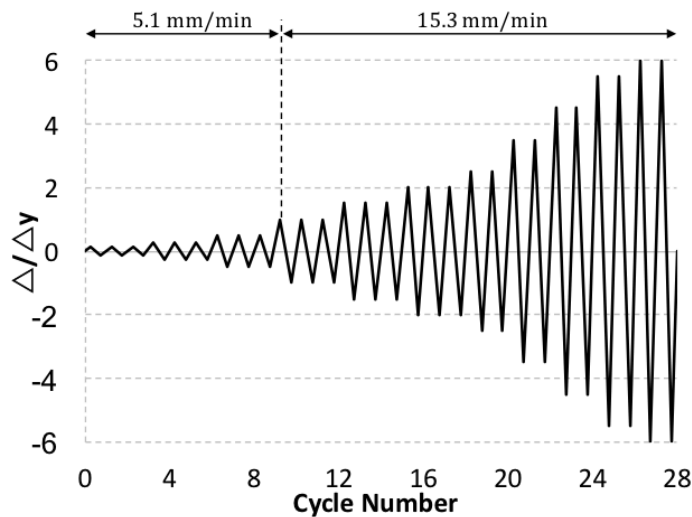
Figure 4.8: Loading protocol for lateral cyclic loading applied in this study

The seismic performance of the scaled down specimens was evaluated using a standard displacement controlled quasi-static cyclic loading with an increment of $0.5\Delta_y$ until reaching the failure. The displacement loading up to $2\Delta_y$ was applied for 3 cycles, later it was reduced to 2 cycles. The rate of loading for the protocol was 15.3 mm/min to make it a pseudo-static test (Ghannoum et al. 2012) and ignore the dynamic behavior of the piers, but a slower rate of 5.1 mm/min was applied up to the yielding of specimen in order to apply the displacement in that range accurately and observe the pier performance in the elastic range. Fig. 4.8 shows the standard loading protocol for cyclic test and the protocol adopted in this study.

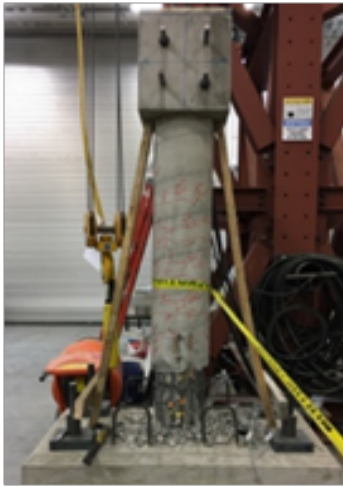
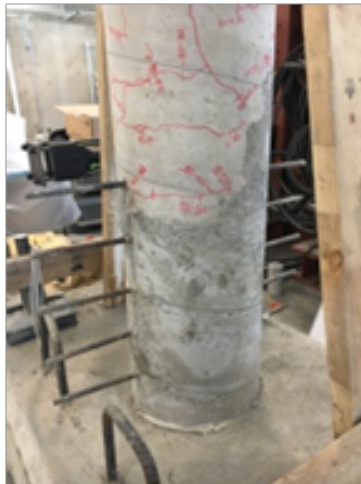
(a) Phase 1

(d) Phase 4

(e) Phase 5

After removing the loads and damaged concrete, the buckled longitudinal reinforcements were almost in a restored position. The fractured ties were removed. The reinforcements were further pushed inward using some wires and externally applied load. New ties were provided with a lower spacing of 50 mm c/c (Fig. 4.9c). This change in spacing did not

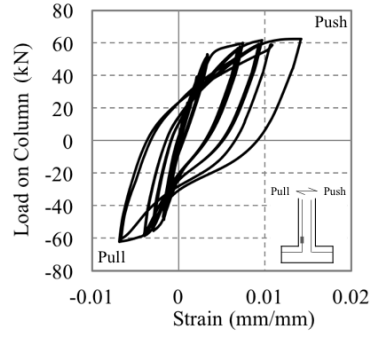
(a) Steel strain of deficient specimen

(b) Concrete strain of deficient specimen

(c) Steel strain of repaired specimen

(d) Concrete strain of repaired specimen

(e) GFRP strain of repaired specimen

(f) Steel strain of retrofitted specimen

(g) Concrete strain of retrofitted specimen

(h) GFRP strain of retrofitted specimen

Strains in the critical section of the plastic hinge regions of the specimens were measured using strain gauges installed on internal rebars, concrete and external GFRP reinforcements. The height of the strain gauges was 75 mm from support. Some strain gauge data were lost during the tests because of gauge failure or unreliable measurements caused by highly localized strains. The yield strain of longitudinal reinforcement was 0.00225. Fig. 4.12 shows the applied lateral load versus strain developed on steel and concrete for deficient specimen, and on steel, concrete and GFRP for repaired and retrofitted specimens, respectively. As shown in Fig. 4.12 (a) and (b), the strain response of steel reinforcement and concrete in deficient specimen follows the material constitutive behavior, with steel yielding at lateral load of 38.9 kN corresponding to 19.6 mm lateral displacement. Whereas, strain hardening is observed for strain response of repaired column as the reinforcements were already loaded and unloaded in previous test (Fig. 4.12 c and d). The full strain response of steel and concrete in this case couldn't be obtained because of strain gauge failure. The GFRP fibres were only subjected to tensile strain as they don't have any compressive resistance (Fig. 4.12 e and h). The strain response of steel, concrete and GFRP followed their constitutive behavior for retrofitted specimen (Fig. 4.12 f, g, h).
