**A NOVEL FUNCTIONALIZED COMPOSITE COATING FOR CONTROLLING BIO-  
CORROSION IN WASTEWATER CONCRETE PIPES**

A THESIS SUBMITTED IN PARTIAL FULFILLMENT OF  
THE REQUIREMENTS FOR THE DEGREE OF

(Civil Engineering)

THE UNIVERSITY OF BRITISH COLUMBIA

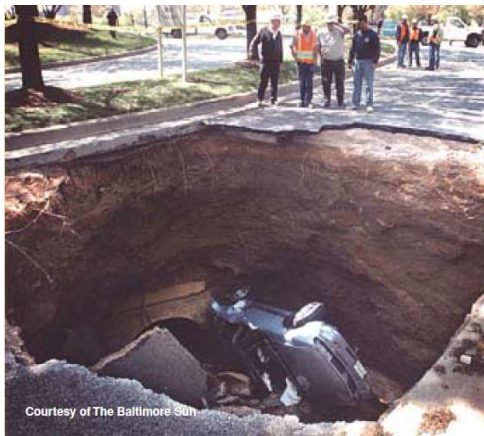
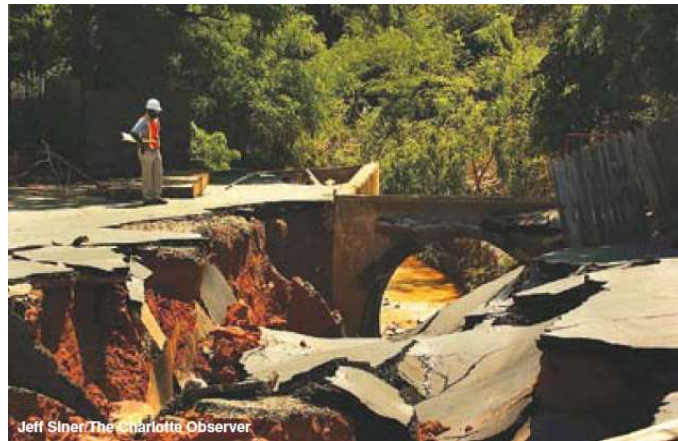
**Figure 1-1:** Examples of pipeline collapses in U.S.

Maryland, Owings Mills , US

North Carolina, Hickory, US

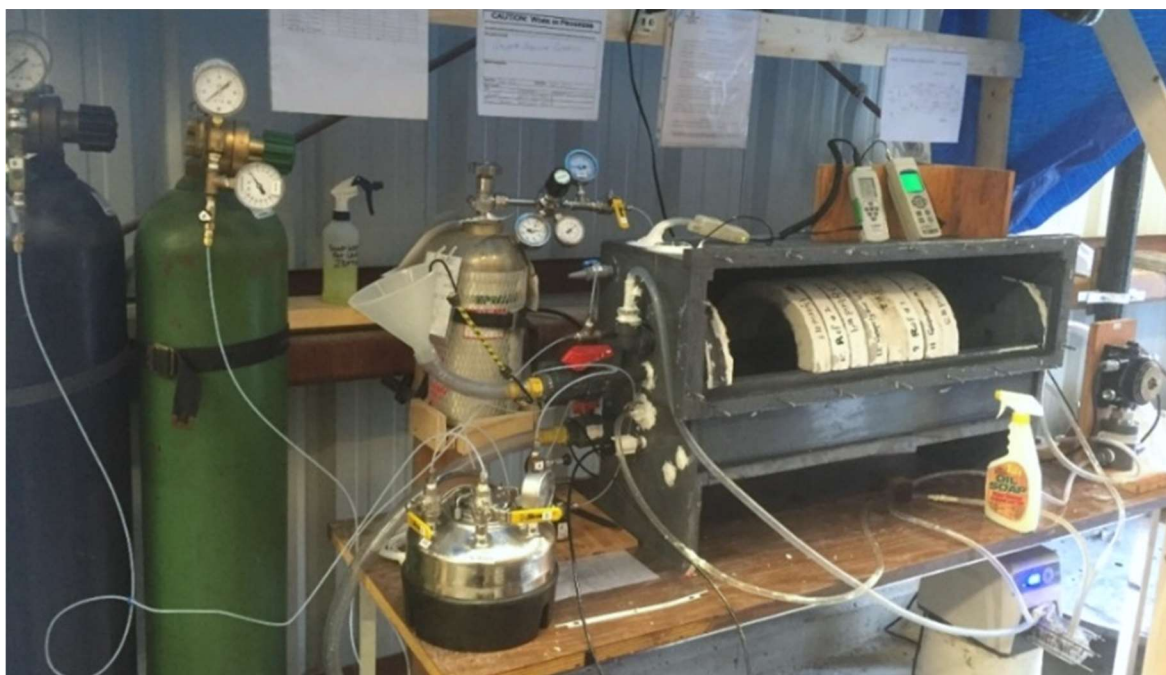
**Figure 2-10:** Developed chamber for simulating bio-corrosion in the laboratory

According to Table 2.1, a chamber was designed to obtain controlled environment simulating that of real sewage pipes (Figure 2.10). The reactor ( $90 \times 20 \times 10$  cm) was constructed of PVC panels of 10 mm thickness with a free water surface to replicate gravity sewer conditions. As can be seen in Figure 2.10, the reactor consisted of an intermediate container, main reaction chamber containing different concrete samples, an air circulation system, a wastewater circulation system,  $H_2S$ , nitrogen and oxygen gas tanks.

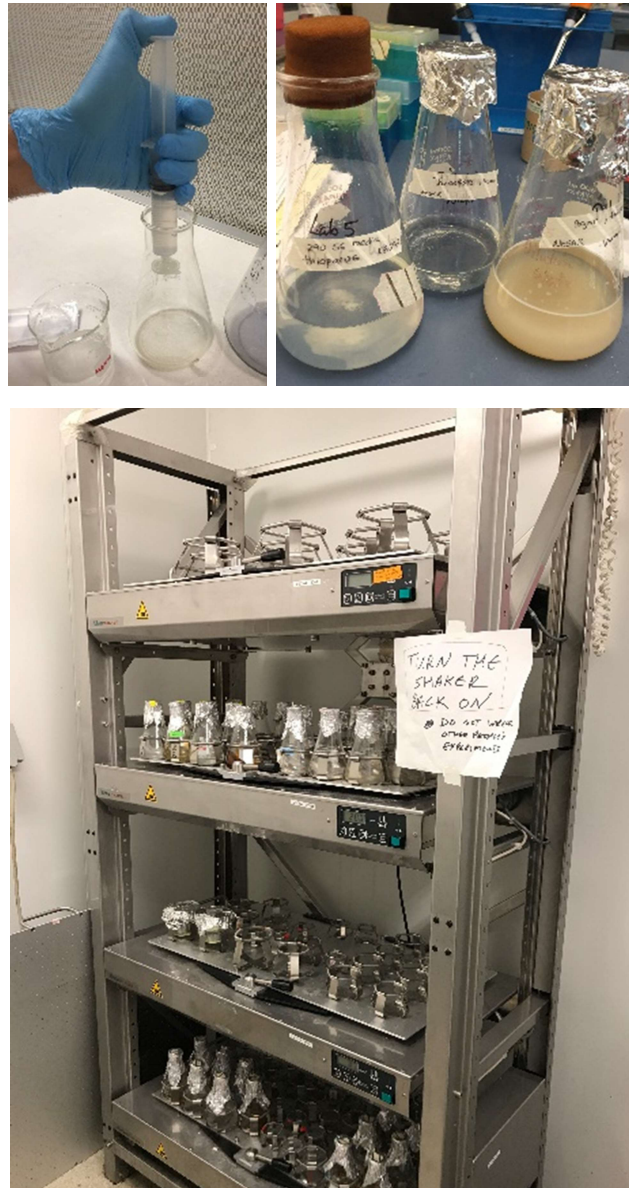
**Figure 2-14:** Bacteria cultivation process

The culture media were used as liquid medium. Each component of the medium was individually prepared and sterilized, and the pH adjusted to the recommended values after mixing the sterile components. The growth of bacteria was studied in a 200 ml flask in a shaker incubator at 30°C and 150 rpm (see Figure 2.14) with 1% v/v inoculum which was also recommended by Yousefi et

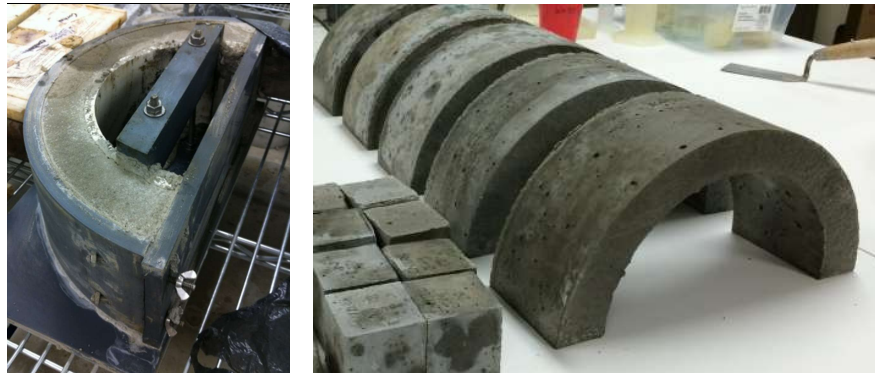
**Figure 2-16: Preparation of arch-shaped test specimens**

According to the literature, bio-corrosion around the circumference of the pipe does not occur evenly. Research indicates that the region of highest deterioration occurs near the sewage level and pipe crown. Moreover, the section of the sewer pipe underneath the water level (submerged part) does not corrode. At the sewage level, three key components are readily available that makes the environment ideal for the microorganisms to grow which includes, moisture, oxygen and nutrients. In this experimental set-up, arch-shaped mortar samples were cast to represent the top half of the concrete pipe and near the water level (Fig 2.16). Prepared cement mortar samples, having a w/c of 0.5 were de-molded at 24 hours, and stored in curing room with 95% humidity and temperature ( $22 \pm 3^\circ\text{C}$ ) for 28 days. The average dry weights of the samples were 1.57 kg.

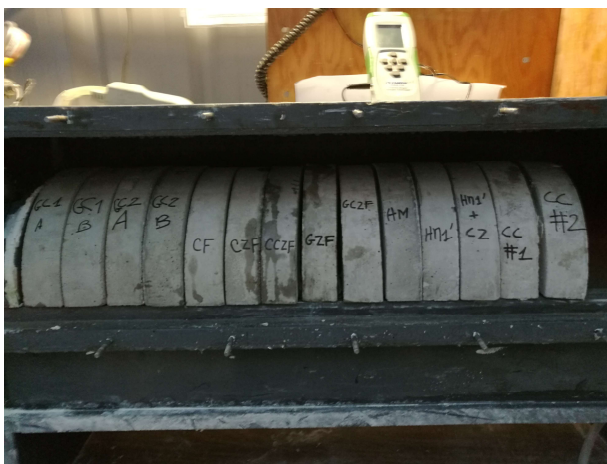
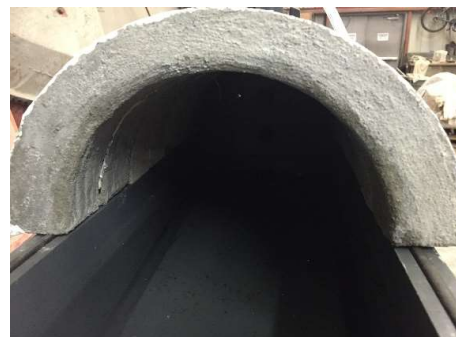
**Figure 2-17: Allocating arch-shaped samples (age 28 days) in the accelerated test chamber**

Figure 2.17 shows how the specimens were positioned in the accelerated test chamber after 28 days.

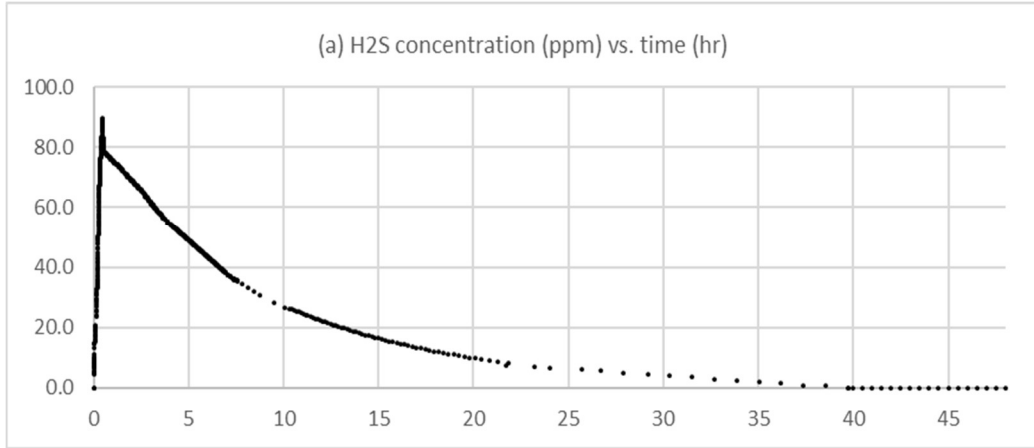
**Figure 3-1:** Gas absorption over time

Gas absorption rate in the chamber was determined in order to have an estimation of how H<sub>2</sub>S was consumed in the system. For this purpose, the reactor was operated with pulse injections of 100 ppm H<sub>2</sub>S<sub>(g)</sub> over around 45 hr period, while wastewater circulation was off in order to minimize the gas absorption to the wastewater. It should be noted that a portion of hydrogen sulfide was lost in the system by wastewater absorption, PVC surfaces and sensors. But for simplicity, the gas absorption by other processes rather than oxidation and samples absorption was considered negligible [Vollersten et al., 2008]. The absorption rate of the H<sub>2</sub>S is plotted in Fig 3.1.

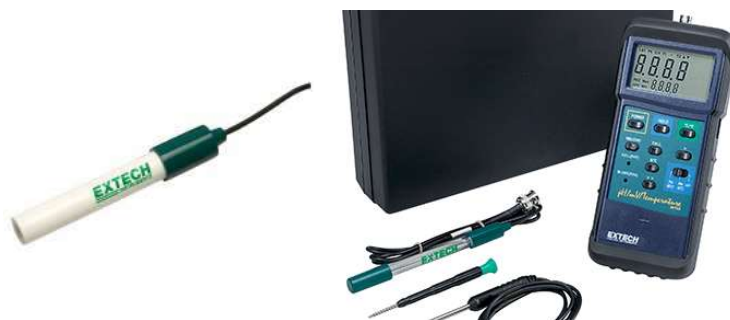
**Figure 3-4:** Flat surface pH electrode (Extech 601100) used to measure surface pH of the samples

Samples surface pH was measured every two weeks for 6 months. A flat surface pH electrode (Extech 601100) was used to measure surface pH over time, Fig 3.4. For each measurement, the surface of the samples were wetted with about 1 ml of water. Five readings were made to determine the average value. Results were plotted in Fig 3.5, 3.6 and 3.7.

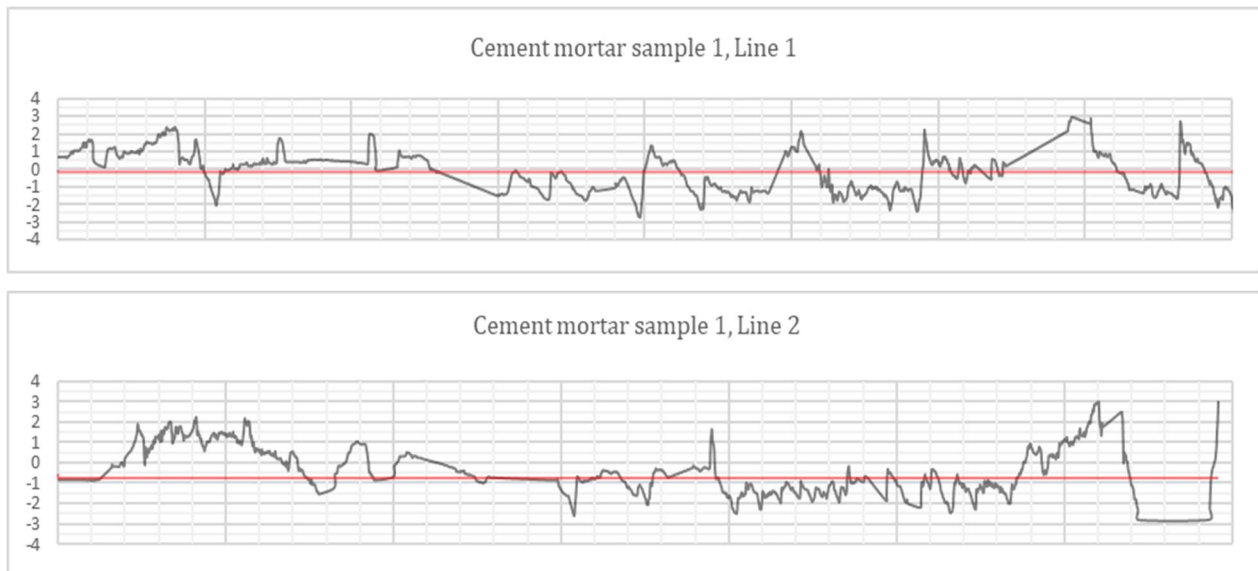
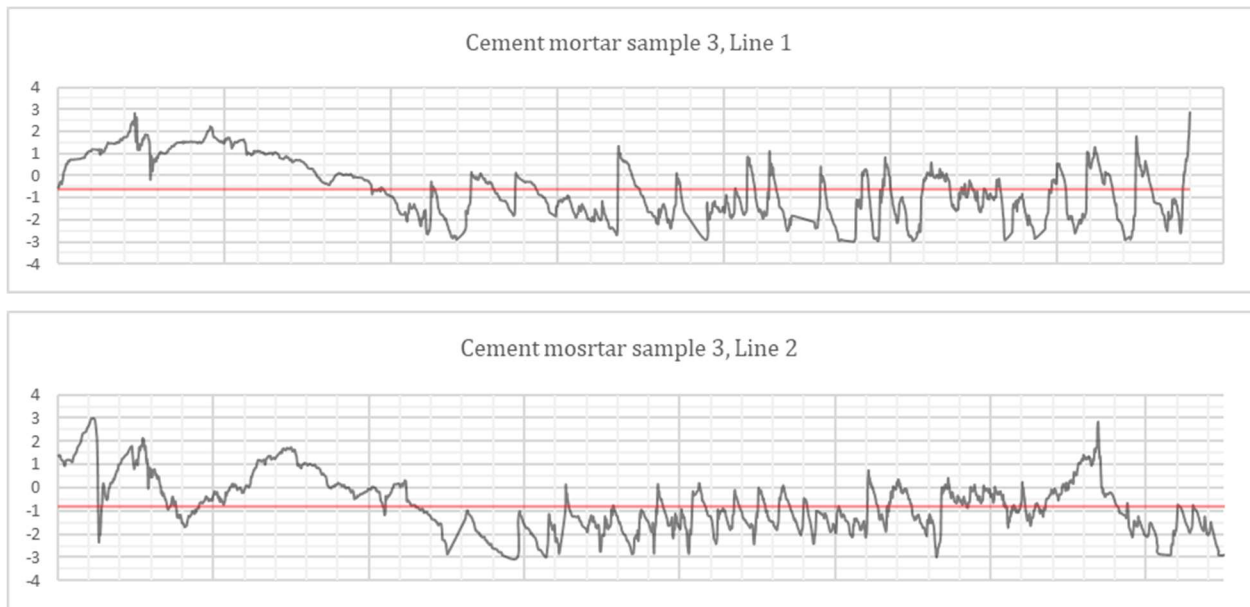
**Figure 3-10:** Cement mortar sample 1 profile depth after corrosion

**Figure 3-11:** Cement mortar sample 2 profile depth after corrosion

**Figure 3-12:** Cement mortar sample 3 profile depth after corrosion

**Figure 3-13:** Cement mortar sample 4 profile depth after corrosion

**Figure 3-14:** Cement mortar sample 5 profile depth after corrosion

**Figure 3-15:** Cement mortar sample 6 profile depth after corrosion

During the measurements, the laser sensor was mounted on a designed set-up which rotates in a semicircular lane with a speed of around 1 mm/s and was able to record around 1900 measurements on each row. The mechanical device allowed adjustment of the height of the sensor. Two parallel profiles in steps of 2 cm was plotted for each specimen at the end of the test. The thickness loss was calculated by subtracting the surface profile plots. Summary of the results (profile depth in mm vs. measured point location along the sample) was plotted in Figures 3.10 to 3.15.

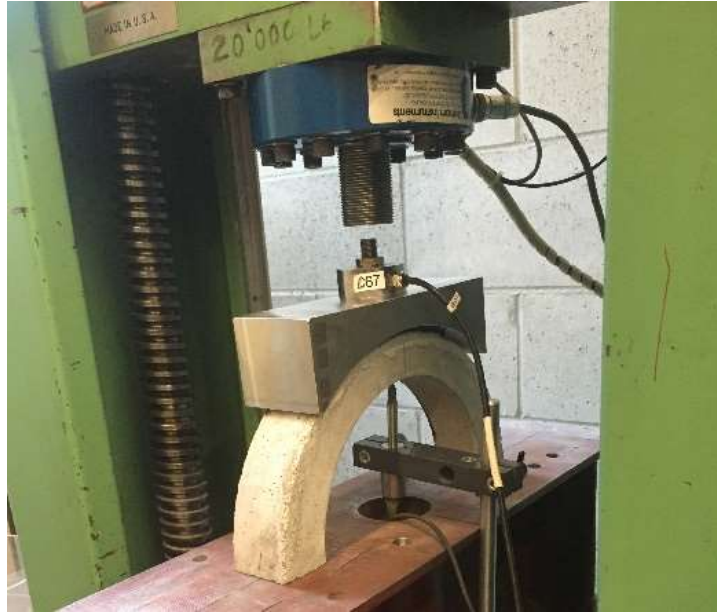
**Figure 3-25:** Test set-up for measuring flexural strength of the samples after and before corrosion

Corrosion products on the surface of the concrete pipes were eroded over time and new surface was exposed to acid attack. This process will continue until the pipeline fails. In this study, resistance (capacity) of arch-shaped concrete samples were tested subjected to three-point bending. The test set-up is illustrated in Figure 3.25 and 3.26.

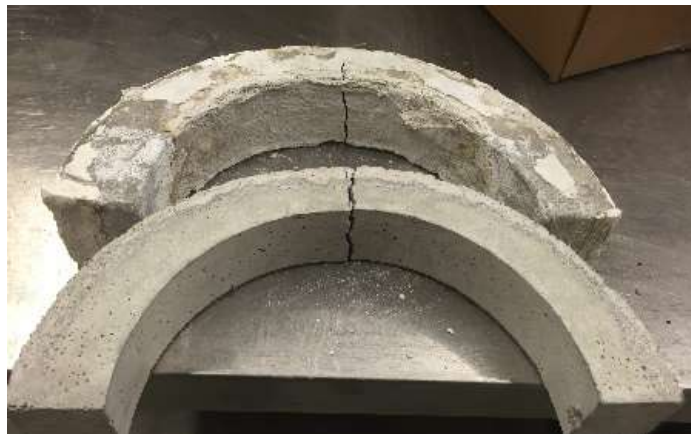
**Figure 3-26:** Measurements of the effect of corrosion on the ultimate load bearing capacity of the samples

After 112 days three samples were removed from the chamber for strength loss measurements, and then returned to the chamber. Samples' final strength loss was measured after 180 days.

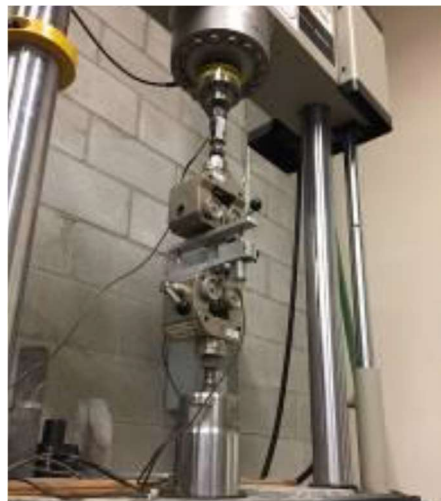
**Figure 4-10:** Uniaxial tensile test set up

Uniaxial tensile test was performed on 11 different batches of fiber reinforced geopolymer (0.1% PVA fiber was used), Table 4.8. A closed-loop controlled Instron testing system was used in displacement-controlled mode, see Figure 4.10. The testing gauge length was 60 mm and loading rate set at 0.001 mm/min. Typical load-deflection curves are presented in Figure 4.11 to 4.17.

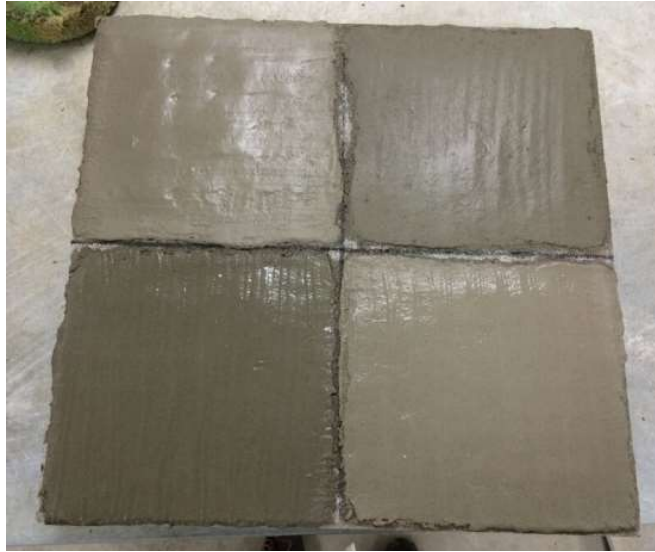
**Figure 4-29:** Application of the mixes for the adhesion test

M2, M5, M9 and M10 were applied onto a well-scrubbed and SSD concrete blocks (Figure 4.29). Then the samples were initially cured for 24 hours by plastic tenting to prevent moisture loss. After 24 hours, samples were placed in a closed container for a duration of 14 days (Figure 4.30).

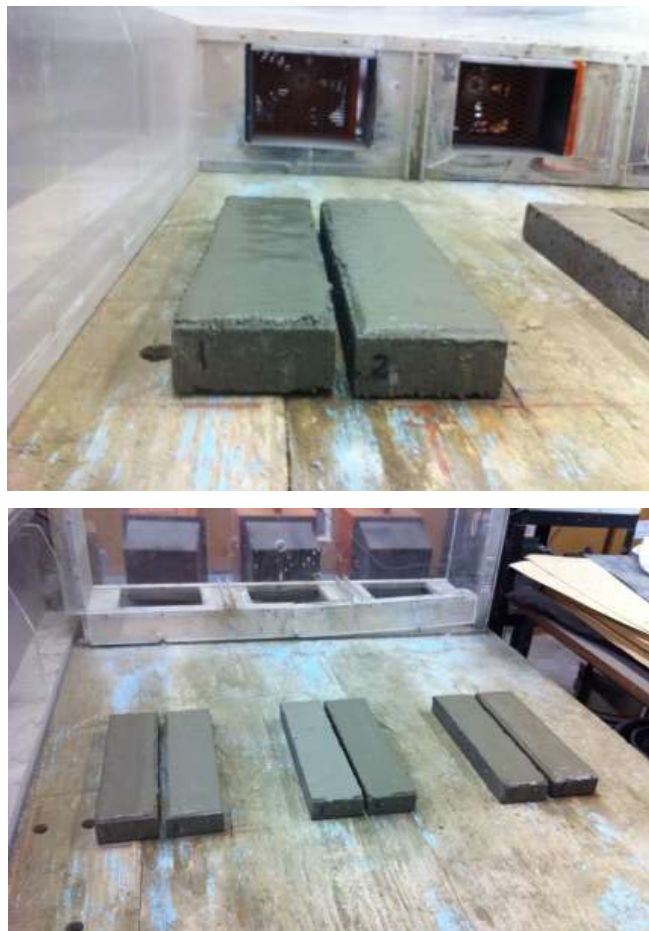
**Figure 4-34:** Application of coating on shrinkage samples for this experiment

In order to create a suitable base for our repair materials, square concrete slabs with dimensions of 50×400×400 mm were purchased and cut into 4 even pieces. Each smaller rectangular piece, 50x100x400 mm, was then thoroughly cleaned with water and a steel wire brush and kept in a saturated surface dry condition (SSD). Developed mixes M1, M2, M5, M6, M9 and M10 were brushed over each base and placed in the environmental chamber, Figure 4.34. A set of six samples were placed in the simulation chamber at a time. Each set of samples were removed after 72 hours and the crack patterns were characterized, Figure 4.35.

With two applicators applying the coating of the 6 samples, the first and last sample had a cast time difference of about 15 minutes. To minimize the potential error due to this cast time difference, each group of samples was tested multiple times, with different application orders.

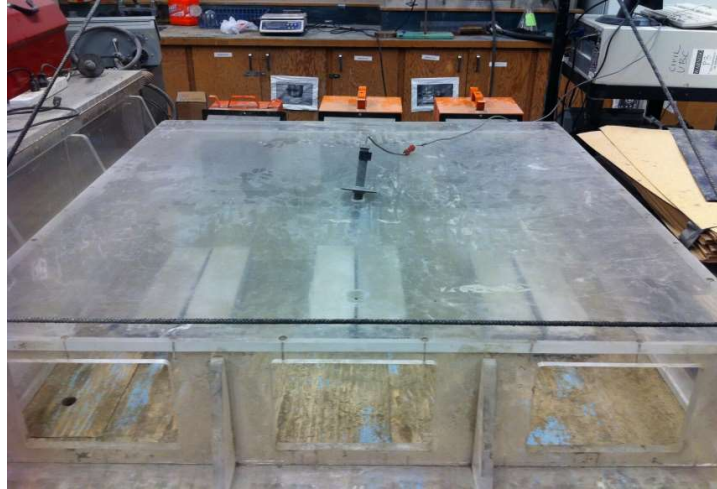
**Figure 4-35:** Plastic shrinkage crack inducing environmental chamber for this experiment

After the first 24 hours, very few cracks were visible on the samples, suggesting that the samples were still hydrating. Within 48 hours, a larger quantity of cracks was visible, Figure 4.35. After 72 hours in the chamber, the samples seemed fully hydrated with visible cracks. A summary of the findings is presented in Table 4.11.

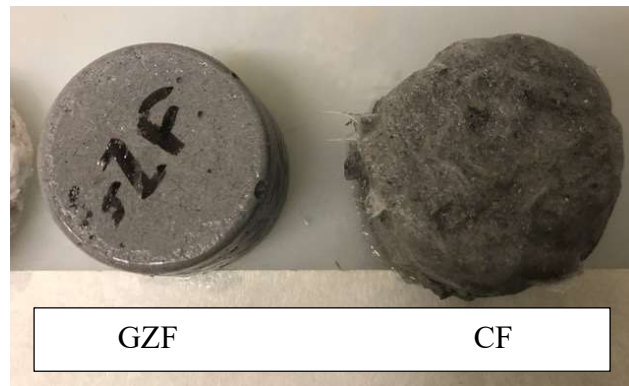
**Figure 4-47:** Deteriorated samples in acidic environment after 16 weeks of immersion

The visual appearance of GZF (geopolymer sample mixed with ZnO) and HMCZ (blended sample of geopolymer and magnesium phosphate mixed with Zn-doped clay particles) and HMZ (blended sample mixed with ZnO) specimens following 16 weeks immersion in acid is shown in Figures 4.47. GZF shows very small alteration in the visual appearance, color change and erosion. Based on visual evaluation, it could be concluded that geopolymer and composite coatings appear to be durable solutions in acidic environments.

In addition to acid leaching, according to Figure 4.47 and 4.48, CZF (cement mortar sample mixed with ZnO) and CF (cement mortar sample without zinc) had deformed and degraded completely in acid solution compared to other mixes which is explainable according to their higher calcium content compare to other specimens. CCZF (cement paste combined with Zn-doped clay particles) also exhibited severe erosion and significant dimensional change. Leaching was clear on the surface of the samples after 6 weeks. However, the amount of leached Zn in CCZF was 50% less than CZF.

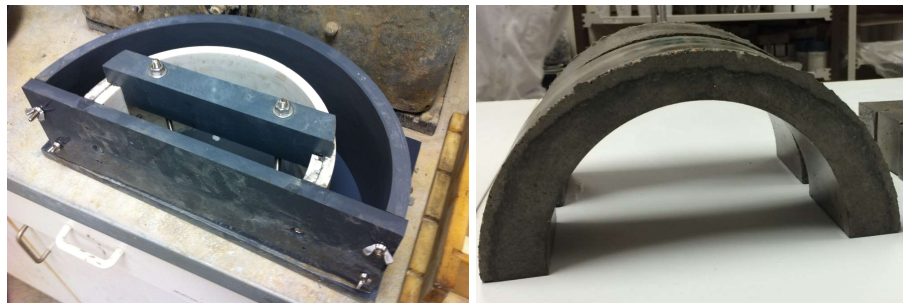
**Figure 5-1: Casting arch-shaped mortar base for coatings**

Arch-shaped mortar samples were cast to represent the top half of the concrete pipe and near the water level (Fig 5.1). Prepared cement mortar samples, having a w/c ratio of 0.5 were de-molded at 24 hours, and stored in curing room with 95% humidity and temperature ( $22 \pm 3^\circ\text{C}$ ) for 28 days. The average dry weights of the samples were 1.57 kg.

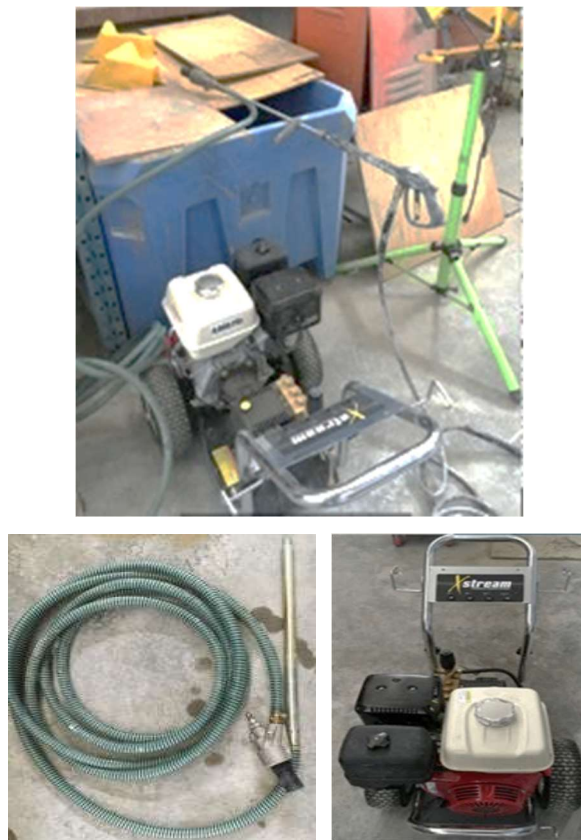
**Figure 5-2:** Sandblasting system

Different coating materials were applied on arch-shaped samples, see Table 5.2. Surface roughness plays an important role in the interfacial bond strength of coating materials. Therefore, before applying coating materials, arch-shaped samples were sand blasted to make sure that a good bond was developed afterwards. Performed sand blasting was very challenging and difficult due to the sample's special shape and achievement of even roughness along the samples. An industrial wet sandblasting kit was used from ATPRO Powerclean Equipment (398cc Honda GX390 4000 PSI BE). It consisted of sandblasting blue tank and plywood cover and an industrial floor lamp as could be seen in Figure 5.2.

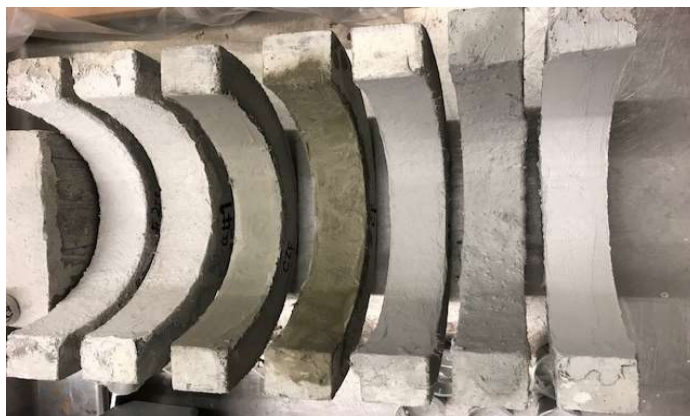
**Figure 5-3: Application of different coatings on the surface of arch-shaped samples**

Once the surface preparation process was completed, coatings were applied on samples (Figure 5.3). Then samples were covered with plastic tenting to avoid moisture loss for 24 hours. Samples were then placed in a closed container and sprayed with water twice daily for a duration of 14 days. The humidity inside the box was measured to be at 90% ( $\pm 2\%$ ).

Poor drying conditions, over-brushing during the application, thickness of the coatings or the geometric shape of the samples caused small shrinkage induced surface cracks on some samples.

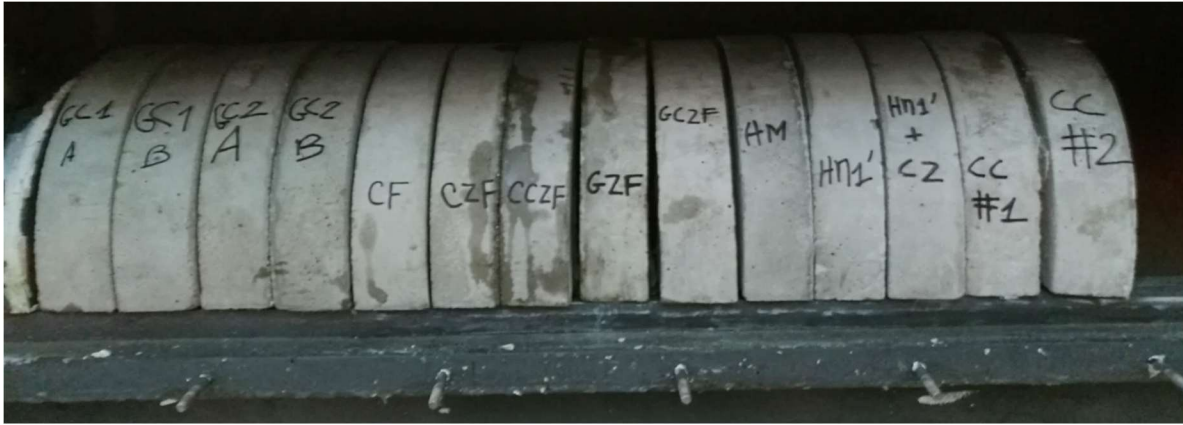
**Figure 5-4:** Position of the specimens in the designed accelerated test chamber

Excellent adhesion to the host material, acceptable mechanical strength after corrosion and high chemical and corrosion resistance of coating material are the most important factors that make the material suitable for pipeline applications. In this study, a combination of multiple evaluation tests and indicators are conducted to compare the relative performance of different coating materials after bio-corrosion. The corrosion rate determined by measuring the reduction in flexural strength and evaluating the corrosion resistant properties of different coating materials. Also, the corrosion products were investigated by SEM. During the test, the chamber's condition (pressure, Humidity, gases concentrations, sewage pH and temperature) were monitored continuously. Figure 5.4 shows how the specimens were positioned in the accelerated test chamber.

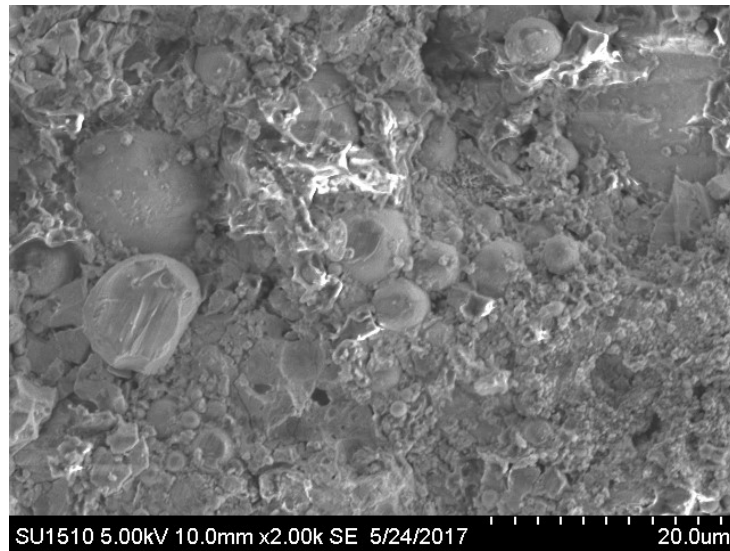
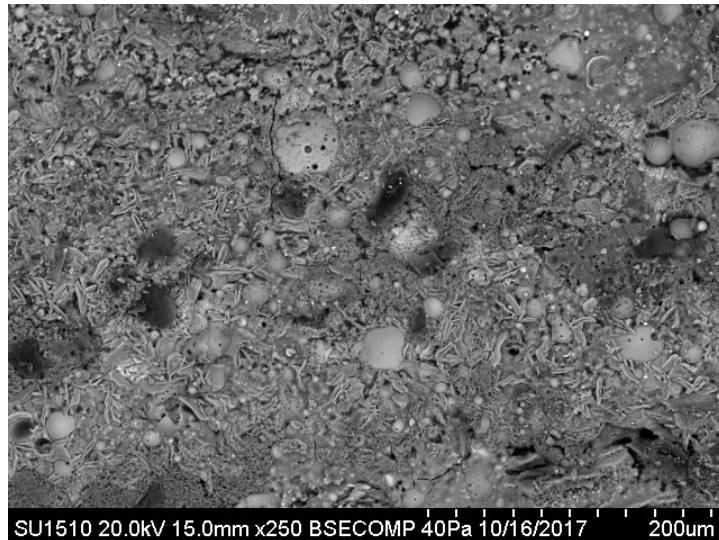
**Figure 5-11:** SEM images of GF coating before and after biocorrosion process

(a) GF- Before corrosion

(b) GF- After corrosion

Properties and microstructure of the coatings before and after corrosion were studied using scanning electron microscope (SEM), Figure 5.8, 5.9 and 5.11.

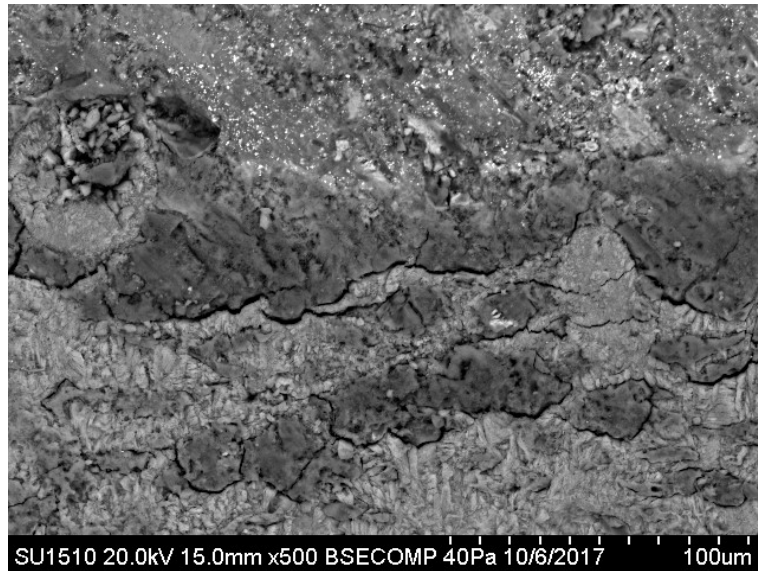
**Figure 5-14:** SEM image of interface between corroded and non-corroded parts in HMZ coating, Top: non-corroded part, Bottom: corroded part

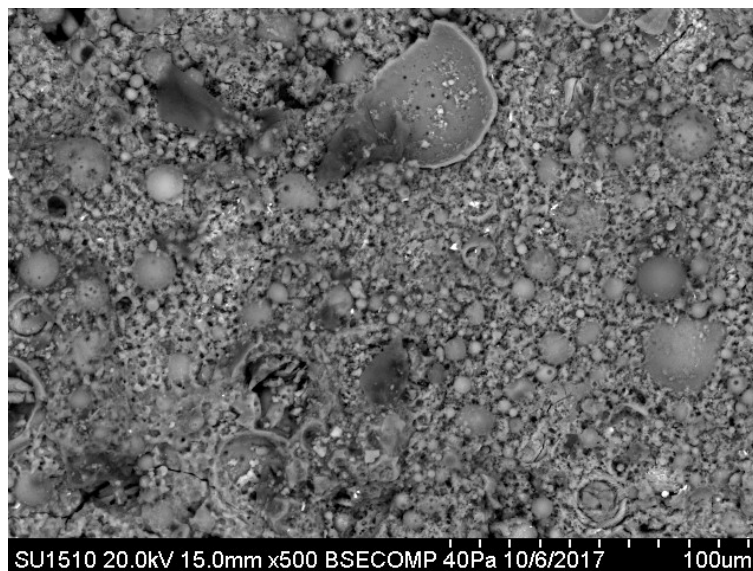
**Figure 5-16:** SEM images of HMCZ coating before and after biocorrosion process

(b) HMCZ after corrosion

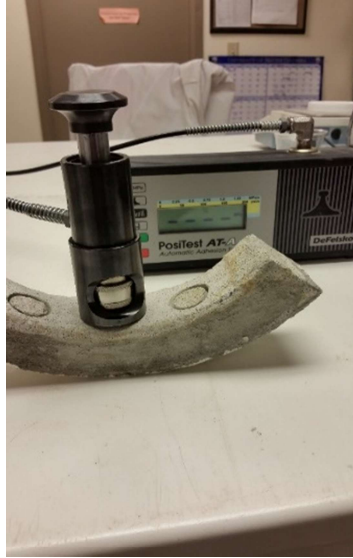
**Figure 5-18: Pull-off test set-up**

Pull-off testing was conducted following ASTM standard D7234-12 on corroded samples. Three to five samples were taken from each arch to obtain a value for bond strength. The purpose of the pull-off test is to verify if the coating surfaces still have sufficient strength to resist delamination. Uncertainties from the test included the amount of micro-cracking along the surface from flexural testing, and the curvature of the bonding surface.

With an average bond strength of 1.87 MPa and 1.92, the HMZ and HM corroded systems were able to display a good bond strength after accelerated bio-acid attack. Geopolymer-based samples performed at a pull-off strength of average 2.11 MPa, 2.29 MPa, and 2.78 MPa for GZF, GCZF and GF respectively. However, bond strength of CF, HMCZ and CZF and CCZF were below 1.2 after the bio-corrosion process.
