**Green Infrastructure in the City of Vancouver: Performance Monitoring of
Stormwater Tree Trenches and Bioswales**

A THESIS SUBMITTED IN PARTIAL FULFILLMENT OF
THE REQUIREMENTS FOR THE DEGREE OF

MASTER OF APPLIED SCIENCE

(Civil Engineering)

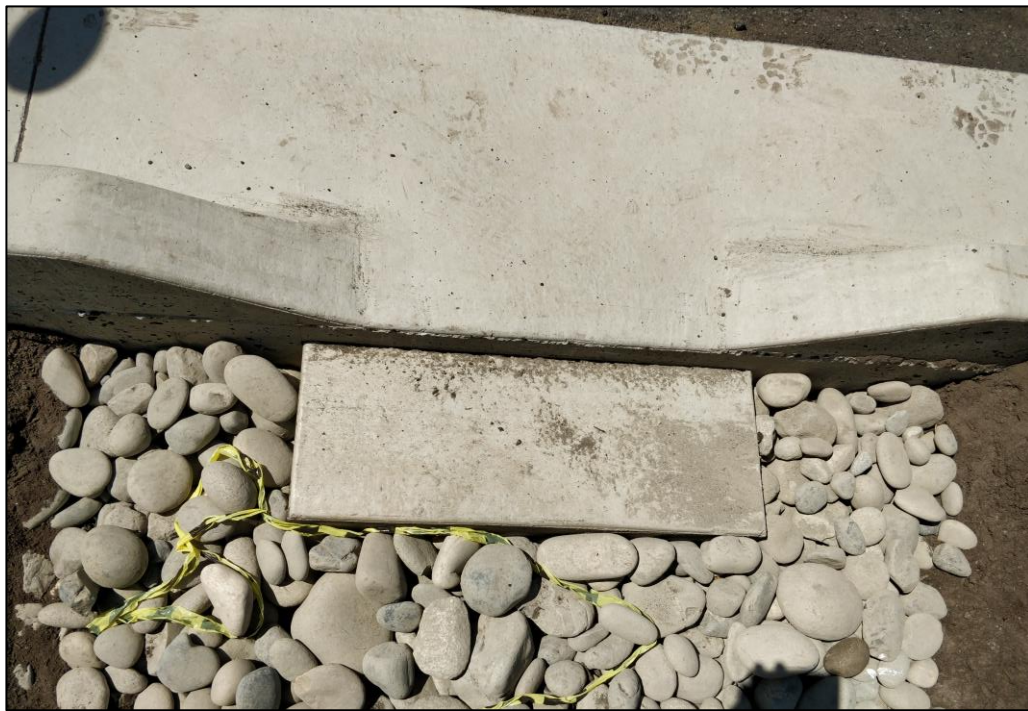
Figure 4.2: Bioswale Inlet Design shortly after being completed. Opening is flush with the street curb's gutter. Water flows into the inlet and drops into a concrete slab with the purpose of trapping fine sediment. The water is dispersed radially into river stone to disperse sediment and reduce flow speed.

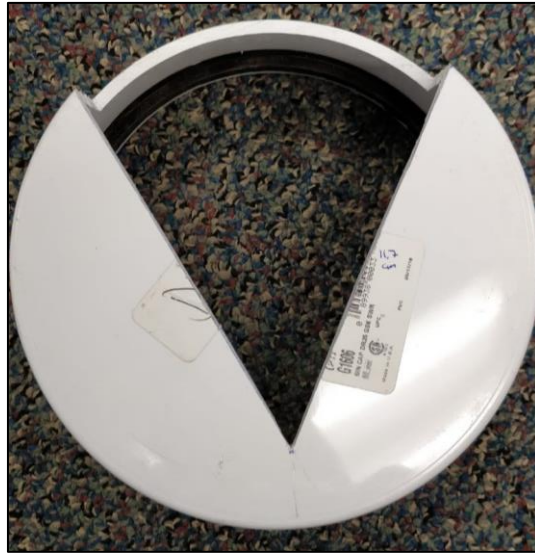
Figure 4.5: PVC weir cap with 53.13° V-notch

Based on the results of Table 4.3, the 53.13° V-notch was selected as it provides the greatest maximum discharge out of the 6" PVC cap dimensions. Figure 4.5 shows a PVC weir cap with a 53.13° V-notch which was utilized for a project, outside the scope of this thesis. The maximum discharge is more than capable of tolerating the peak flows calculated in Table 4.2 except for the most intense duration.

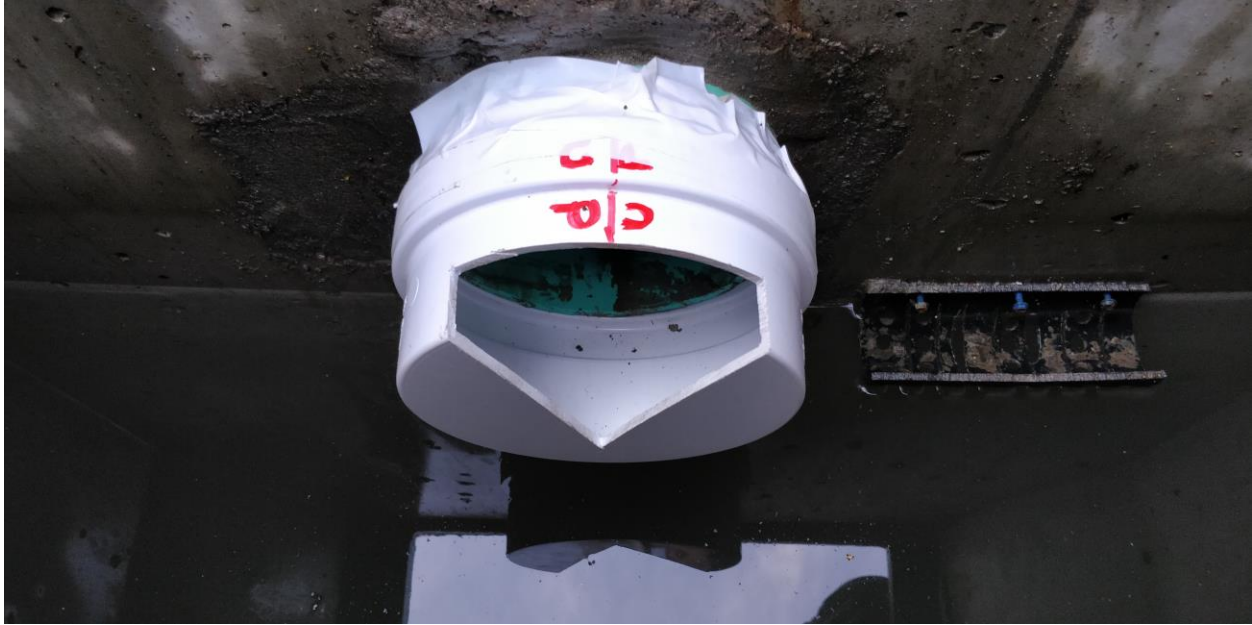
Figure 4.6: 6" PVC weir cap installed in a 6" distribution pipe inside a typical CoV CB

For cases where the peak flows exceed the maximum discharge of a V-notch, it is important to note that the maximum discharge of the V-notch, as provided in Table 4.3, only includes the area where the formula provided by the ASTM D5242 document is valid. Figure 4.6 shows the same PVC weir cap but deployed in the field. In this vantage point it can be shown that the PVC weir cap has larger opening which provides extra flow capacity, reducing the chances of making the PVC weir cap the bottle neck. The calculations of the extra flow capacity are beyond the scope of this thesis due to the complexity of the analysis.

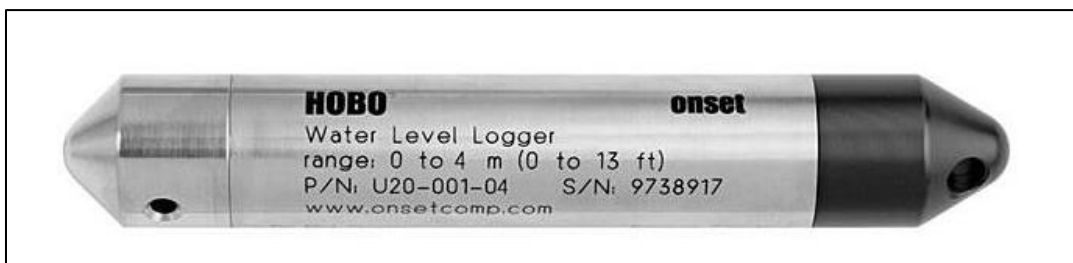
Figure 4.8: HOBO U20® Water Level Logger. Image source: Onset Computer Corporation (Onset, 2019)

The water level is calculated using the HOBO® software which uses the recorded absolute pressure from the primary sensor and compensates it with the secondary pressure recorded by the secondary sensor (atmospheric pressure). If selected, the software can also make adjustments for the density of the liquid based on temperature and liquid type. These considerations make the water levels calculated by the software more accurate (Onset, 2019).

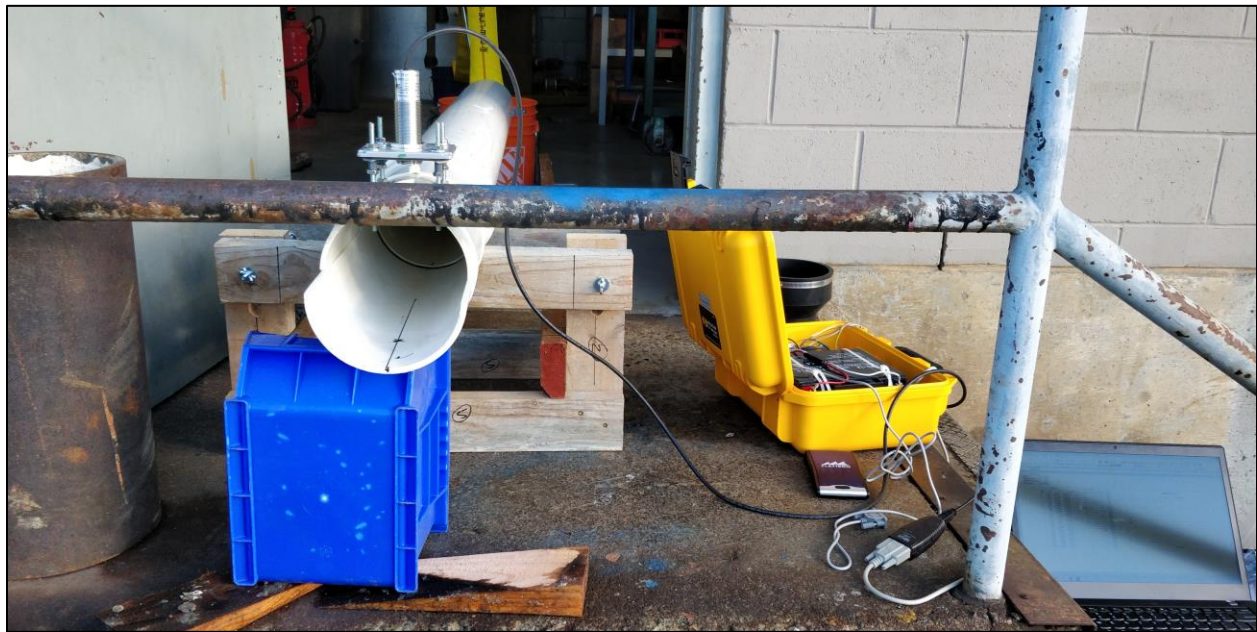
Figure 4.17: Experimental flume device before flow measurement experiment

The flume device was devised and constructed by Paul Lightfoot, Landscape Architect of the Green Infrastructure Branch. The flume device utilizes a wooden frame which controls the slope of the 6” through pipe section where the flow sensor was placed. The sensor was carefully positioned and angled so that the sensor would capture bottom of the channel and not the sides. The sensor and its attachment device will be further discussed in Section 0. The final flume device is shown in Figure 4.17.

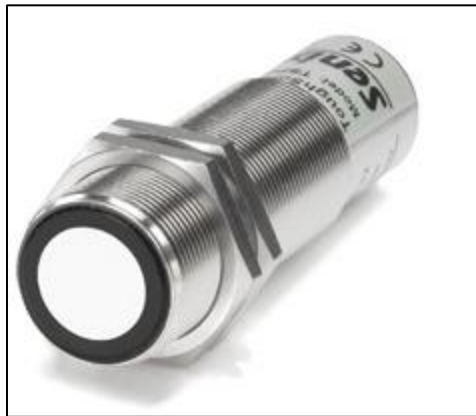
Figure 4.18: Toughsonic 14 Sensor. Image source: The Senix Corporation®

This study required the continuous recording of discharge data to analyze the hydrological performance of the GI practices. A non-contact sensor is recommended as outflows from the GI practices can have sediment. Over time this sediment builds-up, rendering any flow contact sensor device useless unless it is cleaned. The non-contact sensor chosen was the Toughsonic 14® (TS14) shown in Figure 4.18. This sensor is a low power consumption sensor that has IP68 certification. The resolution of this sensor is of 0.086 mm. The sensor has an optimal operating range of 3 m, a deadband of 100mm and an error of 0.2% of the target distance under stable ambient conditions (Senix Corporation, 2010, 2015).

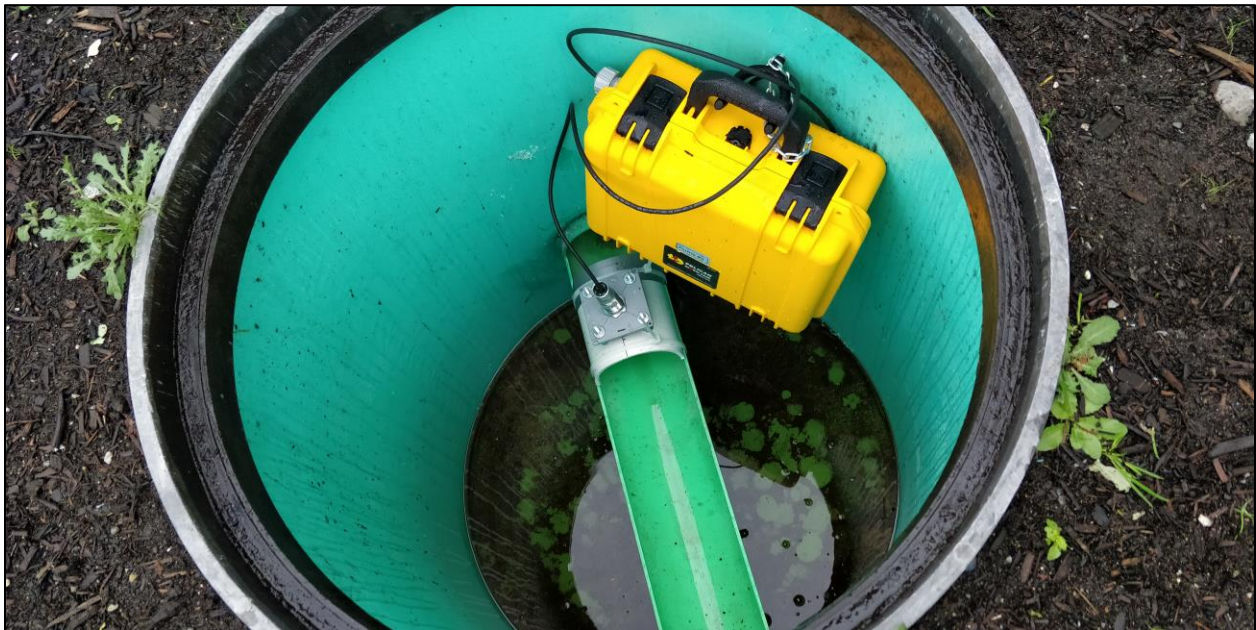
Figure 4.21: Flow sensor system installed in through pipe and data logger deployed in the field

The mounting attachments shown in Figure 4.19 were secured in the through channels by zap straps to ensure that the attachment is held in place. The sensor top was pointed toward the lowest point of the through channel to ensure that the proper water level is recorded. The data logger box was suspended and secured by hooking the data logger box handle to a utility hook that was bolted to the PVC manhole. A zinc chain was wrapped around the handle and the utility hook as a precaution measure in case the handle falls from the utility hook. Figure 4.21 shows the sensor deployed in the field.

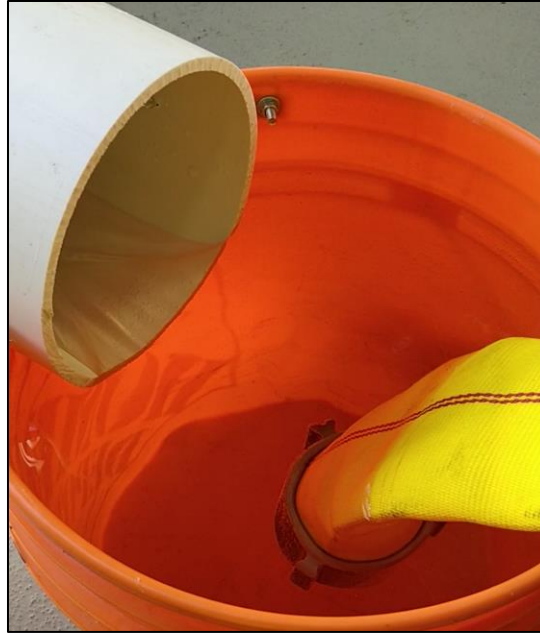
Figure 4.22: Hosepipe mouth placement in reservoir

The flow experiment was conducted at Manitoba Yards, one of the CoV's work yards. The flow meter used in the experiment is several years old (age unknown) and measured gallons per minute with a resolution of a single decimal place. Due to the type and age of the flow sensor device, the target flows were difficult to keep stable. This source of uncertainty will be discussed in Section 4.2.3. An industrial flexible hosepipe connected the flow meter device and the experimental flume reservoir. The hosepipe's mouth was placed at the bottom of the reservoir to avoid introducing turbulence at the mouth of the pipe as shown in Figure 4.22.

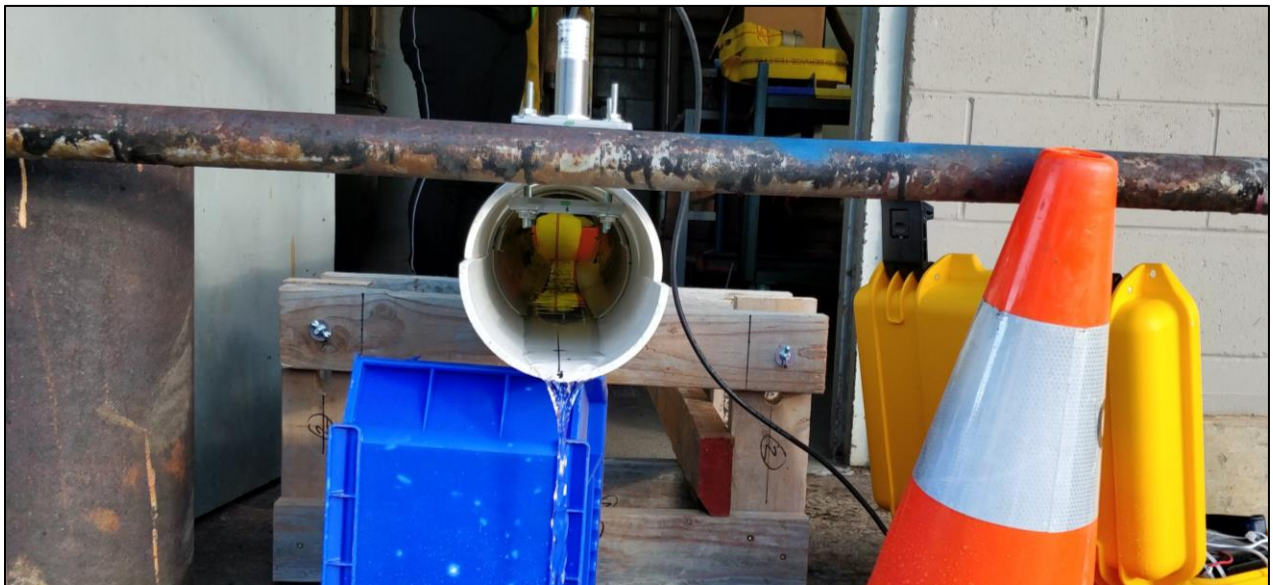
Figure 4.23: Flow experiment capture which shows flow width changes due to coupling transitions

The flow experiment was conducted based on the slope conditions of the through channel summarized in Table 4.5 and the 16 discharges shown in Table 4.6. The TS14 sensor readings were used to estimate the water level. Figure 4.23 shows a capture of the test in progress.

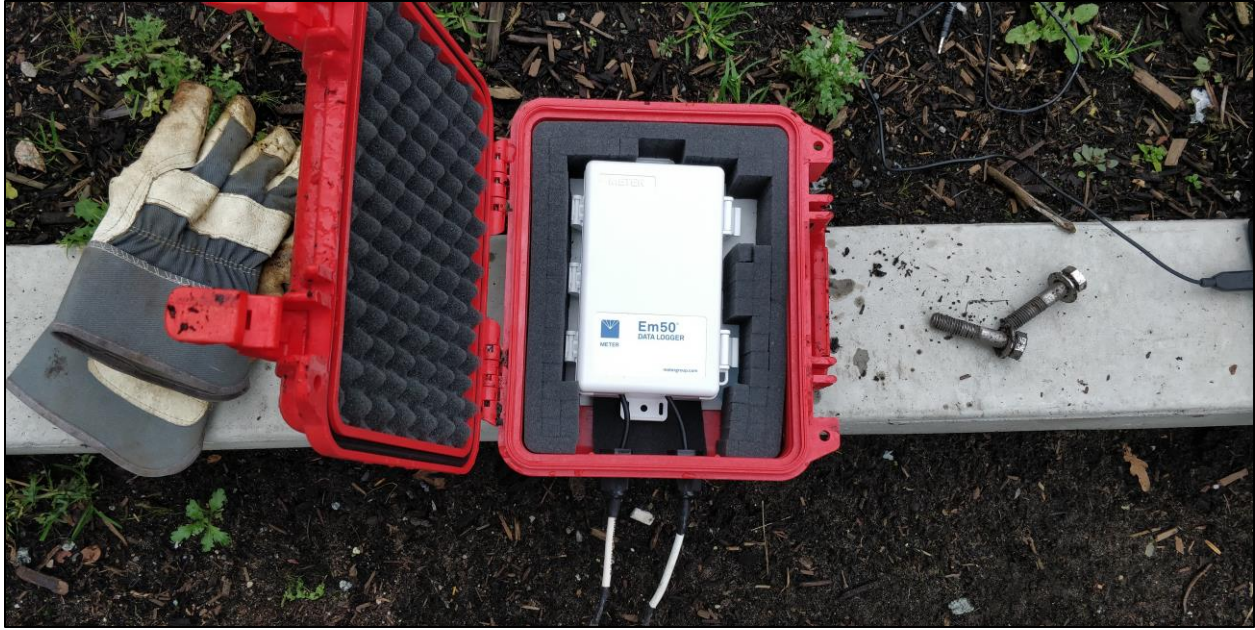
Figure 4.26: In-house made data logger box

The data logger chosen for this study was the Em50®. This data logger can record up to 5 devices simultaneously and it can be deployed for several years uninterrupted. The information can be downloaded through a stereo to USB cable (Meter, 2002). The data logger was enclosed in a pelican box (model 1200) to ensure that the logger is not damaged by moisture. The pelican box was modified to connect the sensor to the data logger inside. Desiccant packs were left in each box to absorb any left-over moisture. Figure 4.26 shows the final product after being deployed in the field.

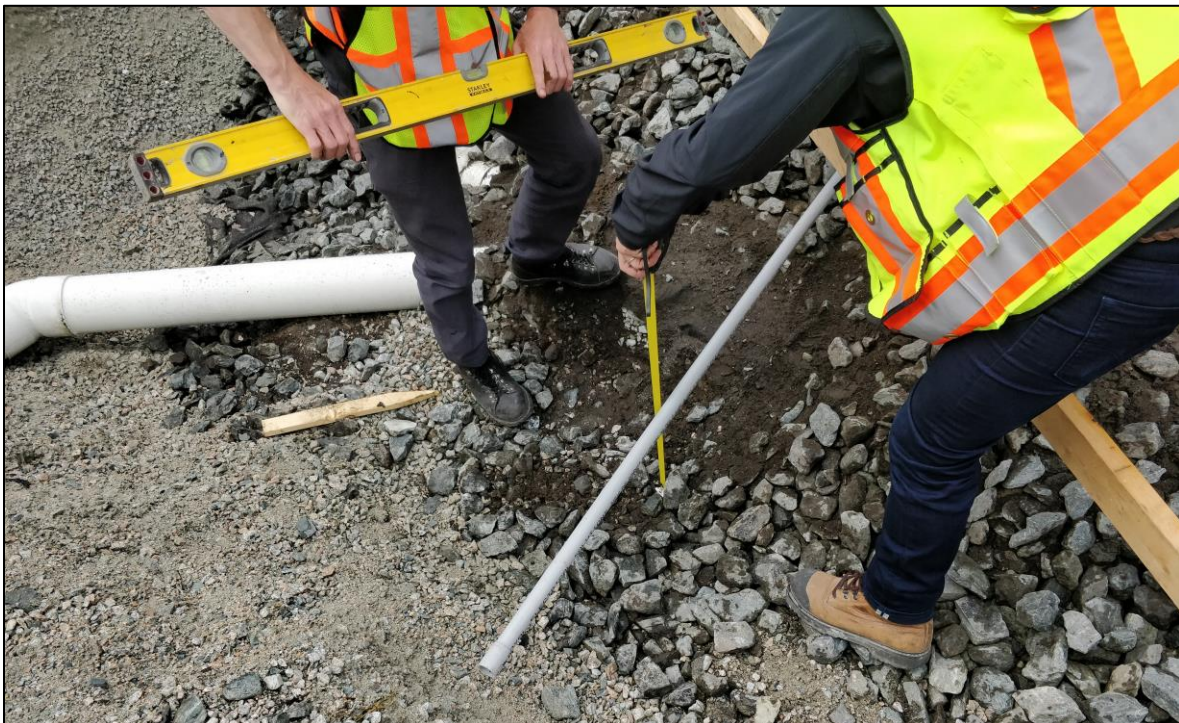
Figure 4.28: Assessment of the conditions for the soil sensor installation. The horizontal 1" PVC pipe in the picture was left by the CoV crews as a protection bridge to guard the soil sensors cables to the valve box.

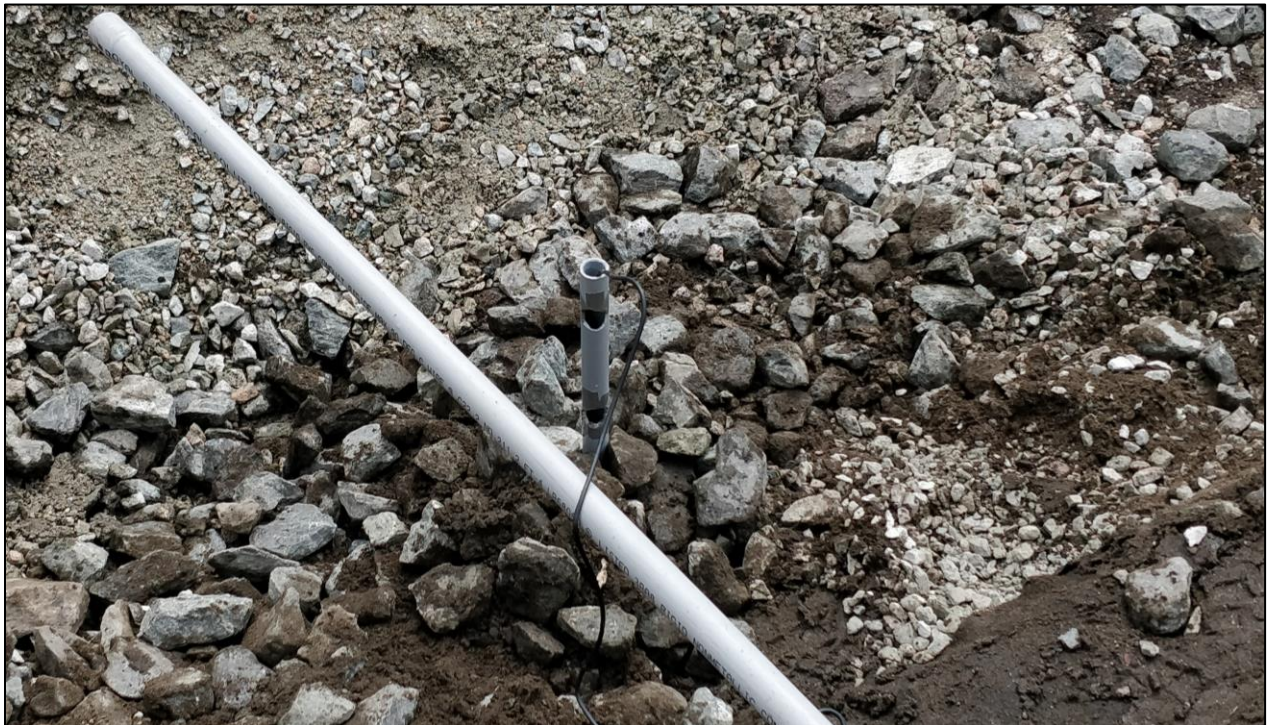
Figure 4.29: Installation of second soil sensor at a 40cm depth. The cables of the soil sensors were slipped into the holes in the PVC pipe for protection. 1" PVC pipe left by CoV crews

The cables of the sensors were protected using a 40cm 3/4" PVC pipe. Holes were cut and drilled on the pipe relative to the depth location of the sensor. The stereo plug ends of the sensors were slipped into the holes during the installation of each sensor as shown in Figure 4.29.

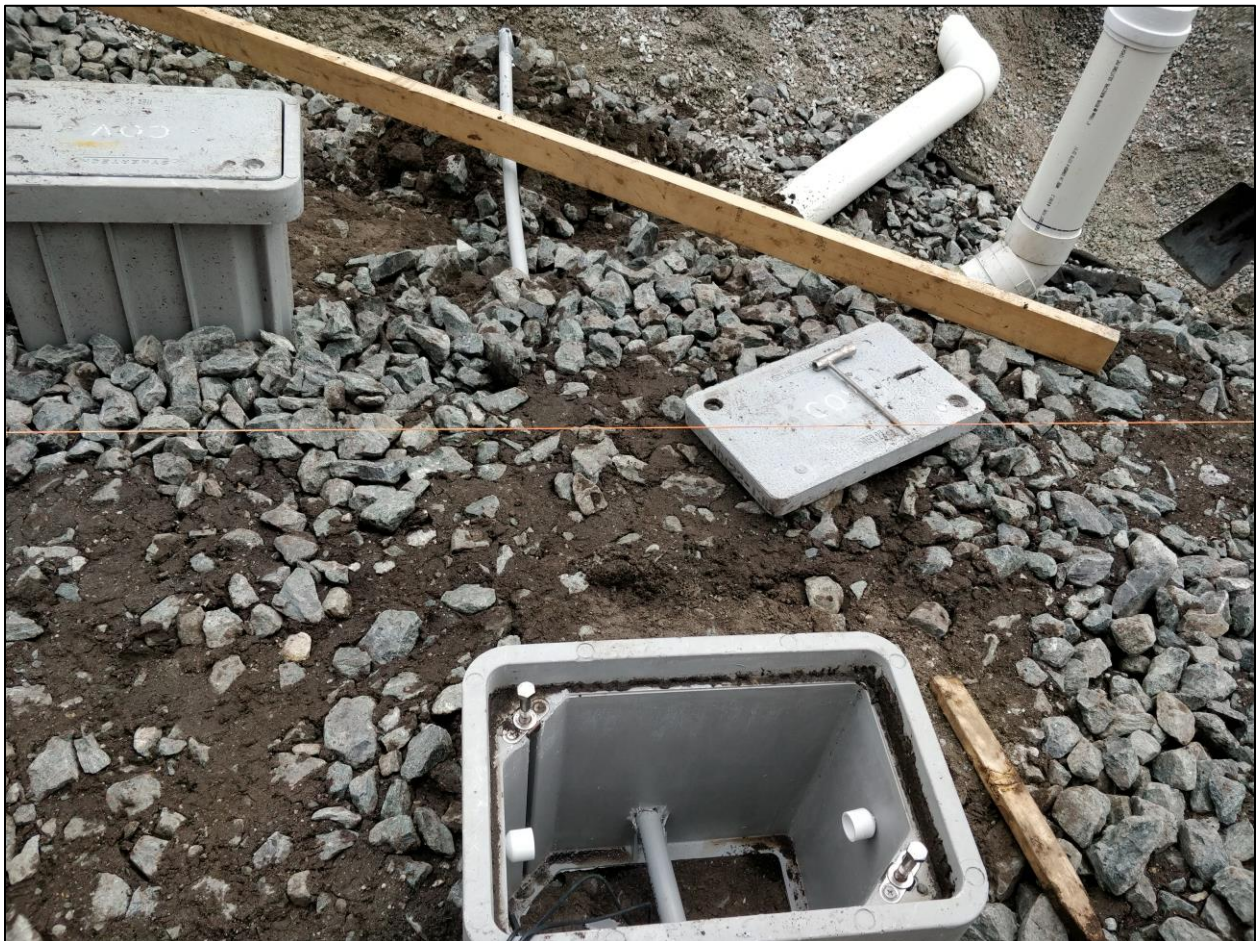
Figure 4.30: Final product. The soil sensor cables were pulled through to the valve box where the data logger installation location.

All the sensors were installed using the aforementioned procedure. The soil sensor cables were later pulled through a 1" PVC elbow that was connected to the 1" PVC bridge left by the CoV crews as shown Figure 4.30. Rocks were placed under the 1" PVC bridge pipe to ensure that the surface loads will be better distributed around the circumference of the pipe. The CoV crews continued the construction of the structural soil cell, including the compaction of the 19mm clear crushed base. The sensors were tested again on June 4, 2018 using the ProCheck kit. The three sensors showed positive signs and readings that they are intact and survived the installation process.

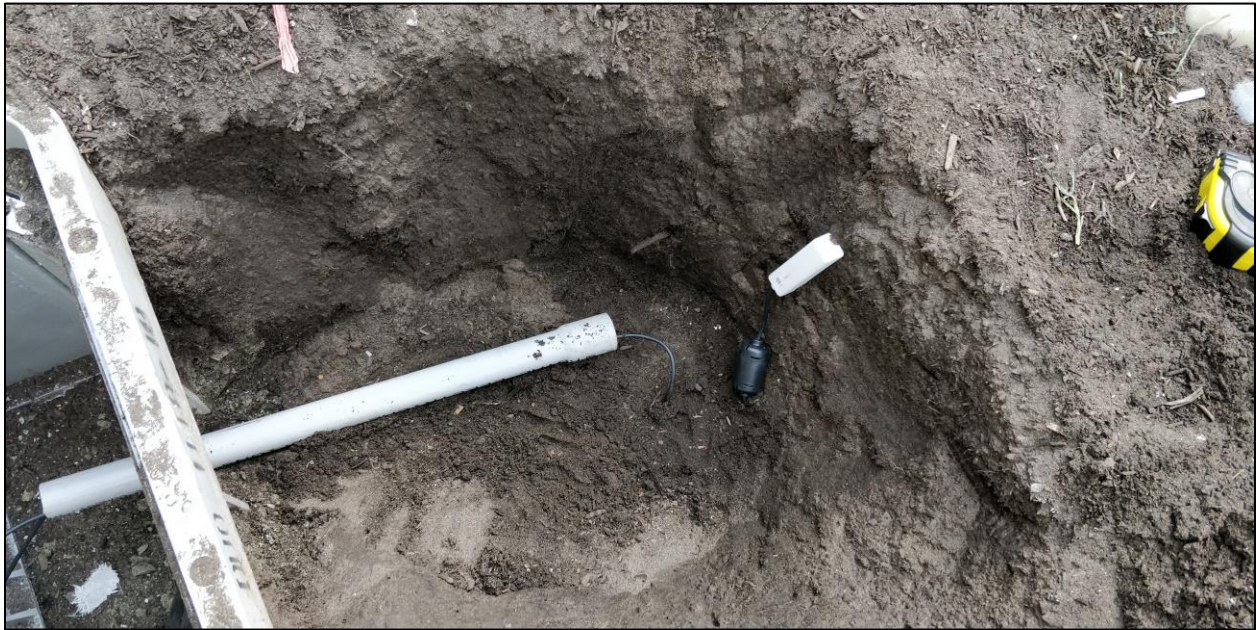
Figure 4.31: Installation of soil sensors in Bioswale 1

Two soil sensors were installed at this location on July 19th, 2018. The sensors were pushed into the soil at the desired elevations. The cables were protected by utilizing the same method as the structural soil: utilizing a 1" PVC pipe to conduct the cable into the composite valve box that houses the data logger box. The sensors were installed at depths of 20cm and 40cm as shown in Figure 4.31.

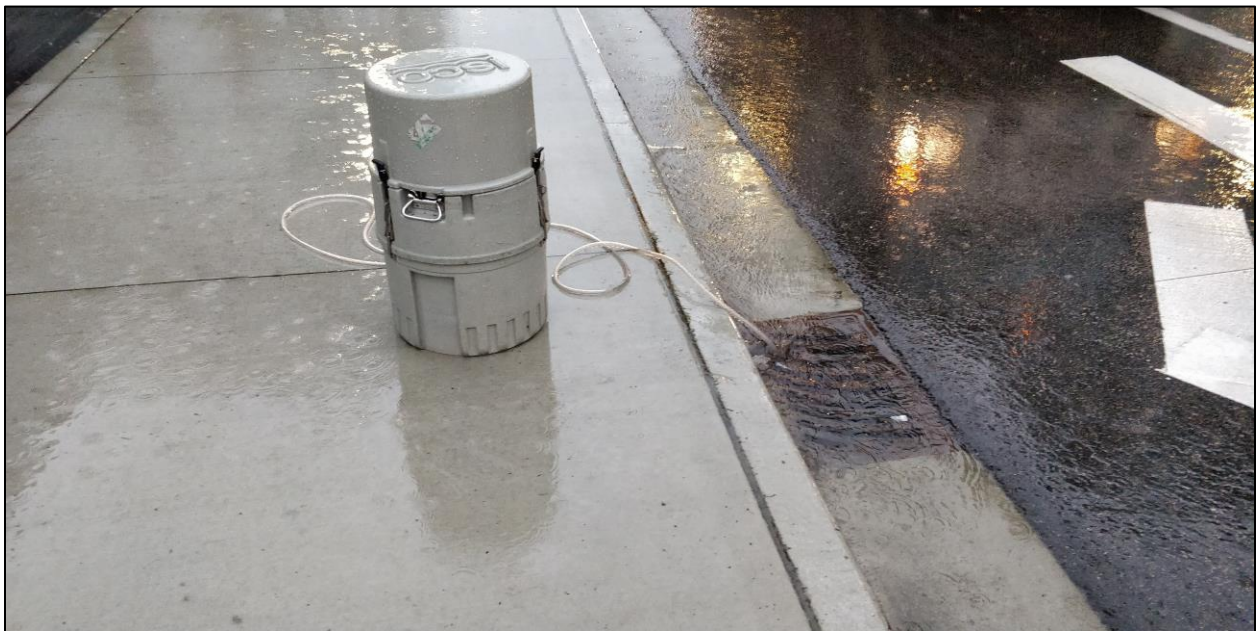
Figure 4.32: ISCO® 3700 sampler deployed at structural soil STT for inflow sampling

The inflow samples for the structural soil STT were obtained from the GICB directly. The tubing was lowered into the CB and left at approximately the same level as the feeder pipe opening. The sampling is shown in Figure 4.32.

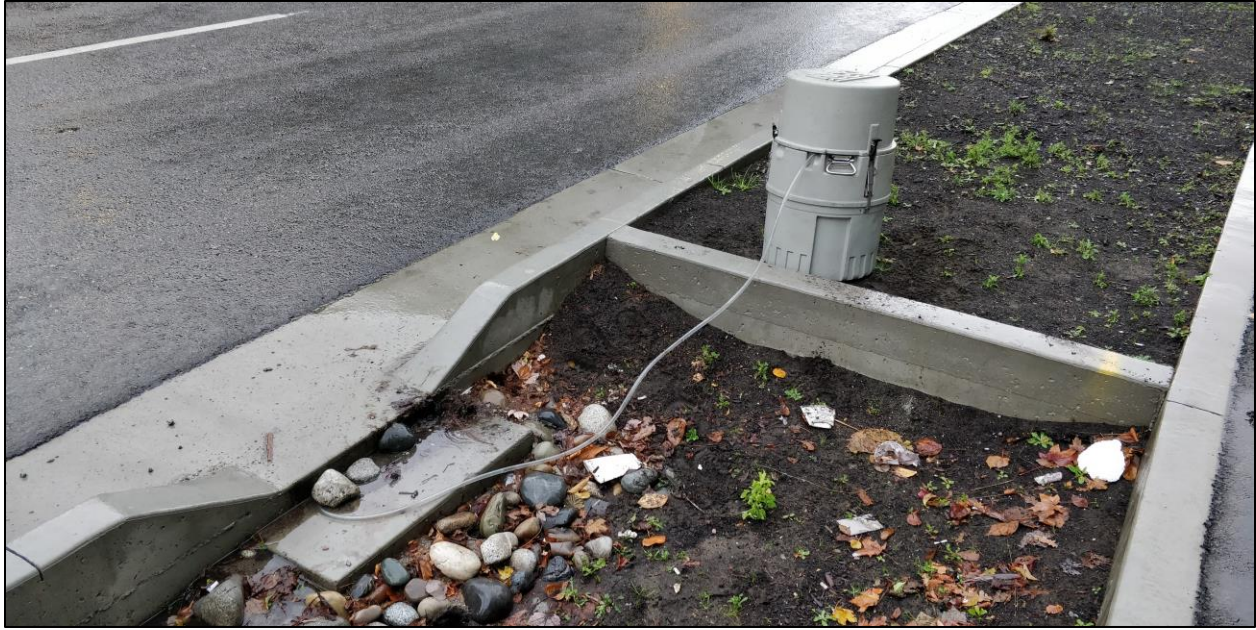
Figure 4.33: ISCO® 3700 sampler deployed at Bioswale 1 for inflow sampling

The stormwater enters the bioswale practices through the inlet curb openings. The water quality samples were taken from the water that drops directly into the sediment pad as shown in Figure 4.33. The PVC tubing was secured in place using rocks. Figure 4.34 shows a close-up of the process at the sediment pad.

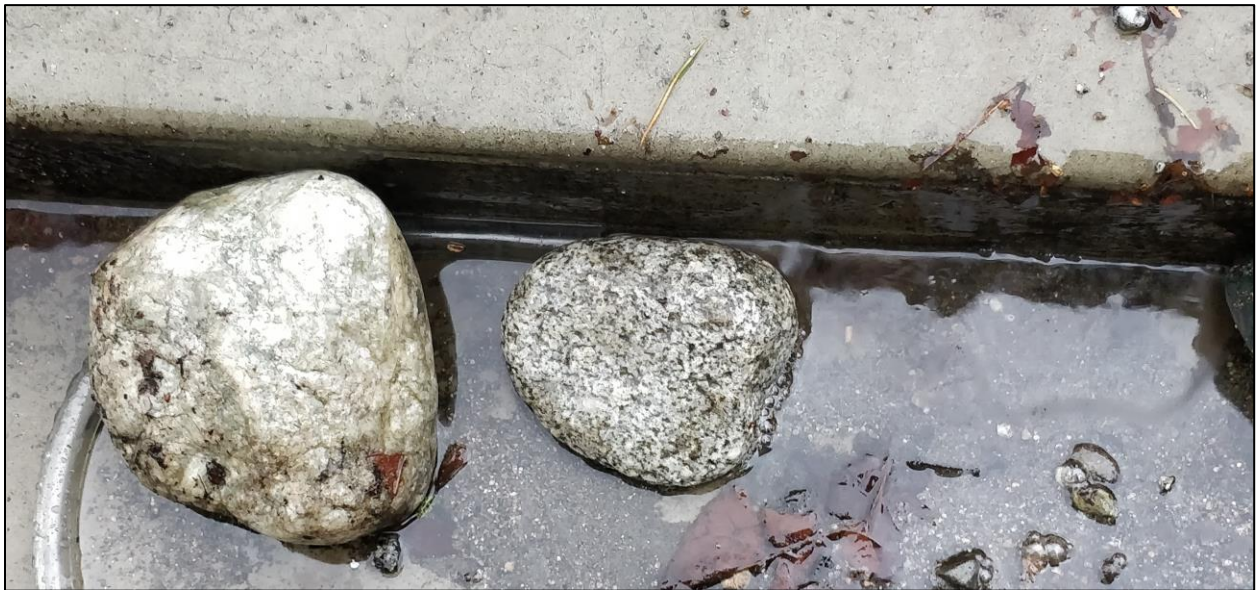
Figure 4.34: PVC tubing hose secured by rock. Rocks are also used here to pool water at the hose inlet to improve suction

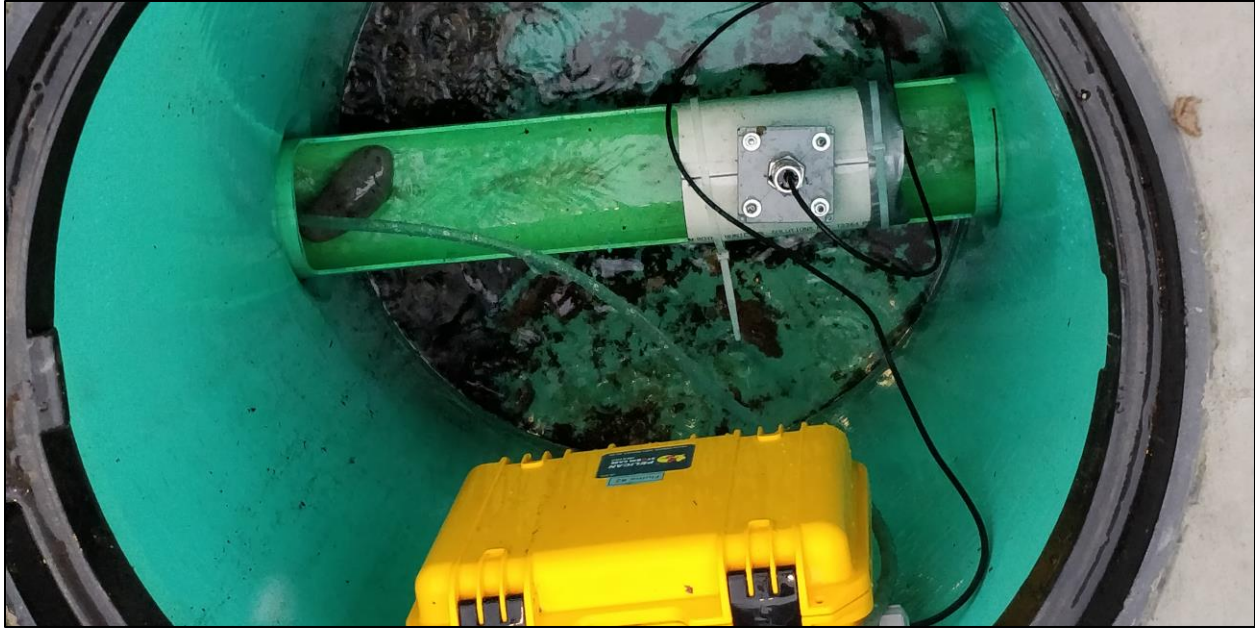
Figure 4.35: PVC tubing sapling from the through channel in the monitoring basin

The outflow system of both the structural soil STT and the bioswales is identical. They all have a monitoring manhole that is connected to the underdrain. The water quality samples were obtained directly from the through channel as shown in Figure 4.35.

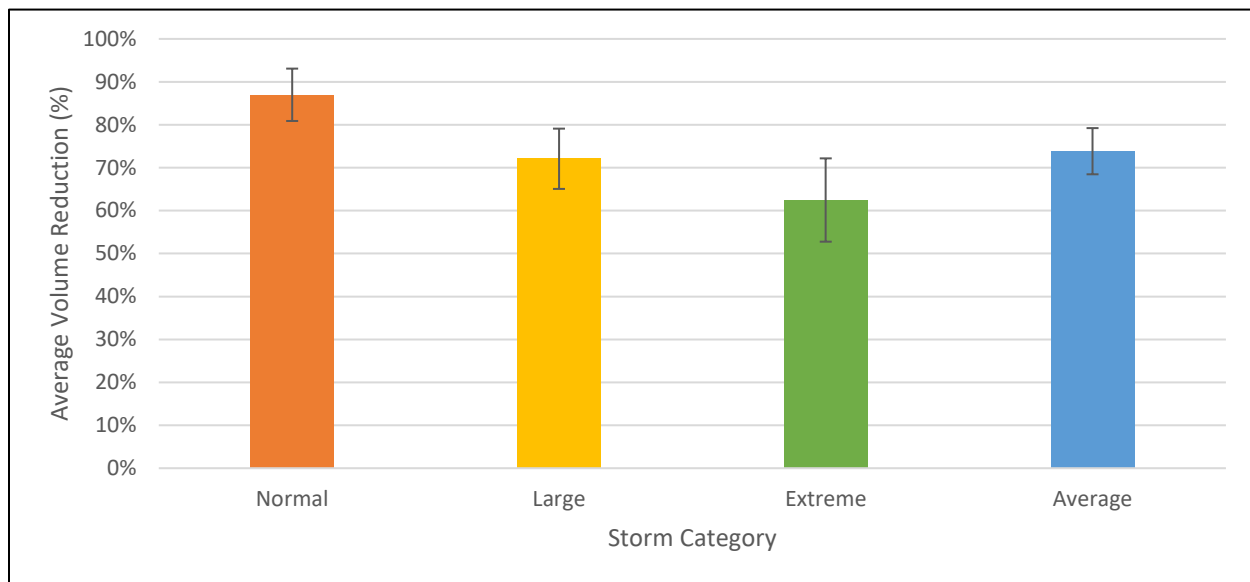
Figure 5.3: Stormwater Volume Reduction with CI of 95%

The average stormwater volume reduction results can be found on Figure 5.3. On average and with all events considered, the structural soil STT has a volume reduction of $74\% \pm 5\%$ (CI 95%). The normal event categories have the highest performance with a reduction of $87\% \pm 6\%$ (CI 95%). The lowest performance was attributed to the extreme event category with a volume reduction of $62\% \pm 10\%$ (CI 95%). The large event category has an average of $72\% \pm 7\%$ (CI 95%).

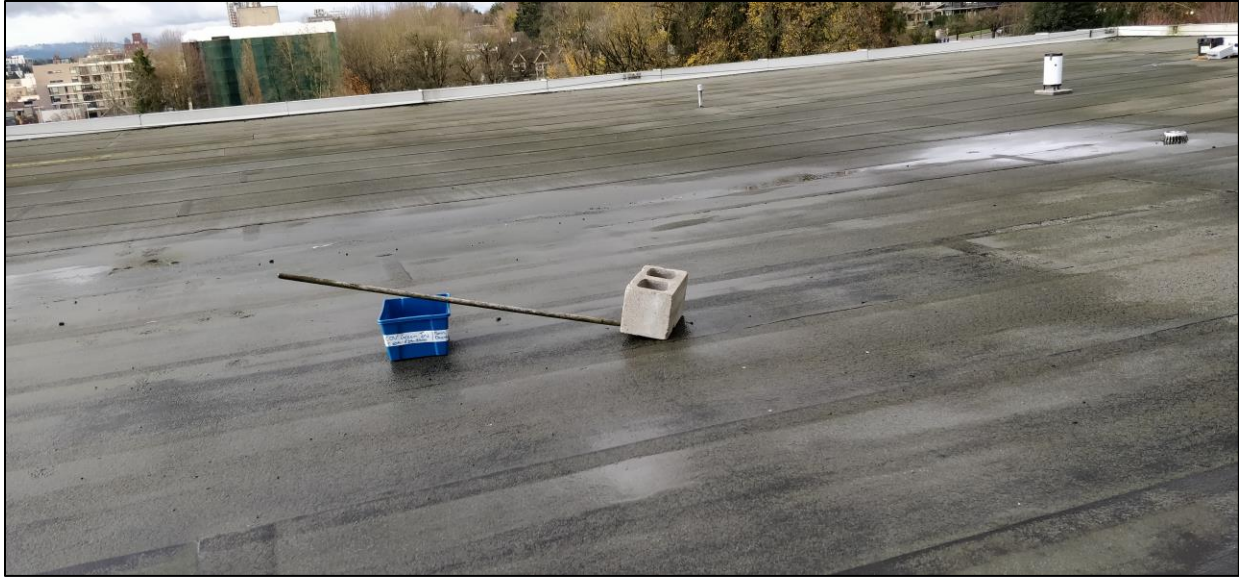
Figure 5.17: Rainwater sampling method and location
