**CHANNEL ADJUSTMENTS AND SALMONID HABITAT ALTERATION DUE TO  
EMERGENCY DREDGING IN CREIGHTON CREEK**

A THESIS SUBMITTED IN PARTIAL FULFILLMENT OF  
THE REQUIREMENTS FOR THE DEGREE OF  
MASTER OF SCIENCE

THE UNIVERSITY OF BRITISH COLUMBIA

September 2020

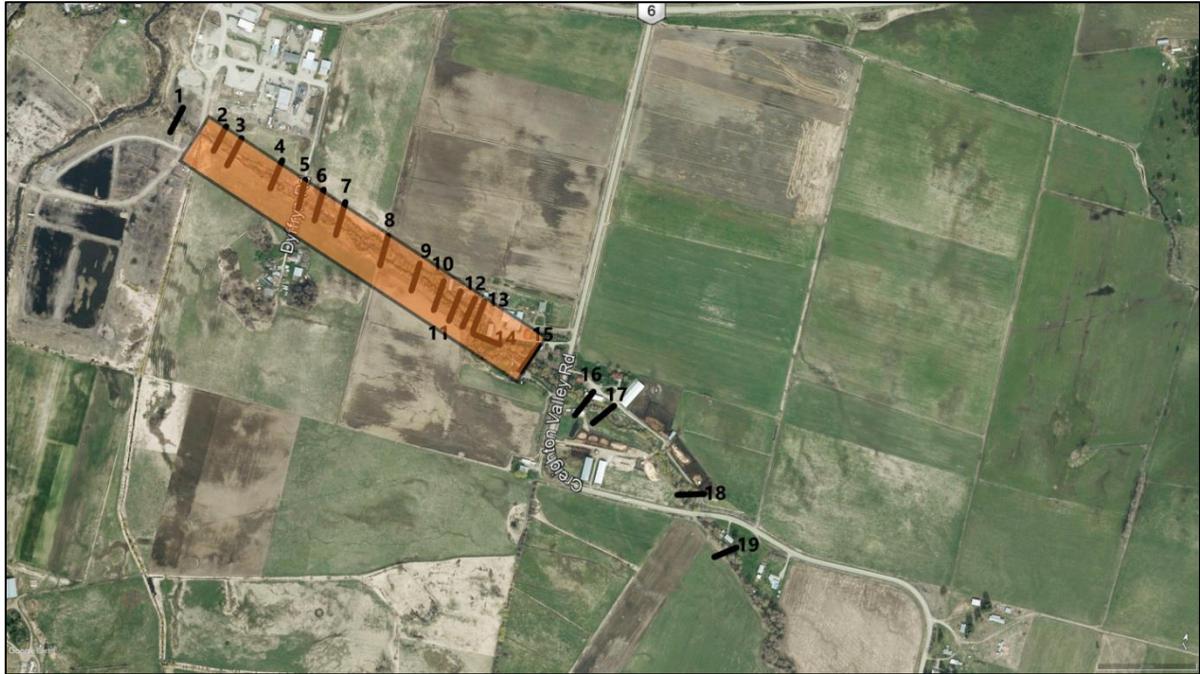
**Figure 3. Location of the 2004 Lower Creighton Creek Restoration Project. Image: Google Earth ©, 2020 CNES / Airbus, Regional District of the North Okanagan.**

In 2003, landowners and consultants observed an increase instream flow in the dredged areas previously containing only dewatered isolated pools. As a response to landowner concerns, consultants prepared the *Restoration Plan for Lower Creighton Creek* (Minor & Hesketh, 2003) outlining detailed stream restoration practices to remove gravels and implement features that would increase the transport capacity. In 2004, the proposed changes were implemented (Figure 3) T. Minor (personal communication, October 2016).

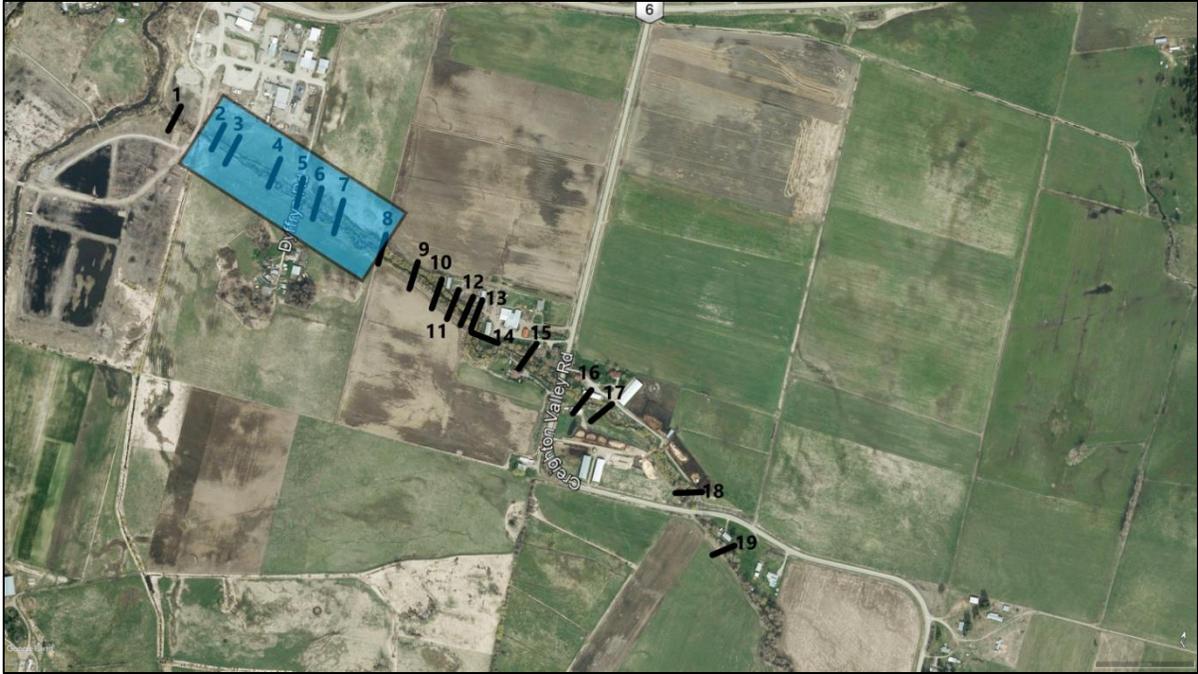
**Figure 4. Location of the 2010 Lower Creighton Creek Restoration Project. Image: Google Earth ©, 2020 CNES / Airbus, Regional District of the North Okanagan.**

A second restoration project was undertaken in 2010 using the same methods as in 2004, but farther downstream, approximately 90 m to 530 m upstream of the Bessette-Creighton Creek confluence (Figure 4). This project included the installation of large woody debris and, most notably, side drainage channels on the left and right banks to accommodate flooding.

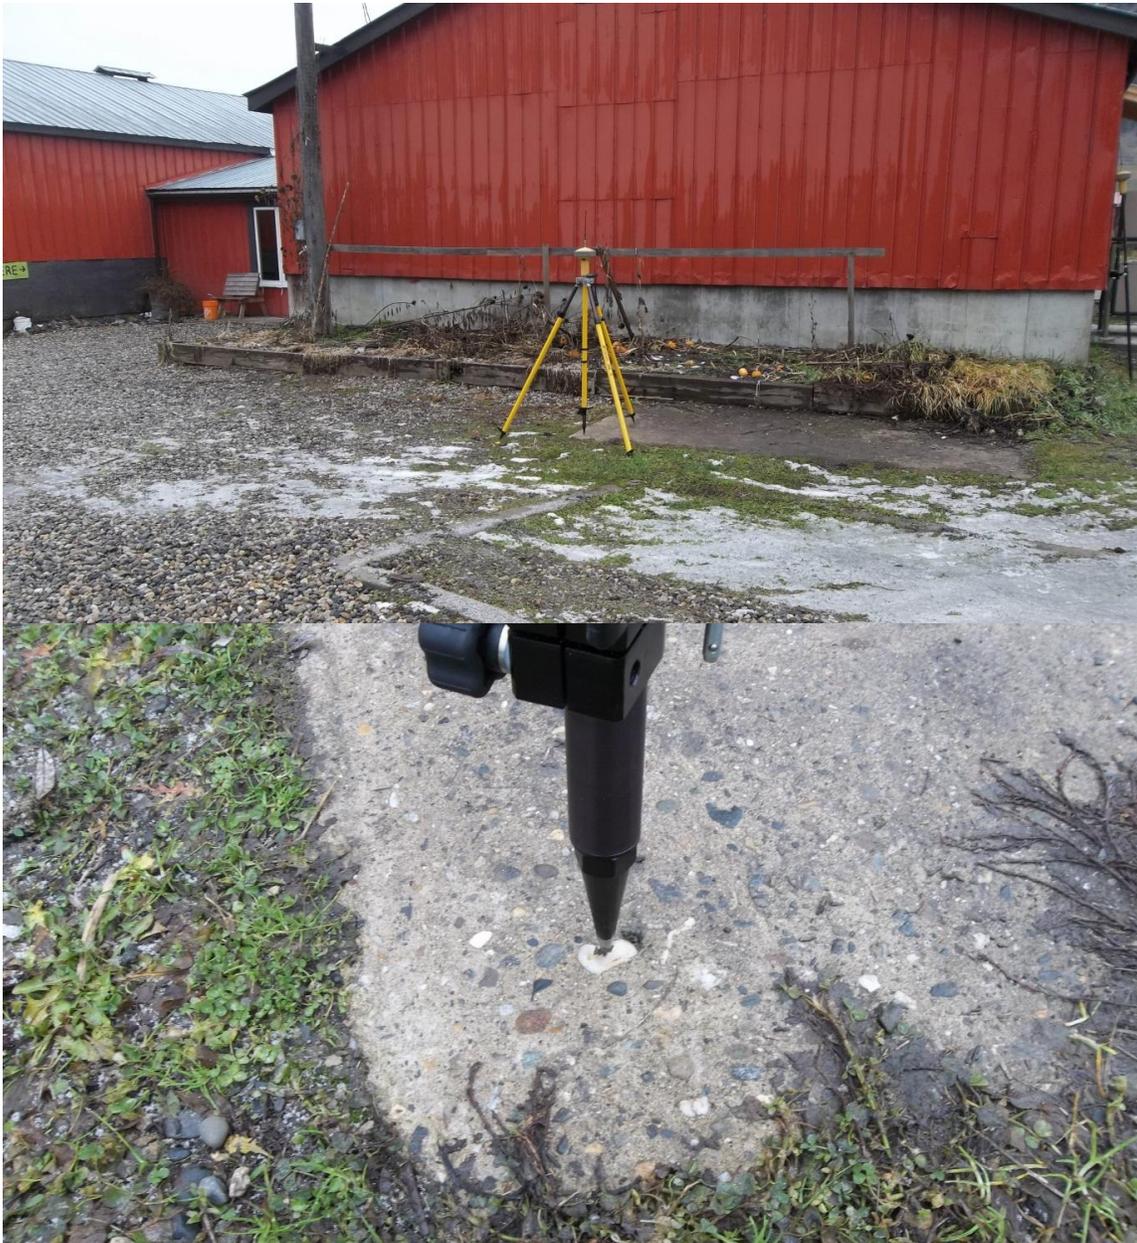
**Photograph 2. The Topcon RTK-DGPS base station set up and the quartz pebble benchmark December 12, 2015 (Photograph: B. Bauer).**

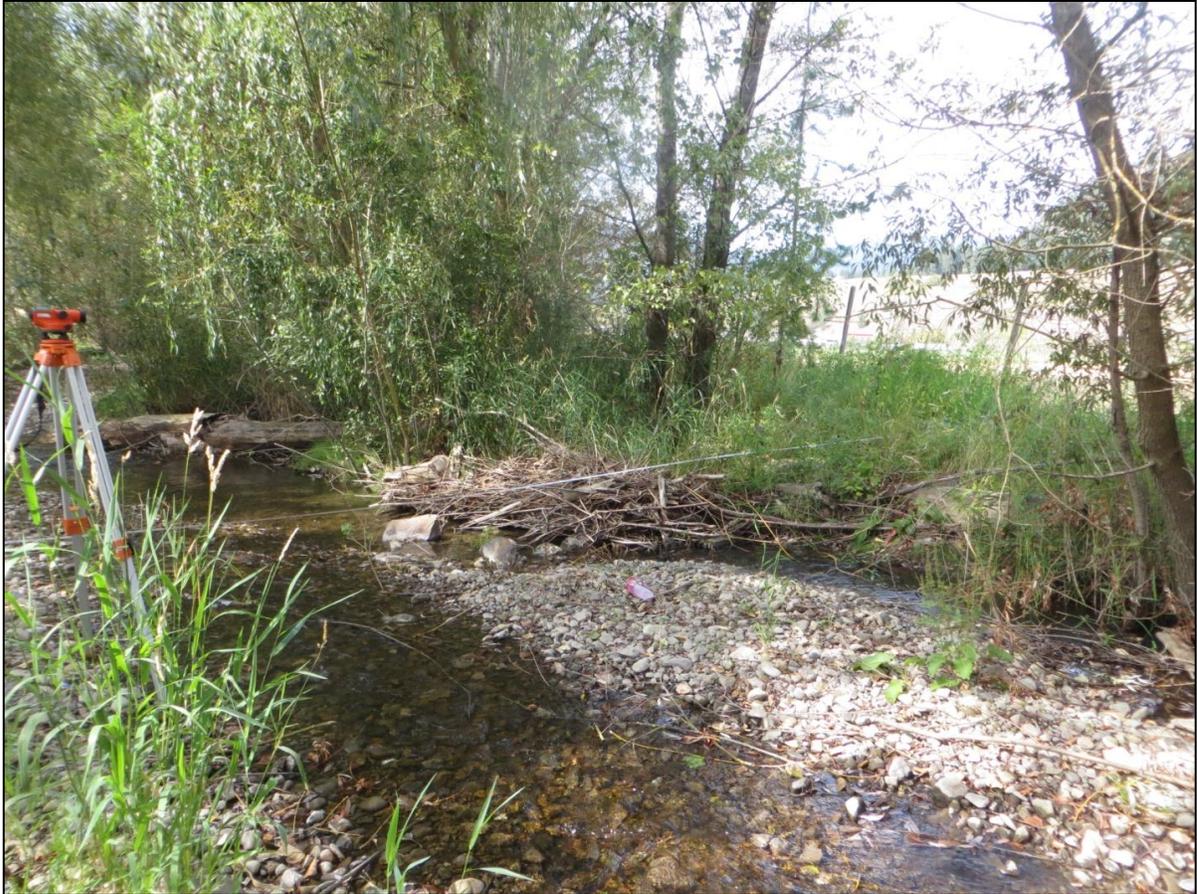
**Photograph 3. Surveying August 30, 2016 using an engineer's level and stadia rod at cross-section 9 (Photograph: L. Hettrich).**

Topographical surveys were taken at each cross-section using an engineer's level tripod, tape measure, and fibreglass stadia rod, following standard surveying protocols (Photograph 3) (Harrelson et al. 1994). The accuracy of this technique is judged to be within  $\pm 0.01$  m. At each sampling point across the channel, height and distance were recorded along with information on substrate material and geomorphic features (e.g., bars, riffles, woody debris). Sample points were not taken at a set interval, but based on their geomorphic significance and the potential to characterize cross-section geometry accurately.

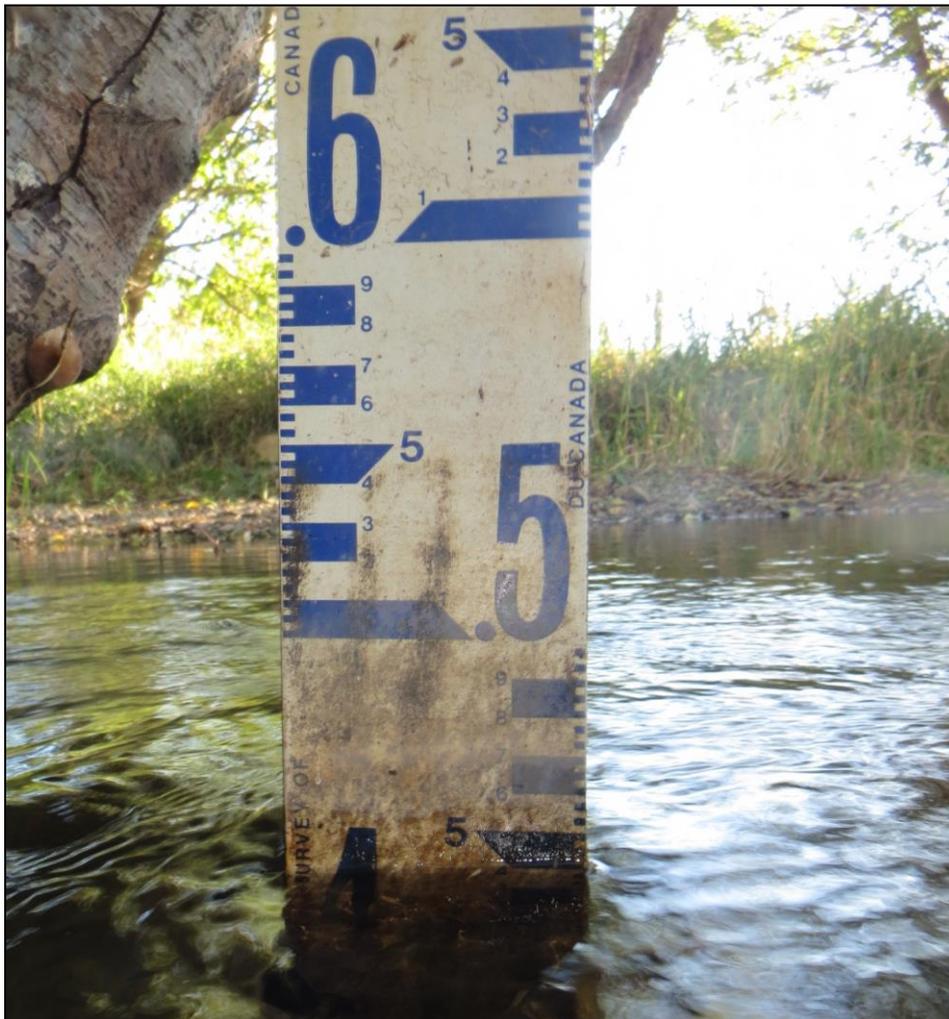
**Photograph 4.** FLNRORD staff gauge located at Creighton Creek, identified as CRE2 (Photograph: L. Hettrich).

Stage was also measured at a staff gauge located at  $50^{\circ}14'45.42''$  N and  $118^{\circ}57'15.03''$  W directly upstream of cross-section 2 (Photograph 4). These stage measurements facilitated the development of a discharge-rating curve, relating discharge (**Q**) to stage height.
