# **The Burns Bog Lagg Zone: An Assessment of Hydrological and Biological Indicators in the Bog**

Hannah Avenant  
Cyra Canonizado  
Robert Jacobson  
Kevin Matsuo

26/04/17  
ENVR 400  
Sara Harris

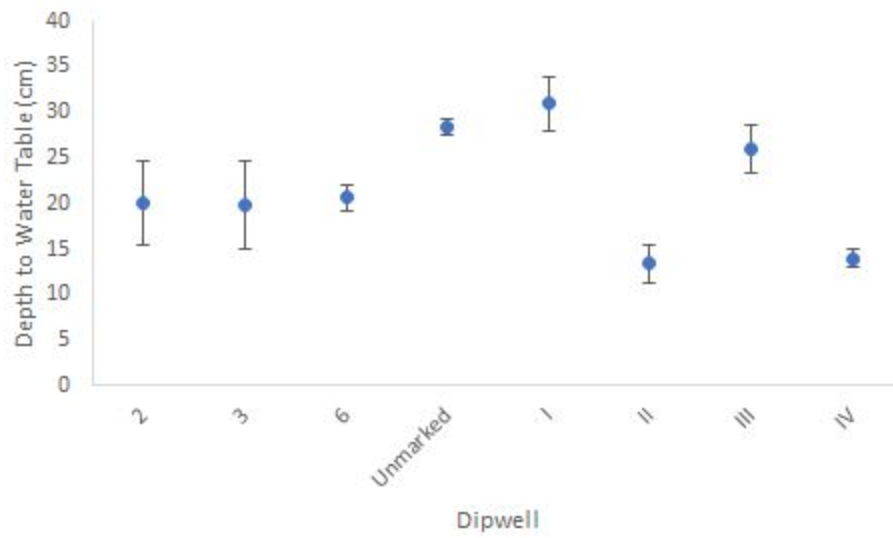
**Figure 8.** Mean depth to water table at various dipwells spread throughout the Delta Nature Reserve. N=4 for each group (except Unmarked, for which N=3). Error bars indicate standard error.

A Welch's ANOVA (Table 2) revealed that depth to water table, pH, and electrical conductivity all varied significantly between dipwells ( $P=0.0072$ ,  $0.034$ ,  $0.00024$  respectively). For depth to water table, the dipwells in the north-west did not differ from any of the other dipwells, but several of the other dipwells differed from one another, though spatial groupings cannot be made (Figure 8). Dipwell I differed from dipwells in the north-west corner and some

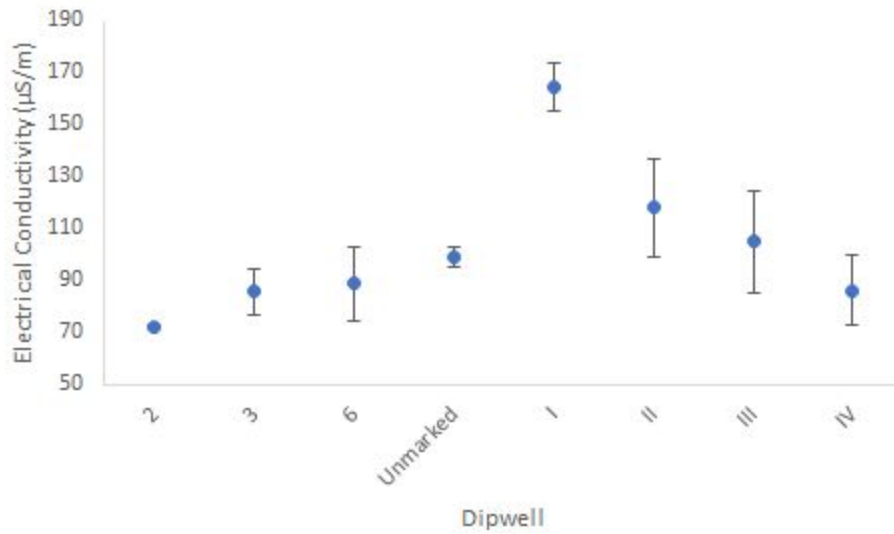
**Figure 10.** Mean electrical conductivity at various dipwells spread throughout the Delta Nature Reserve. N=4 for each group. Error bars indicate standard error.

of the other western dipwells, having a much higher electrical conductivity (Figure 9). Dipwell I also had a lower pH on average than most of the other dipwells, which usually did not differ from one another (Figure 10).

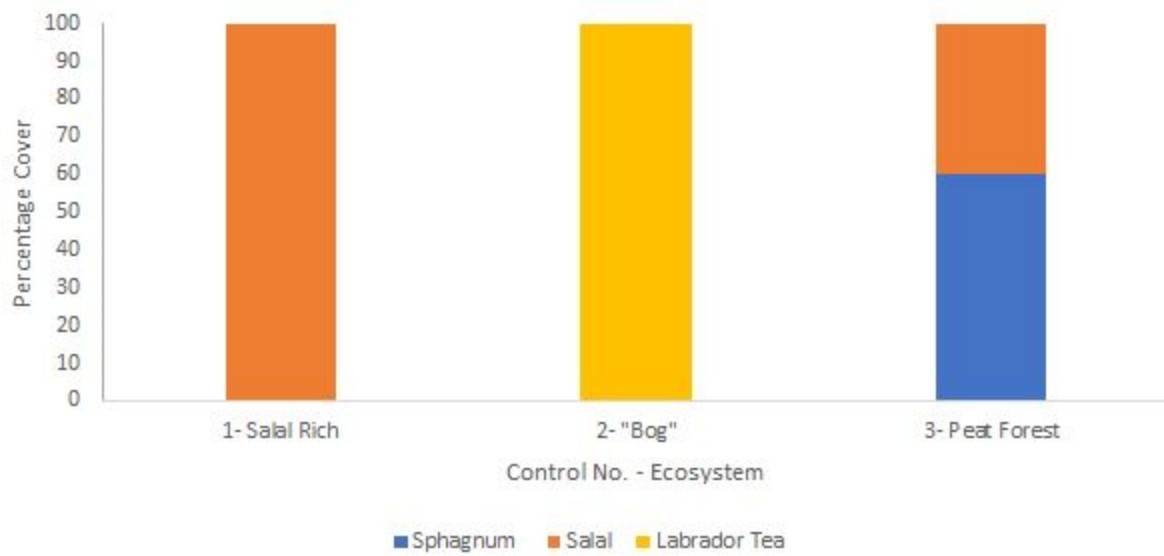
**Figure 12.** Species composition at 8 meters from the boardwalk of the 3 control groups, representing the 3 distinct ecosystems.

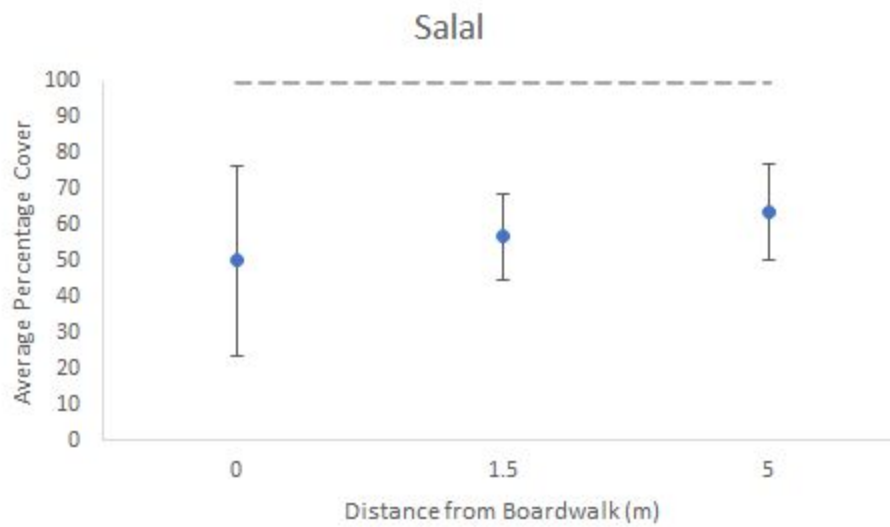
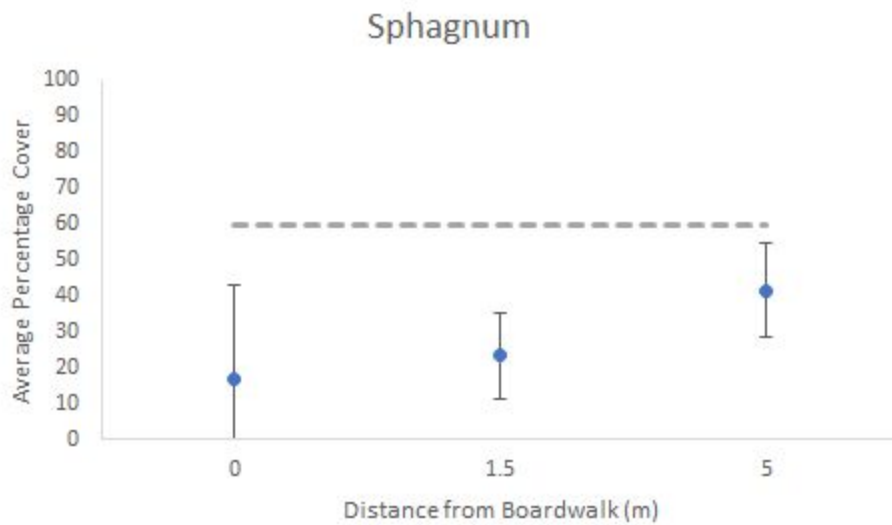
**Figure 13.** Average percentage cover with increasing distance from boardwalk in the three distinct ecosystems: a) Salal - Salal-rich b) Labrador Tea - “Bog” c) Sphagnum - Peat Forest. Error bars represent standard error of the mean (N=3). Dotted line represents the value seen 8 m away from the boardwalk. Species representative of each ecosystem were chosen based on the dominant species in each control.

Selected species of each distinct ecosystem (Figure 13) show a weak pattern of increasing average percentage cover with distance from boardwalk. There is no statistical difference between the different distances from the boardwalk as suggested by standard error. However, there is a significant difference between the three distances from the boardwalk and their respective control (Figure 13). Similarly, there is also no statistical difference between distances from boardwalk for Simpson’s Diversity index (Figure 14). A Simpson’s Diversity Index of 1 suggest no diversity.

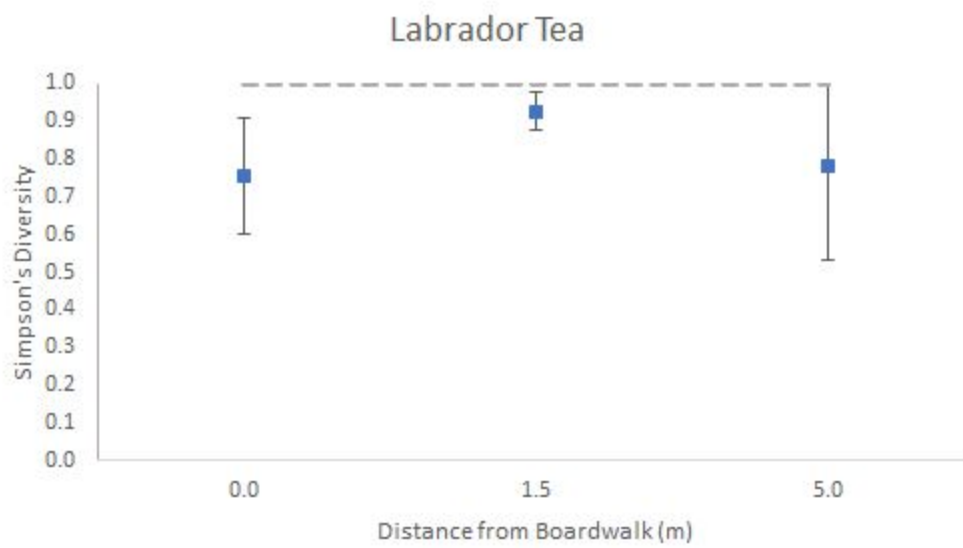
**Figure 14.** Simpson's Diversity indices of different distances from boardwalk of the three ecosystem in the three distinct ecosystems: a) Salal - Salal-rich b) Labrador Tea - "Bog" c) Sphagnum - Peat Forest. Error bars represent standard error of the mean (N=3). Dotted line represents the value seen 8 m away from the boardwalk.

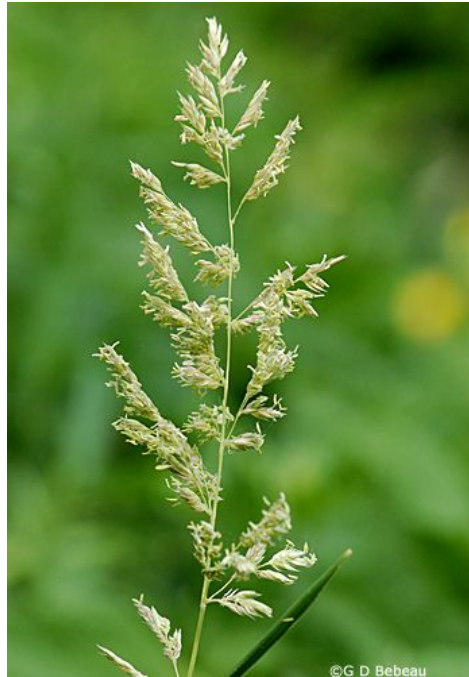
**Figure 16.** Reed canary grass in seed. Picture retrieved from:  
<http://www.friendsofthewildflowergarden.org/pages/plants/reedcanarygrass.html>

Along the Northeast side of the Delta Nature Reserve runs a North-flowing man-made stream that drains the residential neighbourhoods above it. This stream, though originally excavated as a method of drainage, has become a salmon-bearing stream and supports a small ecosystem. However, because of human disturbances, invasive species have spread along its banks in close proximity to the fragile ecosystem of the bog within the Reserve. One in particular, *Phalaris arundinacea*, or reed canary grass, has the ability and tendency to form dense, monotypic stands in areas it has colonized (Bahm *et al.*, 2014). Reed canary grass is a perennial, and can reproduce both sexually through seeds and asexually through vegetative rhizome growth (Canadian Wildlife Service, 1999). Reed canary grass, once established, has been shown to be extremely difficult to eradicate, and because of the sensitivity of the surrounding ecosystem, removal methods must be effective yet minimally toxic. The above-ground biomass, rhizomes, and seed bank must be targeted for complete, long-term eradication (Gillespie and Murn, 1992).

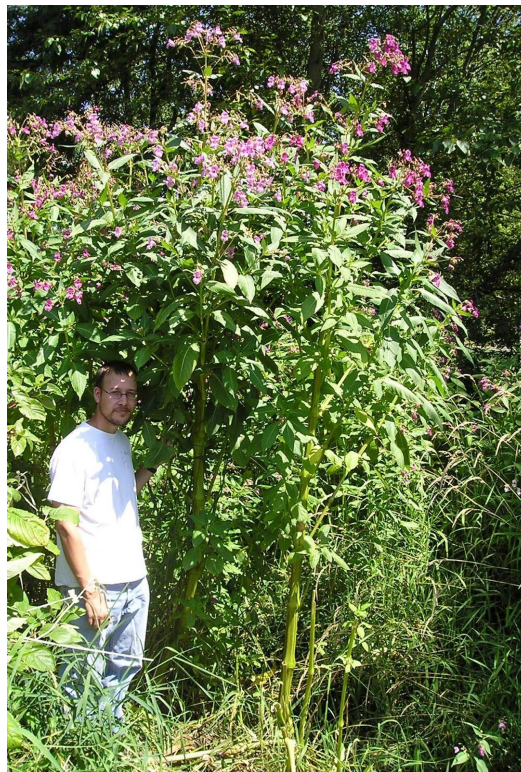
**Figure 16.** Policeman's helmet in bloom. Picture retrieved from:

typically found in riparian habitats, and prefers moist soils and partially shaded to sunny environments (KCNWCP, 2010). The plant grows to a height of between 3-8 feet, and has pink or purple flowers that resemble a policeman's helmet (Clements *et al.*, 2008). Seeds are dispersed explosively from parent plants, and can remain viable for up to 18 months as they are dispersed along adjacent waterways. The negative impacts of Policeman's helmet are plentiful - the large plant tends to shade out native species, compete for pollinators such as bees, and cause stream bank erosion after it dies out in the fall (Kelly *et al.*, 2008). Stands of Policeman's helmet have been observed in the Delta Nature Reserve.
