# Life-cycle System Performance of Bridges: a Robustness-based Approach

**ABSTRACT:** Corrosion in reinforced concrete and steel structures is among the most damaging phenomena to structural safety and therefore one of the most demanding when facing the life-cycle analysis of such structures. However, the onset and progression of corrosion is highly uncertain. Because damage due to corrosion appears due to environmental aggressive agents which progress on time, it is of interest to develop suitable life-cycle measures of structural robustness with respect to a progressive deterioration of the structural system performance. In this paper, a robustness-based approach as presented in Cavaco et al. (2013) is used to quantify the effect of corrosion on safety and life-cycle maintenance. The level of corrosion is considered as an uncertain parameter. In this way, a probabilistic measure of the robustness, seen as the tolerance to damage, can provide a comprehensive description of the life-cycle system performance. Therefore, a robustness definition and the calculation of the corresponding robustness index are proposed in the paper and further applied to one reinforced concrete and one s

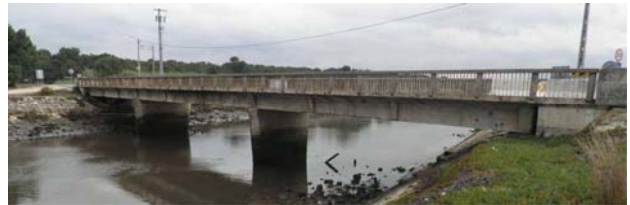
Figure 1: Lateral view of Tercenas Bridge.

Tercenas Bridge (see Figure 1) was built in Portugal in 1968 in Leiria district, providing access to Vieira beach. Due to its sea proximity, very earlier, the bridge started presenting signs of deterioration due to corrosion. These signs were aggravating year after year leading to the bridge demolition and substitution in 2012. Decision about bridge demolition was taken based mainly on its current condition in 2012 and concerns about the existing safety levels at the moment, neglecting the bridge robustness and its ability to tolerate corrosion. A significant investment was made in a new bridge, leaving less available funds to repair the remaining structures of the district.

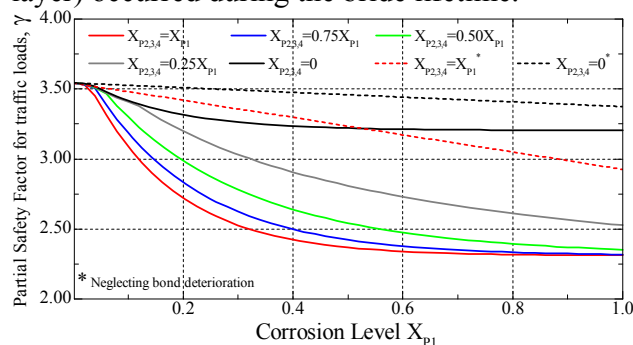
keeping dead load constant, until maximum load carrying capacity of the bridge deck was achieved. Figure 4 shows the maximum partial safety factor applied to the traffic loads as a function of normalized corrosion on girder 1 for the 5 different corrosion scenarios. Maximum normalized corrosion respect to 50% weight loss of steel bars (on the most external reinforcement layer) occurred during the bride lifetime.

Figure 4. Safety factor for traffic loads as a function of the corrosion level on beam 1.

For the intact and uncorroded structure, the maximum safety factor resulted in 3.54, a relatively high value attending to the fact that the bridge was designed considering much lighter traffic loads, however obtained considering mean values for the material properties and for dead loads. For the worst case scenario, where corrosion was considered equal in all girders ( $X_{p2,3,4}=1.00 X_{p1}$ ), the safety factor for traffic loads decreases at a higher rate for corrosion levels up to 30%, mainly due to bond reduction as observed in Figure 4 by comparing with results obtained for identical corrosion scenario but neglecting bond deterioration. From this stage onward, safety factor reduction was almost residual, as reinforcement was mainly disconnected from concrete, decreasing to a minimum value equal to 2.30. As shown in Figure 4, considering less corrosion on girders 2 to 4, resulted in less safety reduction due to the redundant behavior of the bridge deck, mainly provided by the cross beams and top slab, which allow load redistribution from more corroded and heavier loaded girder 1 to remaining girders. For the hypothetical scenario of corrosion affecting

only girder 1 ( $X_{p2,3,4}=0.00X_{p1}$ ), traffic loads safety factor reduction is minimal, from 3.54 to 3.20. Robustness assessment resulting from the normalized area bellow each curve in Figure 4 is summarized in Table 1:

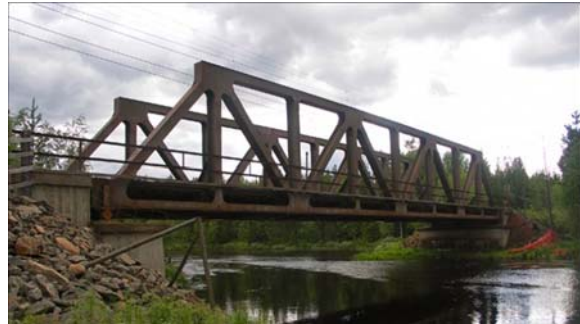
Aby Bridge is a simply supported steel truss structure with a span-length of 33 m (Figure 5). The bridge is of the through type with two main longitudinal trusses connected by transverse beams at the floor level. Since it was built in 1951, it was designed according to the present trainloads type F46 which corresponds to 25 tons axle load which also is the present load on the railway. According to the design specification, the steel quality is of types S1311 for the stringer beams, verticals and diagonals and S1411 for the main truss and cross girders (Swedish specifications). The yielding strength is 240 and 270 MPa and the ultimate strength 360 and 430 MPa respectively. The bridge had to be removed and for this reason a test to failure was carried out. After the bridge was taken out of service it was put on temporary supports close to the tracks where the sensors were mounted. The force on the bridge was induced by two jacks where the jack is attached to a girder that distributes the load to four equally distributed point loads. In order to be able to archive the force needed to load the bridge to failure the jacks needed to be attached to solid rock.

Figure 5: Lateral view of Aby Bridge.

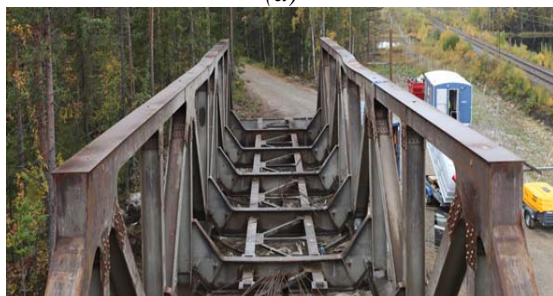
Also the case of generalized corrosion in all elements (CGEN) is presented. As expected, the most sensitive member to corrosion is the upper chord, as the failure is due to buckling of this compressed element at mid-span (see Figure 9 and 10).

Figure 10: The global failure mode, buckling of the top frame in the truss: (a) numerical results vs. (b) experimental results.
