# **SOIL BIOENGINEERING FOR CONTROL OF SOIL EROSION IN A RE-CONSTRUCTED WATERWAY ON AN ALBERTA OIL SANDS OVERBURDEN DUMP**

Pierre Raymond, Site Rehabilitation Specialist,  
President

Terra Erosion Control Ltd.  
2304 Silver King Rd.  
Nelson, BC, V1L 1C9  
[www.terraerosion.com](http://www.terraerosion.com)

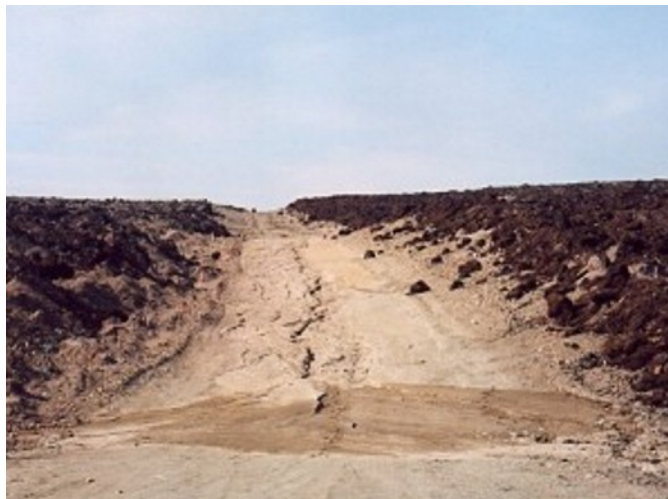
The constructed swale has an average gradient of 7% (4°) and is approximately 600 m long (see figure 1). It is composed of two minor lateral swales connecting onto the main swale. The substrate consists of muskeg placed over clay capping and oil-sands tailings.

**Figure 1. Prior to treatment 2004.**

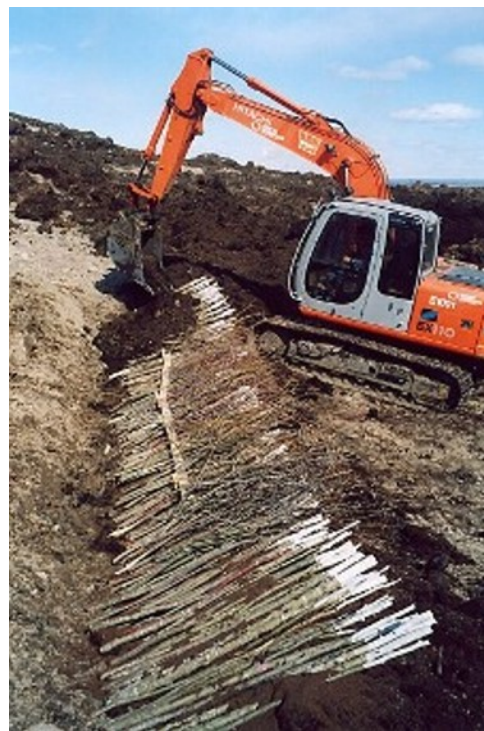
**Figure 3. Brush Sill Installation 2004.**

- Twenty nine brush sills installed across the swale (see figure 3).
- Smaller diameter cuttings installed in the middle of each sill to improve water dispersion.
- Contour fascines installed across the swale in two locations above the brush sills as a trial (see figure 2).
- An upstream wetland was created as a result of seeds germinating from within the seed bank of the applied muskeg; the area was also planted with long live stakes.
- The swale was fertilized and broadcast seeded with a nurse crop of barley.

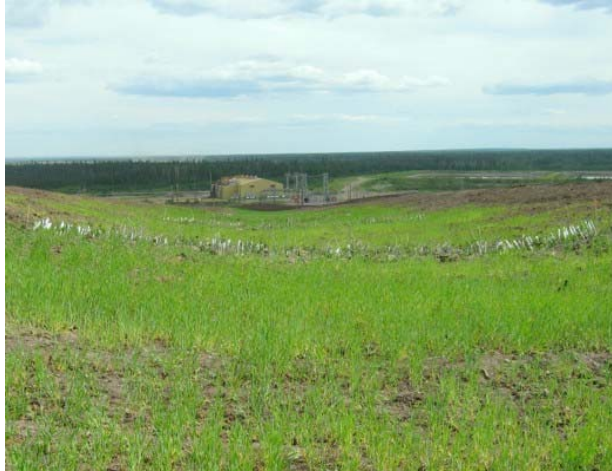
The site was monitored in 2004 and survival of brush sill cuttings was estimated at approximately 70%, with shoot growth averaging 60 cm (see figures 4 and 5).

**Figure 4. August 2004.**

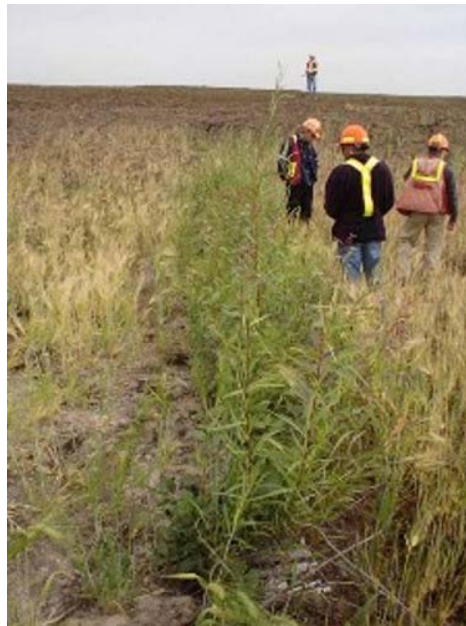
**Figure 5. August 2004.**

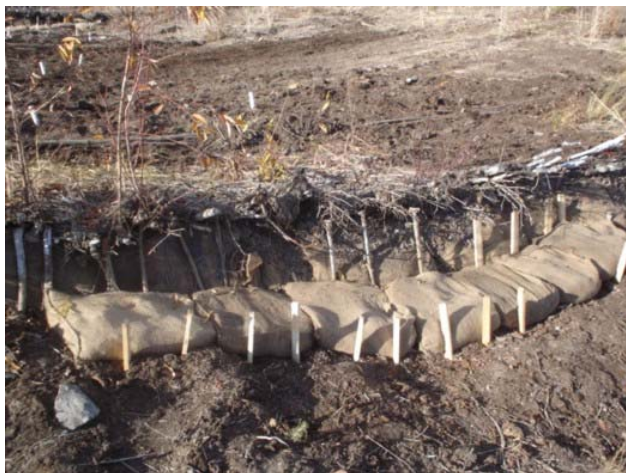
**Figure 6. Muskeg Filled Burlap Sacks, October 2005.**

- Replacement of brush sill sections where mortality occurred.
- Addition of contour fascines above all existing brush sills.
- Live staking in the centre of the swale.
- Installation of muskeg and seed-filled burlap sacks to fill in eroded areas (see figure 6).
- Application of additional soil amendments and broadcast seeding with a native grass mix.

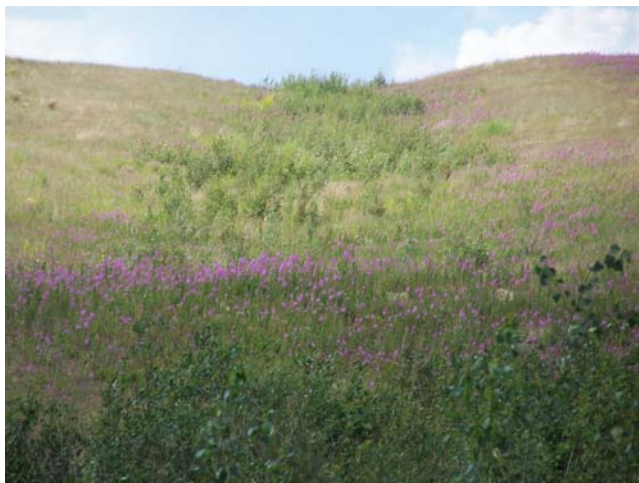
Minor maintenance work was also required after the spring 2006 snowmelt. Condition of the swale and created wetland was monitored in 2007 and 2009 and assessed as good to excellent (see figures 7, 8 and 9).

**Figure 7. July 2007.**

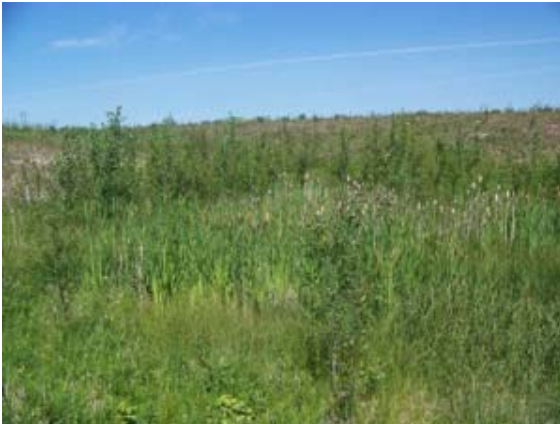
**Figure 8. Created wetland, (note *Salix exigua* and *Populus balsamifera* surrounding established aquatic species), July 2009.**

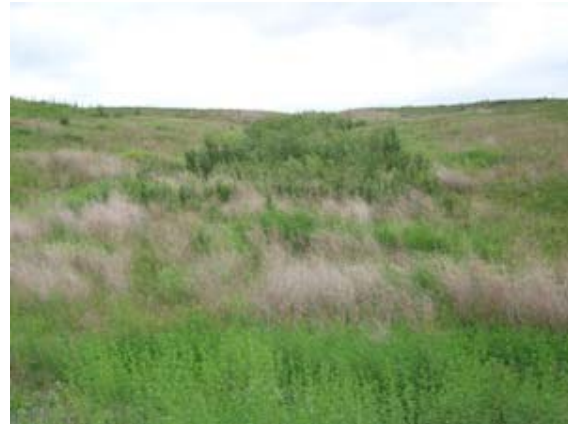
**Figure 9. Alpha Swale, July 2009.**

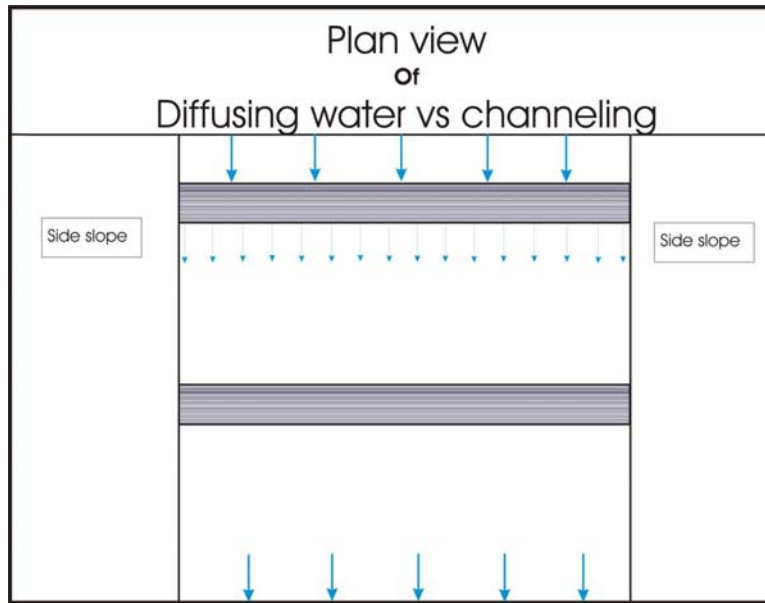
Brush sills result in channel erosion. When combined with accumulated organic debris these results in falling water (hydraulic jump) and the creation of splash erosion (see figures 10 and 11). The use of contour fascines, without brush sills, appears to be diffusing water instead of creating channels and splash erosion (see figures 12 and 13).

**Figure 13. Diffusion of water flow vs. channeling.**

Based on these findings, trial sites, using large diameter (30 cm) contour fascines, were established in the spring of 2010 over two newly constructed swales (waterways) within an overburden mine dump.
