# AN EVALUATION OF FACTORS INFLUENCING SPONTANEOUS VEGETATION SUCCESSION IN NORTHERN LATITUDE DISTURBANCES: ASSESSMENT OF NATURAL RECOLONIZATION OF DISTURBANCES IN YUKON

D. Lister, P.Eng.

Altura Environmental Consulting PO Box 2004 Marsh Lake, Y.T. Y0B 1Y2

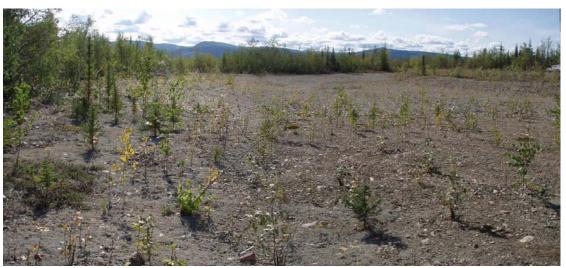
Figure 1. Sparse recolonization at site KV-07, an approximately 50-year old decommissioned borrow pit located in central Yukon. At the clearing centre, all growth is less than 2m high with less than 5 percent cover. The primary filter to natural recolonization at this site appears to be low moisture availability as influenced by: i) low precipitation (325mm annually), ii) a low proportion of silt to clay-sized particles (7 percent), iii) location at least 10m above local water table, and iv) pebble 'armouring' of the smooth surface.

The various aspects of moisture availability filters are best illustrated through examples from some of the sites. Figures 1 and 2 show two sites within 14 km of each other in the Klondike valley area of central Yukon. Although the disturbances differ in age by almost 40 years, the younger disturbance shows areas of abundant natural recolonization which appear to be largely due to slope aspect and a higher proportion of silt to clay-sized particles in the substrate.

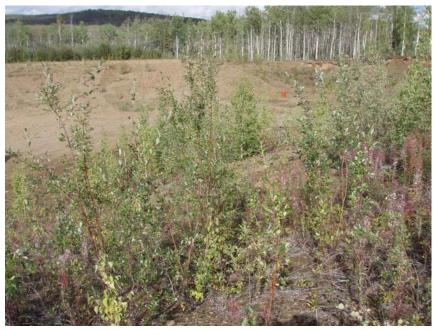
Figure 2. Abundant natural recolonization on a gentle north-facing slope at site KV-03, a decommissioned borrow pit (13 years previous) near the closed Brewery Creek Mine. This site is approximately 14 km from and 120m higher than site KV-07 shown in Figure 1, and has similar precipitation. However, the substrate at this site is relatively high in silt to clay-sized particles (estimated at greater than 20 percent), and the north-facing aspect serves to enhance moisture availability. On the other hand, the south-facing and flat sectors in the background show much lower natural colonization.

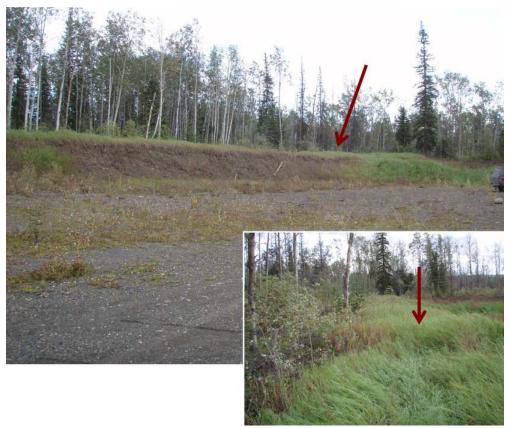
Figure 3. Site KV-04, central Yukon, seeded in 1998. Along the clearing edge (arrows in main and inset photos), a thick cover of seeded smooth brome (<u>Bromus inermis</u>) is impeding natural encroachment of the surrounding tree and shrub species.

On a qualitative level, it could be seen that at some seeded sites, certain of the initial seeded cover species were still the dominant species some 10 to 20 years following seeding, and in some cases, that the seeded species were impeding the expected natural colonization. This was particularly evident where brome species (*Bromus spp.*) were included in the original seed mix and where the original seed application had taken well. One example is shown in Figure 3, a small borrow pit seeded in 1998. At this location smooth brome (*Bromus inermis*) became well- established along the clearing edge, a location where typically one would see the most rapid recolonization by local deciduous trees and shrubs. As a result, a thick grass fringe with very sparse colonization by trembling aspen and willow (*Populus tremoloides* and *Salix spp.*) has instead developed. Some sites with a heavy seeded cover also showed a heavy thatch development of dead material. While this thatch appeared to impede colonization of native forbs as well as shrubs and trees, it did serve to foster development of certain moss and lichen species in the moist environment at the underlying soil level.

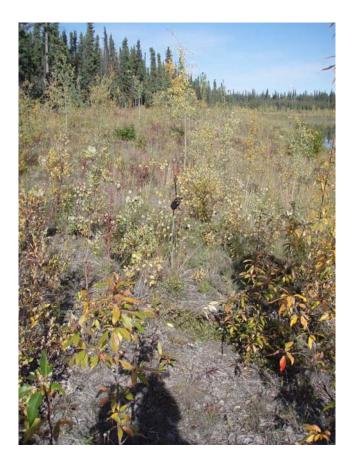
Figure 4. Site KL 02 in the Beaver Creek region of central-west Yukon, with integration of both seeded cover and spontaneous revegetation growth. This site receives just over 400mm of precipitation annually, approximately 25 percent greater than many sites in central and south-central Yukon.

Some seeded sites show good balance between seeded and naturally colonizing species, such as is observed at site KL-02 in the Beaver Creek region of central-west Yukon (Figure 4). This site was decommissioned and seeded in the late 1990's, and has formed a moderate to sparse cover of grass and legumes (no brome species evident) that does not appear to impede the colonization of native species.

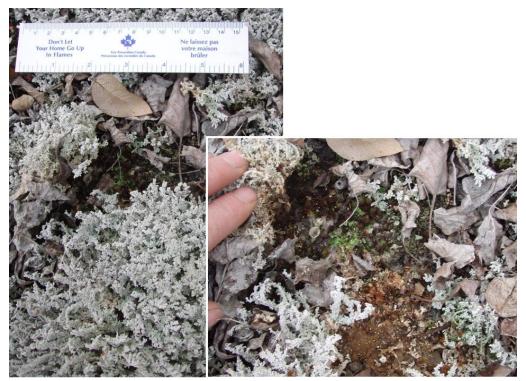
Figure 5. Stereocaulon sp. lichen colonization (left) and underlying moss and lichen community (right) at site KV-06, central Yukon.

The *Stereocaulon* species was observed at several sites (KV-06, KV-07, KV-08, other un-documented sites along the North Klondike Highway, and at HR-01 on the Haines Highway). Closer examination of one of these zones at site KV-06 is shown in Figure 5 and reveals the development of a diverse moss and lichen community under the cover of the *Stereocaulon* lichen.
