DECOMMISSIONING AND REMEDIATION OF THE PINCHI LAKE MINE

B. Donald, P.Eng.¹, M. Unger, B.Sc.¹, Rob Marsland, P.Eng.²

ABSTRACT

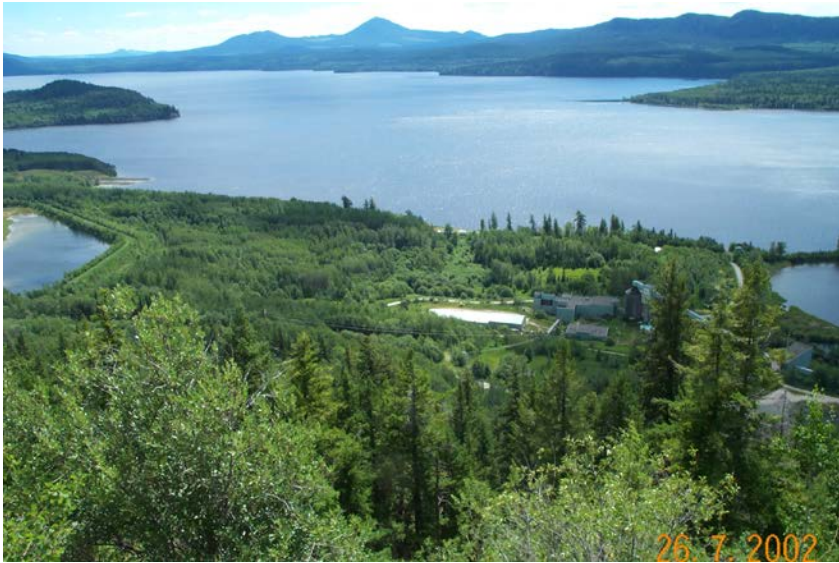
Figure 1 –
Pinchi Lake Mill Site

from this process were deposited underground for backfill purposes and the finer fractions were deposited into an impermeable tailings impoundment area (TIA). The modern plant operated from 1968 to 1975 (Figure 1), at which time the facility closed due to declining mercury prices. As mineral reserves remained, the processing plant was placed under care and maintenance and remained intact until permanent decommissioning began in 2010. The 1940s processing practices occurred before the

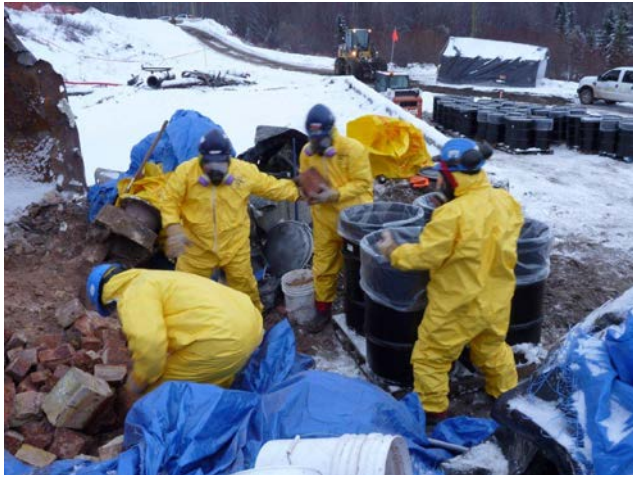
There was an elaborate procedure to dismantle the roaster after the building had been removed from around it. The roaster was contained before being laid on its side, cut open, and manually emptied of its contents (Figure 2) to minimize spreading of contaminants. This occurred in mid to late December so it was conducted under winter temperature conditions. Demolition of the facilities was essentially completed by December 23rd 2010 with final cleanup of demolition debris occurring in January 2011. During the demolition process there were no loss time accidents and no workers had unacceptable mercury exposures as monitored through the urine tests.

Figure 2
Preparing roaster soot & brickwork
for off-site disposal

Another significant challenge was encountered when trying to dispose of the liquid mercury and other mercury contaminated debris responsibly in a manner acceptable to Teck’s Product Stewardship Committee. There was approximately 47,000 kg of mercury contaminated residues and debris that required off-site disposal. Much of this material was from the site’s mercury roaster and building. Recycling facilities and disposal locations for mercury within Canada are very limited. After carefully considering a number of options, the preferred option was to ship the materials to Clean Harbour’s facility in Quebec for recovery of the mercury from the residuals. The cleaned residues were stabilized and then landfilled at the Clean Harbour’s Lambton facility in Ontario. An environmental audit of the Clean Harbour’s facility was done prior to shipping the residues to them. The liquid mercury separated from the residues was shipped to the Bethlehem Apparatus Co. in the US where the mercury was further purified by roasting and then sold as a marketable product. Bethlehem sells their mercury to reputable manufacturing companies to produce mercury containing products such as fluorescent light bulbs. It was important to ensure that the mercury was not inadvertently getting into the black market, which is then commonly used to mine gold in developing countries. It took more than a year to verify the preferred disposal option, obtain adequate contractual documents, and to dispose of the residues.
