# **Oak Street Bridge Half Bent Test On As Built and Retrofitted Specimens**

A THESIS SUBMITTED IN PARTIAL FULFILLMENT OF  
THE REQUIREMENTS FOR THE DEGREE OF  
MASTER OF APPLIED SCIENCE

THE UNIVERSITY OF BRITISH COLUMBIA

June 1994

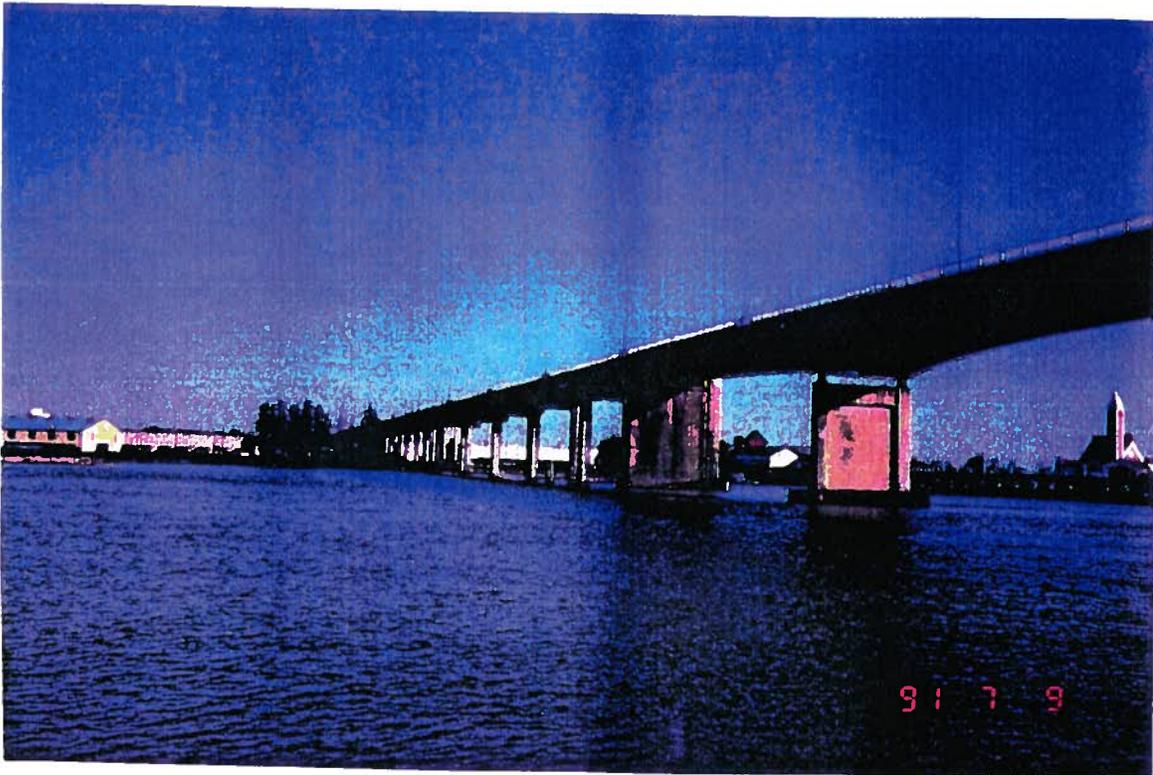
Figure 1.1 Photograph of the Oak St. Bridge

The approach spans consist of a series of four span continuous haunched concrete girders, supported on five concrete bents each with two columns. In the south approach, the 6.5" thick deck slab is supported on 5 reinforced concrete beams. These beams are supported on concrete bents having varying heights. The superstructure is continuous over five supports with expansion joints located at the end of the each four span section. Figures 1.1 and 1.2 show the elevation of the bridge and the general arrangement.

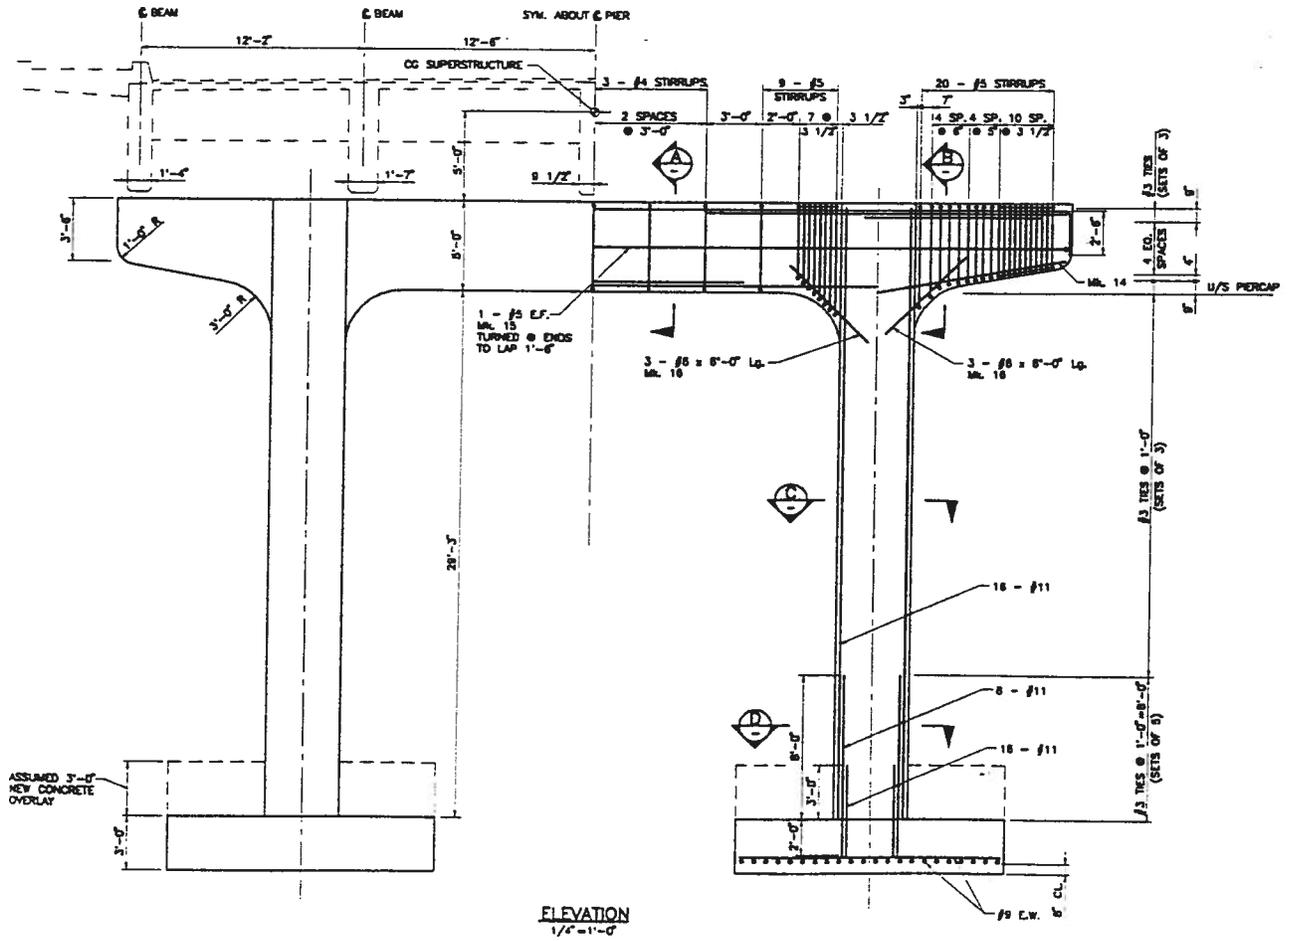
Figure 1.3 Bent S28-reinforcing details of prototype (Elevation)

The cap beam of bent S28 has a cross section of 3'6"x5' with two 8'6" long tapering cantilevers at the ends. Two 4'x4' reinforced concrete rectangular columns of length 32.2' provide support for the superstructure at bent S28. See Figs. 1.3 to 1.5, Bent S28 reinforcing details. The columns are supported on 14'6"x14'6"x3' foundations which are on 24 timber piles driven into sandy clay which is overlain on glacial till (Kennedy et al., 1992).

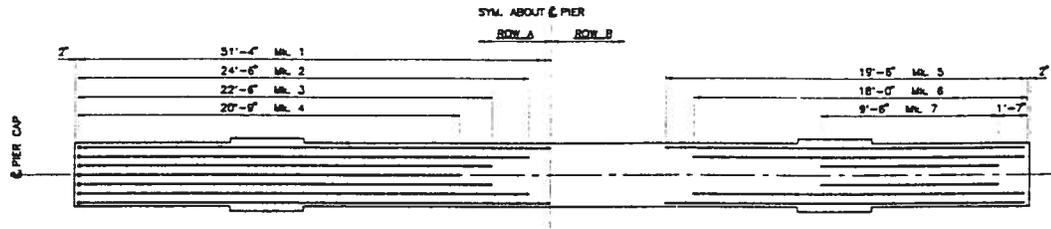
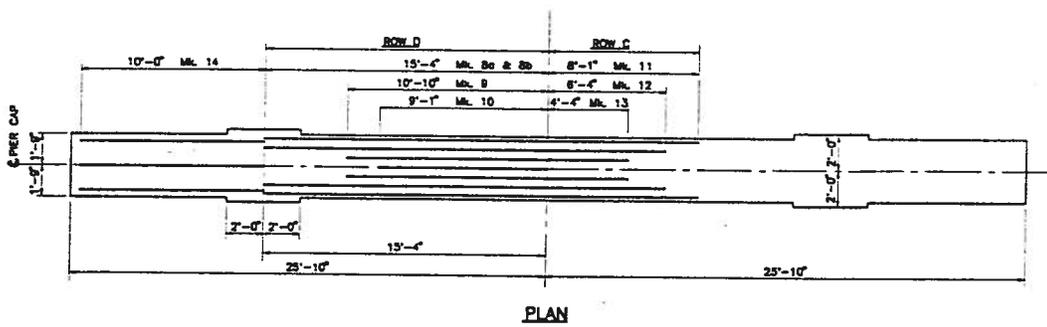
Cap beam showing top steel

Cap beam showing bottom steel

Fig. 1.4 Bent S28 reinforcing details of prototype (Plan)

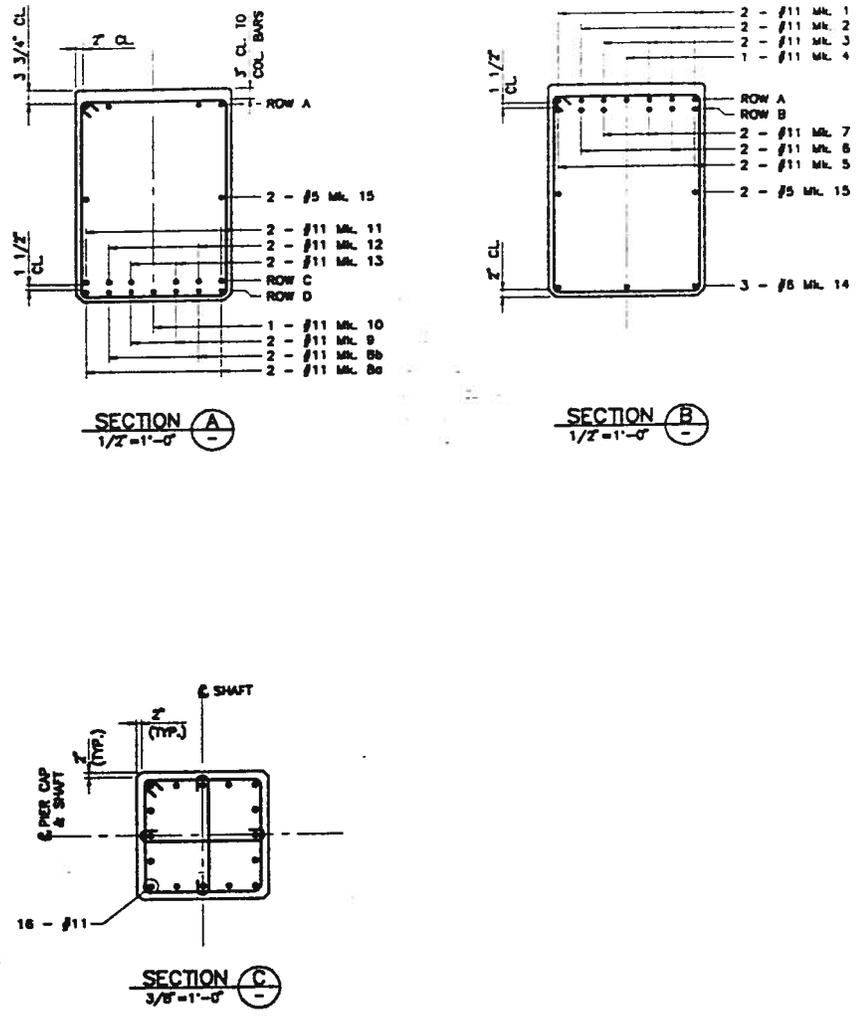
Fig. 1.5 Bent S28 reinforcing details prototype (Sections)

1. The shear capacity of the columns may be inadequate. These contain about 1% (Figure 1.5 ) longitudinal reinforcement but have only #3 ties at a spacing of 12" which is inadequate for these large columns. This insufficient shear reinforcement will result in the possibility of a brittle shear failure in the column and it will not allow energy absorption through flexural hinging which is the preferred method of seismic energy dissipation. Buckling of longitudinal bars and spalling of concrete is also common due to widely spaced tie reinforcement.

2. The cap beam also contains about 1% longitudinal steel at Sections A and B. (Figure 1.5) The shear reinforcement in Section A consists of #4 closed stirrups at a spacing of 3 feet. Due to inadequate shear capacity in the cap beam, brittle shear failure might occur in the cap beam due to lateral seismic loading.

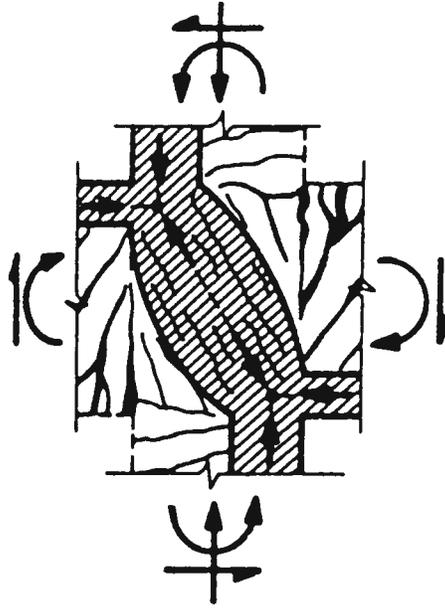
Fig. 1.6 Compression strut mechanism

During seismic loading the force transfer from the beam to the column through the joint can be modeled by truss action, consisting of concrete struts and tension ties formed by the transverse reinforcement steel within the joint, which is activated by the bond stress and anchorage (Priestley and Paulay, 1991). This truss mechanism (Fig. 1.7) is relatively soft, compared with the alternative direct compression strut (Fig. 1.6). The direct compression strut does not require reinforcement within the joint and therefore it does not rely on the bond characteristics. The strut, however, does have to be anchored at the joint boundaries. This is a stiff mechanism and when concrete damages load will transfer through the joint by the softer truss mechanism. In practice, the behaviour of the joint probably falls somewhere between these two mechanisms.

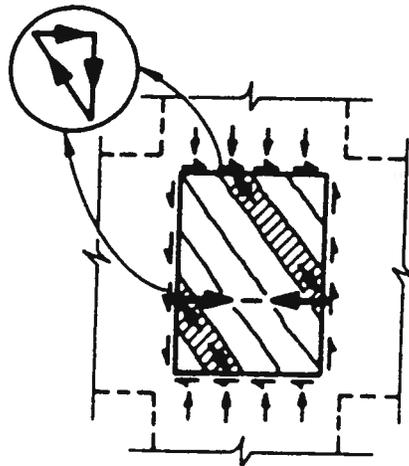
Fig. 1.7 Truss mechanism

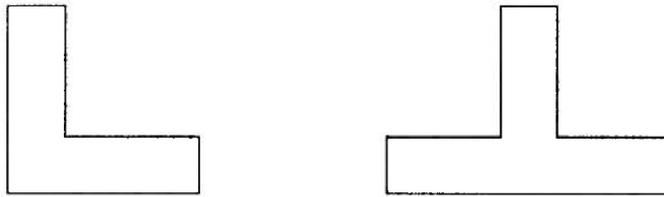
Fig. 2.1 Basic specimen configurations

The specimens can be tested either up side down or right way up depending on the requirements. The specimen configuration and the loading arrangement can be chosen to

model the loading and deformation in a real structure in side sway due to lateral earthquake loading. The vertical and horizontal jacks at the top will provide pinned connections at the tip of the column. The testing is confined to two dimensions as the interaction of the beams and columns are along the same frame.

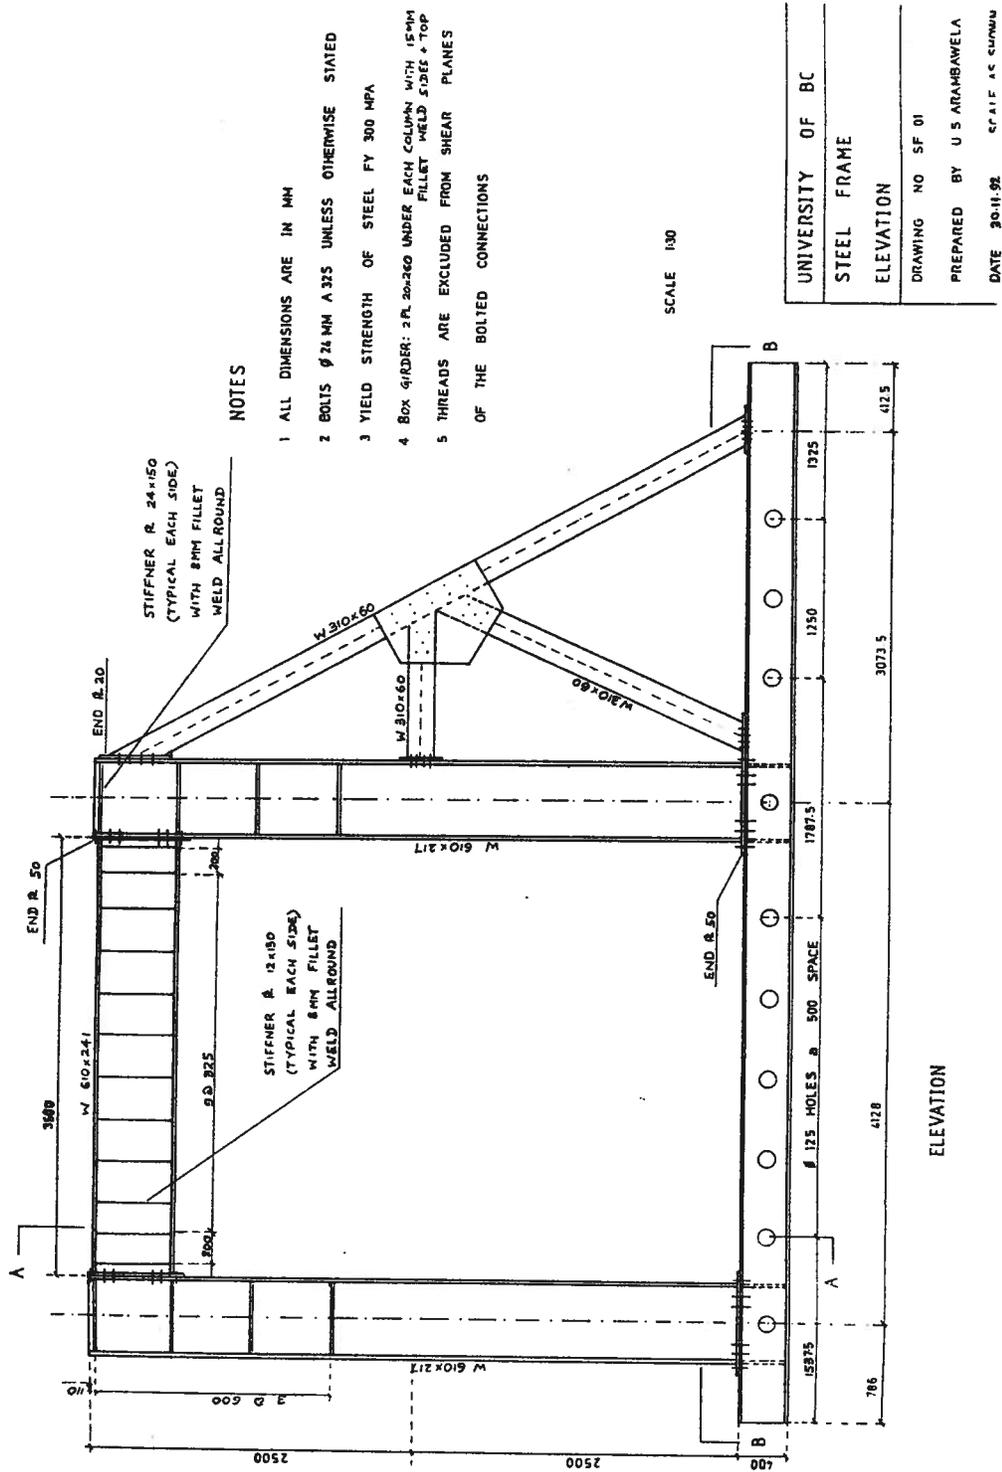
Figure 2.3 Construction drawing (Elevation)

Within the specimen configurations shown above a wide range of specimen sizes can be tested using this test setup. An elevation is shown in Fig. 2.3. The number, type (i.e. pin or roller) and the places of the boundary conditions at the bottom of the specimen can be changed so that the required loading can be obtained in the beam stub. The vertical and the lateral position of the load application on the column can be changed as described in Section 2.2. As two vertical jacks can be used at the column tip it is possible to obtain a required moment and the axial load at the column tip and therefore it is not necessary to have an inflection point at this location. The lateral jack can be used to apply the shear in the column. It is also possible to apply a vertical load directly on the beam stub if necessary (i.e. dead load on the beam stub).

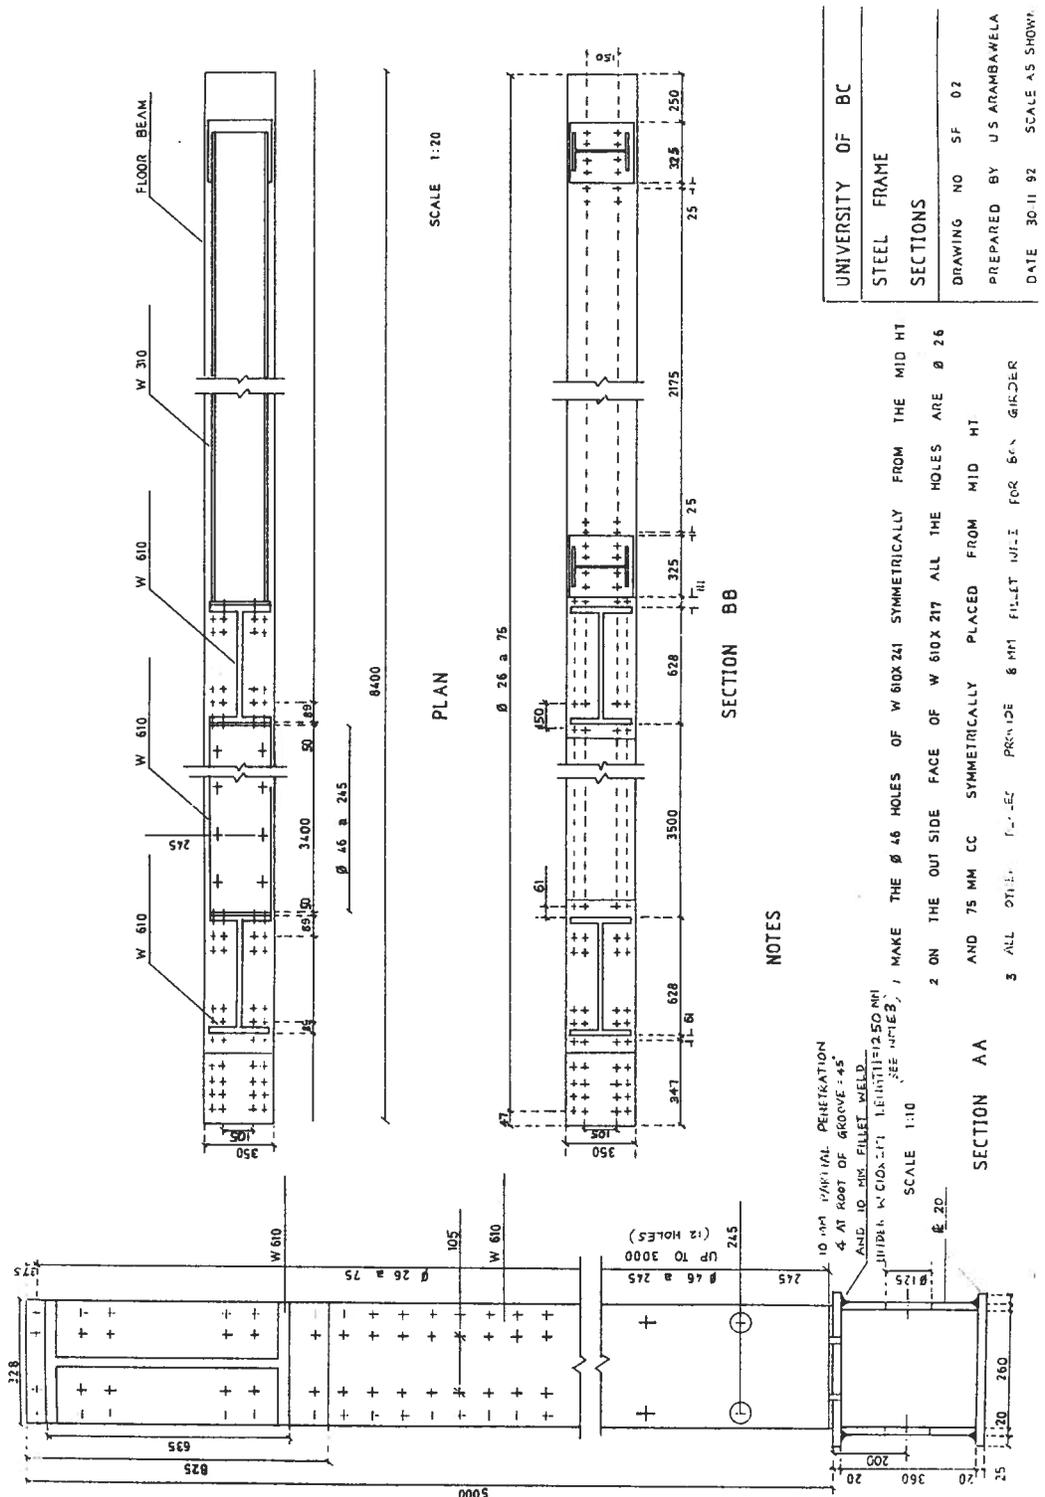
Fig 2.4 Construction drawing (Plans)

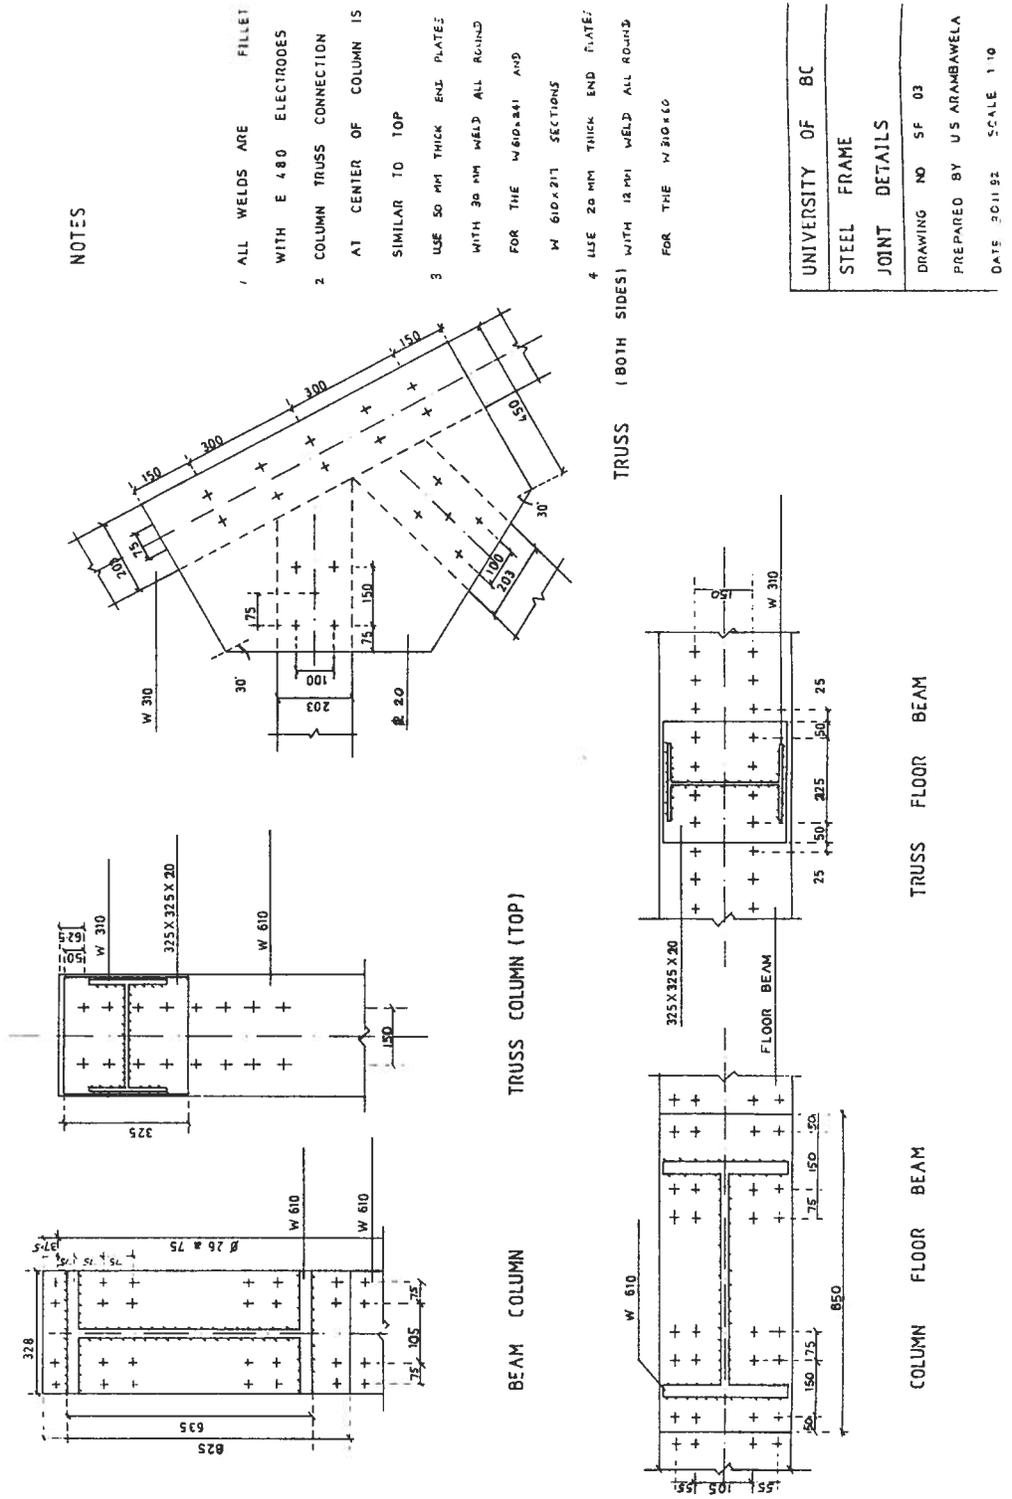
Fig 2.5 Construction drawing (Connections)

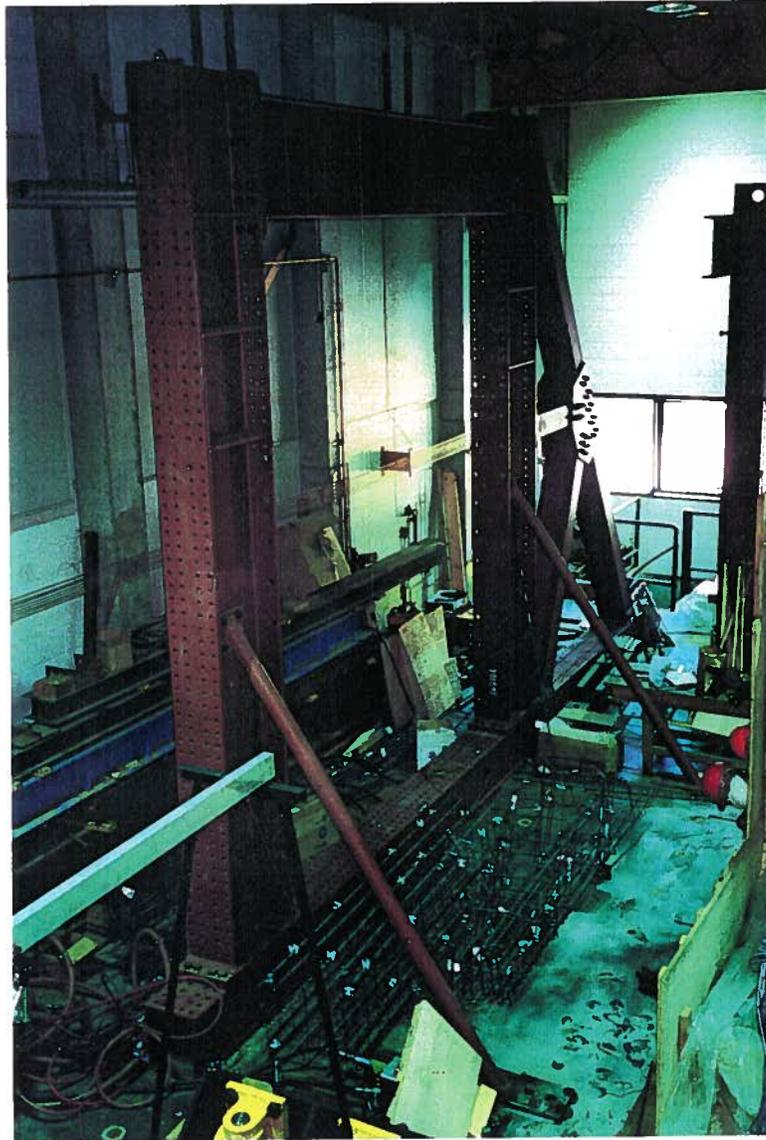
Fig 2.6 Photo of the steel frame

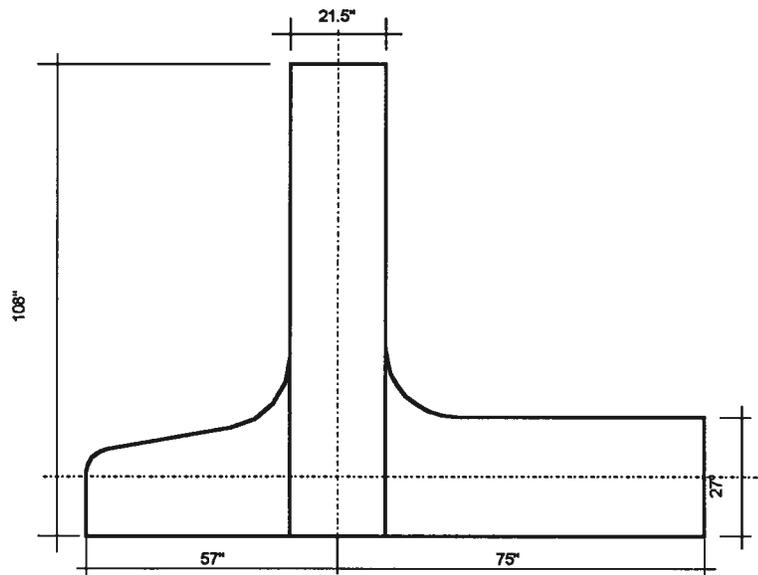
Fig. 3.1 Specimen OJ1

specimens have similar material properties, but the cap beam of the second specimen was retrofitted by post tensioning. Geometry of specimen 1 and 2 are shown in the Figs. 3.1 and 3.2. Bearing dimensions are given in Section 6.1. The reinforcing steel for both specimens was contributed by MOTH is therefore same as for the MOTH model. Concrete properties of the half bent test are given in Table 3.1 and 3.2.

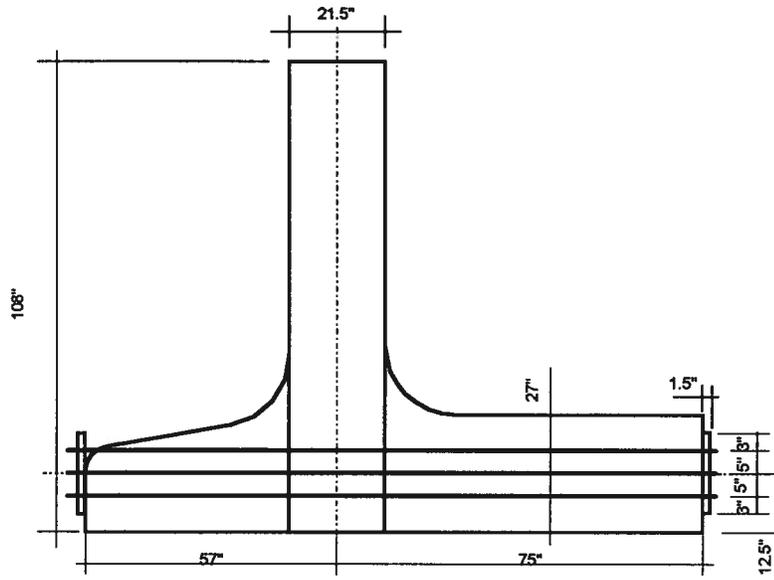
Fig. 3.2 Specimen OJ2

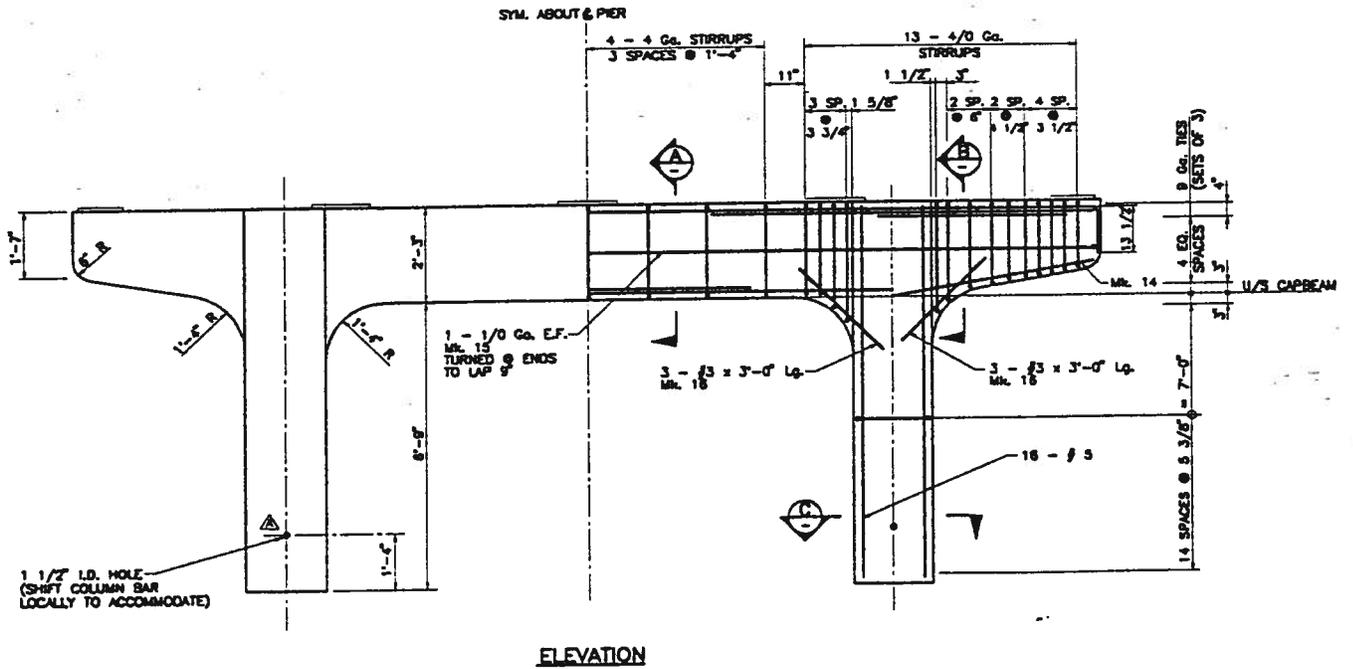
Fig. 4.3 MOth model elevation

The MOTH model was at 0.45 scale and the cap beam had a cross section of 1'7" x 2'3" with 4 - #5 bars at the top and 13 - #5 bars at the bottom. The gauge 4 stirrups were spaced at 1'4". The column had a cross section of 1'9.5" x 1'9.5" with 16 - #5 bars. Gauge 9 ties in the column were spaced at 5 3/8". Fig. 3.3 through 3.5 show the MOTH full bent. The material strengths obtained from the prototype testing were used for the experiment, as it is important to have correct material properties in order to identify the critical failure modes. Therefore  $f_c'=40$  MPa and  $f_y=345$  MPa were used for the MOTH full bent model. The concrete cylinder strengths obtained from the first two MOTH specimens indicated much higher average values of 47.6 and 51.1 MPa respectively.

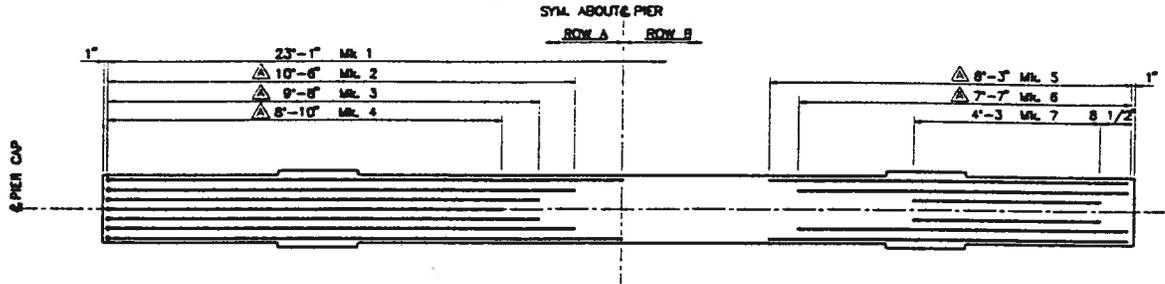
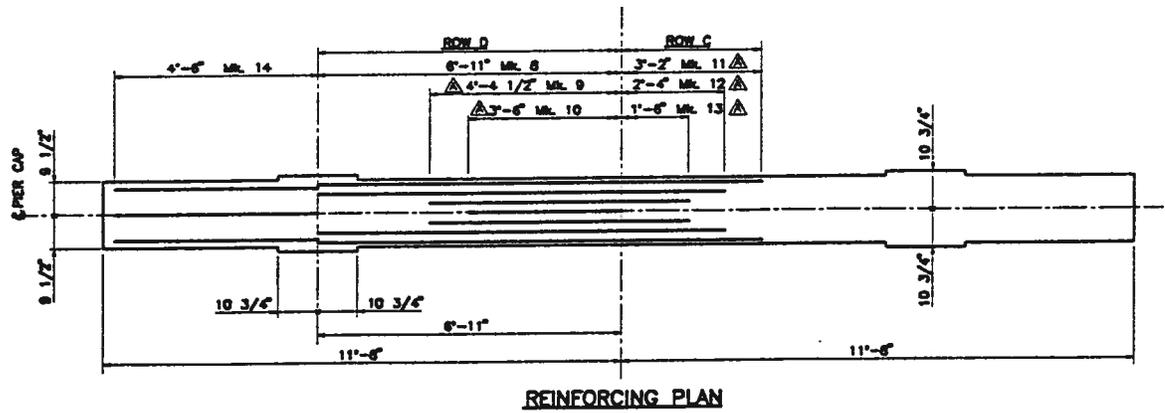
REINFORCING PLAN

Top steel

Bottom steel

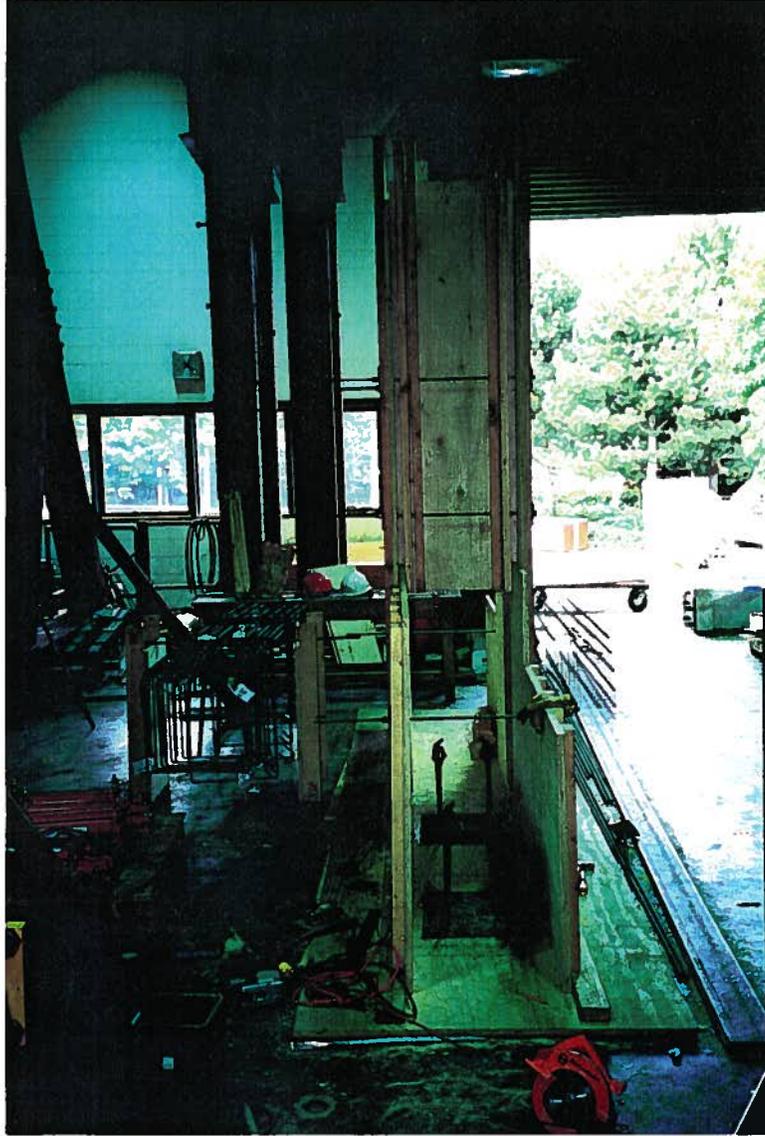
Fig. 3.6 A photograph of the form work

As testing was planned to carry out upside down it was decided to construct the specimens upside down, i.e. beam laying flat on the floor. Half inch diameter tie rods which can carry 4500 pounds and quarter inch snap ties which can carry 2250 pounds in tension were used to support the liquid concrete pressure. One inch thick plywood was used so that the number of ties required for the lateral load supporting scheme could be minimized. Fig. 3.6 is a photograph of the form prior to placing concrete.

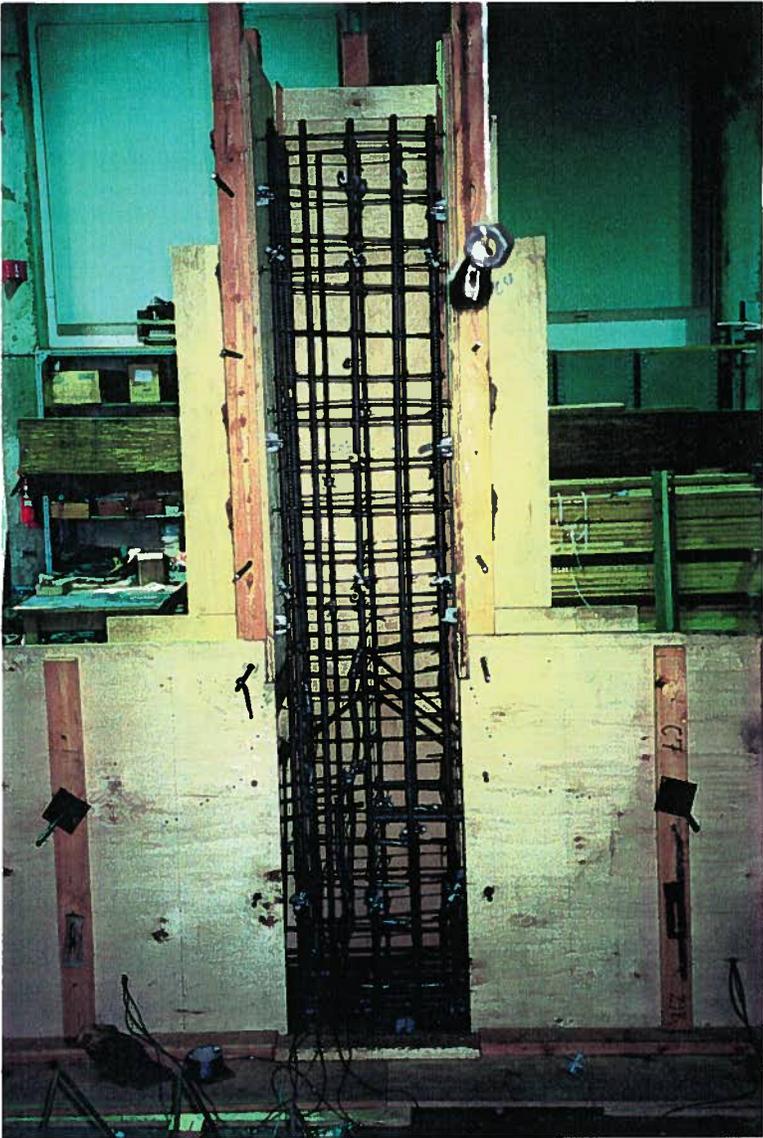
Fig 3.7 A photograph of the steel cages

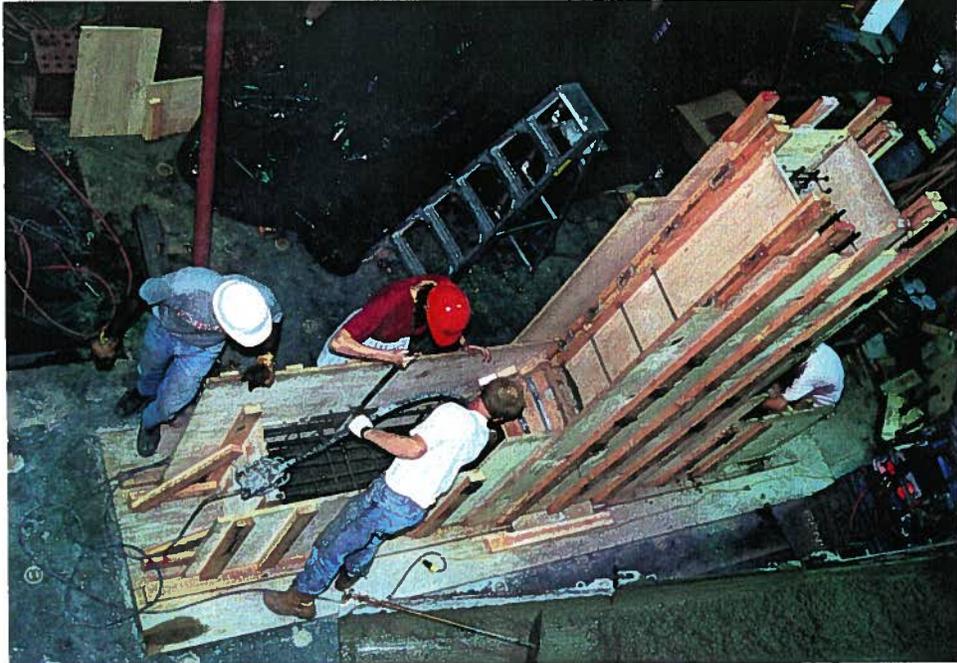
Fig. 3.8 Photograph showing pouring of the concrete

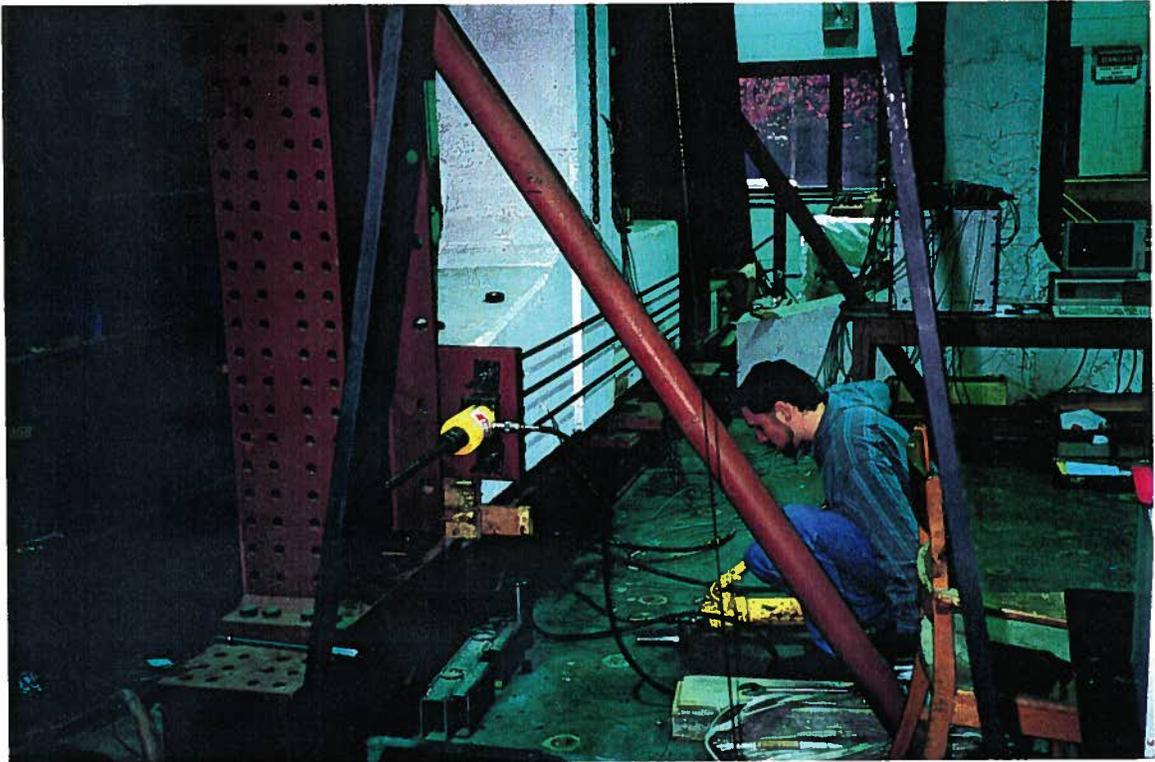
Fig. 3.9 Post-tensioning of bars

The cap beam of the second specimen was post-tensioned using 6 Dywidag bars of diameter 5/8". Each Dywidag bar was tensioned to 35 kips which is 0.8fpu. The resultant post tensioning force before relaxation of the bars is 210 kips acting 12.5" below the top face of the cap beam. This provides the same prestress as the MOTH full bent test.

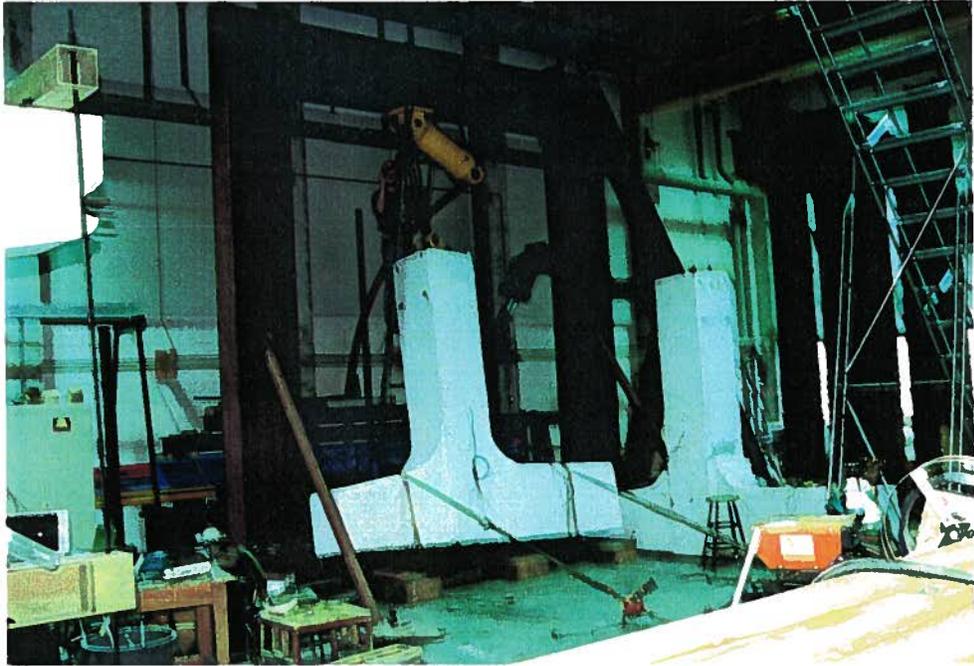
Fig. 3.10 Installing the specimen in the frame

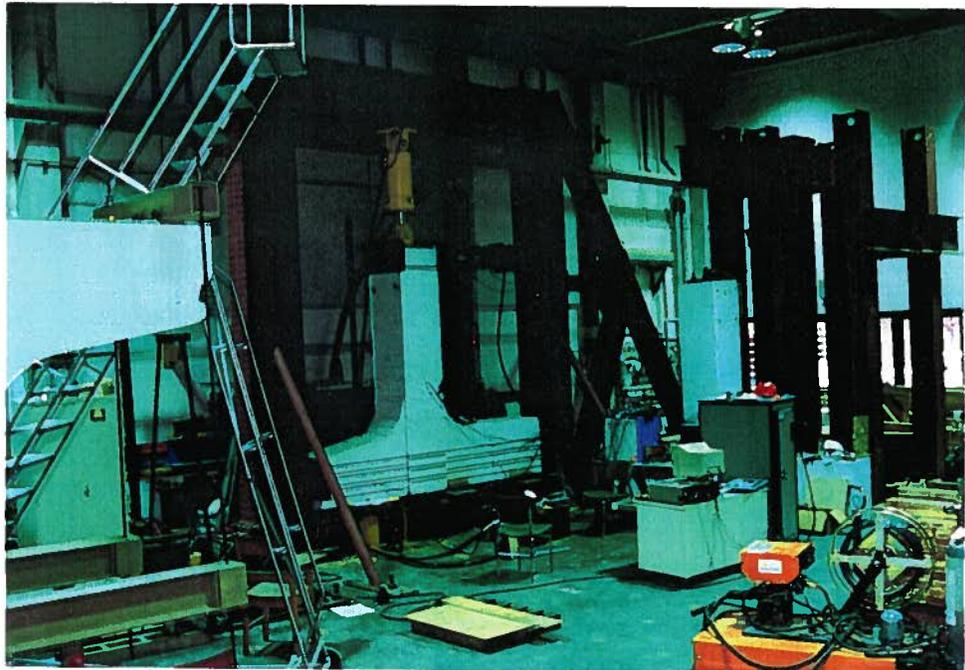
Fig. 3.11 Specimen and the frame

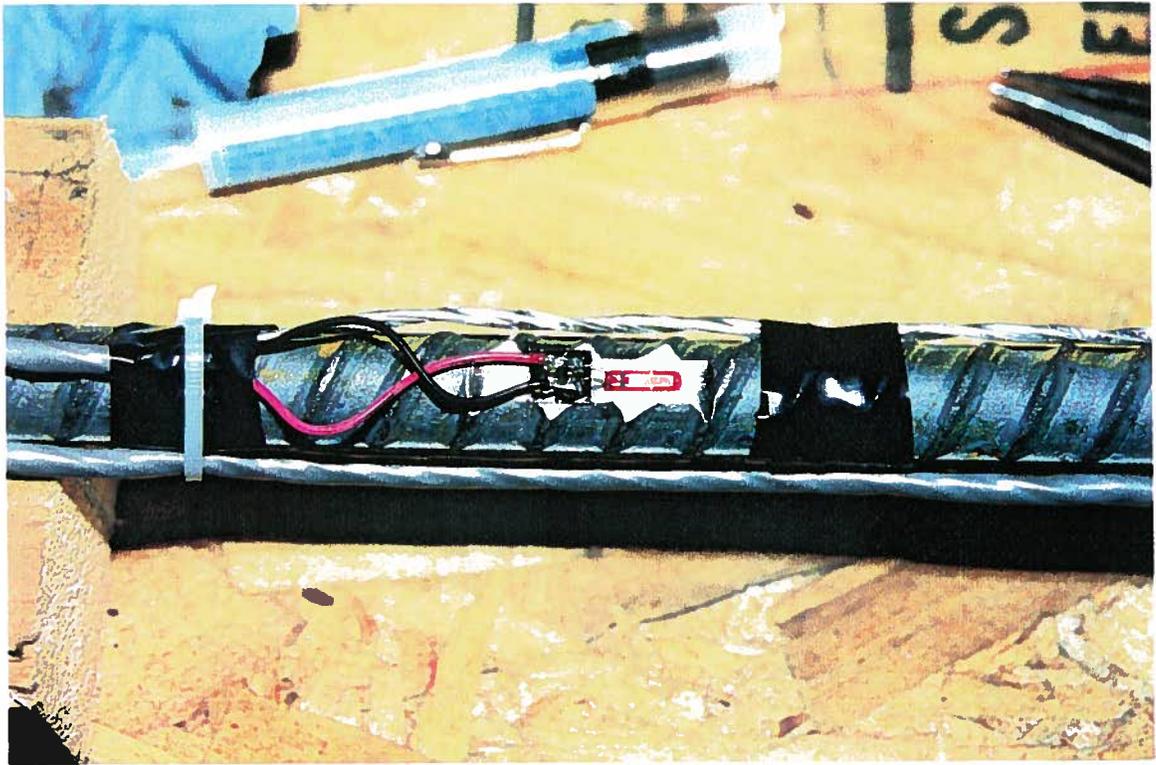
Fig. 4.1 Photograph of a strain gauge in a bar

The measuring devices used were strain gauges, linear variable differential transformers (LVDT displacement transducers), and a load cell attached to the lateral loading MTS jack. The strain gauges type was FLA-5-11, the resistance and the gauge length were 120 ohm and 5 mm respectively. Fig 4.1 shows an individual strain gauge mounted on a reinforcing bar.

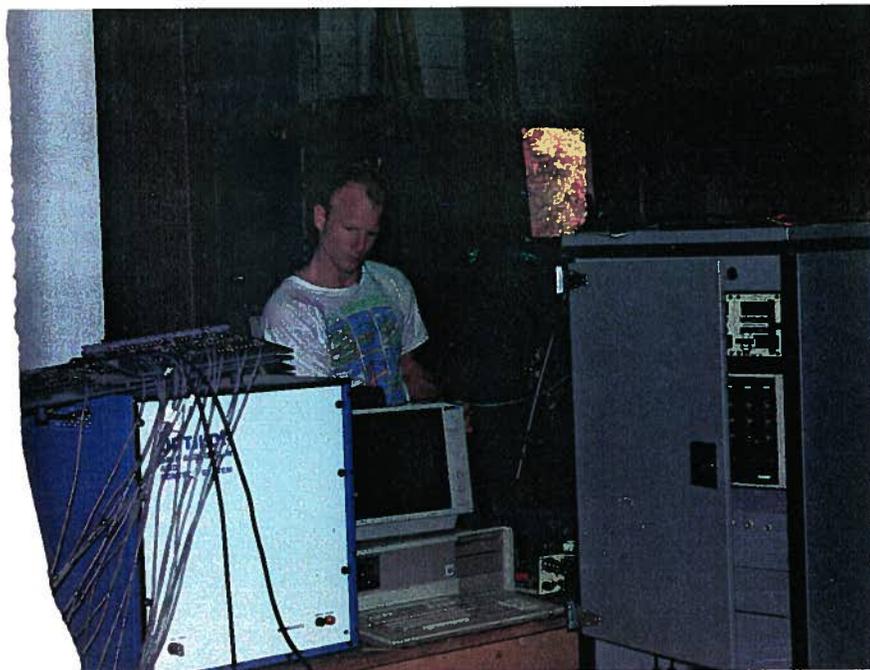
Fig. 4.2 Photo of the data acquisition system

26 different measurements were recorded using the OPTILOG 120 data acquisition system for the specimen OJ1. Those consist of 20 strain gauges, 4 LVDTs ,1 Load Cell and 1 pressure transducer. For the specimen OJ2 there was an additional pressure transducer for the third jack. The data acquisition system scanned the devices at a constant time interval of 2 seconds. Fig. 4.2 shows the data acquisition system.

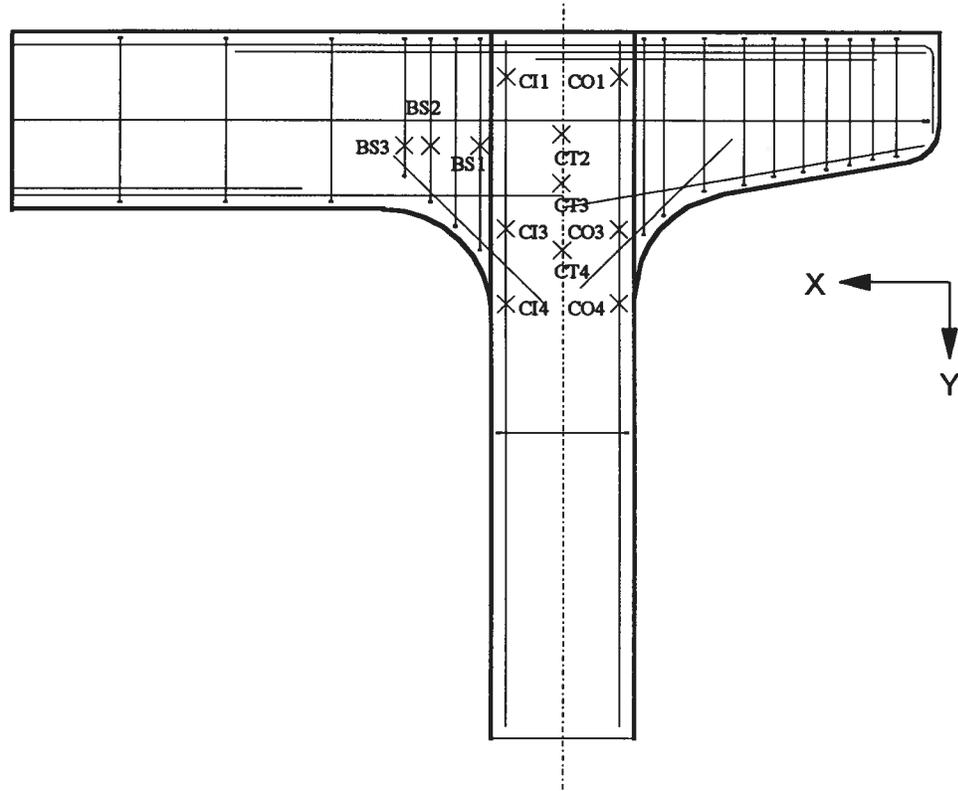
Fig. 4.3 Strain gauge locations (Elevation). Plan in Fig. 4.4

Strain Gauge	X (inches)	Y (inches)
CI1	8	7
CI3	8	31
CI4	8	37
CO1	-8	7
CO3	-8	31
CO4	-8	37
CT2	0	14
CT3	0	23
CT4	0	29
BS1	12	16
BS2	19	16
BS3	34	16
BT1	-13	2
BT3	0	2
BT4	6	2
BT5	14	2
BT6	22	2
BB1	6	24
BB2	14	24
BB3	21	24

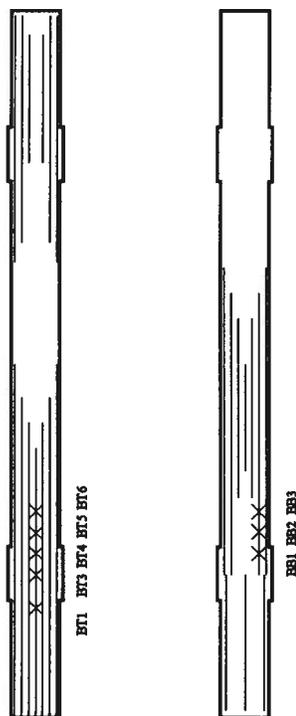
Fig. 4.4 Strain gauge locations (Plan). Elevation in Fig. 4.3

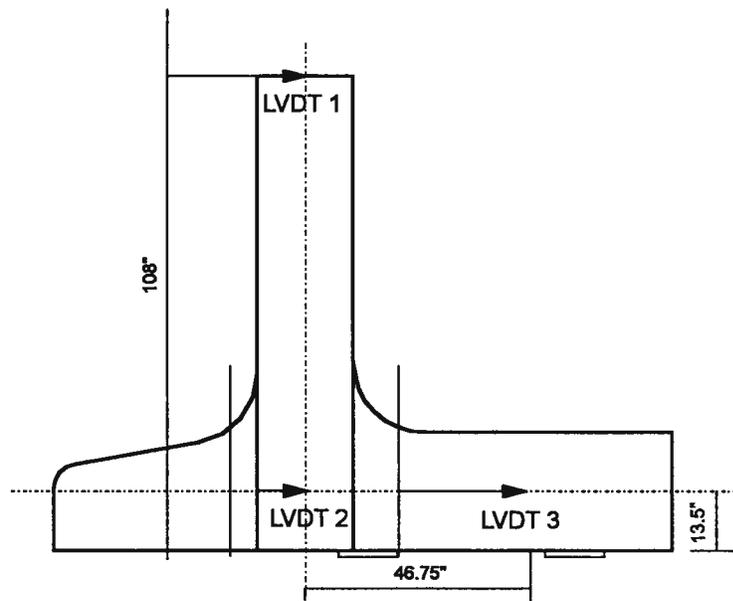
Fig. 4.5 LVDT locations

The second LVDT was located 13.5" from the bottom of the specimen in the center line of the column. The third LVDT was located 3' 10.75" horizontally away from the second LVDT in the beam stub. See Fig. 4.5 and 4.6. The latter two LVDTs can be used to measure the crack widths in the beam stub, and the horizontal displacements in the joint and the beam stub.

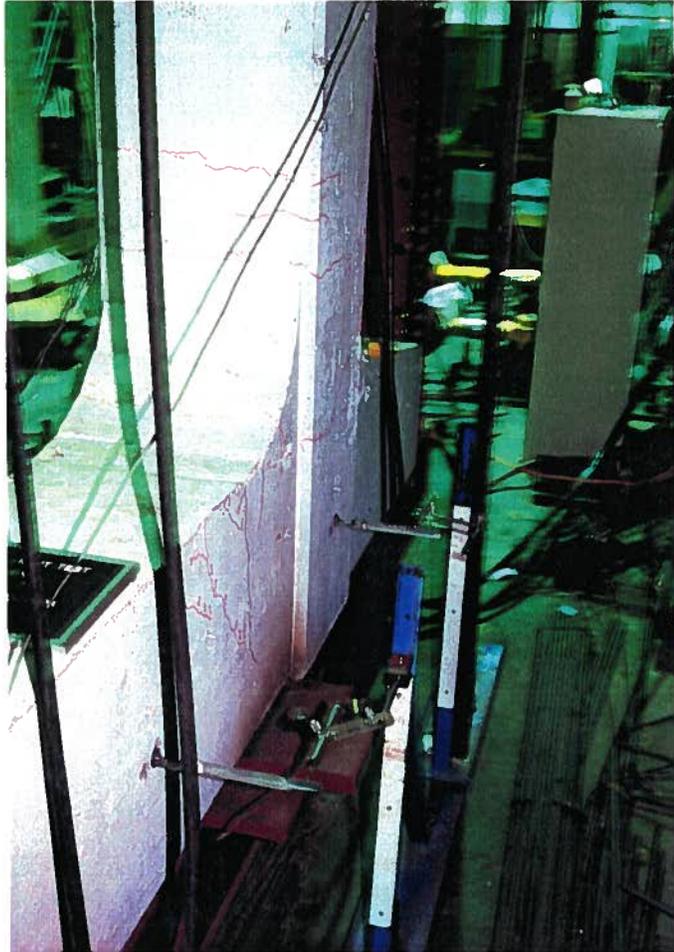
Fig. 4.6 Photo of LVDT locations
