# **Oak Street Bridge Half Bent Test On As Built and Retrofitted Specimens**

A THESIS SUBMITTED IN PARTIAL FULFILLMENT OF  
THE REQUIREMENTS FOR THE DEGREE OF  
MASTER OF APPLIED SCIENCE

THE UNIVERSITY OF BRITISH COLUMBIA

June 1994

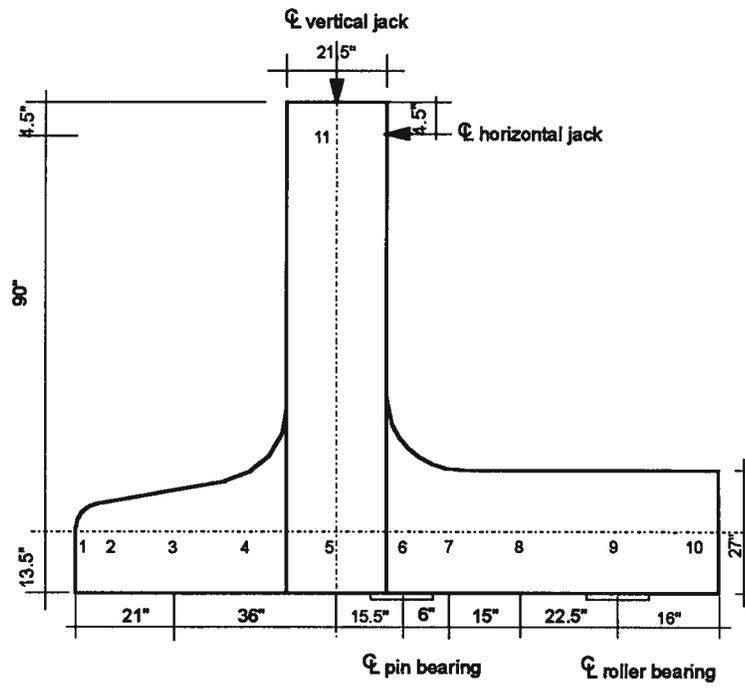
Fig. 5.1 Specimen OJ1 bearing locations

Two supports (bearings) were used for the half bent specimen. The "first interior" support is a pin to take the total lateral load, and the "middle" support is a roller so that it will share the vertical reaction due to the lateral seismic load with the pin support. These bearings consist of 2 steel plates of 2" and 1.5" thick and a 3/8" elastomeric pad between the plates. The bearing locations are shown in Figs. 5.1 and 5.2. The bearing arrangement is shown in the Fig. 5.3. The bolts attaching the top bearing plate to the bottom plate at the pin support is provided with 1/8" play so that the top bearing plate can rock on the elastomeric pad. At the roller support 1.5" slotted holes were drilled to allow for the horizontal movement of the specimen on the bearing pad. Figures 5.4 and 5.5 are photographs of pin bearing and, the vertical and horizontal jack connection detail.

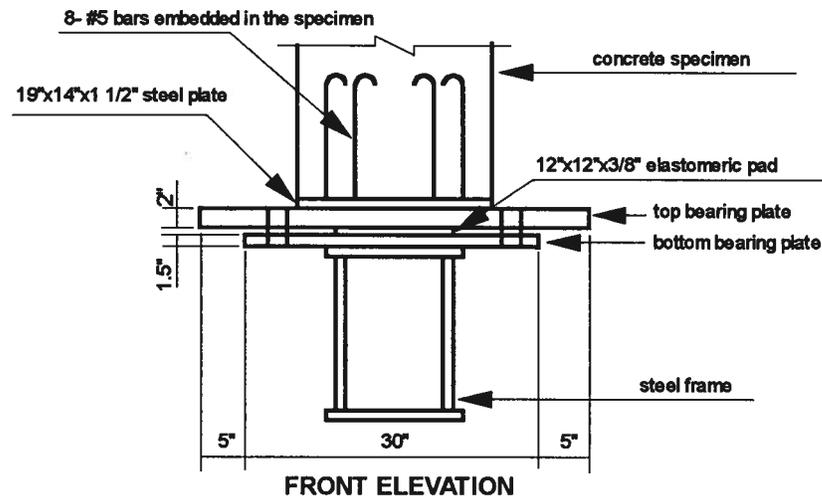
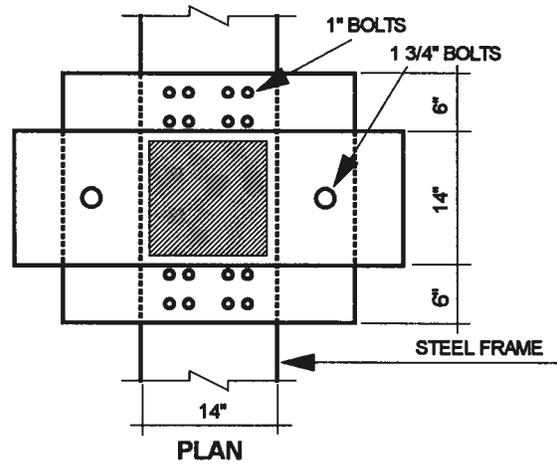
Fig. 5.3 Bearing arrangement

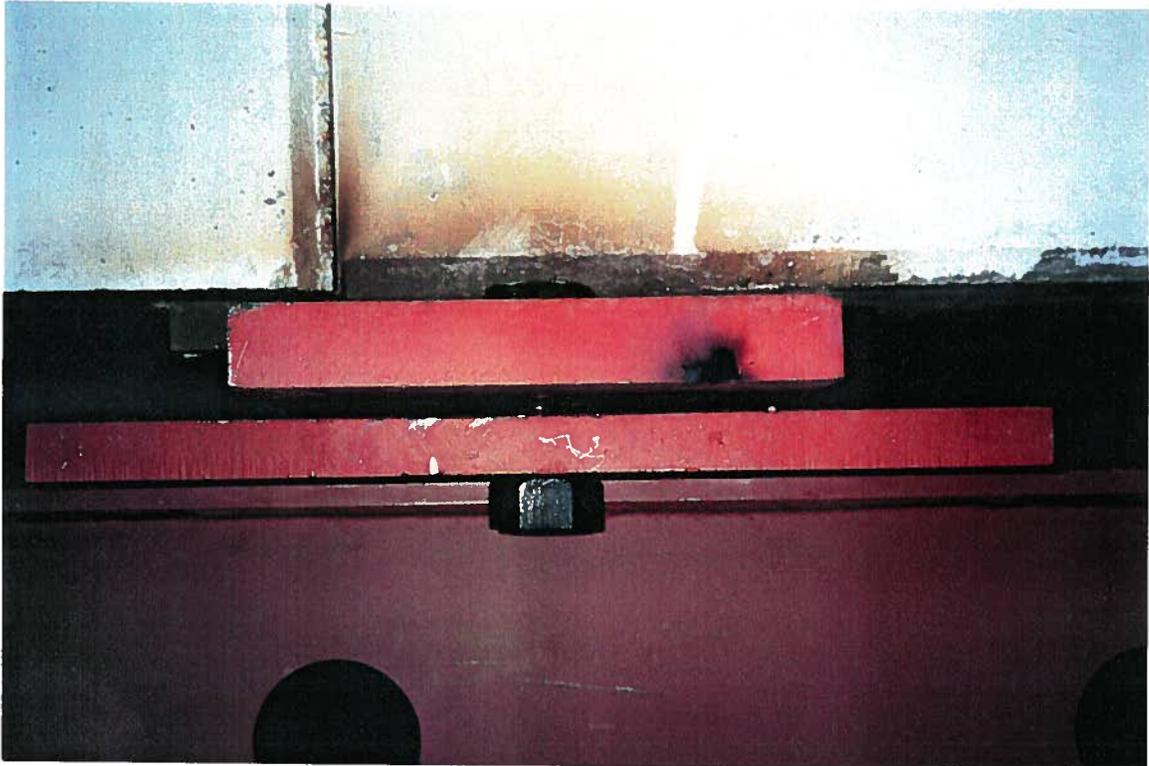
Fig. 5.4 Photograph of the pin bearing

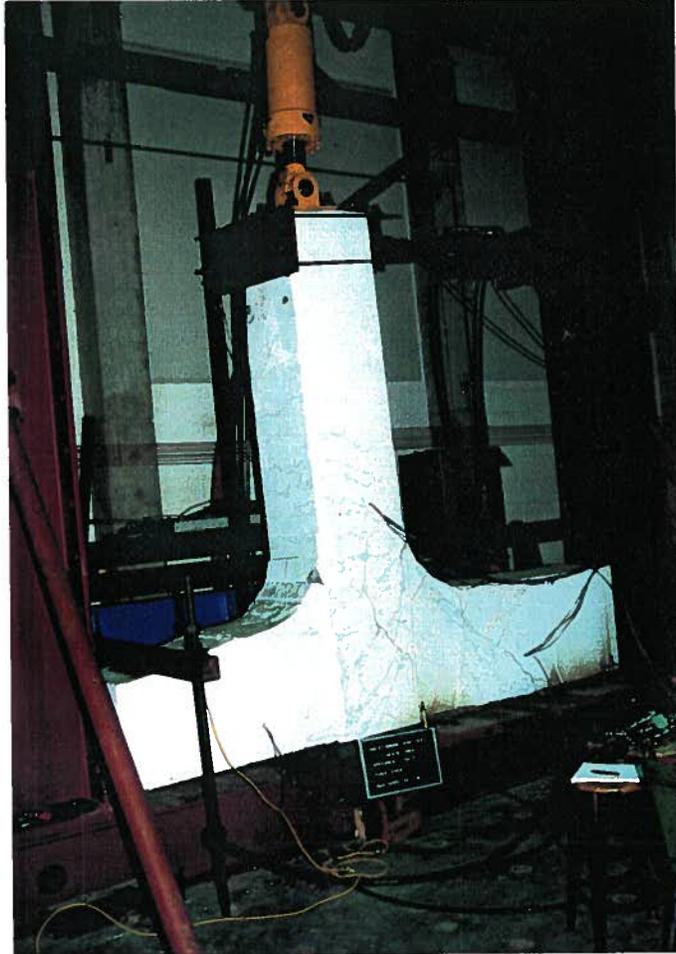
Fig. 5.5 Horizontal and vertical jack connection.

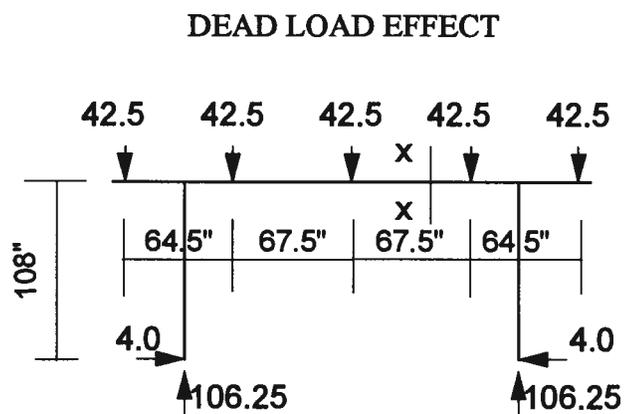
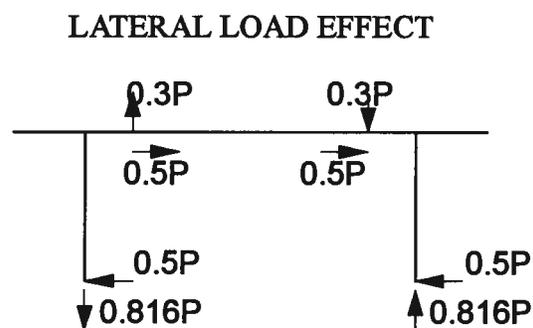
ALL LOADS ARE IN  
KIPS

P = LATERAL LOAD

Fig 5.6 Dead and lateral loads on full bent test

In the Oak St. Bridge, dead load from the deck acts at the five bearing positions on the cap beam of the bent. The lateral load is assumed to act on the center of gravity of the deck which is 5' above the center line of the cap beam. Fig. 5.6 shows the forces and reactions due to dead and lateral loads acting on the MOTH full bent model. Section x-x is taken to the right of mid span of the cap beam. The lateral load is denoted  $P$  and is analogous to the seismic base shear. As the half bent specimens were tested upside down, the dead loads have been taken as 42.5 kips, reflecting the total dead load of the specimen including the column.

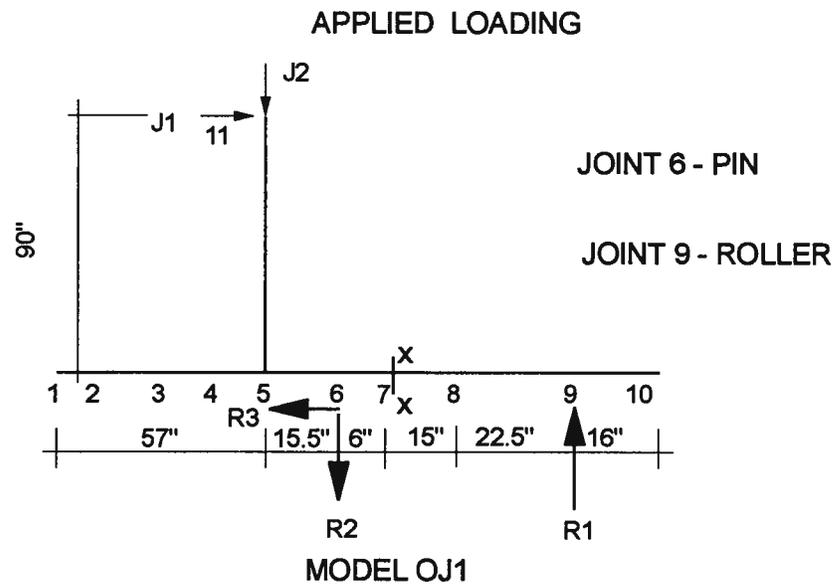
$$R1 = 2.07 J1 - 0.35 J2$$

$$R2 = 2.07 J1 - 1.35 J2$$

For the half bent specimen the corresponding shear in the cap beam based on the geometry and support conditions of the specimen OJ1 (Fig. 5.7) is,

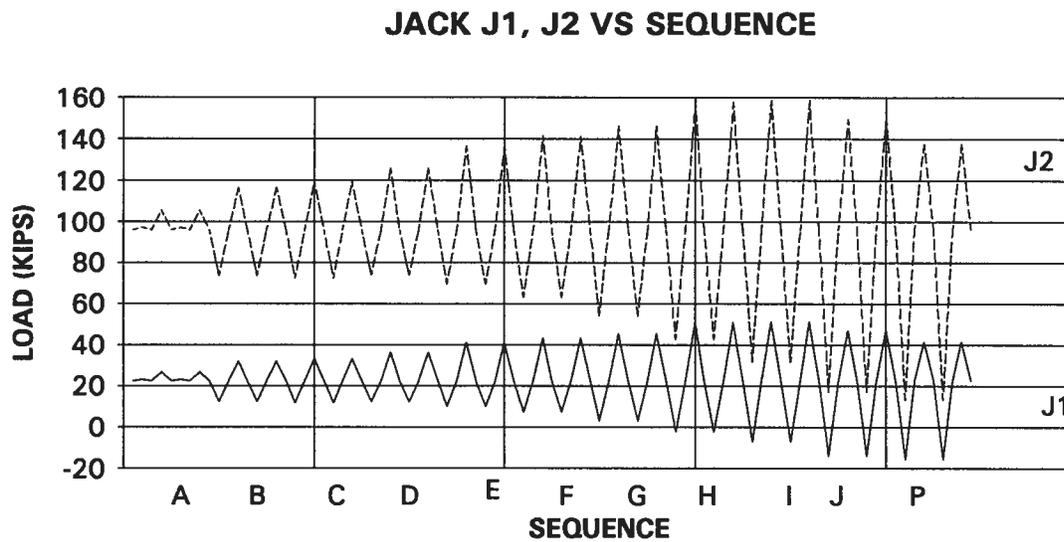
Fig. 5.8 Applied jack loads specimen OJ1

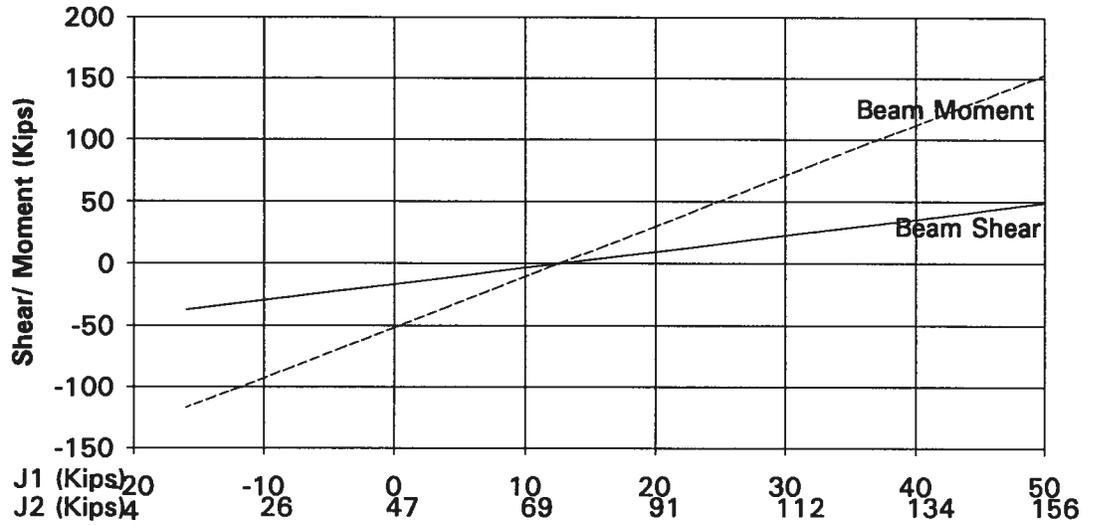
Fig. 5.9 Shear/Moment variation of OJ1 cap beam section xx with jack loads

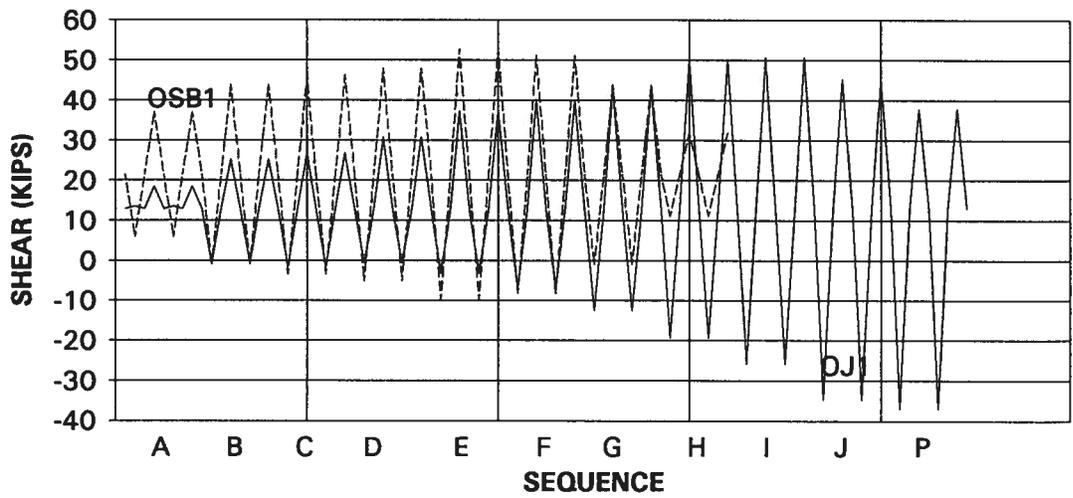
Fig. 5.10 Cap beam shear variation of specimen OJ1 and OSB1

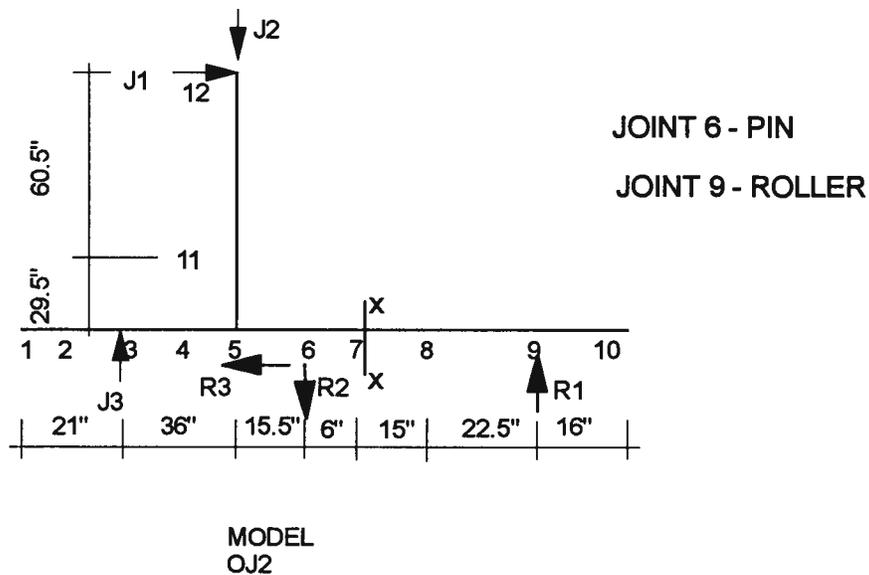
$$R1 = 2.1J1 + 0.8J3 - 0.4J2$$

$$R2 = 2.1J1 + 1.8J3 - 1.4J2$$

In specimen OJ1 the major concern was cap beam shear. Therefore during testing of specimen 1 correct shear in the cap beam was applied using two jacks at the column tip. But in the retrofitted specimen column shear is also of major concern. Therefore the correct column reactions were applied at the tip of the column using J1 and J2, and a third jack (J3) was controlled to obtain the correct shear in the cap beam. Loads in both vertical jacks were allowed to change in proportion with the lateral jack. The lateral jack was on reversed cyclic loading under displacement control. The third jack J3 was 3' away from the joint 5 on the cantilever side.(Fig.5.11)

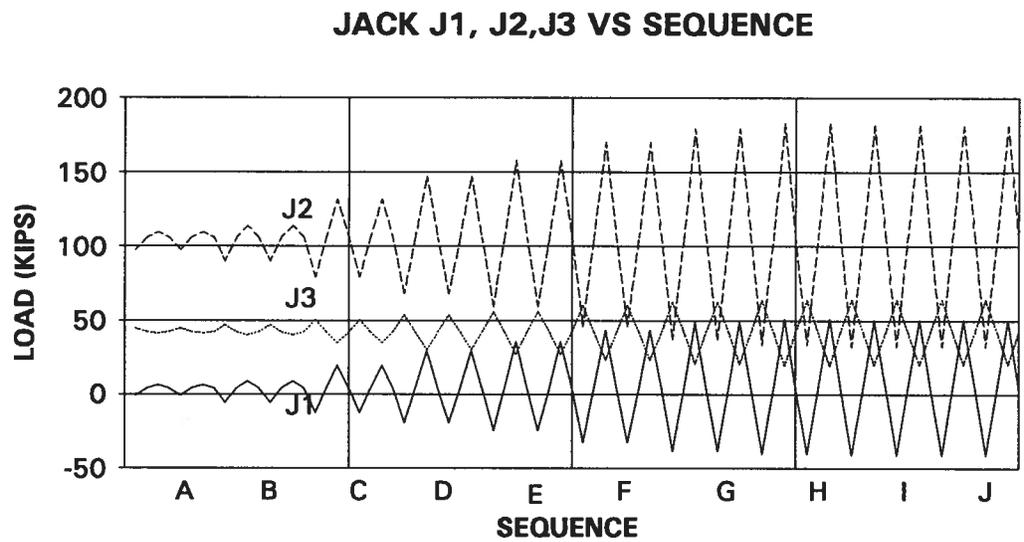
Fig. 5.12 Applied jack loads specimen OJ2

The initial load of J1 for the second test was  $J1=4$  kips acting to the right hand side to account for the dead load reaction at the column tip. The other two jacks were varied according to equations (5) and (6). Thus at  $J1=4$  kips,  $J2=106.25$  kips, and  $J3=42.5$  kips. This simulates the dead load condition.

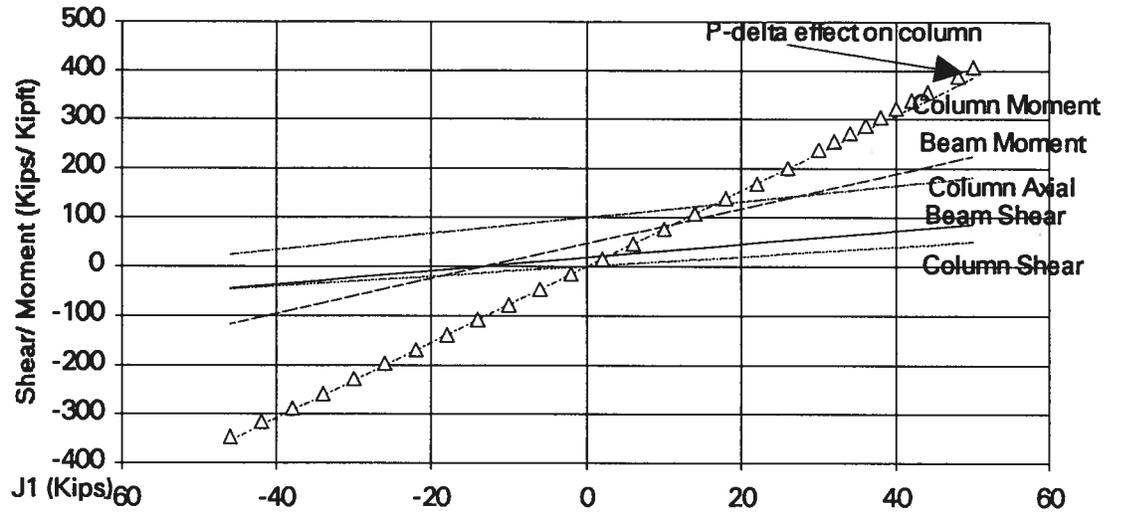
Fig. 5.13 Shear /Moment variation at x-x of OJ2 with jack loads

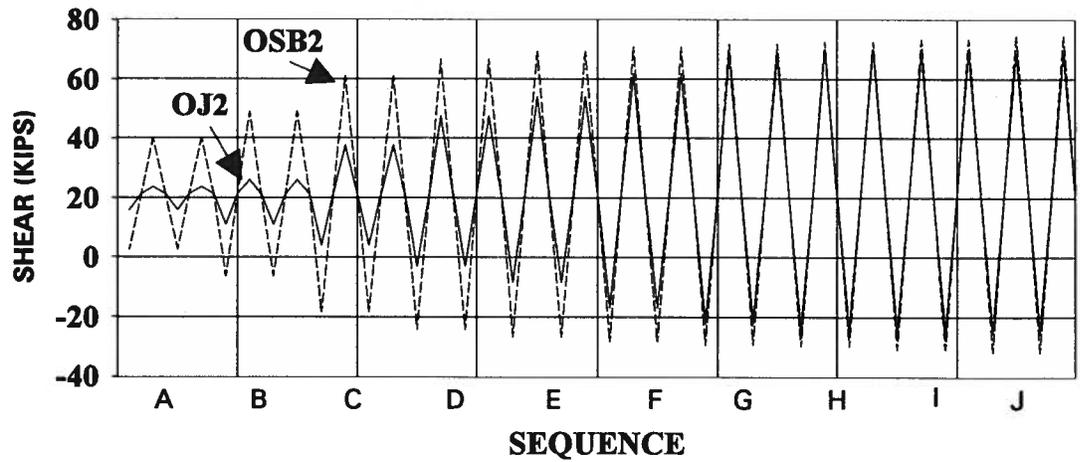
Fig. 5.14 Cap beam shear variation of specimen OJ2 and OSB2

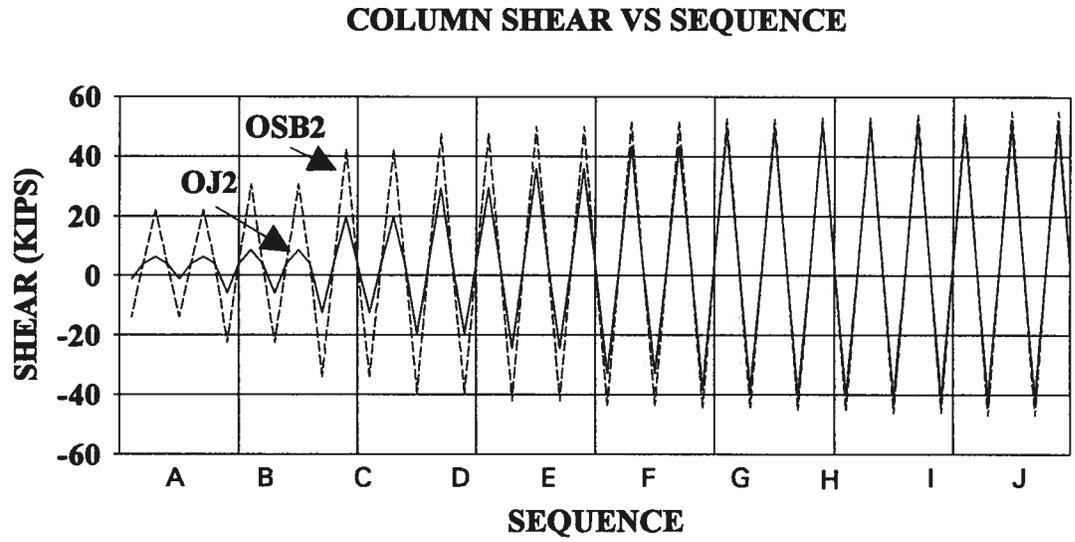
Fig. 5.15 Column shear variation of specimen OJ2 and OSB2

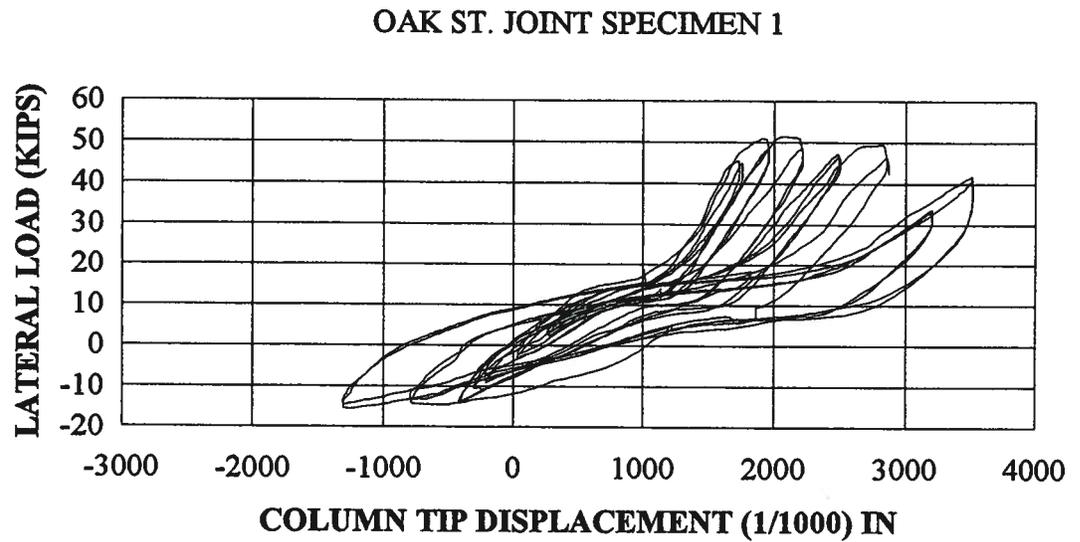
Fig 6.1 OJ1 Load displacement at the column tip

Flexural cracks in the column (south side ) appeared when pulling to the north in sequence A at 0.1" displacement. These cracks extended in the subsequent cycles. In sequence E at 0.5" displacement (pulling) and a lateral load (J1) of 41.2 kips first flexural cracks at the top side (bottom on the upside down specimen) of the cap beam appeared. These cracks extended in the subsequent sequences. Fig. 6.2 shows the cracks of sequence F at 0.6" lateral column tip displacement. At sequence F the lateral load J1 applied was 43.4 kips and the cap beam shear at section xx (Fig. 5.7) was 40.3 kips. The peak lateral load was obtained in sequence H at 1" column top displacement. At this sequence the width of the cap beam shear crack was about 0.6mm. Up to sequence J (i.e. 1.5" column tip deflection) when loading north (pulling) the cap beam top shear crack opened up without forming other cracks. After sequence H the strength and the stiffness of the specimen started degrading. This can be clearly seen from the lateral load displacement hysteresis loops of the column tip (Fig. 6.1). The initial position of the lateral loading jack for this test was 1.4". In sequence O at 2" lateral column tip deflection (Fig. 6.3) a major shear crack started spreading in the joint region when pushing South. At this sequence the lateral load applied was 49.5 kips and the cap beam shear at section xx was 48.3 kips. The

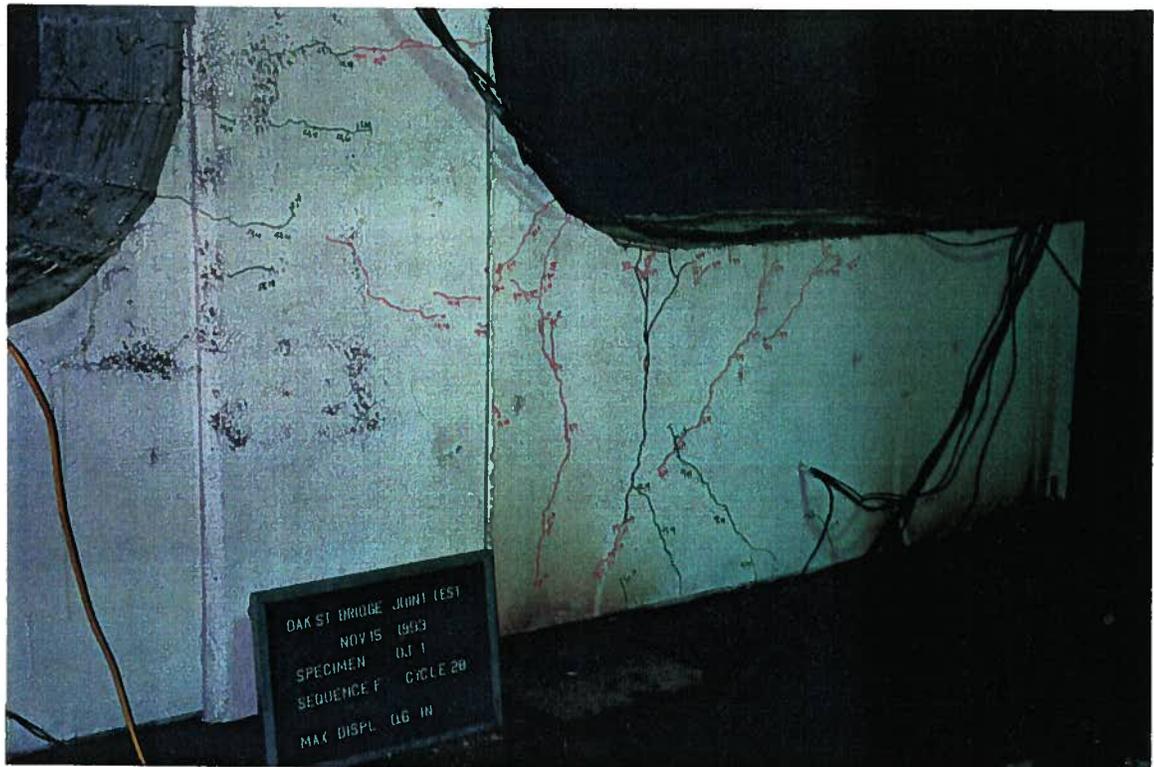
Fig. 6.2 Photograph of crack patterns at sequence F

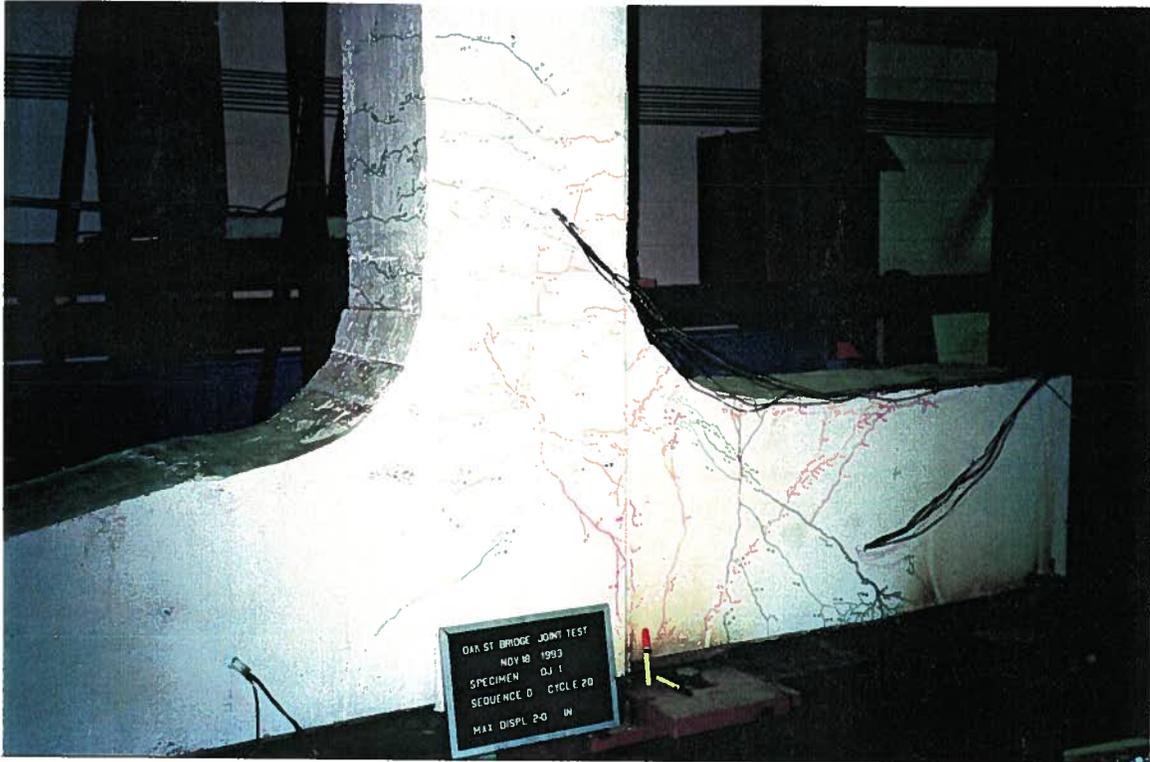
**Fig. 6.3** Photograph of crack patterns at sequence O

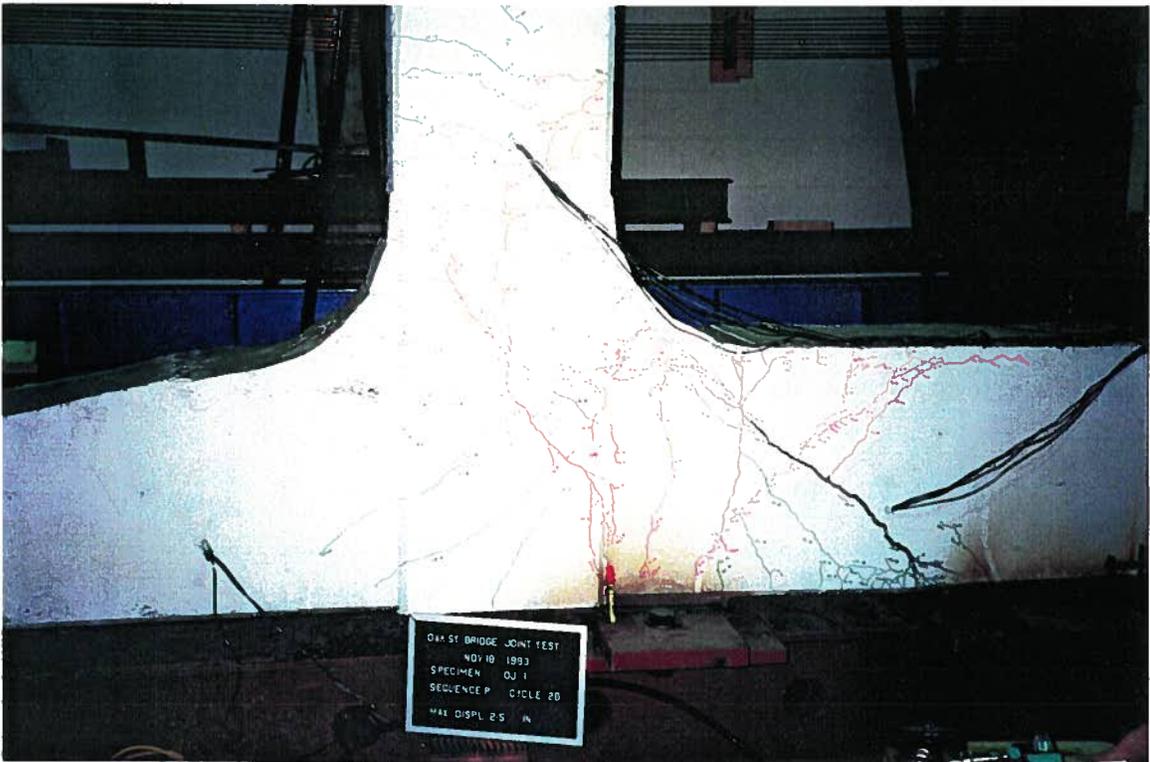
**Fig. 6.4** Photograph of crack patterns at sequence P

width of the cap beam top shear crack was about 8 mm in this sequence. The lateral load dropped to 41.6 kips in sequence P at a displacement of 2.5"(Fig. 6.4 ).

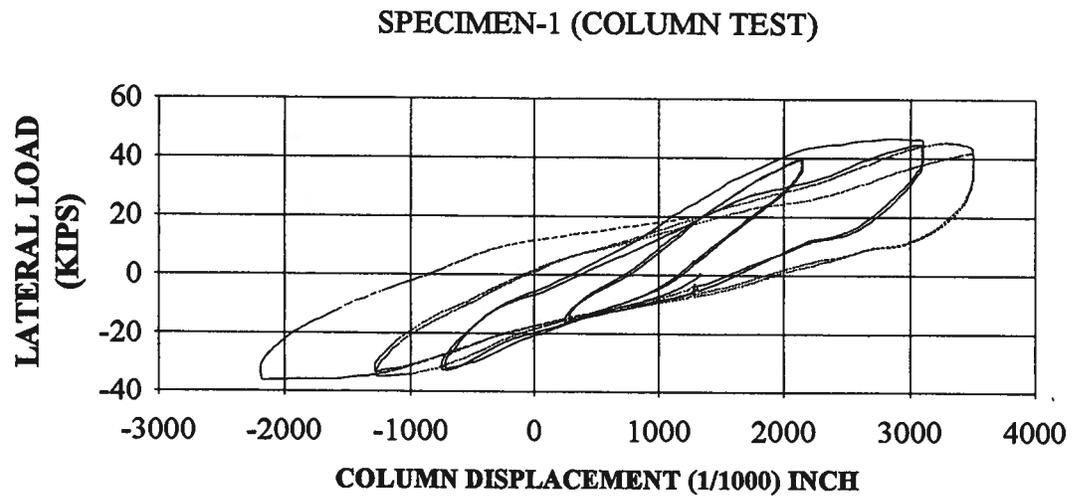
**Fig 6.5 Load displacement at the column tip (Column Test)**

As explained in the section 5.4 (by using an extra support and a tie down on the cantilever side of the cap beam), a separate column test was carried out with four load sequences. The load displacement curve of this test is shown in the Fig. 6.5 and the cracking at the last sequence is shown in the Fig. 6.6. In these sequences there was no major cracking in the column apart from the extension of the cracks that were already formed. Hysteresis loops of the column test clearly shows the yielding of column steel in both directions (Fig. 6.5).

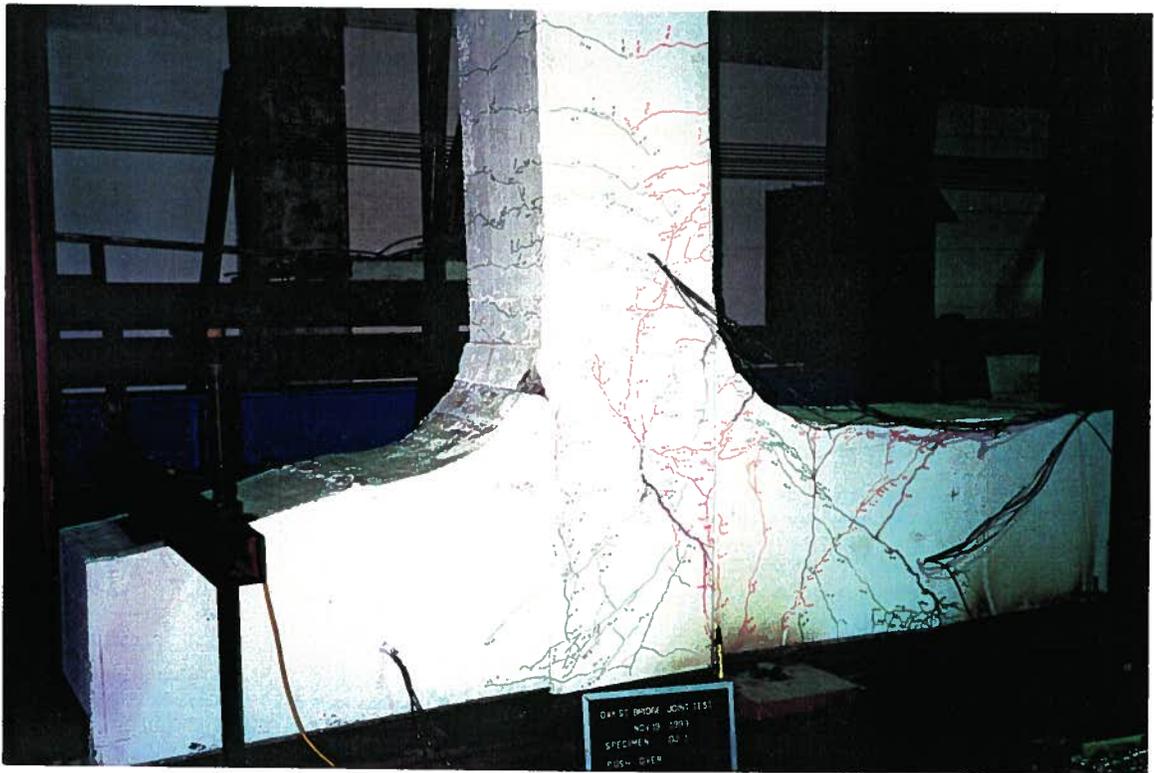
**Fig. 6.6 Photograph of crack patterns at Push Over**

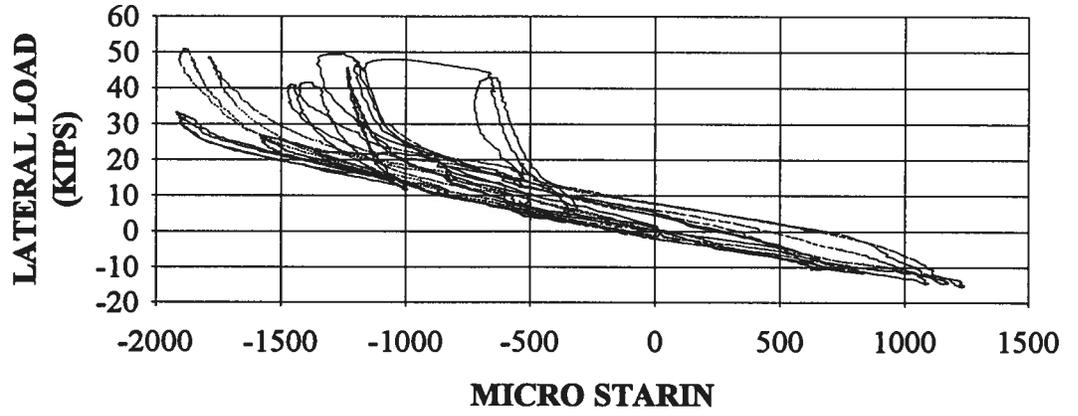
SPECIMEN 1 BEAM BOTTOM STRAIN GAUGE (BB3-12)

Fig 6.7 Strain gauge BB3

The reinforcing bar yield stress is 345 MPa. Therefore yield strain should be around 0.001750 (1750 Micro strain). Surprisingly most of the beam stirrup strain gauges of specimen 1 close to the shear crack and column tie strain gauges of specimen 2 close to the flexural crack indicated very low strain values, (i.e. around 50 micro strain) in both tests. When there are cracks propagating across reinforcing bars then those bars are expected to carry most of the load if not all. Therefore the stirrup and tie strain gauge values are questionable. Bottom bar strain gauge BB3-12 of specimen 1 (Fig. 6.7) is clearly yielding in the last couple of cycles when pulling North. The other strain gauges of beam main bars also carried very high strains in the last couple of cycles i.e. BB2-11, BT5-5, BT6-6.

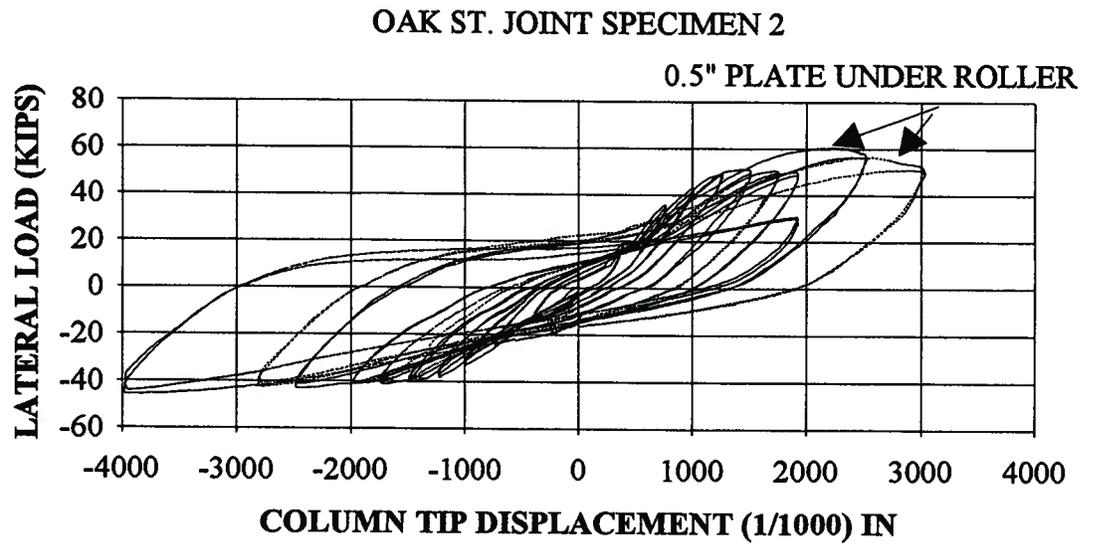
Fig. 6.8 OJ2 Load displacement at the column tip

Flexural cracks in the column started in the sequence D (Fig. 6.9) at 0.6" lateral deflection of the column tip around 29 kips lateral load. At a lateral column tip displacement of 1" in the sequence F more flexural cracks in the column appeared. At this stage spacing of cracks in the column in both directions were around 6". This was very close to the spacing of the ties in the column which is 5 3/8". Flexural cracks in the cap beam appeared in sequence G at 1.25" lateral deflection of the column tip around 50 kips lateral load. At sequence H diagonal shear cracks in the column started to develop. This was at 1.5" lateral deflection of the column tip. As the test was started with an initial offset so that the correct dead load effects can be imposed, there was only 2" stroke in the North direction pulling. Therefore it was decided to insert a 0.5" steel plate at the roller bearing along with the neoprene pad to give an extra 1" of northward stroke to the lateral column tip jack. In sequence L (Fig. 6.10) at a lateral column tip deflection of 3" and a lateral load of 56 kips, the column flexural cracks just above the beam curve opened widely. At sequence M when the column tip deflection was 4" the column concrete started spalling.(Fig. 6.12).

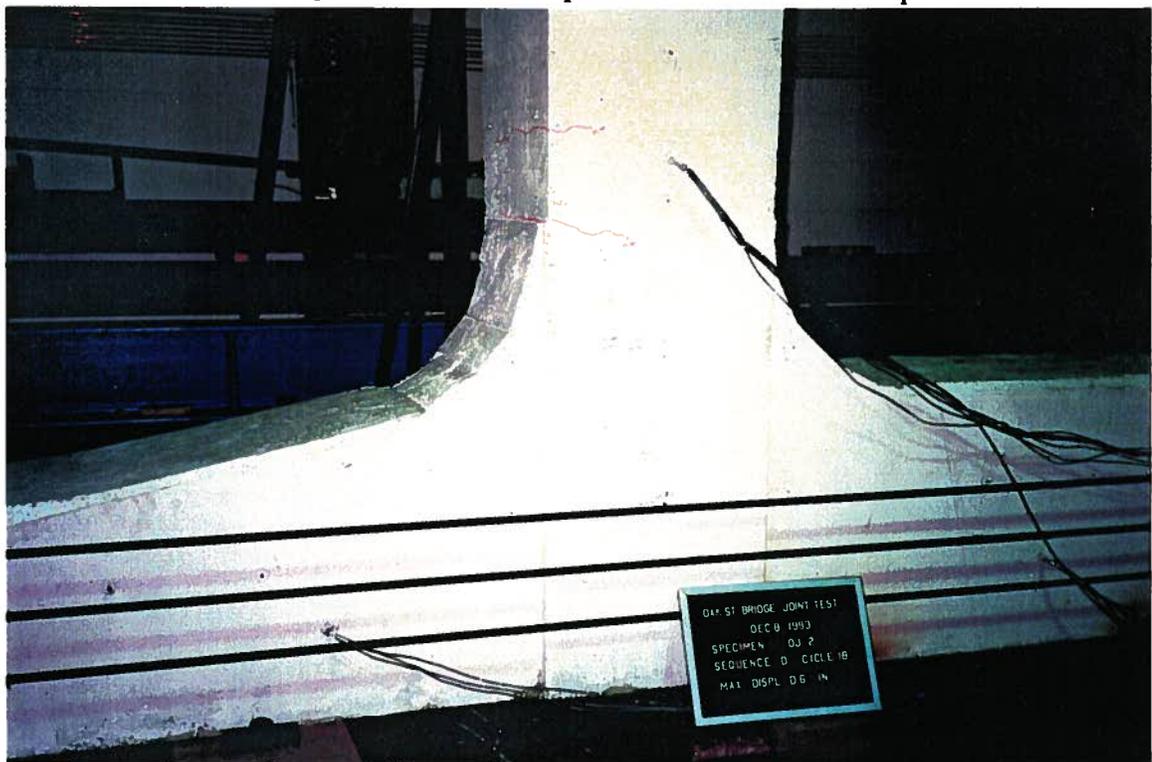
Fig. 6.9 Photograph of crack patterns at sequence D

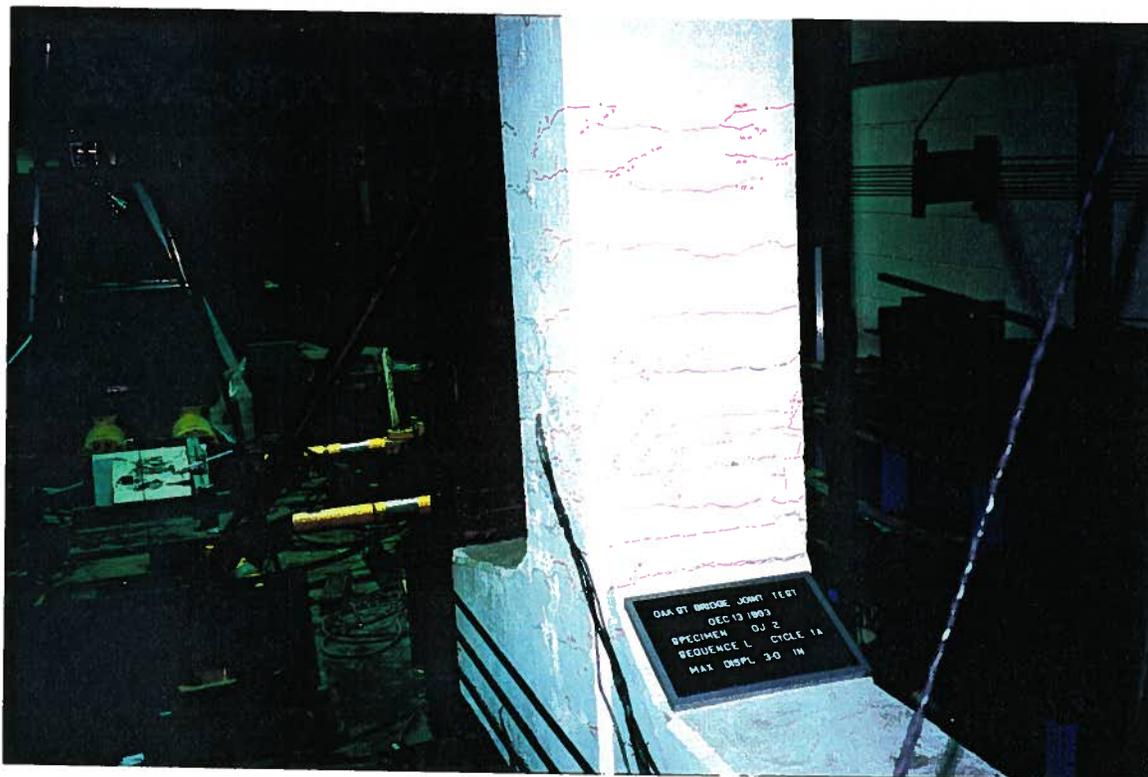
Fig. 6.10 Photograph of crack patterns at sequence L

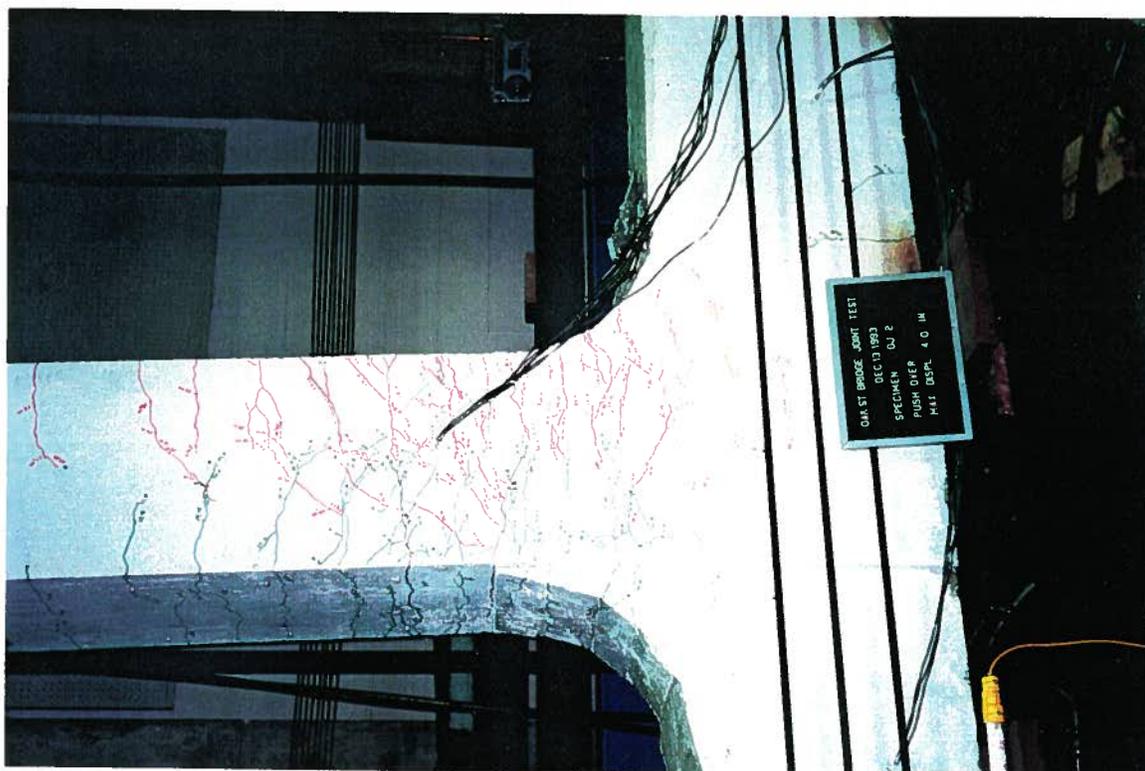
Fig. 6.11 Photograph of crack patterns at Push Over

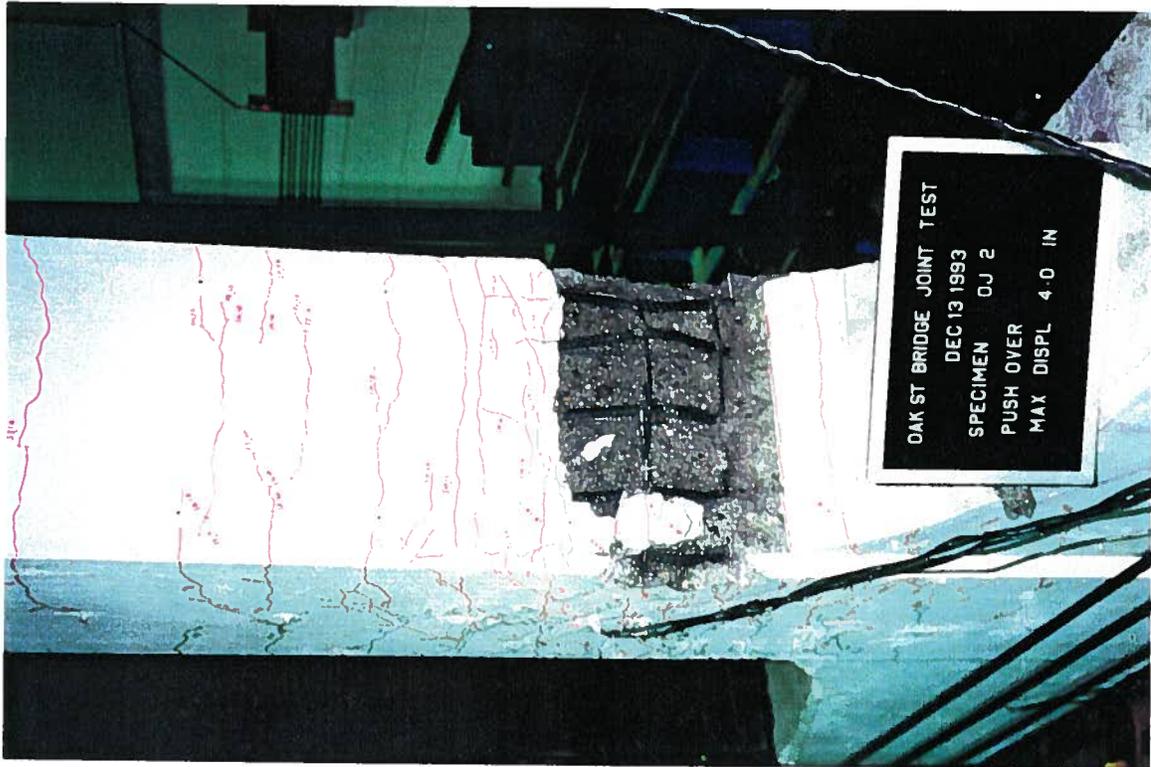
Fig. 6.12 Photograph of crack patterns at Push over

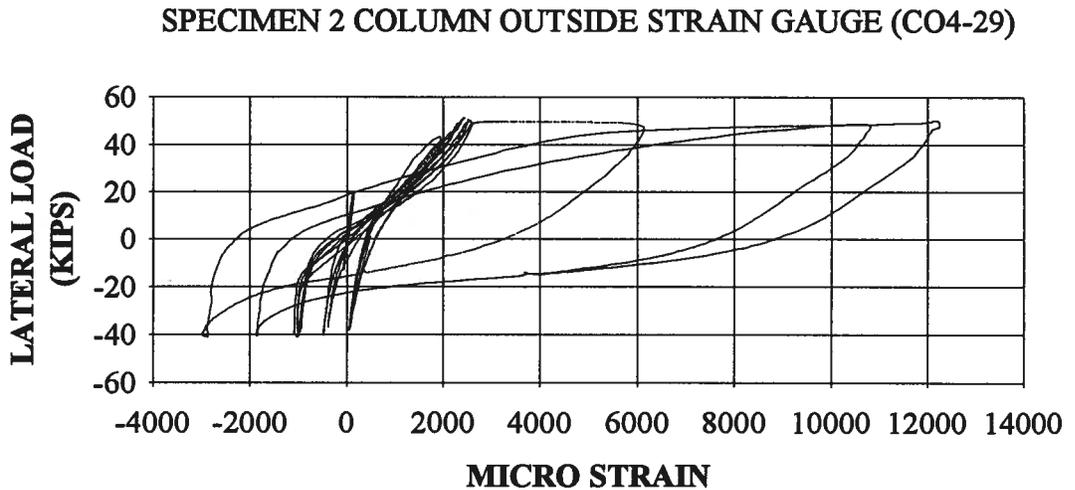
Fig 6.13 Strain gauge CO4

In the specimen OJ2 column outside strain gauge CO4-29 (Fig. 6.13) yields when pulling North with 45 kips. The inside strain gauge CI3-23 (Fig. 6.14) yields when pushing south in the last couple of cycles. These high strain values clarifies the very high bending moments expected at specimen cross sections along these strain gauges. Strain gauges BB2-11 and BB3-12 of specimen OJ2 carries much lower strains than BB2-11 and BB3-12 of the specimen OJ1. This was due to the prestressing force applied to the cap beam of specimen OJ2.

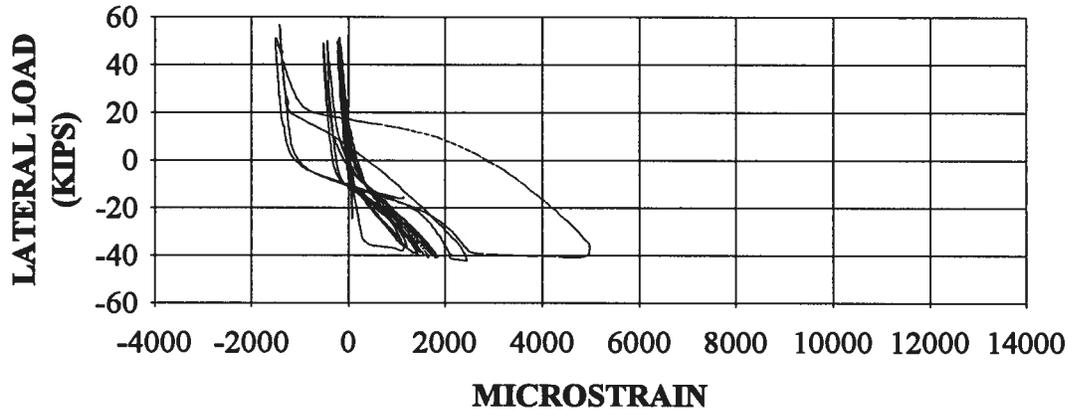
SPECIMEN 2 COLUMN INSIDE STRAIN GAUGE (CI3-23)

Fig 6.14 Strain gauge CI3

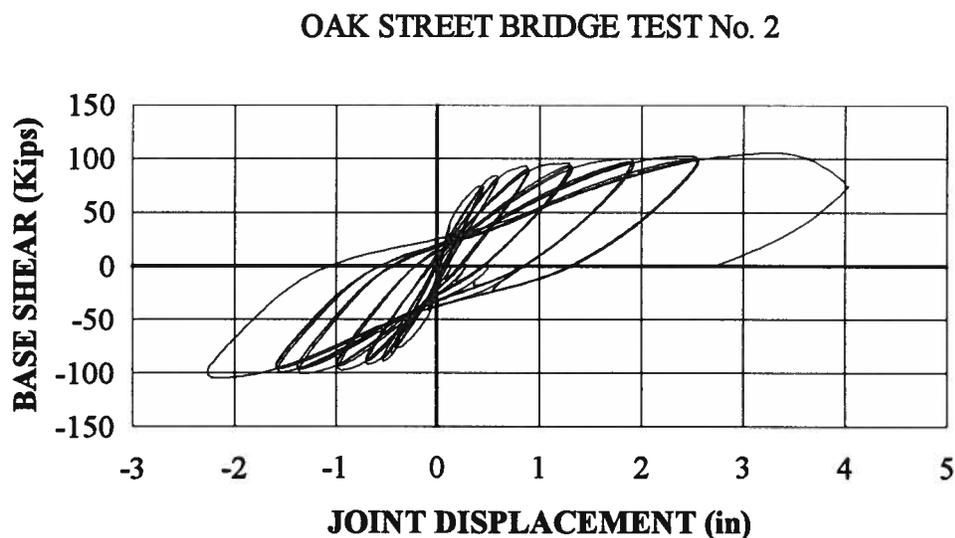
Fig 6.15 Hysteresis loop of bent test 2 (OSB2)

Fig. 6.15 shows hysteresis loops from test OSB2. The displacement at the column tip of specimen OJ2 at  $\mu=1$  was 1.25" and the displacement of OSB2 at the joint for the same level of ductility was around 0.3". This difference is partly due to the simplified boundary conditions of the specimen OJ2. i.e. the roller bearing of the specimen OJ2 will stop the vertical movement of the cap beam at that location and also the bearings did not function as expected. The pin allowed the specimen to slide a little instead of allowing rotation. This can be seen in the load displacement curve of specimen OJ2 (Fig.6.8) by the sudden change in stiffness close to zero displacement in both pulling and pushing.

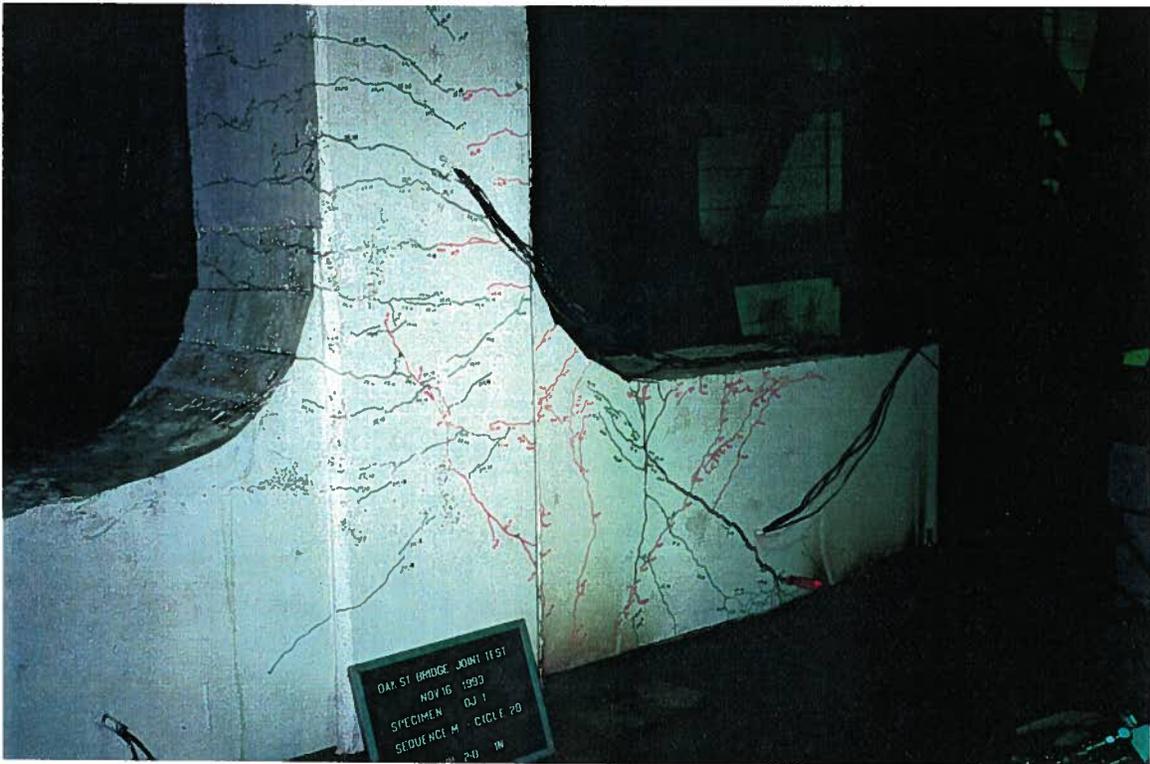
Fig.6.16 Cap beam cracking specimen OJ1

The cap beam of both the Joint specimen OJ1 and the Bent specimen OSB1 failed in shear (Fig.6.16 and 6.17). The major shear crack of OSB1 starts at the top of the cap beam exactly 5.0 ft away from the center line of the column. This crack propagates towards the column at angle of around 45 degrees. In the specimen OJ1, as the two bearing positions in the cap beam are 2'2" shorter than the full bent, the major shear crack originated closer to the column (4.0 ft from the center line of the column) and it extended at a much steeper angle (50 degrees) to the longitudinal axis of the cap beam (Fig. 6.18). The specimen OJ1 cap beam carried a maximum shear force of 49.7 kips at yield. This compares with the 53.6 kip shear force carried by the cap beam of specimen OSB1 (Appendix B Figs. B5 and B6).
