# **Oak Street Bridge Half Bent Test On As Built and Retrofitted Specimens**

A THESIS SUBMITTED IN PARTIAL FULFILLMENT OF  
THE REQUIREMENTS FOR THE DEGREE OF  
MASTER OF APPLIED SCIENCE

THE UNIVERSITY OF BRITISH COLUMBIA

June 1994

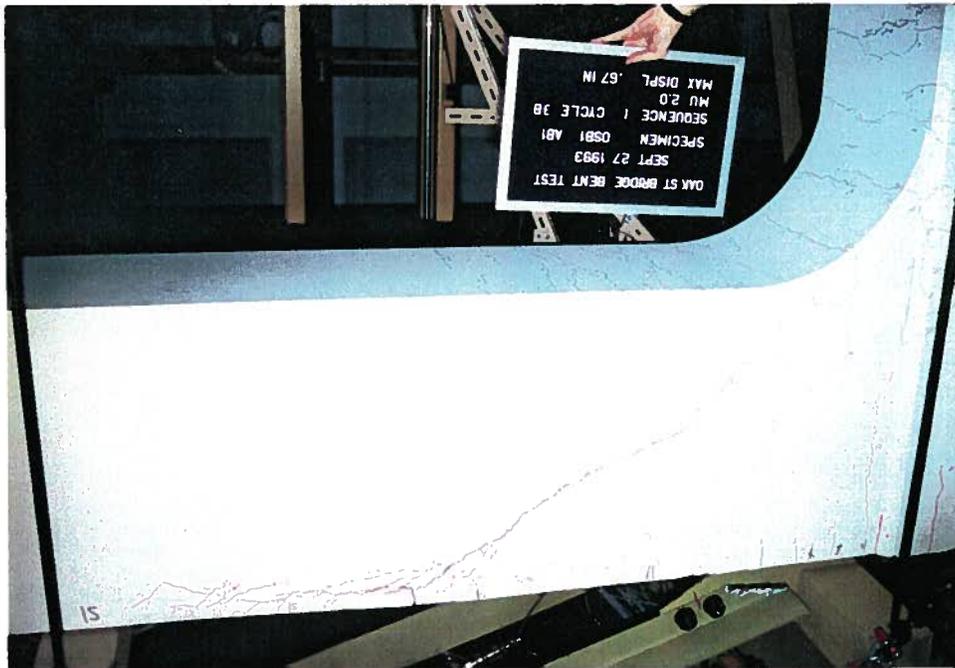
Fig. 6.17 Cap beam cracking Specimen OSB1

The cap beam of both the Joint specimen OJ1 and the Bent specimen OSB1 failed in shear (Fig.6.16 and 6.17). The major shear crack of OSB1 starts at the top of the cap beam exactly 5.0 ft away from the center line of the column. This crack propagates towards the column at angle of around 45 degrees. In the specimen OJ1, as the two bearing positions in the cap beam are 2'2" shorter than the full bent, the major shear crack originated closer to the column (4.0 ft from the center line of the column) and it extended at a much steeper angle (50 degrees) to the longitudinal axis of the cap beam (Fig. 6.18). The specimen OJ1 cap beam carried a maximum shear force of 49.7 kips at yield. This compares with the 53.6 kip shear force carried by the cap beam of specimen OSB1 (Appendix B Figs. B5 and B6).

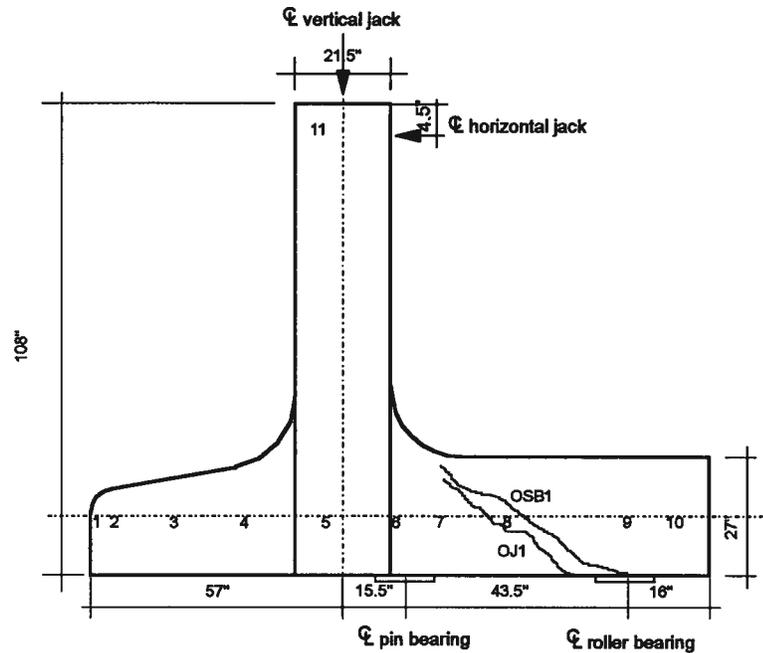
Fig. 6.18 Crack pattern of OJ1 and OSB1

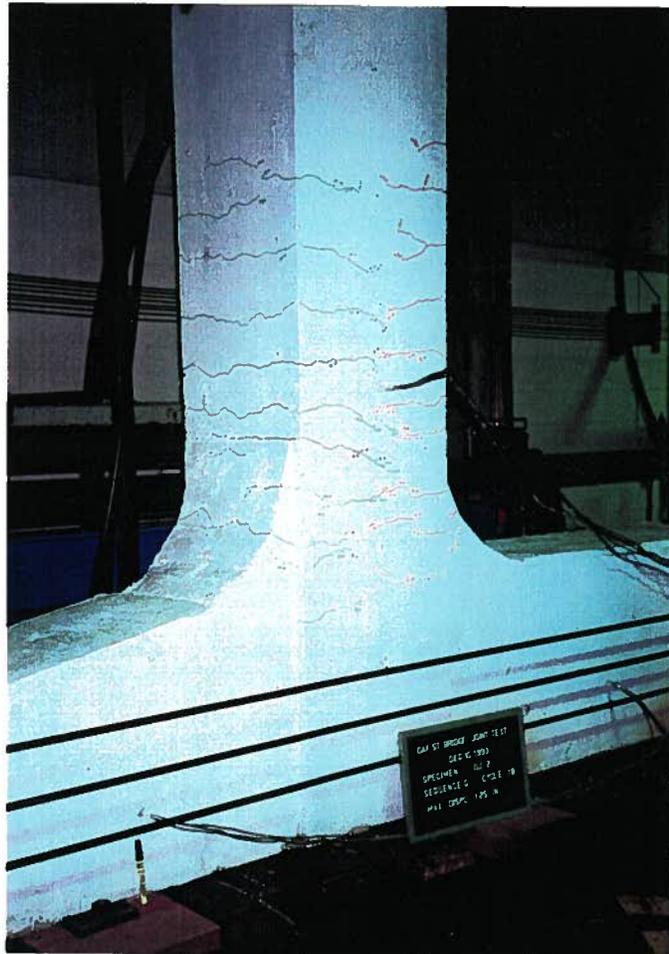
Fig. 6.19 Column cracking specimen OJ2

In joint specimen OJ2 and bent specimen OSB2, the crack pattern and spacing of cracks in the columns are very similar to each other (Fig.6.19 and 6.20). Initially the column flexural cracks started closer to the joint and extended down to the middle of the column in the subsequent sequences. It is difficult to compare crack patterns at different sequences for the OJ2 and OSB2 specimens as the load displacement relationships were different. There were very few cracks in the cap beams of specimen OJ2 and OSB2 as compared to the Specimens OJ1 and OSB1. The shear force carried by the cap beam and the column of specimen OJ2 were 67.4 kips and 50.5 kips respectively. These values are comparable with the shear carried by the cap beam and the column of OSB2 80.2 kips and 56.4 kips respectively (Appendix B Figs. B13 and B14).

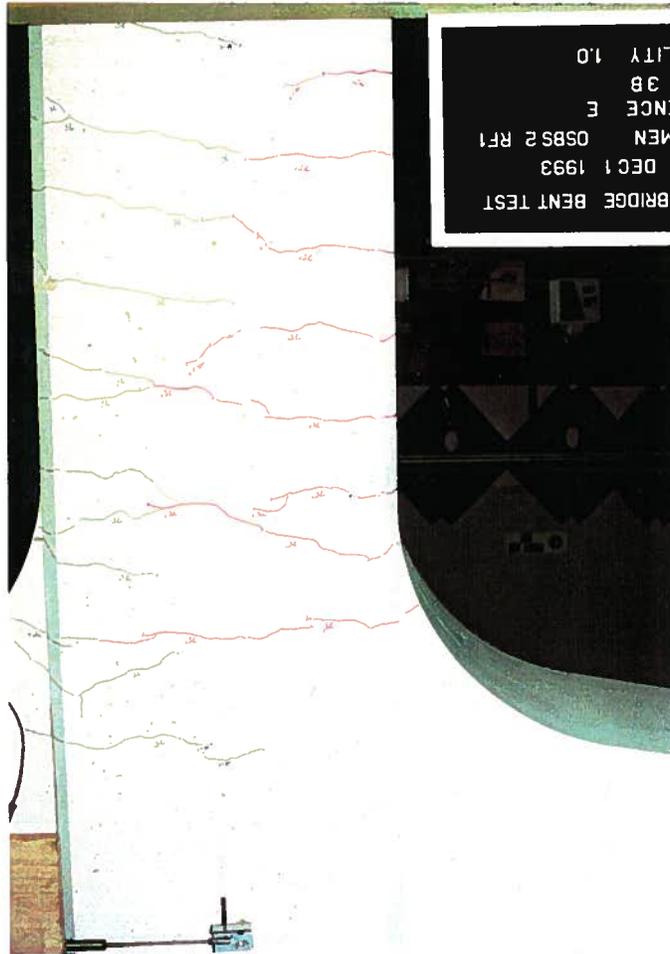
Fig. 6.20 Column cracking specimen OSB2.

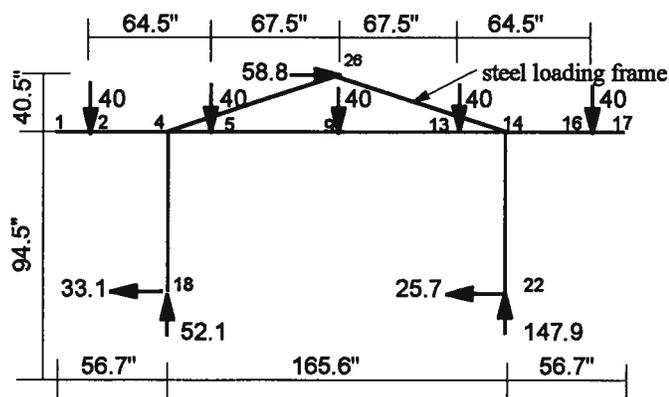
Fig. B.2 Maximum loading on OSB1

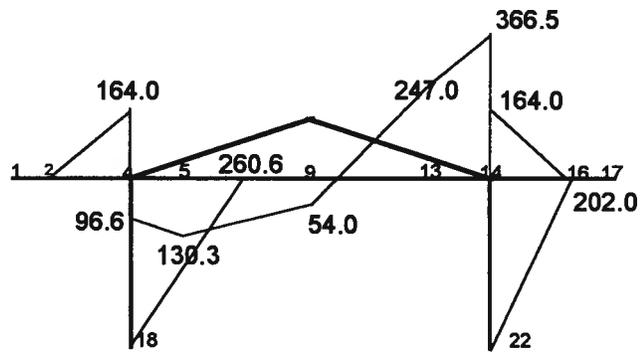
Fig. B.8 Bending moment on OSB1

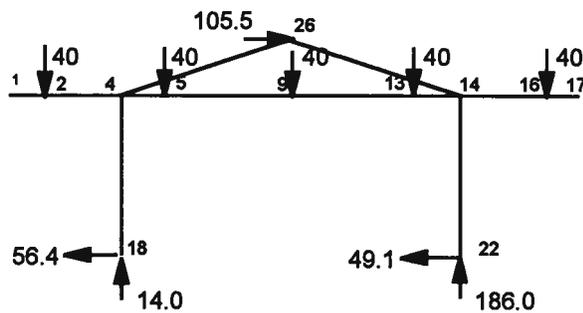
Fig. B.10 Maximum loading on OSB2

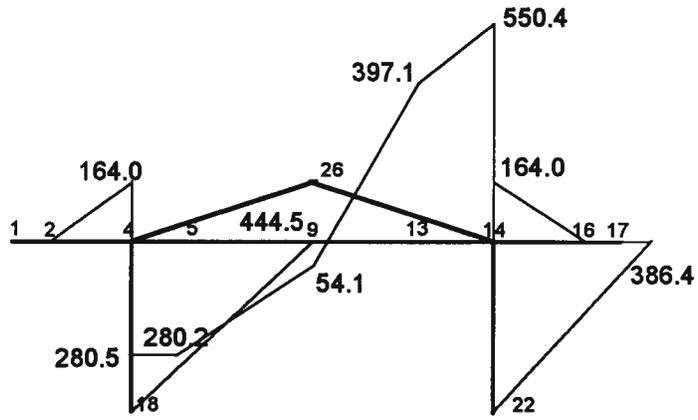
Fig. B.16 Bending moment on OSB2
