# **Retrofitting Beam-to-Column Joints for Improved Seismic Performance**

A THESIS SUBMITTED IN PARTIAL FULFILLMENT OF  
THE REQUIREMENTS FOR THE DEGREE OF  
MASTER OF APPLIED SCIENCE

THE UNIVERSITY OF BRITISH COLUMBIA

December 1992

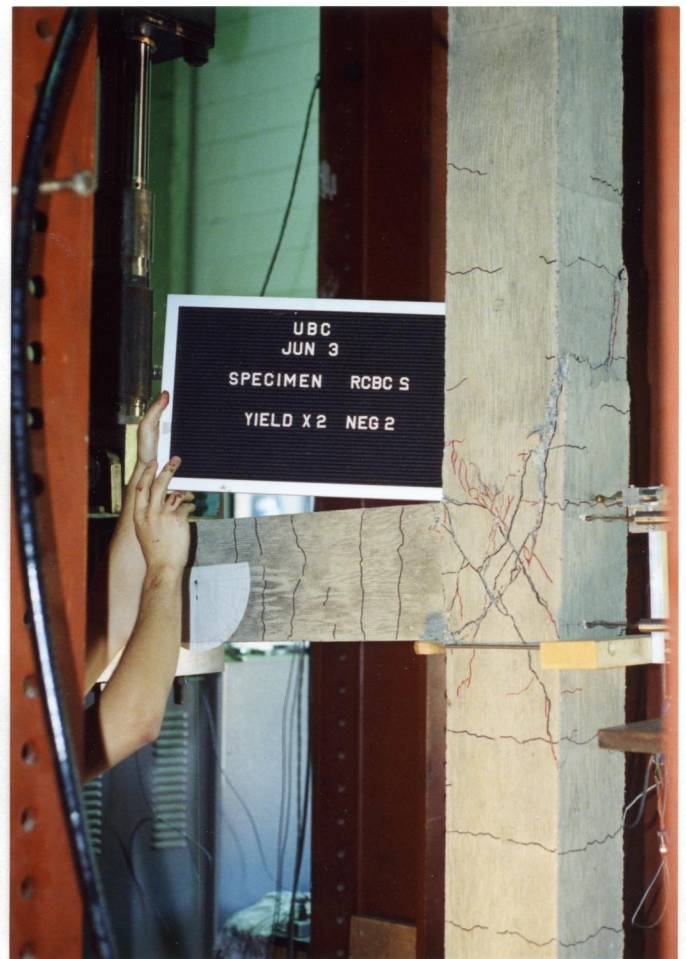
*Figure 5-2 Joint Damage in Unretrofitted Specimens*

*b) RCBC2*

The failure mechanism within the joint area was complex. At the point when failure of the specimen was considered to have taken place, the size of the cracks in the joint were visibly large (fig. 5-2), particularly during the negative load cycle. The top layer of longitudinal reinforcement consisted of 4 bars in the part of the beam adjoining the column, as opposed to only 2 bars in the bottom layer. The larger amount of steel in the top layer prevented hinging during the positive cycle, which in turn pushed the damage into the joint region. However, the reinforcement in the bottom layer of steel actually attained the yield stress, and a plastic hinge formed in the beam near the interface of the beam and the column (fig. 5-3a). During the negative portion of the cycle, a different type of failure occurred, as the stress in the top layer of steel never reached yield stress. The attainment of maximum moment was limited by the failure of the bond between the longitudinal reinforcement bars and the surrounding concrete in the joint area, as well as by the large amount of straining in the cracked concrete within the joint area (fig. 5-3b). Evidence of bond failure was indicated by the spalling of the cover concrete, particularly on the rear face of the joint along the column (fig. 5-3c). This suggests that the hooked ends of the longitudinal reinforcement moved outwards to split the cover and lose its bond with the

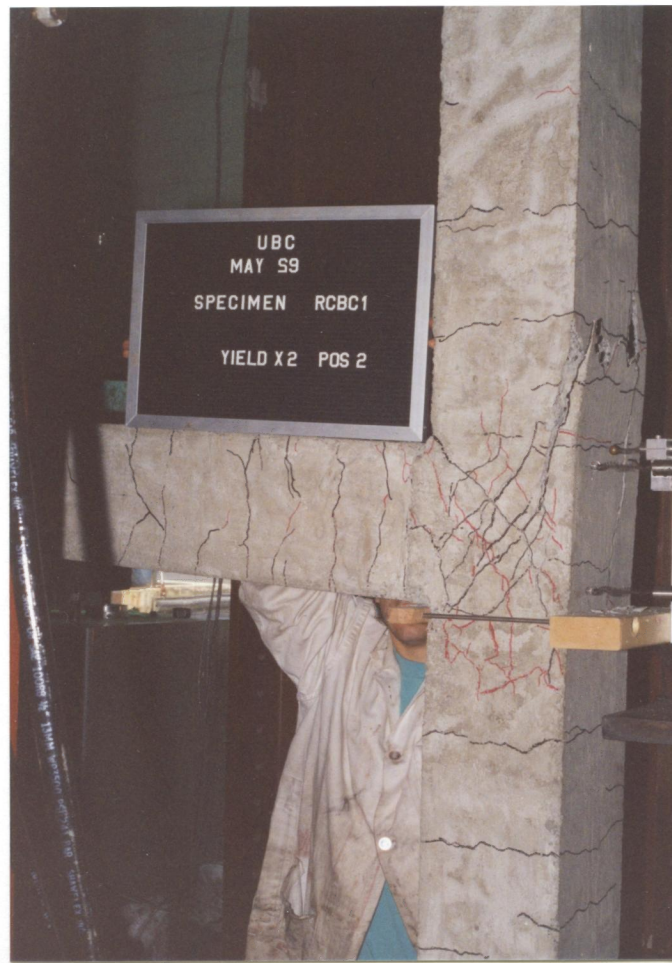
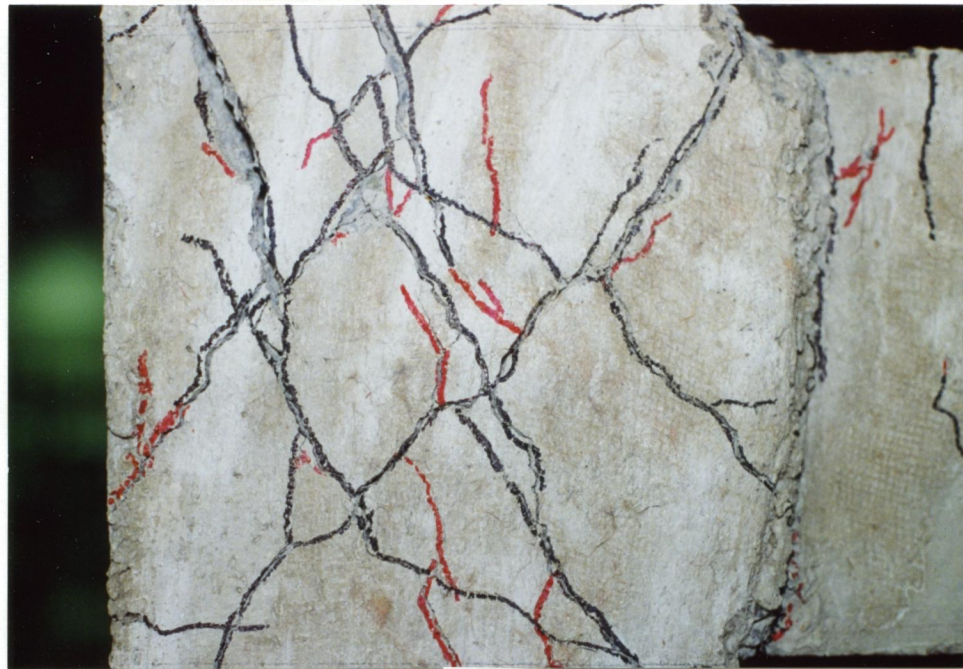
*Figure 5-3 Failure of Unretrofitted Specimens*

*a) Hinge in Joint*

*b) Shear Cracking in Joint Area*

*c) Spalling on Rear Face of Column*

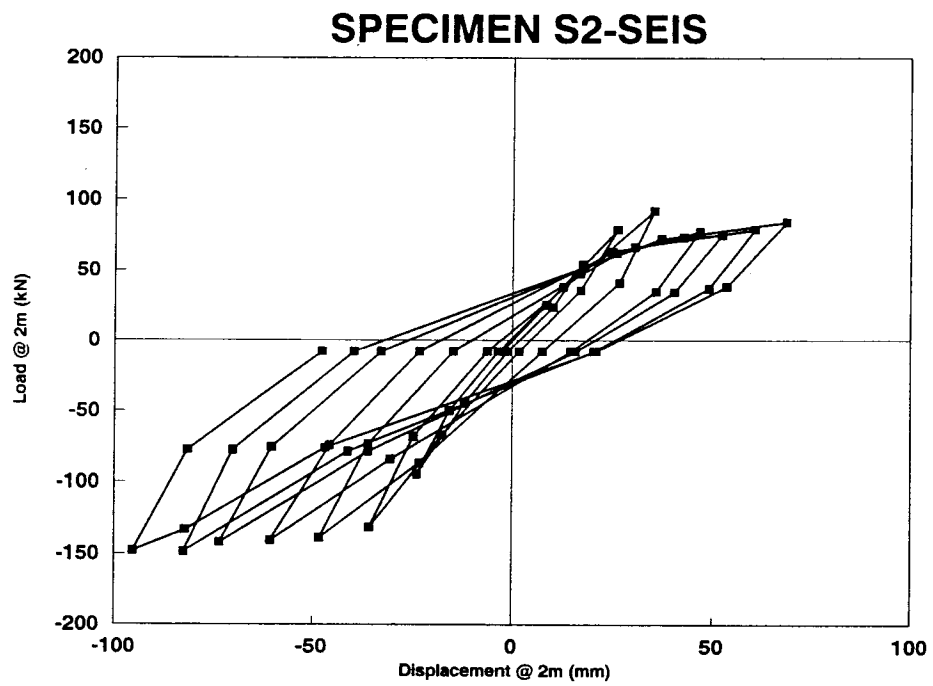
*Figure 5-4 Hysteresis Loop of a Specimen of Modern Design*

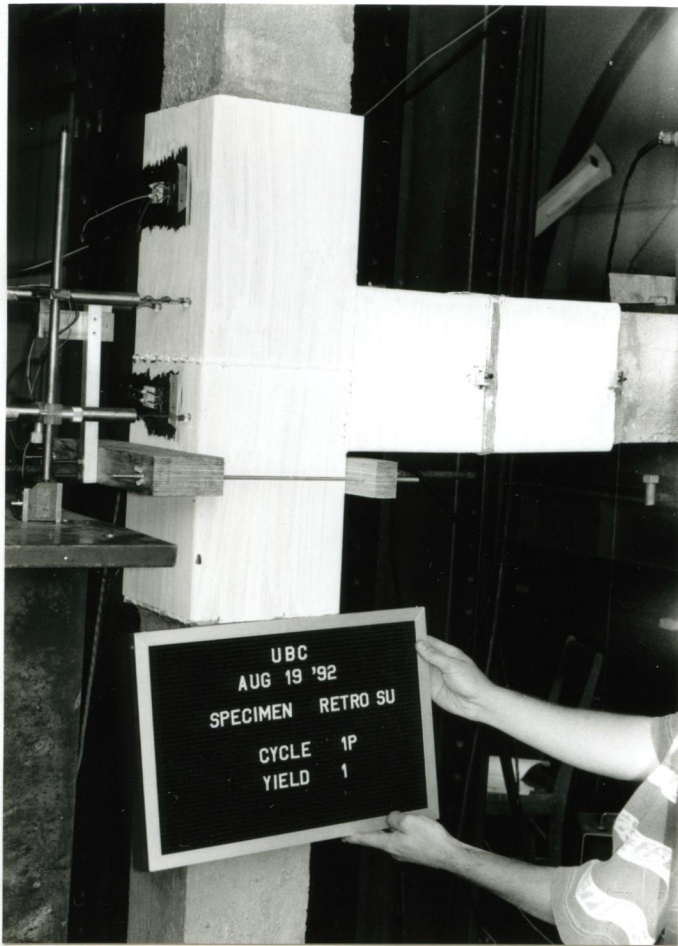
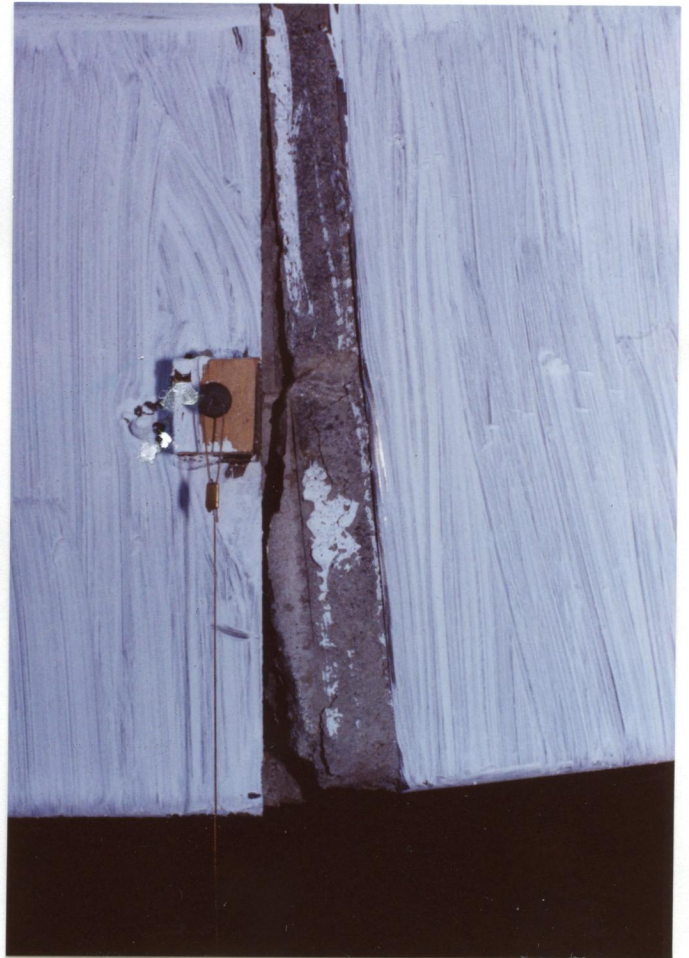
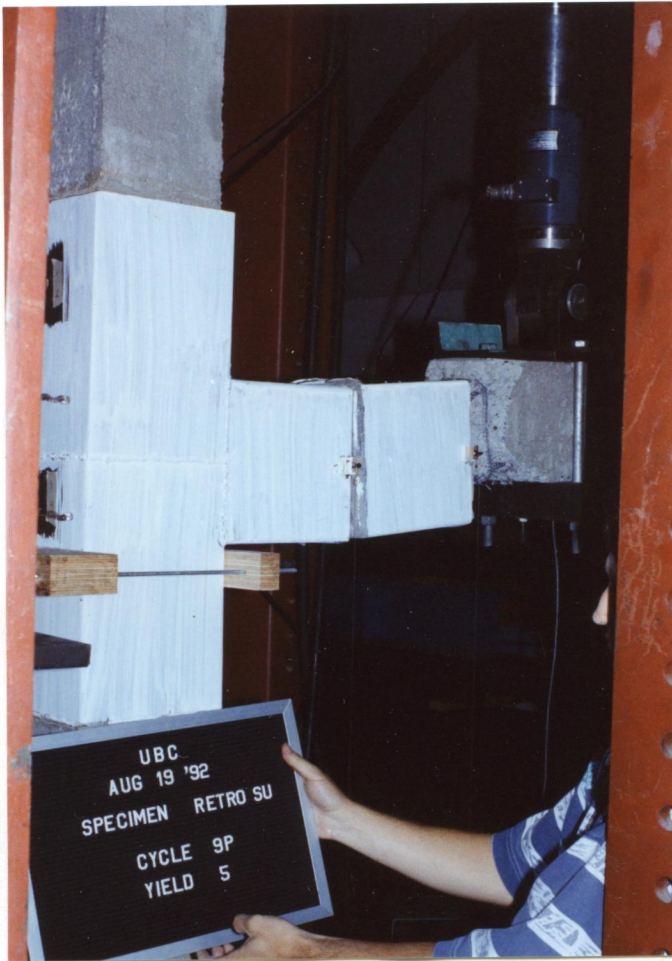
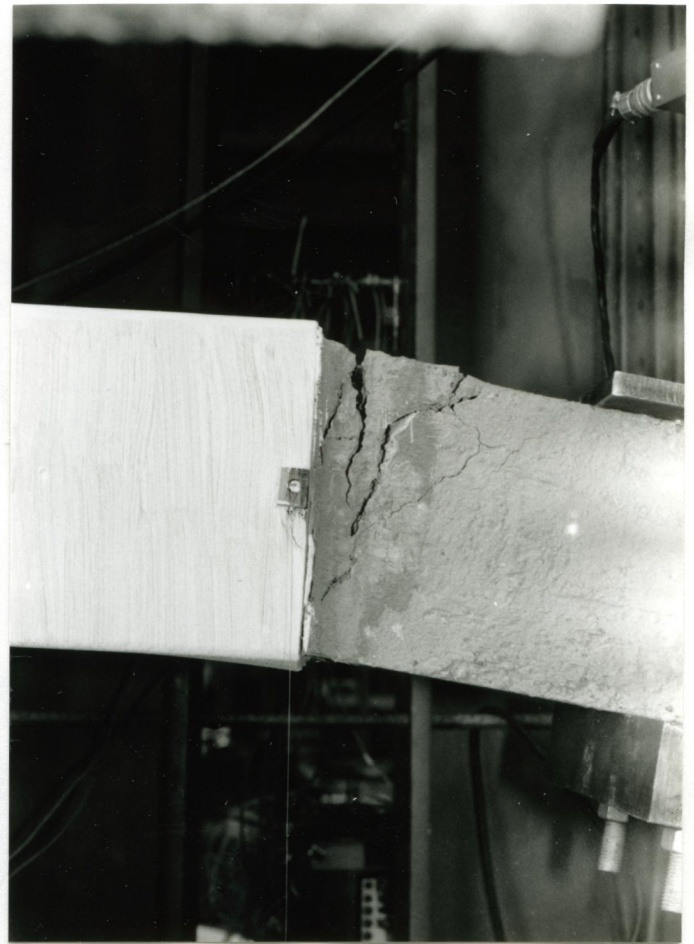
*Figure 6-1 Retrofitted Specimen RETRO-SU*

RETRO-SU (fig. 6-1a) developed two modes of failure, depending on the direction of the loading. With positive (upward) loading, a flexural hinge formed at the gap between the two sections of steel jacket in the beam (fig. 6-1b). With negative (downward) loading, a flexural hinge formed at the end of the retrofit area of the beam (fig. 6-1c). With repeated cycling this flexural hinge progressed into a shear failure of the specimen at this point (fig. 6-1d). The flexural hinge that had been developing on the bottom face of the gap area stopped expanding once the shear cracks on the upper face became very large. The failure of the specimen outside of the retrofit area was considered to be undesirable in the extreme. A subsequent section analysis of the specimen showed that the moment capacity during negative loading at the gap was large enough to deflect failure to the end of the retrofit.

*a) Before Test*

*b) Hinge Formation During Positive Loading*

*c) Hinge Formation During Negative Loading*

*d) Failure*

During the test of this specimen, a number of "pops" were heard as the bond between portions of the concrete and the steel jacket was lost and the jacket buckled outwards. This was not unexpected, since square tubing has a tendency to buckle under compression. The question of load transfer through bond became quite prevalent in this study. If no bond existed between the concrete and the steel jacket, flexural failure of the specimen should have occurred in the joint area, as in the unretrofitted specimens, since this was the location

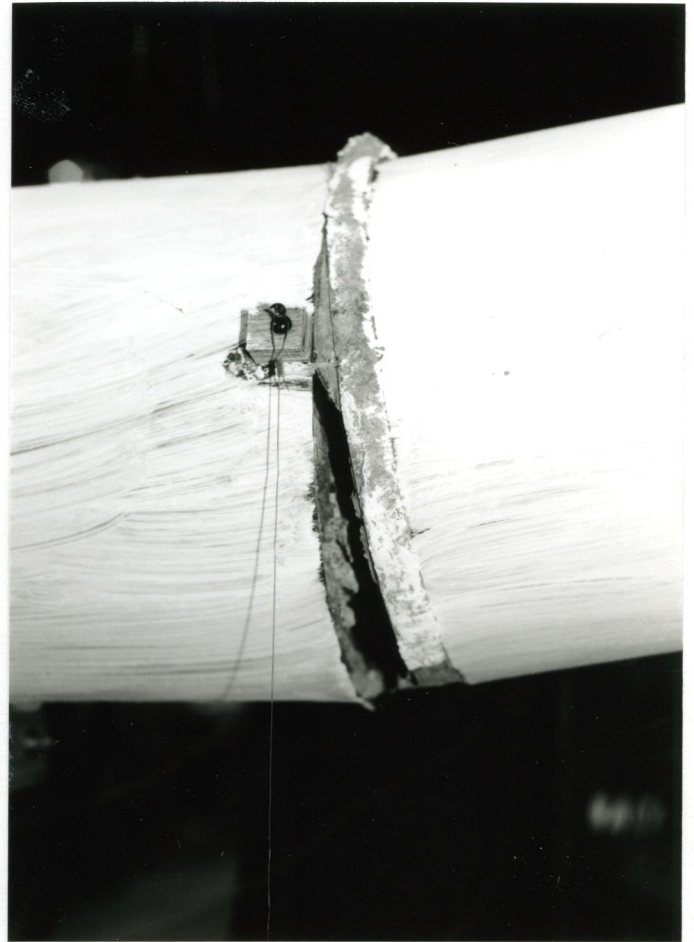
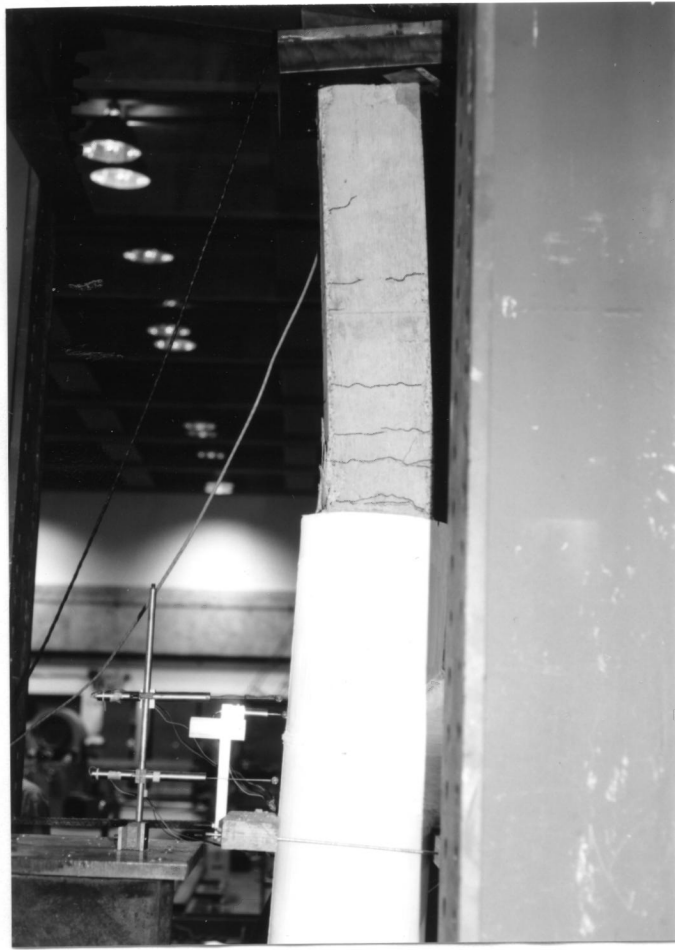
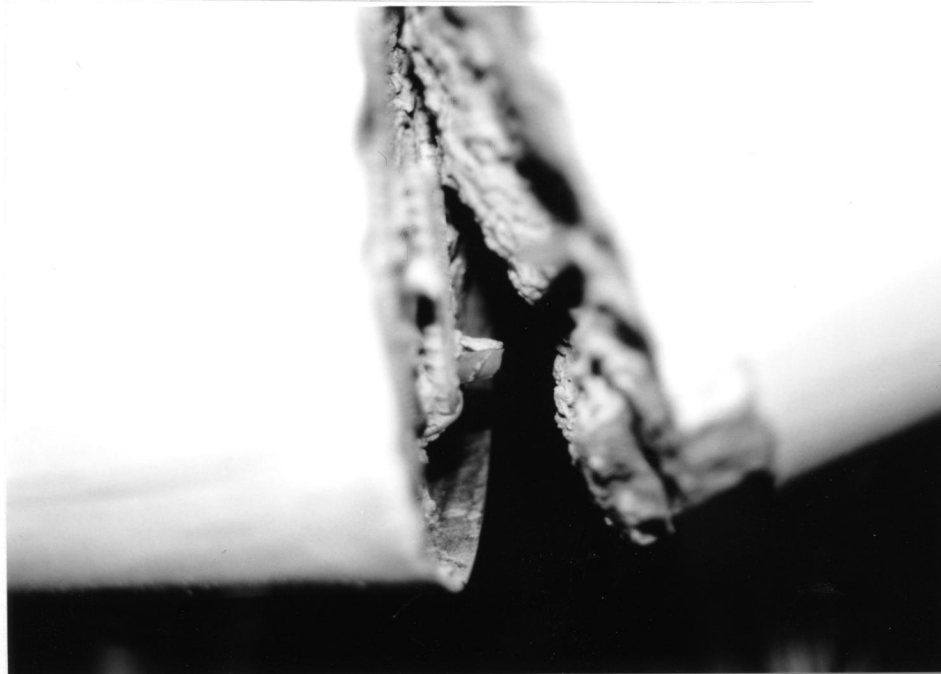
*Figure 6-4 Retrofitted Specimen RETRO-CU*

Specimen RETRO-CU (fig. 6-4a) also developed two modes of failure, depending on the direction of loading. With positive loading, a flexural hinge developed at the gap between the two sections of the steel jacket surrounding the beam (fig. 6-4b). With negative loading, a flexural hinge once again formed outside the retrofitted region, but in this case its location was at the end of the retrofit on the upper portion of the column (fig. 6-4c). In order to avoid a catastrophic buckling failure of the column, negative loading past a ductility factor of  $\Theta=1.5$  was avoided, since it was deemed more desirable to observe the effects of the development of the plastic hinge within the retrofitted zone. Had the experiment continued according to the originally planned cycle of loading in both the positive and

*a) Before Test*

*b) Hinge Formation During Positive Loading*

*c) Column Hinge Formation During Negative Loading*

*d) Failure*

During positive loading, when the flexural hinge developed within the retrofit gap, there was no loss of strength of the specimen (fig. 6-5a,b). However, a reduction in the strength of the specimen occurred during negative loading due to P- $\delta$  effects. Fig. 6-5 indicates that some reduction in the stiffness of the section and some hysteresis loop pinching took place during the test, most noticeably during the negative loading, when failure occurred within the unretrofitted section of the column.

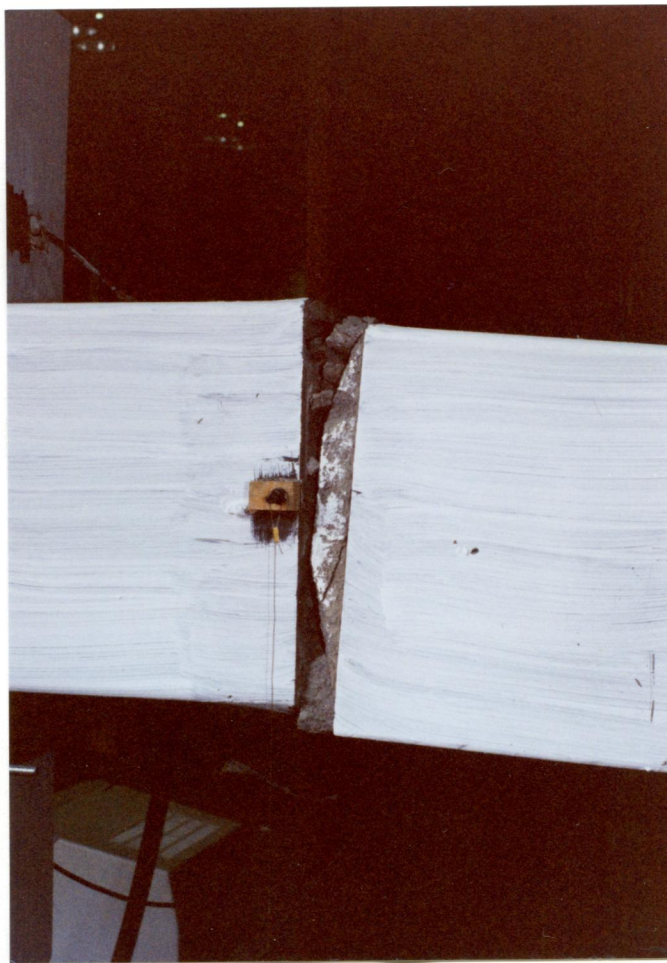
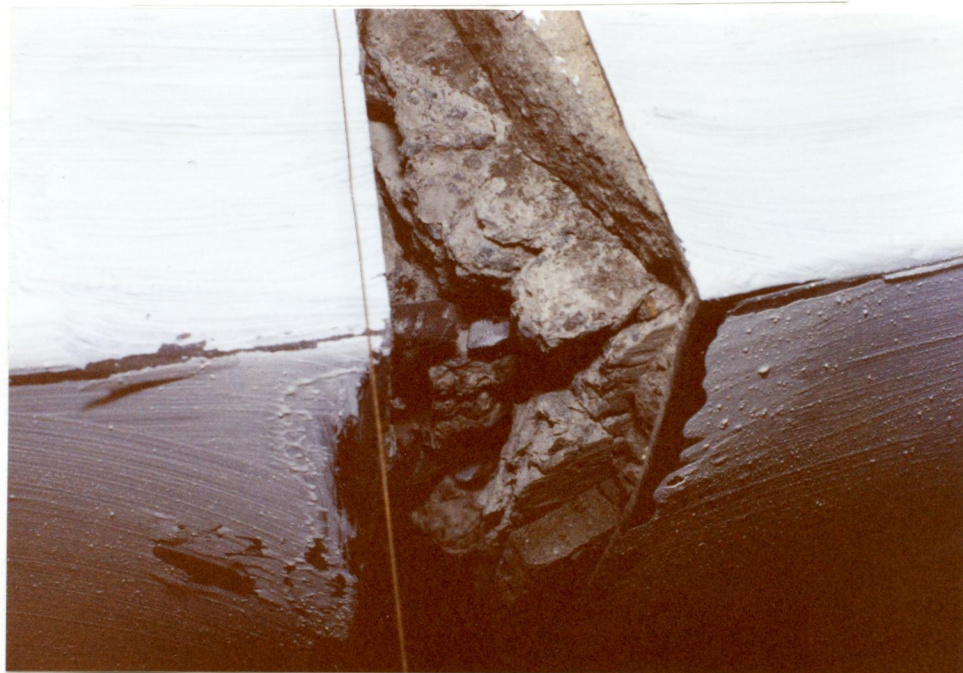
*Figure 6-7 Retrofitted Specimen RETRO-SD*

Failure of the specimen was caused by flexural yielding and tensile rupture of the

*a) Before Test*

*b) Hinge Formation During Positive Loading*

*c) Hinge Formation During Negative Loading*

*d) Failure*
