SLOPE STABILITY OF NEMO AND WEE SANDY CREEK BASINS  
NEAR SLOCAN LAKE, BRITISH COLUMBIA

A THESIS SUBMITTED IN PARTIAL FULFILMENT OF  
THE REQUIREMENTS FOR THE DEGREE OF  
MASTER OF APPLIED SCIENCE

THE FACULTY OF GRADUATE STUDIES  
DEPARTMENT OF GEOLOGICAL SCIENCES  
(Programme of Geological Engineering)

July 1982

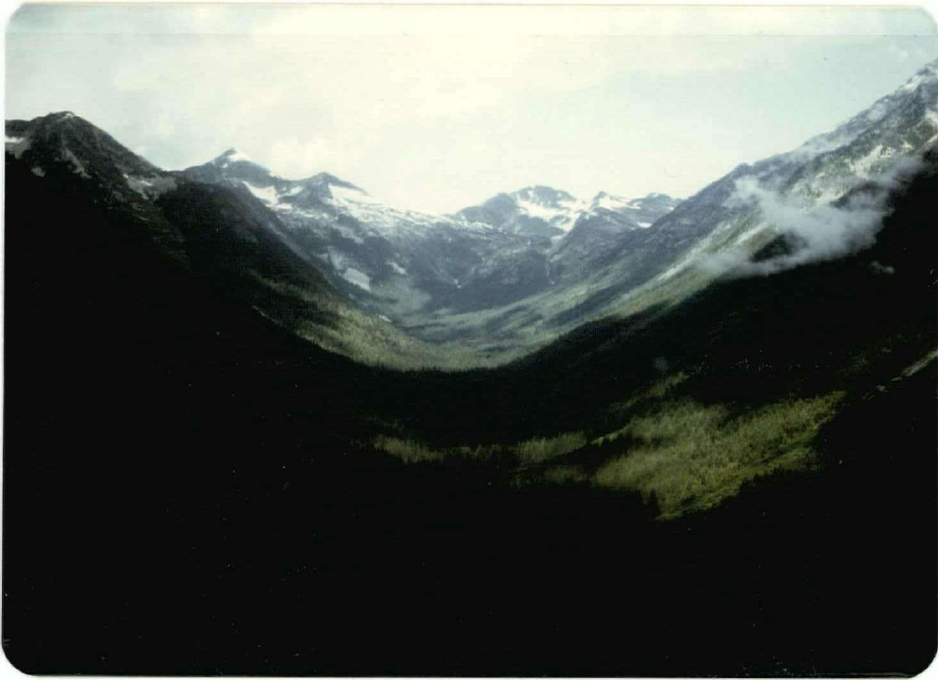
Figure 2.1. Aerial view of upper Nemo Creek Basin.

The upper end of Nemo Creek is dominated by Mount Meers to the north, Hela Peak to the south, and a series of cirque basins with floors at elevations between 1850 and 2150 meters. Lower Nemo Creek is flanked to the north by rugged cliffs, which rise some 1060 meters from the valley bottom. Nemo Creek has numerous small tributaries that enter from cirque basins on both the north and south sides of the upper valley and a few minor tributaries which feed from the straight, steep slopes of the lower valley. Valley geometry is typically U-shaped in the upper reaches but becomes dominately V-shaped in the lower valley. Figure 2.1 illustrates the U-shaped geometry of the upper Nemo Creek Basin.

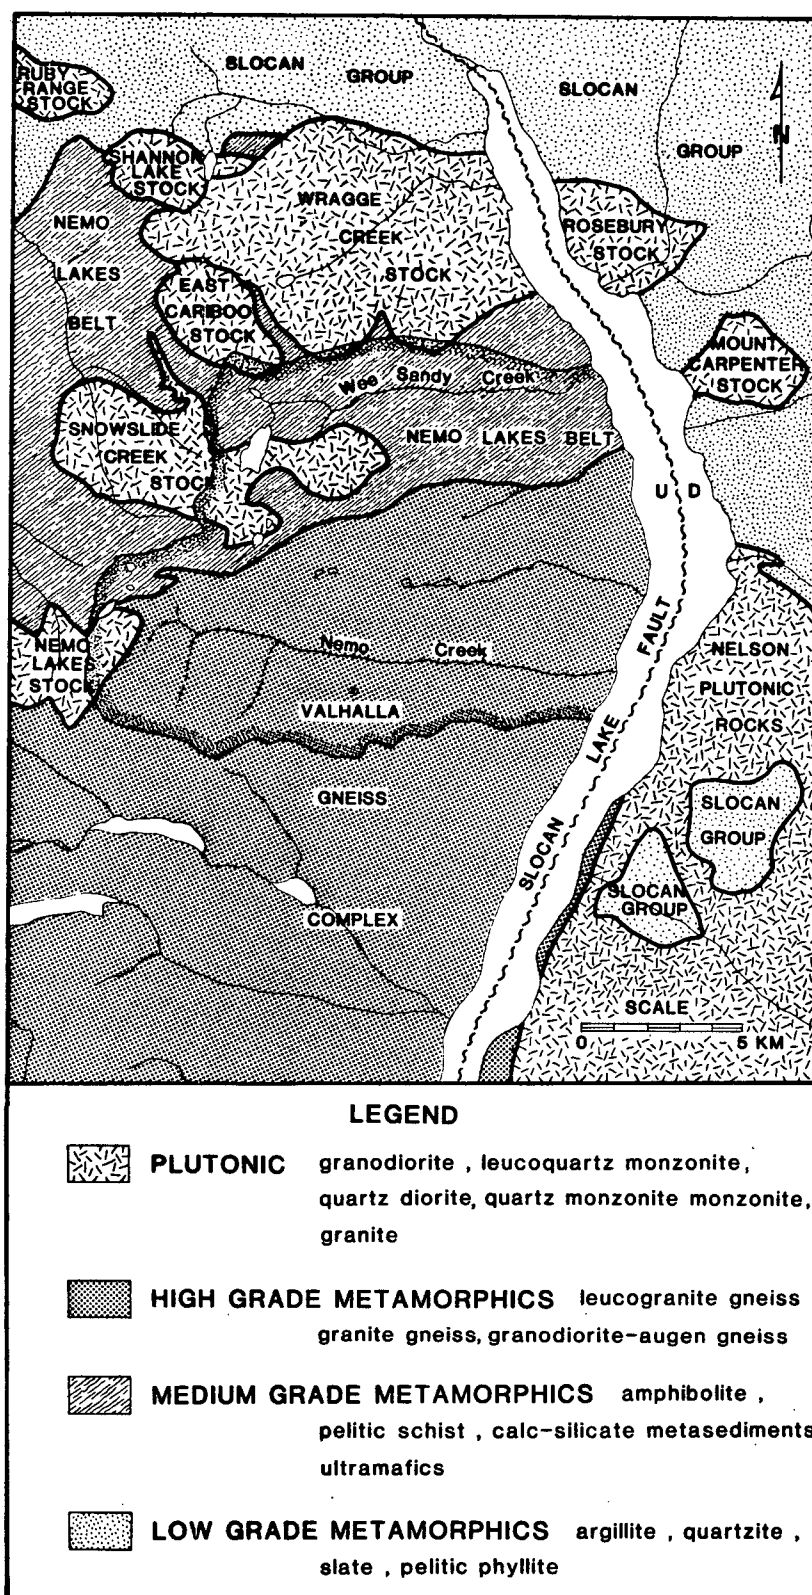
Figure 2.2 Geology of the study area.

At the head of Nemo Creek, the monzonitic Nemo Lake Stock intrudes the gneiss complex. A mixture of metamorphic and plutonic rocks constitute a zone of "mixed gneiss" at the

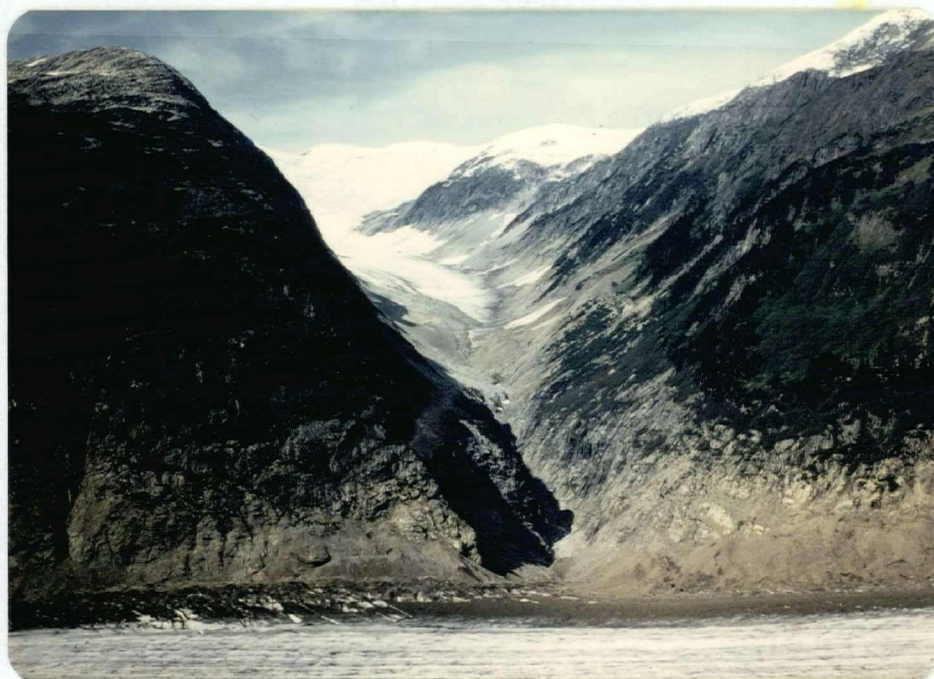
Figure 2.3 Salmon Glacier, near Stewart, B.C. showing the retreat of a tributary glacier prior to the disappearance of the main trunk glacier. The tributary valley occupies a valley similar in geometry to that of both Nemo and Wee Sandy Creeks. (Photo taken by W.H. Mathews).

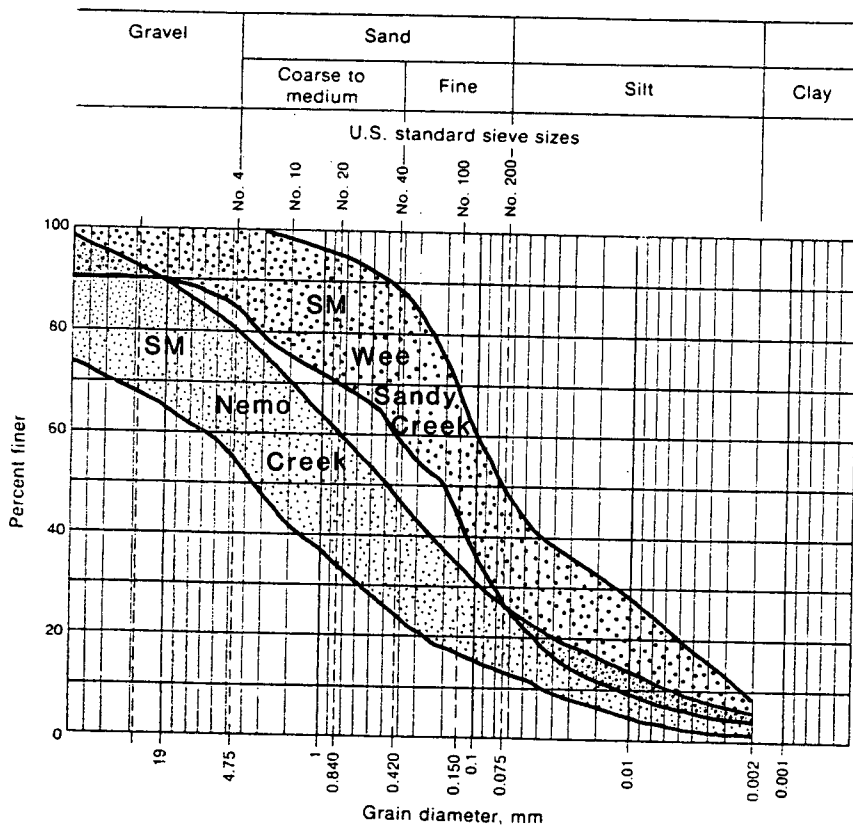
Figure 2.4 Grain-size distributions for morainal SM soils sampled in Nemo and Wee Sandy Creek Basins.

fractions generally less than 20% and only minor clay. Ablation morainal deposits in Wee Sandy Creek basin tend to have finer sand components resulting from comminution of finer grained schists. Figure 2.4 illustrates the obvious difference between

the grain-size distributions of morainal silty sand deposits (SM in the Unified Soil Classification) sampled in Wee Sandy Creek

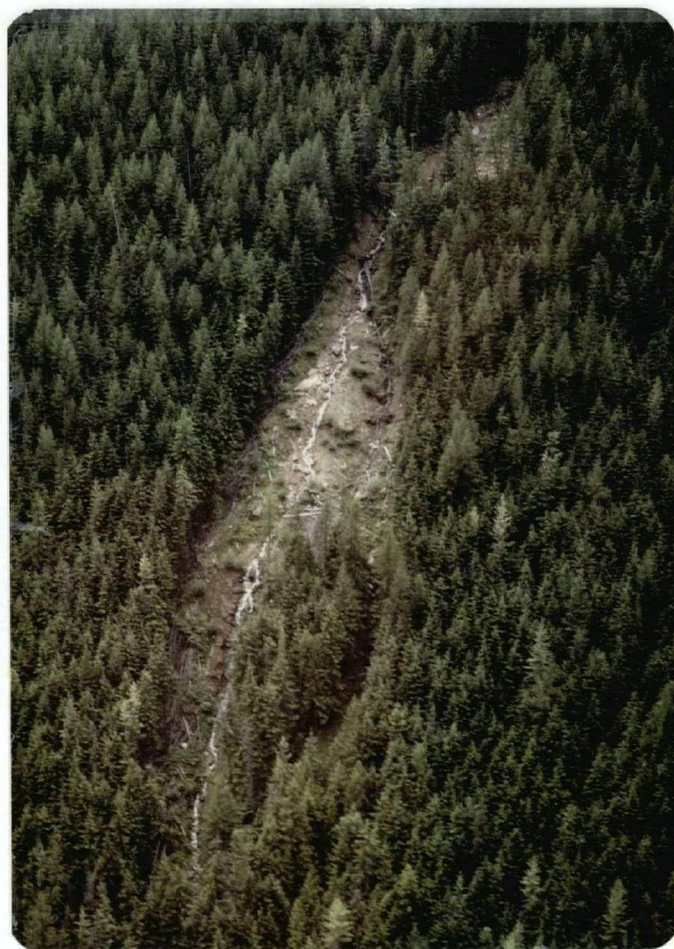
Figure 2.5. Debris avalanche on a north-facing slope of the lower Nemo Creek Basin.

unweathered granite gneiss shear surface inclined at  $30^{\circ}$  in lower Nemo Creek Basin.

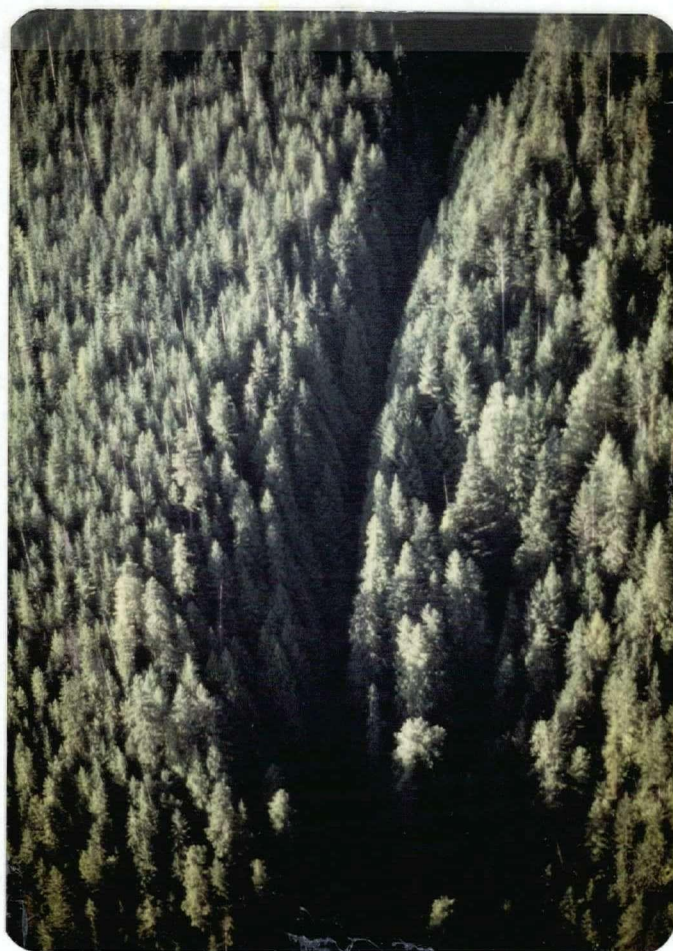
Figure 2.6 Debris avalanche - debris flow path subsequently reforested on the north-facing slope of lower Wee Sandy Creek Basin.

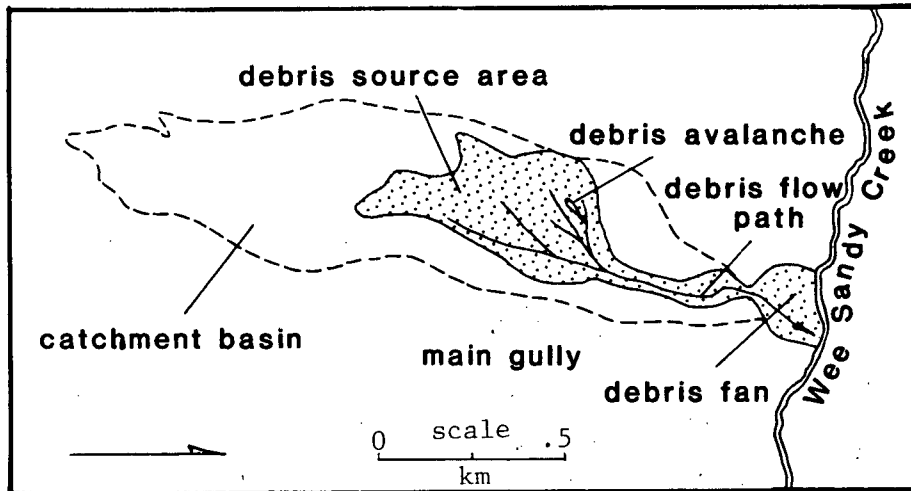
Figure 2.7 Debris flow system on the north-facing slope of the lower Wee Sandy Creek Basin showing the debris source, the main gully, and the debris fan.

2.7 is the plan view of a particular gully network incised into a glaciofluvial blanket that serves as a debris source area for a recurrent debris flow system. The size of the debris fan at the base suggests that this debris flow system has been only slightly active since the last glaciation. There is little evidence of fluvial erosion at the toe of the fan.

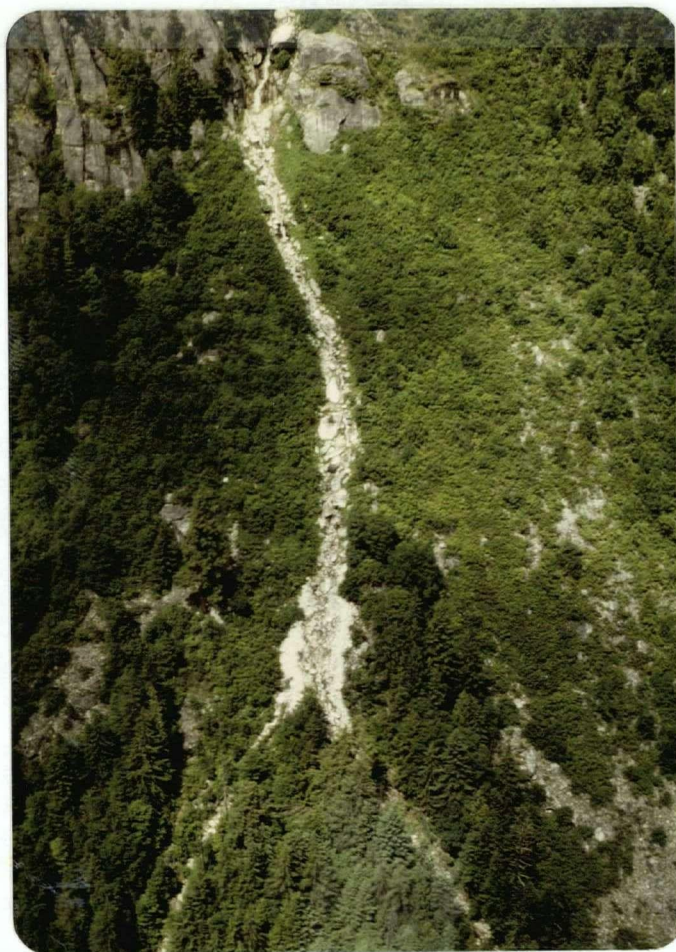
Figure 2.8 Debris flow that has bifurcated on a debris fan of upper Nemo Creek Basin.

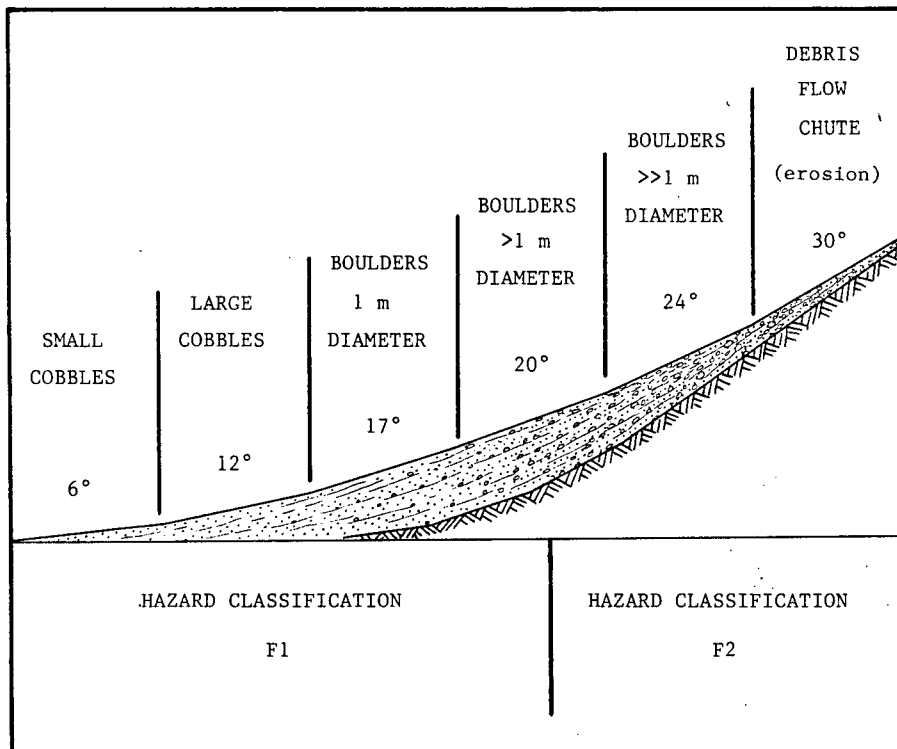
Figure 2.9 Profile of a debris flow on a debris fan in upper Nemo Creek Basin showing the sizes of the largest rock fragments deposited as levees along the flow path. Included are the hazard subdivisions for debris fans discussed in Chapter 5.

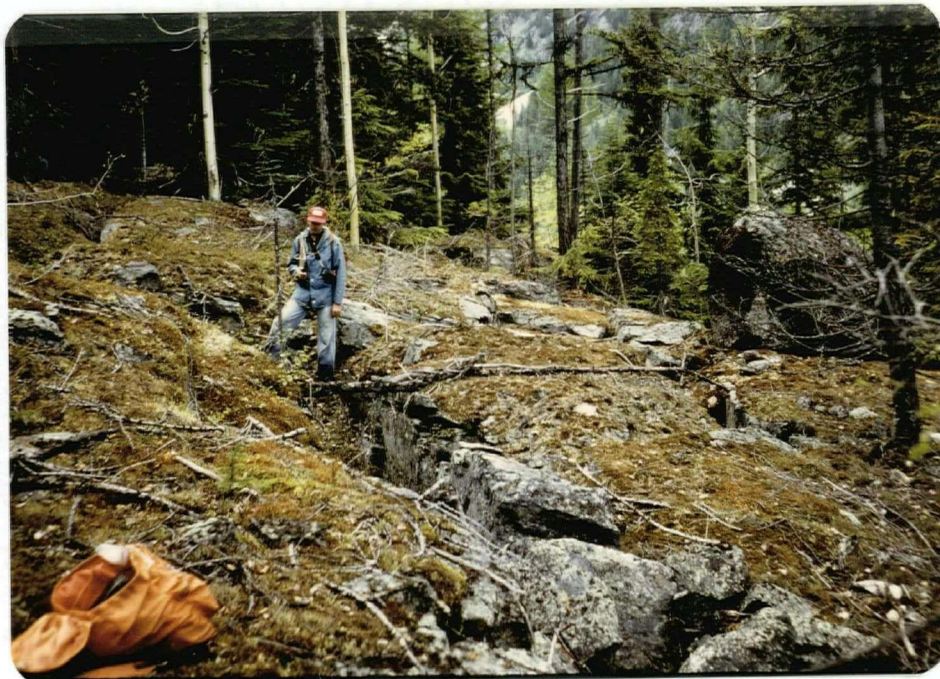
Figure 2.10 Toppling rock failure in lower Nemo Creek Basin.

forms below. Near lower Nemo Creek, the toe of a large rotational rock slide is undergoing toppling failure as evidenced by deep cracks shown in Figure 2.10. It is supposed

that northward dipping foliations, coupled with glacially oversteepened slopes are contributing to these slides. They are large enough to constitute mappable rock units, but because they either (1) retain their mantle of original surficial materials or (2) form blocky colluvial slopes similar to other non-sliding areas, they have not been mapped individually. Small rockslides are confined to areas of steep rock and colluvium where failure is controlled by exfoliation jointing and perhaps initiated by frost-wedging or seismic activity.

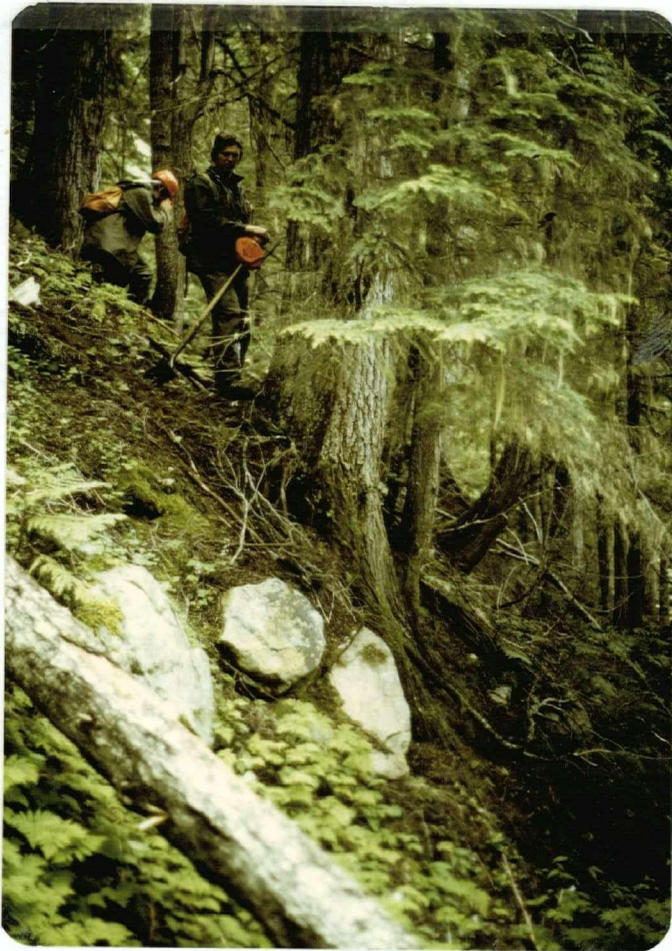
Figure 2.11 Buttressing effect of tree roots resisting soil creep.

Trees tipped or bowed along their entire length, indicative of incipient landsliding or soil creep, were rarely observed in the study area. The non-viscous properties of sandy to gravelly soils have limited soil creep processes to those associated with the incremental movement of discrete particles accelerated by tree rooting and tree overthrow. Only on slopes inclined in excess of  $35^{\circ}$  was strong evidence of soil creep observed. Figure 2.11 shows the buttressing effects of a tree on a  $40^{\circ}$  slope subject to soil creep and perhaps some minor sloughing.

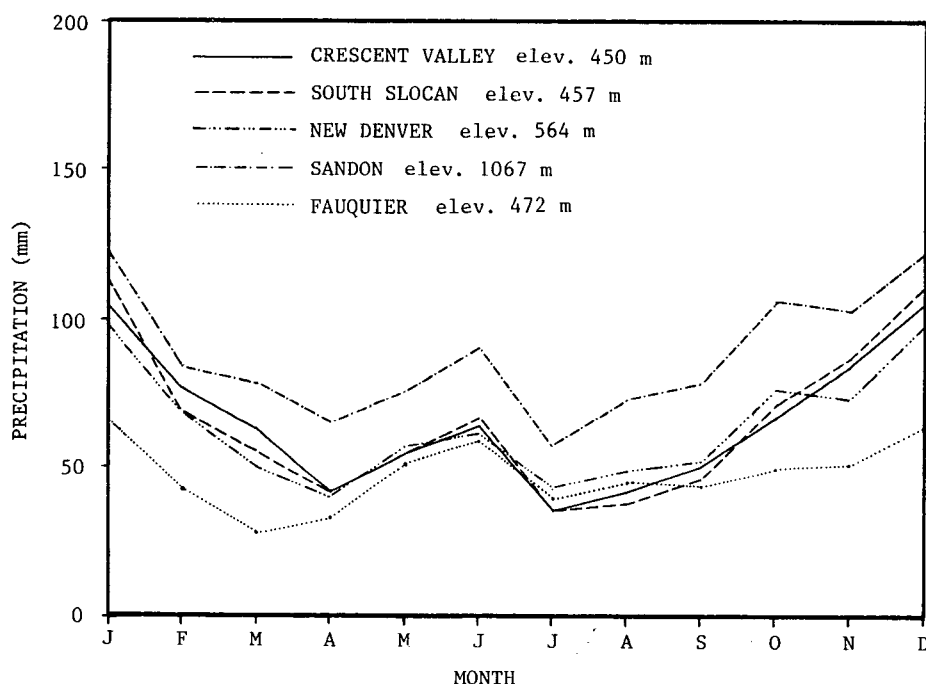
Figure 2.13 Mean total monthly precipitation for selected weather stations near the study area (Air Studies Branch, B.C. Ministry of Environment).

Slocan Valley proper are similar from station to station at the lower elevations of the valley bottom and that precipitation increases significantly with elevation in the New Denver - Sandon area (see Figure 2.13). Extreme 24-hour precipitation intensities between 1941 and 1970 are shown in Figure 2.14 for New Denver, Fauquier and Sandon. At all stations, the most

intense storms occurred during the months of June and September with intensities ranging between 41 and 56 mm/day. The unstable air patterns which dominate the summer season give rise to large thunder cells that affect localized areas only. The random nature of these storm events precludes the determination of any areal distribution pattern. However, it has been suggested that summer thunderstorms may increase in frequency and intensity at upper elevations (Utzig 1978). The 48-hour precipitation extremes for New Denver are given in Figure 2.15 showing a maximum of 77 mm per 48-hour period.

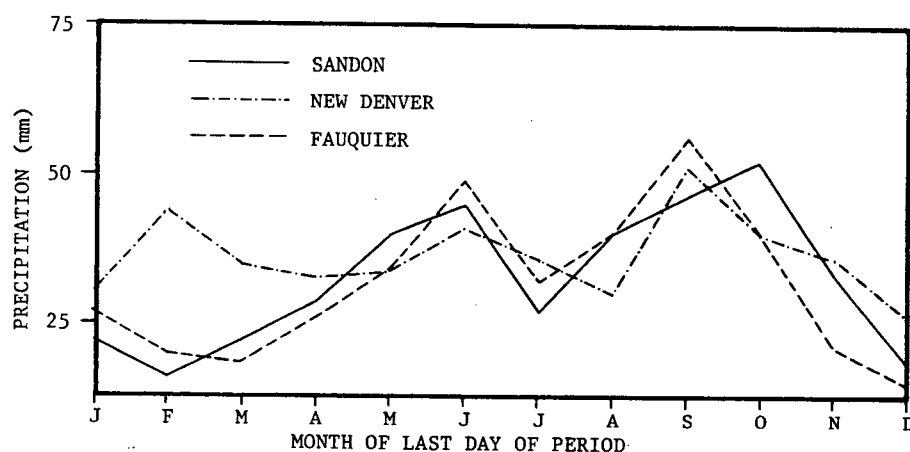
Figure 2.14 Twenty-four hour precipitation extremes for New Denver, Sandon and Fauquier from 1924 to 1979 (Air Studies Branch, B.C. Ministry of Environment).

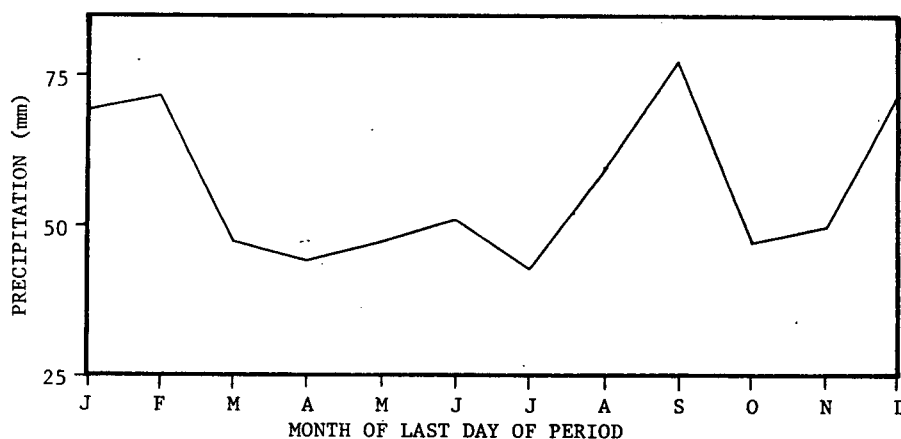
Figure 2.15 Forty-eight hour precipitation extremes for New Denver, B.C. from 1924 to 1979 (Air Studies Branch, B.C. Ministry of Environment).

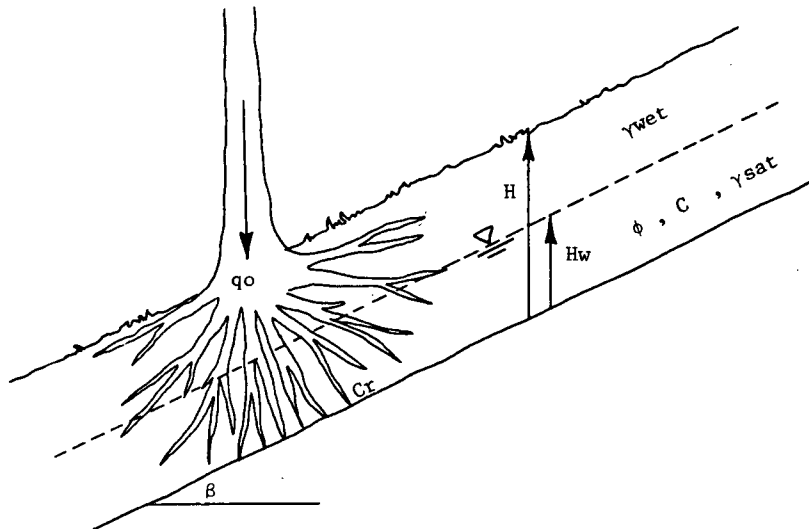
- $\beta$  = slope inclination
- $\phi$  = range of angles of internal friction of soil
- $C$  = soil cohesion
- $C_r$  = root cohesion
- $q_0$  = tree surcharge load
- $\gamma_{wet}$  = unit weight of soil
- $\gamma_{sat}$  = unit weight of saturated soil
- $\gamma$  = unit weight of water
- $H$  = height of soil mantle above shear surface
- $H_w$  = height of water table above shear surface
- $M = H_w/H$

Figure 3.1. Definitions of input variables used in the deterministic geotechnical model.

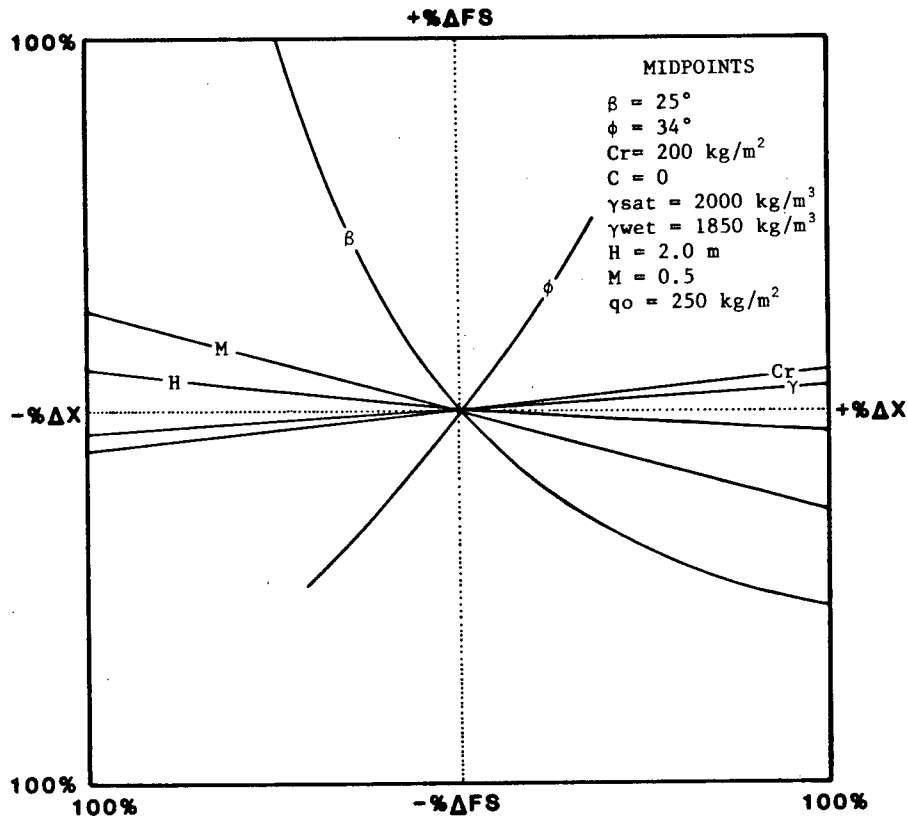
Figure 3.2 Diagram showing the sensitivity of the factor of safety FS to variations in model variables.

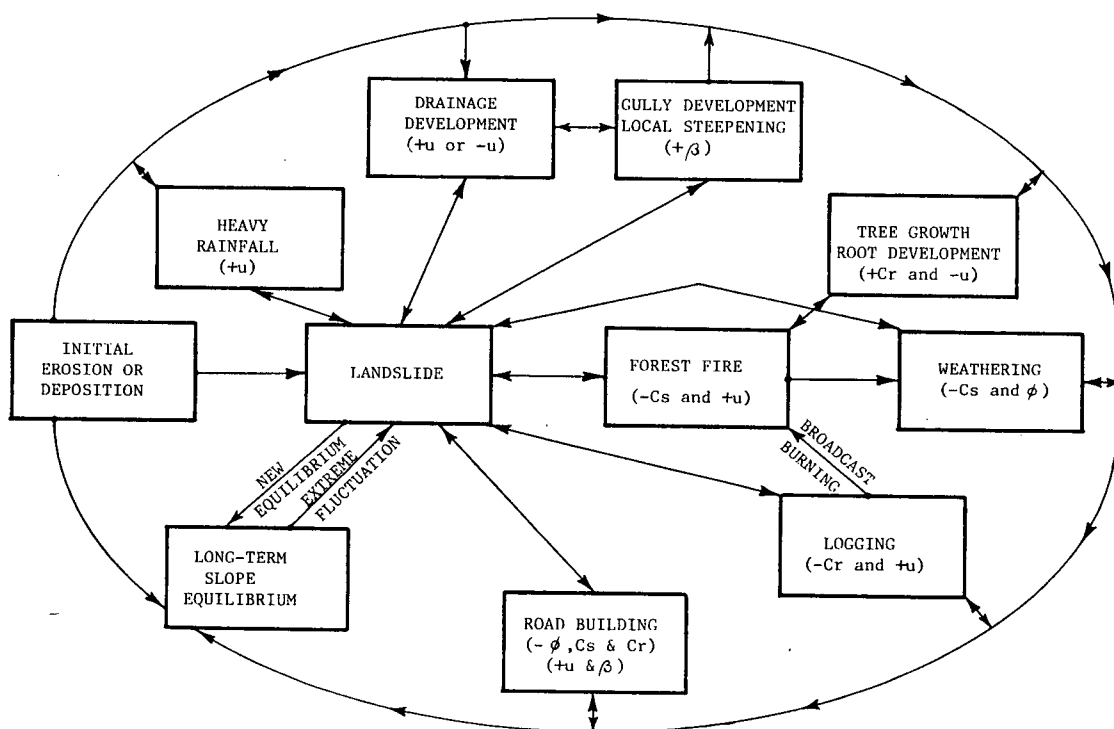
Figure 3.3 Alterations to slope equilibrium subsequent to glaciation leading to long-term stability.

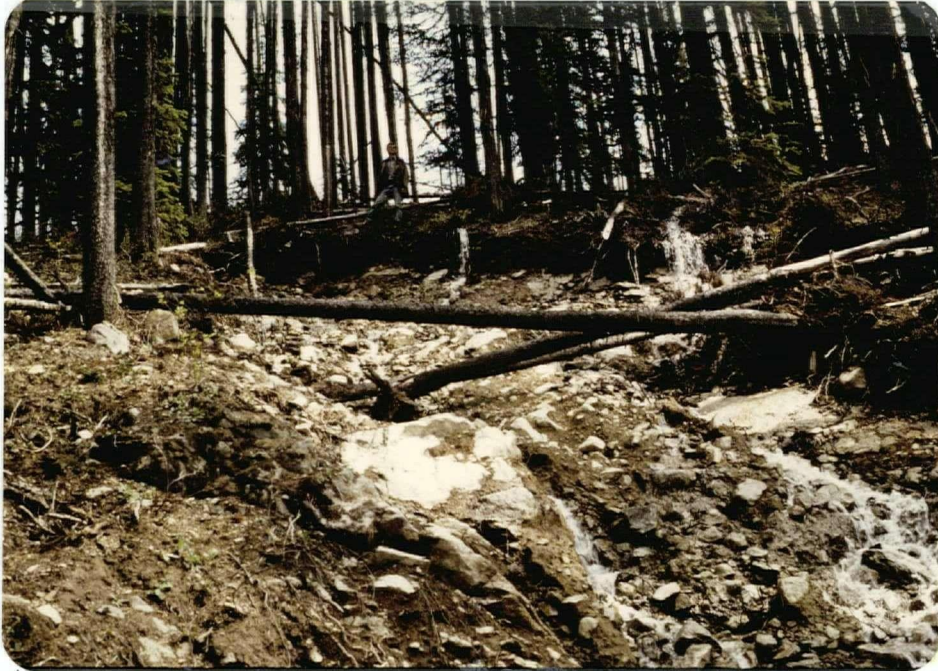
Figure 3.5. Landslide D-14 showing the failure of a thin veneer of soil on a planar bedrock shear surface.

estimated for firm GW soil<sup>1</sup>,  $H = 1.0$  meters and  $\beta = 35^\circ$  were directly measured and  $\gamma_w = 1000 \text{ kg/m}^3$  is a physical constant. Firsthand observations of water issuing from the head scarp

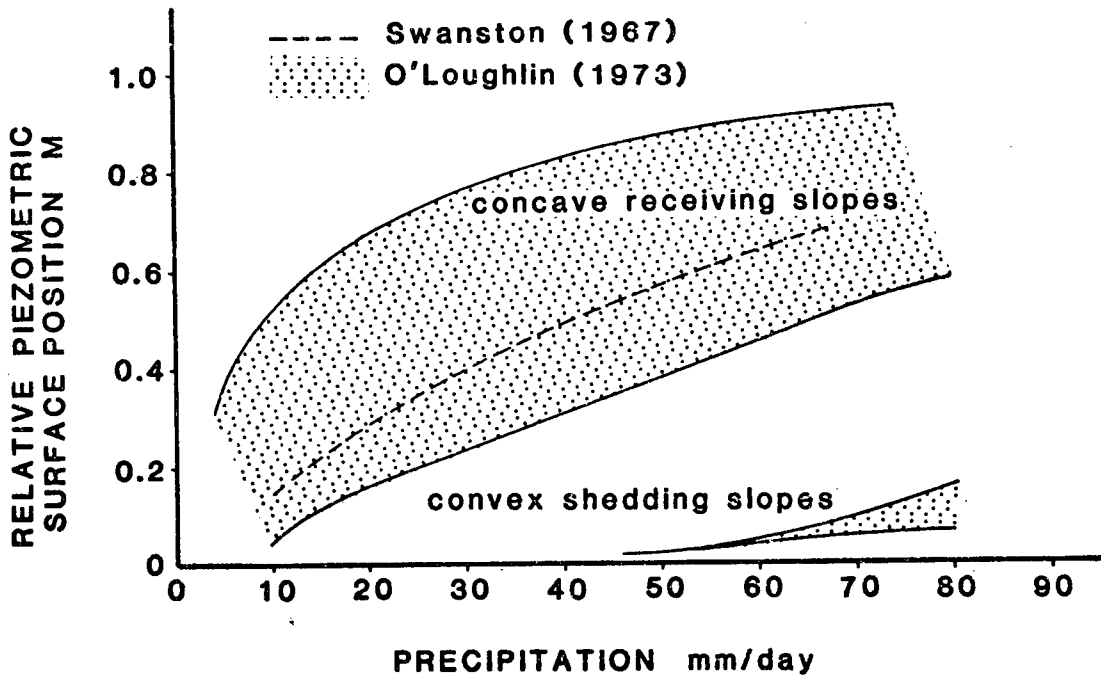
Figure 3.6. Variation of the relative piezometric head  $M$  with respect to 24 hr rainfall inputs as determined by Swanston (1967) and O'Loughlin (1973).

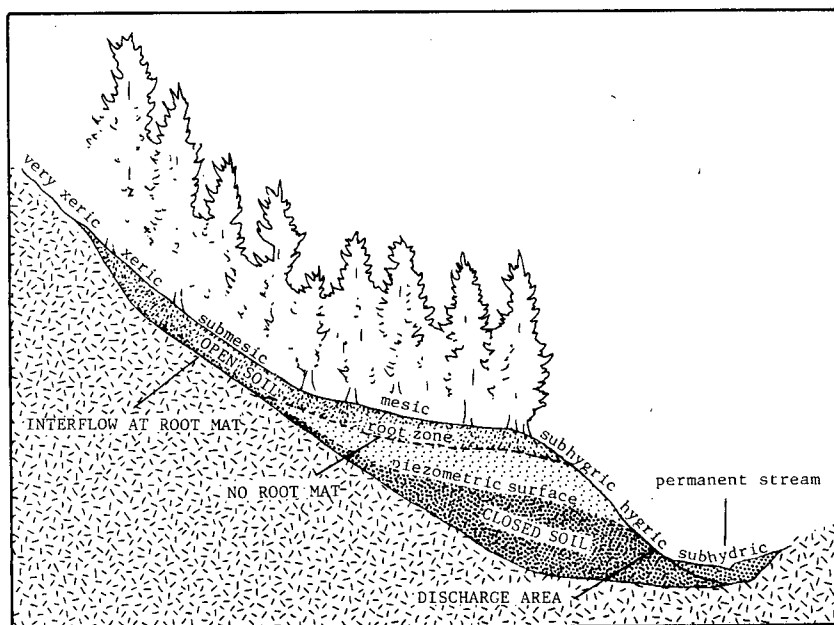
Figure 3.7 Typical profile of an idealized hillslope in the study area showing moisture regimes, probable groundwater table positions and surficial material types.

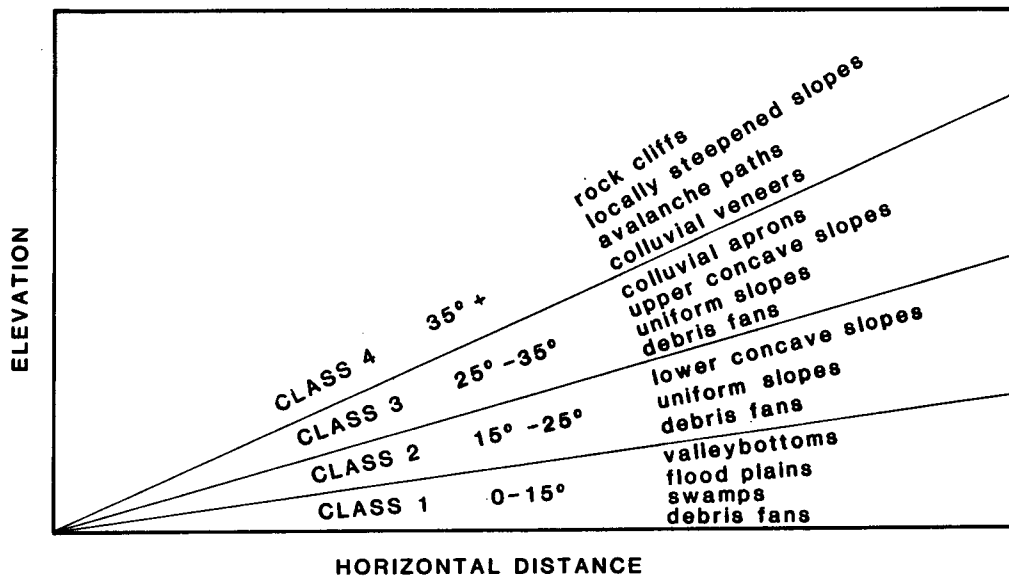
Figure 3.8. Slope class intervals used for the study area showing the types of slopes occurring within each class.

On the basis of these general observations, the slopes of the study area are somewhat arbitrarily grouped into the 4 classes shown in Figure 3.8.

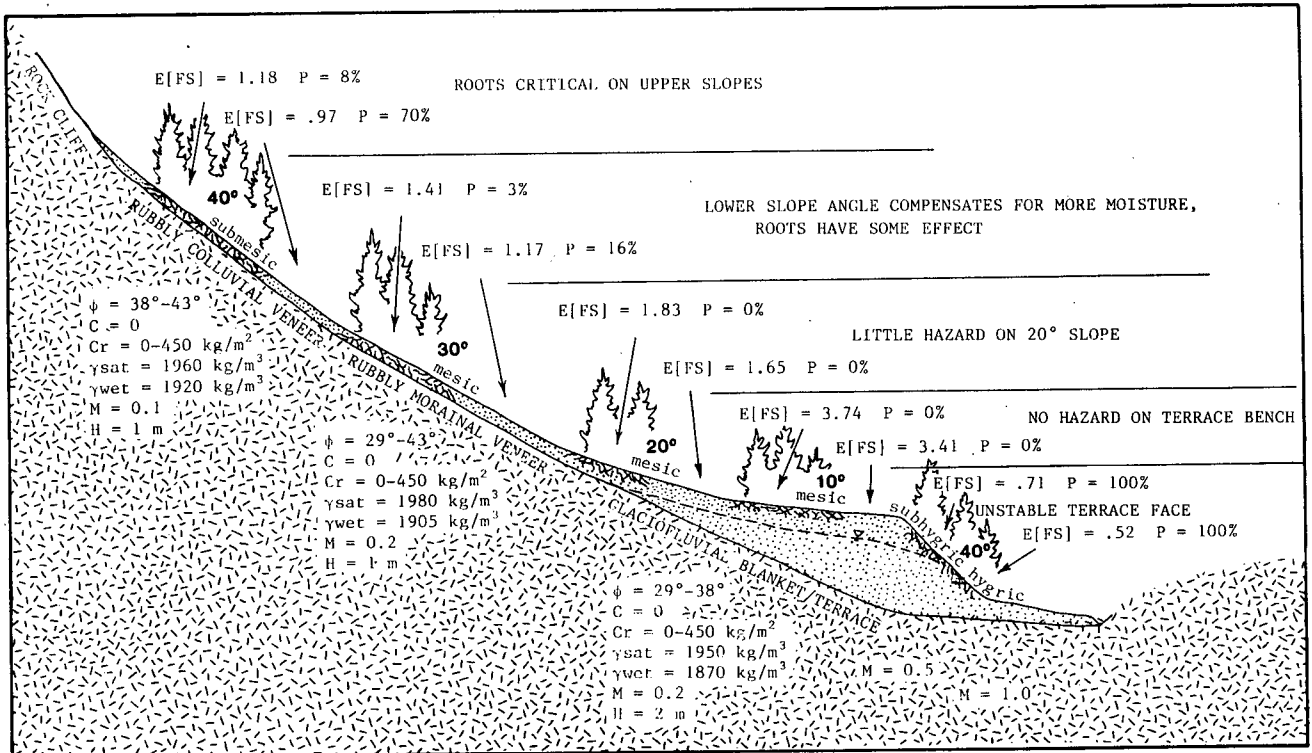
Figure 3.10. Profile of a typical slope in the study area showing the relative stability resulting from various combinations of quantified variables of the stochastic geotechnical model.

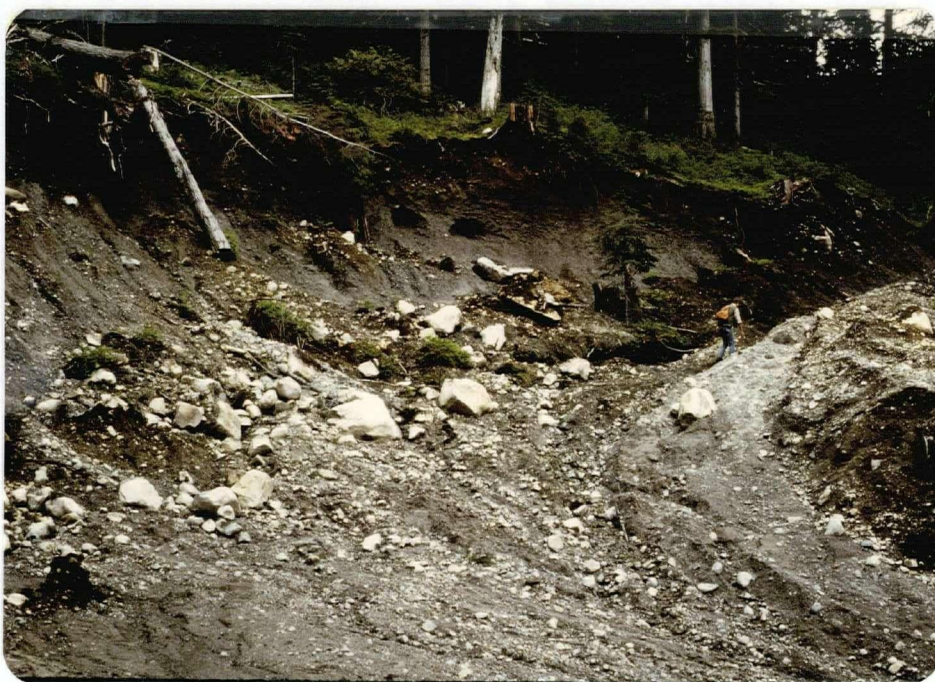
Figure 4.1 Cut-slope failures caused by seepage on the cut face of a logging road in the Cariboo Creek area (Landslide D19 - see Appendix F).

Landslides D19, D20 and S1 are examples of this type of failure (see Appendix F for landslide data and locations). Two of the three slides were relatively minor, involving less than 72 m<sup>3</sup>, and of little consequence to the road. Landslide D19, on the other hand, blocked approximately 25 meters of road with 225 m<sup>3</sup> of saturated sandy morainal debris (see Figure 4.1). Evidence of

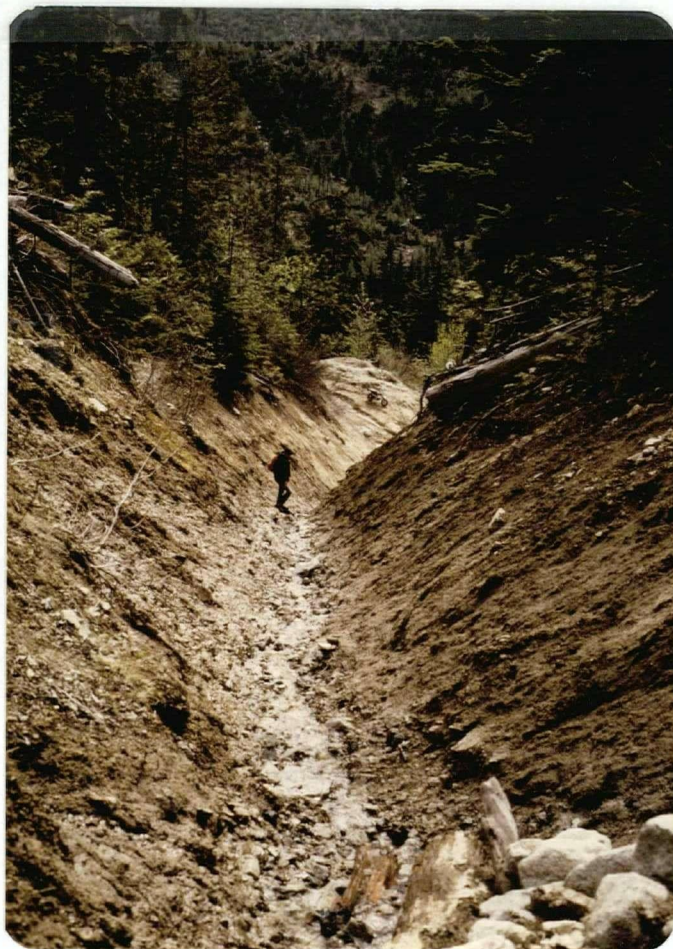
Figure 4.2. V-shaped profile of the path of a debris avalanche-debris flow caused by the saturation of road fill material near Wragge Creek Road.

Where water is allowed to run uncontrolled down fill slopes, the resulting erosion will eat away at the road surface and undercut the embankment sufficiently to cause landsliding. Landslide D3 on Shannon Creek Road is an example of where the improper placement of a culvert has led to erosion which in turn promoted accelerated ravelling (Figure 4.3). Water diverted onto natural slopes can also initiate landslides such as D14 described in section 3.4.2 (see Figure 3.5). Landslides initiated solely due to loss of root cohesion following logging were never observed on uniform slope mantled with surficial material near the study area.

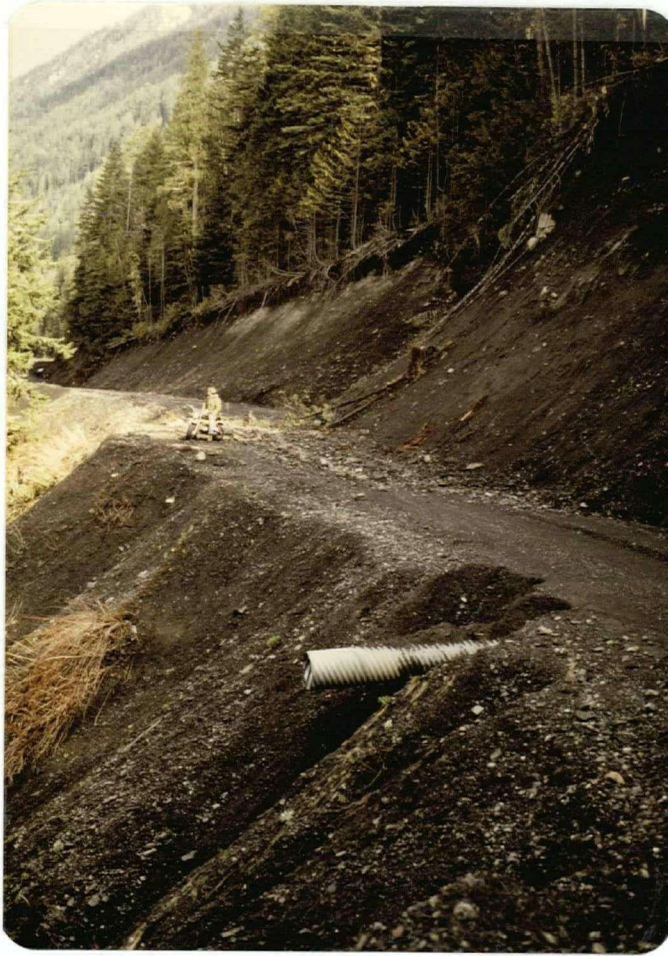
Figure 4.3. Fill slope erosion and ravelling resulting from improper water control at the culvert exit.

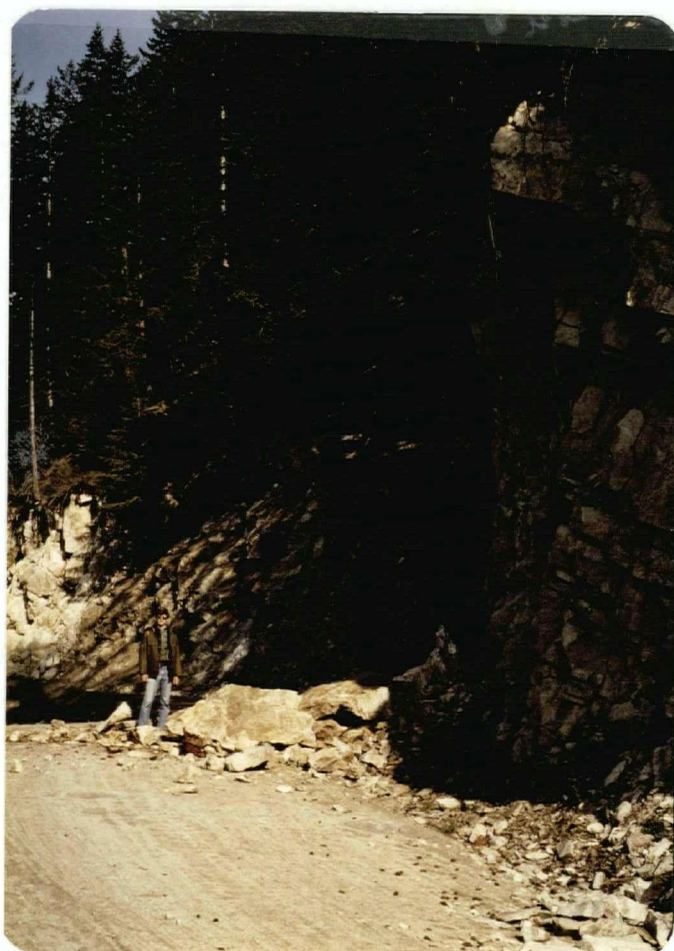
Figure 4.4. Rock failure on lower Shannon Creek Road.

Damage to productive soils, timber destruction and debris avalanche initiation where rock is thrown downslope can also result from overblasting on steep slopes. Because slope angles are generally greater than the angle of internal friction of sidecast material, large scars descending long portions of the slope frequently result. Landslides D9, D10, D13 and A5 in Appendix F are all examples of rock cuts where sidecast material has descended into the adjacent creek bed. Environmental damage can be significant in these cases. Near site D4, a large scar visible from at least 25 km away has resulted from the failure of rock sidecast.

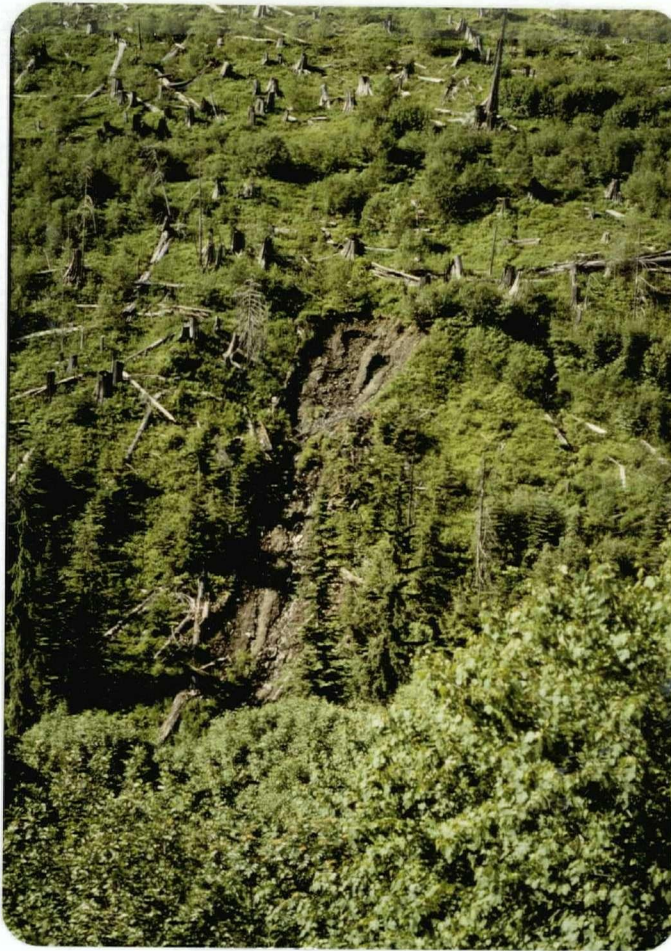
Figure 4.5. Landslide on a terrace slope near Shannon Creek initiated by loss of root cohesion (Landslide D3 - see Appendix F).

ago, numerous slides have developed on terrace fronts near Shannon Creek, one of which is shown in Figure 4.5. These slides

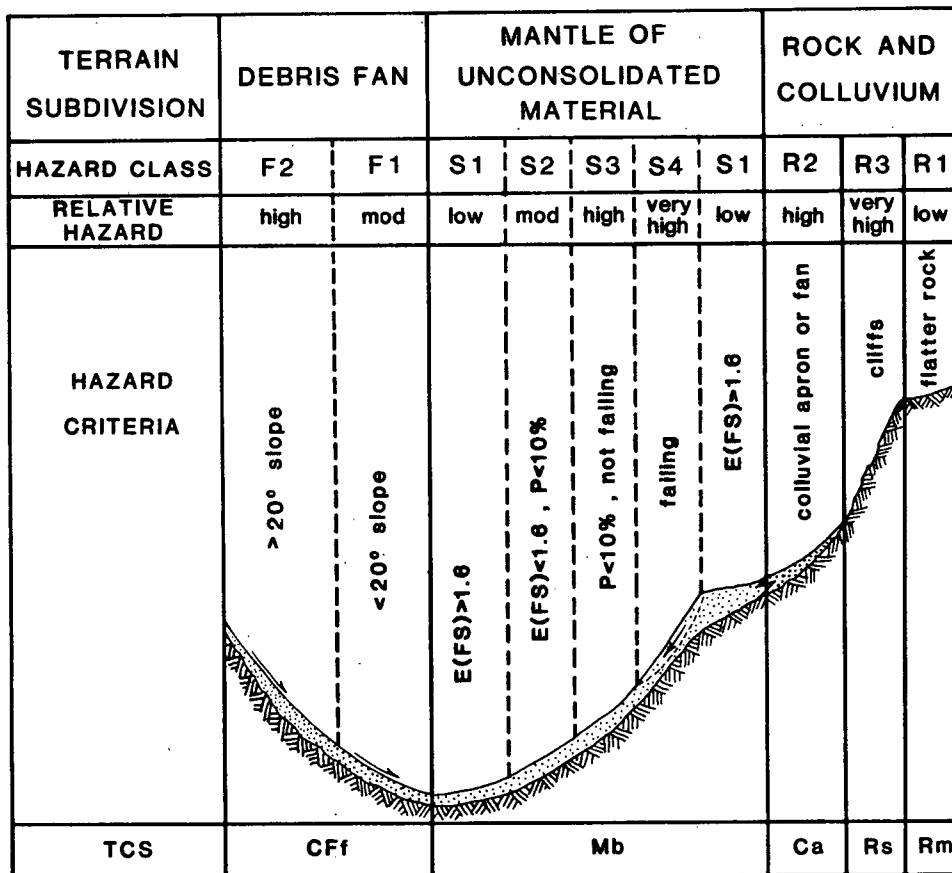
Figure 4.6. A hypothetical slope illustrating the use of the landslide hazard classification system.

In summary, hazard classes in the study area are divided primarily according to natural terrain subdivisions, then further subdivided according to the observed engineering behaviour of similar slopes in other areas. Figure 4.6 illustrates the use of the hazard classification system on a hypothetical slope, and can be used as a quick reference to the defining criteria of each class. It is noted that many land-use planners prefer to use a 3 to 4 class hazard rating system for decision making purposes, as more complex systems tend to confuse and complicate the issue, particularly when multiple-use decisions are being made. For this reason, the four ratings: low, moderate, high, and very high were ascribed to the nine more specific hazard classes discussed in this chapter. Thus, both the engineer and the planner can more easily utilize the information.
