THE RUBBLE CREEK LANDSLIDE
GARIBALDI, BRITISH COLUMBIA

DENNIS PATRICK MOORE

A THESIS SUBMITTED IN PARTIAL FULFILMENT OF
THE REQUIREMENTS FOR THE DEGREE OF
MASTER OF APPLIED SCIENCE

GEOLOGICAL SCIENCES

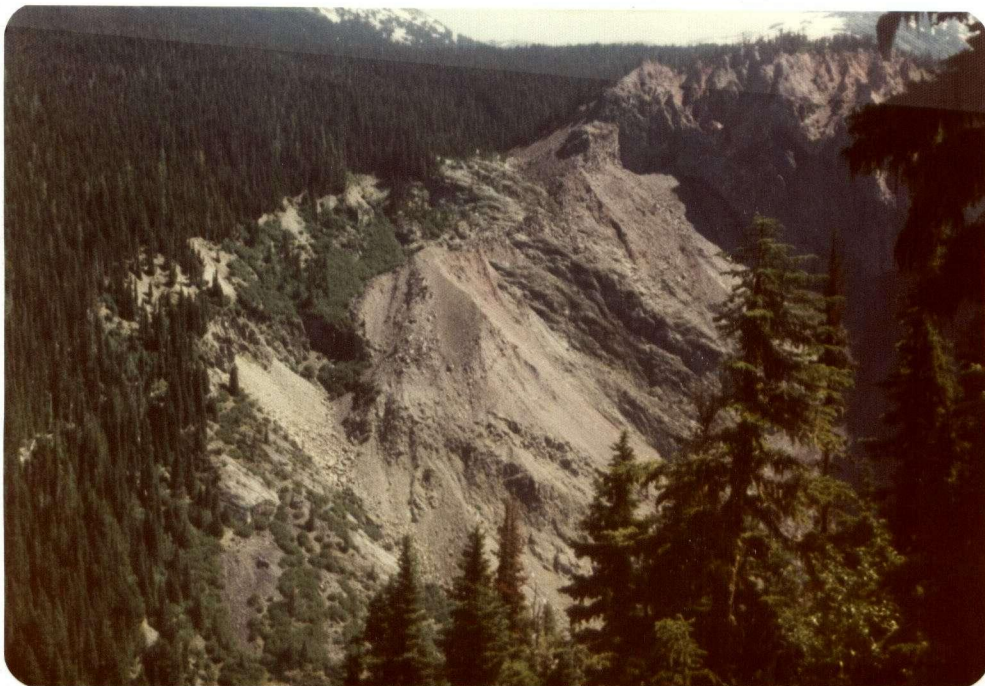
Photograph 2

Northern limit of third lava lobe,
looking towards Barrier Lake.

be seen on Photograph 2. The debris which forms the ridge is bedded and contains large intact blocks of highly fractured dacite. This debris is similar to that which forms the surface and edges of the lava flow elsewhere and is not thought to be normal talus.

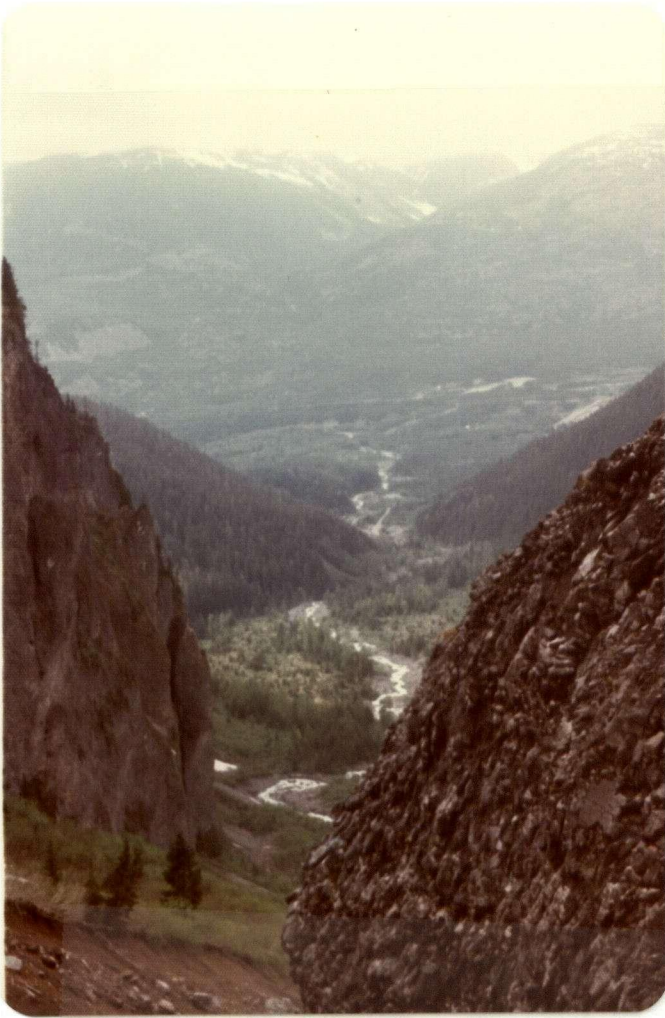
Photograph 4

Black dacite near toe of Barrier, fourth lava lobe and Rubble Creek fan in middle distance.

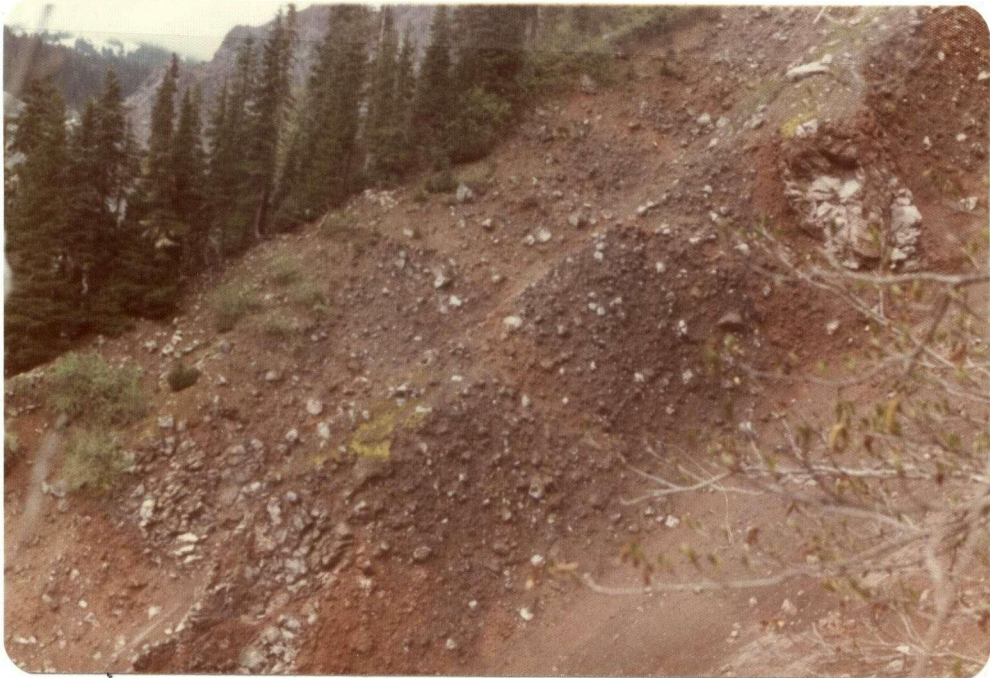
Photograph 5

Bedding in the red rubble which overlies the outcrop shown in Photograph 4.

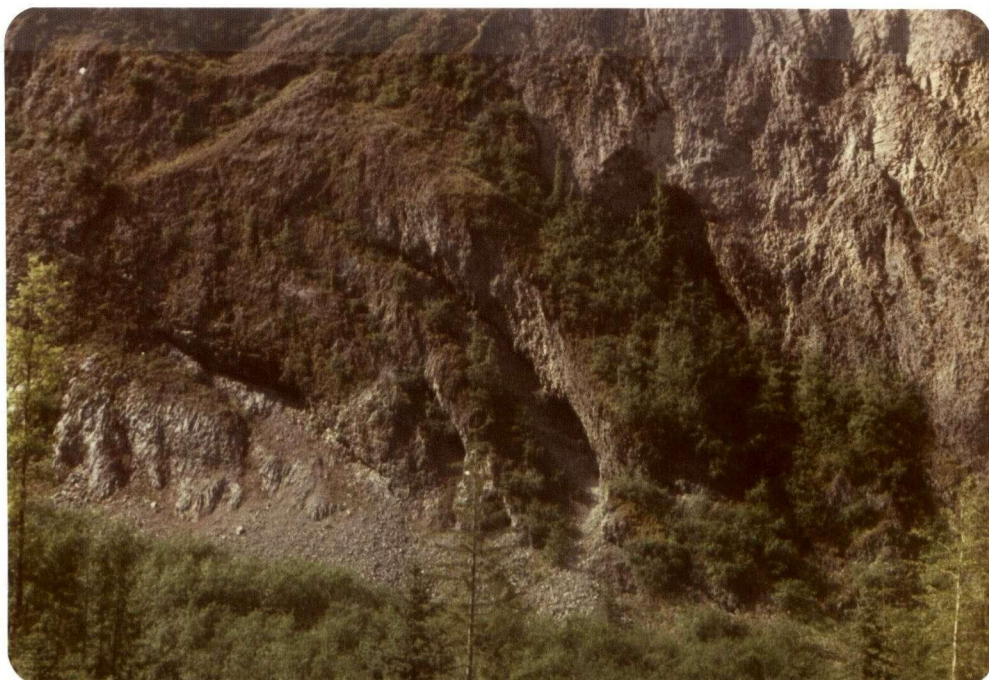
Photograph 7
Crushed zones near the toe of the 4th lava lobe.

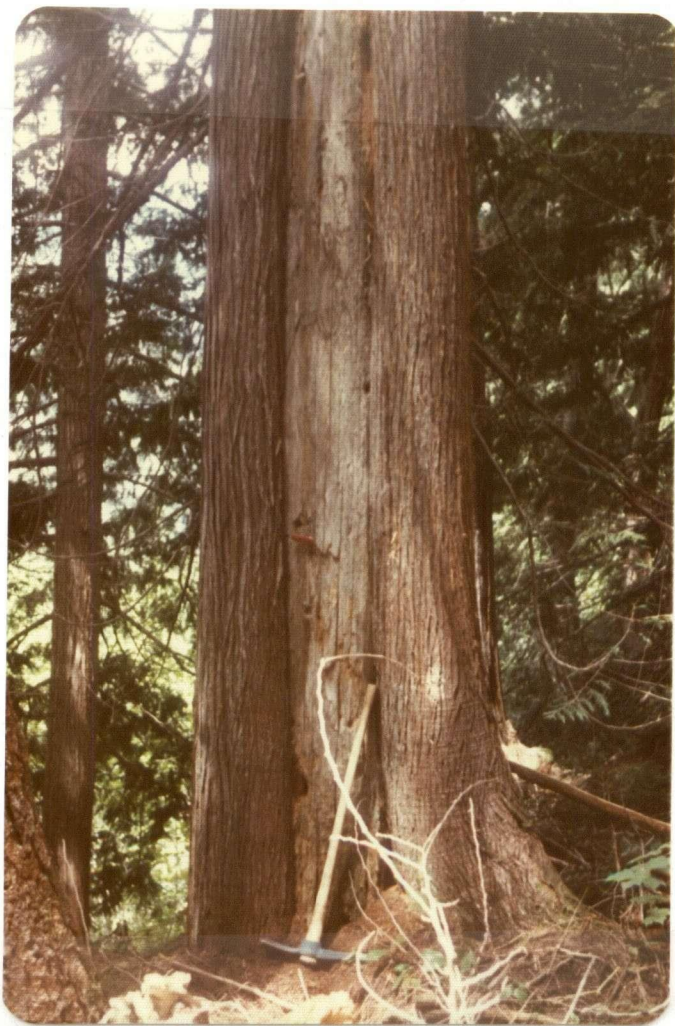
Photograph 8

Cedar tree with volcanic rock embedded just above the knife.

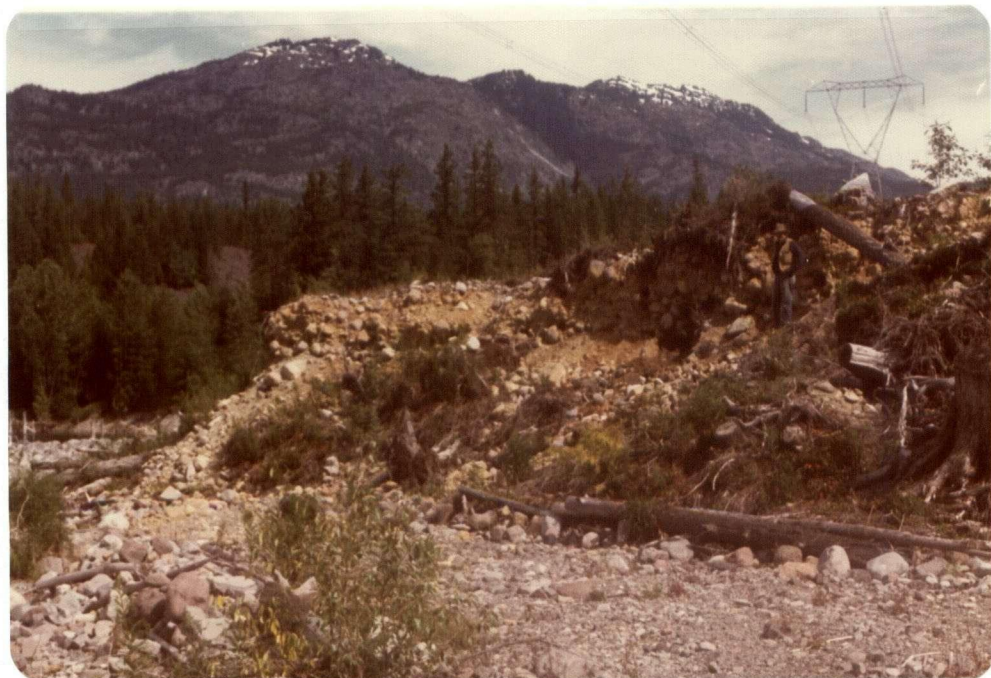
Photograph 9

Iron oxide surface layer which marks the base of the most recent slide debris near the mouth of Rubble Creek.

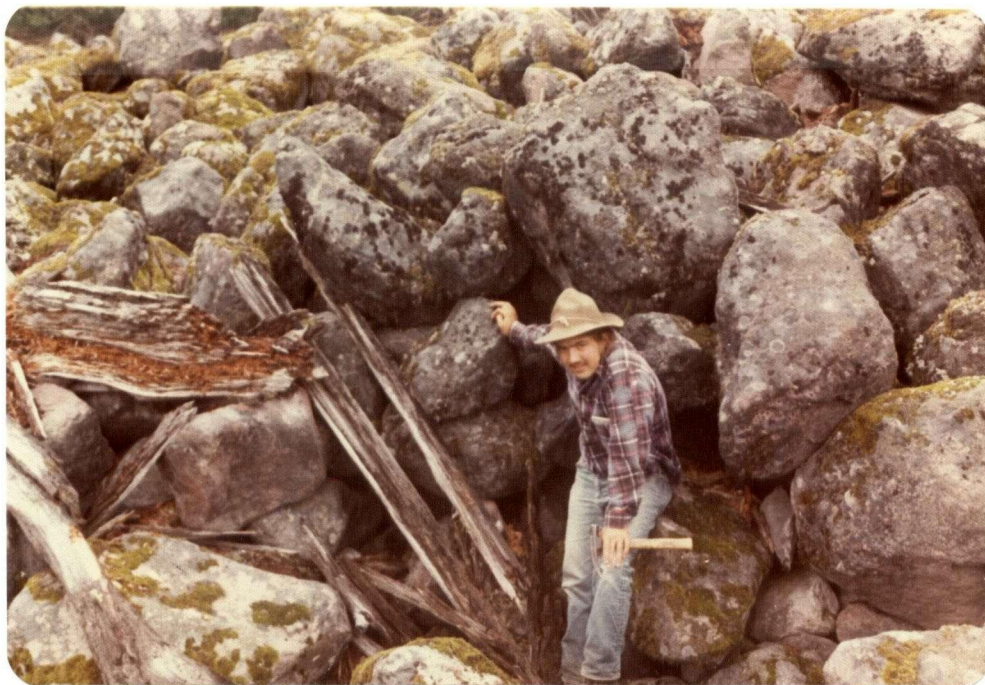
Photograph 10

Buried trees near the center of Sector III
on Rubble Creek fan.

(Photograph 10). The material beneath the surface layer of boulders is very poorly sorted volcanic debris. This sector has a generally uniform topography except for gullies marking former locations of Rubble Creek which has apparently changed its channel several times since the slide, and some shallow gullies which tend to start and die out a few hundred feet downslope. The boundaries of the area are very sharp and volcanic debris was not found much beyond the present extent of the fan except on the West bank of the Cheakamus River where debris occurs about 15 feet above the railway track. The boundary of volcanic debris was not easily traced near its western end because of the subsequent road and railway construction in the area, however, the debris appears to have reached an elevation on the west bank of the Cheakamus approximately equal to that of the top of the east bank of the river. Many buried trees occur along the boundaries of Sector III, these trees were growing prior to the slide and buried by it without being tilted, broken, or having their bark torn from the trunk. Only one area of buried trees was found in the interior of Sector III. The age of some of these trees was determined by a count of their annual rings to be greater than 200 years. The trees were apparently buried by the slide although still standing and then they died and fell on top of the debris, as shown on Photograph 10. The debris piled up 6 feet high on the upstream side of the trees and a depression was formed on the downstream side. Some of the boulders piled against the trunk were 2 to 3 feet in diameter. This is in marked contrast to the other areas of the slide where the pre-slide vegetation was carried away and even trees adjacent to the slide path were scarred and broken.

About 1000 feet downhill of the buried trees in Photograph 10, two curious features were observed. The pile of red rubble, shown on Photograph 11 and a similar mound found 40 feet away are debris cones similar to those found on the slide deposits at Sherman Peak (Shreve, 1966) and elsewhere. The mound shown in the photograph has a stump on it which was over 60 years old, hence it is probable that the mound was not man-made. The adjacent mound rises only a few feet above the surrounding boulder field and it is composed of the same poorly sorted, red rubble as the mound in the photograph. The material ranged from silt-size to at least 1.5 feet in diameter. There does not appear to be a large block of debris underlying these mounds as observed at Sherman slide for example (Shreve, 1966).

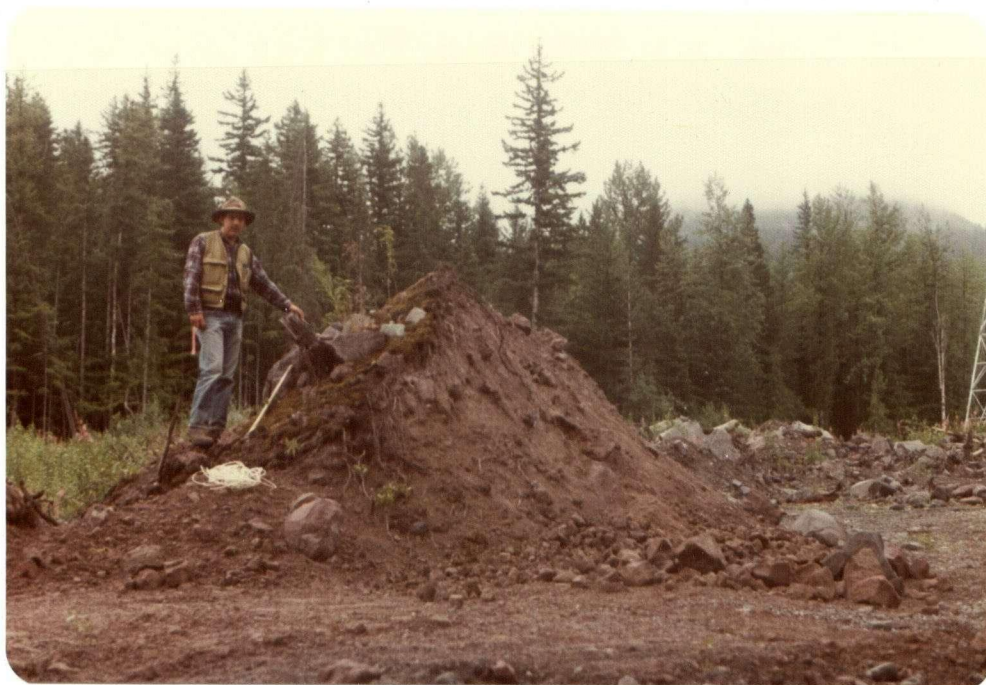
Photograph 11

Xenolithologic debris cone in Sector III
Rubble Creek fan. Tree stump is more
than 60 years old.

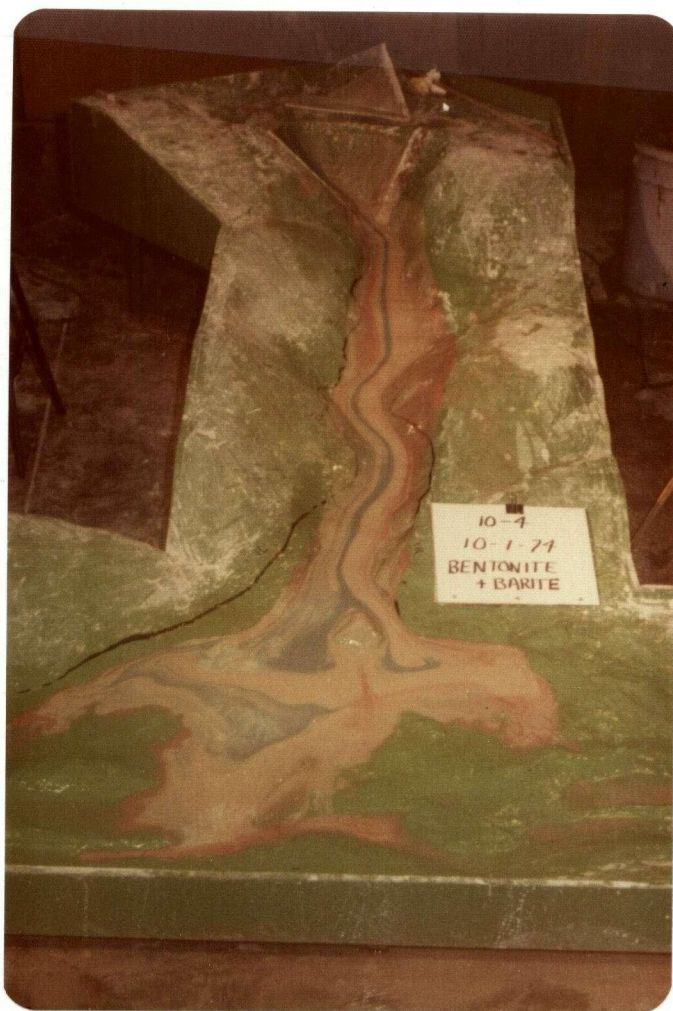
Photograph 12

Typical model slide showing coloured stripes. The slide material was horizontally layered at the start with red at the toe, blue at the top and brown between the two.

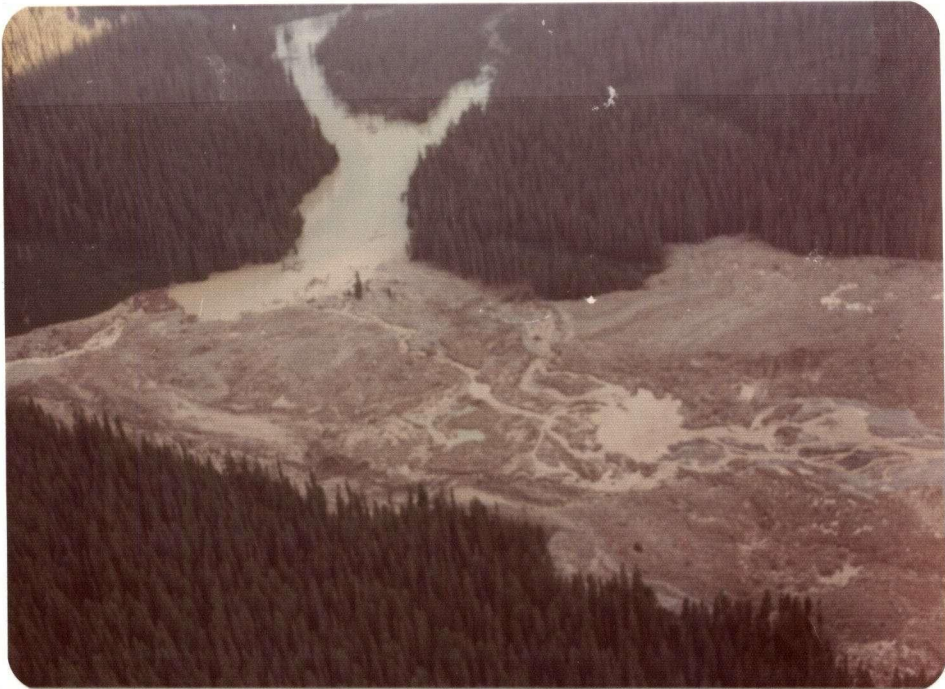
Photograph 14

Devastation Glacier Slide deposit, striping in the debris and imprint of subsequent mudflow.

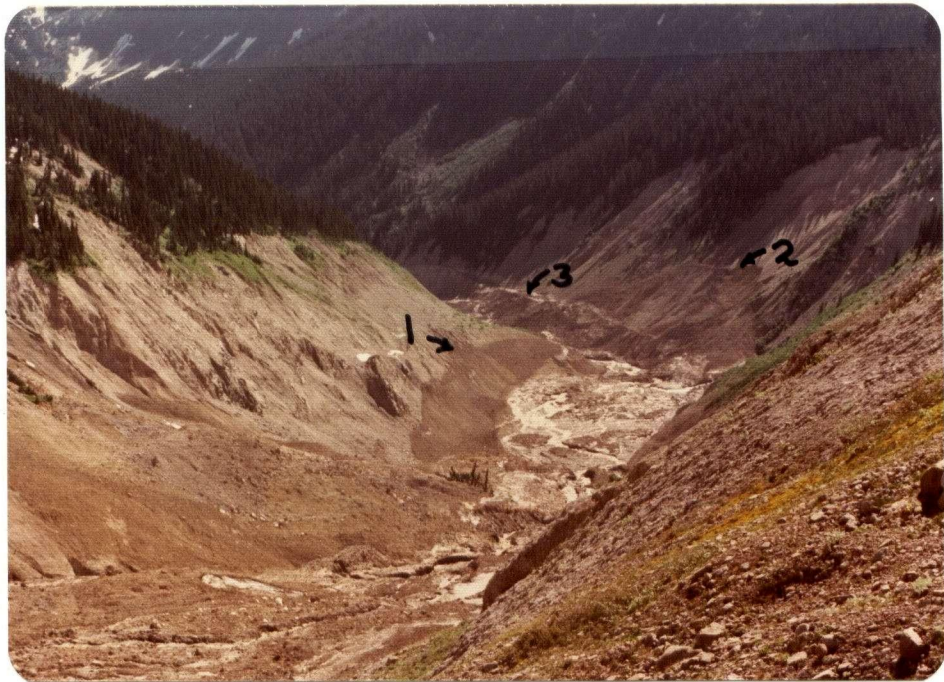
Photograph 15

Devastation Glacier Slide Path, showing banking of the high velocity tongue as it rounded a corner (1, 2) and the nearly horizontal line of the subsequent mudflow (3).

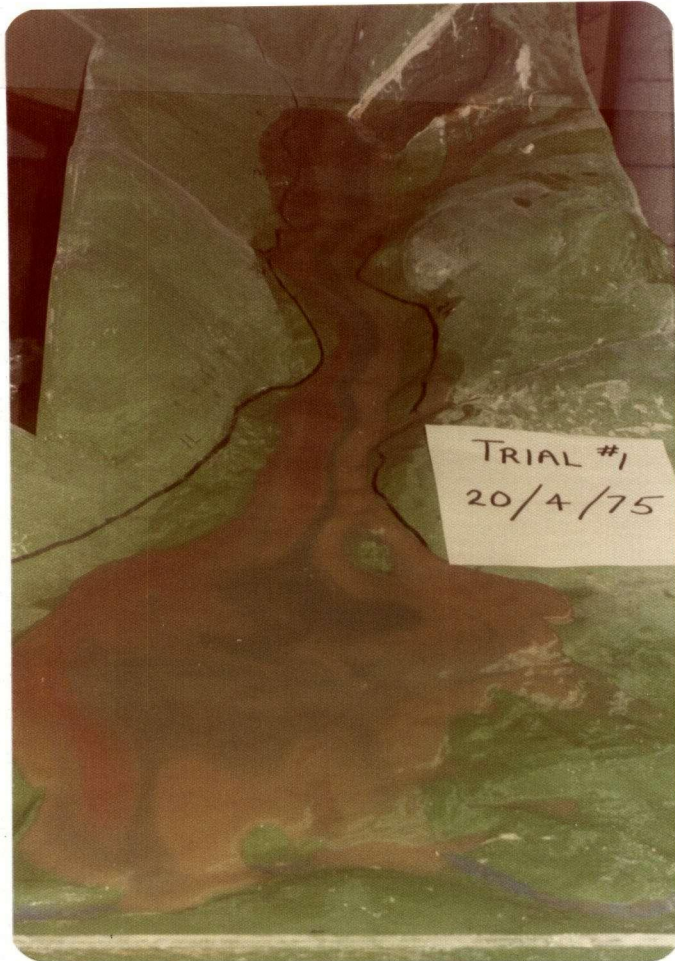
Photograph 16

Model slide equivalent to 91,000,000 cubic yards from the Fourth Lava Lobe. Cheakamus Dam is on the lower left side of the photograph, source of slide on the upper right.

Although most tests were carried out using a volume of mud similar to the estimated volume of the 1856 slide, several tests were carried out using smaller or larger volumes. It was found that the larger the volume for a given mixture, the farther and faster it travelled. The paths of slides from the same source area were essentially the same for all volumes although the larger volumes rode higher on the curves and were deposited farther down the fan and the smaller volumes rode lower on the curves and were deposited near the apex of the fan or in the valley. The model slides released from the fourth lobe moved directly across the valley and swept high up on the opposite side. After this first curve the slide followed a similar path to the slides from the third lobe. The final deposit covered a larger area of the fan. (Photograph 16).
