EXAMINATION OF TOPPLING BEHAVIOUR IN LARGE ROCK SLOPES

USING THE UDEC COMPUTER CODE

A THESIS SUBMITTED IN PARTIAL FULFILLMENT
OF THE REQUIREMENTS FOR THE DEGREE OF
MASTER OF APPLIED SCIENCE

THE UNIVERSITY OF BRITISH COLUMBIA

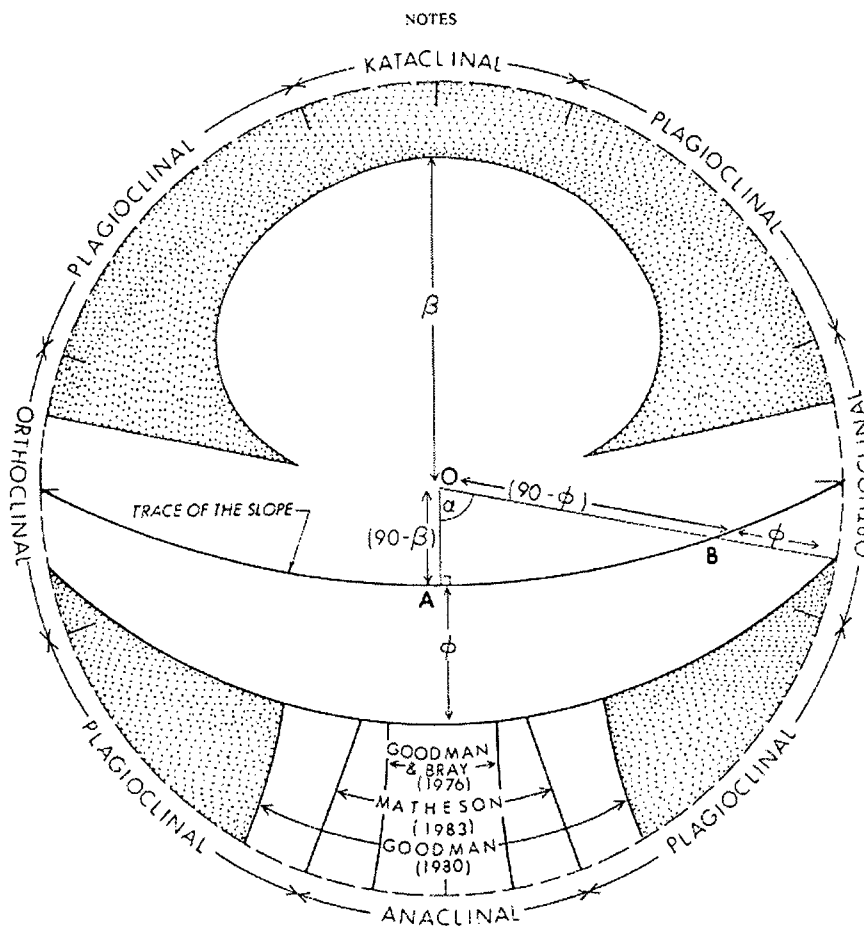
Figure 2-3: Limits of poles to discontinuities that permit common toppling on a 70° slope with $\phi = 30^\circ$ (Cruden, 1989, Fig. 4).

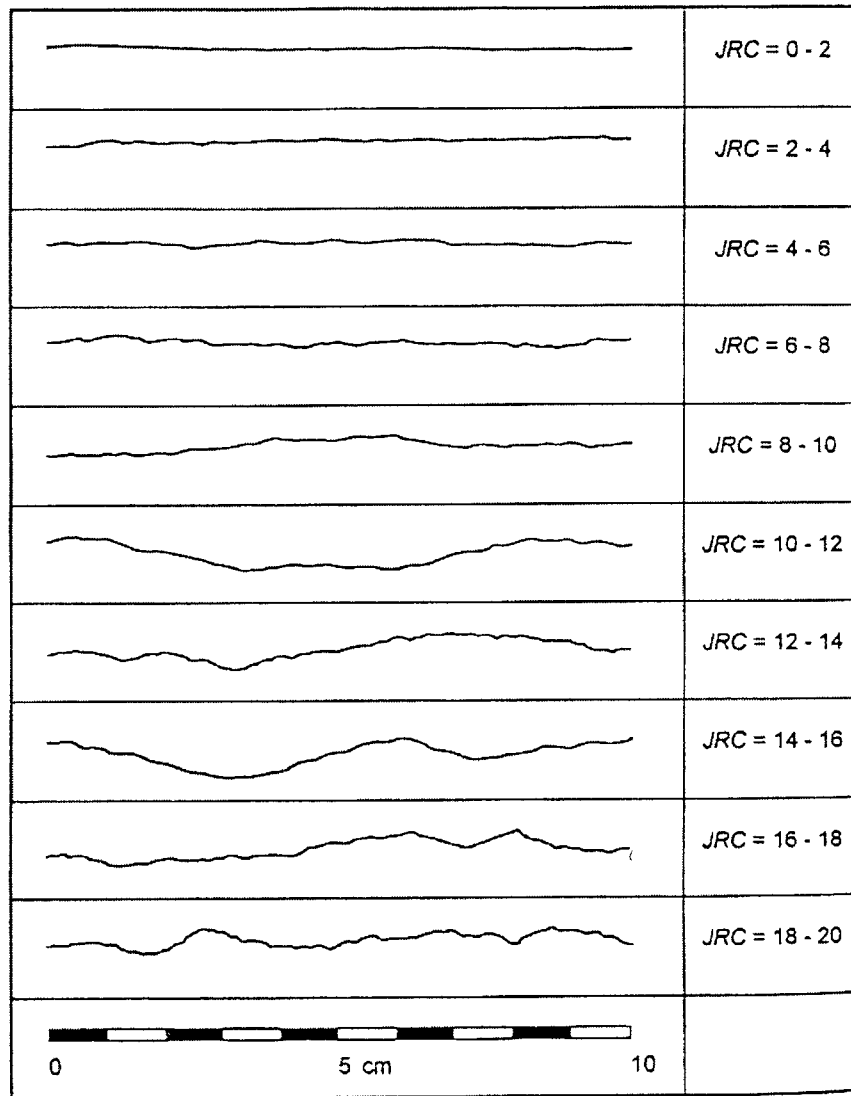
Figure 2-5: Joint Roughness Coefficient (JRC) values (from Hoek et al., 1995, after Barton and Choubey, 1977).

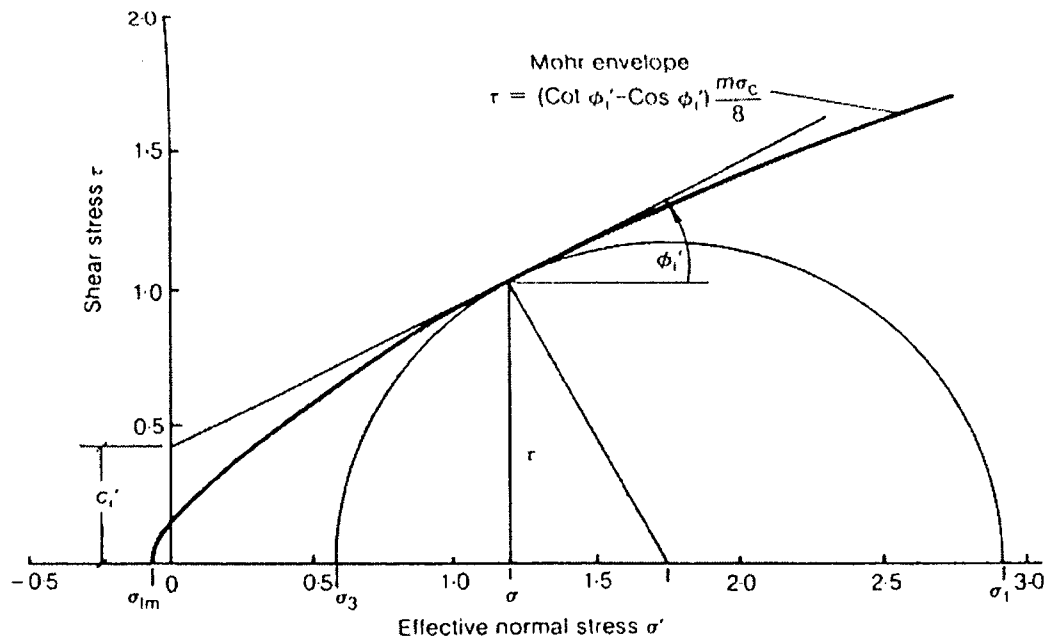
Figure 2-7: Typical curved shear strength envelope defined by Hoek-Brown theory for rock mass strength (Hoek, 1983, Fig. 3).

Another empirical method was developed by Hoek and Brown (1980, 1988, 1997; Hoek et al., 1992, 1995) using observations from field and laboratory studies and a strength criterion derived from the Griffith crack theory of rock fracture. Three parameters are required to define the curved (i.e., non-linear) strength envelope: the uniaxial compressive strength of the intact rock, and two dimensionless material constants, m (dependent on rock type) and s (dependent on degree of fracturing). A typical curved shear strength envelope is shown in Figure 2-7. In the equation given in Figure 2-7,

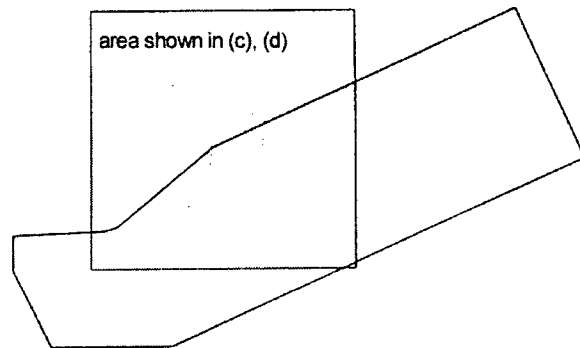
(b) index to (c) and (d);

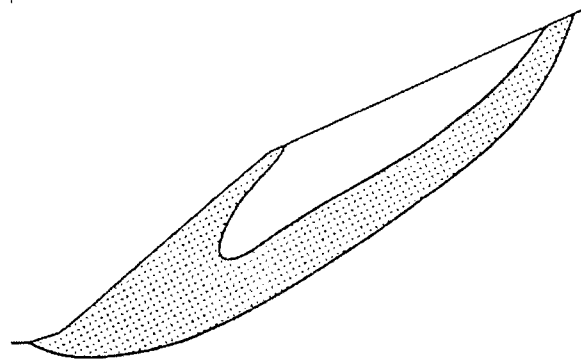
(c) zone of failure (plastic condition);

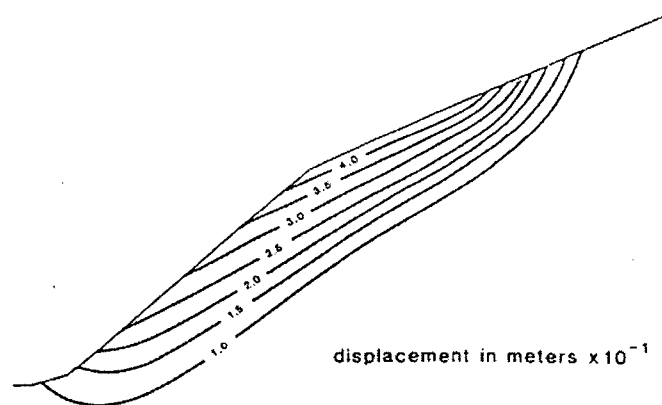
(d) horizontal displacement contours.

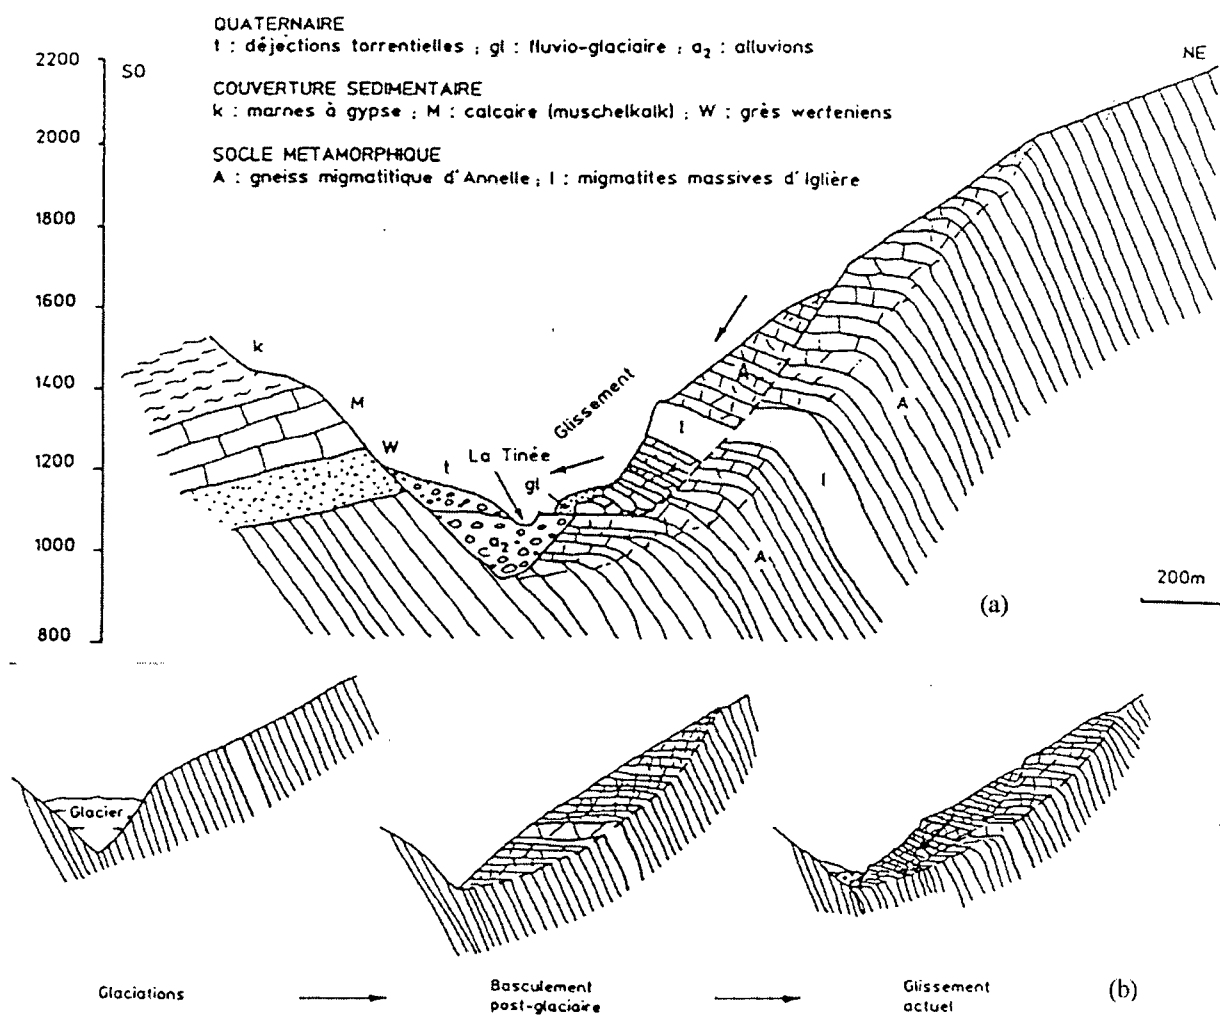
Figure 4-3: Failure mechanism of La Clapière: (a) cross-section; (b) stages of failure development (Anon., 1992 after Follacci, 1987).

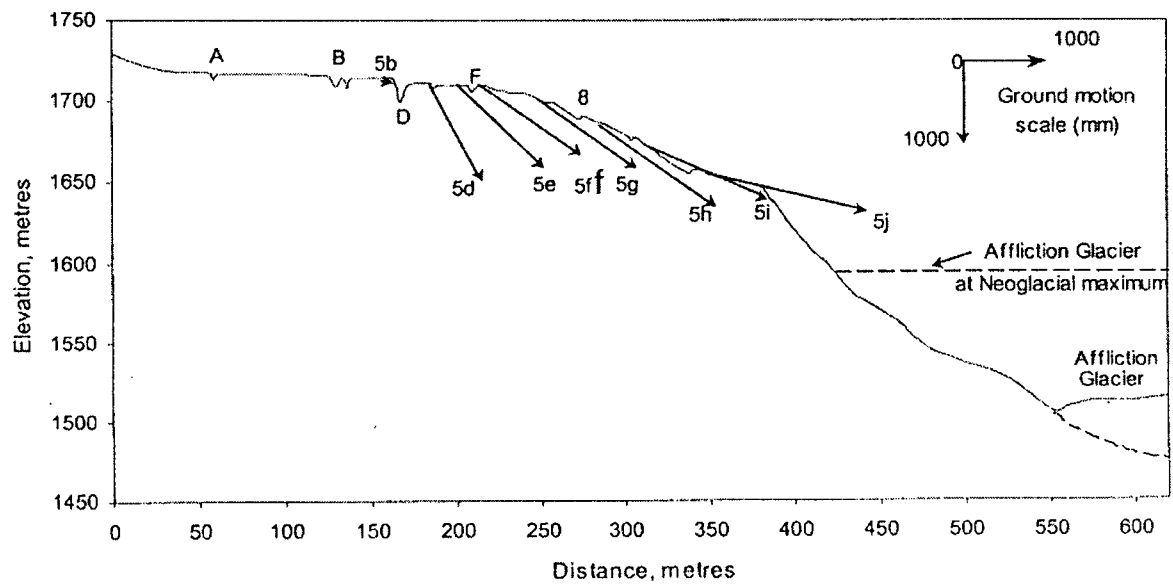
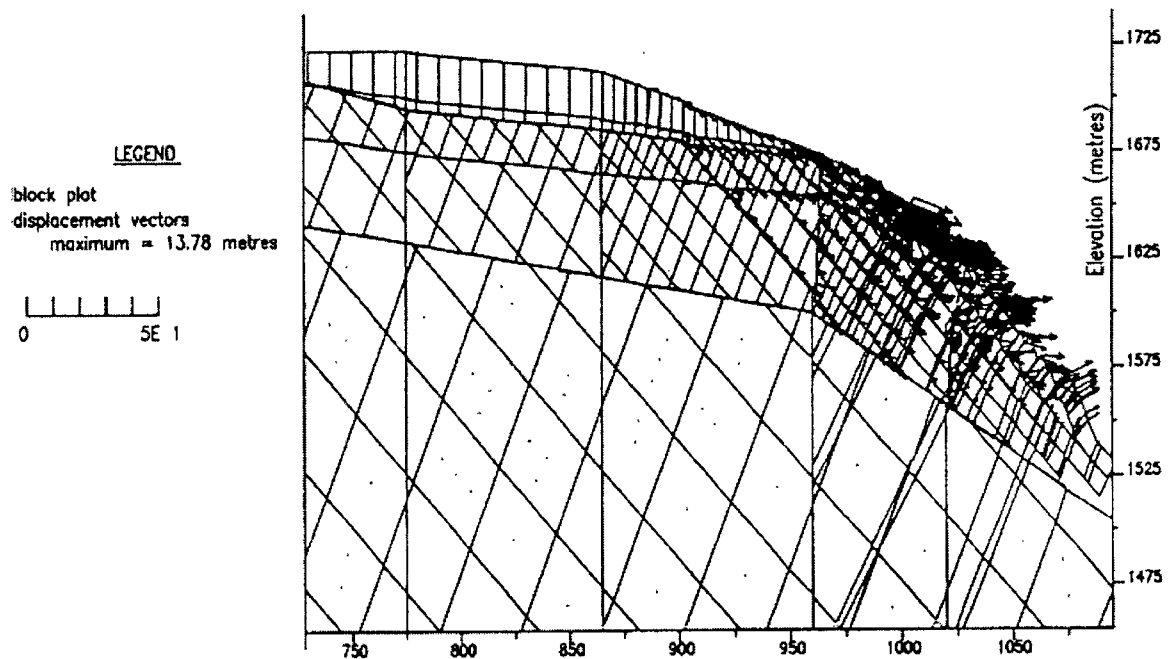
Figure 4-5: Affliction Creek (a) ground-motion vectors; (b) modelled displacements (Bovis and Stewart, 1998).

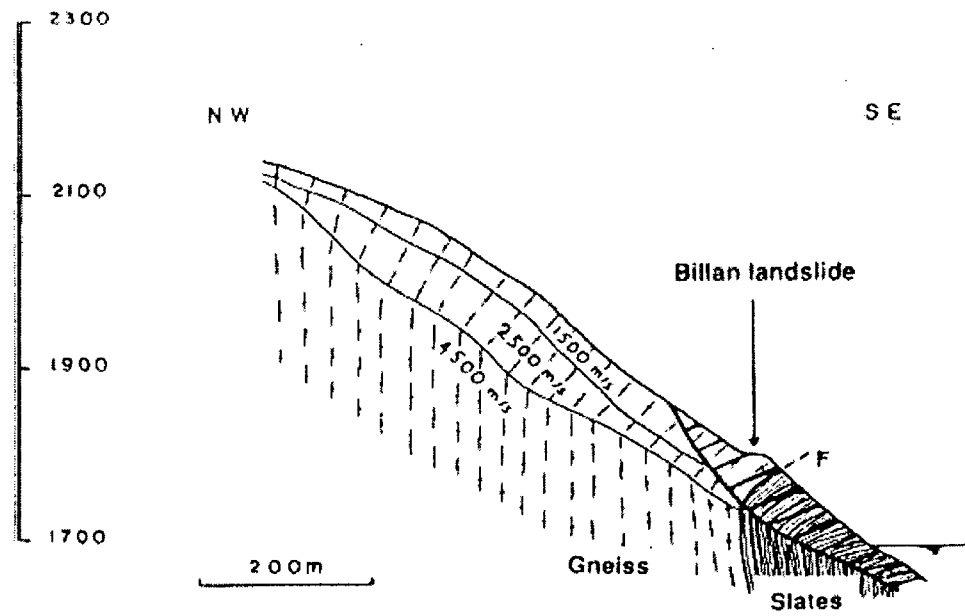
Figure 4-8: General slope profile of the Billan landslide (Giraud et al., 1990).

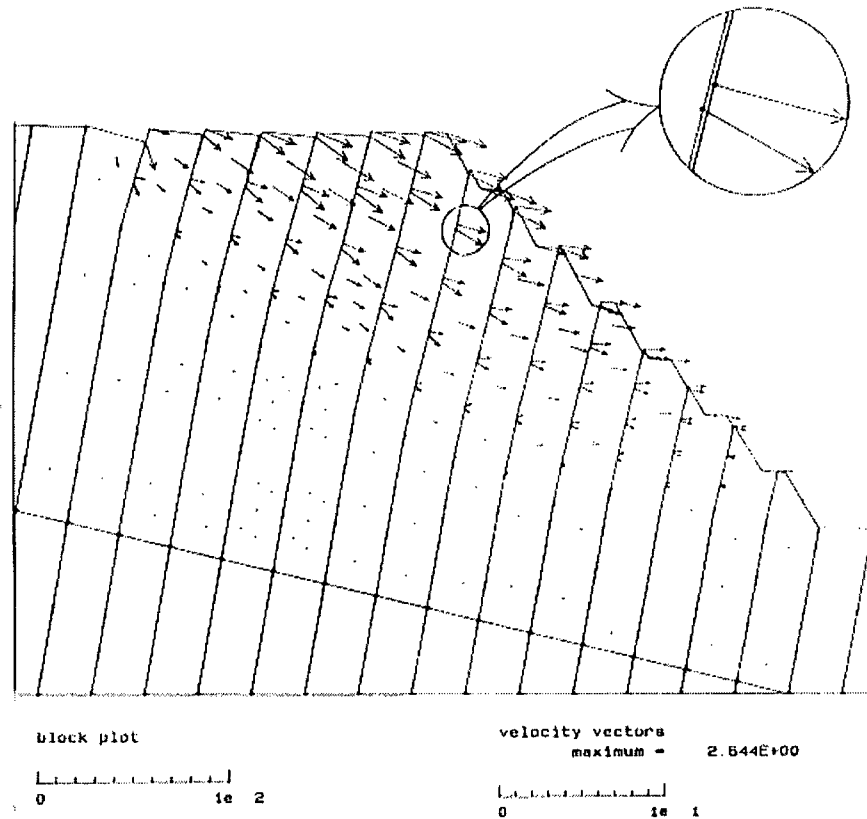
Figure 4-10:
Pure flexural
toppling
deformation at
Brenda Mine:
(a) with grid
point velocities
(dry slope);
(b) horizontal
displacement
contours (after
Pritchard, 1989,
Figs. 4.7a, b).

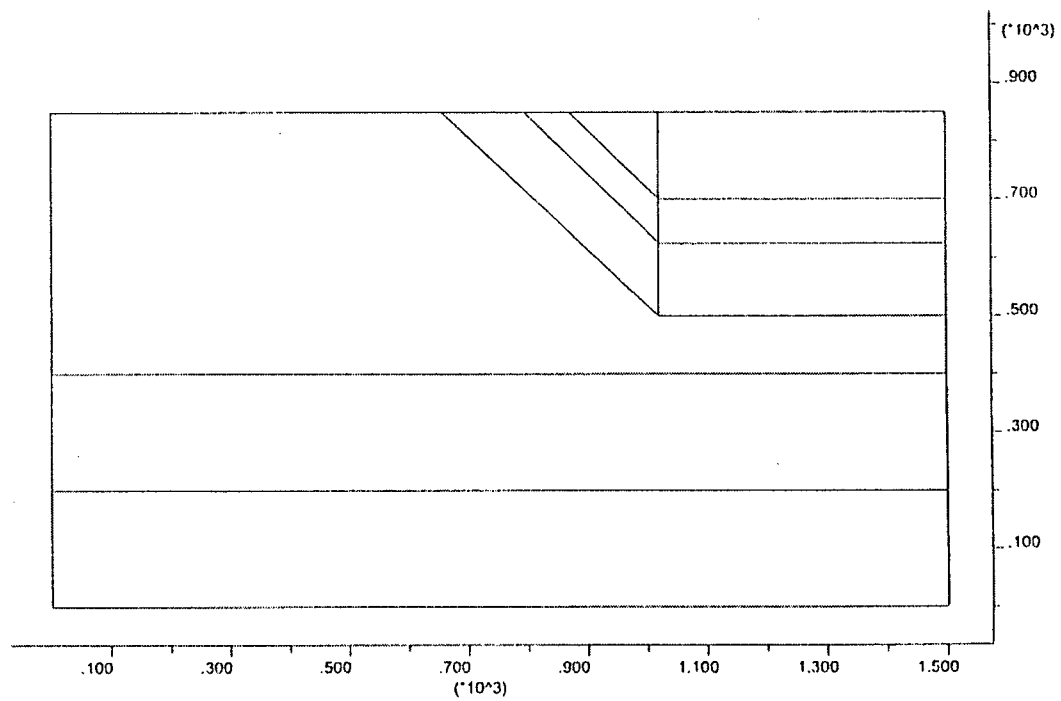
Figure 5-1: Initial Model Set Up for Parametric Study

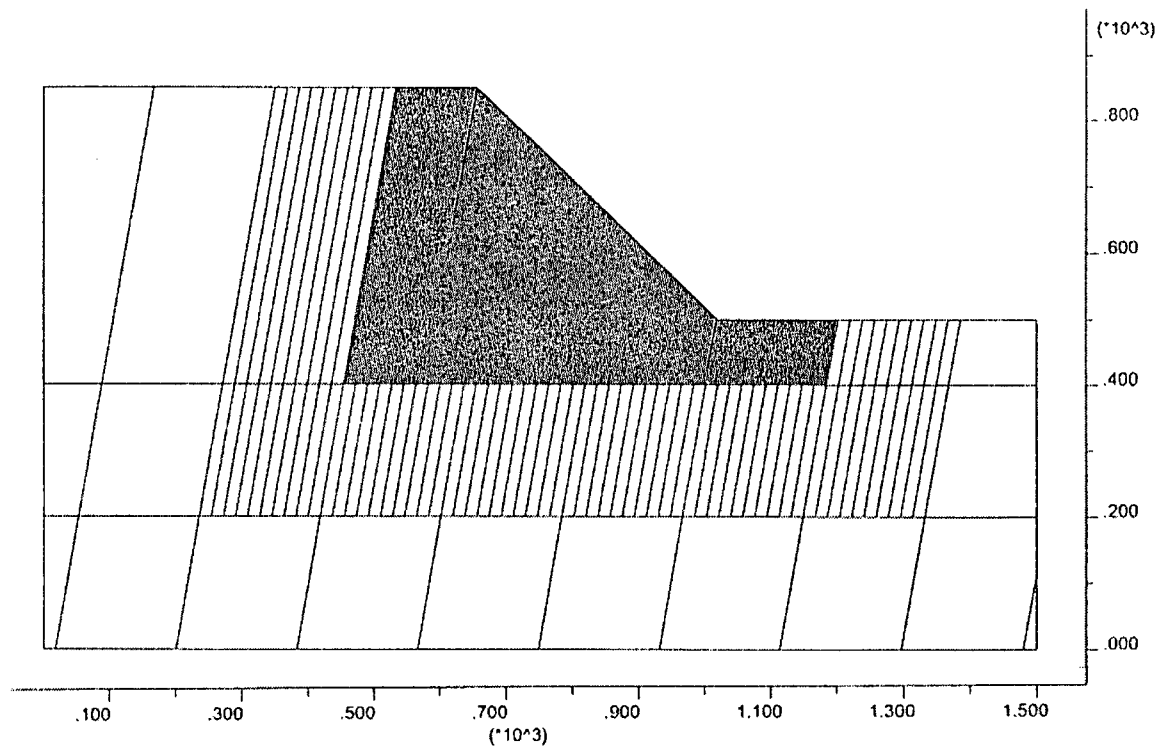
Figure 5-2: Outer Slope Geometry for Parametric Study. Three zones with different joint spacing shown: outer zone, 180 m; middle zone, 18 m; inner zone, 3 m.

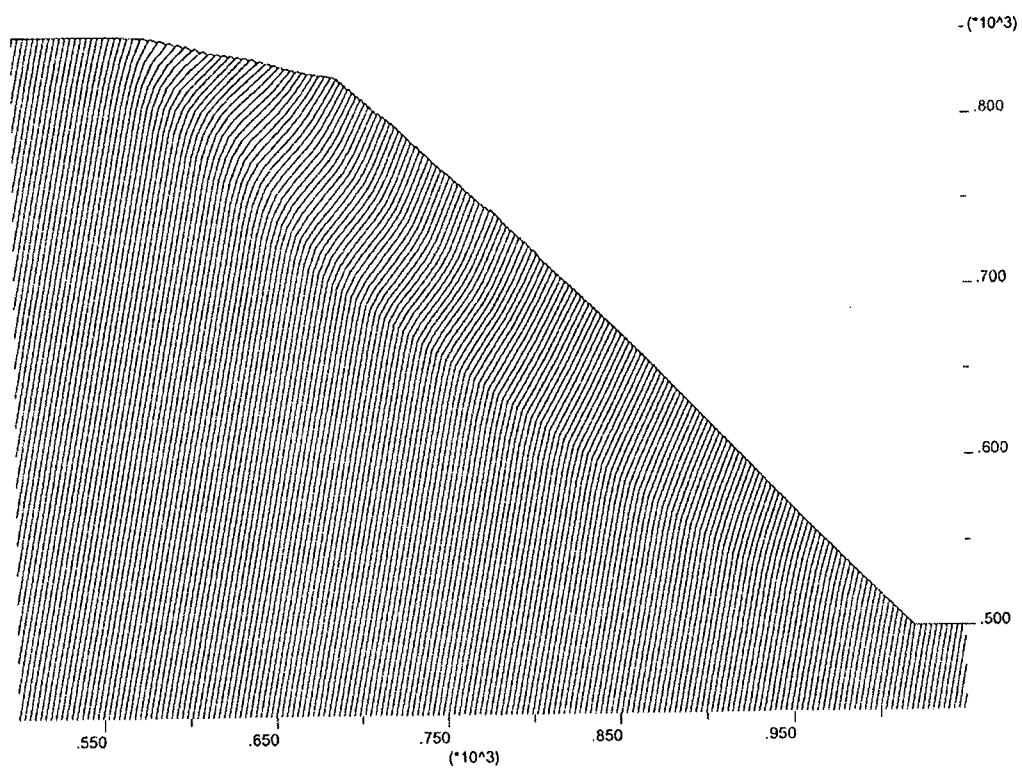
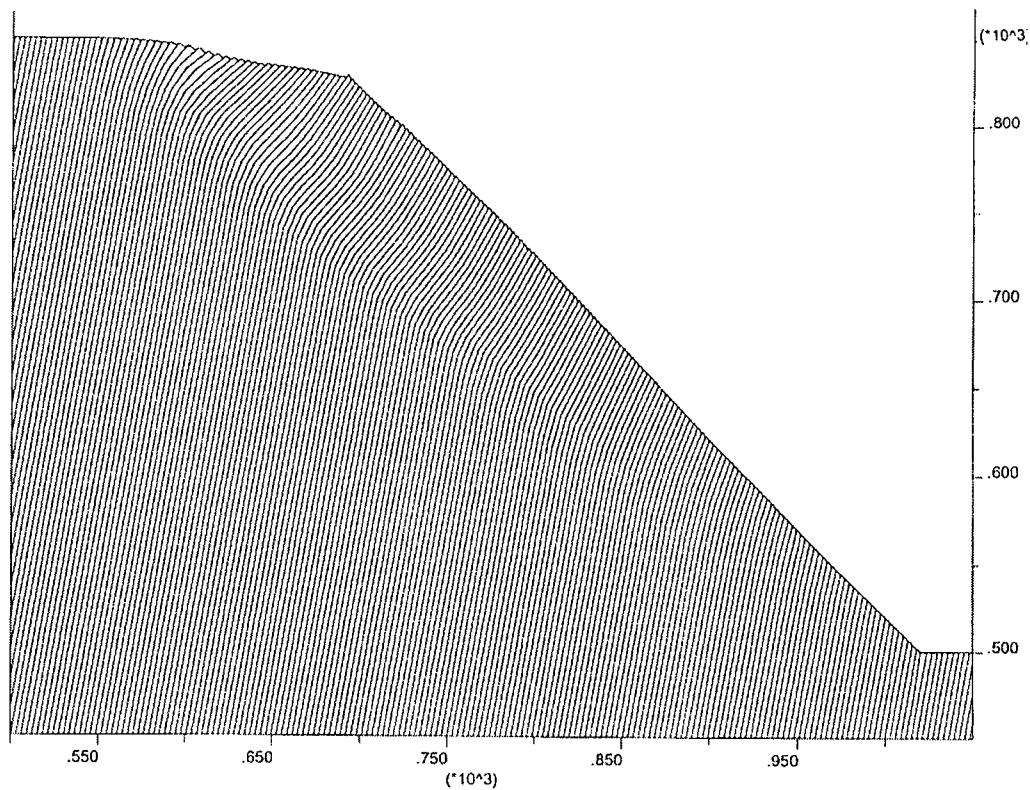
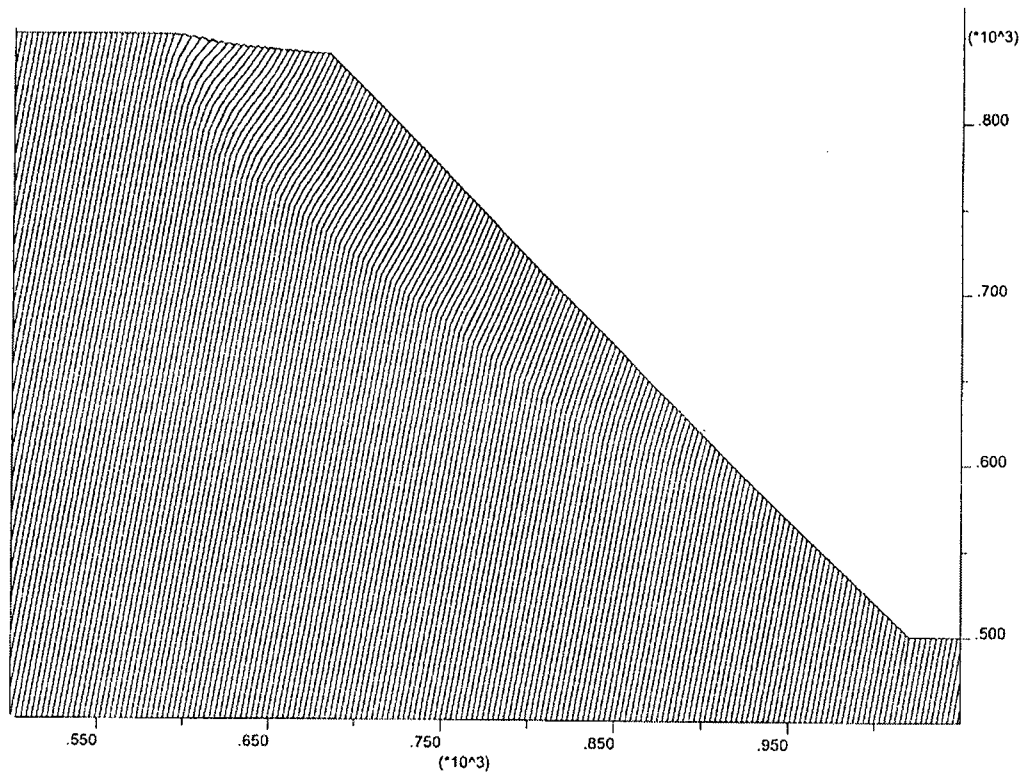
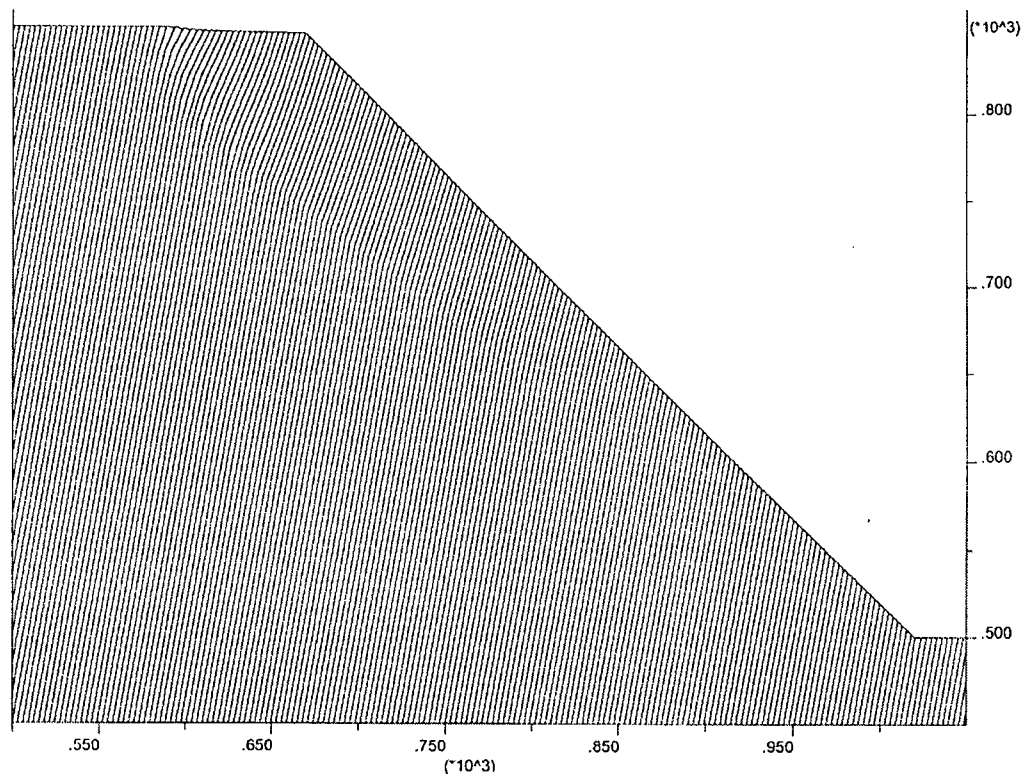
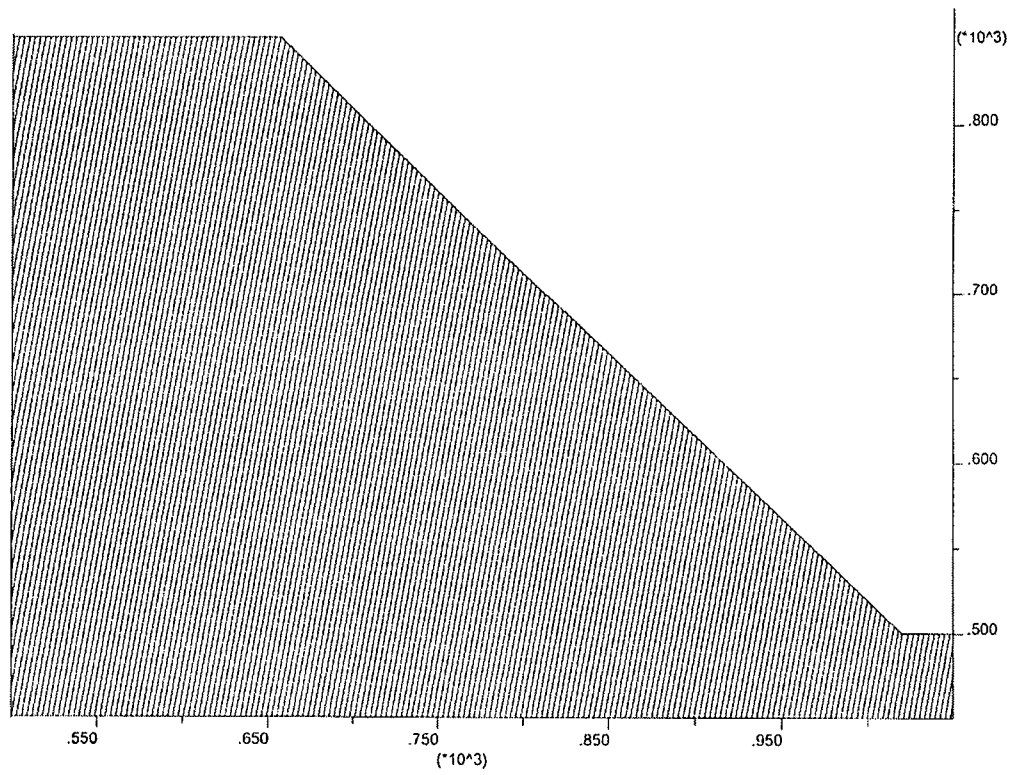
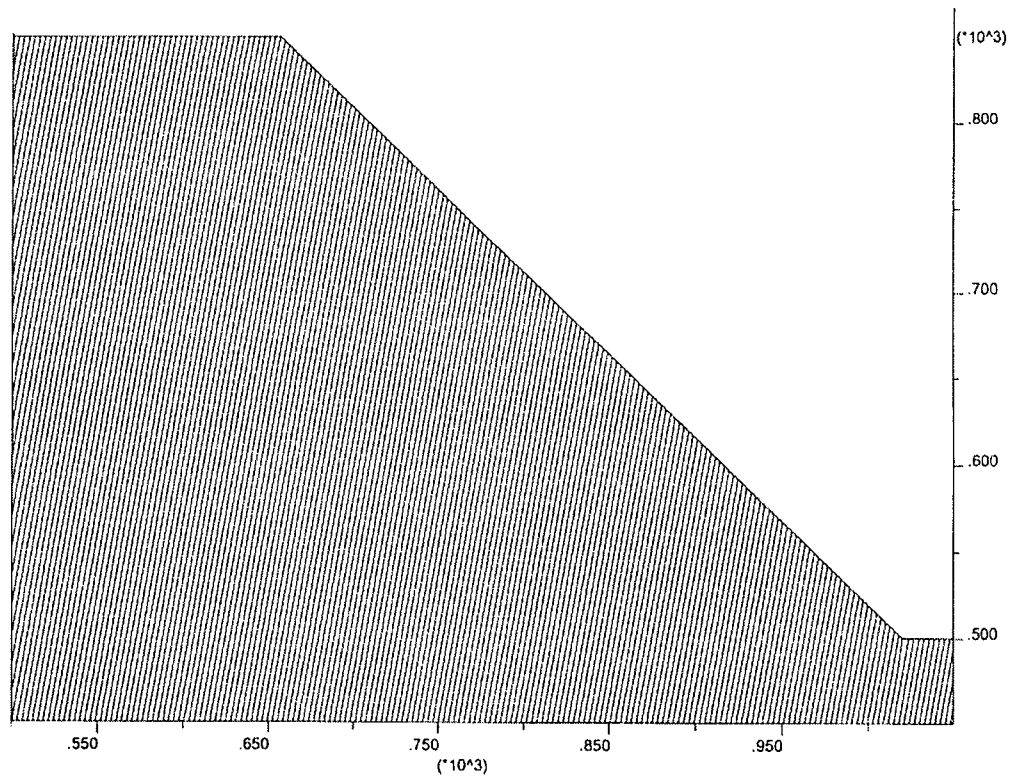
Figure 6-1:
Block plots
for
variations of
intact rock
strength
after approx.
20 s run
time.

(a) UCS =
10 MPa

(b) UCS =
20 MPa

(c) UCS =
40 MPa

(d) UCS =
60 MPa

(e) UCS =
80 MPa

(f) UCS =
100 MPa

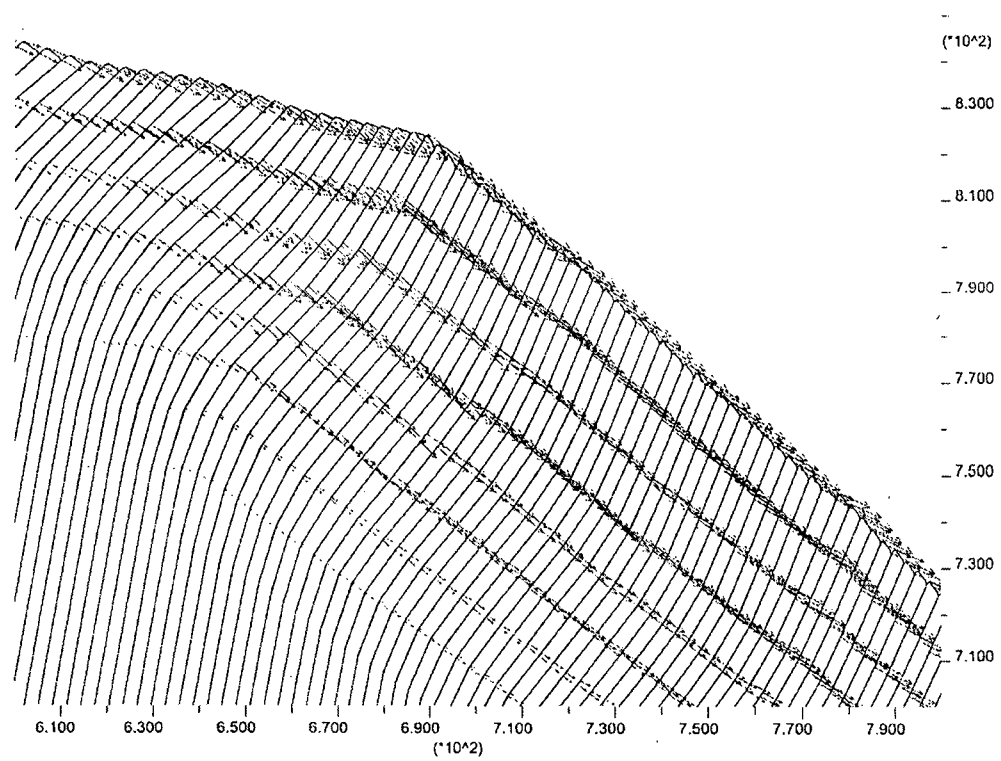
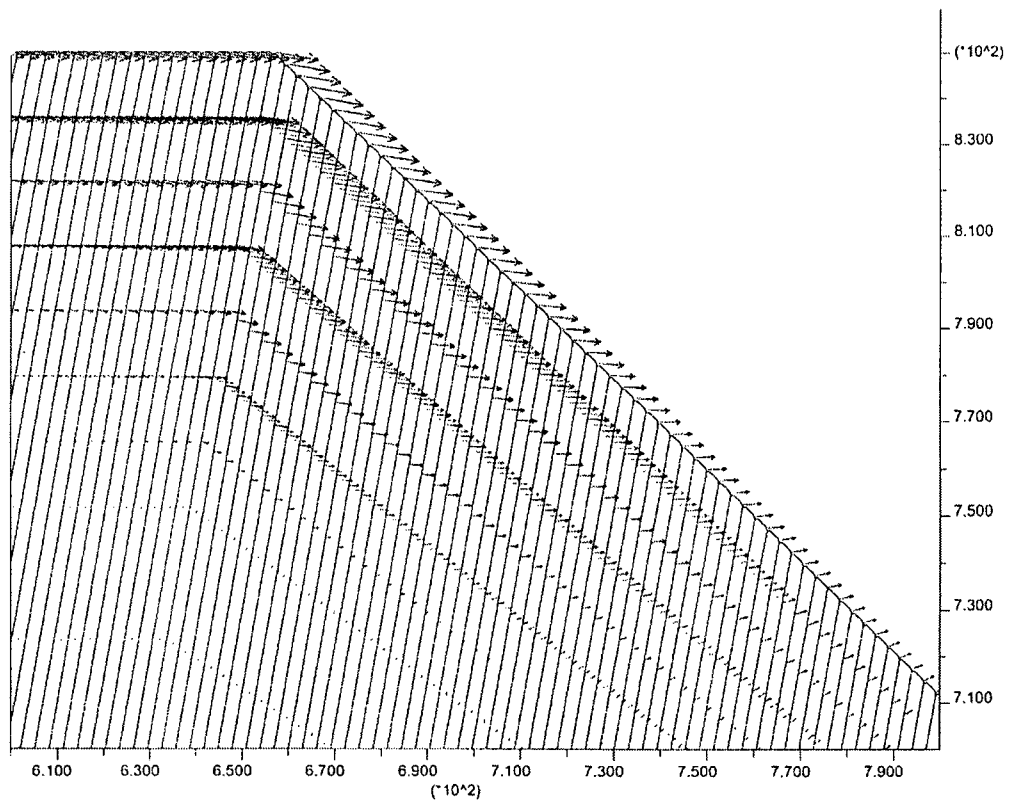
Figure 6-2:
Detail of
displacement
vectors for
variations of
intact rock
strength after
approx. 20 s
run time.

(a) UCS =
10 MPa

(b) UCS = 80
MPa

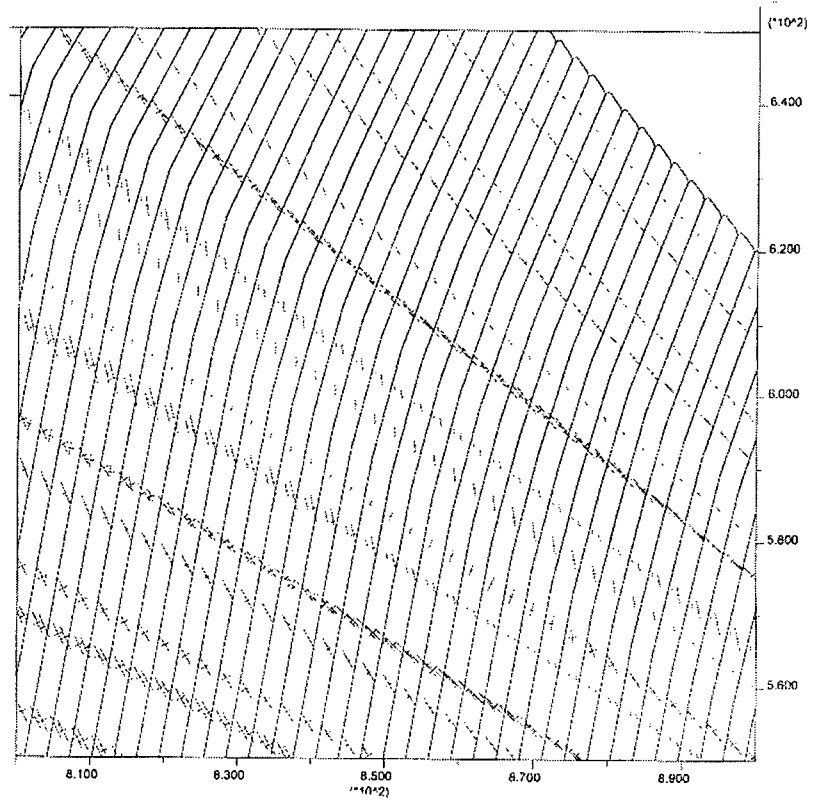
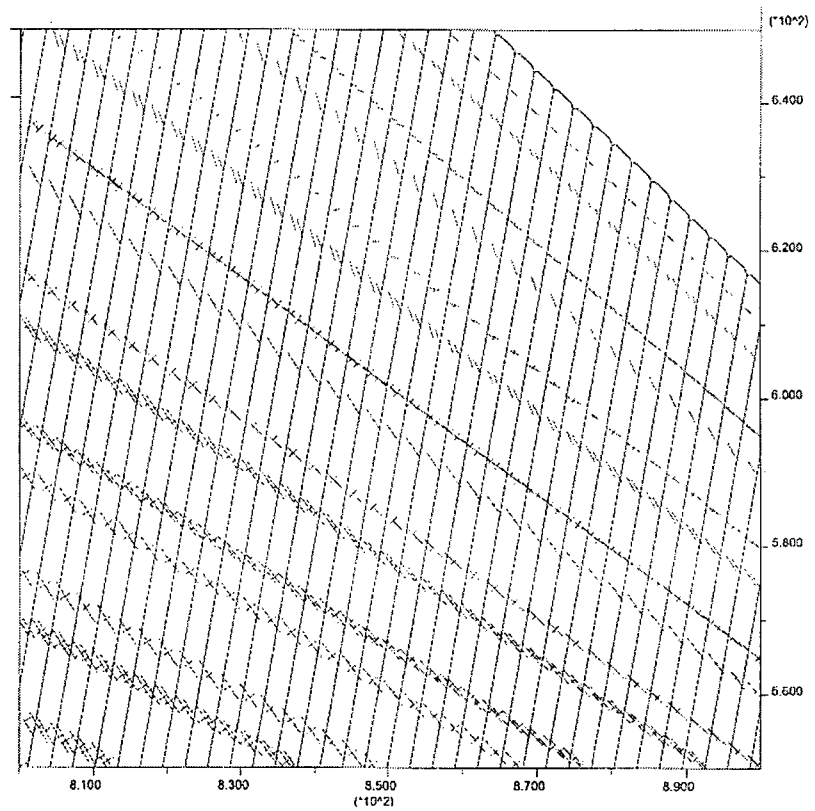
Figure 6-3:
Detail of principal
stresses for variations
of intact rock strength
after approx. 20 s run
time.

(a) UCS = 20 MPa

(b) UCS = 80 MPa

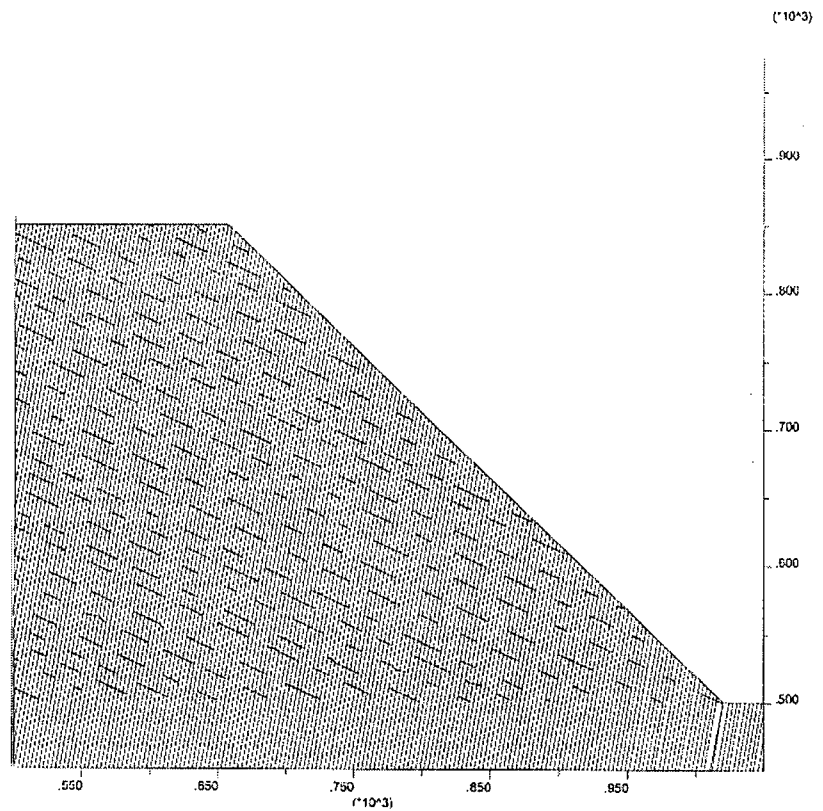
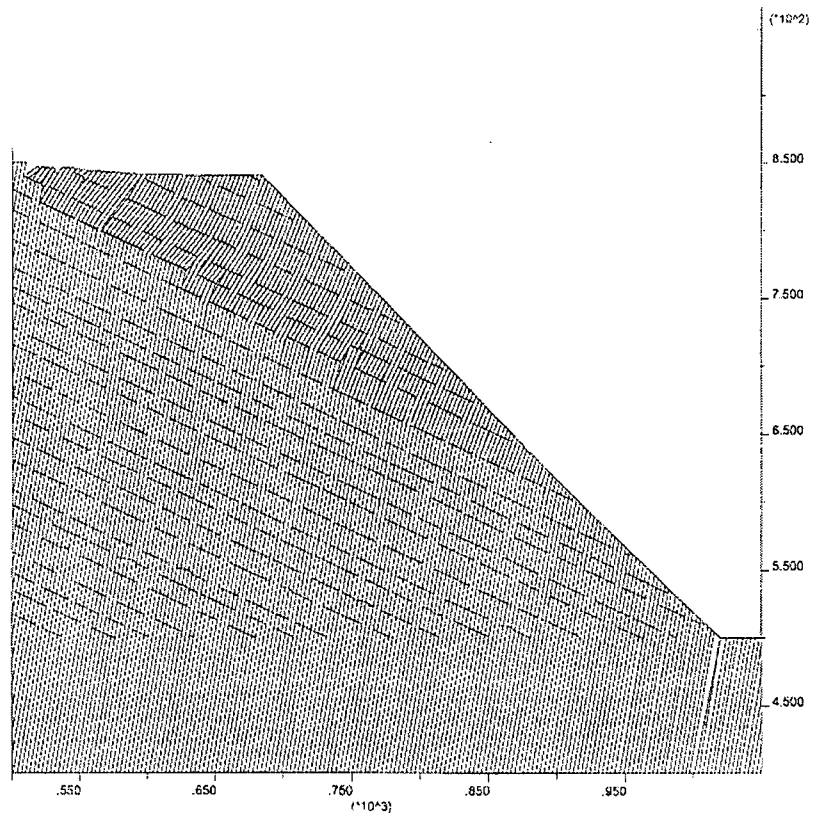
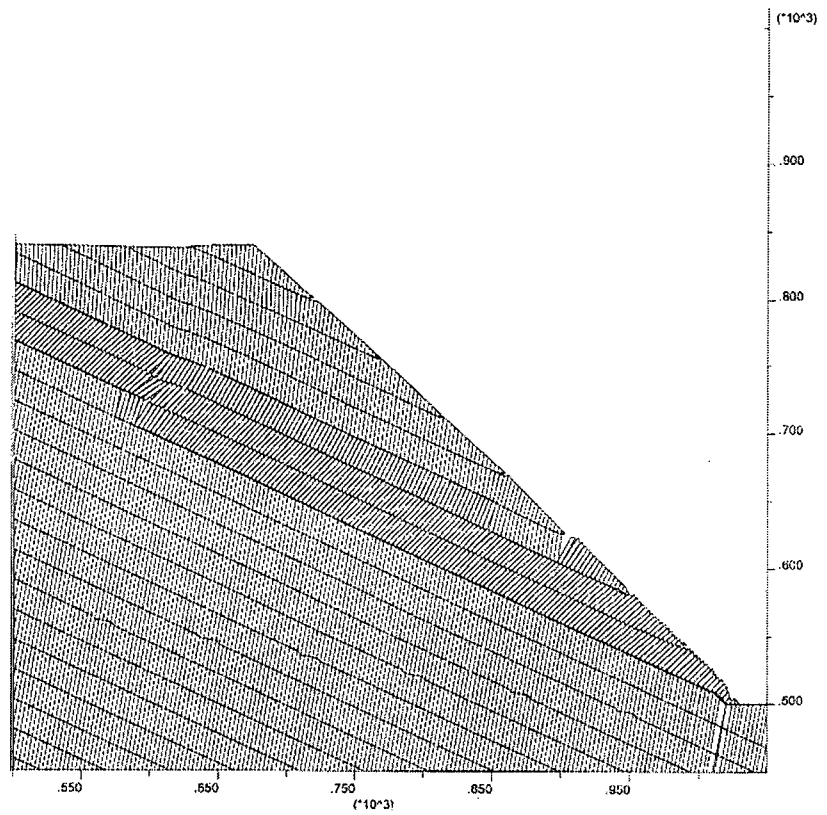
Figure 6-4:
Block plots for variation in cross-
joint persistence after approx. 18 s
run time (refer to Table 5-4,
Figure 5-3).

(b) Test 0

(d) Test 2

(e) idealized cross-joints

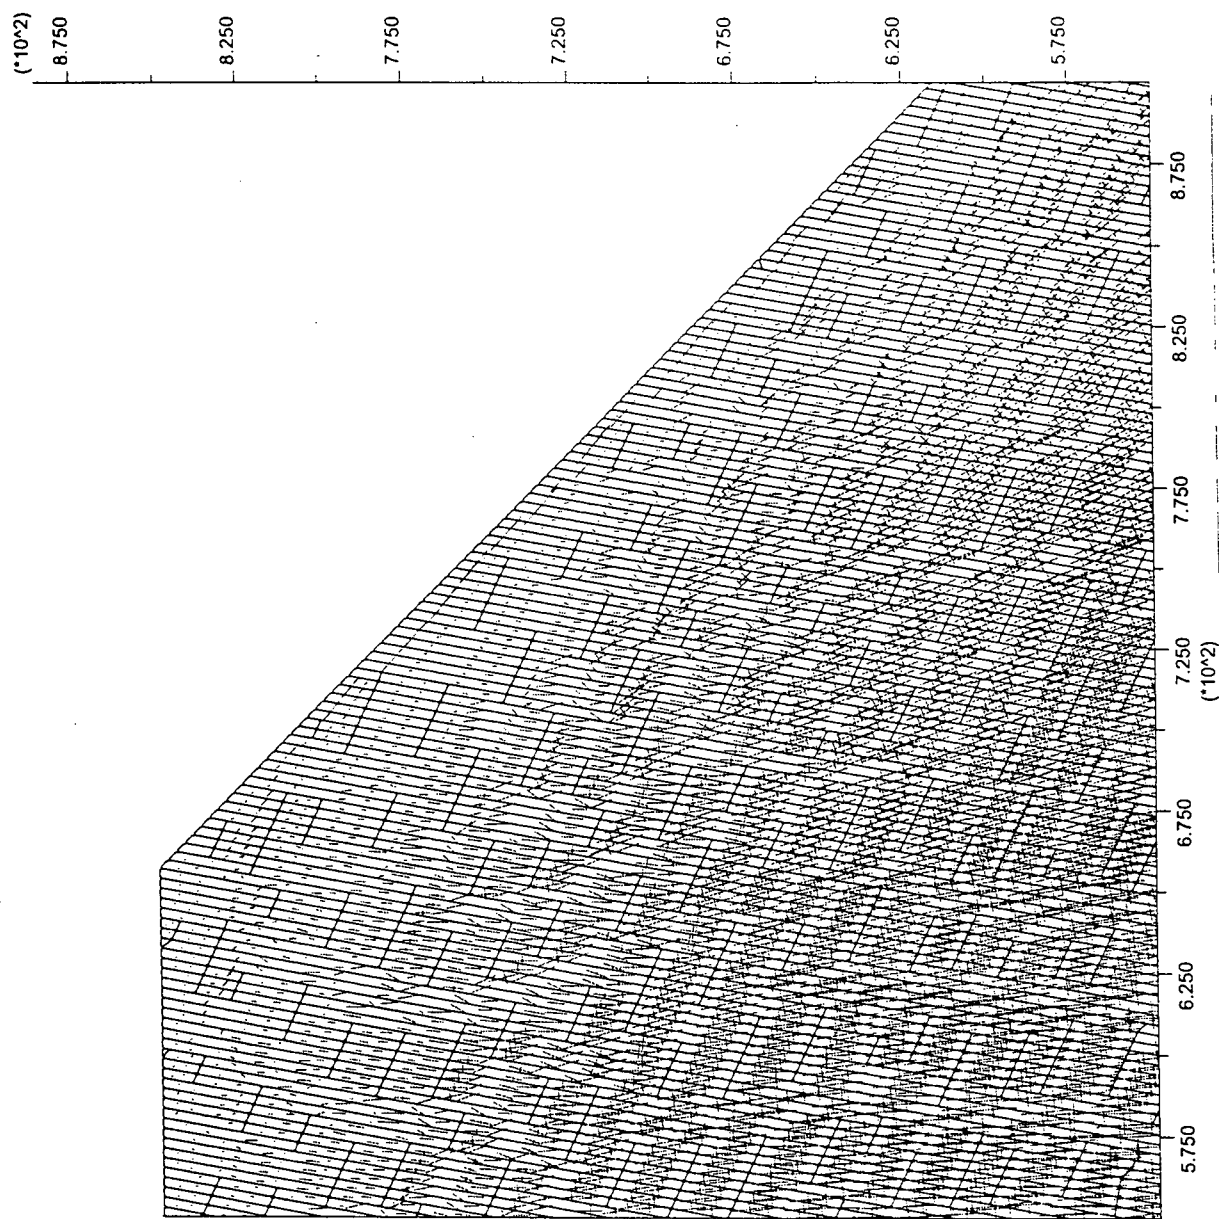
Figure 6-5:
Stresses in the Slope for Test 0
(refer to Table 5-4, Figure 5-3).

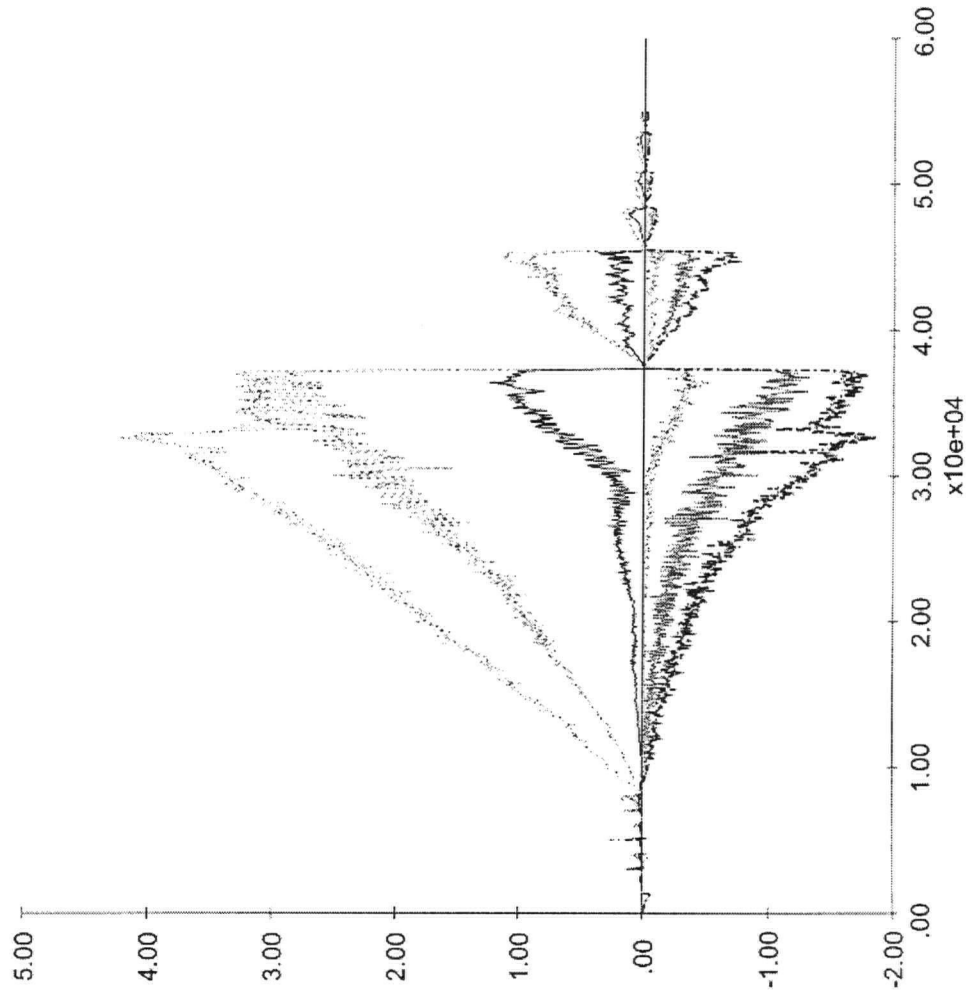
Figure 6-6: Velocity History for Test 2; see text for detailed discussion (refer to Table 5-1 for locations on the slope).

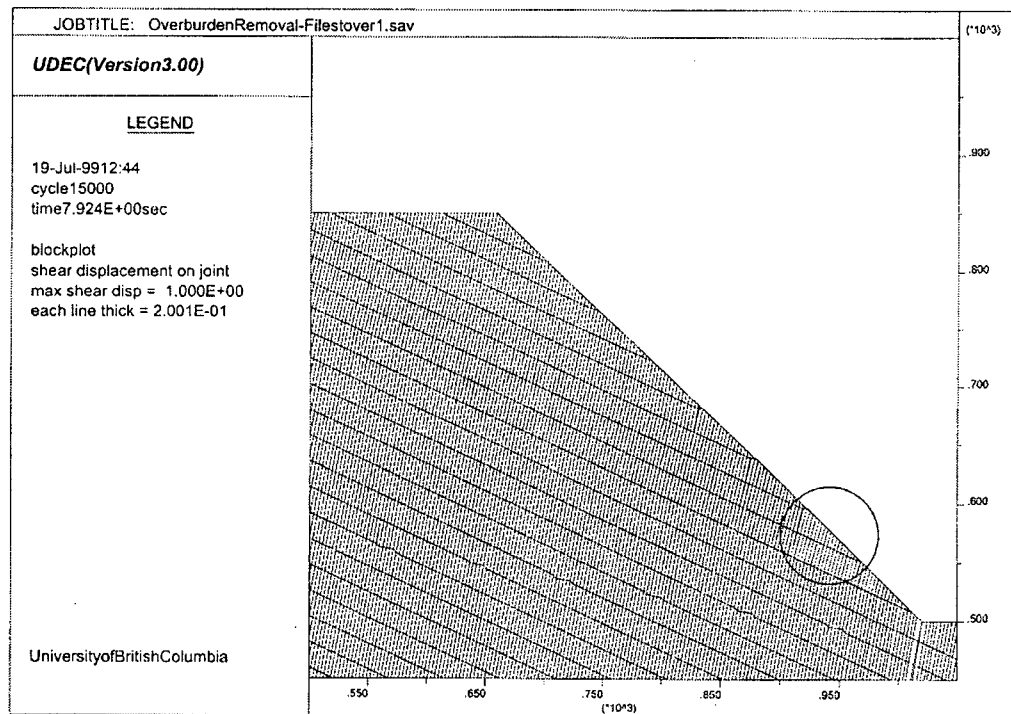
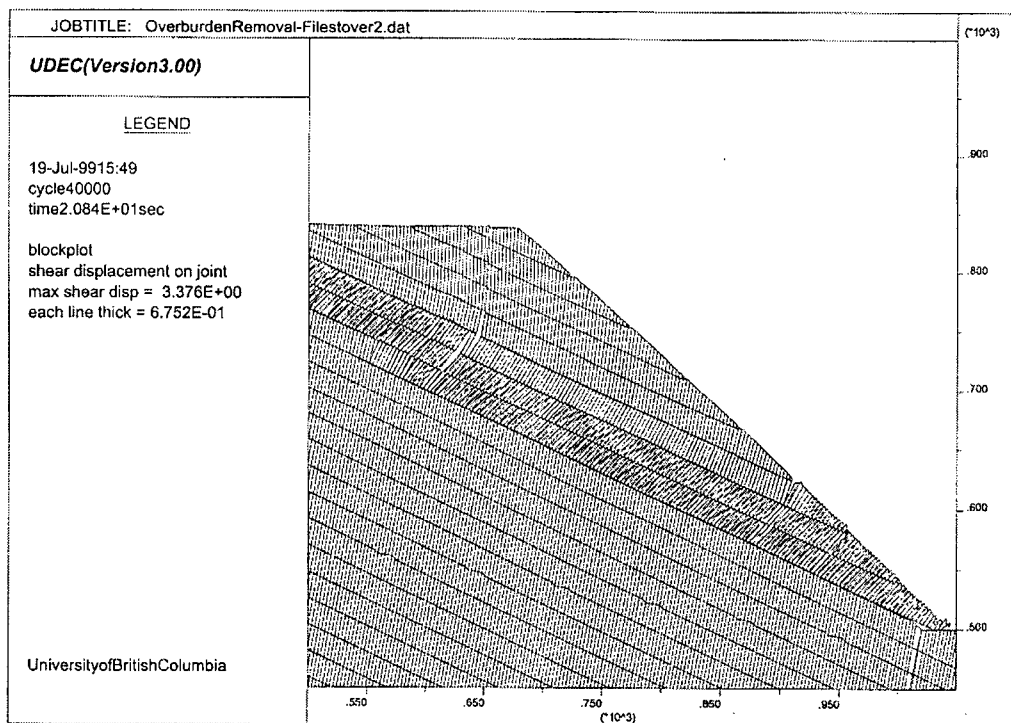
Figure 6-7:
Shear
Displacement
for Idealized
Cross-Joints.

(a) after
15000 cycles
(shear shown
in circled
area)

(b) after
40000 cycles
