EXAMINATION OF TOPPLING BEHAVIOUR IN LARGE ROCK SLOPES

USING THE UDEC COMPUTER CODE

A THESIS SUBMITTED IN PARTIAL FULFILLMENT
OF THE REQUIREMENTS FOR THE DEGREE OF
MASTER OF APPLIED SCIENCE

THE UNIVERSITY OF BRITISH COLUMBIA

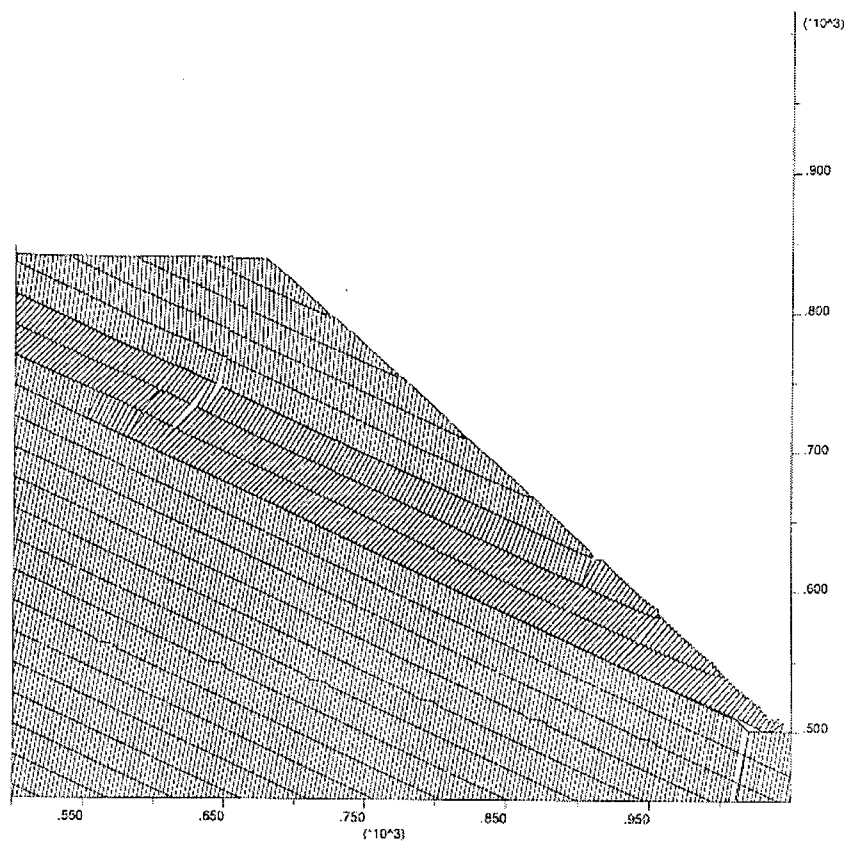
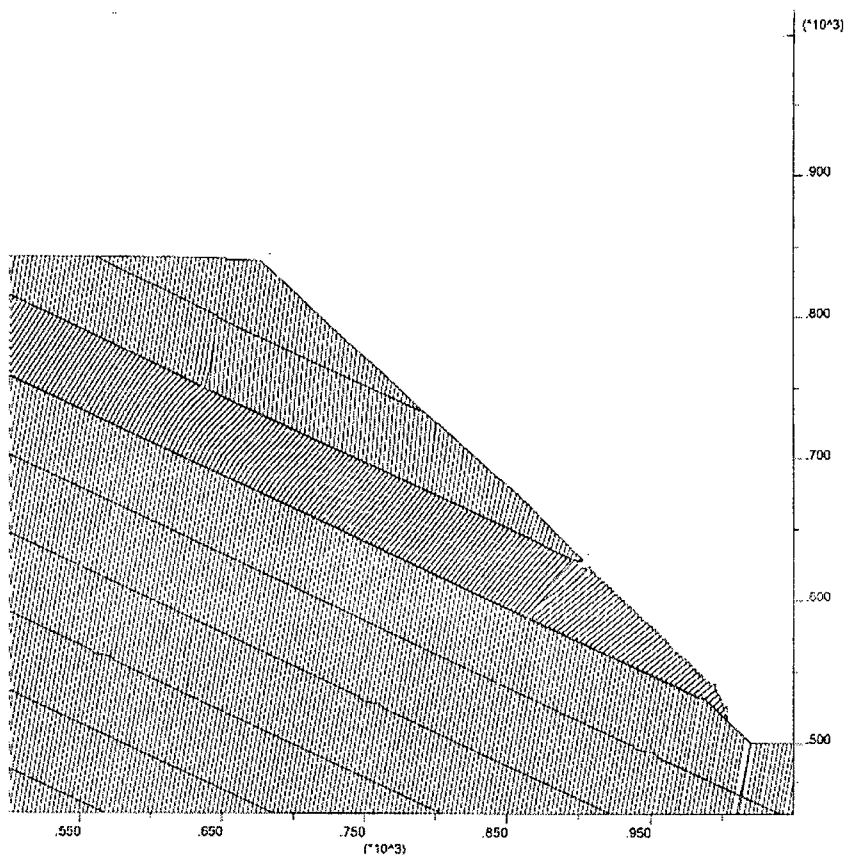
Figure 6-8:
Block plots for variation in
spacing normal to cross-
joints after approx. 20
seconds run time.

(a) spacing 20 m

(b) spacing 50 m

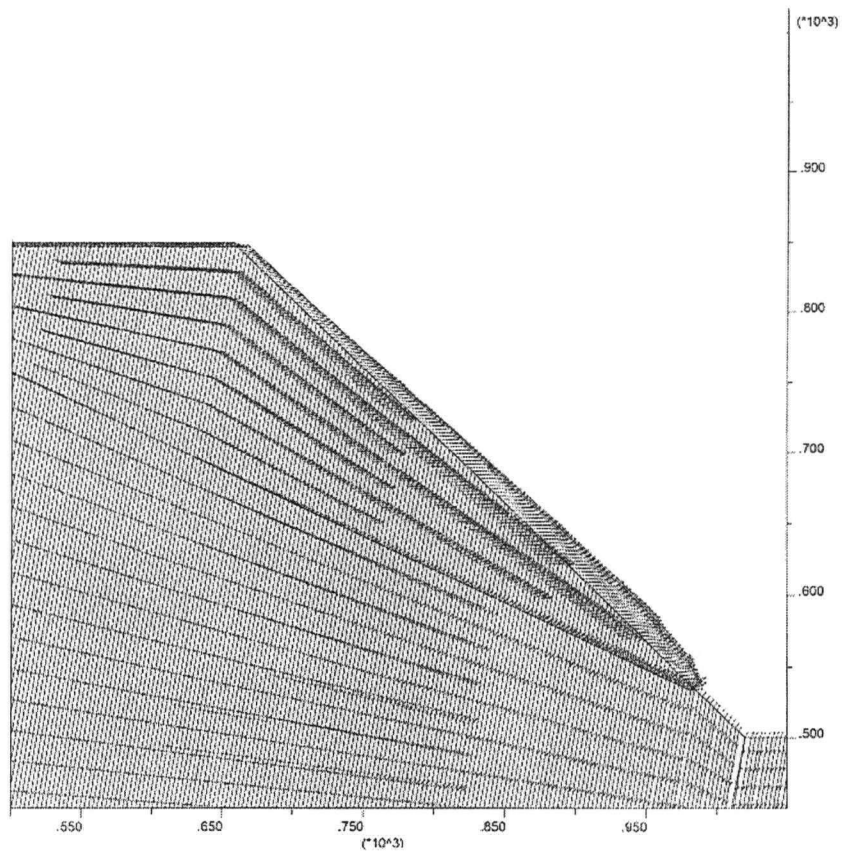
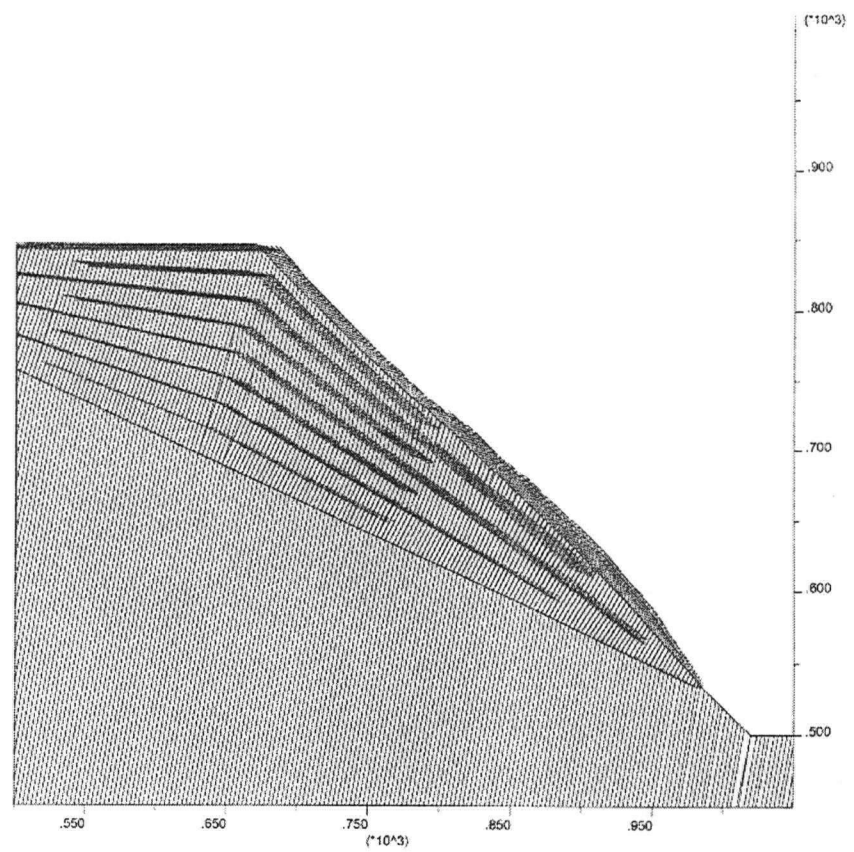
Figure 6-9:
Displacement Vectors for a
Single Cross-Joint.

(a) after 20000 cycles

(b) after 75000 cycles

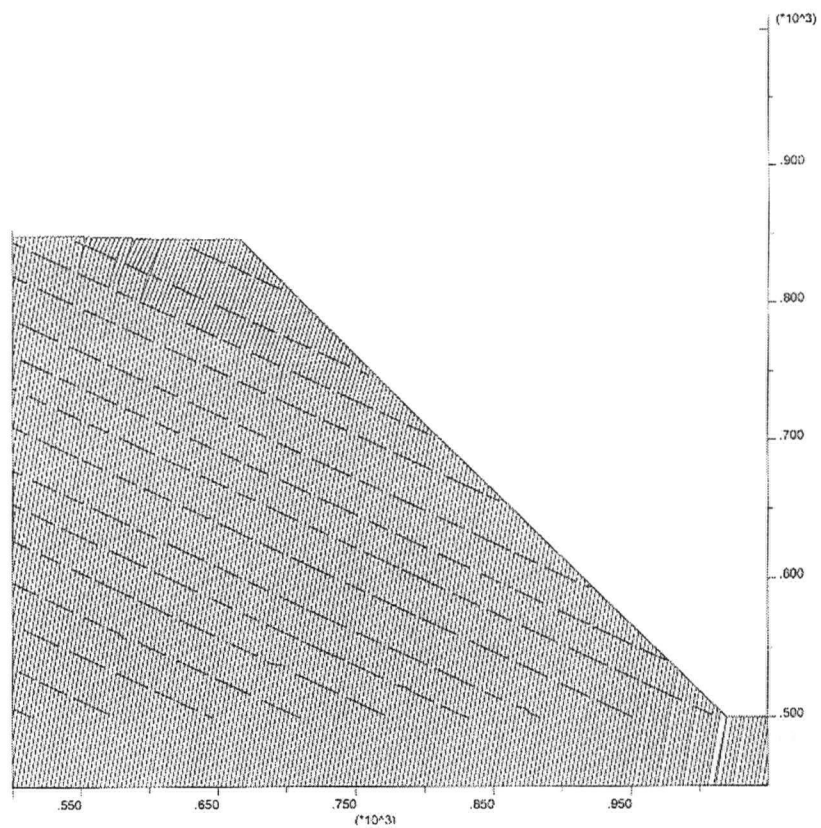
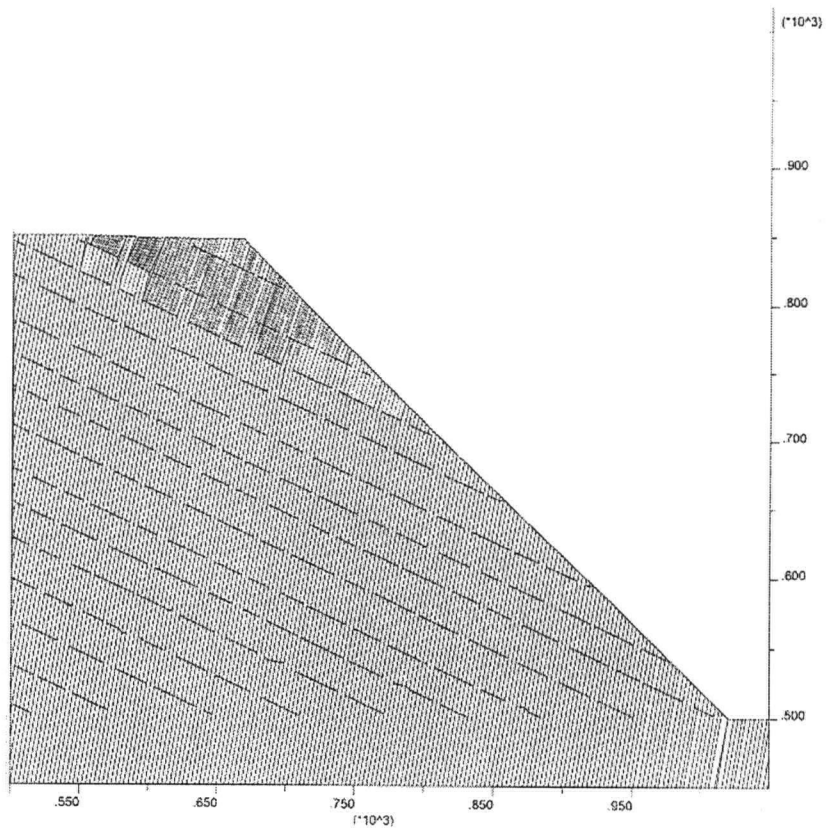
Figure 6-10:
Test 3 after approx. 20 s
run time.

(a) block plot

(b) shear

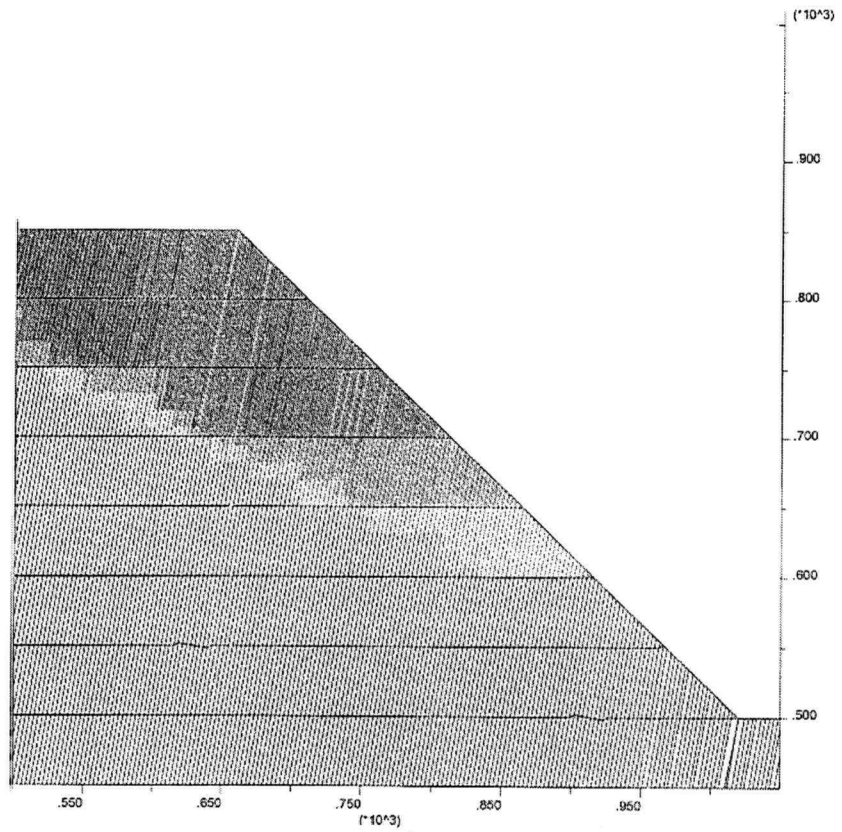
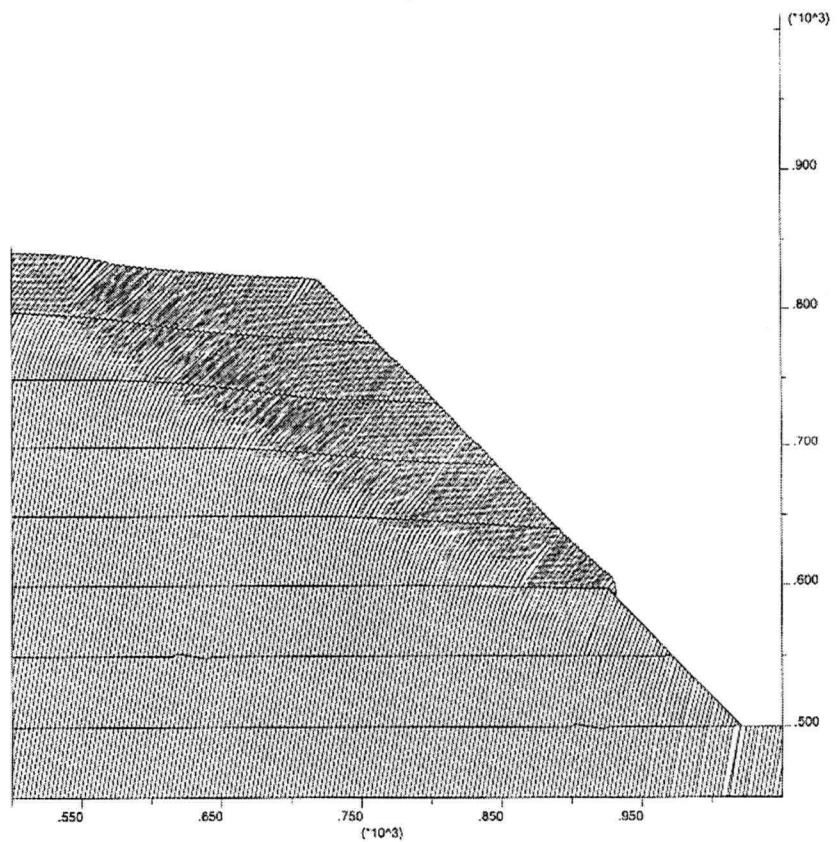
Figure 6-11:
Shear plots for horizontal
cross-joints (normal
spacing 50 m).

(a) after 20000 cycles

(b) after 70000 cycles

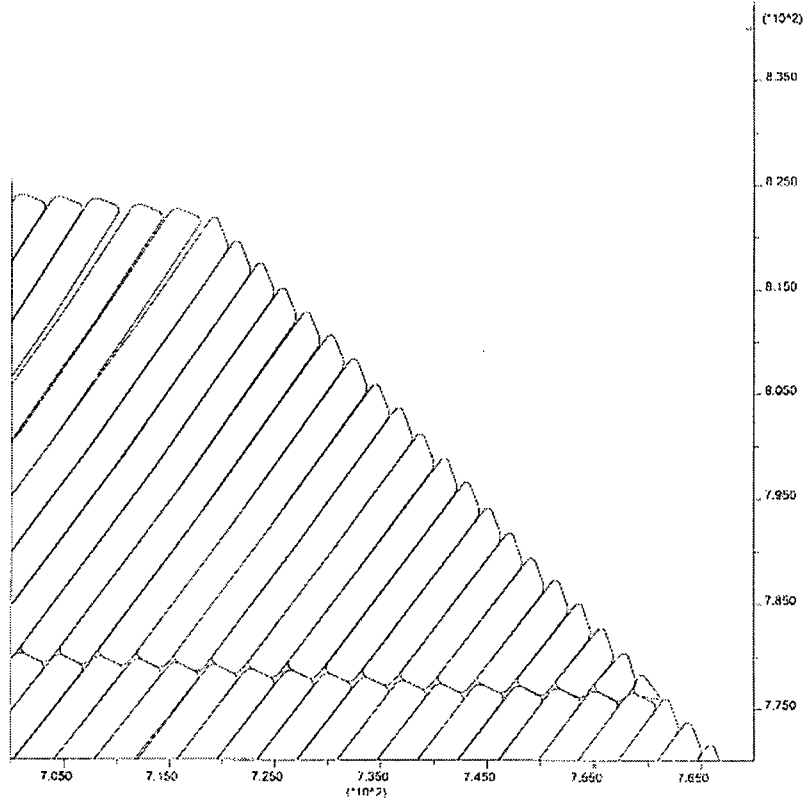
Figure 6-12:
Detail of Horizontal
Cross-Joints After
70000 cycles

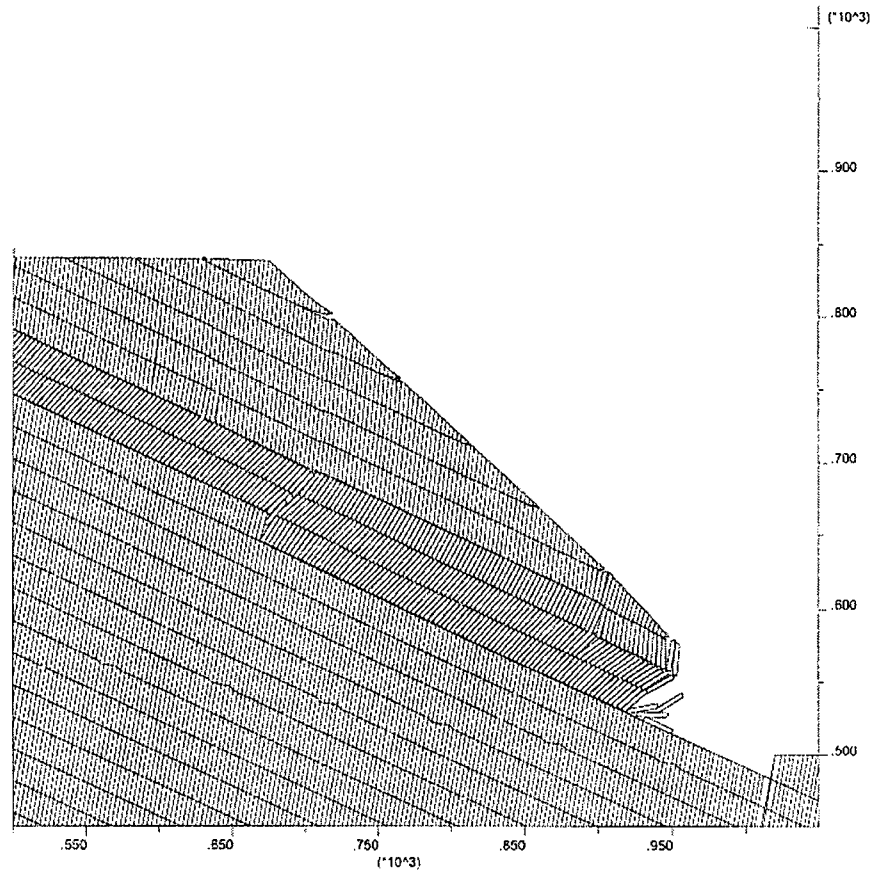
Figure 6-13:
Block Plot of
Oversteepened
Slope #1 After
40000 Cycles
(compare with
Figure 6-4(e)).

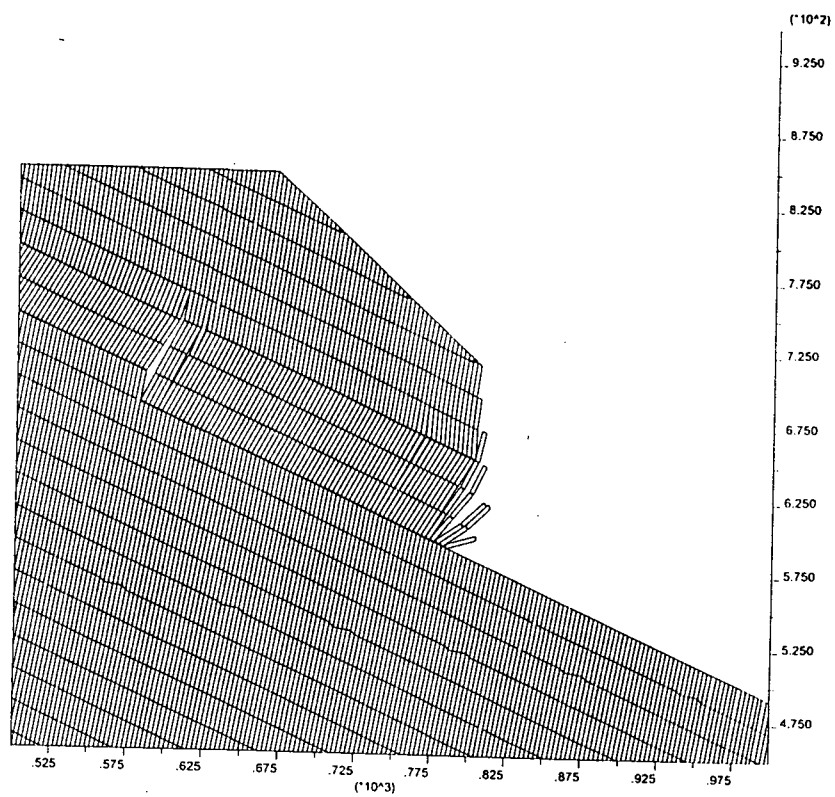
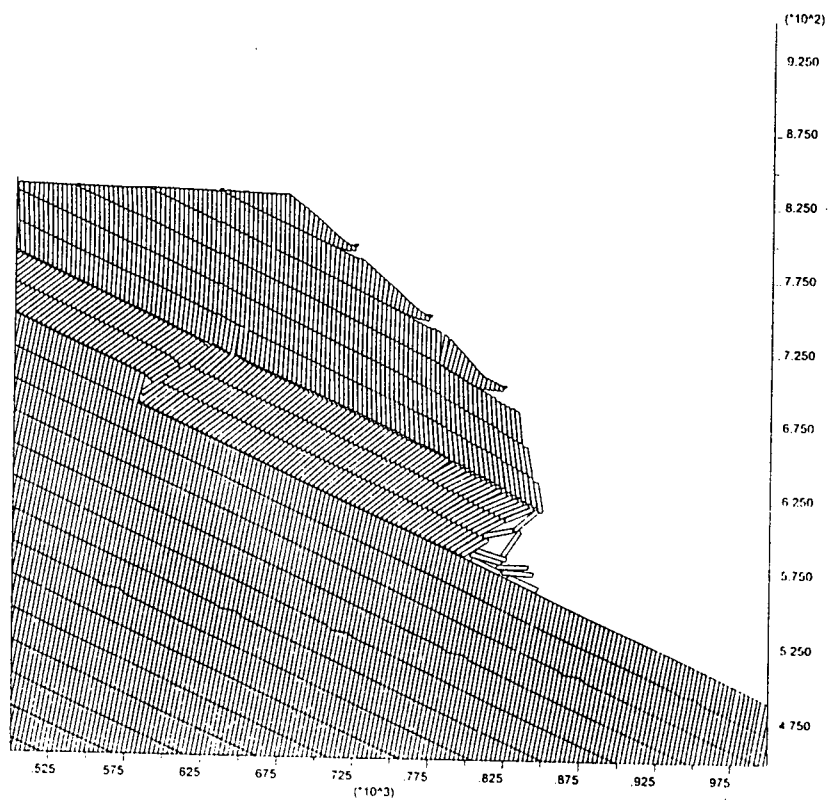
Figure 6-14:
Block Plots for
Oversteepened
Slope #2.

(a) 20000 cycles

(b) 40000 cycles

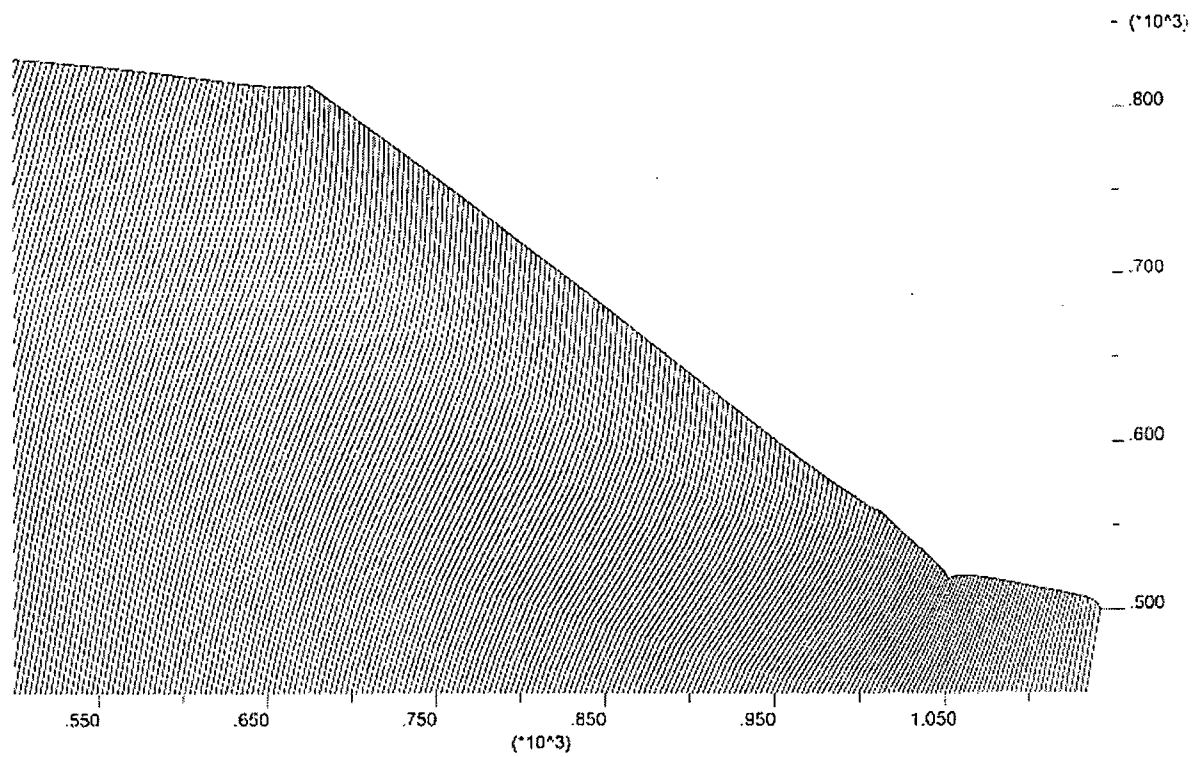
Figure 6-15: Block Plot with GSI = 48, $m_i = 2.5$, UCS = 10 MPa

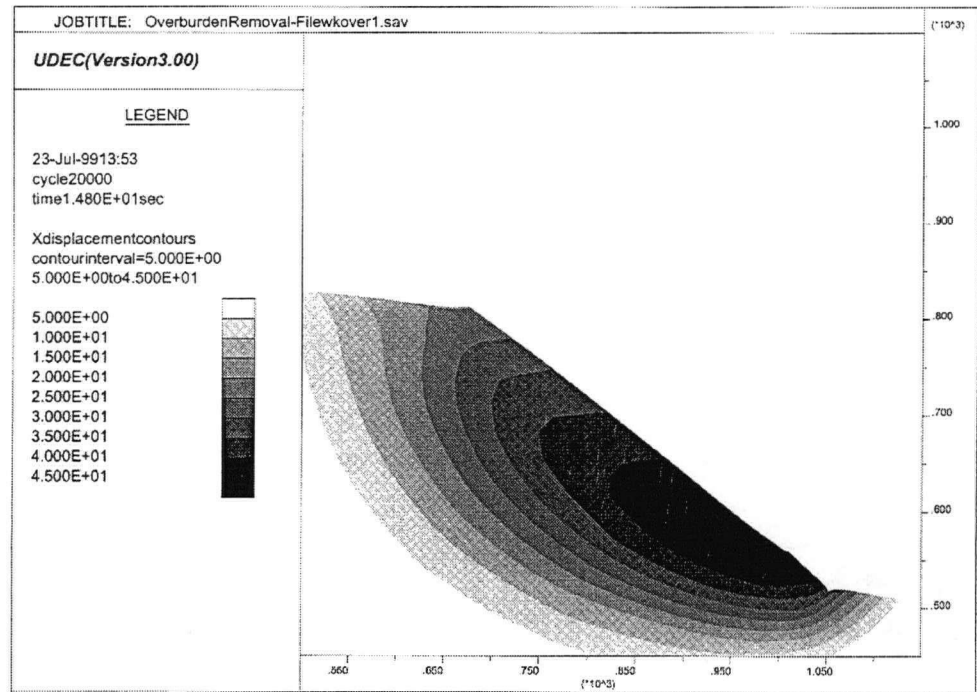
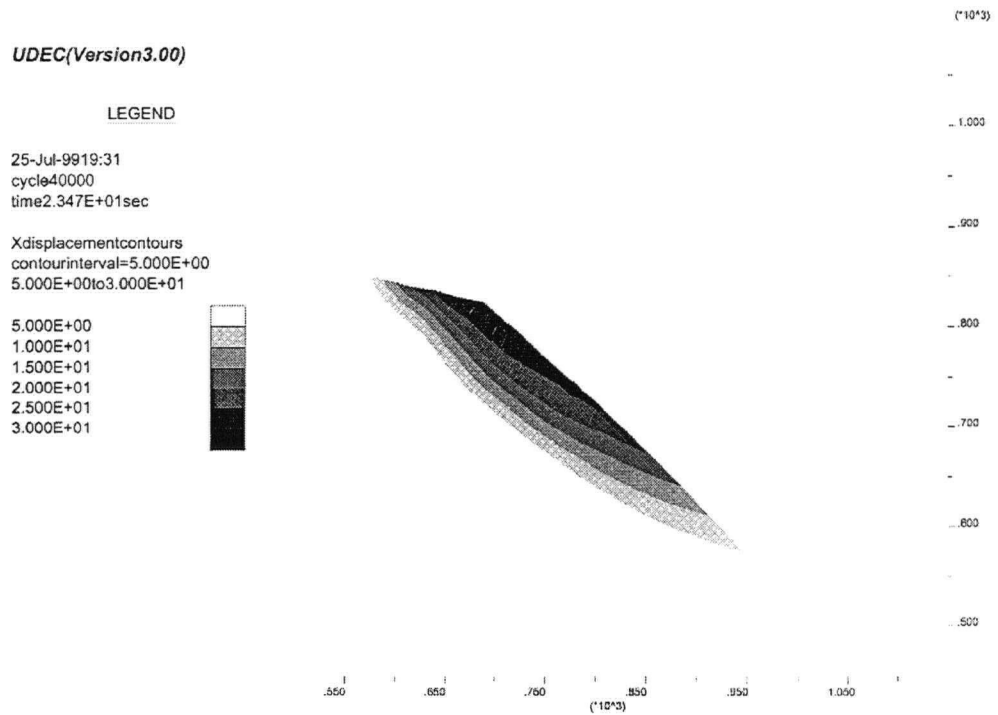
Figure 6-16:
X-Displacement
Contours

(a) GSI = 48,
mi = 2.5,
UCS = 10 MPa

(b) GSI = 62,
mi = 12,
UCS = 10 MPa

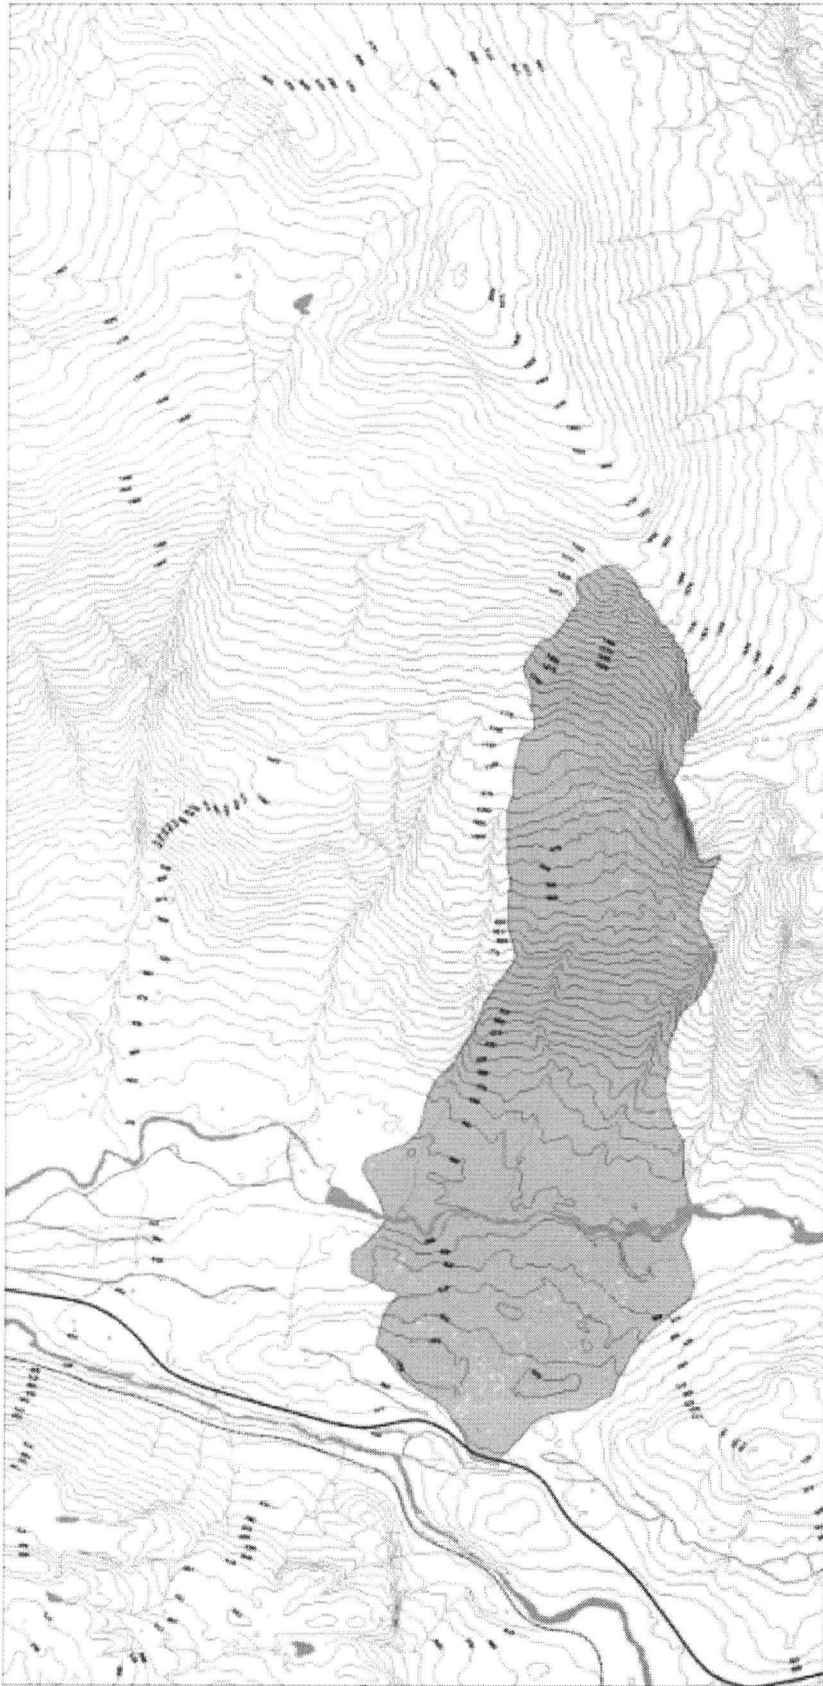
Figure 7-2:
Overview of the
Mystery Creek
rock avalanche;
north is to the left;
contour interval 25 m;
top of slide area is at
El. 1650 m; scale is
approx. 1:40,000
(GSC data, processed by
GeoSolutions Consulting,
Nepean, Ontario).

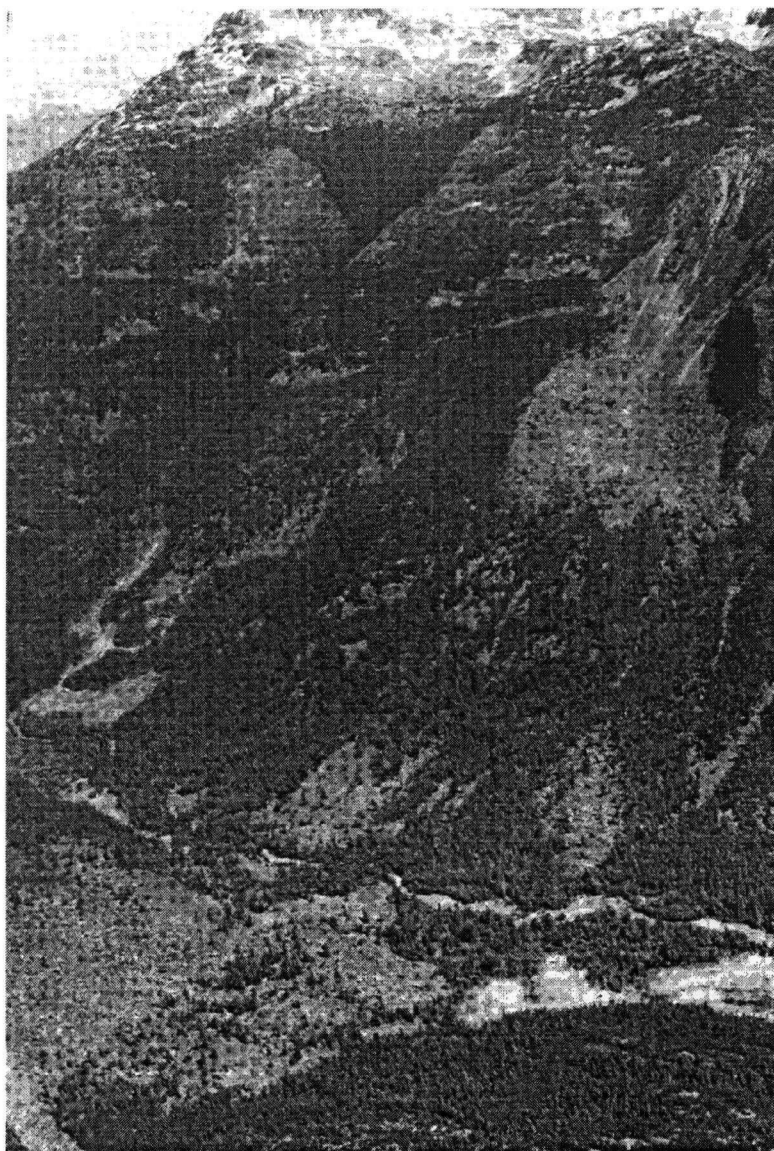
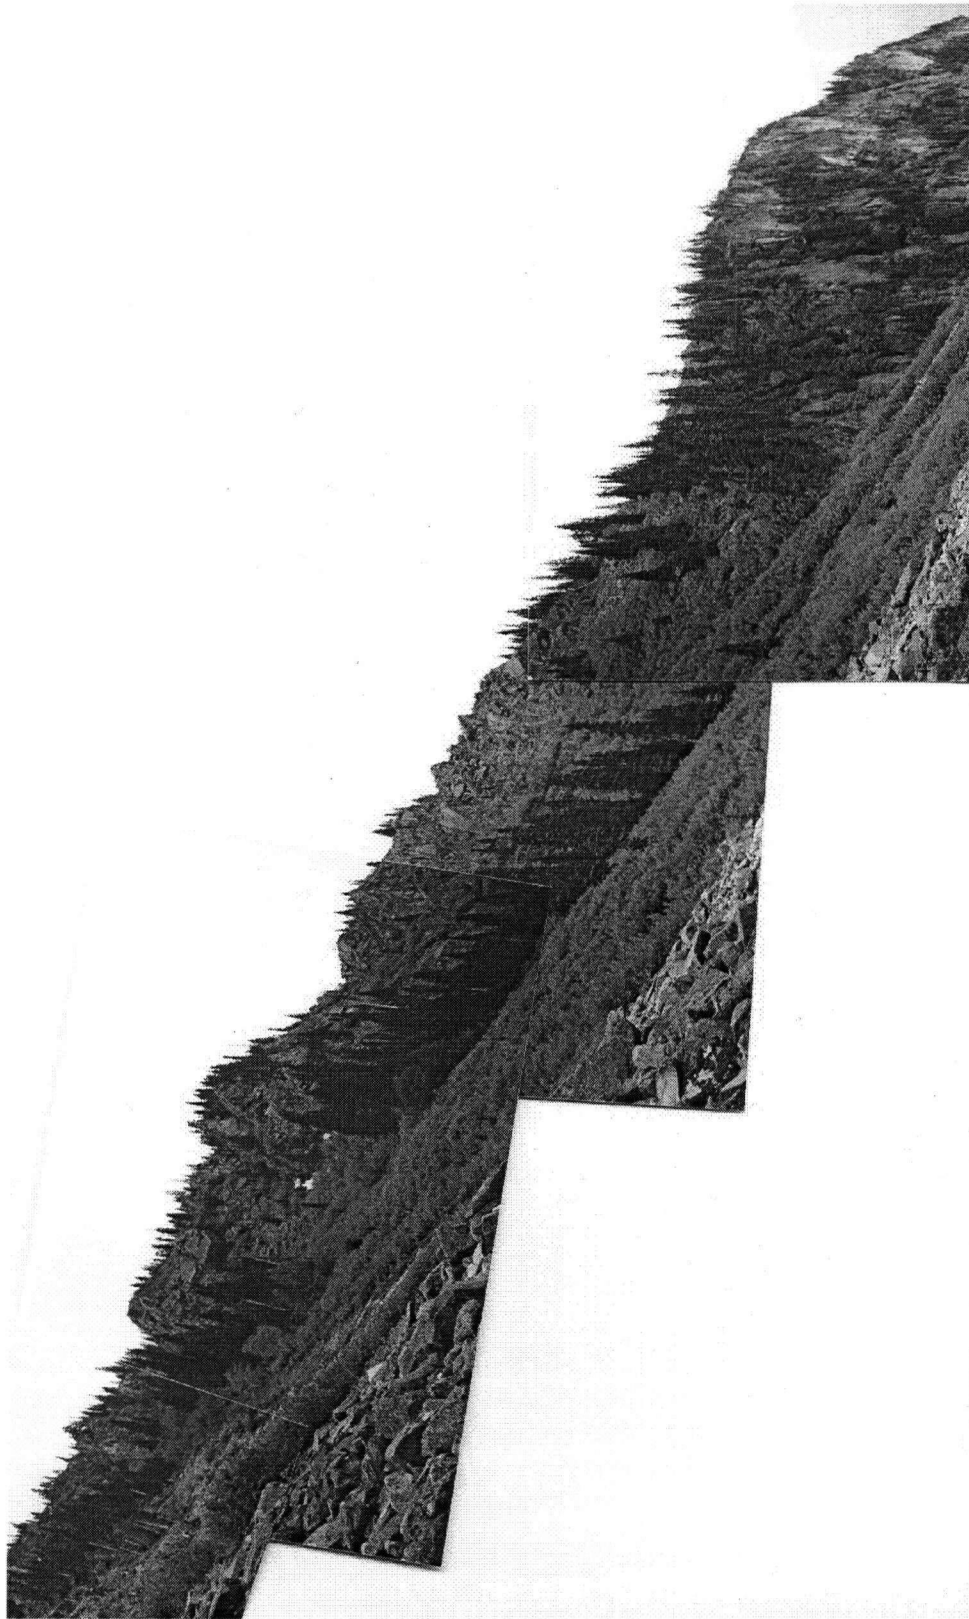
Figure 7-4: Photographs of toppling in rock mass on southern edge of scar – note sub-vertical cliff at right
(4-photo series taken by the author).

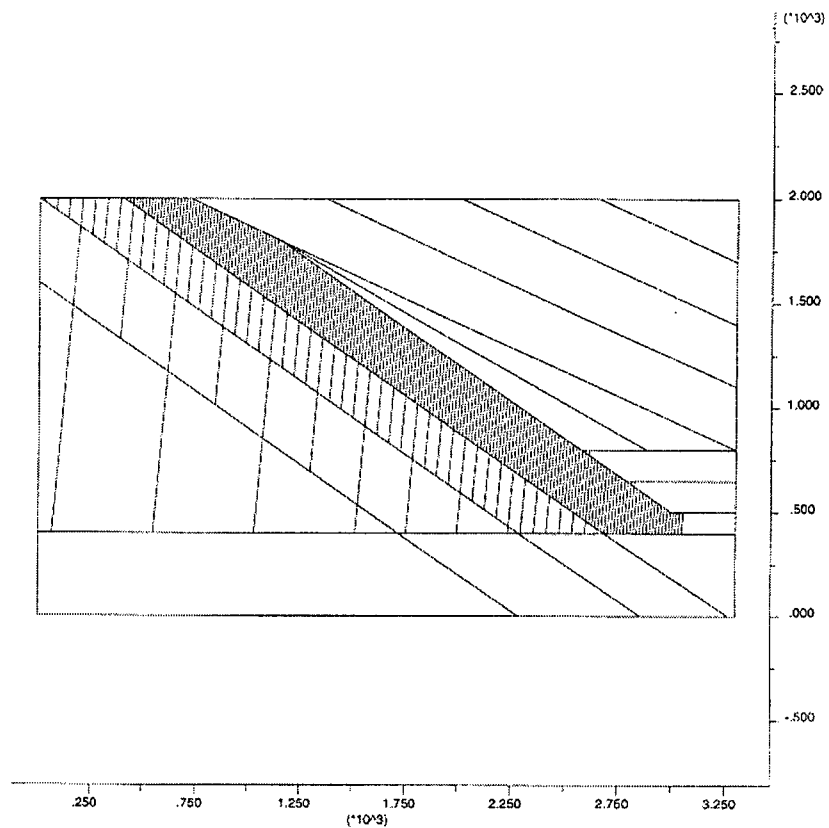
Figure 7-7:
Displacement and shear
without cross-joints in
Mystery Creek model.

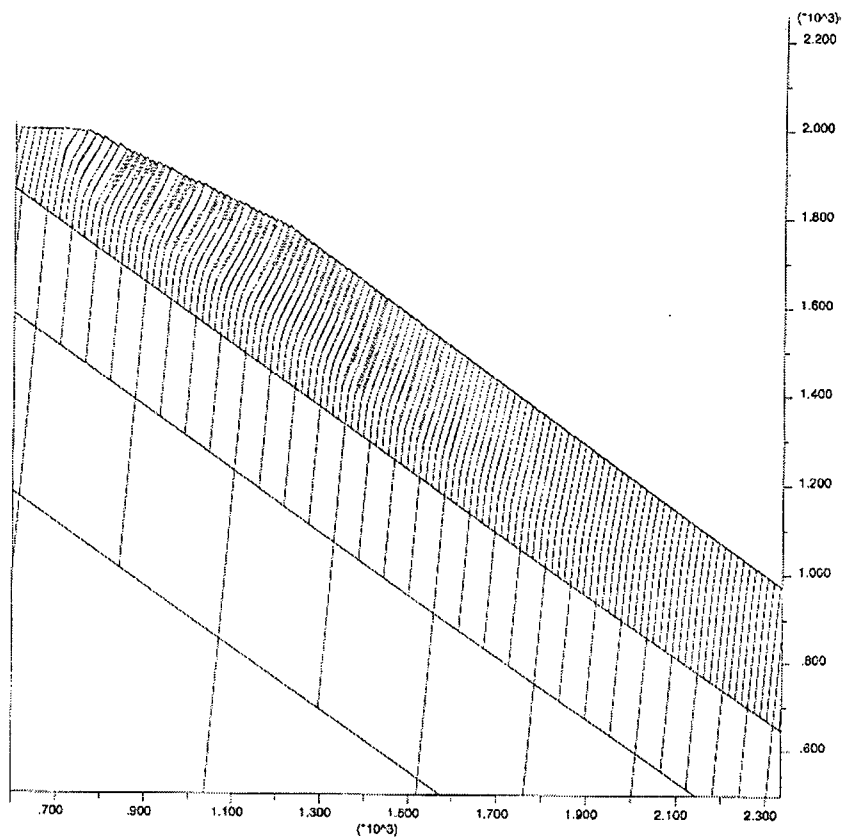
Figure 7-8:
Block plot of fully
continuous cross-joints
after 50 000 cycles.

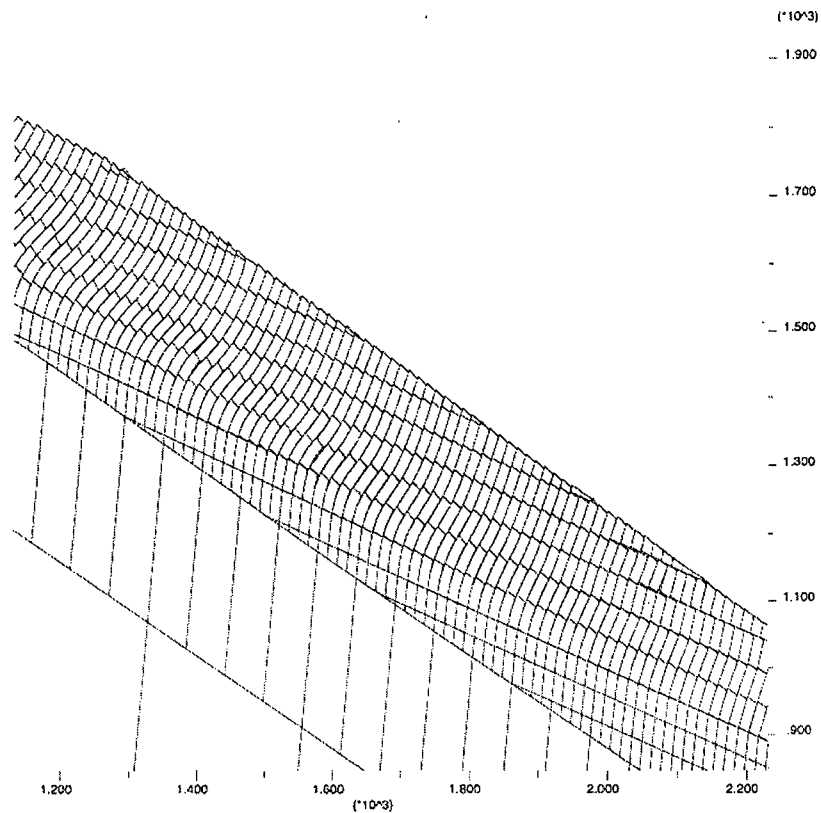
Figure 7-9:
Block plot of cliff in
Mystery Creek model
after 30000 cycles.

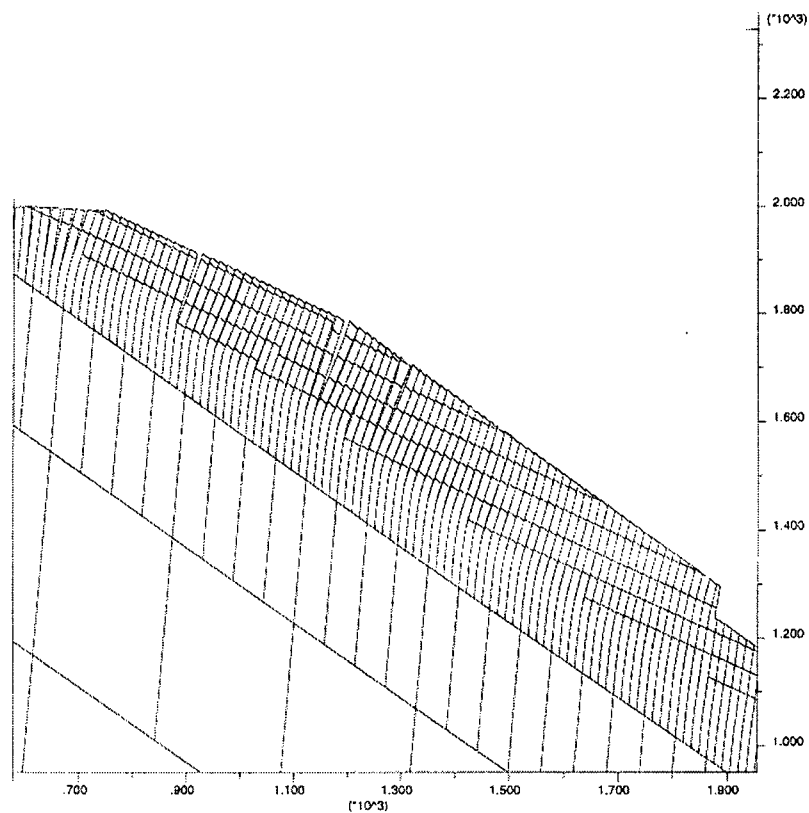
Figure 7-10:
Block plot of cliff
in Mystery Creek
model after 49000
cycles.

Allowing the model to run, further flexure of the columns occurs, with block toppling of blocks at the cliff (Figure 7-10). X- and y-displacement plots show that the deformation of the slope is controlled by the cross-joints, and that there is a significant amount of movement between El. 1200 and El. 1800, the location of the actual failure surface. Velocities indicate catastrophic failure.

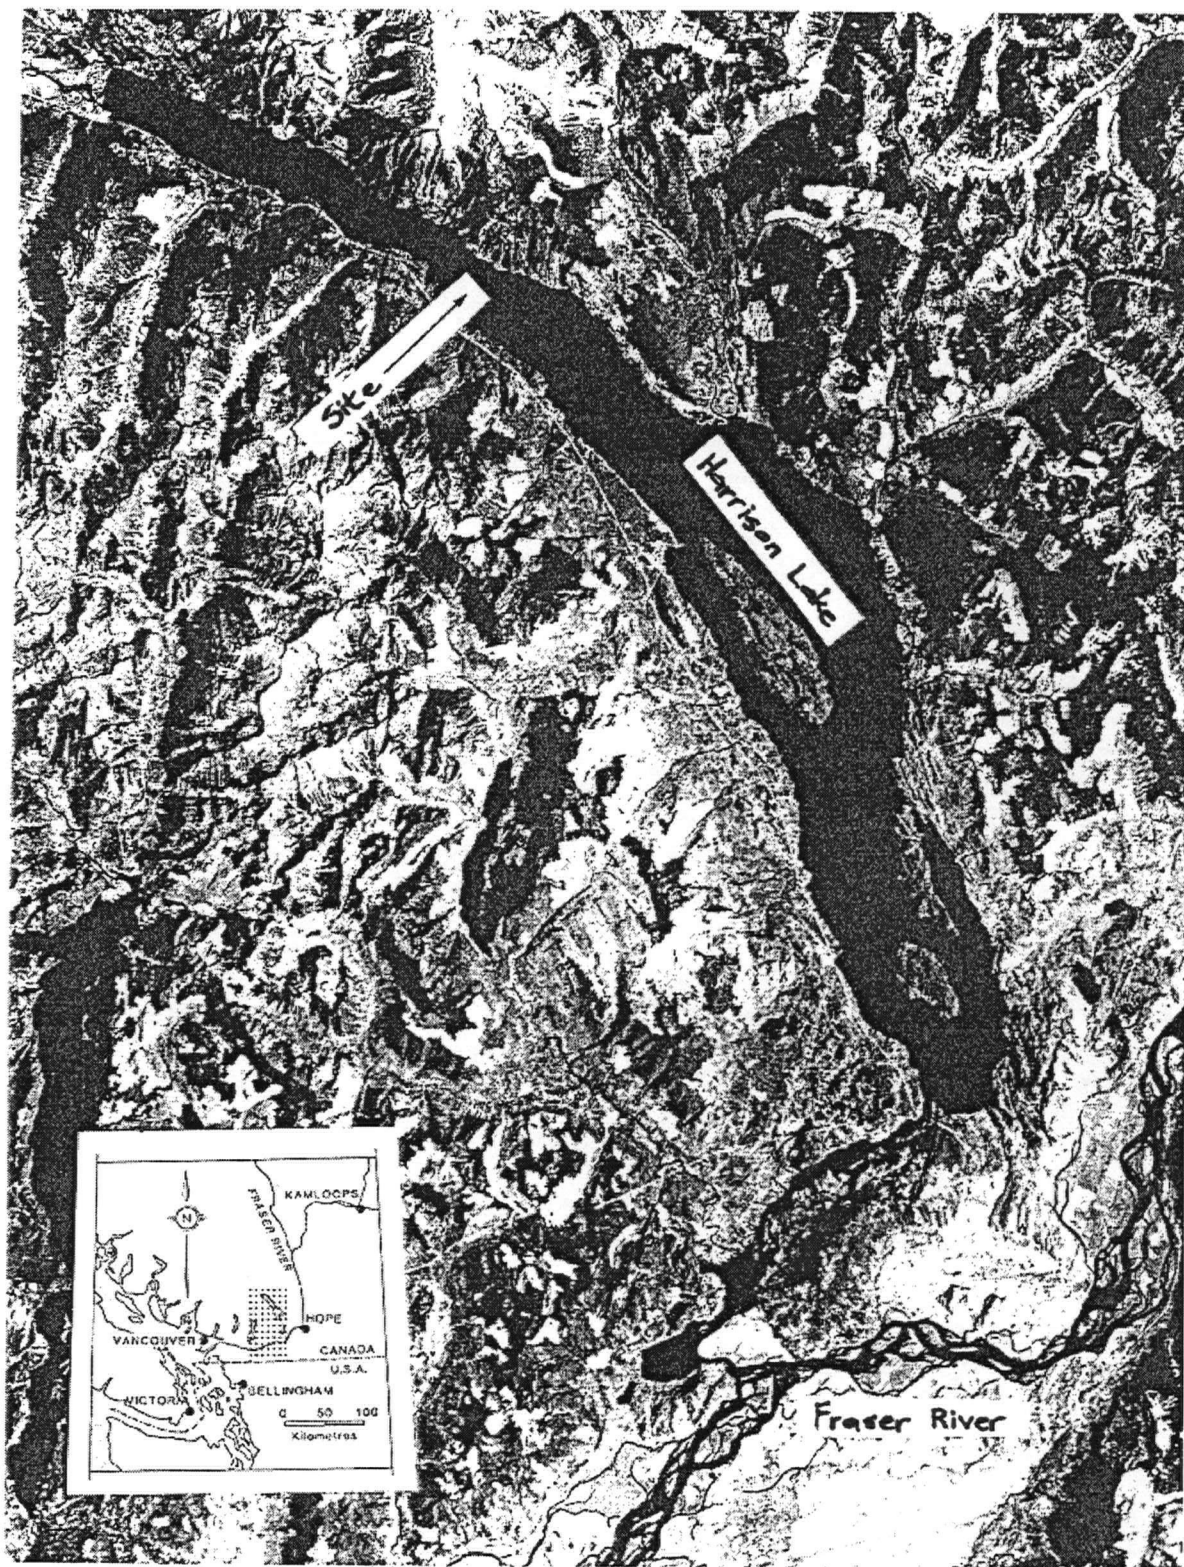
Figure 8-1: Location of Mt. Breakenridge slope movement (Anon., 1990, Fig. 1).

Harrison Lake is located in a north-northwest trending valley approximately 100 km east of Vancouver (Figure 8-1). The east valley slope rises from the lake at El. 10 m a.s.l. to the summit of Mount Breakenridge at El. 2403 m. The unstable area is located on a promontory having a slope angle of 41.4° up to a ridge at El. 1000 m, with lower angles on the flanks and crest of the ridge above this elevation (Figure 8-2). Adjacent to the site the lake bottom is featureless and roughly U-shaped in cross-section, typical of formerly glaciated valleys, and has a maximum depth of 250 m.

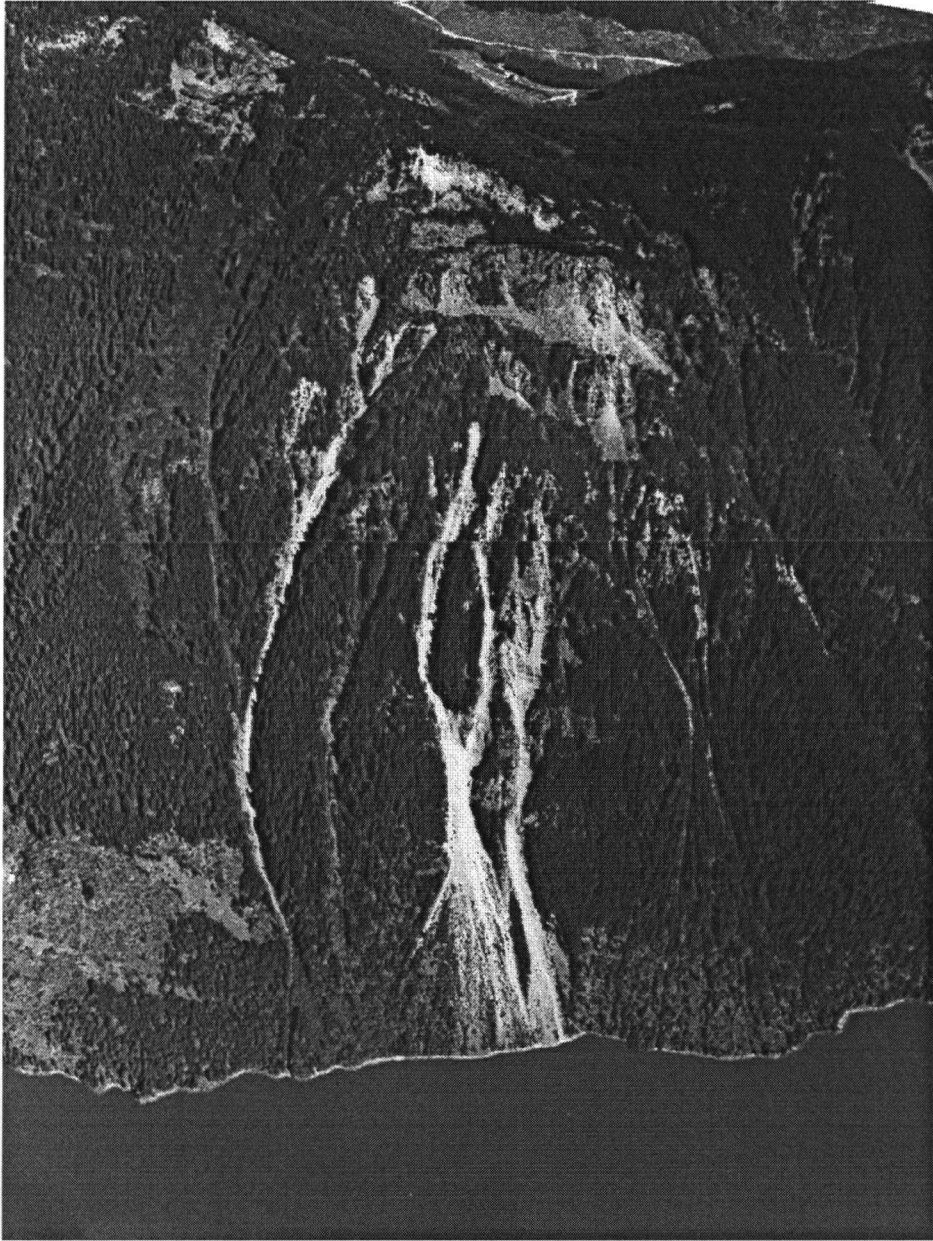
Figure 8-2: Photo of the Mt. Breakenridge disturbed slope.

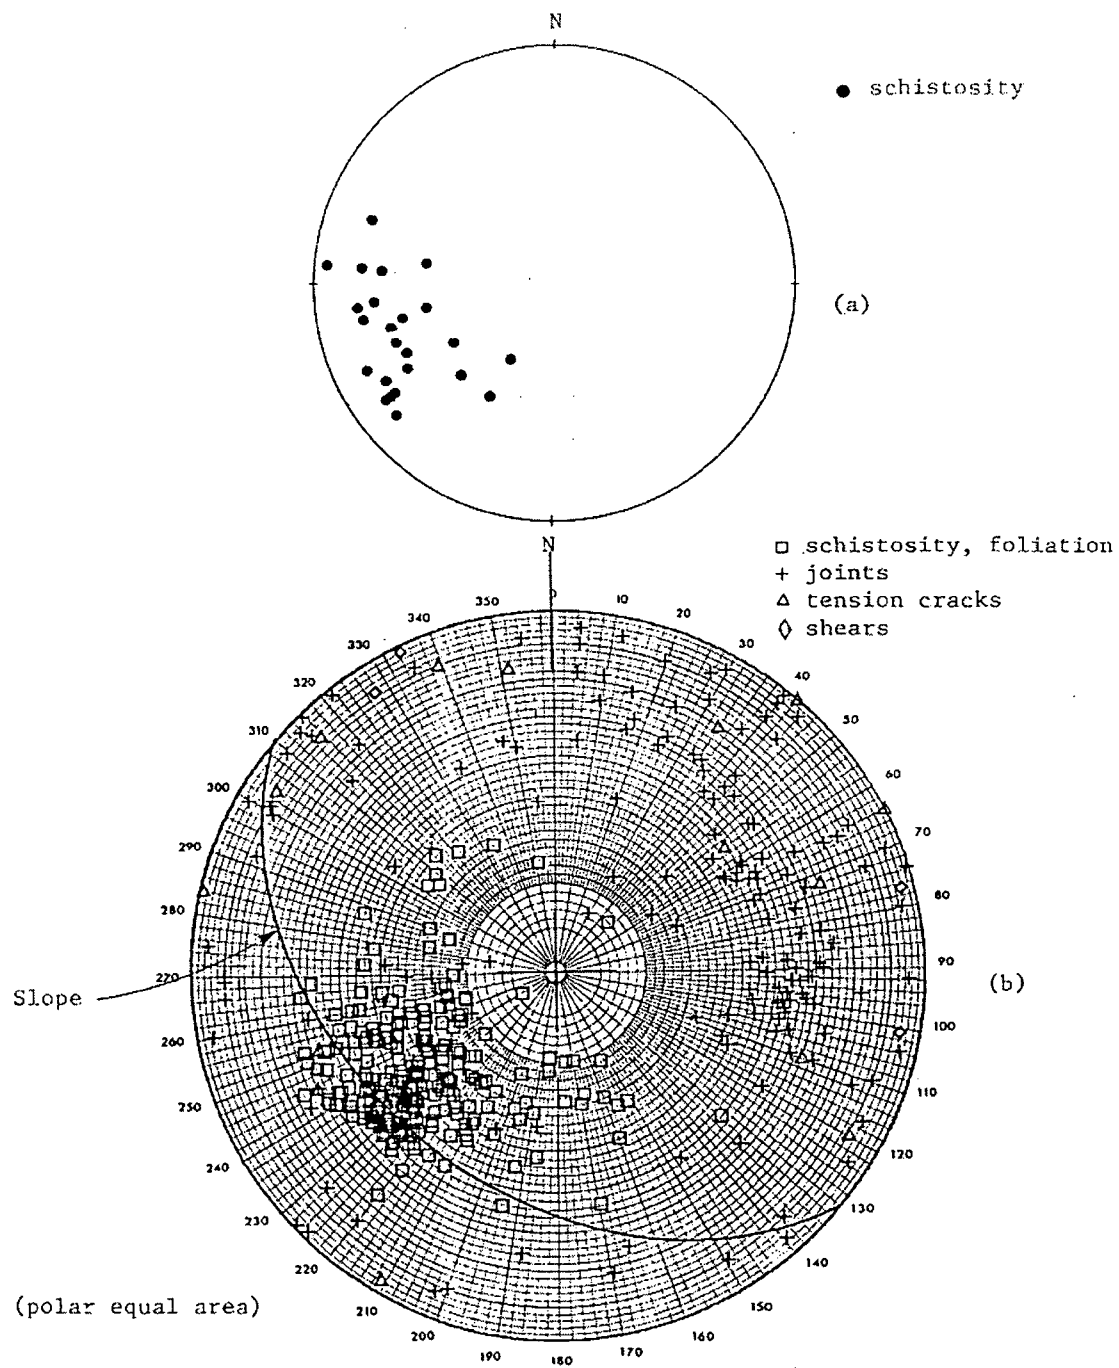
Figure 8-4: Structural data from the Sloillicum Formation (from Anon. (1990), Figure 6):
 (a) Monger (1986); (b) Anon. (1990).
