EXAMINATION OF TOPPLING BEHAVIOUR IN LARGE ROCK SLOPES

USING THE UDEC COMPUTER CODE

A THESIS SUBMITTED IN PARTIAL FULFILLMENT
OF THE REQUIREMENTS FOR THE DEGREE OF
MASTER OF APPLIED SCIENCE

THE UNIVERSITY OF BRITISH COLUMBIA

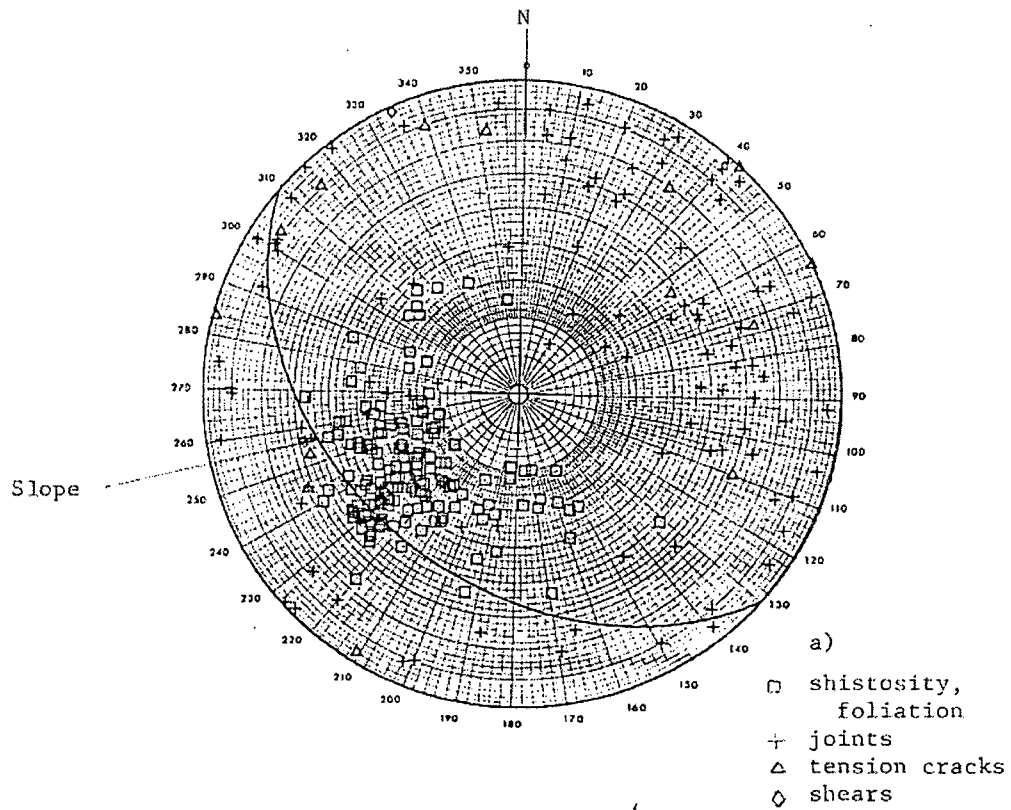
Figure 8-5: Comparison between structural orientations (from Anon. (1990), Figure 7):
 (a) inside disturbed area; (b) outside disturbed area.

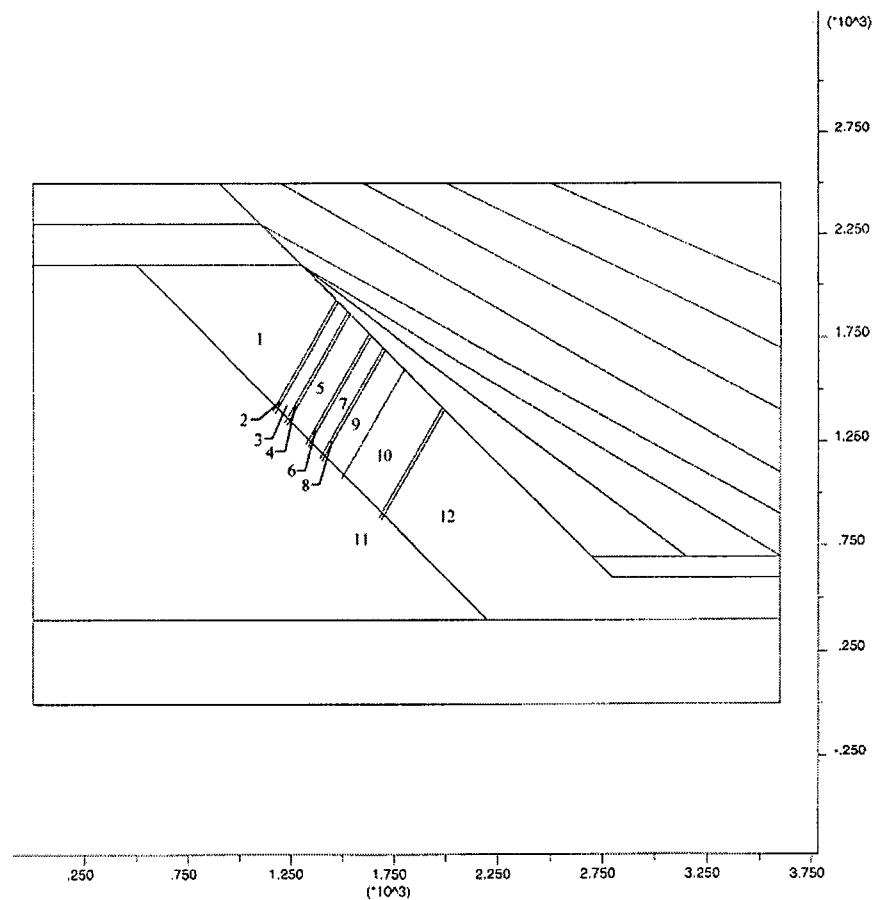
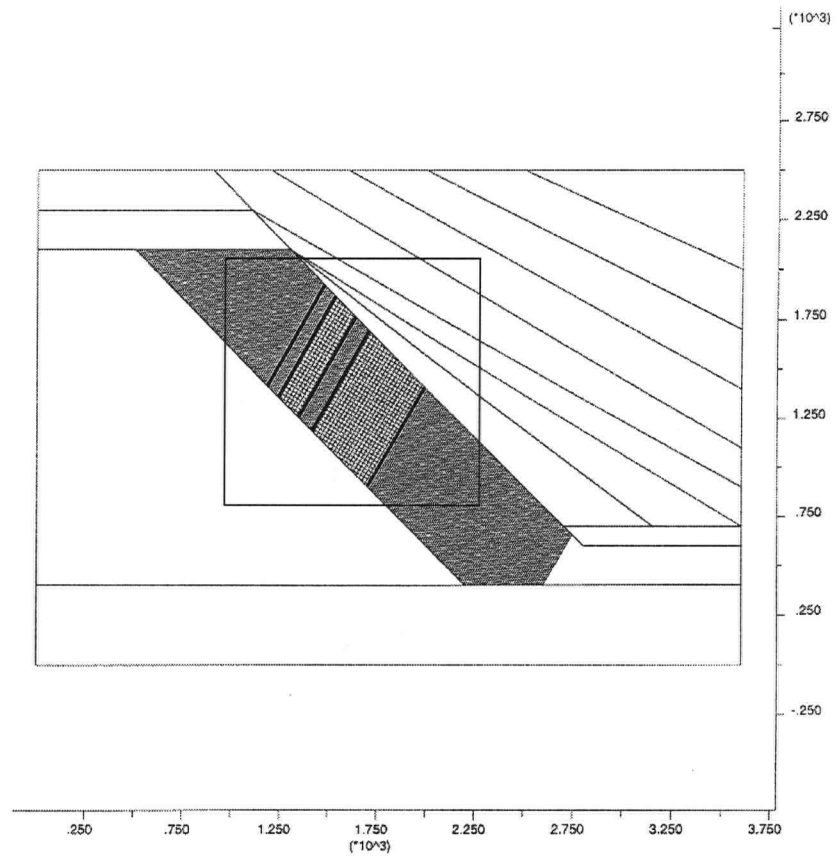
Figure 8-8: Initial input geometry for Mount Breakenridge UDEC model: (a) with joints (boxed area shown in (b)); (b) inset area shown in (a).

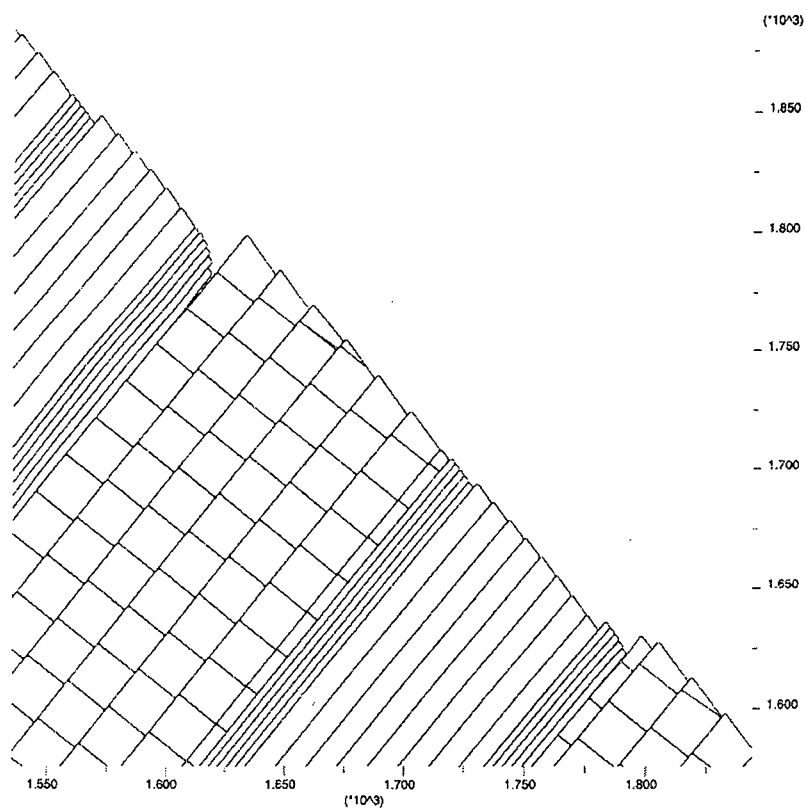
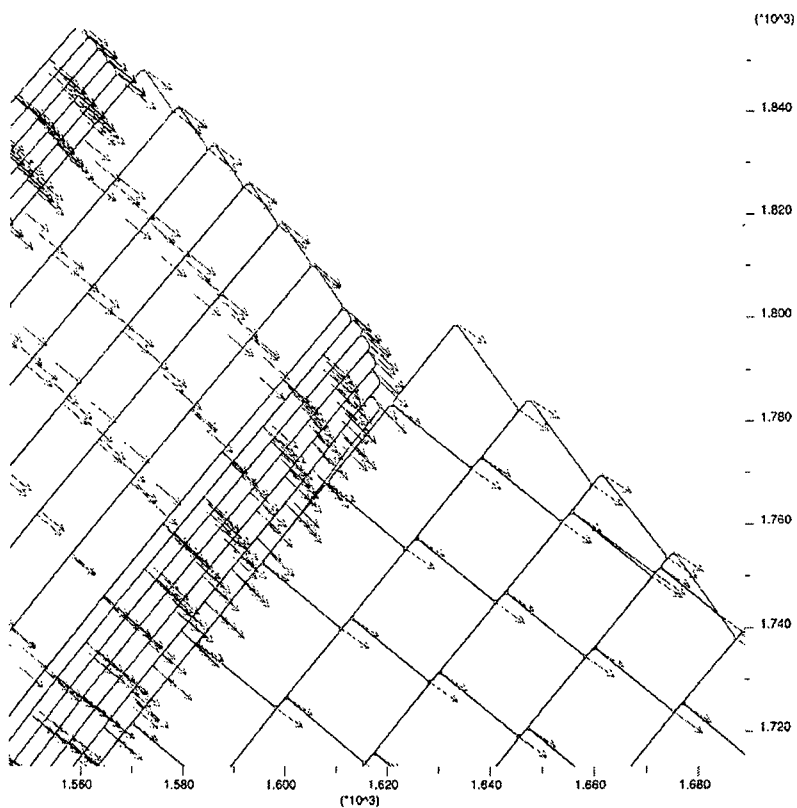
(a) block plot

(b) displacement vectors

Figure 8-9: Detail of deformation in upper portion of Mount Breakenridge slope.

Of interest is the relative displacement of the different units (Figures 8-9 and 8-10). Uphill-facing scarps have developed in all three units, although the columns do not bend to 30° dips as observed in the field. The slopes of the deformed units get progressively steeper moving from toe to crest until the upper quartz schist units, where the slope flattens. This roughly reproduces the observed slopes, if allowance is made for preferential weathering of the schists.
