STABILITY OF THE KAMLOOPS SILT BLUFFS

A THESIS SUBMITTED IN PARTIAL FULFILLMENT OF
THE REQUIREMENTS FOR THE DEGREE OF
MASTER OF APPLIED SCIENCE

THE FACULTY OF GRADUATE STUDIES
Department of Civil Engineering
University of British Columbia

March, 1979

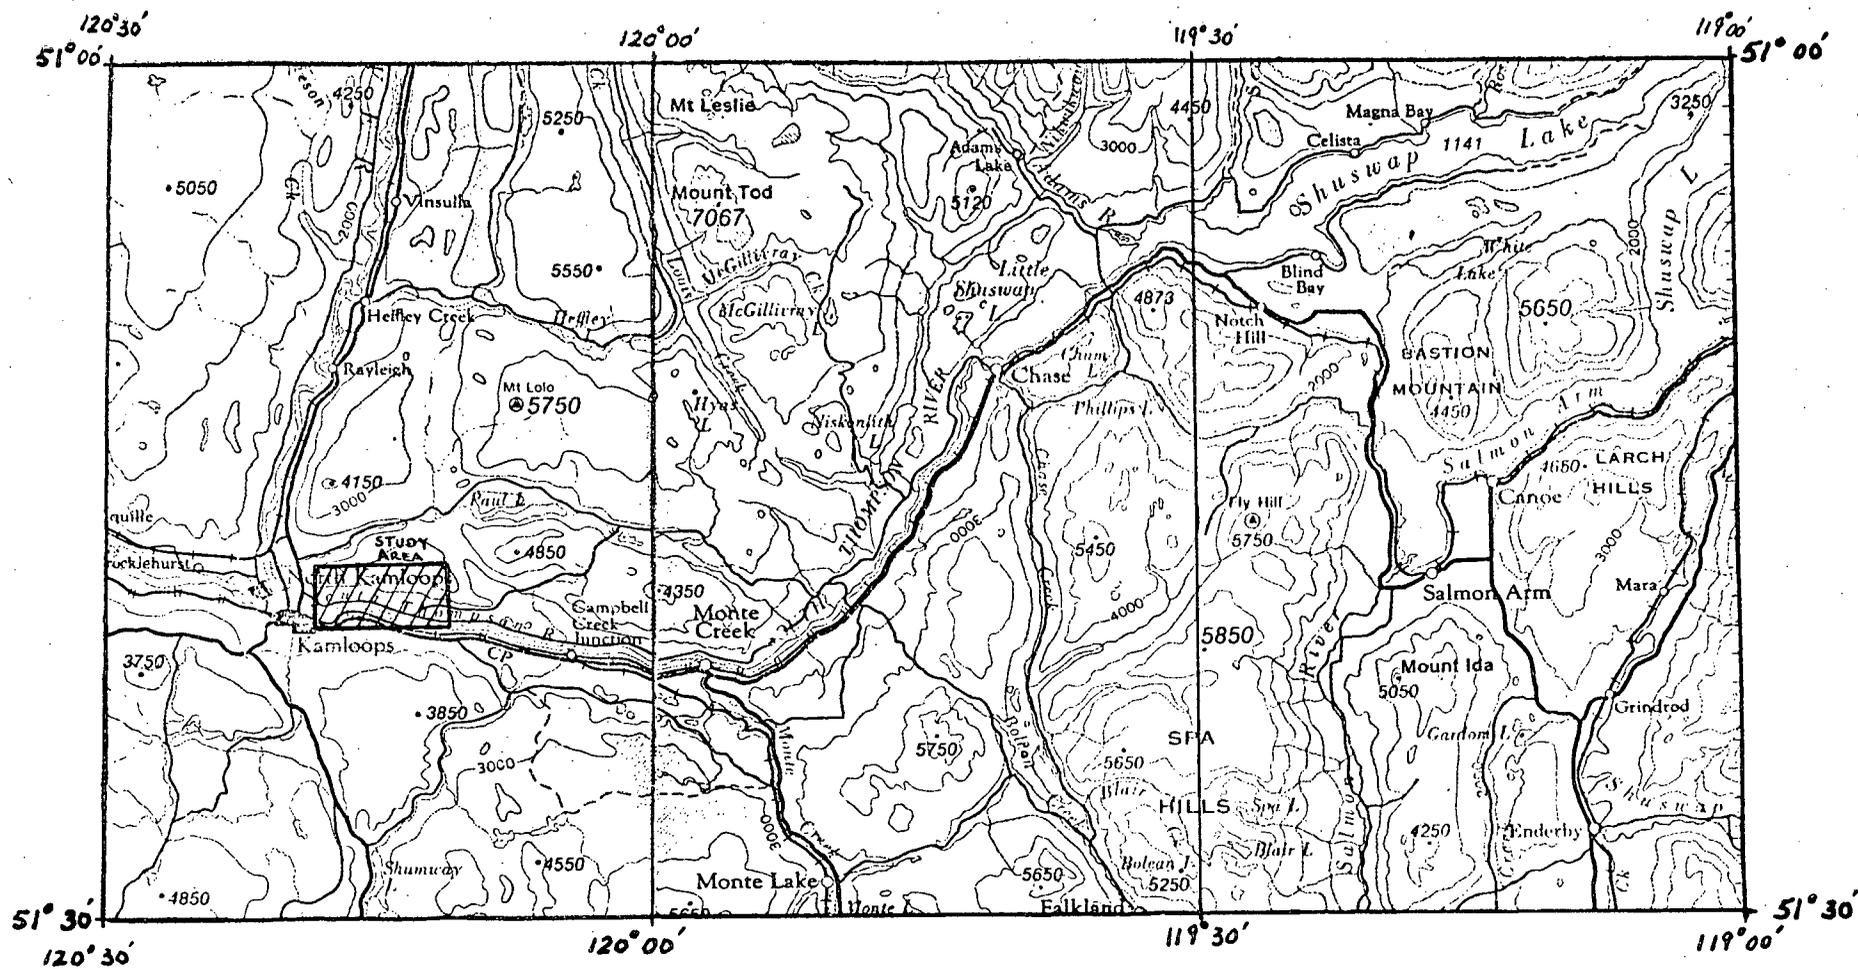
FIG 1. TOPOGRAPHIC MAP OF THE SOUTH THOMPSON VALLEY

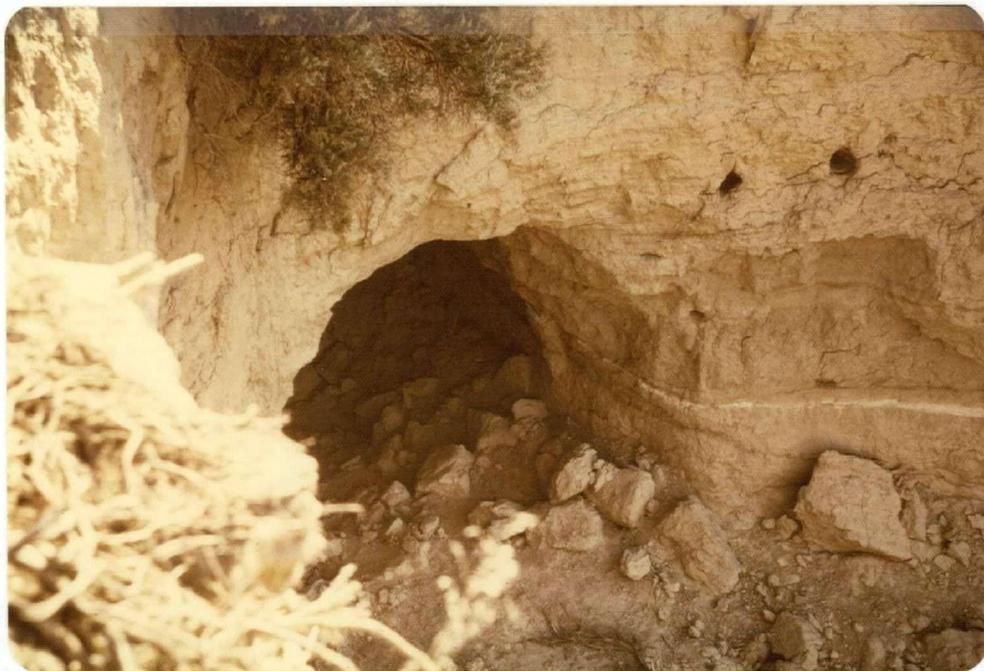
Figure 2. Horizontal pipe in colluvium is approximately 12 feet in diameter. Note the presence of the tephra layer (white, horizontal band).

Many pipes were found in the colluvial deposits and although less numerous, they exist within the glaciolacustrine silt. Pipes exist as shaft-like voids with their axes near horizontal, near vertical or inclined with the slopes. (fig 2 & 3). Pipe openings as large as 12 feet in diameter have been found. The origin of these pipes has been attributed to (1) the piping process as a result of water erosion in which silt particles are dislodged and carried away by flowing water and/or (2) the collapse of the loose soil structure as a result of wetting.

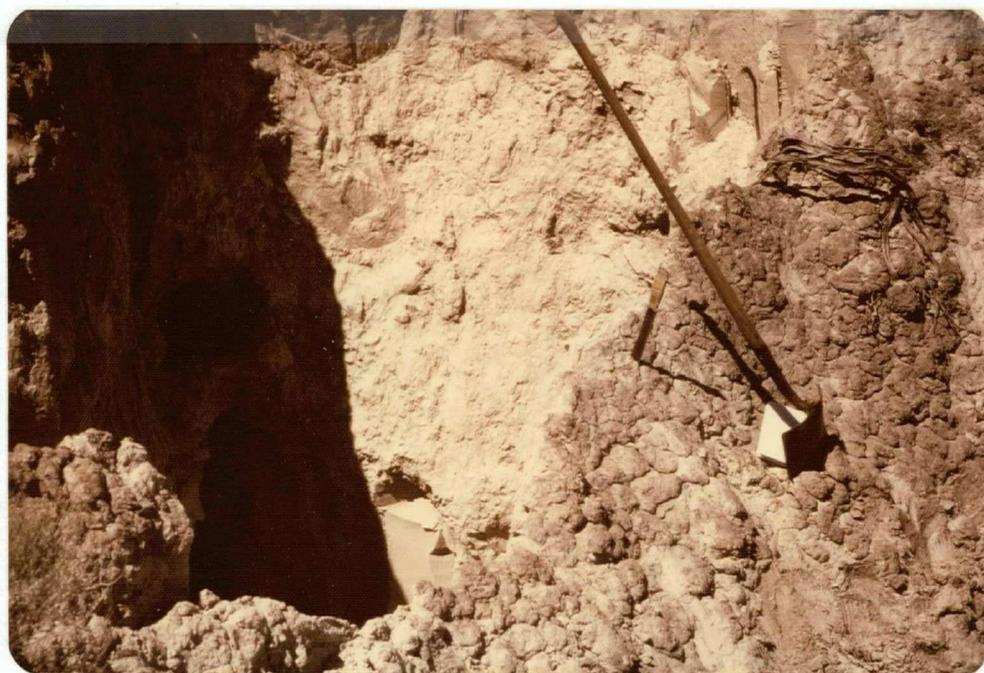
Figure 3. Vertical pipe in colluvium near the base of a steep bluff face within Magazine Gully.

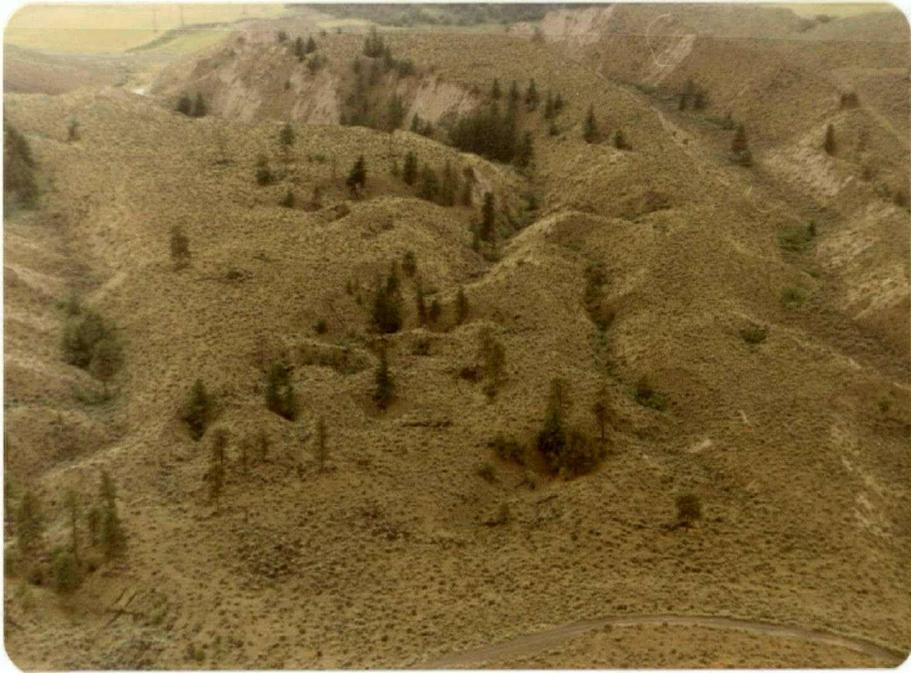
Figure 4. Sinkholes on the bench surface generally appear in alignment with gullies.

A related feature is the presence of large ground depressions or "sinkholes" found on the bench surface. They occur either as isolated depressions or in alignment with gullies (fig 4 & 5). These have been attributed to (1) the caving of the ground above a subterranean pipe or (2) to the collapse of soil structure upon wetting, either of the near surface silt or at depth followed by successive caving of the overlying material (Hardy, 1950; Evans & Buchanan, 1976; Nyland & Miller, 1977).

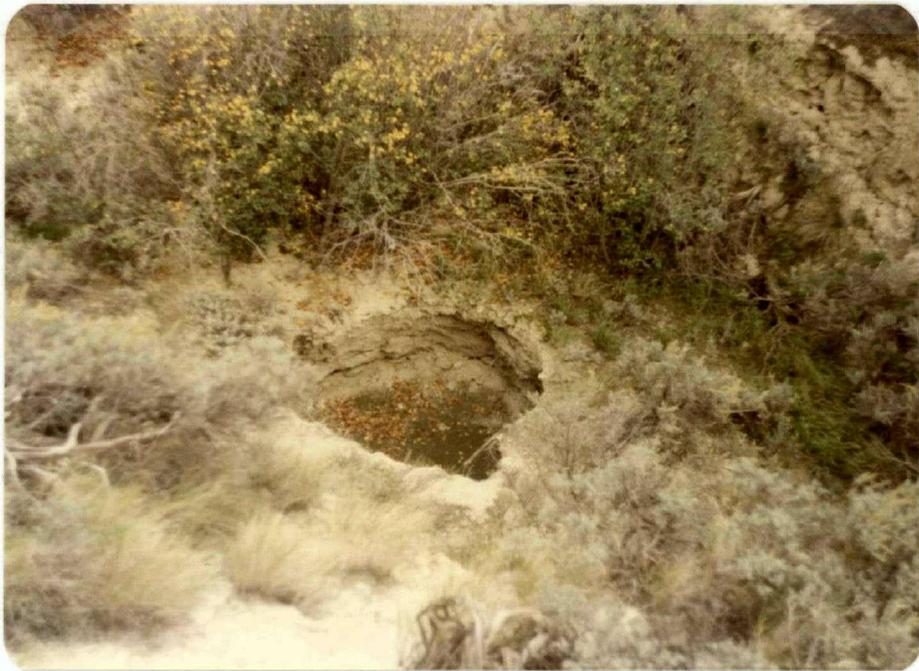
Figure 5. A single isolated sinkhole within the colluvium at the bottom of Magazine Gully.

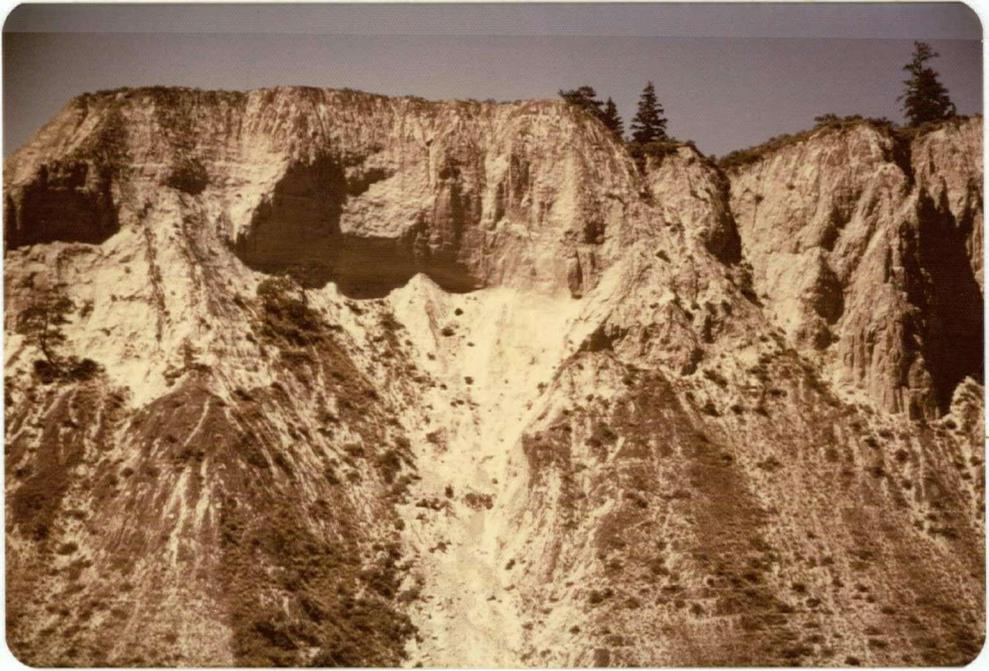
Figure 6. Evidence of a slope failure on the east face of Magazine Gully.

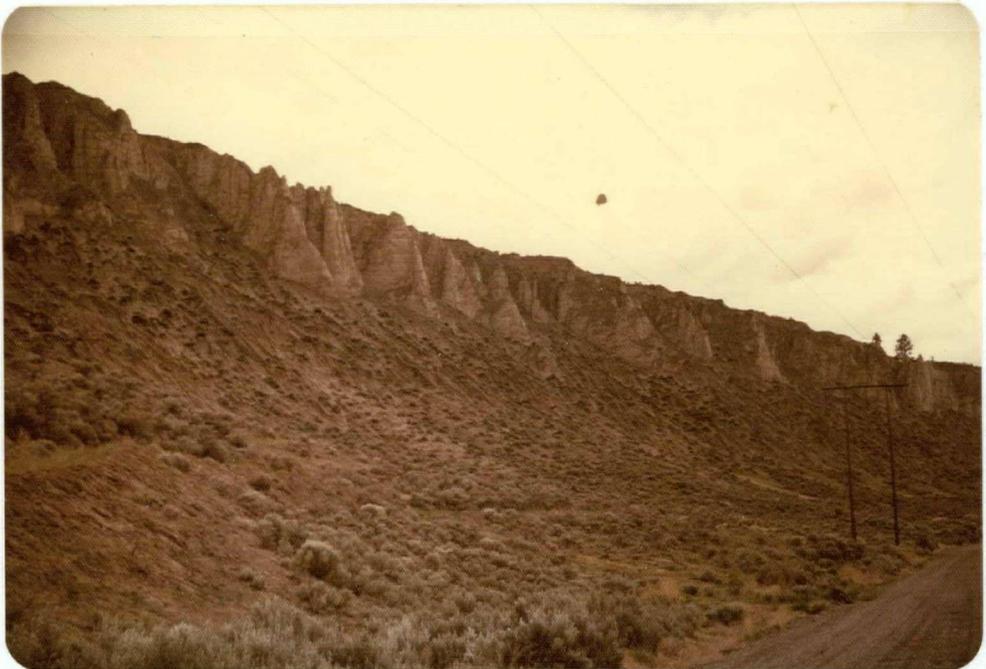
Figure 7. The bench facing the South Thompson River consists of a steep irregular bluff wall which breaks into colluvial slopes.

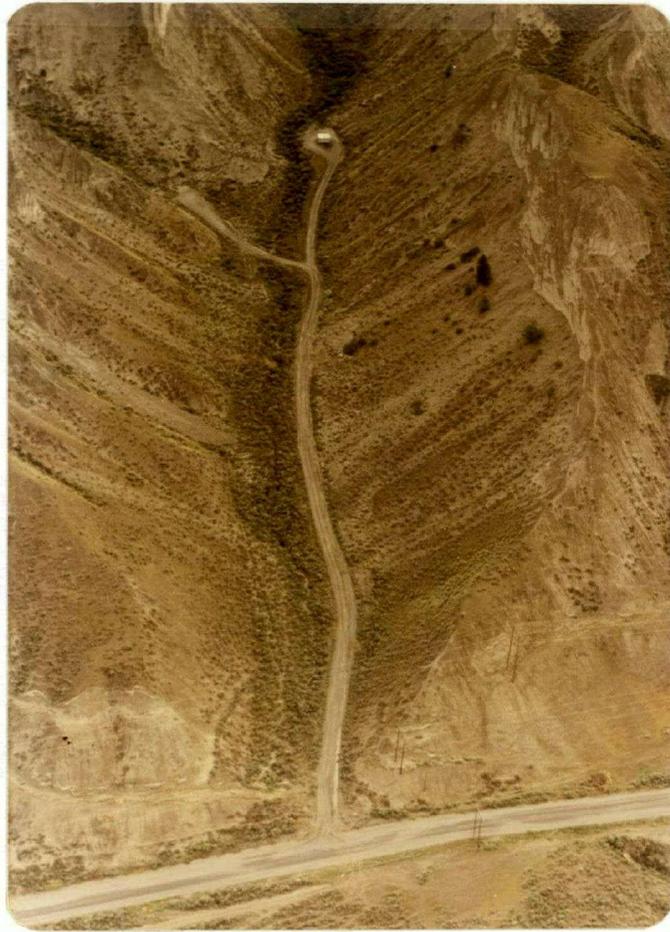
Figure 8. Oblique aerial view of the detail study area (Magazine Gully) looking north.

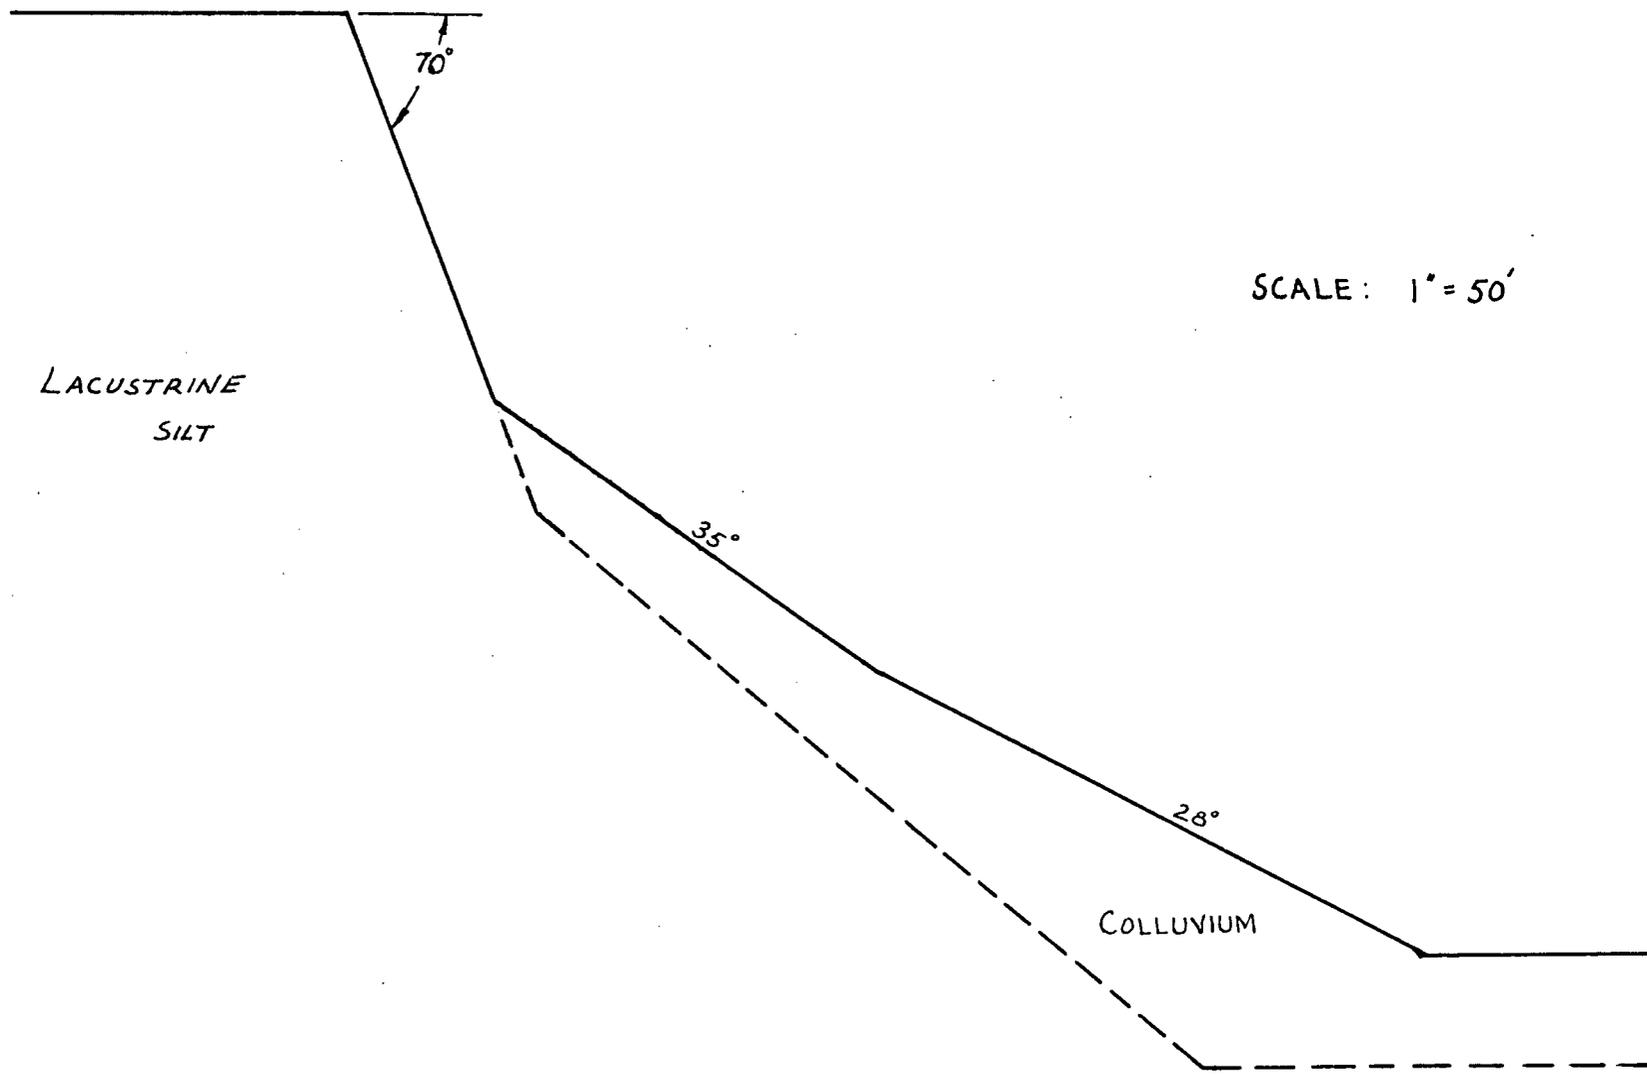
FIG. 9 GENERAL SLOPE GEOMETRY
WITHIN MAGAZINE GULLY

could be approximated by a uniform slope angle of 28° from the horizontal.

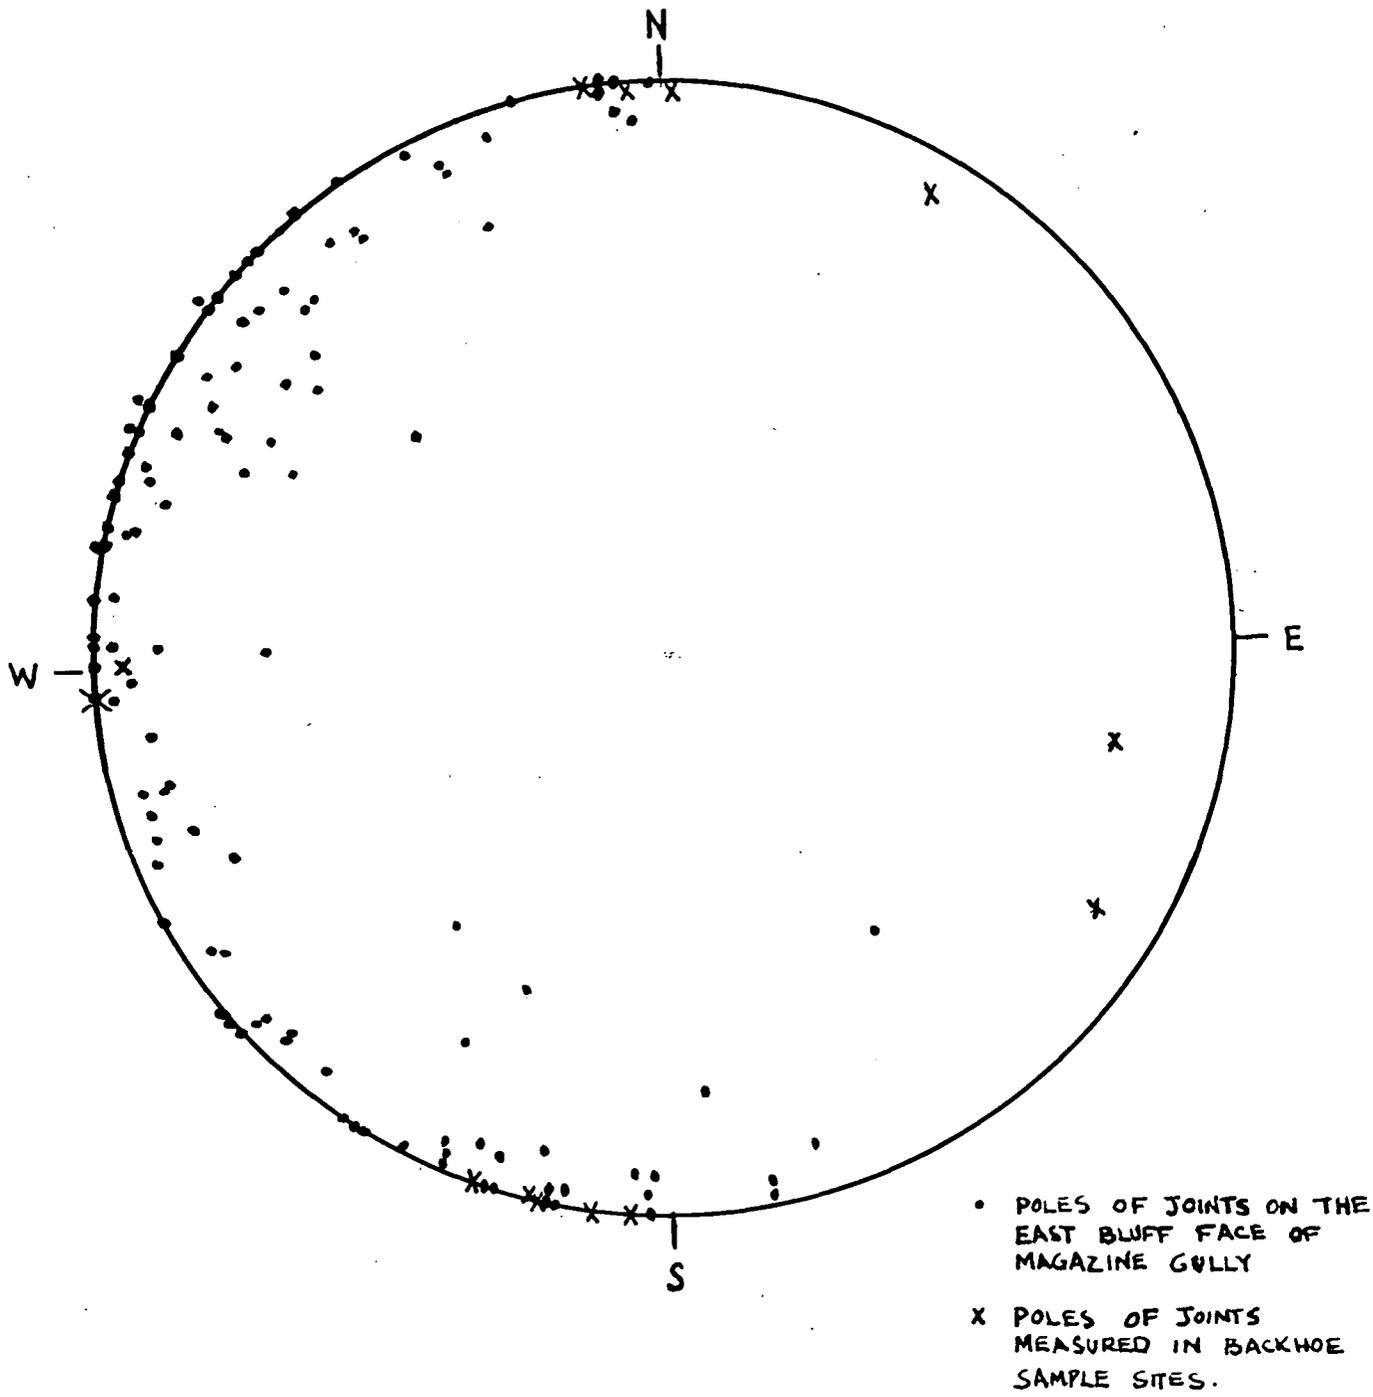
A small joint survey was carried out by running traverses along the base of the steep bluff face with a Brunton compass. As in all joint surveys, human bias and accessibility problems must be kept in mind. Joint orientations were measured, mainly from the east face of Magazine Gully which trends approximately North-South. The stereonet plot (fig. 10) shows the poles of joints plotted in northern hemisphere projection of a Wulf net (Hoek & Bray, 1974). The joints are mainly steeply dipping towards the western sector. This is expected since joints dipping east would represent unstable conditions on the eastern bluff face. Since the joints are all near vertical, a rose diagram is plotted (fig. 11) with radial lengths representing the number of joints falling within each 10° sector of the stereonet. The rose diagram indicated that four major joint sets exist nearly perpendicular to the almost horizontal bedding. Two major sets exist at strikes of 30° and 120° while two weaker sets occur at approximately 0° and 90° . The combination of these joint sets forms the local columnar jointing seen in the field (fig. 39). This type of

FIG. 10 STERONET PLOT OF JOINTS.

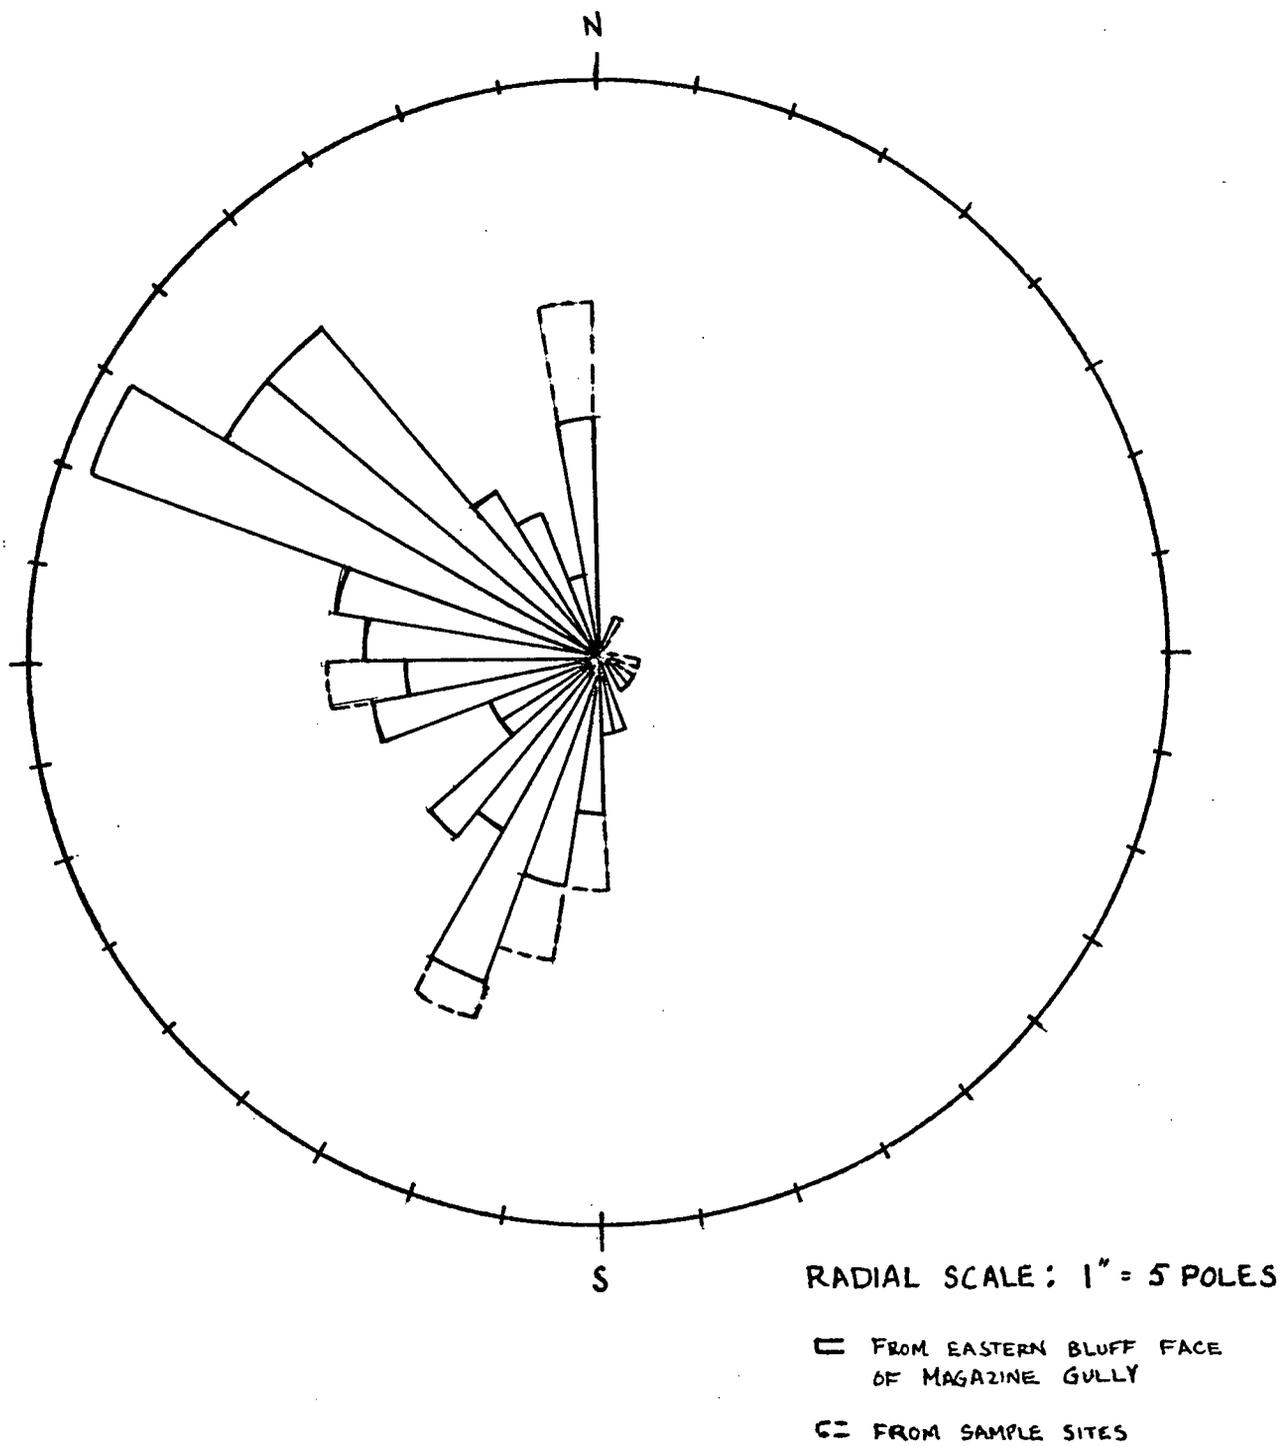
FIG. II. ROSE DIAGRAM

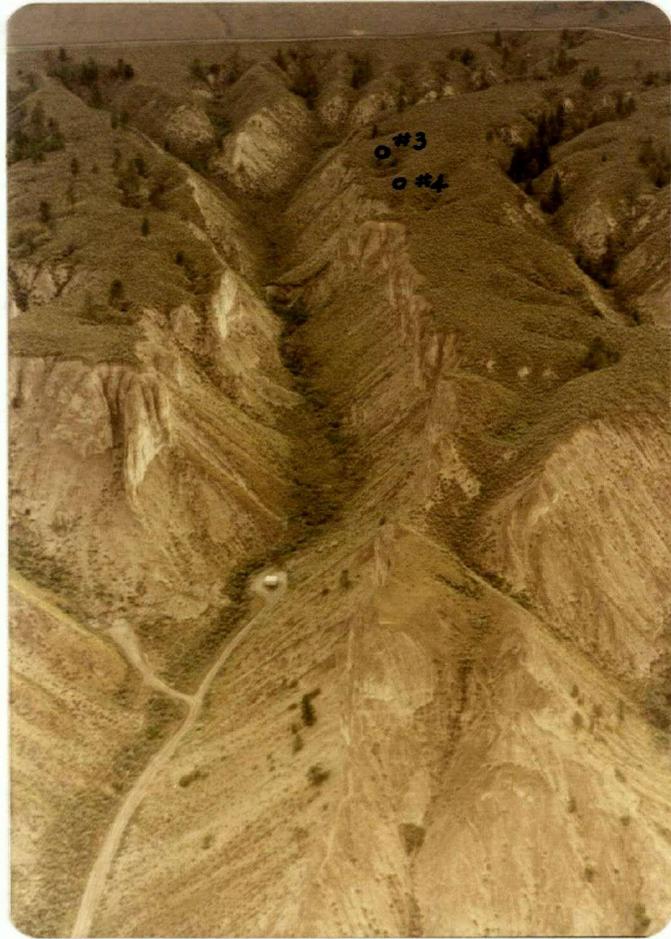
Figure 12. Aerial photograph of Magazine Gully showing the backhoe sampling site locations (Sites #3 & #4).

Block samples were obtained from two backhoe pits on the bench surface adjacent to Magazine gully (fig. 12) at a depth of $4\frac{1}{2}$ to $5\frac{1}{2}$ feet. The blocks were hand carved with a sharp knife, making use of existing in-situ fractures. During sampling, the weather was generally cloudy with brief periods of sunshine. The temperatures reached 31°C with a humidity of 15% (June 29, 1976). To prevent moisture loss, the soil samples were immediately wrapped with "saran wrap" in the field and transported to the Kamloops laboratory for waxing. The samples were then taken by car to the University of British Columbia where they were re-waxed with a low

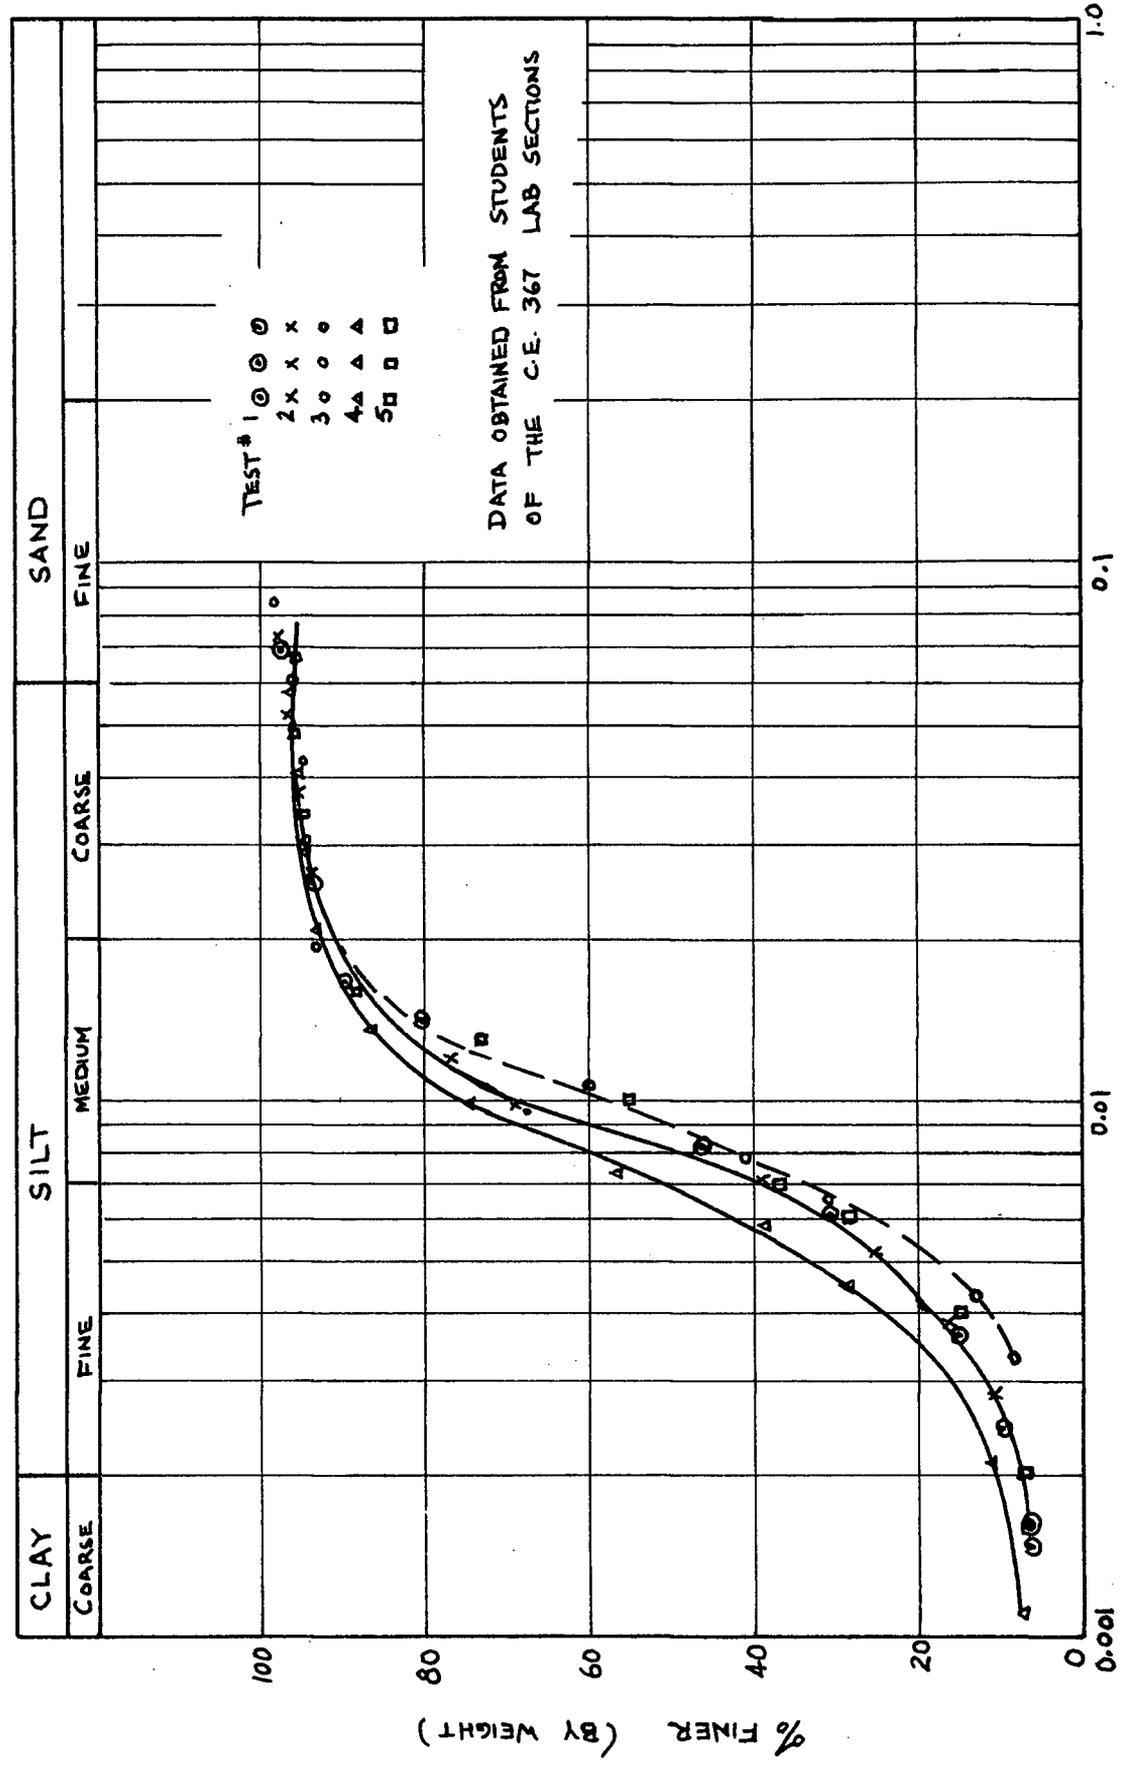
FIG. 13. GRAIN SIZE DISTRIBUTION (MIT CLASSIFICATION) OF KAMLOOPS SILT

PARTICLE SIZE (m.m.)

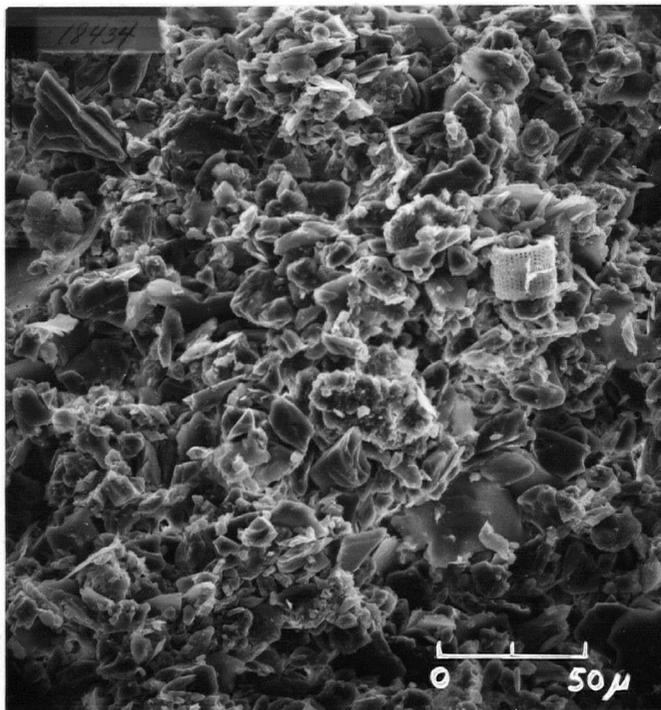
Figure 14. Photomicrograph of the Kamloops silt, undisturbed sample, side view, at 400X magnification.

Electron photomicrographs of the soil are presented in figures 14 to 19. Stereopairs (not shown) of the samples showed a strong horizontal preference in orientation of the platy particles in the undisturbed and remolded silt. Structurally, there appears to be little difference between the remolded and undisturbed lacustrine silt other than the void ratio differences (1.14 and 1.28 respectively).

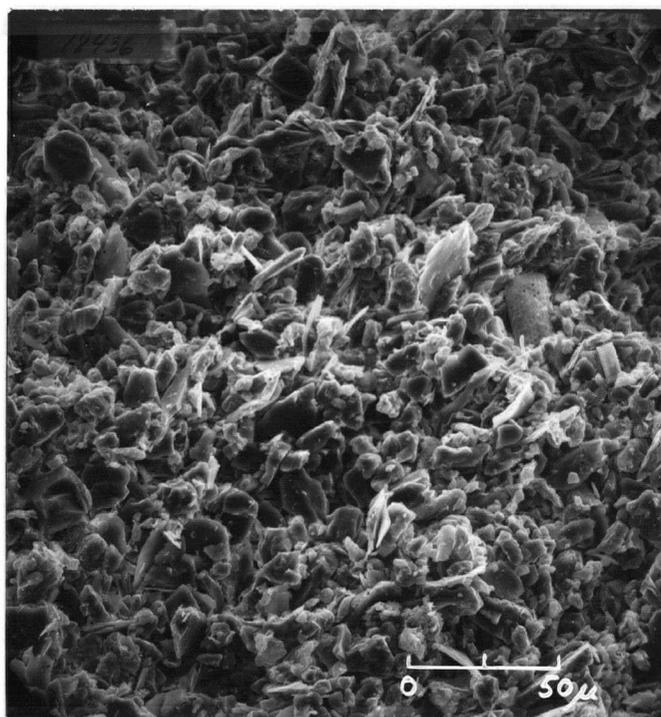
Figure 15. Kamloops silt, remolded sample, side view, 400X magnification.

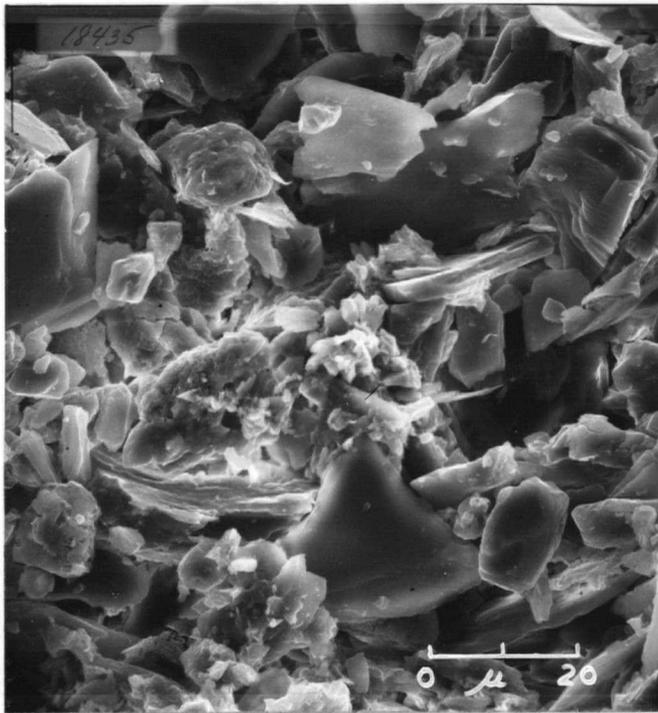
Figure 16. Photomicrograph of undisturbed Kamloops Silt at 1000X magnification, viewed parallel to the bedding.

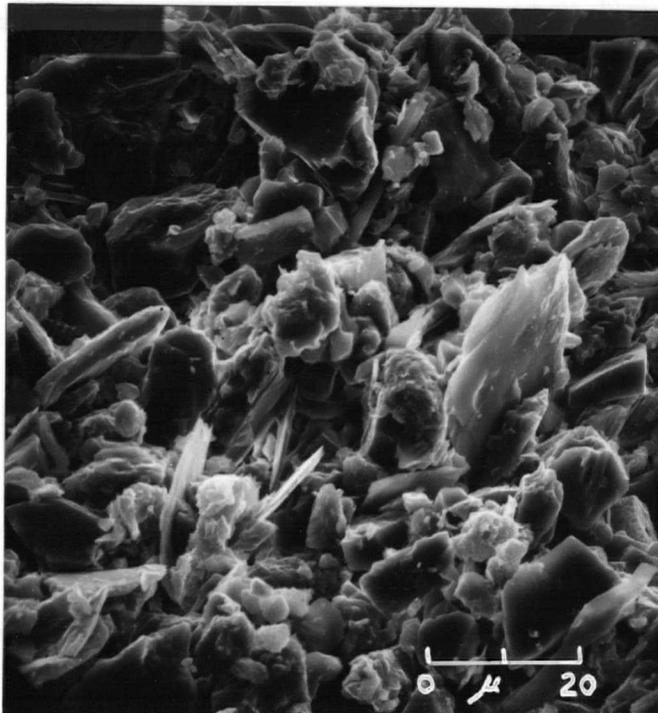
Figure 17. Photomicrograph of remolded silt (Kamloops silt) at 1000X magnification, viewed from the side, ie. perpendicular to the sedimentation direction.

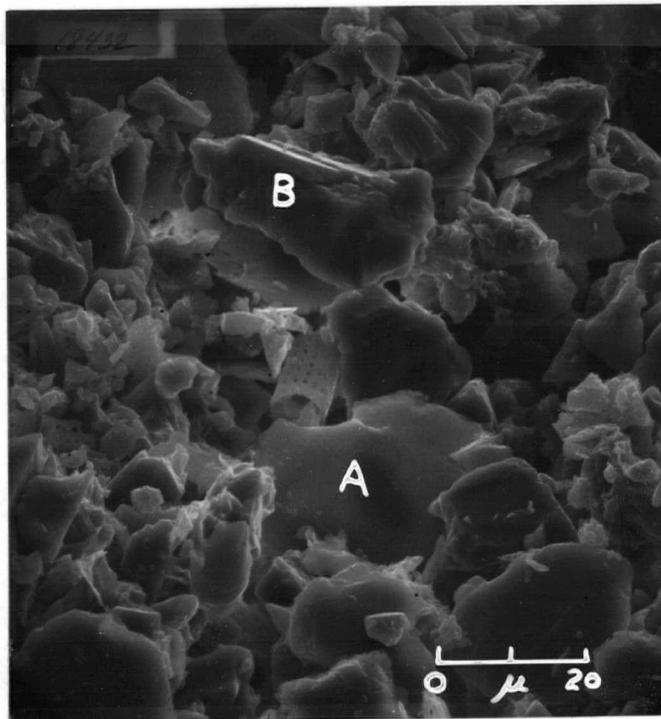
Figure 18. Plane view of the undisturbed Kamloops Silt at 1000X magnification. Particles 18A & 18B were studied under the Electron Microprobe.

A microprobe (Ortec Multichannel Analyser, Model 6200) was used in an attempt to identify the mineralogy of the particles. But interpretation is always difficult when only elemental data can be obtained and the quantitative data being questionable. The particles 18A, 18B, 19A and 19B in figures 18 and 19 yield the following elements, listed in decreasing peak intensity.

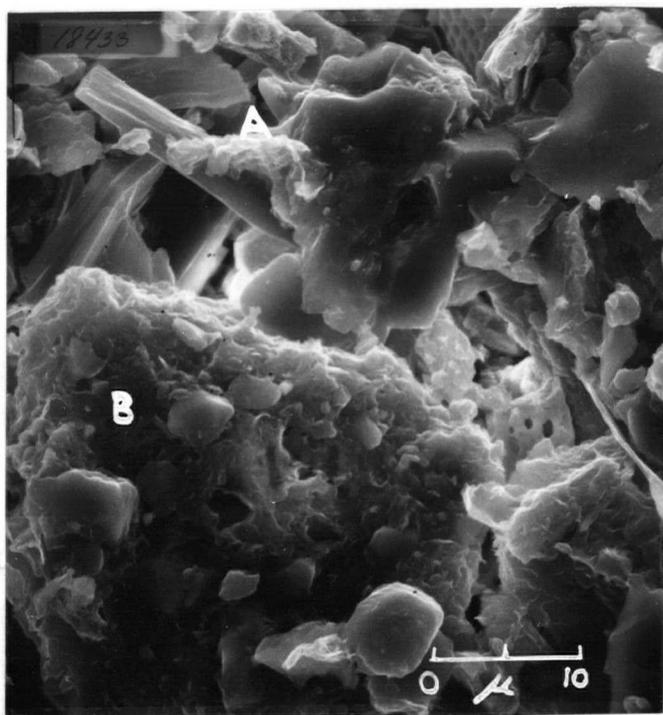
Figure 19. Plane view of the undisturbed silt at 1000X magnification. Peds 19A & 19B were studied under the Electron Microprobe. Note the clay bridging formed by 19A.

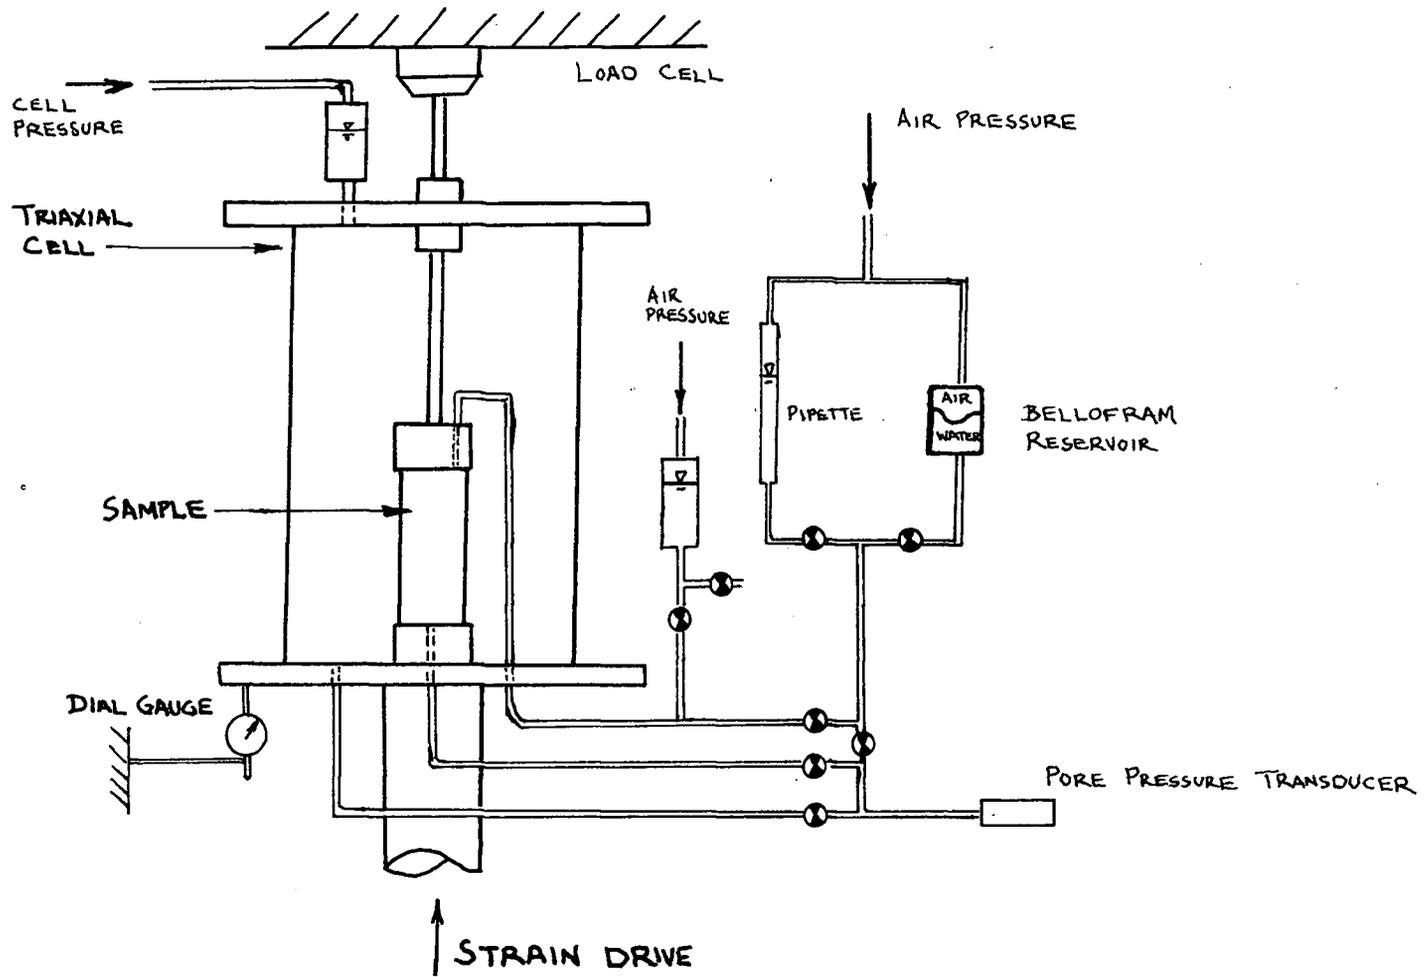
FIG. 21 SCHEMATIC OF TRIAXIAL APPARATUS

The vertical deformation rate was pre-set on the 5 Ton Wykeham Ferrance Compression Machine through a set of gears. The deformation rate was checked by a dial gauge during the test. The load was measured by a beryllium copper diaphragm load cell placed above the loading rod. Electrical signals from the load cell and pressure transducer were automatically recorded by the Vidar Autodata Eight unit. Data reduction was carried out by transferring the information onto computing cards and fed to the main U.B.C. computer.

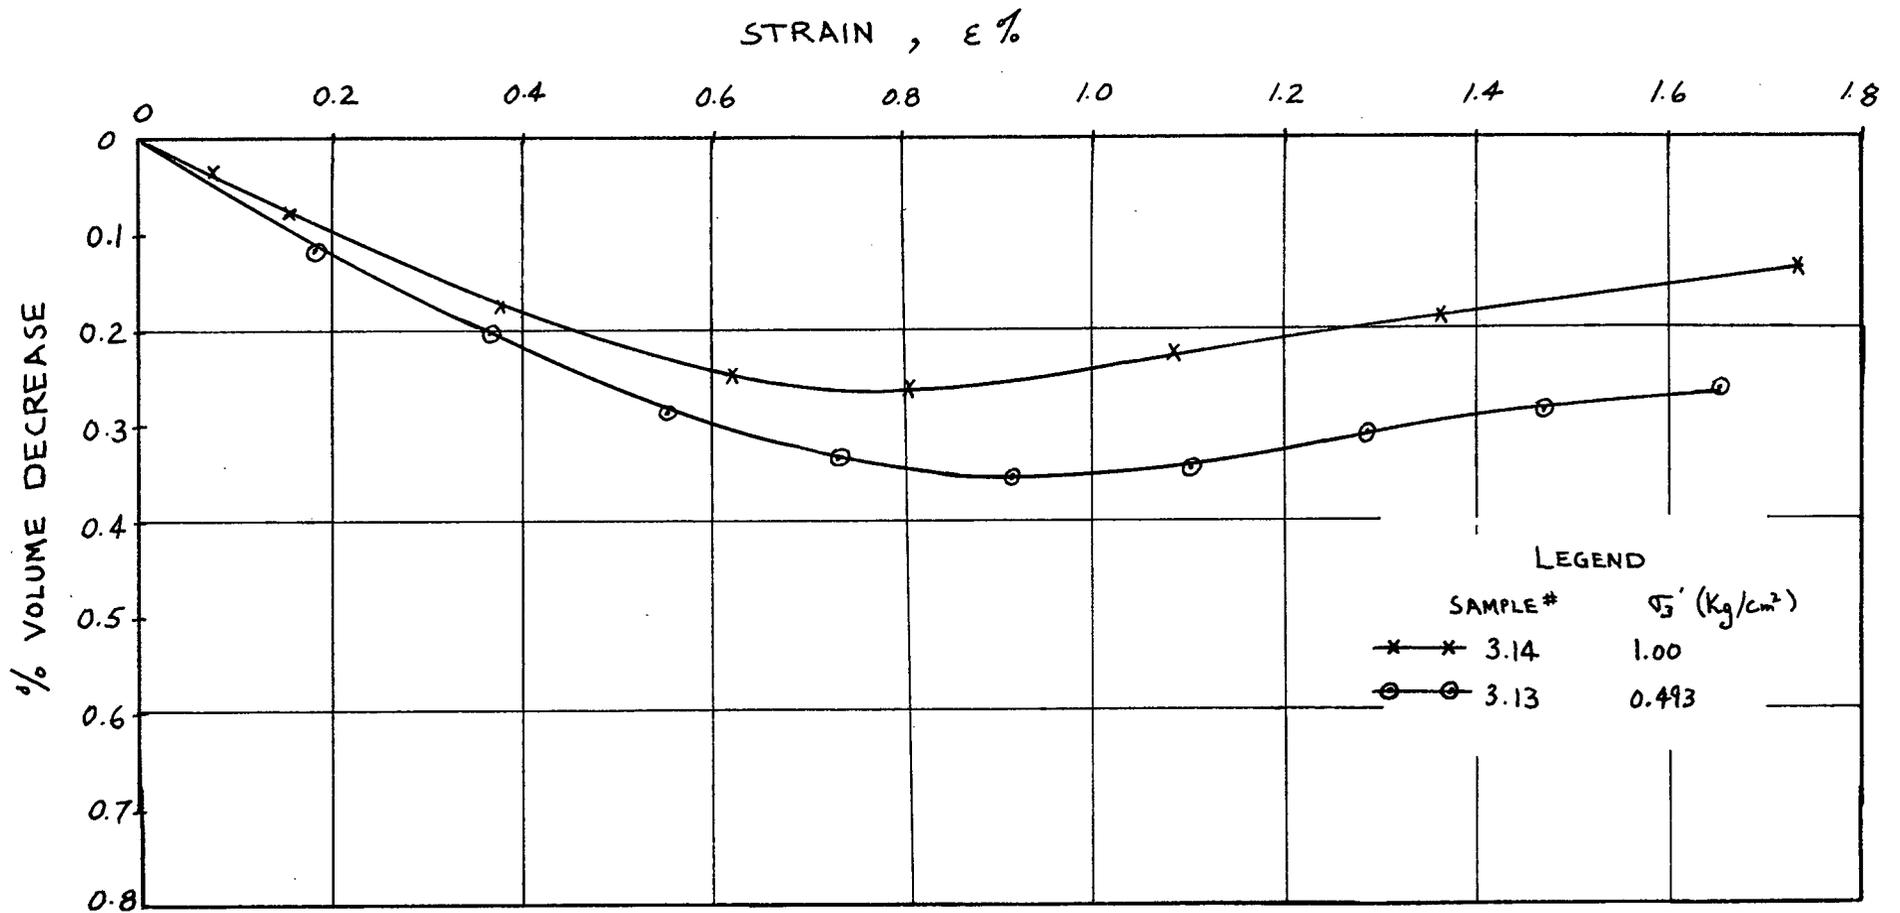
FIG. 24 % Δ VOL. VS $E\%$ FOR O.C. STRESS REGION.

Changes in sample volume were measured during shearing by recording the amount of water expelled from the sample into the calibrated pipette. Within the overconsolidated region, a general decrease in sample volume occurred up to the point of failure followed by sample dilatancy (fig. 24). Samples sheared in the normally consolidated region showed a decrease in bulk volume with increasing strain with no dilatant behaviour observed (fig. 25).
