STABILITY OF THE KAMLOOPS SILT BLUFFS

A THESIS SUBMITTED IN PARTIAL FULFILLMENT OF
THE REQUIREMENTS FOR THE DEGREE OF
MASTER OF APPLIED SCIENCE

THE FACULTY OF GRADUATE STUDIES
Department of Civil Engineering
University of British Columbia

March, 1979

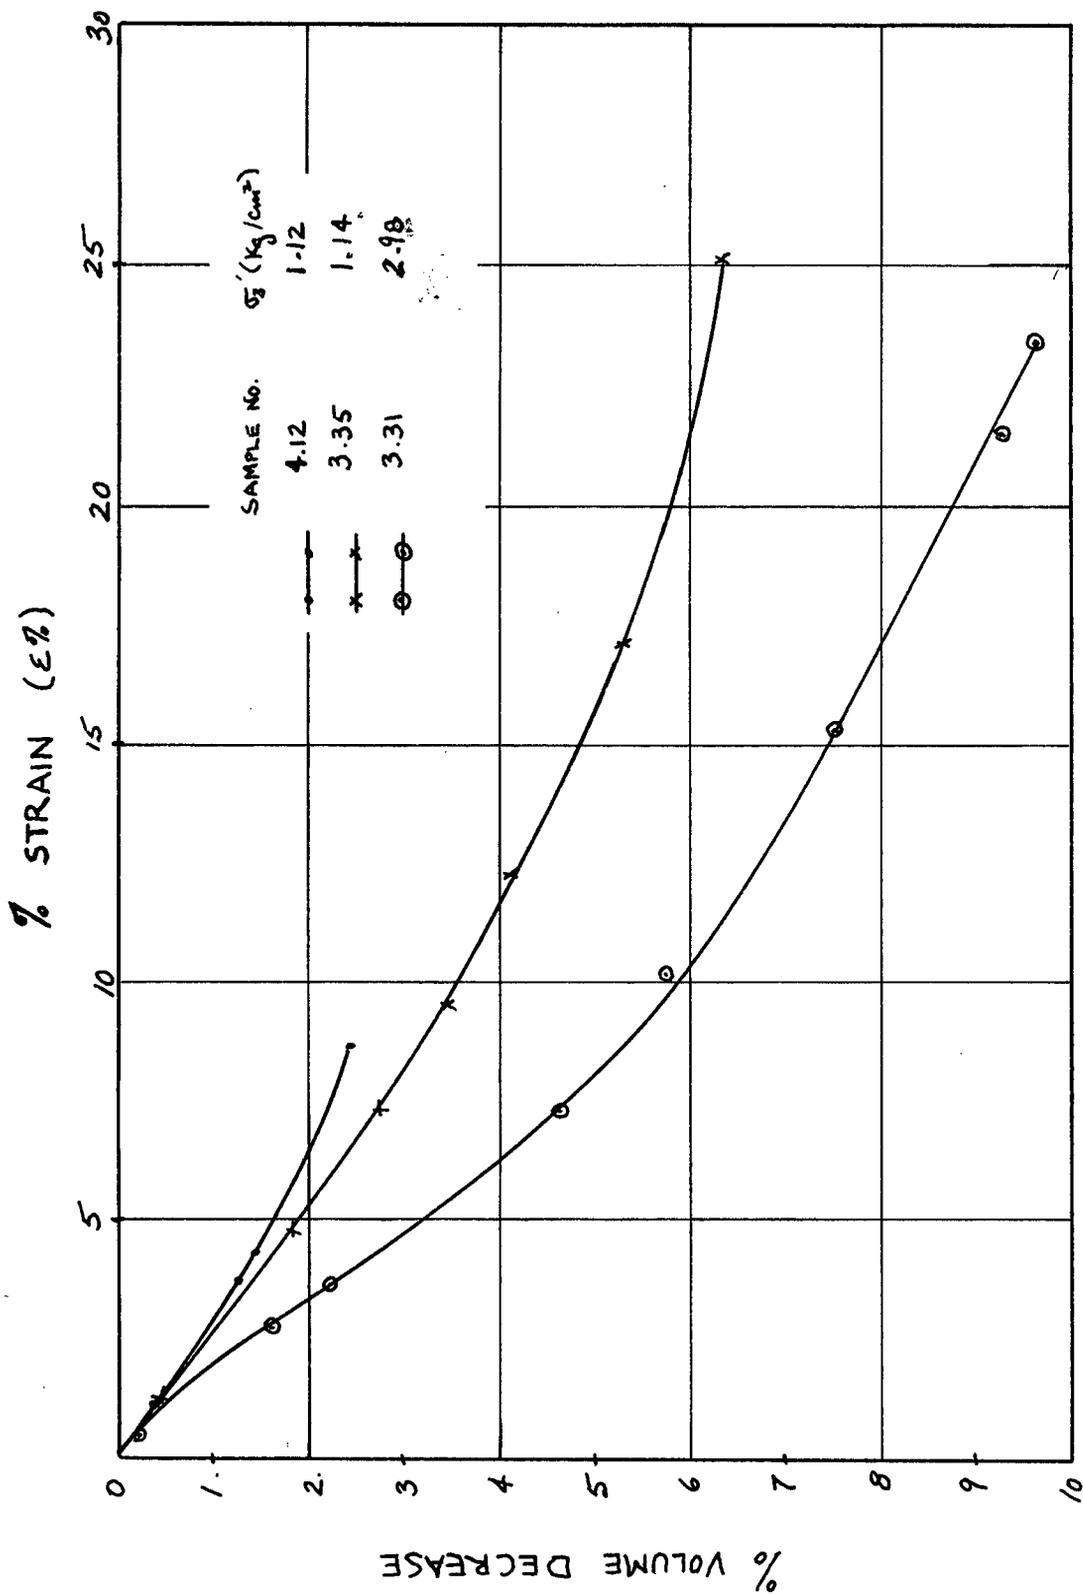
FIG. 25 % Δ VOL. VS. $\epsilon\%$. FOR. N.C. STRESS RANGE

Changes in sample volume were measured during shearing by recording the amount of water expelled from the sample into the calibrated pipette. Within the overconsolidated region, a general decrease in sample volume occurred up to the point of failure followed by sample dilatancy (fig. 24). Samples sheared in the normally consolidated region showed a decrease in bulk volume with increasing strain with no dilatant behaviour observed (fig. 25).

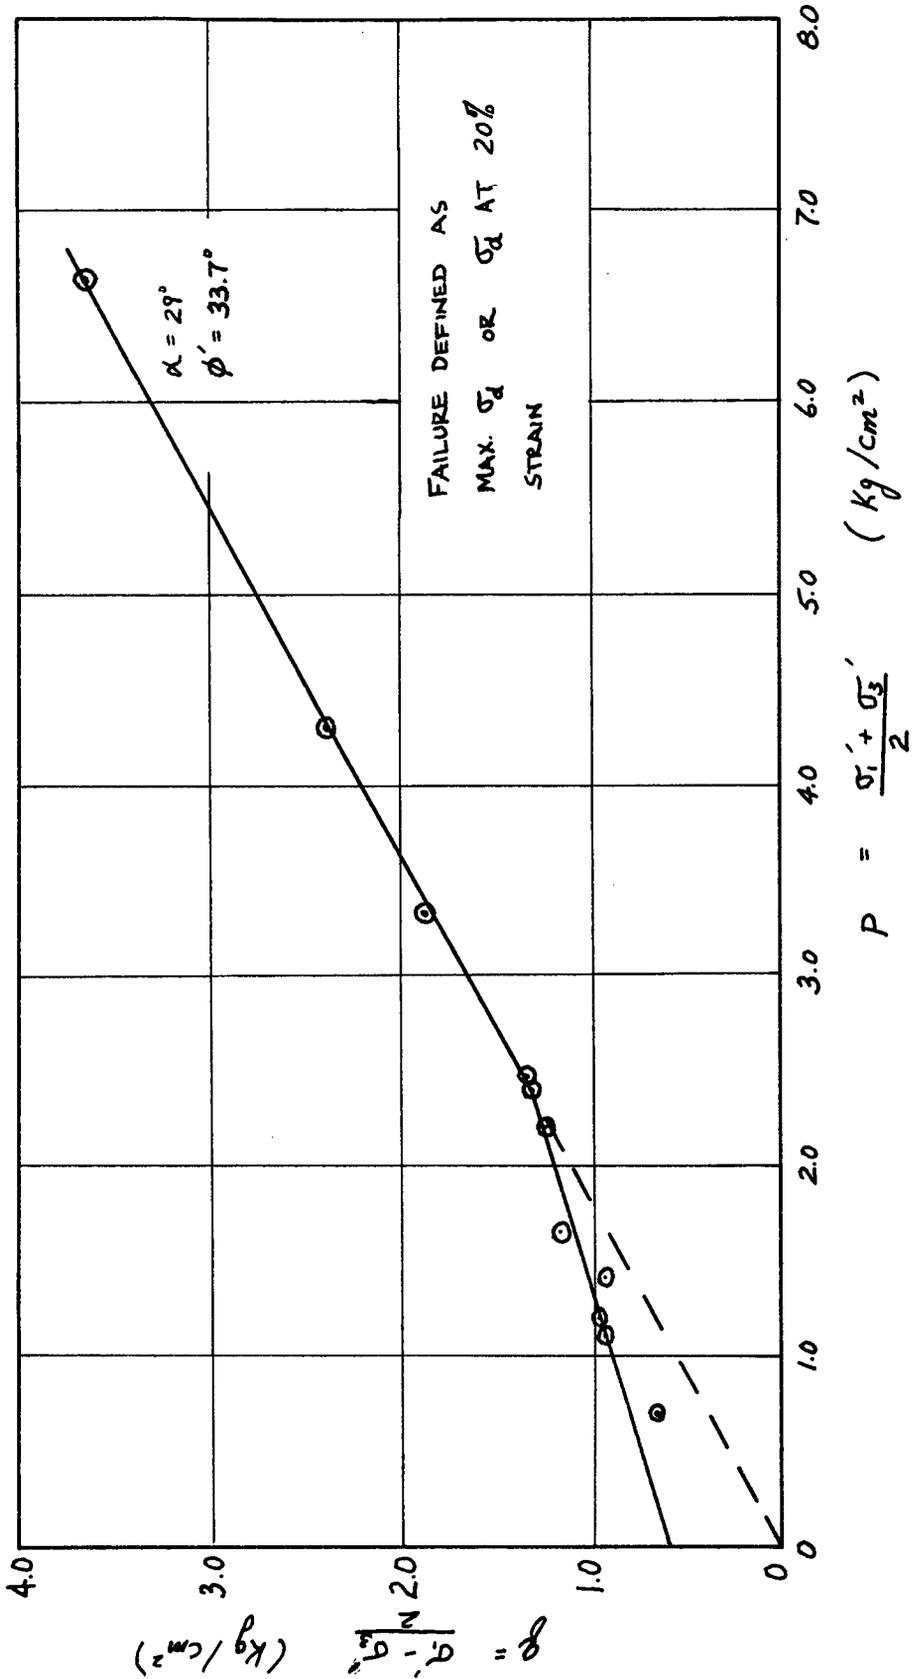
FIG. 26 P-Q DIAGRAM FOR KAMLOOPS SILT
(CD TRIAXIAL TEST DATA)

The failure stress conditions are plotted in figures 26 & 27 in the form of a $\frac{1}{2}(\sigma'_1 - \sigma'_3)$ versus $\frac{1}{2}(\sigma'_1 + \sigma'_3)$ failure envelope. If α is the slope angle of the best line drawn through such points, it can be shown that $\sin \phi' = \tan \alpha$ where ϕ' is the effective angle of frictional resistance. Similarly, if 'a' is the $\frac{1}{2}(\sigma'_1 - \sigma'_3)$ intercept, then $c' = a / \cos \phi'$ (Lambe & Whitman, 1969). From figure 26, $\alpha = 29^\circ$ and therefore, $\phi' = 33.7^\circ$ within the normally consolidated stress field.

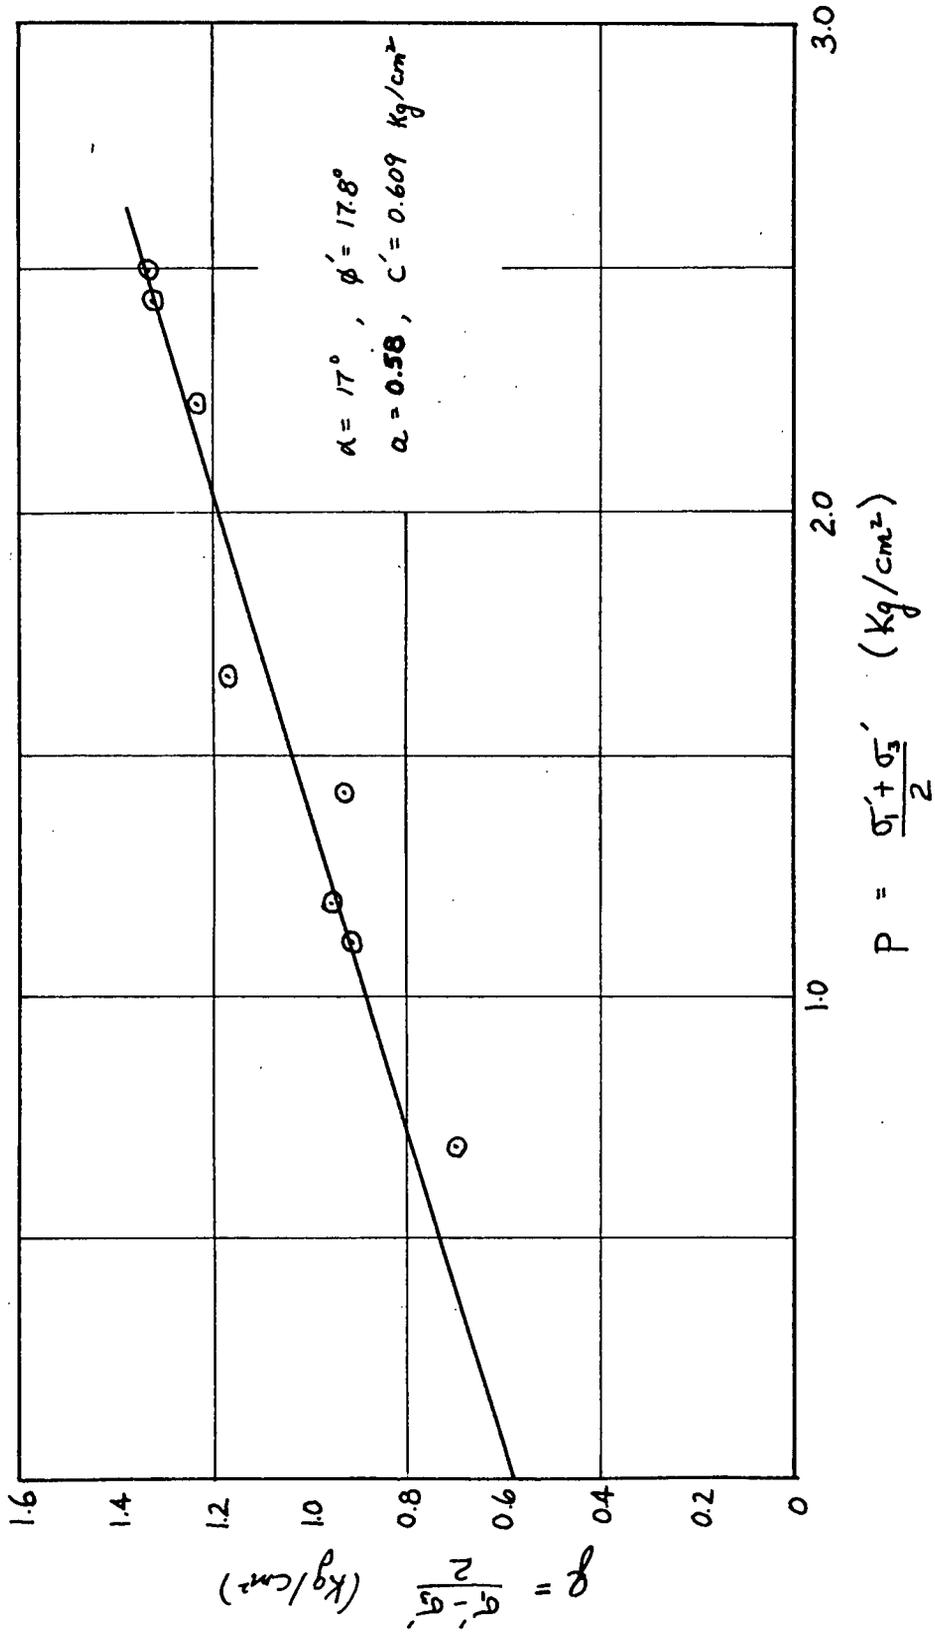
FIG. 27 P-Q DIAGRAM FOR KAMLOOPS SILT (O.C. REGION)

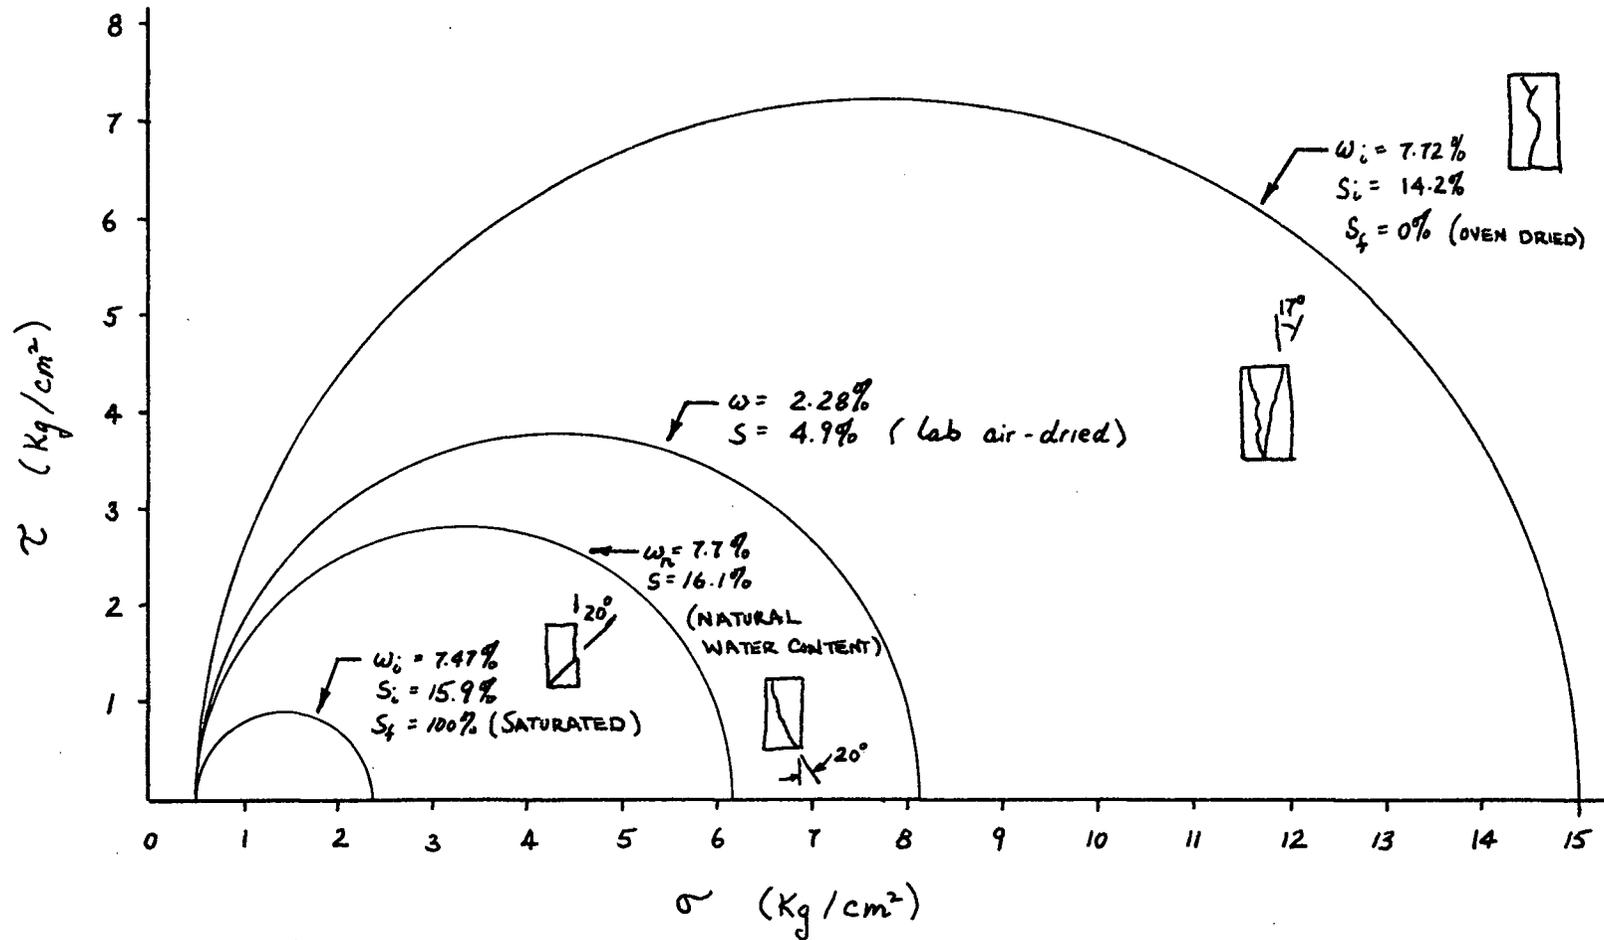
FIG. 28 MOHR CIRCLE OF FAILURE AT VARIOUS SATURATIONS

The test results are plotted in figure 28 as Mohr circles of failure. From figure 29, it is evident that the strength is sensitive to the

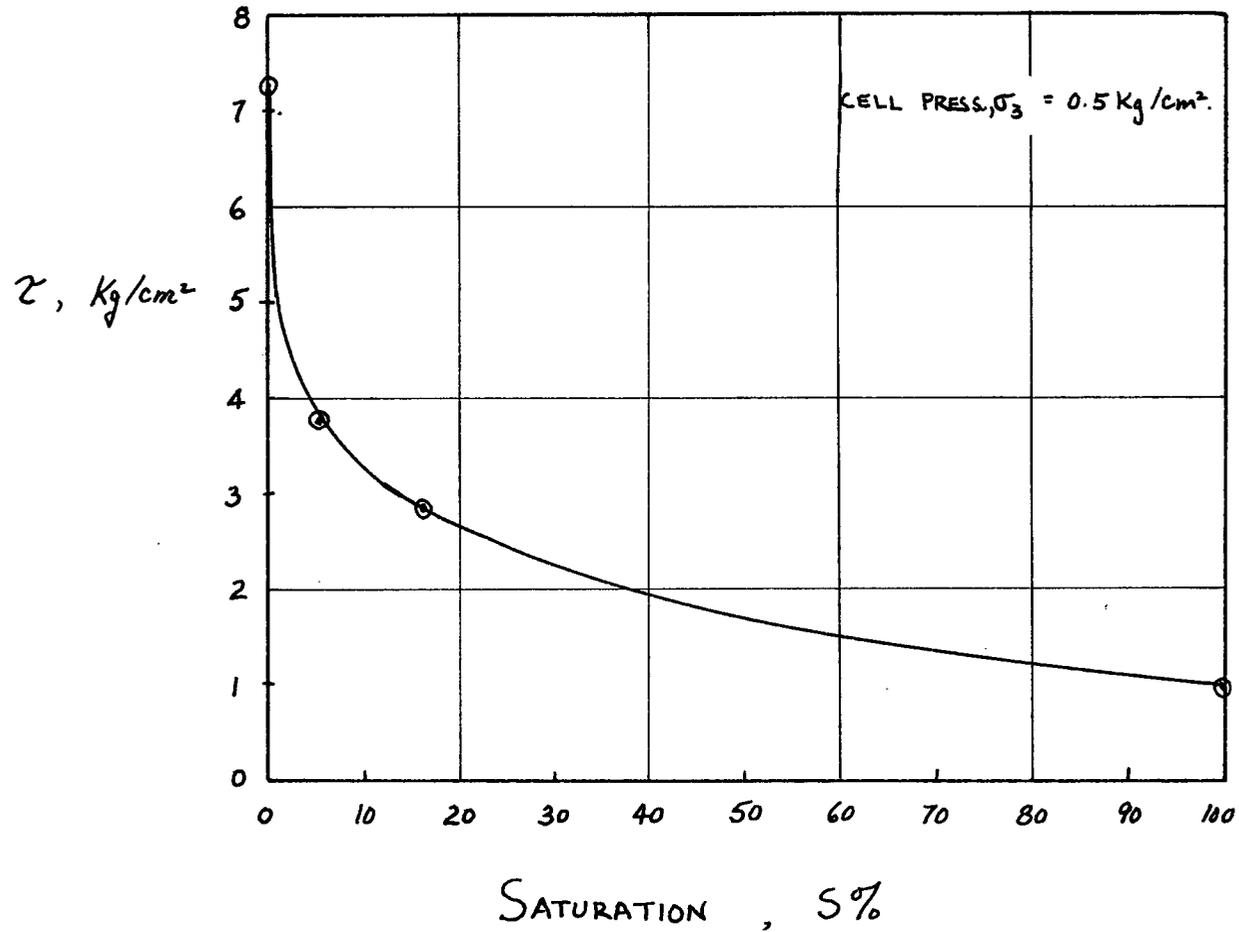
FIG. 29 SHEAR STRENGTH VS. SATURATION
(FOR KAMLOOPS SILT)

degree of saturation, especially towards the drier states. Lutton (1969) found a similar behaviour for Vicksburg loess under unconfined compression. Also, Holtz & Gibbs (1951) reported a different Mohr envelope exists for various saturations of the Kansas and Nebraska loess.

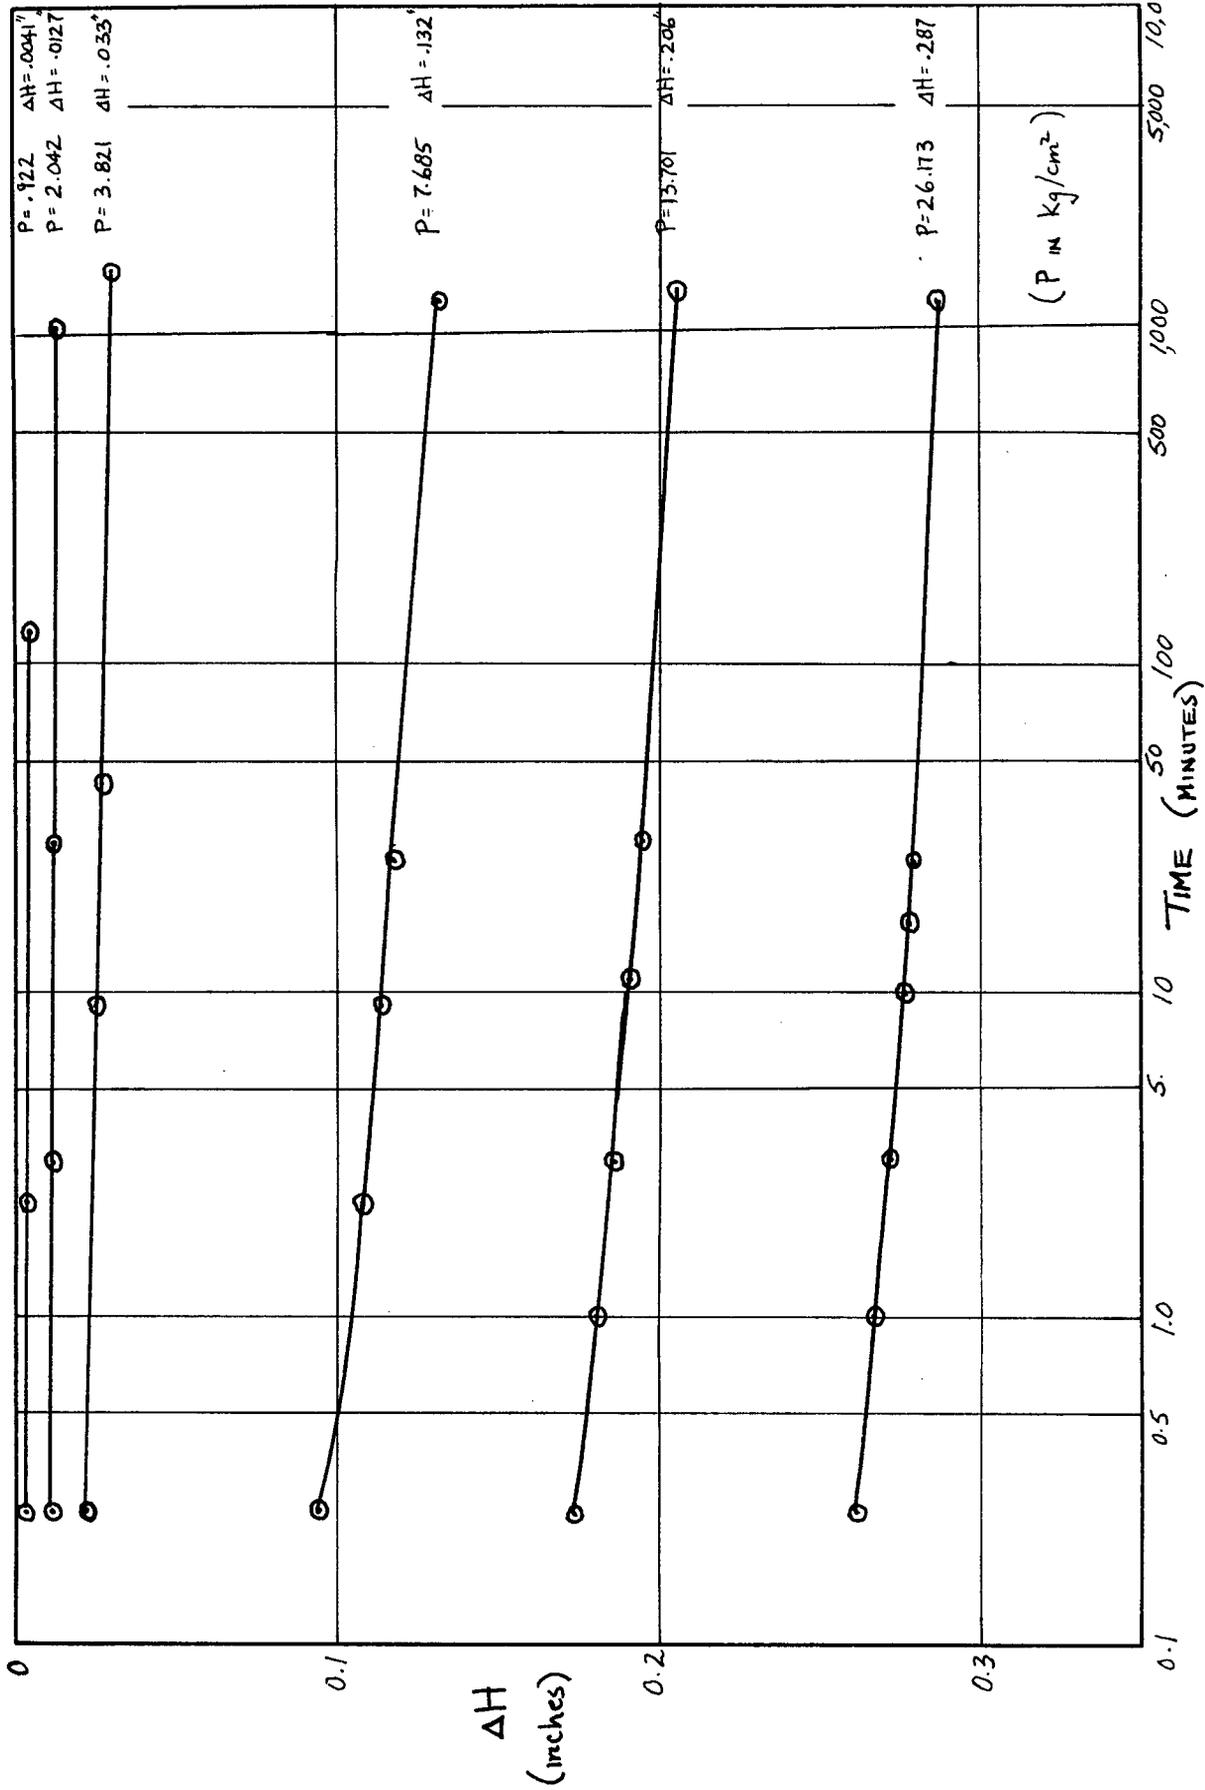
FIG. 32 ΔH VS. LOG(TIME) PLOT FOR INCREMENTAL LOAD CONSOLIDATION OF SATURATED KAMLOOPS SILT (SAMPLE #333, SINGLE DRAINAGE)

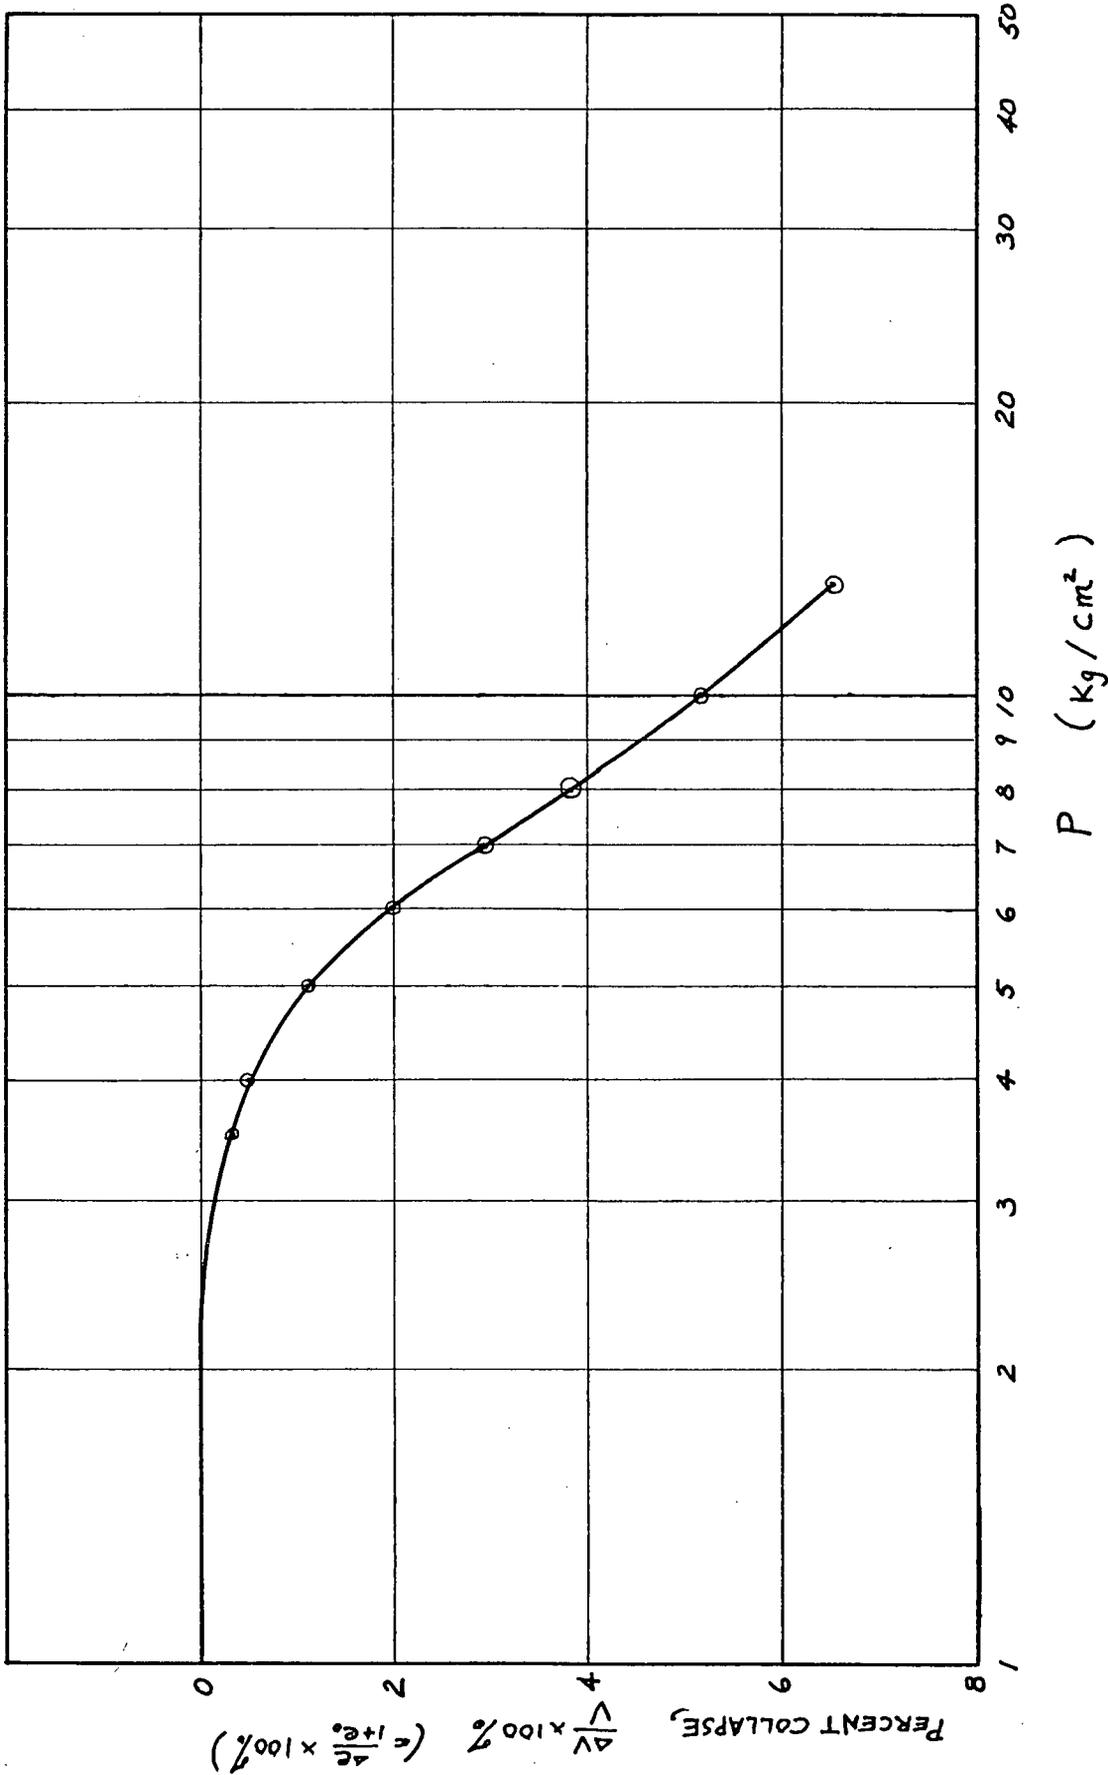
FIG. 37. % COLLAPSE VS P

The 'maximum preconsolidation pressure' is approximately 26 kg/cm^2 for the air-dried state and 6 kg/cm^2 for the flooded state. Therefore, very little subsidence due to wetting would be expected to occur at stresses less than 6 kg/cm^2 (see fig. 37). The collapse is approximately 2% at 6 kg/cm^2 . For the stress levels commonly encountered in footing designs and most engineering problems, the Kamloops silt is not a problem soil from the collapse aspects inspite of its high in-situ void ratio (fig. 37). However, the leaching of the soil by acidic water will cause additional subsidence. The 'maximum past pressure' for the silt flooded with 0.01M HCl is 2.4 kg/cm^2 . At this stress, the laboratory collapse is approximately 2%. At higher stresses, settlement problems may arise especially when differential settlements could easily result due to local flooding by acidic solutions. Although the acidic concentrations

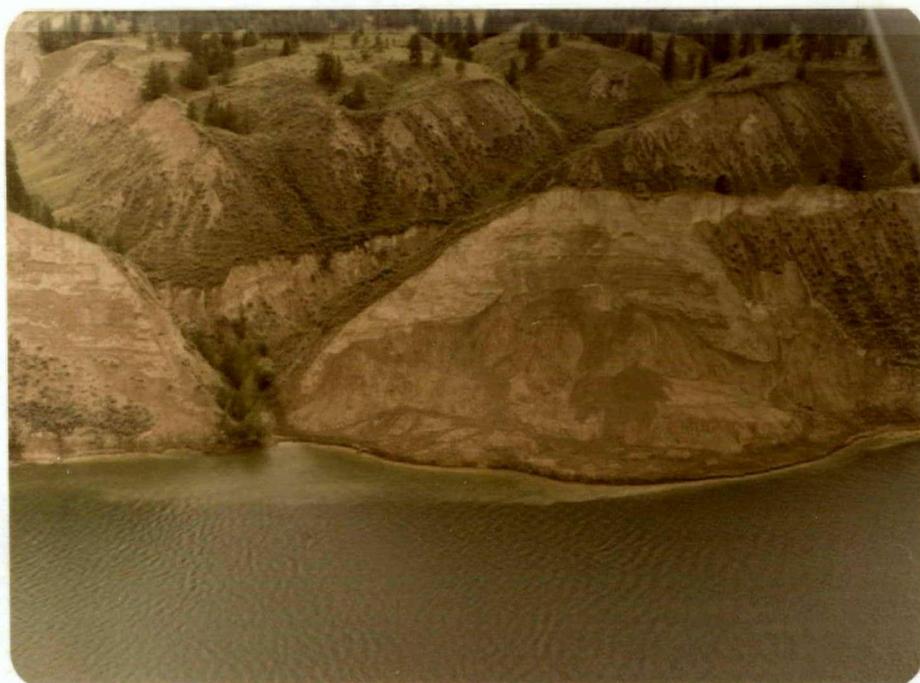
Figure 38. Slope failures caused by oversteepening as a result of river erosion of the toe. (Near Pritchard, on the South Thompson River, looking north).

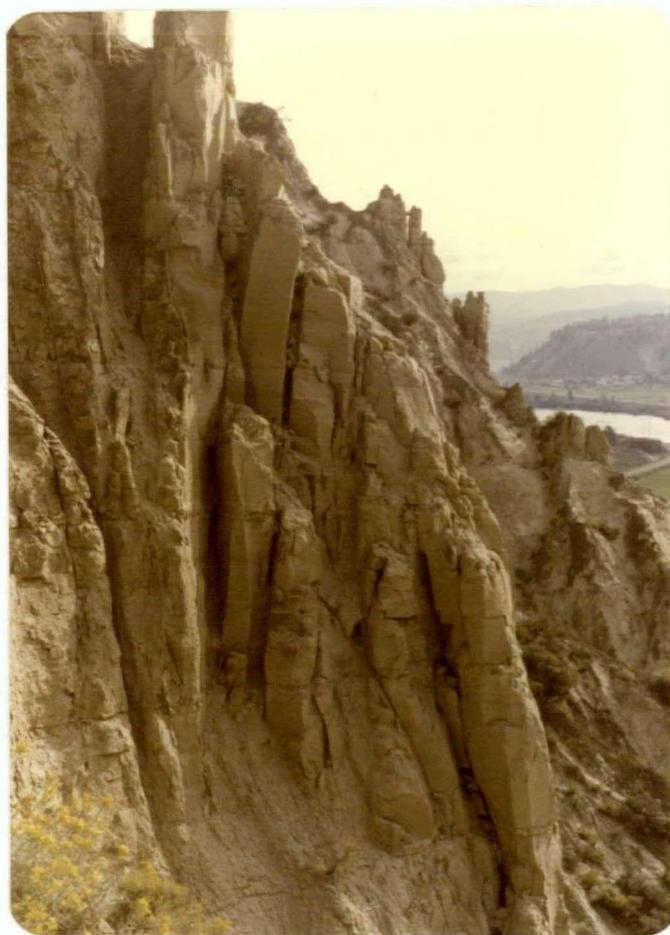
Figure 39. Columnar jointing within the lacustrine silt; slope facing south towards the South Thompson River.

A small joint survey was carried out by running traverses along the base of the steep bluff face with a Brunton compass. As in all joint surveys, human bias and accessibility problems must be kept in mind. Joint orientations were measured, mainly from the east face of Magazine Gully which trends approximately North-South. The stereonet plot (fig. 10) shows the poles of joints plotted in northern hemisphere projection of a Wulf net (Hoek & Bray, 1974). The joints are mainly steeply dipping towards the western sector. This is expected since joints dipping east would represent unstable conditions on the eastern bluff face. Since the joints are all near vertical, a rose diagram is plotted (fig. 11) with radial lengths representing the number of joints falling within each 10° sector of the stereonet. The rose diagram indicated that four major joint sets exist nearly perpendicular to the almost horizontal bedding. Two major sets exist at strikes of 30° and 120° while two weaker sets occur at approximately 0° and 90° . The combination of these joint sets forms the local columnar jointing seen in the field (fig. 39). This type of

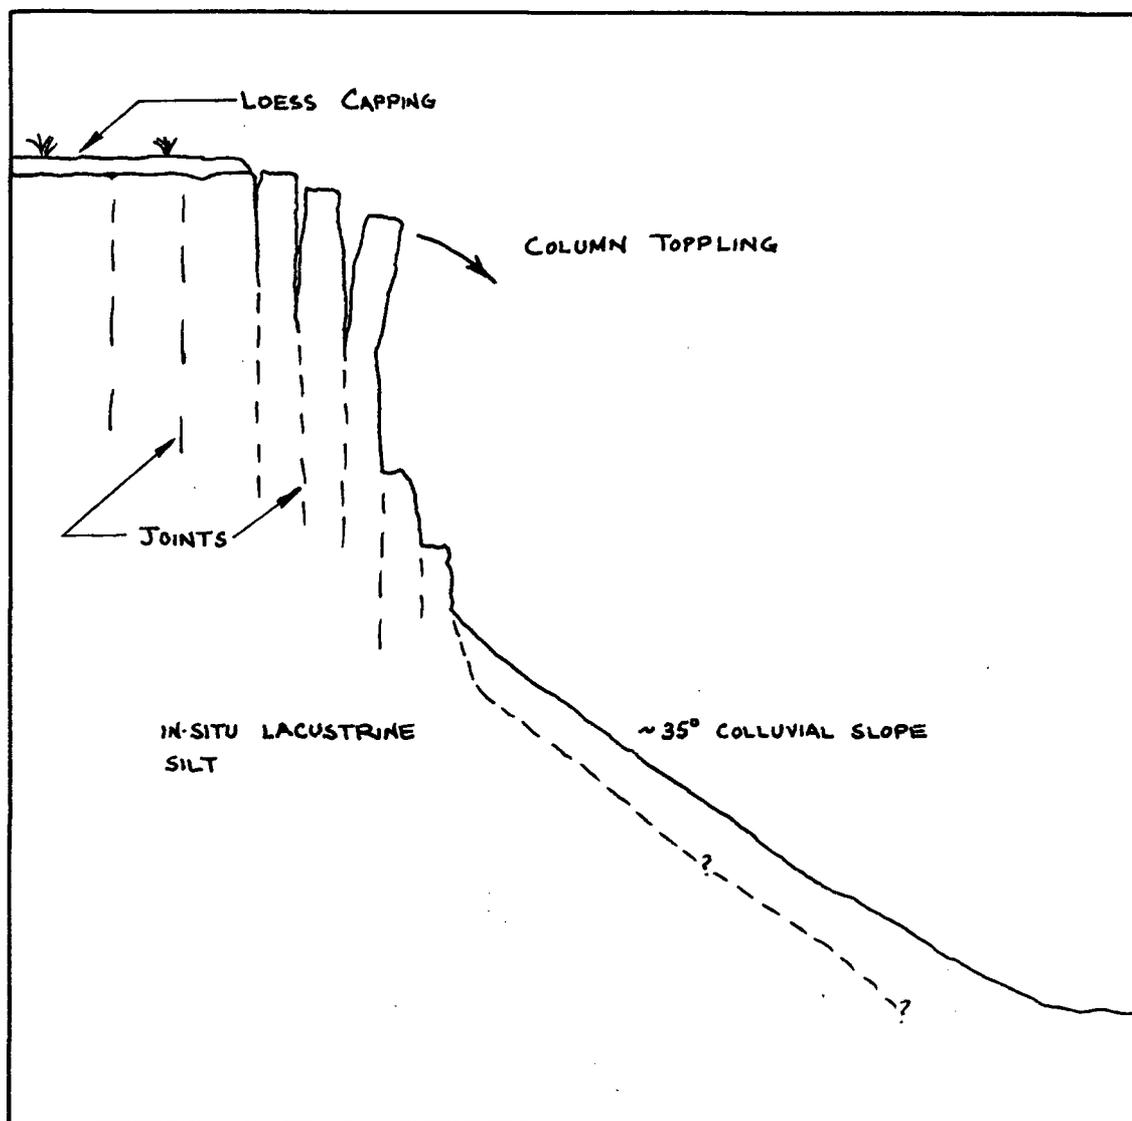
FIG. 40 DIAGRAMATIC REPRESENTATION OF THE COLUMN TOPPLING MODE OF FAILURE

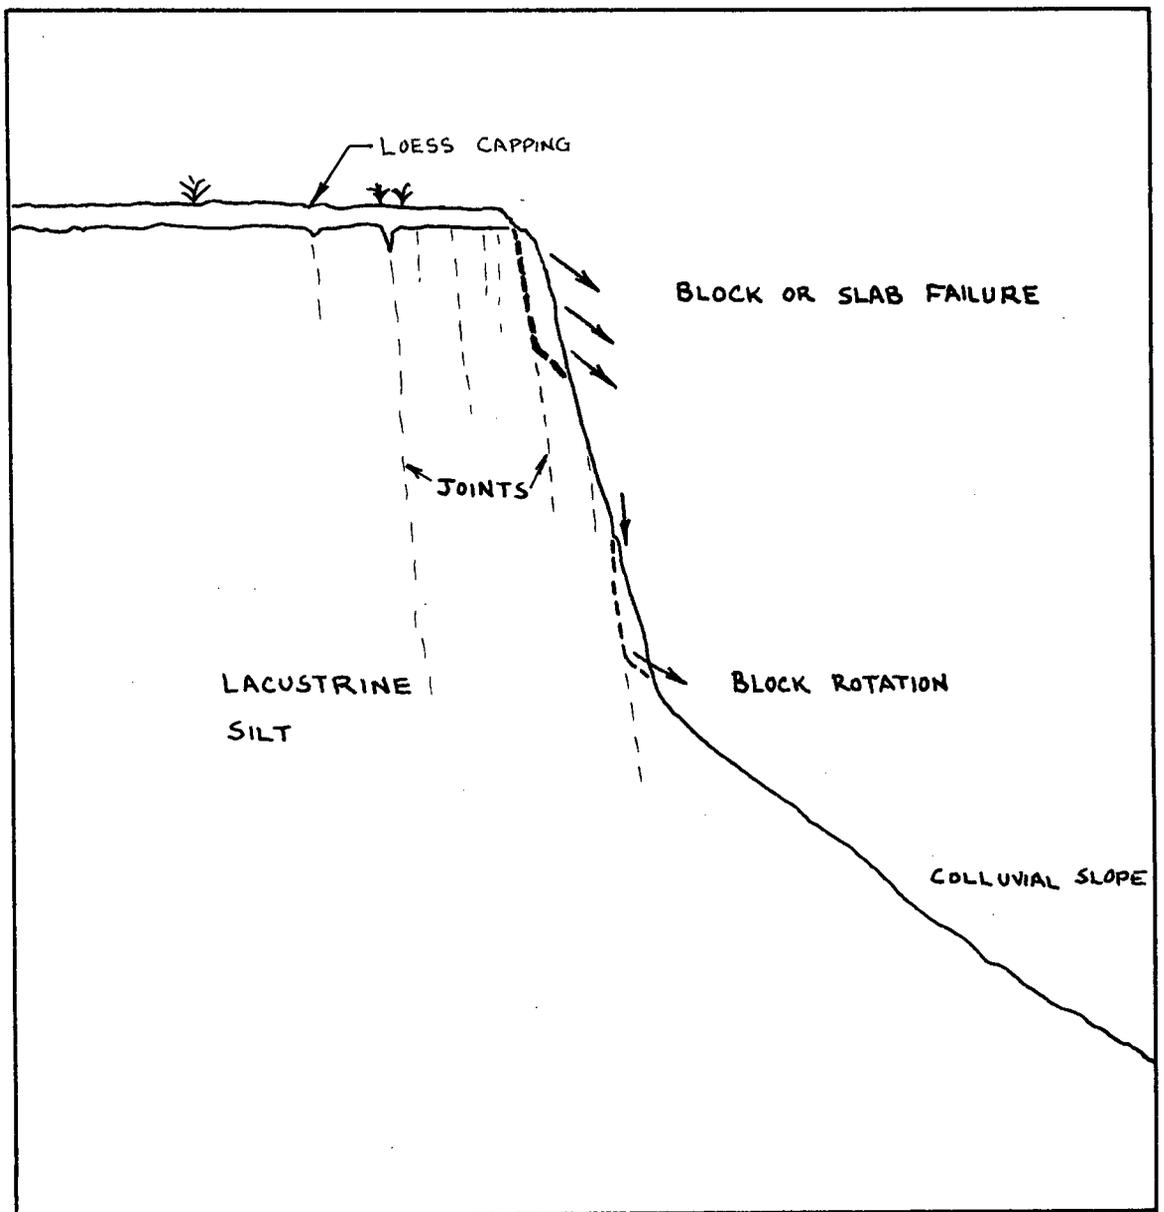
FIG. 41 DIAGRAMATIC REPRESENTATION OF
 (1) BLOCK OR SLAB FAILURE MODE
 AND (2) BLOCK ROTATIONAL FAILURE MODE

A similar mechanism frequently encountered is failure by rotation of intact blocks. The base of the block rotates out while the upper end of the block moves downwards along the rear joint surface. Rotated intact blocks similar to that in figure 42 are frequently observed in the field.

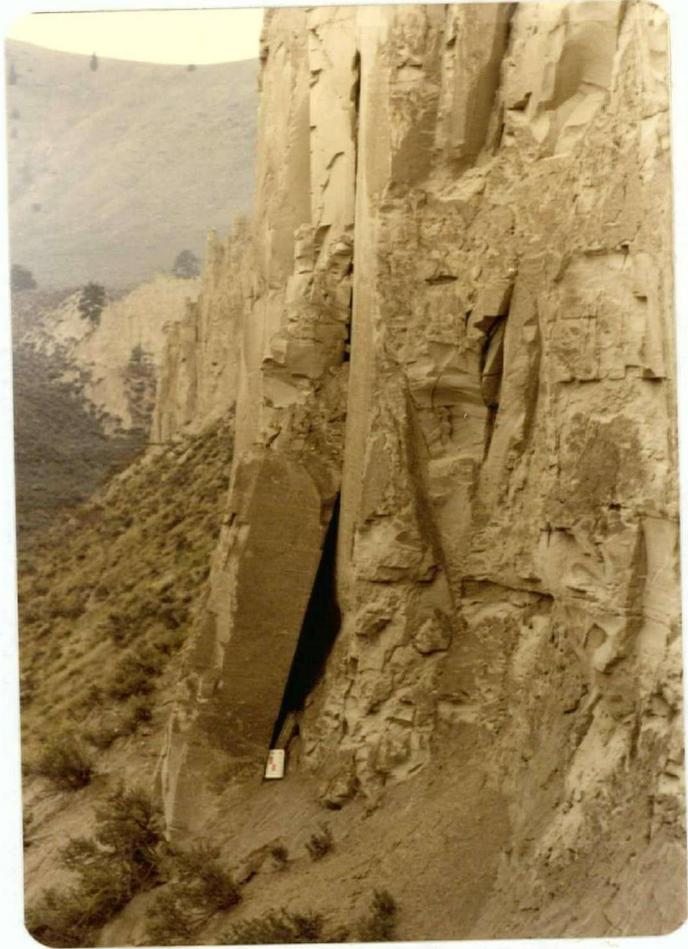
Figure 42. Rotated intact block within Magazine Gully.
