OUT-OF-PLANE SEISMIC PERFORMANCE OF UNREINFORCED CLAY BRICK MASONRY WALLS

A THESIS SUBMITTED IN PARTIAL FULFILMENT OF
THE REQUIREMENTS FOR THE DEGREE OF

MASTER OF APPLIED SCIENCE

THE UNIVERSITY OF BRITISH COLUMBIA

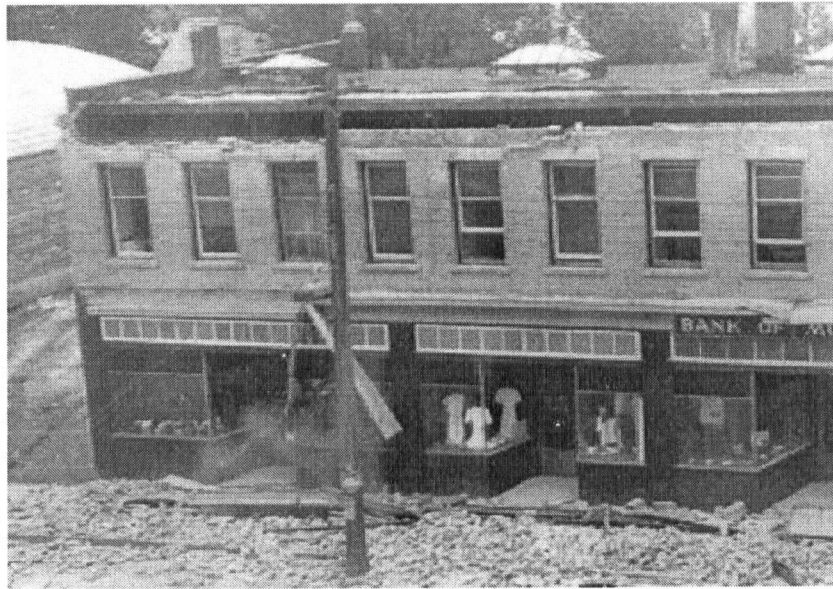
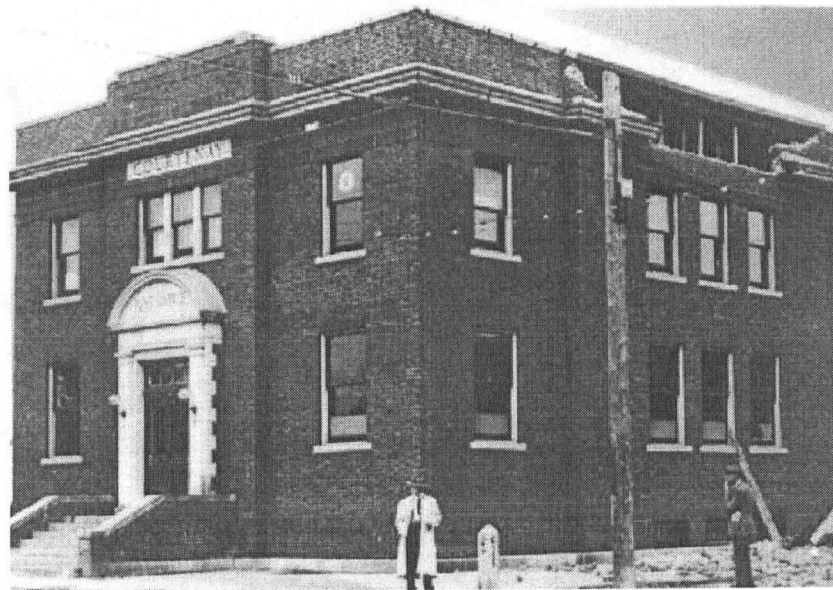
Figure 1.1 URM Damage from the M7.3 Vancouver Island Earthquake of 1946

(a) Damage to the Bank of Montreal Building, Port Alberni B.C.

(b) Masonry Failure of Post Office, Courtenay B.C.

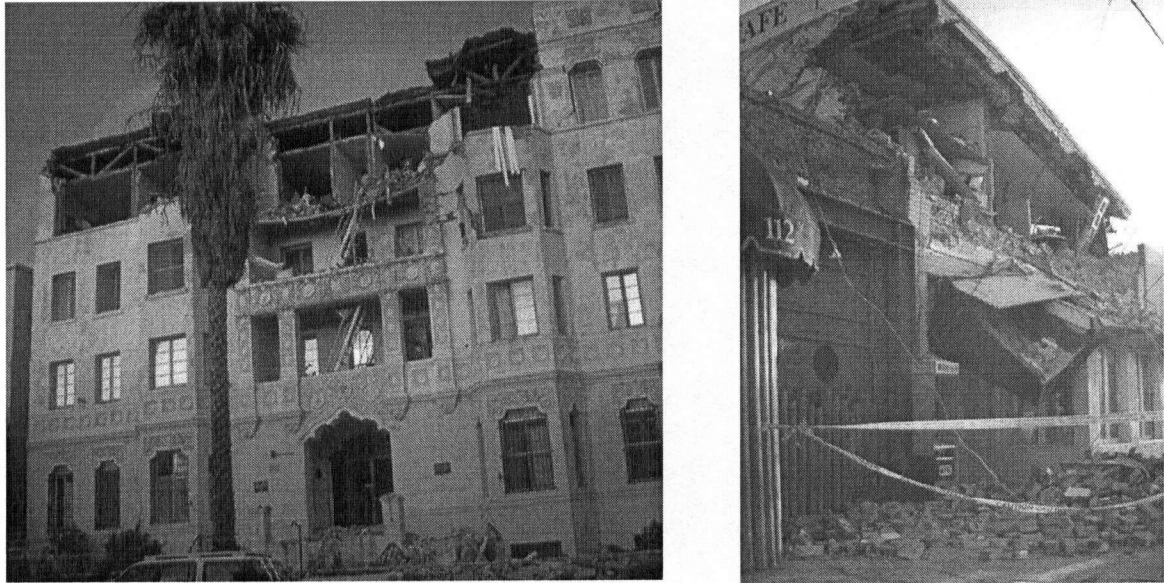
Figure 1.2 Upper Storey Out-of-Plane URM Failure from the 1994 Northridge Earthquake

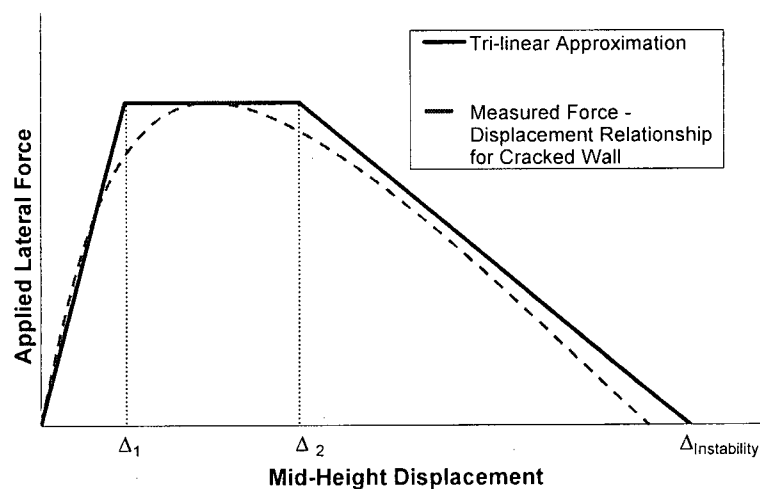
Figure 2.1 Tri-linear Stiffness Model

Rayleigh damping was incorporated into the model with 5.9% of critical damping at a period 0.5s and 8.9% at 1.0s. The analysis was conducted assuming a moderate level of damage in the wall, which defines $\Delta_1 / \Delta_{Instability}$ as 13% and $\Delta_2 / \Delta_{Instability}$ as 40% [Doherty, 2000]. This model was calibrated based on the results of dynamic shake table tests on single-wythe walls. Further details on the equations of motion used and modeling procedure can be found in Griffith et al. [2003]. Results from the current study will enable verification of the model for three-wythe clay-brick walls.

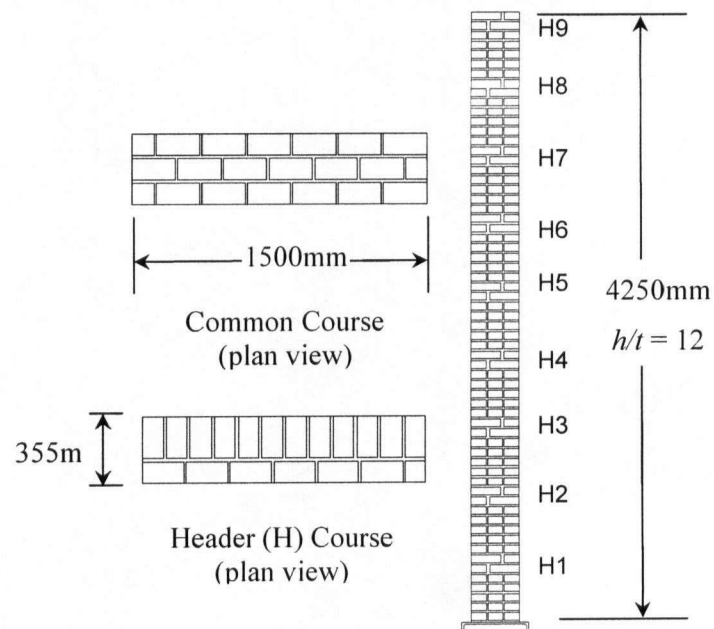
Figure 3.4 Wall Dimensions

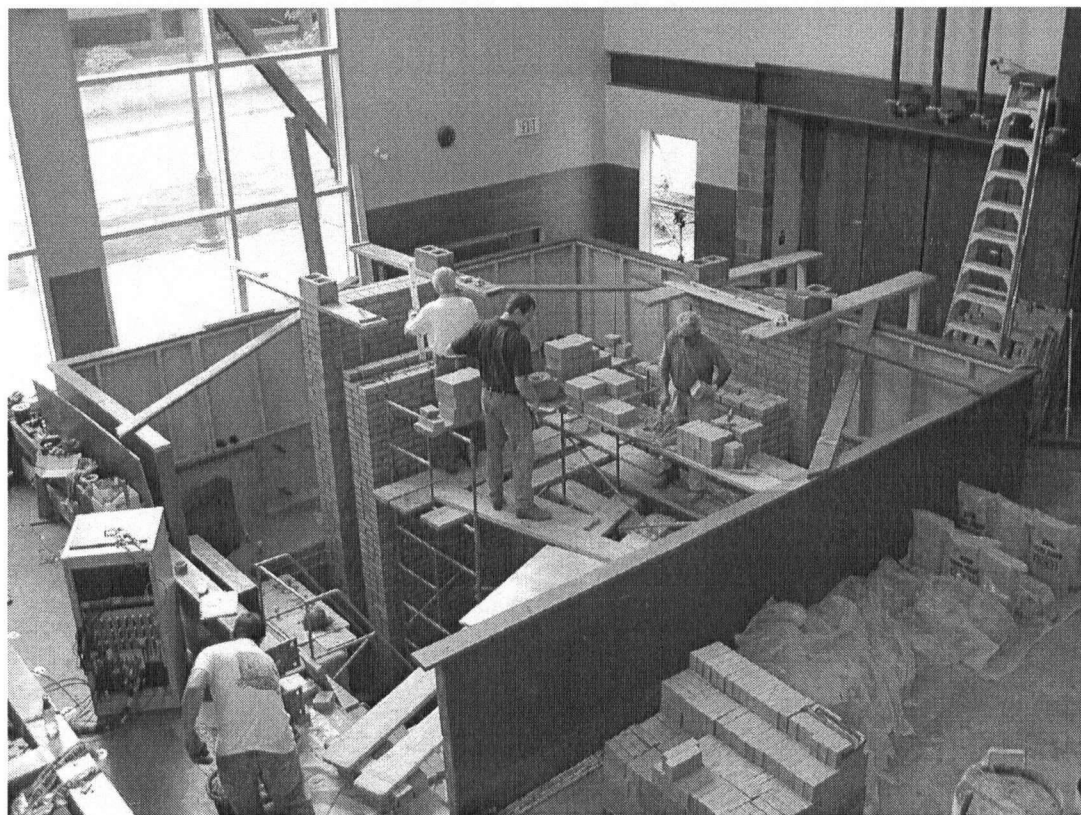
Figure 3.6 URM Walls Under Construction

The walls were constructed and cured under dry conditions in the laboratory (Figure 3.6). The average density of the walls was 1837 kg/m^3 . This was measured by weighing the walls before testing, and weighing a representative sample of the broken wall after testing. In this way, mortar that partially filled the collar joints is taken into account. The mass, density, and geometry can be found in Appendix B. Before testing, the walls were painted white to help locate cracks.

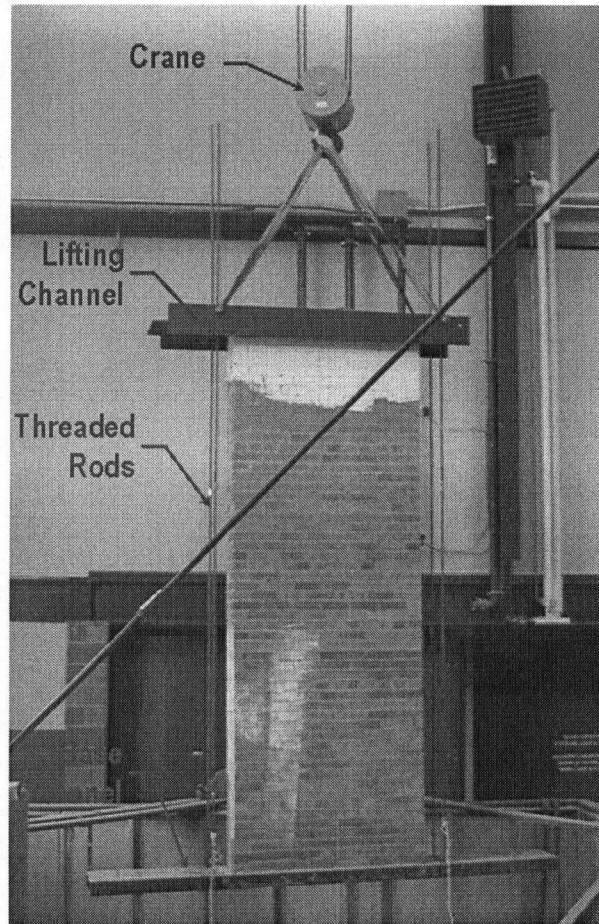
Figure 3.7 Wall Lifting Apparatus

In order to move the specimens onto the shake table, the walls were built on top of a steel channel section. A lifting beam was then lowered and placed on the top of the wall, and threaded rods were installed near the four corners of the wall. The rods were then tightened, placing a vertical compressive load onto the wall. The wall was then lifted using an overhead crane attached to the lifting beam, thereby lifting the wall from the base, and keeping the wall stable during transport (Figure 3.7). No cracking was observed in the walls due to transport.

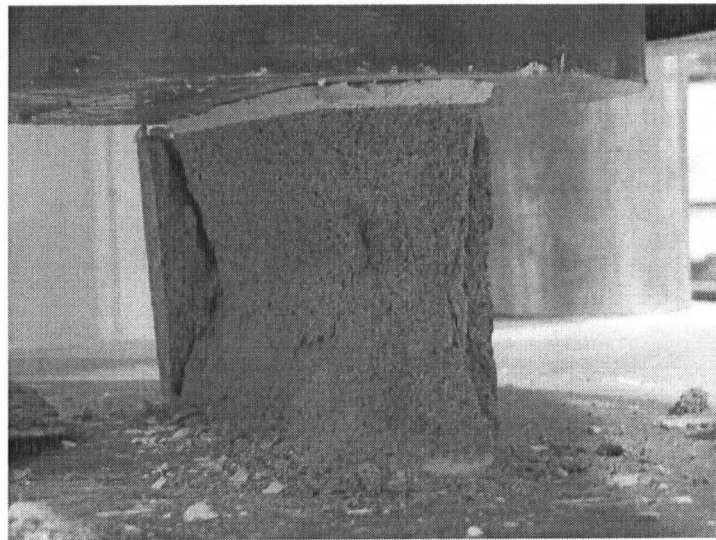
Figure 3.9 Typical Brick Unit Compression Failure

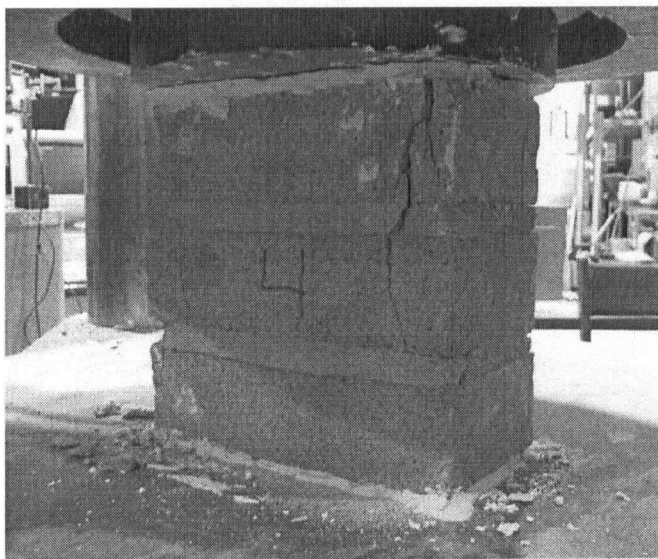
Figure 3.10 Typical Masonry Unit Compression Failures

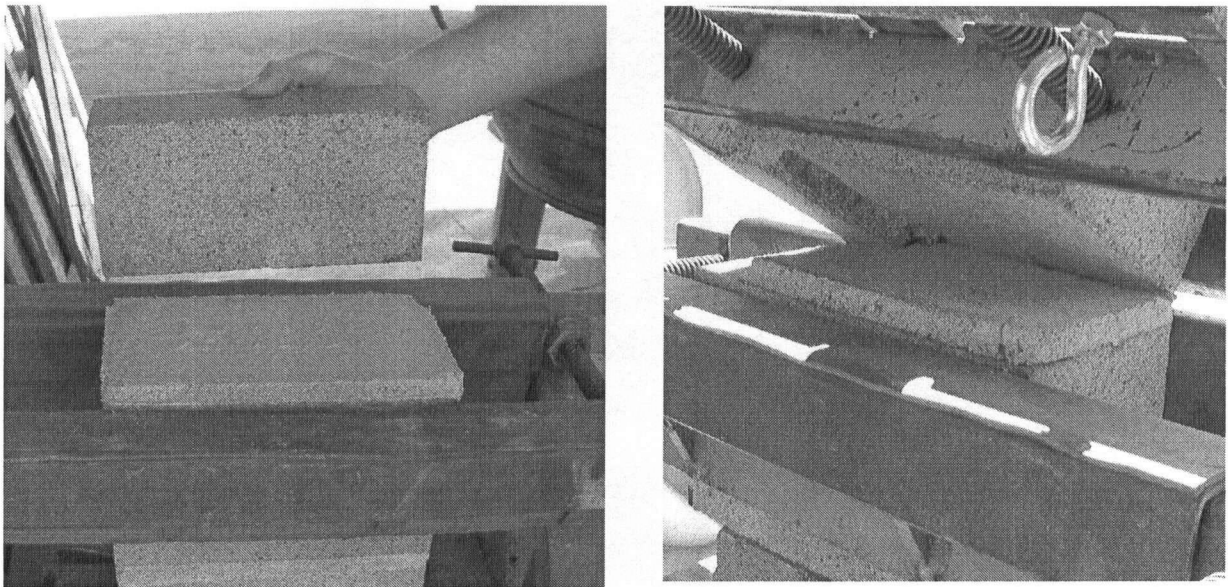
Figure 3.11 Typical Masonry Bond Wrench Flexural Failure

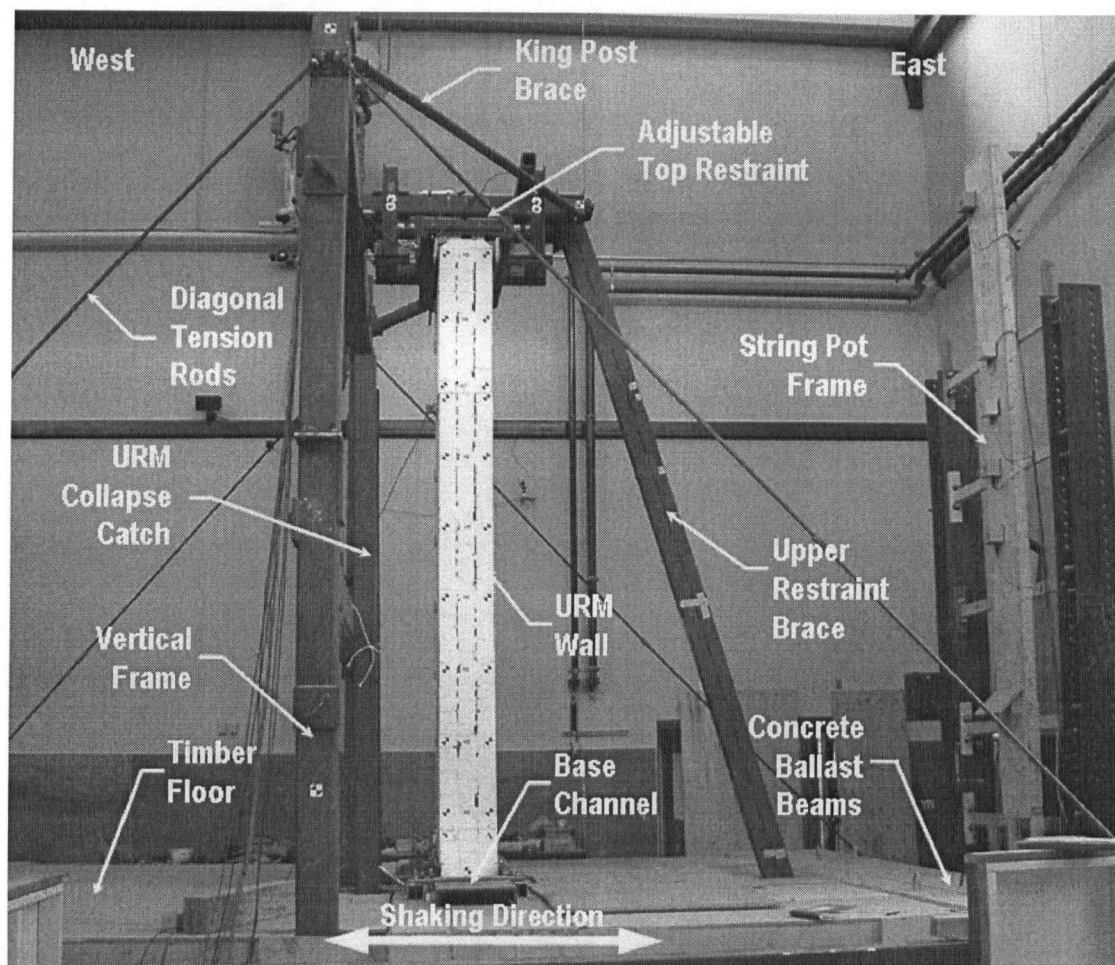
Figure 3.13 Experimental Set-Up

To provide representative boundary conditions of a simply supported URM wall, a braced steel frame was attached to the table (Figure 3.13, Appendix C). The stiffness of the braced frame was designed to represent, as closely as possible, a building system with URM shear walls and stiff concrete diaphragms. It was assumed that a URM building with this type of structural system provide equal and in phase input motions at the base and top of the wall. This is not the case, however, where the floor diaphragms are flexible (e.g. timber floor systems). In this situation, there may be different input motions at the base and top of the wall [Simsir, 2004], and is beyond the scope of this study. Equal and approximate in-phase input motions at the base and top of the wall were confirmed by comparing the absolute displacements of the table and top of the braced frame for each dynamic test, and showed close agreement (Figure 3.14).

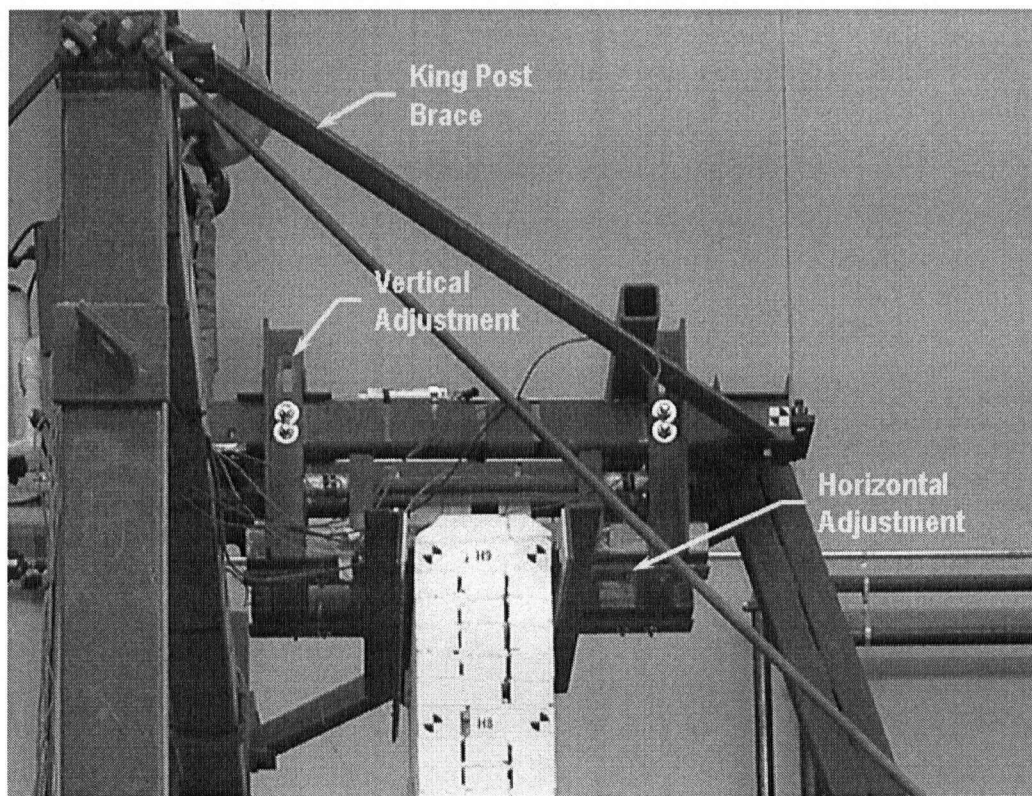
Figure 3.16 Elevation View of Top Connection

steel angle. A stiff rubber spacer and an Ultra High Molecular Weight Polyethylene (UHMW) strip were attached to the wall; the angle on the restraint also had a UHMW strip. The UHMW strips are a wear resistant plastic with a low coefficient of friction and high impact strength, allowing for low friction during vertical movement of the wall. The stiff rubber spacer allows for the wall to rotate. The UHMW strips were not used for the first wall tested. During the first shake table test, it was noted that the top and upper edges of the wall bared against the top connection arm and angle (Figure 3.17) at large rotations during rigid body rocking. To prevent this contact, the upper edges of the wall were beveled, and bricks underneath the connection arm were removed (Figure 3.18). The top restraint was also designed to allow for varying floor diaphragm stiffness by the insertion of coiled springs. As previously mentioned, these series of tests considered only a rigid diaphragm so the coiled springs were replaced with steel tubing (Figure 3.17). Details of the top connection can be found in Appendix C.4.

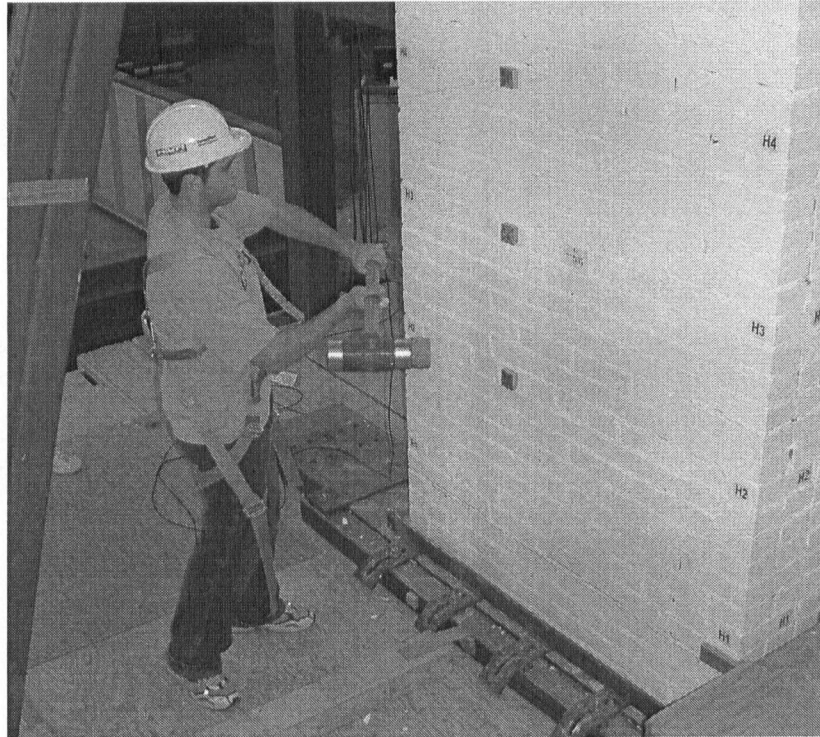
Figure 3.20 Impact Hammer Test

Before and after each shake table test, impact hammer tests were conducted on each wall in order to record the dynamic properties (natural frequencies and damping) of the wall. These tests also helped to understand how much damage has occurred in the wall after each test. Hammer tests were conducted at various locations on the wall (Headers 3, 6 and 8) in order to excite higher modes in the wall. At each header course, the hammer was swung at least 3 times (Figure 3.20), allowing sufficient time between each impact for the accelerations in the wall to dampen out. During the hammer tests, accelerations along the wall and the input force of the hammer were recorded.

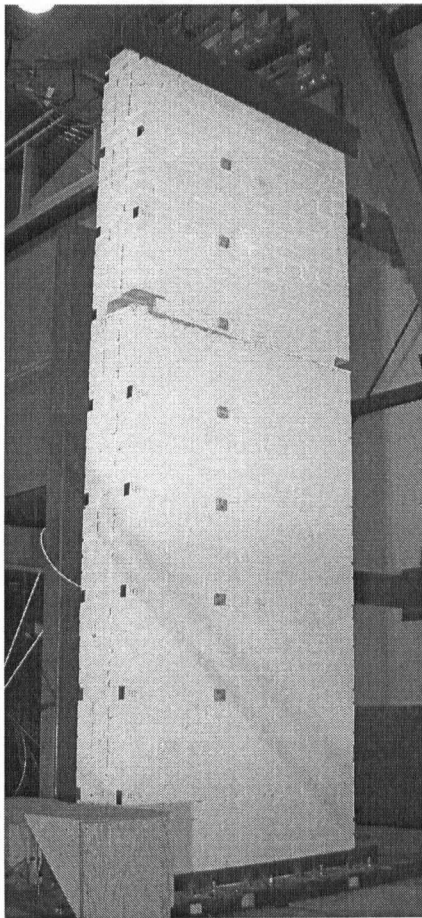
Figure 4.1 Crack at Header 6 and Dislodged Bricks (GC4-1.21)

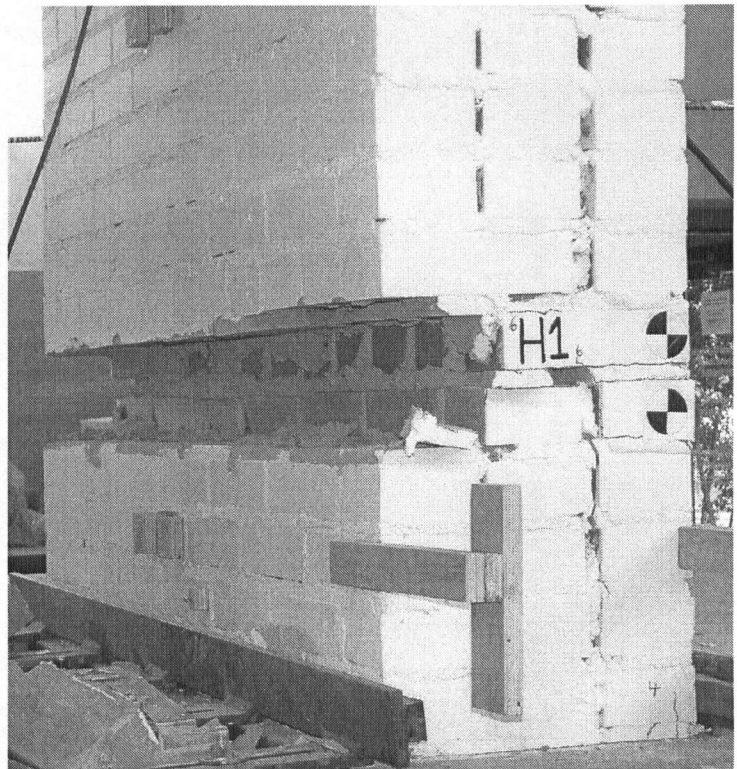
Figure 4.2 Loss of Bricks at Header 1 (PC7-1.75)

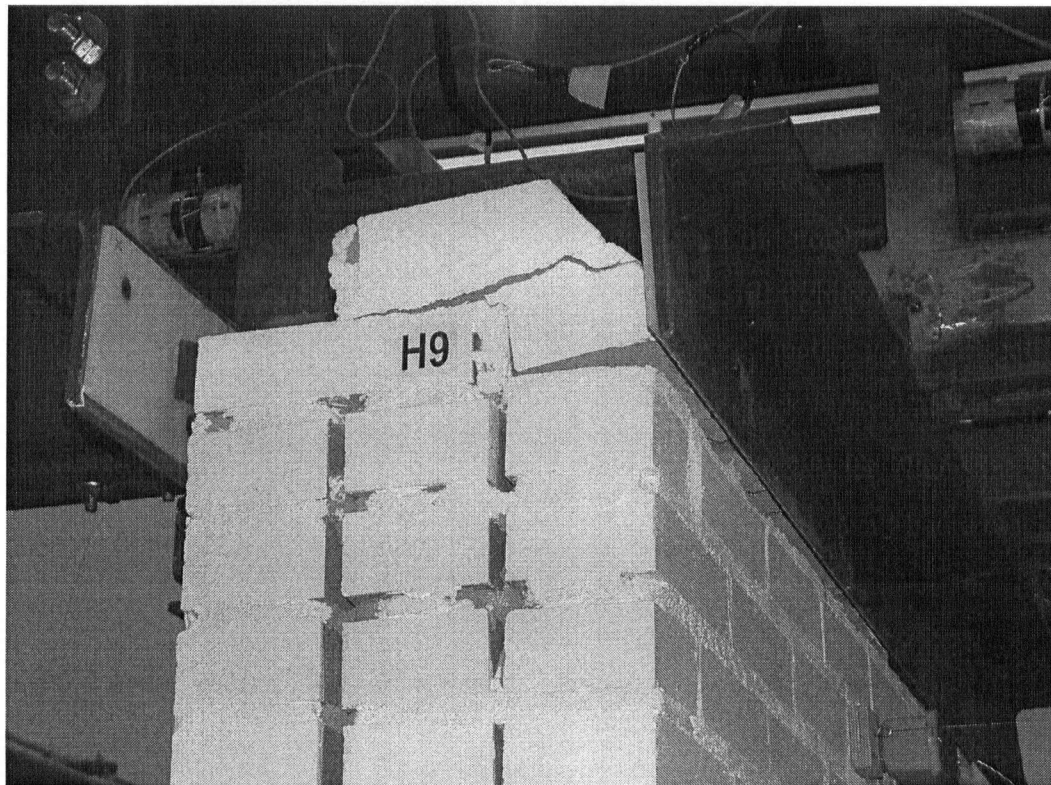
Figure 4.4 Dislodged Bricks at Header 9 Formed During Test PD5-1.66

At the Test 4, (GD4-1.24 and PD4-1.20), both walls exhibited crushing of the outer wythe bricks at the crack. For the poor quality wall, at scaling levels of 1.66 and greater (Tests 5 and 6), a crack formed at the top of the wall (header 9), with a row of bricks becoming dislodged, as shown in Figure 4.4. It is believed that this damage to the wall did not have a significant effect on the overall performance of the wall, as the dislodged bricks still tightly remained between the undamaged portion of the wall and the top restraint. For the good quality wall, for scaling levels of 1.65 and greater, a brick was lost at header 7 and a new thin crack formed at headers 2 and 3. Examples of the level of damage observed at the crack towards the later testing stages are shown in Figure 4.5.

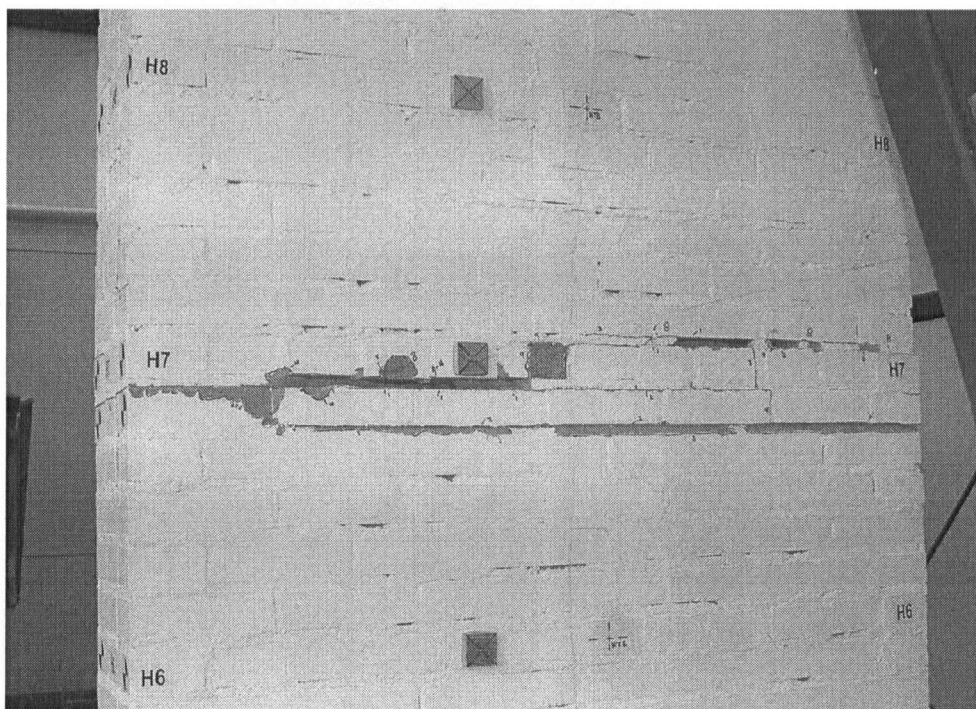
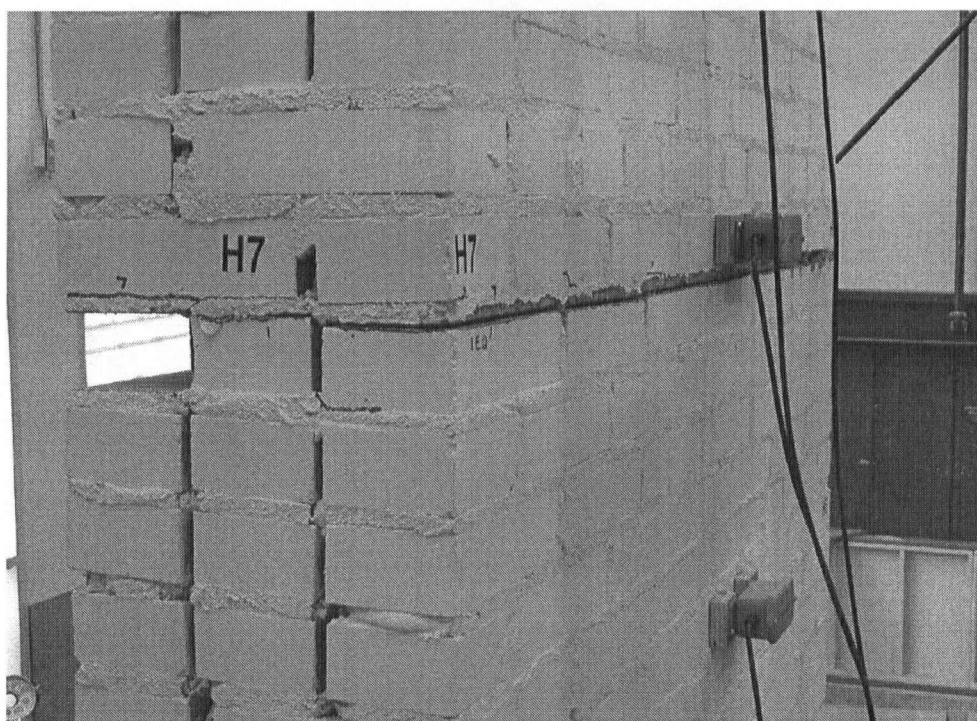
(a) Brick Crushing, and Mortar Spalling at Header 7, after Test PD5-1.66

(b) Dislodged Brick and Mortar Crushing at Header 7 after Test GD5-1.65

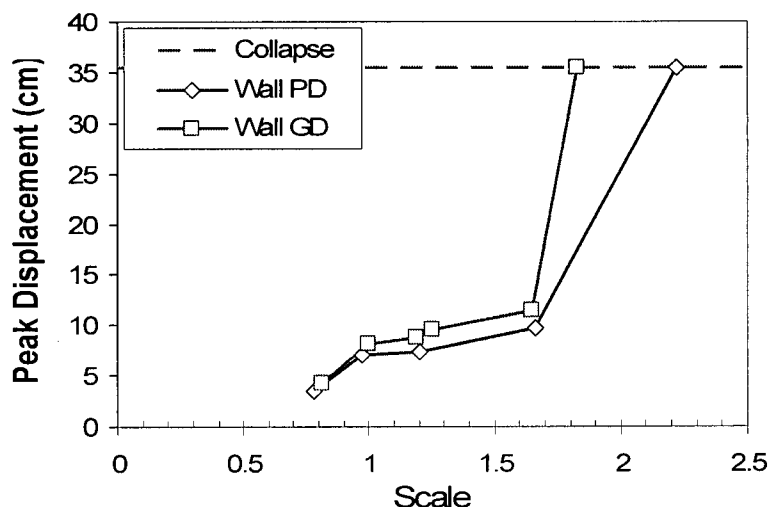
Figure 4.6 Peak Mid-Height Displacement vs. Ground Motion Scaling (Site Class D)

Figure 4.6 shows the maximum displacements versus scale factor for the two walls. Both the poor and good quality wall had very similar peak displacements indicating that the overall performance was not significantly affected by the quality of construction. For tests up to a scaling level of 1.65, there is a gradual increase in peak relative displacement at the crack. For tests slightly above 1.65, the walls become unstable, indicating that collapse of the wall happens suddenly.

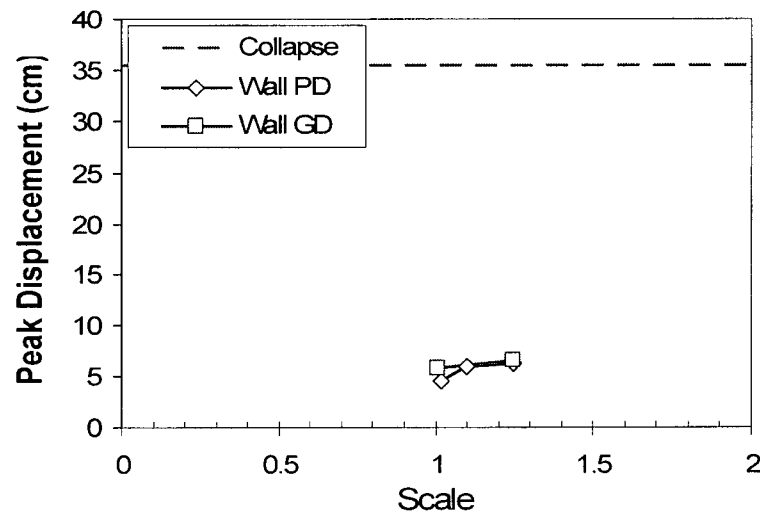
Figure 4.7 Peak Mid-Height Displacement vs. Ground Motion Scaling (Subduction)

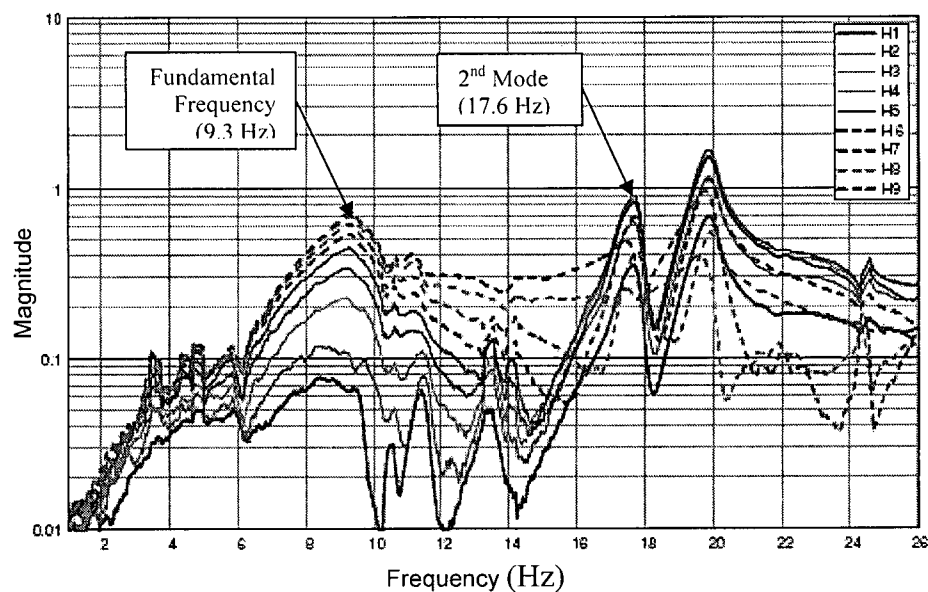
Figure 4.8 FRF for the Un-Cracked Wall PC

fundamental frequencies are for the entire system including the wall and restraints, but still provide valuable information regarding the degradation of the walls through subsequent tests.

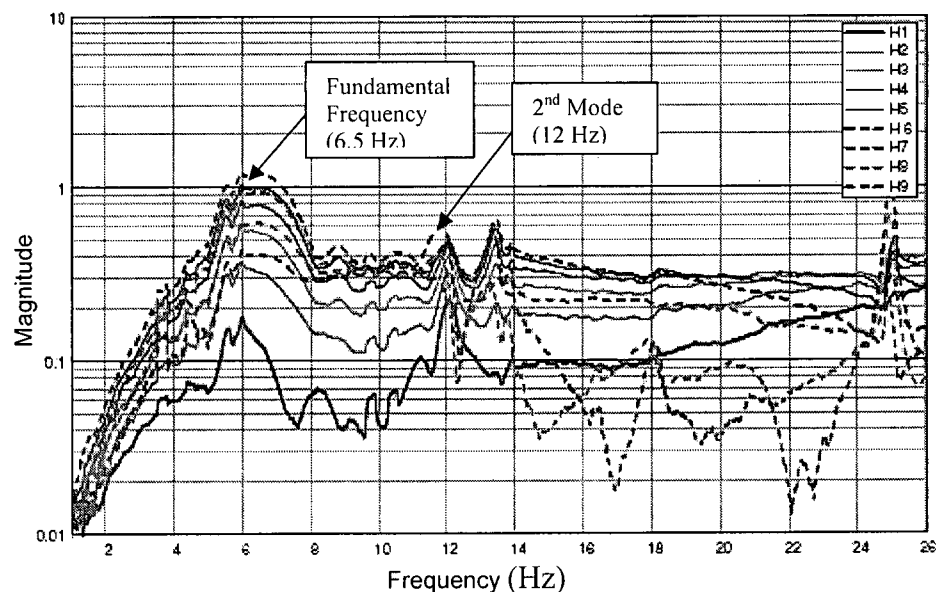
Figure 4.9 FRF for the Cracked Wall PC4-1.40

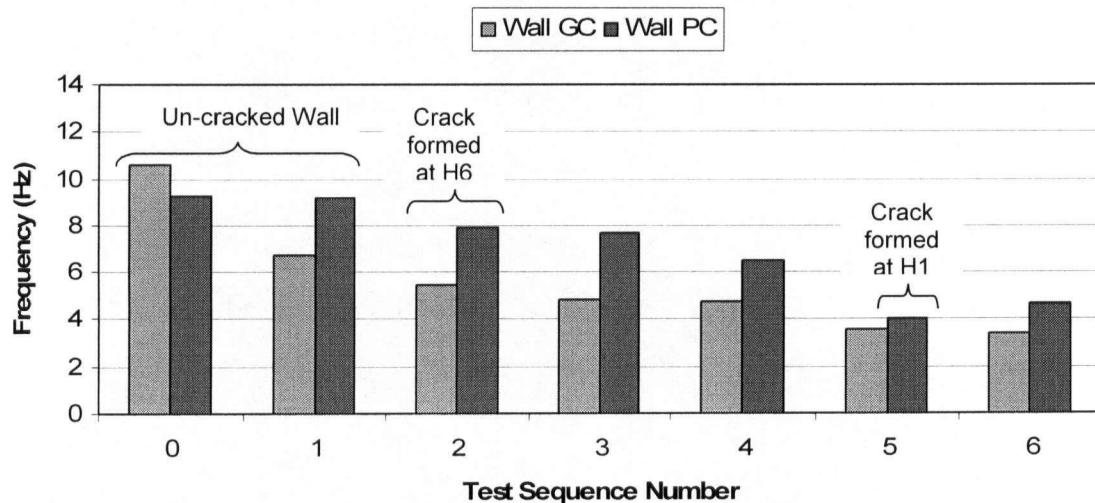
Figure 4.10 Hammer Natural Frequencies for Site Class C Ground Motions

at headers). There is also a slight decrease in the natural frequency through subsequent tests even if no new major cracks appear. This may be due to damage at the crack plane caused by increased crack widths, loss of mortar and bricks, and crushing of mortar and bricks. In general, the good and poor quality collar joint walls have similar un-cracked and cracked natural frequencies, indicating that the collar joint quality had little effect on the walls natural frequency characteristics. For Wall GC, the wall appears to have undergone damage after the first test (test sequence 1), as indicated in the significant drop in natural frequency (Figure 4.10). However, this damage was not noted by any visual observations such as cracking. Also note that the frequencies of Wall GC are lower than those of Wall PC once the wall has cracked. This difference may be due to the location of the crack; as the crack in Wall PC formed at 65% of the wall height from the base, whereas in Wall GC the crack formed at 55% of the wall height. On average the un-cracked walls had a natural frequency of 9.0 Hz (period 0.11s), for a single crack at header 6 or 7 their natural frequency dropped to 5.9Hz (0.16s), and with further cracking (headers 1, 2, and 3) to 4.7Hz (0.21s).

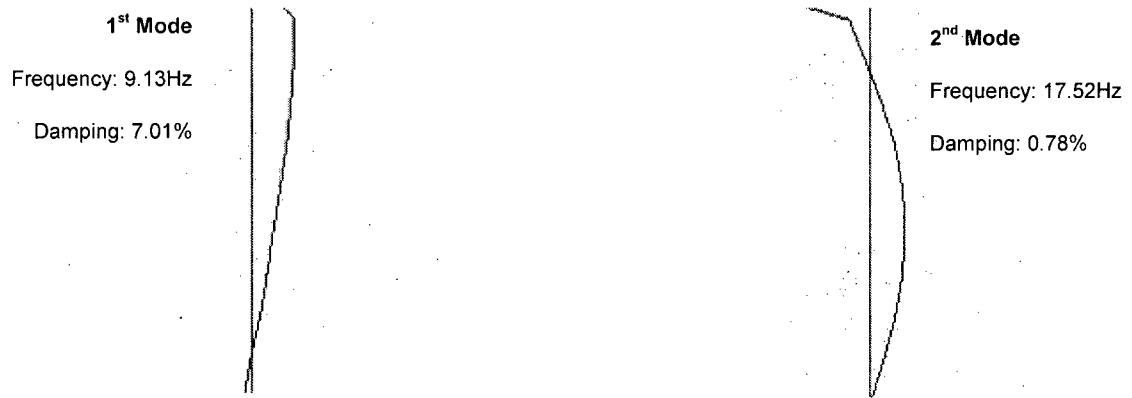
Figure 4.12 Mode Shapes of the Un-Cracked Wall PC

Mode shapes were also estimated using ARTeMIS, (Figure 4.12 and Figure 4.13). For the un-cracked wall, the mode shapes are smooth and continuous; indicating that the wall is indeed un-cracked. The flexibility of the rubber spacers can be seen at the top of the wall in the 1st mode shape. In Figure 4.13, the presence of a crack at header 6 is clearly evident in the mode shape and bending of the wall segments above and below the crack is very limited compared with the rigid body rotation of the segments.

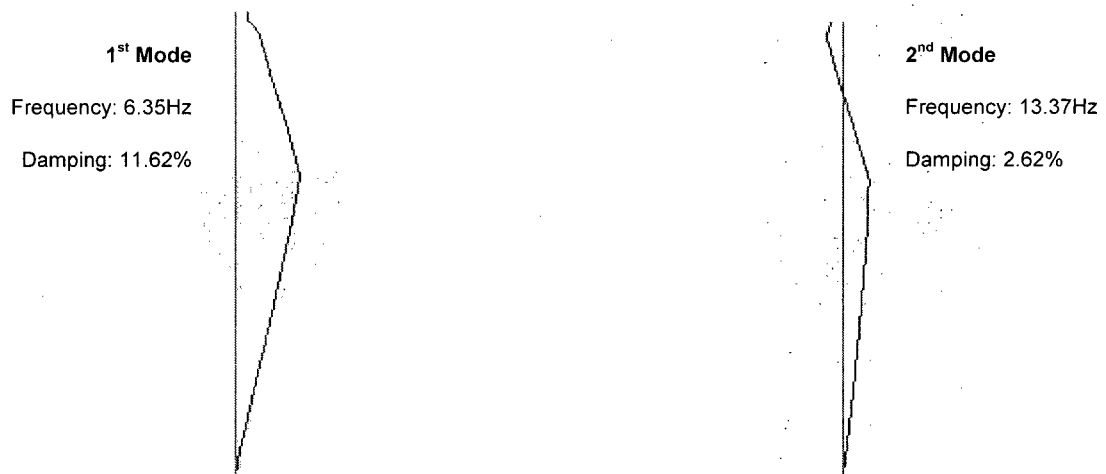
Figure 4.13 Mode Shapes of the Cracked Wall PC4-1.40

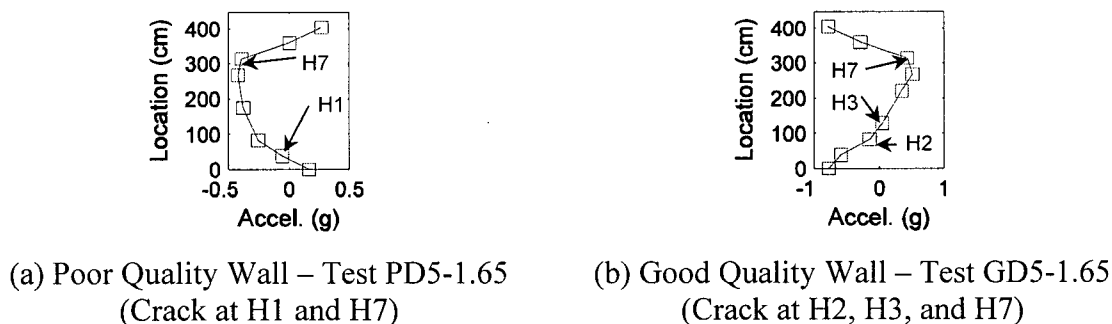
Figure 4.18 Multiple Rigid Body Rocking Acceleration Profile

Test PD2-0.78, and header 2 and 3 during Test GD5-1.65 of the good quality wall. This caused the walls to rock as three and four rigid bodies respectively. The multiple, rigid body rocking can be seen in the acceleration profiles of the walls in Figure 4.18. An example acceleration time history is shown in Figure 4.19. Figure 4.19 (b) shows a close-up view of the acceleration time history. Note that the acceleration at header 6 (the crack location) is out of phase with header 9 and the table. Further time histories can be found in Appendix G.

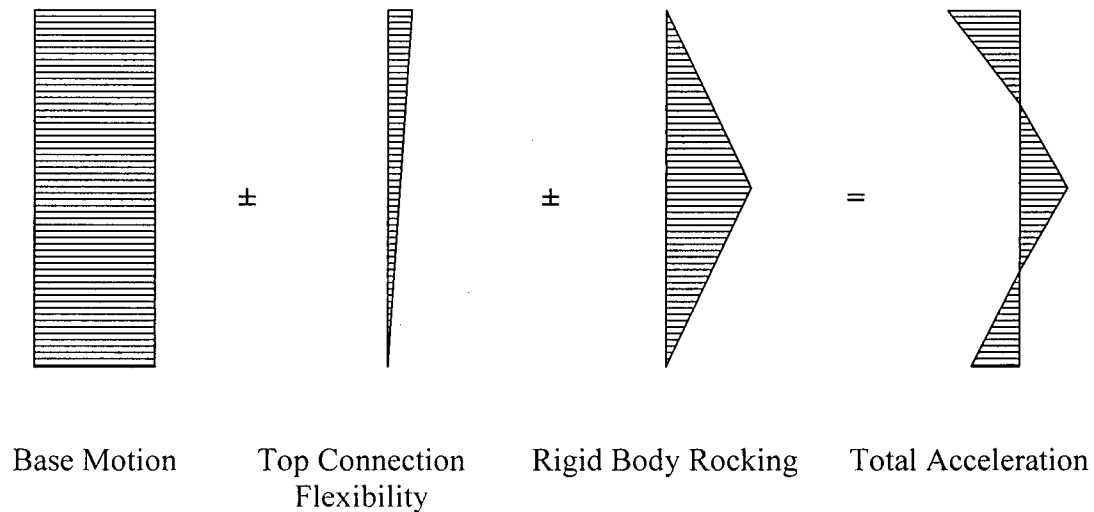
Figure 4.20 Acceleration Profile Components

The acceleration profile exhibited by the wall consists of three components (Figure 4.20): the base motion, top connection flexibility (diaphragm stiffness), and the rigid body rocking motion due to the inertia of the rocking wall. The acceleration due to the top connection flexibility and rigid body motion may not necessarily be in phase with the base acceleration. Note that the total inertia force on the wall for the case shown below may approach zero even though the acceleration at the crack may be as high as 0.5g. If one were to consider the force displacement-relation in a typical lumped mass system, and the force were to approach 0, the system would be considered to be unstable. However, for this system it is still stable, due to varying acceleration profile. One must therefore not only look at the total force-displacement response, but also at the acceleration-displacement response. It is clear from the profile discussed here that each relation will give a different interpretation of when stability occurs.

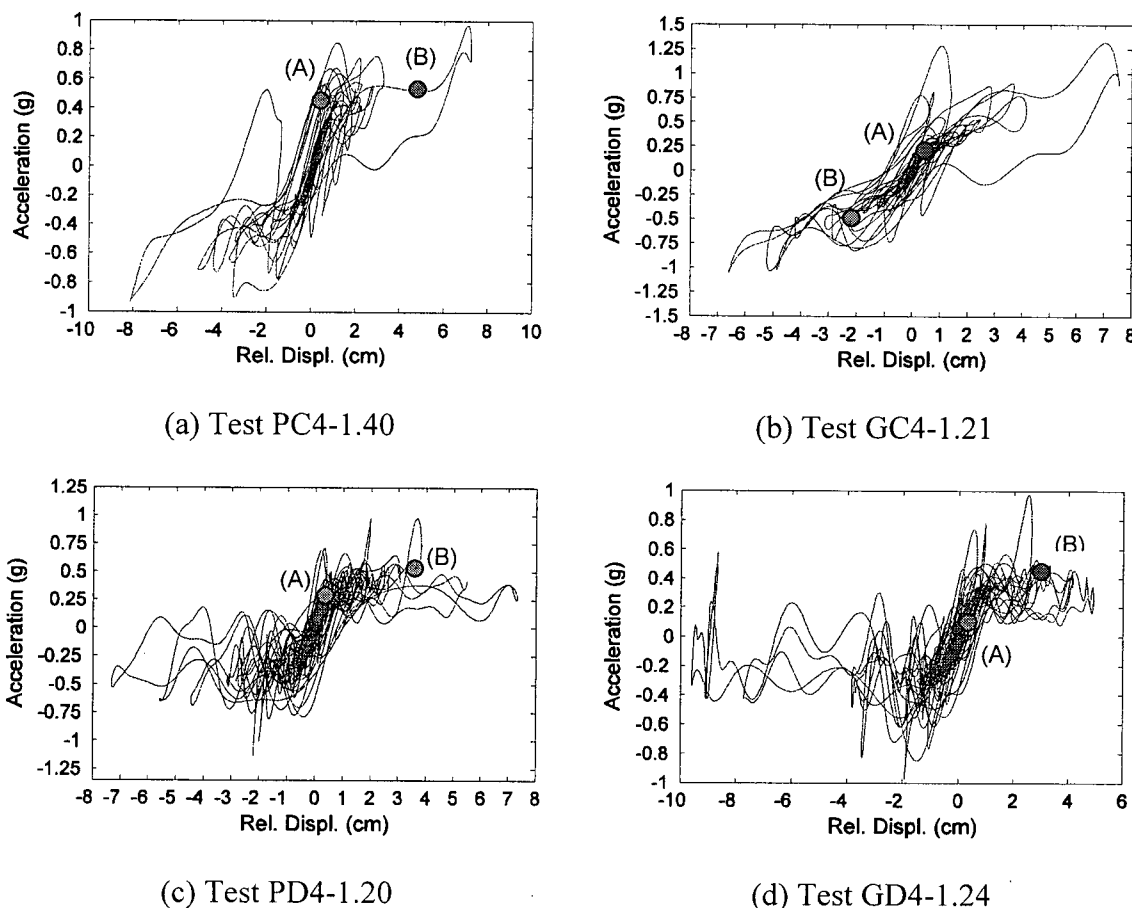
Figure 4.21 Crack Acceleration vs. Relative Crack Displacement Hysteretic Response

The nonlinear elastic rocking behaviour is evident in Figure 4.21 which shows the acceleration at the crack versus the relative crack displacement. In Figure 4.21, at point (A), the relative crack displacements are small (approximately less than 1cm), and the wall behaves essentially linearly. At greater displacements, point (B), the crack has opened sufficiently, allowing the wall to rock, resulting in the nonlinear behaviour.

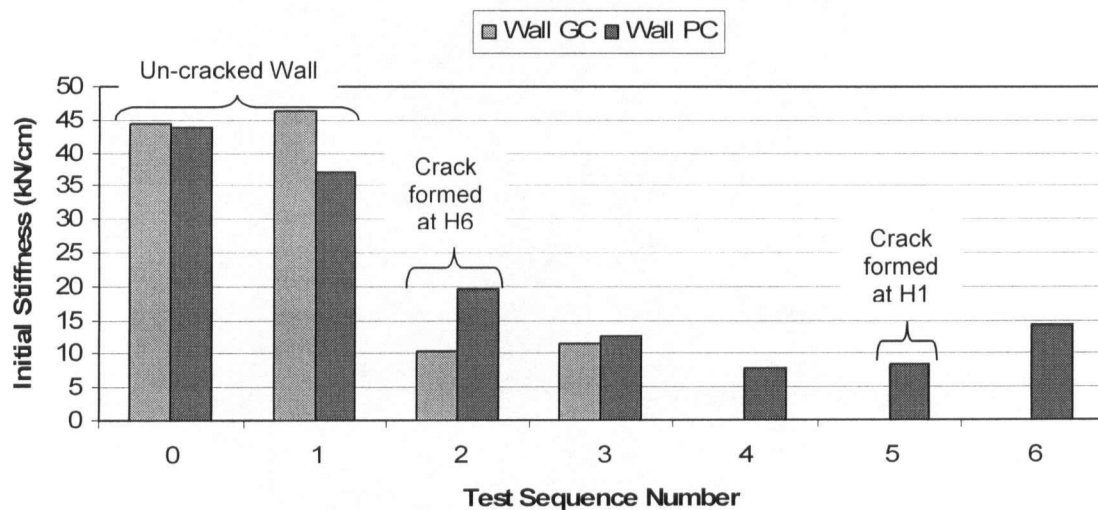
Figure 4.25 Initial Wall Stiffness for Site Class C Ground Motions

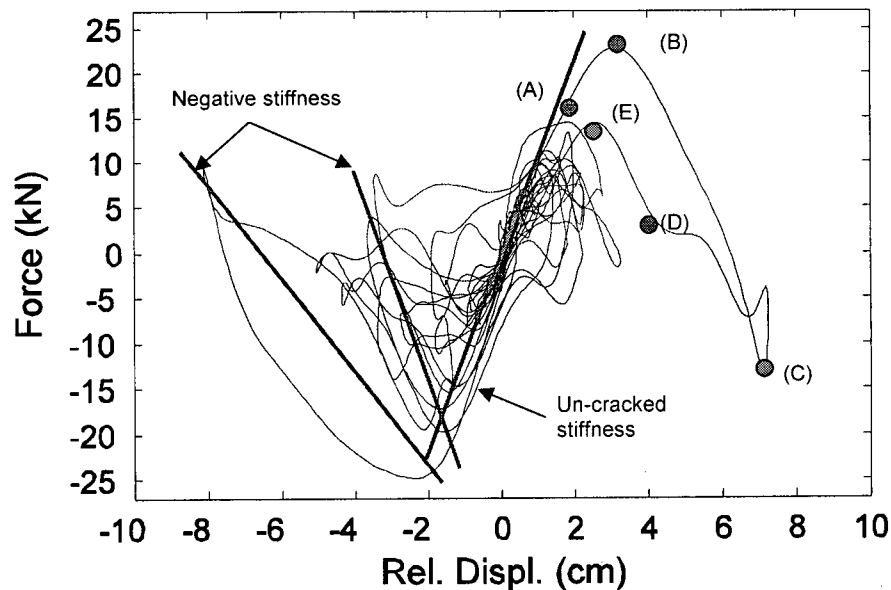
Figure 4.28 Force vs. Relative Crack Displacement Behaviour

Examples of typical non-linear force-displacement relations are shown in Figure 4.27, with key behavioural traits pointed out in Figure 4.28. As will be described in detail below, the negative stiffness evident in the force-displacement response is not comparable to strength degradation due to P-Delta effects or material degradation observed in typical lumped mass systems. Due to the rocking motion of the walls, the inertia force on the wall can drop to below zero with increasing crack displacement, and the walls still remain stable.

For these rocking walls, the negative stiffness occurs due to a drop in inertia force with increasing displacement. At point (A) in Figure 4.28, the wall experiences high applied forces with low relative crack displacements. This is due to the table acceleration and rocking wall inertial acceleration acting in the same direction, as the wall rocks in the positive direction (Figure 4.29). At point (B) the wall experiences a peak in the total force due to the combination of table and wall rocking motion. At point (C) the wall continues to displace in the positive direction, as does the rocking acceleration; however, the table acceleration has changed direction (Figure 4.29). This leads to a reduced acceleration profile for the wall (i.e. reduced total inertial force) with increasing relative crack displacement. At point (D) the table motion has again changed to the positive direction; however, due to the previous table motion cycle, the wall's rocking acceleration has switched to the negative direction, causing a reduction in the relative crack displacement and increase in total inertial force (Figure 4.29). There is a continued reduction in the relative crack displacement, point (E), such that the wall again behaves essentially elastically. Note that the acceleration profiles shown in Figure 4.29 are simplified, and for clarity do not include additional acceleration due to flexibility in the top restraint.

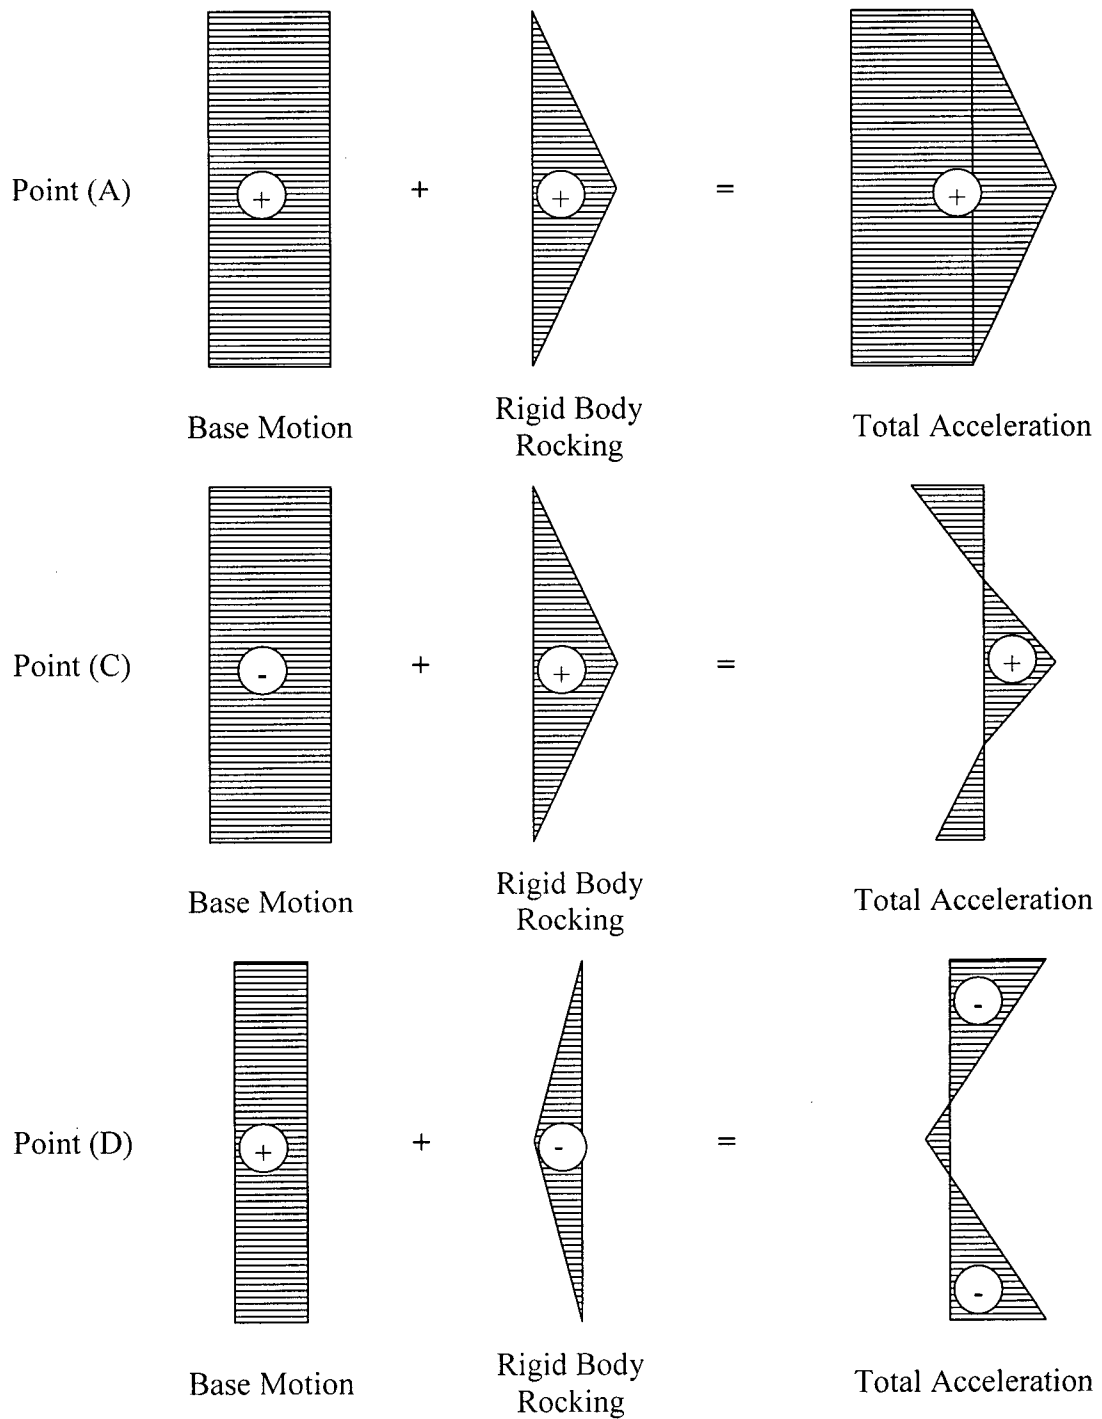
Figure 4.29 Simplified Acceleration Profiles at Various Stages of Table Motion
