OUT-OF-PLANE SEISMIC PERFORMANCE OF UNREINFORCED CLAY BRICK MASONRY WALLS

A THESIS SUBMITTED IN PARTIAL FULFILMENT OF
THE REQUIREMENTS FOR THE DEGREE OF

MASTER OF APPLIED SCIENCE

THE UNIVERSITY OF BRITISH COLUMBIA

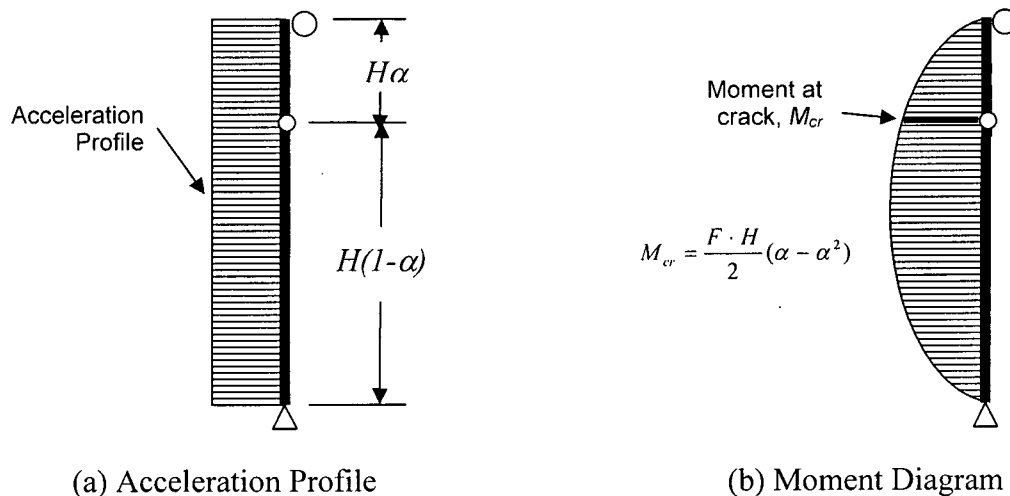
Figure 5.1 Assumed Acceleration Profile and Bending Moment Diagram to Determine the Cracking Force

The cracking strength of the wall was estimated assuming the wall is simply supported, and having a constant acceleration profile as shown in Figure 5.1.

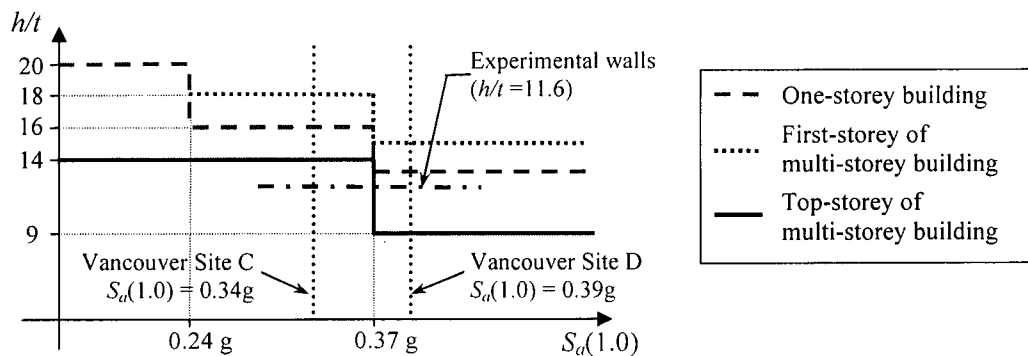
Figure 5.4 FEMA 356 Acceptance Criteria for Vancouver

FEMA 356 requires that the condition of the collar joints be considered when determining the effective wall thickness. Wythes separated by collar joints that are not bonded, or have an effective collar joint void ratio greater than 50%, are not to be considered as part of the effective wall thickness. In the experimental tests, the poor quality walls had an effective collar joint void ratio less than 50%, and therefore, would require a significantly lower effective wall thickness. In these tests all of the cracking and damage occurred at header courses and not at the common running bond courses. This would suggest that the quality of the collar joints at common courses is not as significant if the header courses are of adequate quality, and therefore no reduction in effective wall thickness would be required for poor collar joint quality.

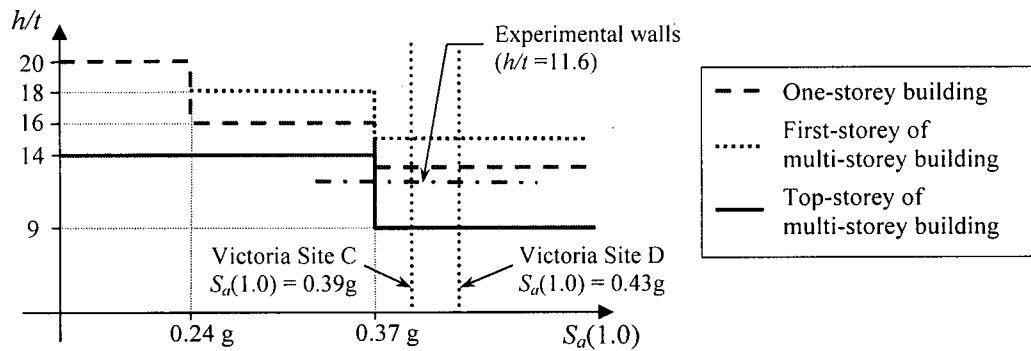
Figure 5.5 FEMA 356 Acceptance Criteria for Victoria

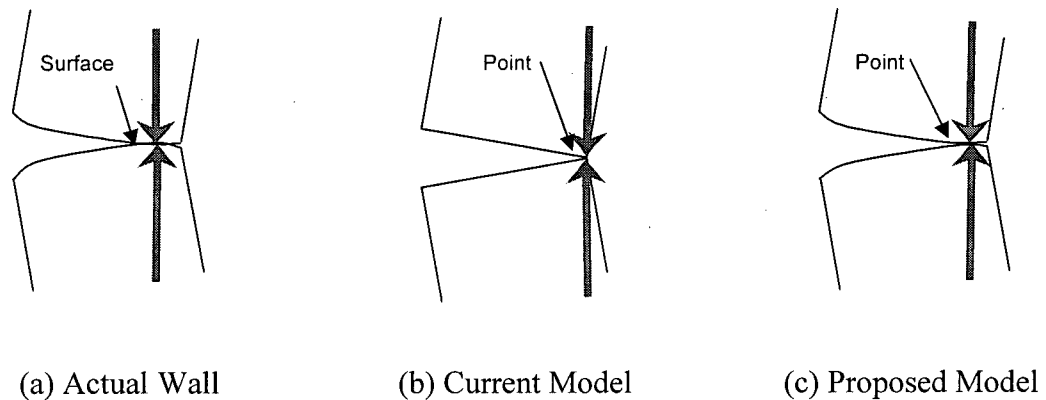
Figure 5.14 Effect of Crack Condition on Reaction Force

Degradation of the wall at the crack location was observed in the full scale tests, where mortar and brick crushing were evident (see Chapter 4). This crack deterioration, combined with the elasticity of the masonry, causes the contact between the upper and lower portion of the wall to act over a surface instead of a point (Figure 5.14 (a)). As the contact takes place over a surface, the resulting reactions shift towards the centre of the wall, decreasing the stability of the wall (due to a lower effective wall thickness). In the current Working Model analysis, the wall is modeled as two rigid blocks (Figure 5.14 (b)) causing the resulting reactions to be located at the outer most edge of the wall once rocking is initiated. In order to mimic the crack damage observed in the test walls, the contact surfaces could be modeled as a shallow ellipse (Figure 5.14 (c)). With this change to the model, the contact between the portions of the wall will still occur at a point, but due to the curvature of their contact surfaces the reaction force would shift towards the centre of the wall.

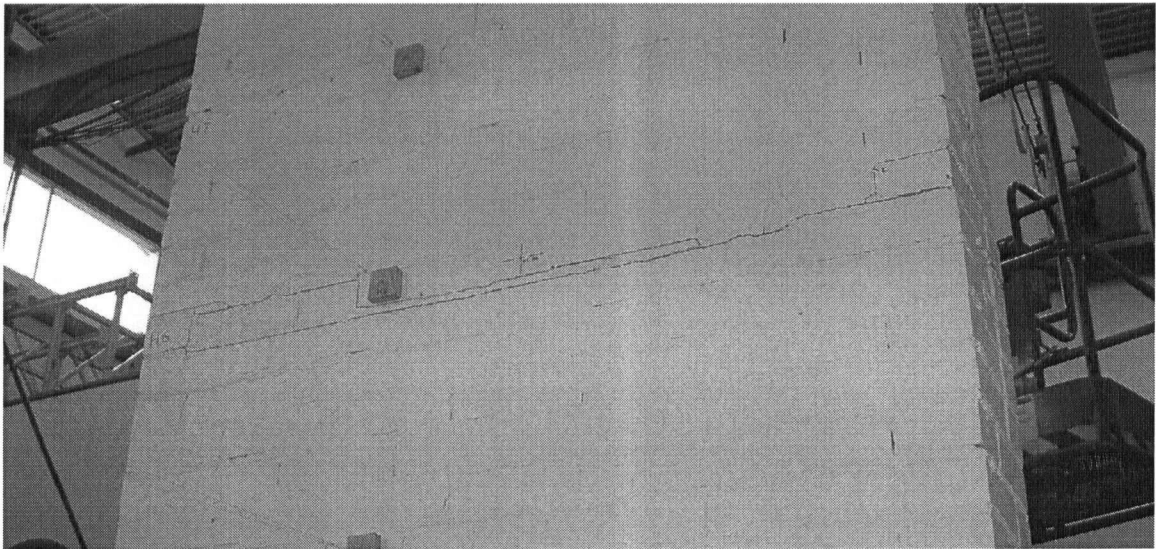
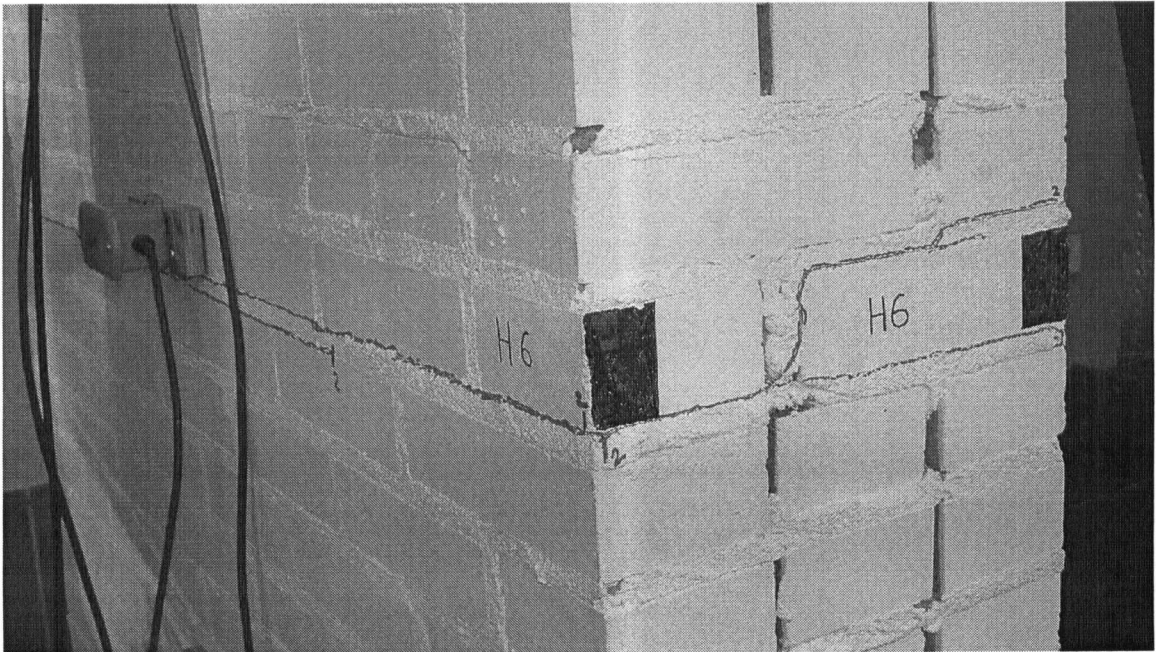
Crack Formed at Header 6 (Test GC2-1.32*)

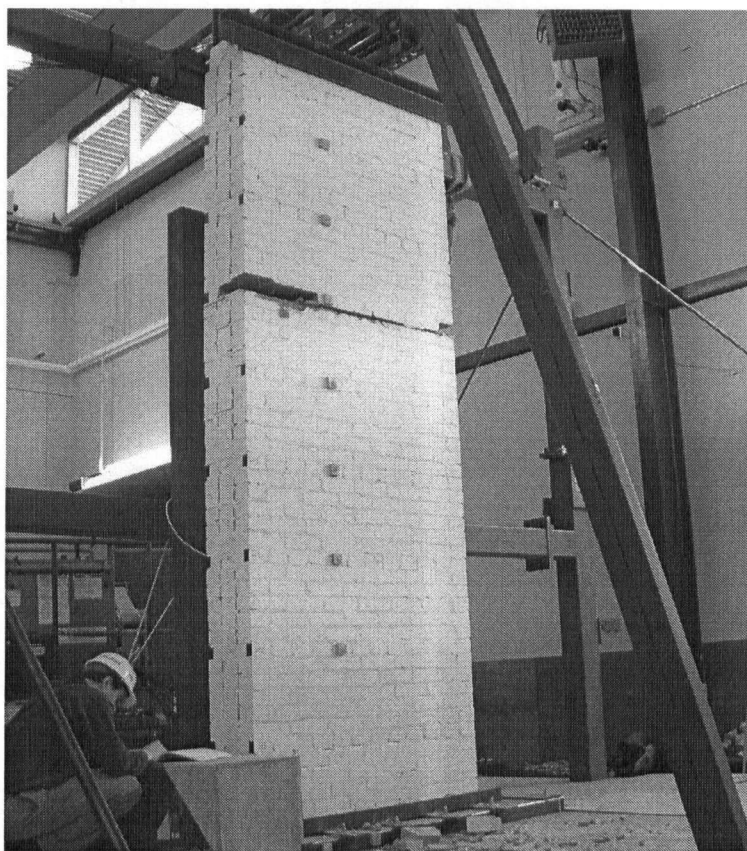
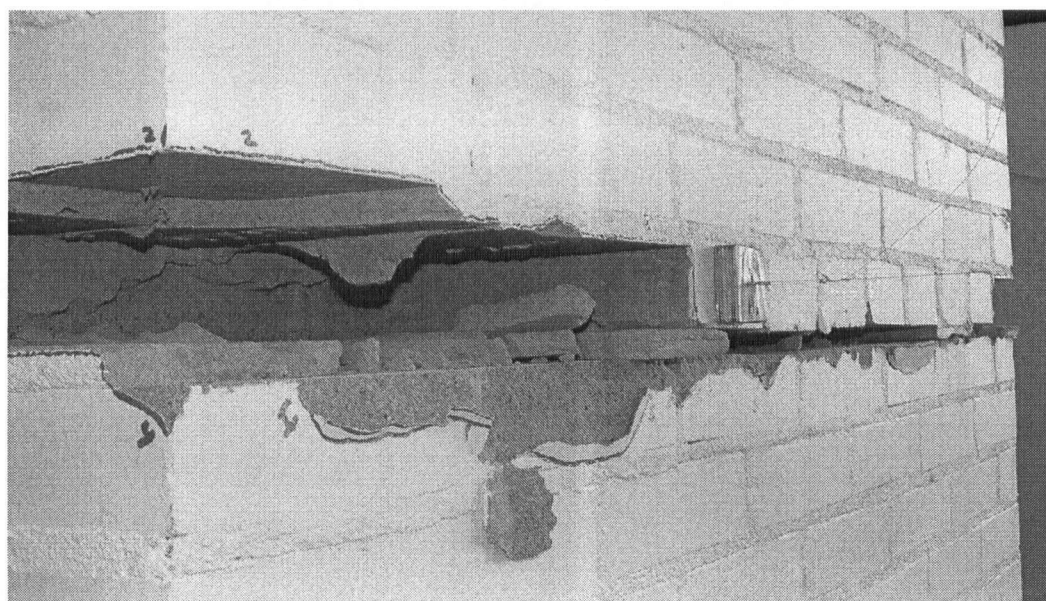
Damage at Header 6 (Test GC6-1.57)

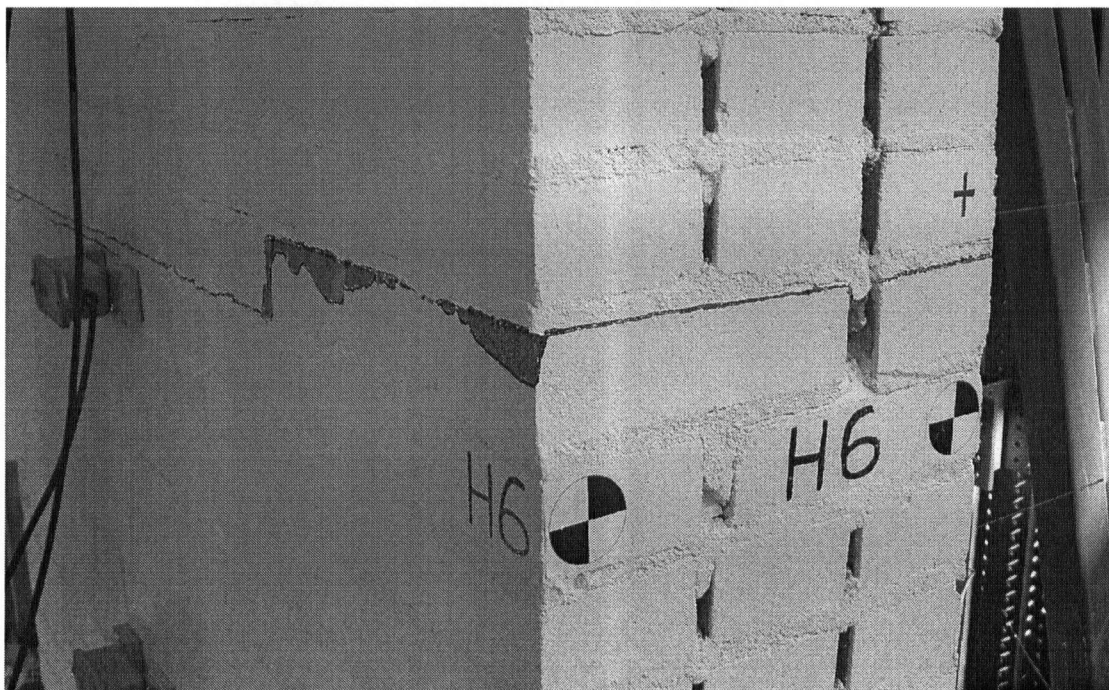
Crack and Brick Crushing at Header 6 (Test PD2-0.59*)

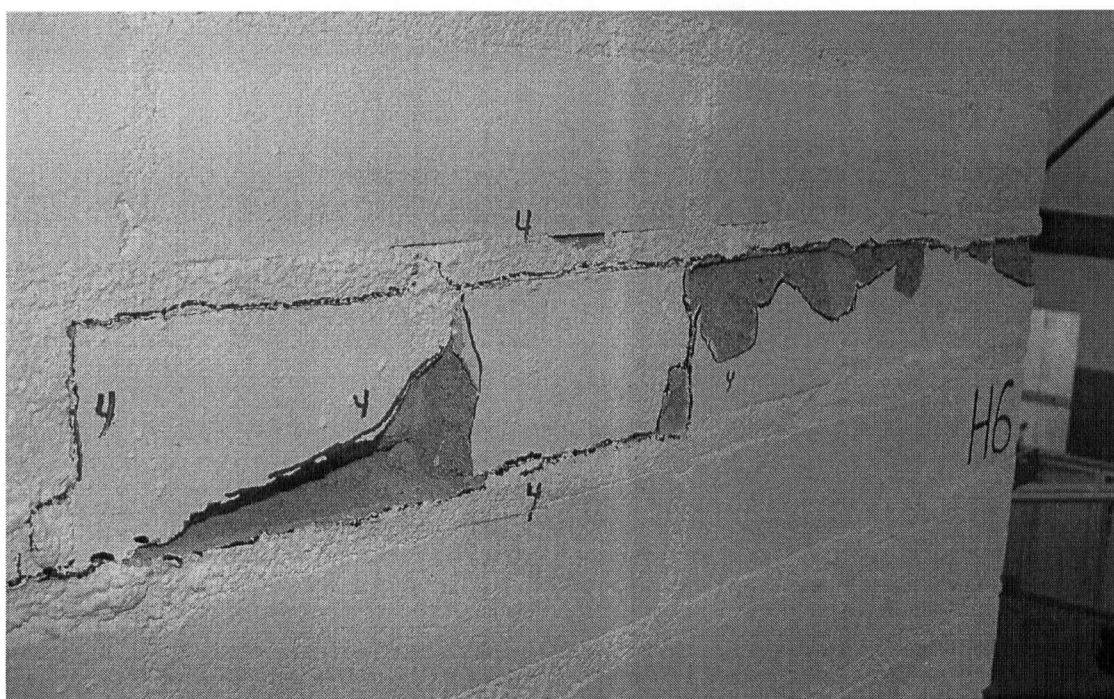
Crack and Brick Crushing at Header 6 (Test PD4-1.40)

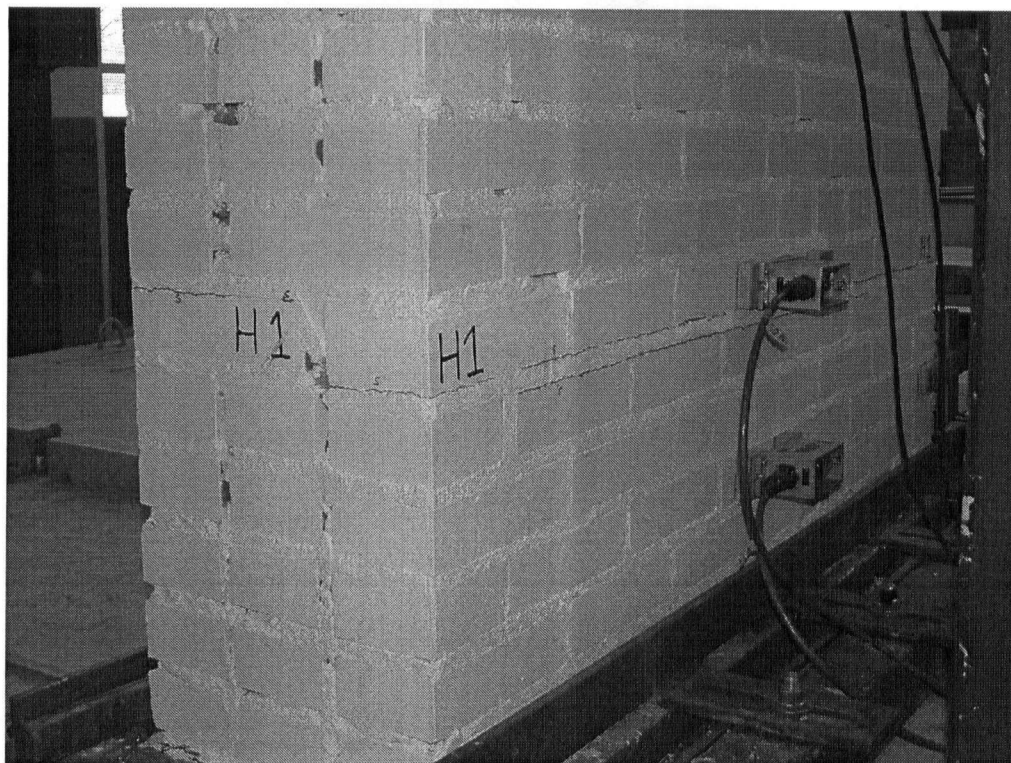
Crack at Header 1 (Test PD5-1.55)

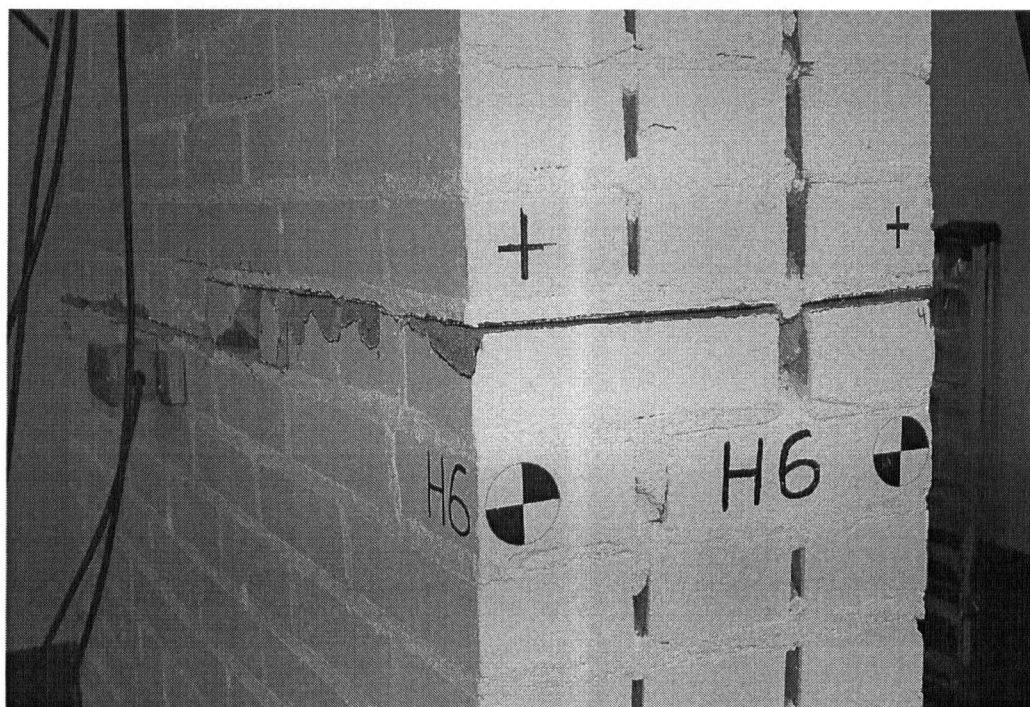
Crack and Brick Crushing at Header 6 (Test PD5-1.55)

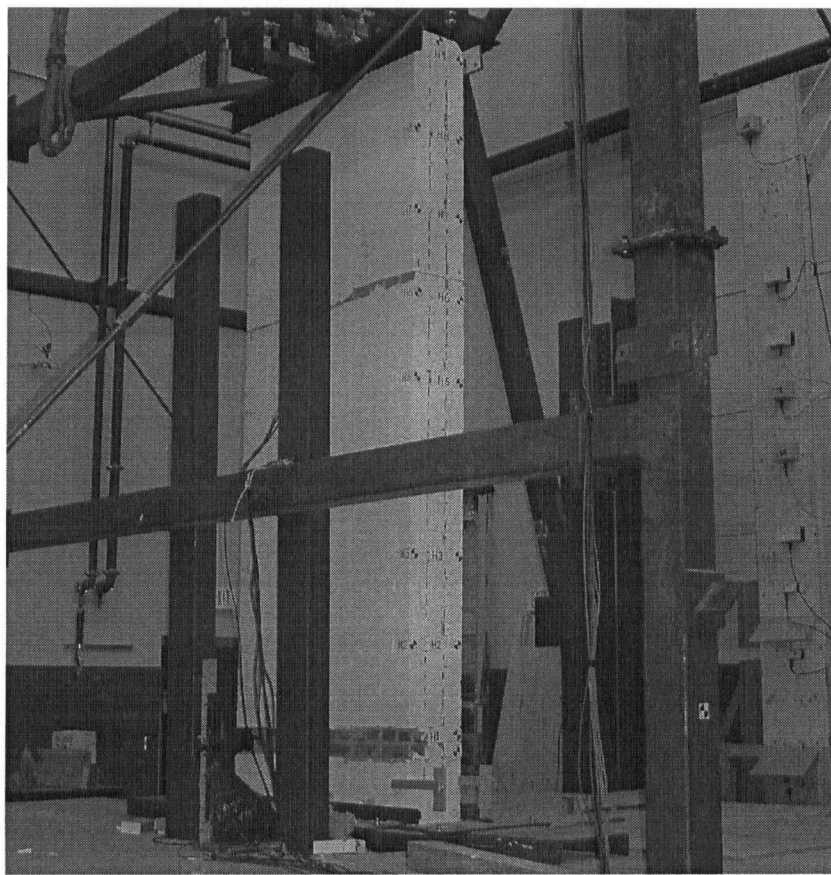
Wall Damaged at Header 1 and 6 (Test PD6-1.57)

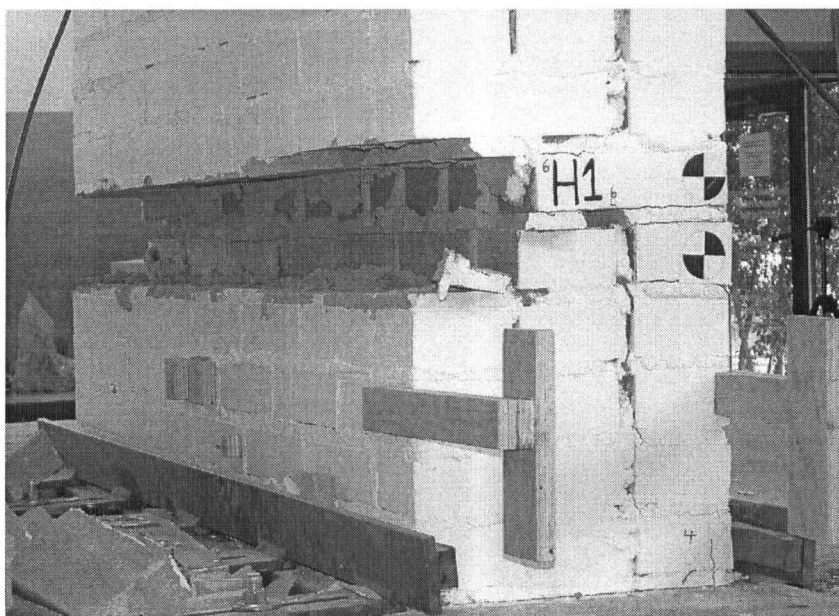
Loss of One Wythe at Header 1 (Test PD6-1.57)

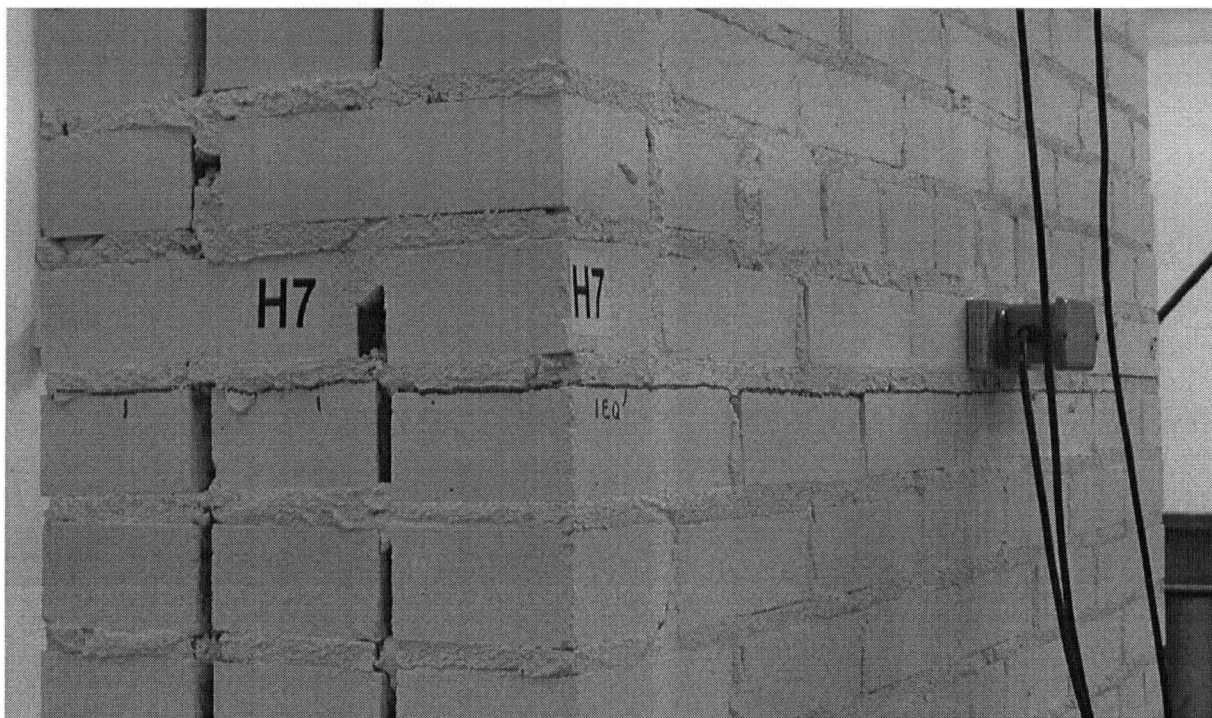
Crack at Header 7 (Test GD1-0.75*)

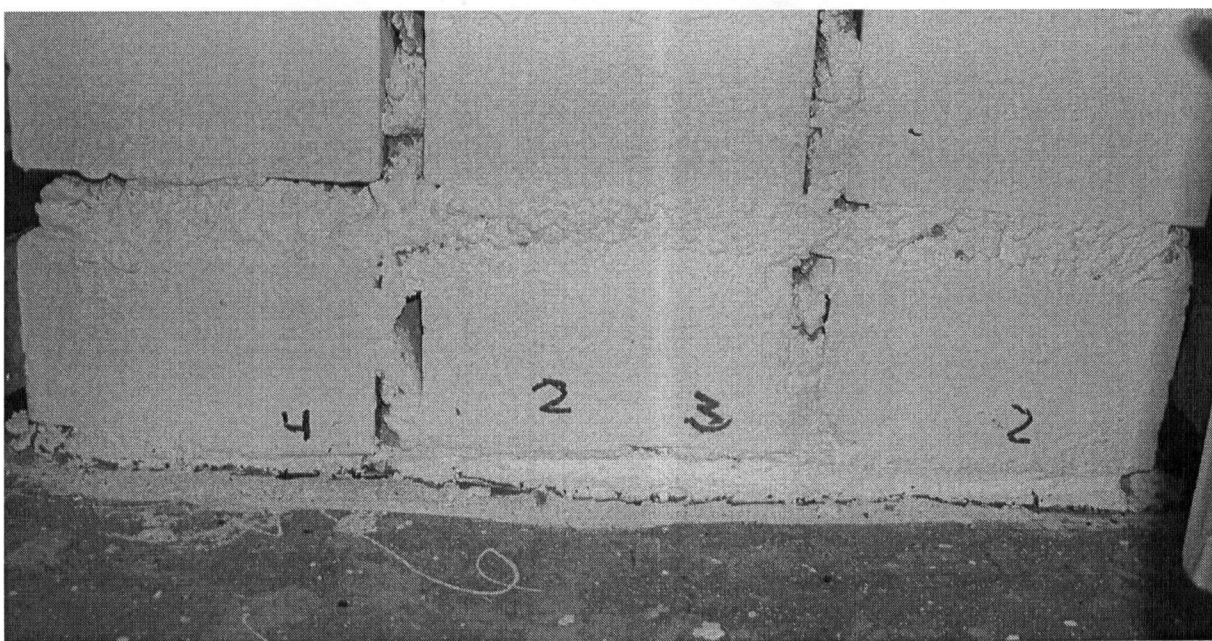
Crack at Wall Base (Test GD4-1.24)

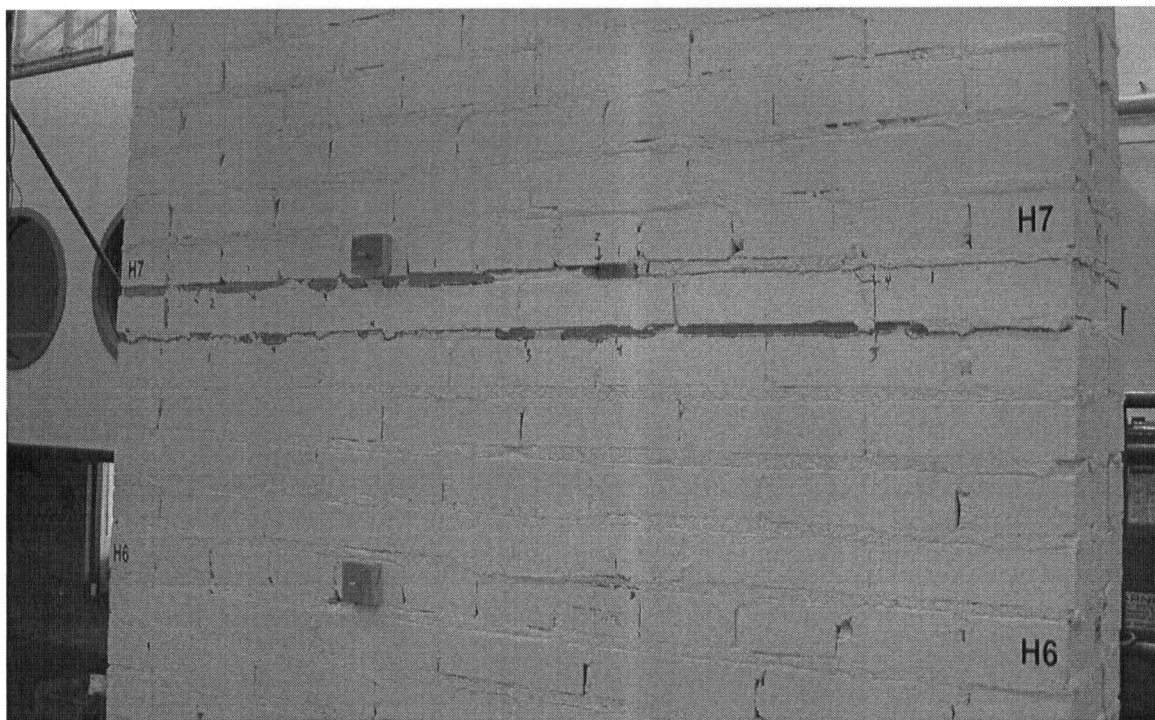
Crack at Header 7 with Mortar Spalling (Test GD4-1.24)

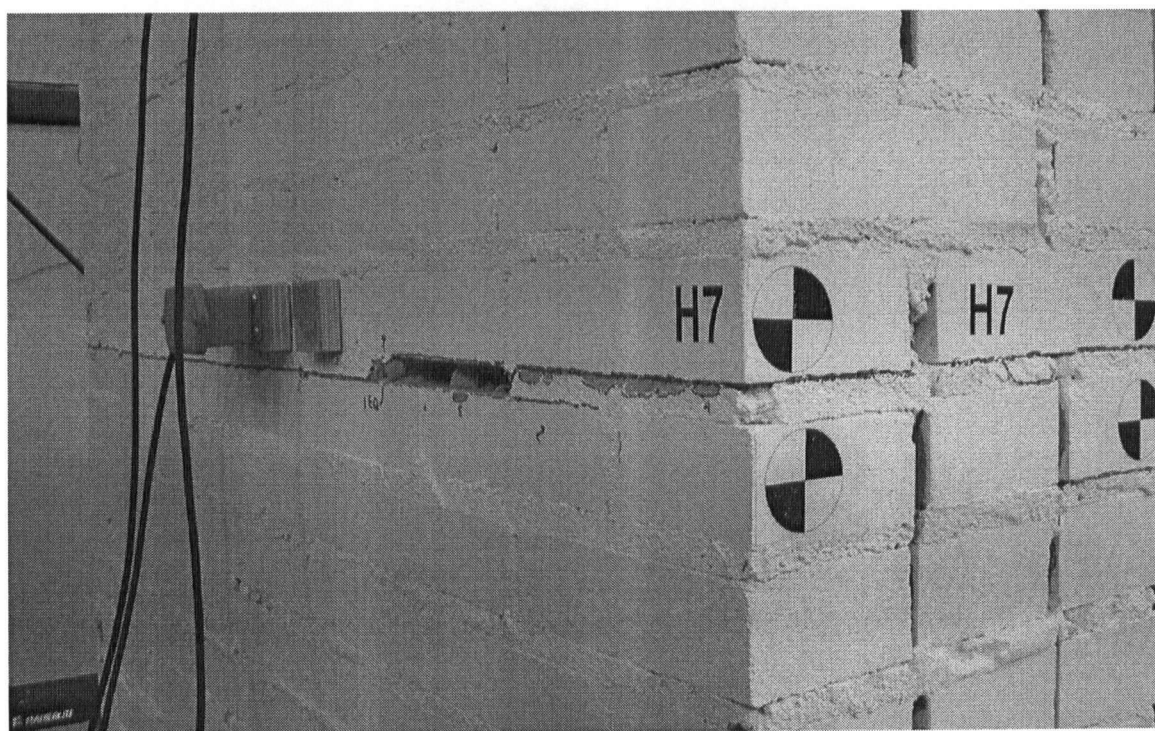
Crack at Header 7 with Mortar Loss (Test GD4-1.24)

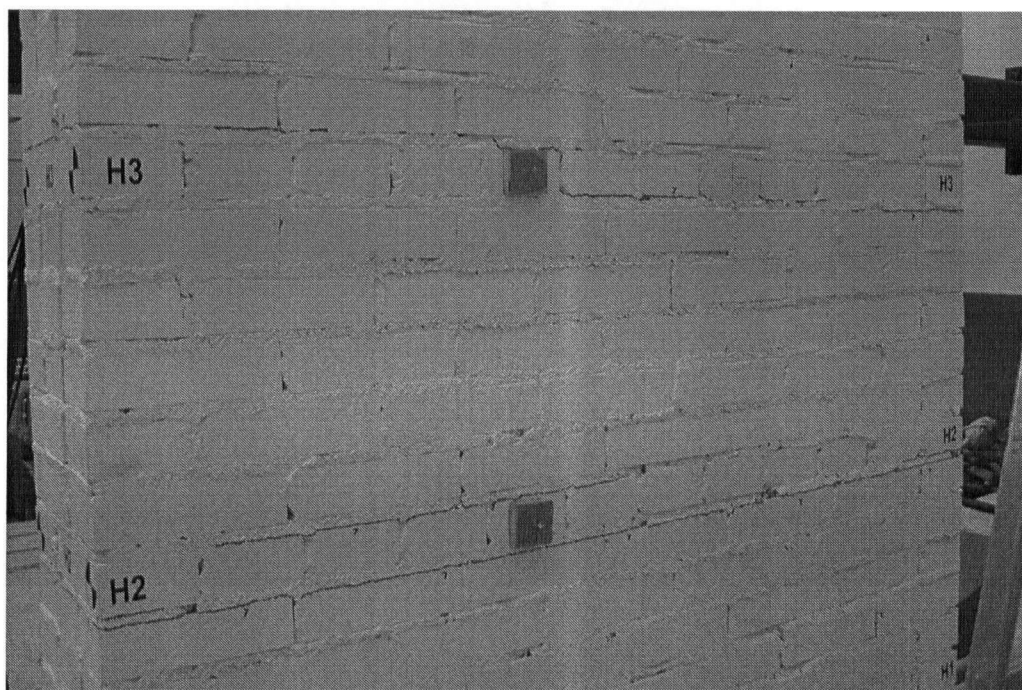
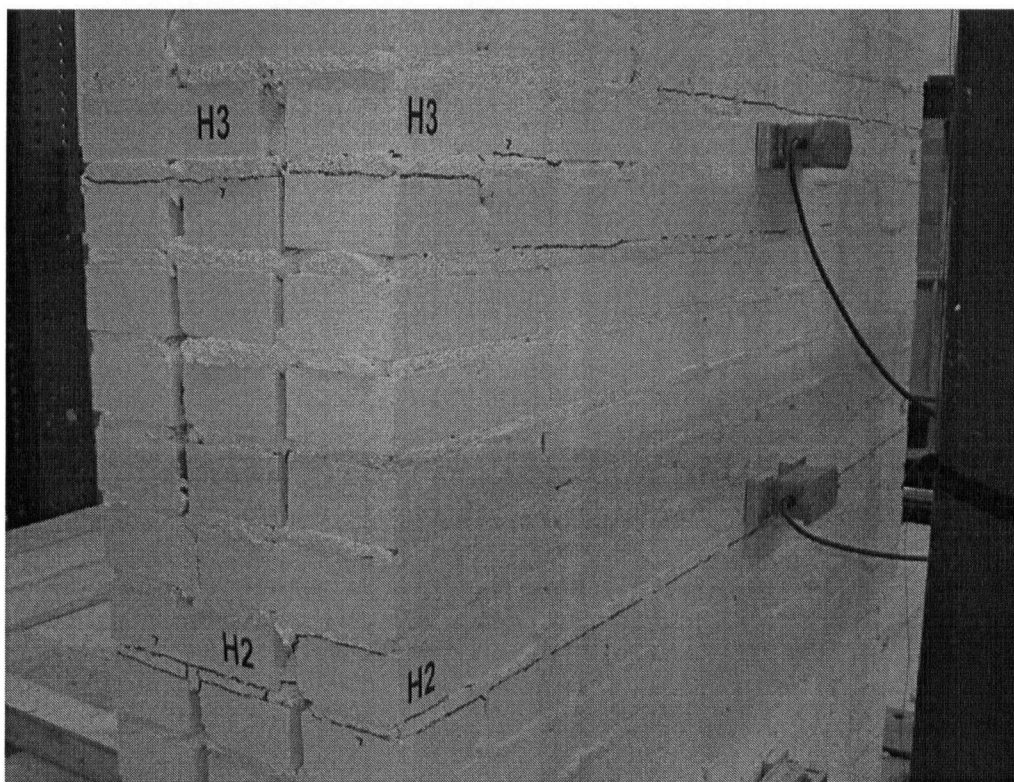
Crack at Headers 2 and 3 (Test GD5-1.65)

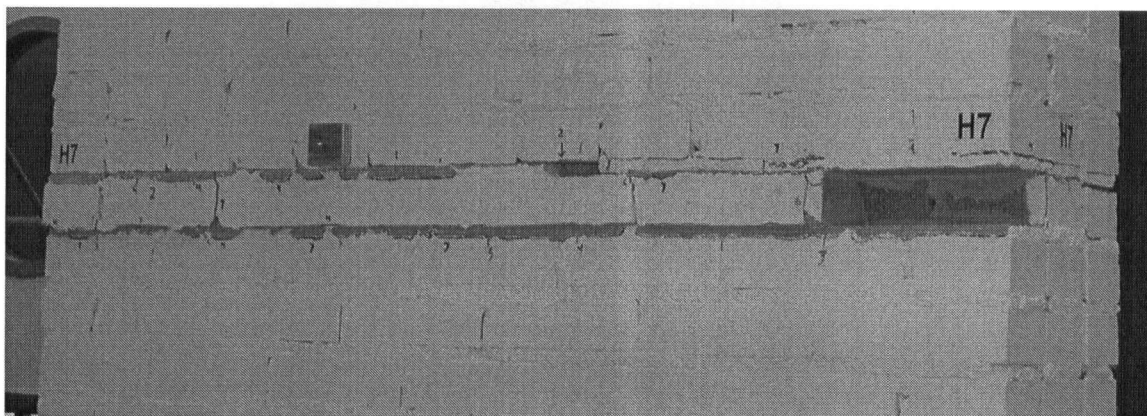
Loss of Brick and Mortar Crushing at Headers 7 (Test GD5-1.65)

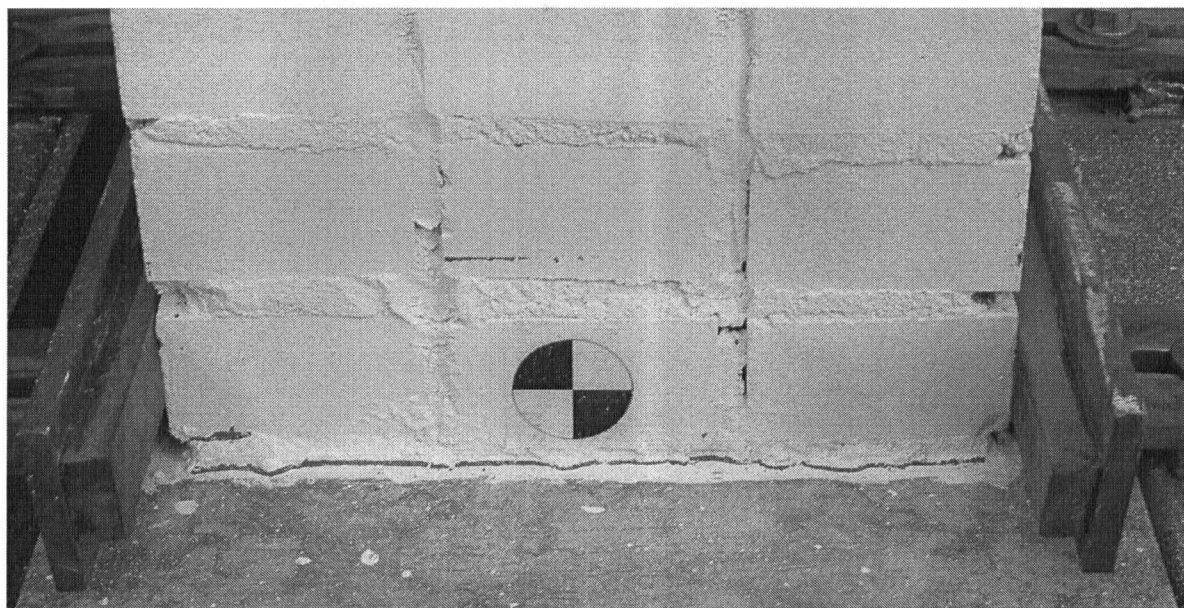
Crack at Wall Base (Test PD1-0.79*)

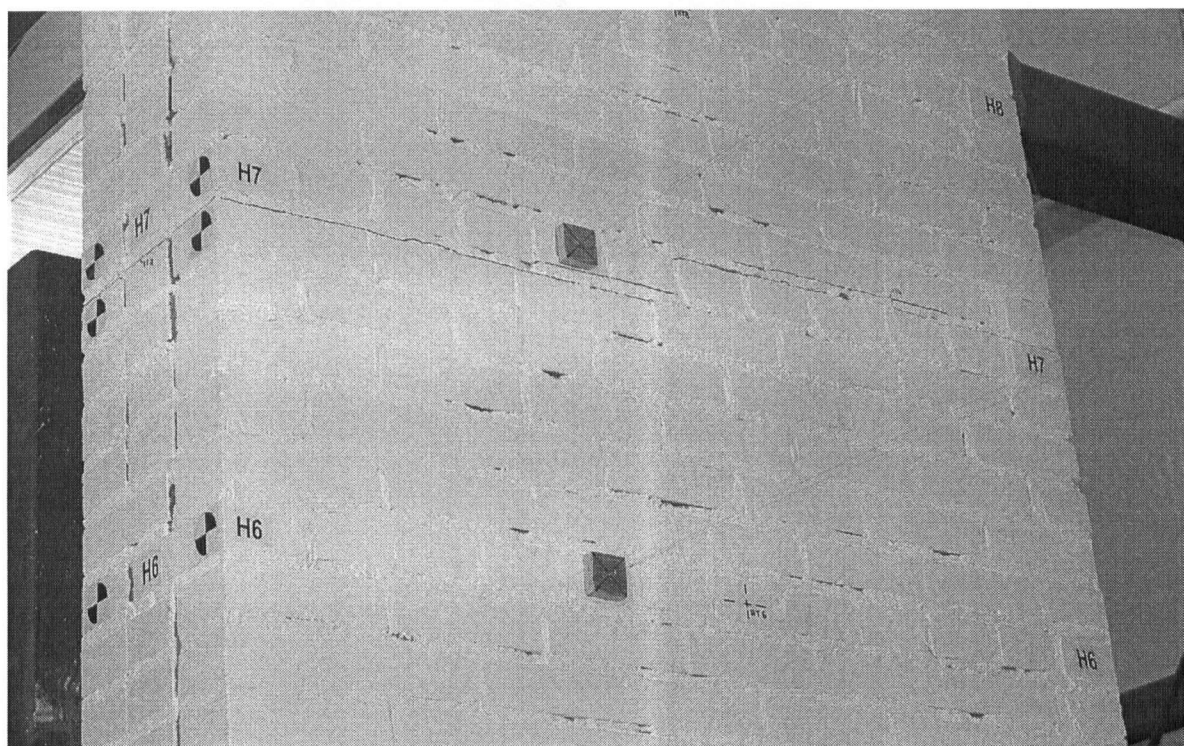
Crack at Header 7 (Test PD1-0.79*)

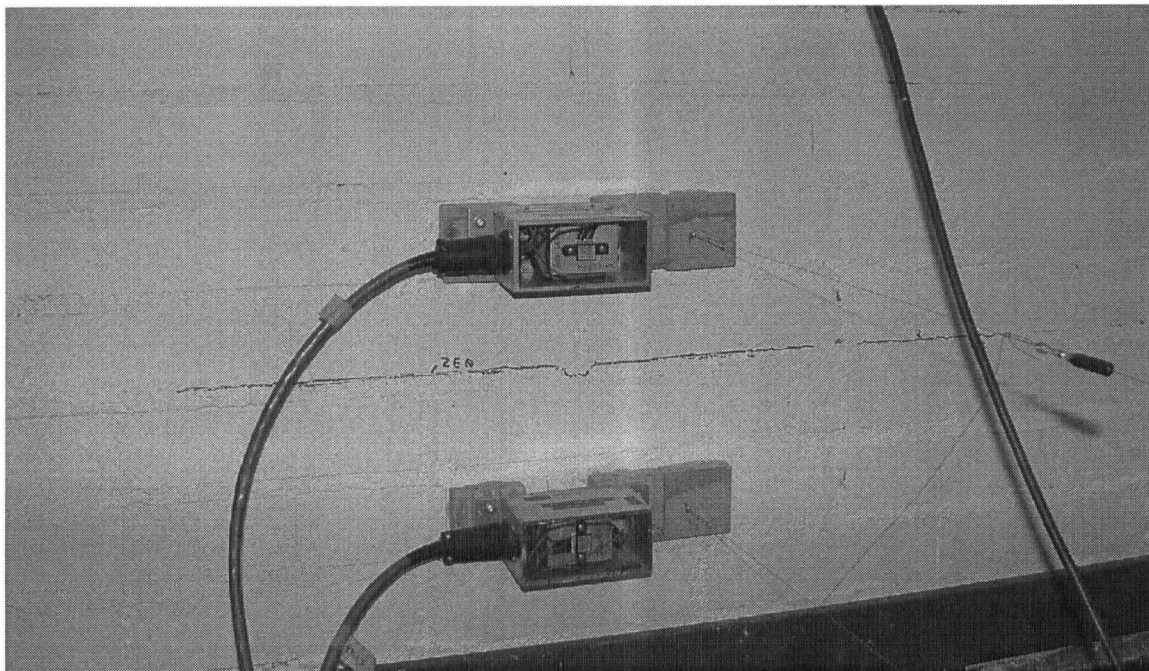
Crack at Header 1 (Test PD2-0.78)

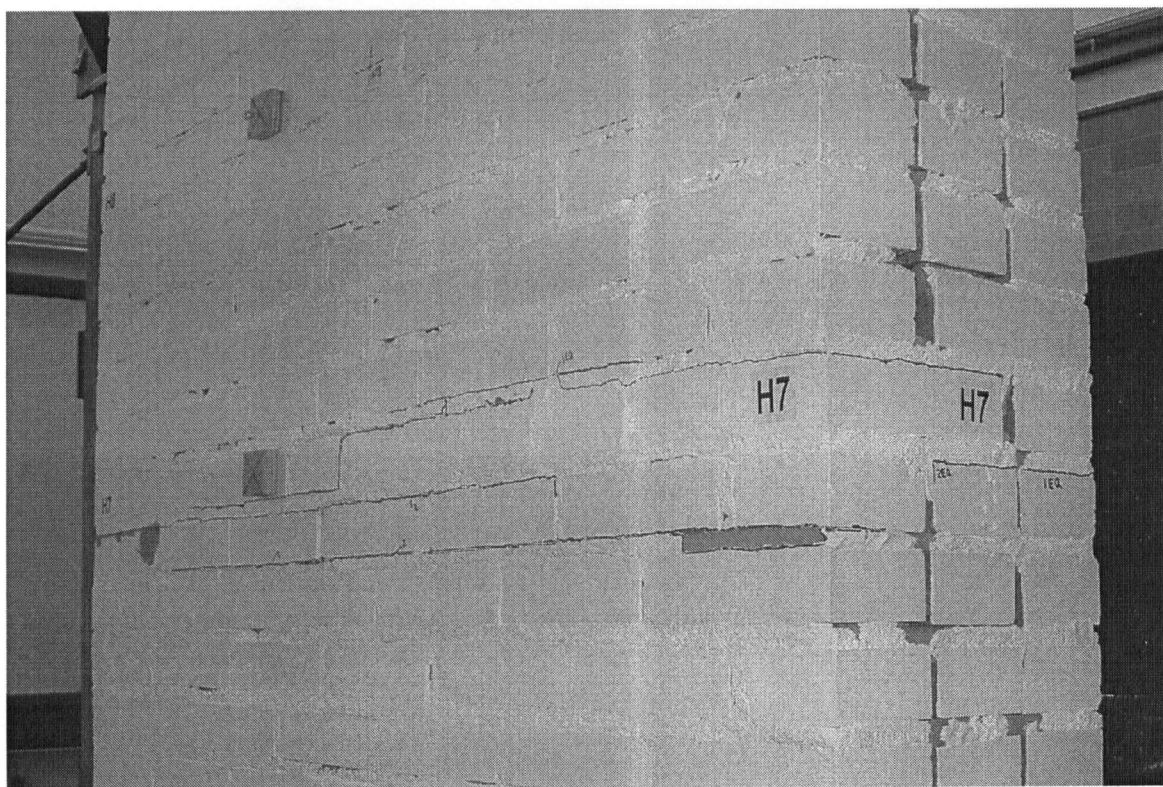
Crack at Header 7 (Test PD2-0.78)

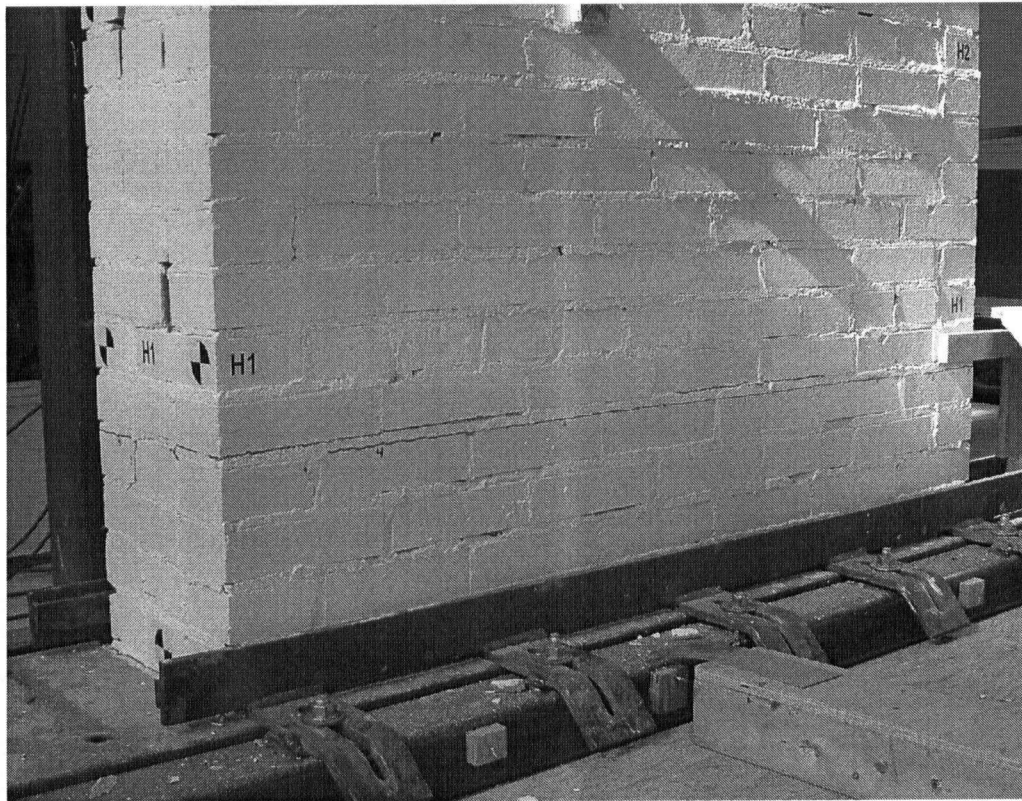
Cracks at Header 1 (Test PD4-1.20)

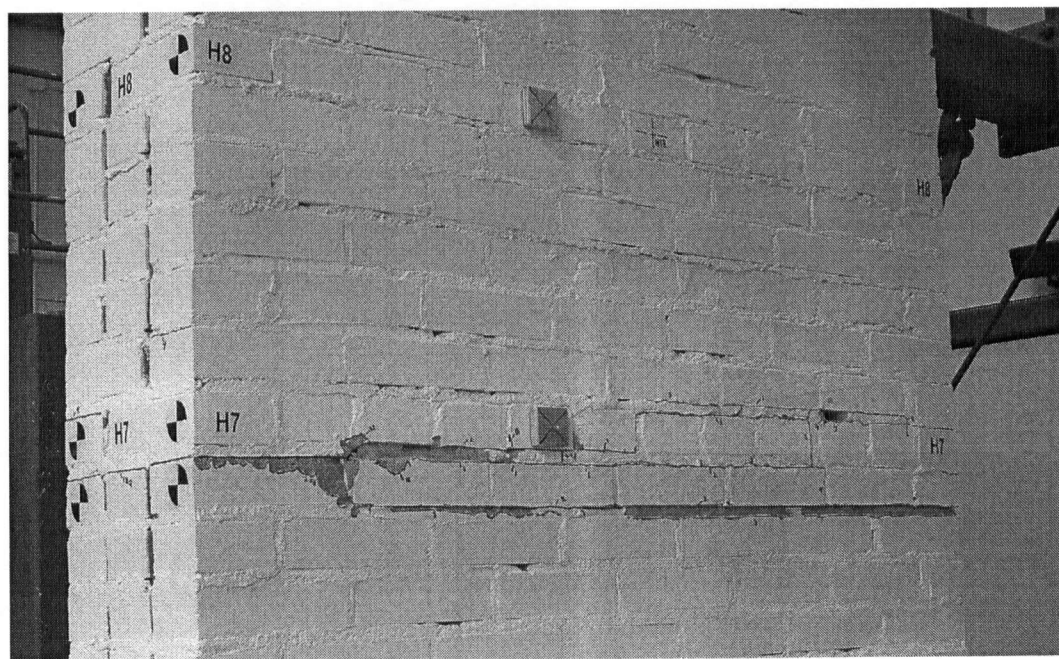
Crack at Header 7 (Test PD4-1.20)

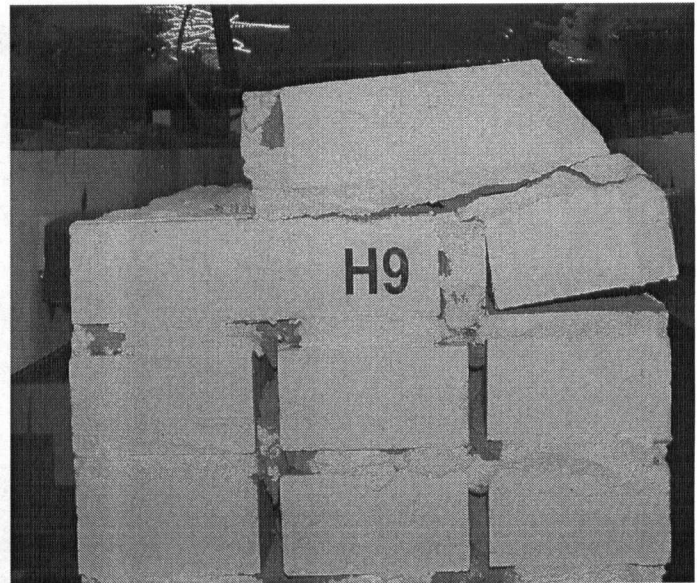
Crack at Header 9 (Test PD5-1.66)

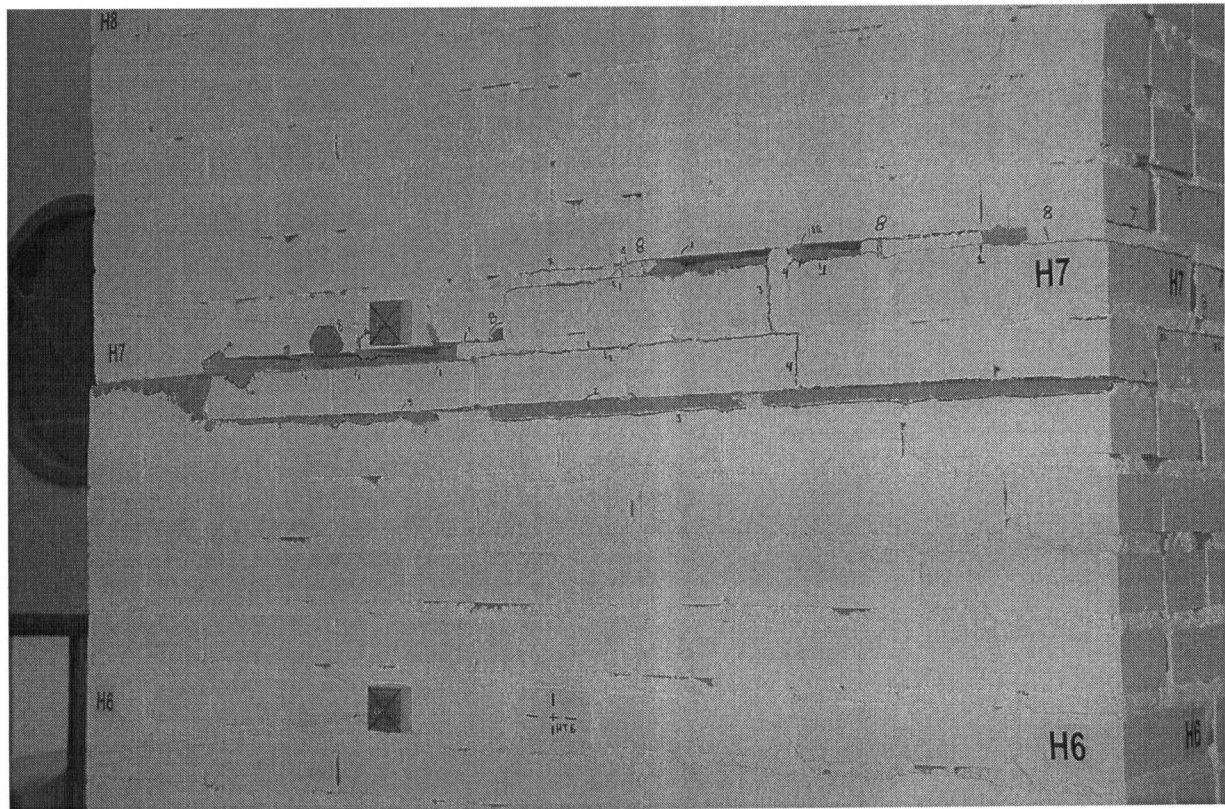
Crack at Header 7 with Mortar Loss and Brick Crushing (Test PD5-1.66)

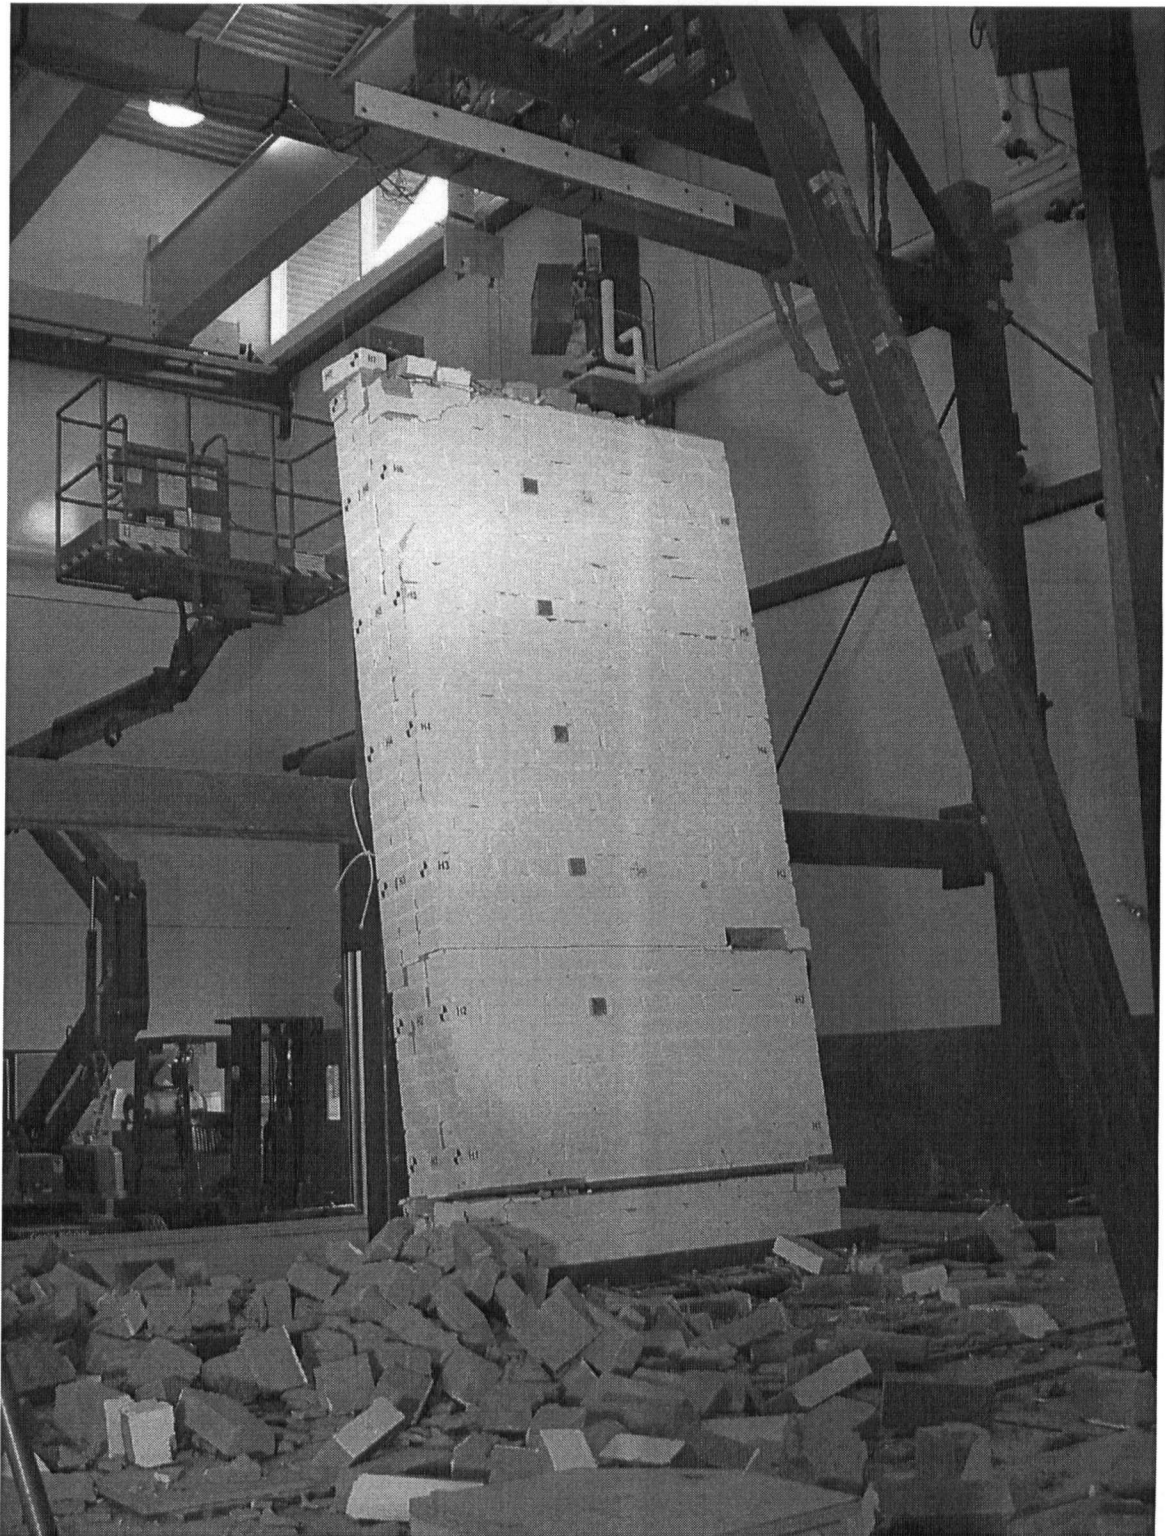
Collapsed Wall (Test PD6-2.22)
