OUT-OF-PLANE SEISMIC PERFORMANCE OF UNREINFORCED CLAY BRICK MASONRY WALLS

A THESIS SUBMITTED IN PARTIAL FULFILMENT OF
THE REQUIREMENTS FOR THE DEGREE OF

MASTER OF APPLIED SCIENCE

THE UNIVERSITY OF BRITISH COLUMBIA

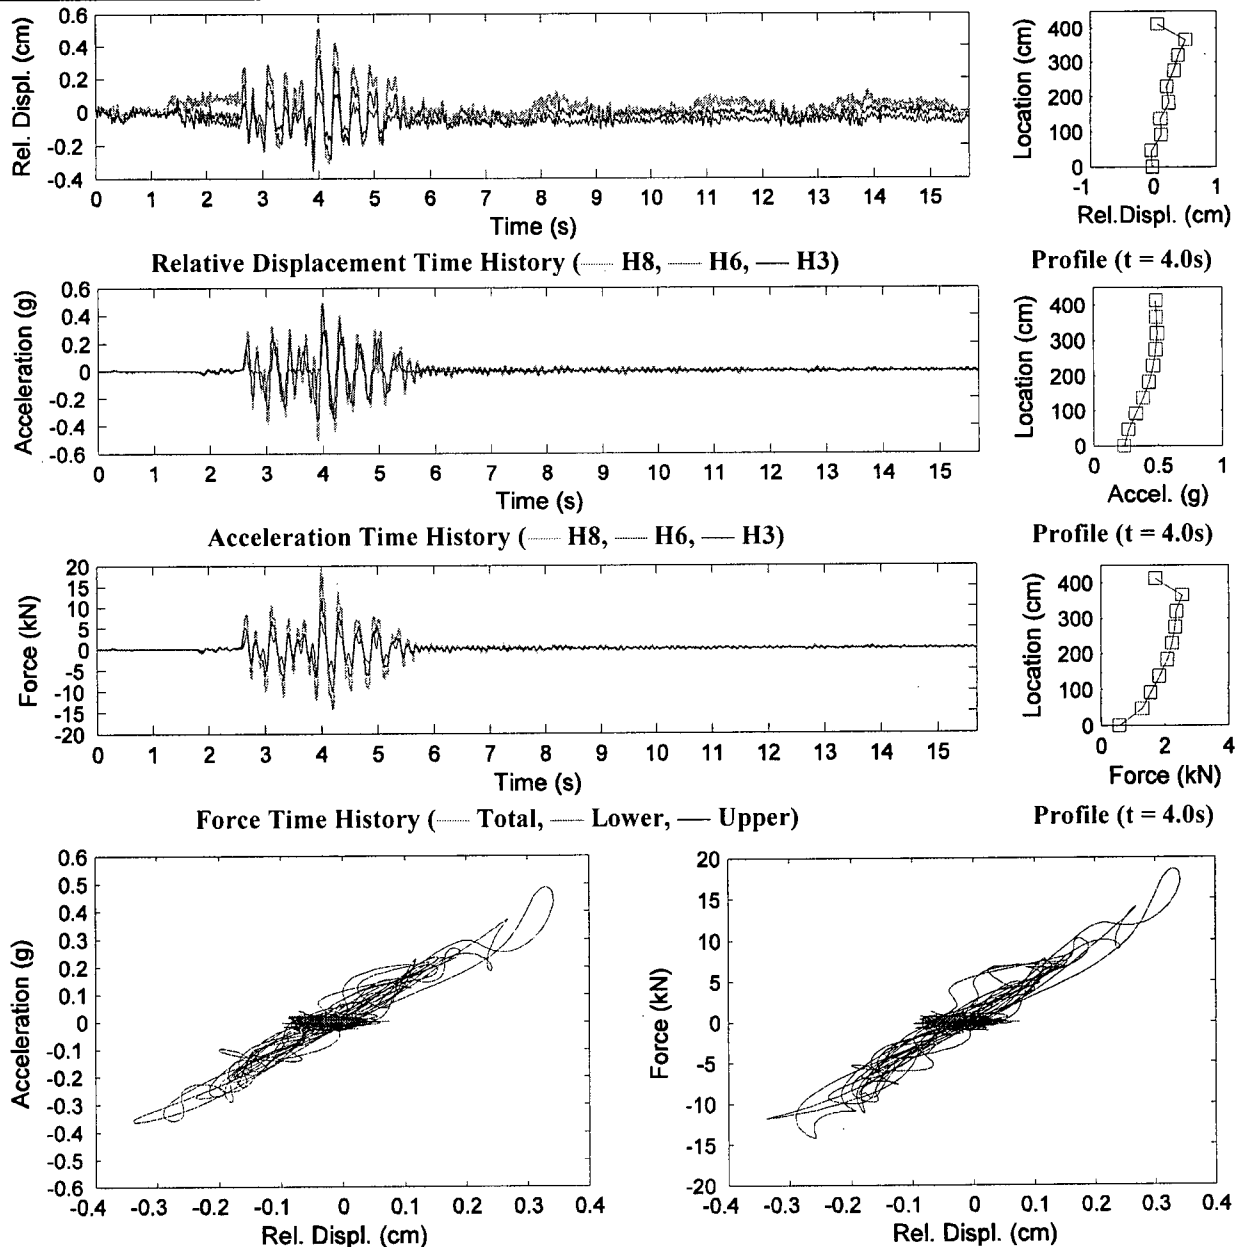
Wall:	Good Quality Collar Joint	Test Sequence:	1	Test Number:	GC1-0.71	
Earthquake Record:	Gilroy	Scale:	0.71*	Site Class:	C	
		PGA:	0.34g	PGD:	1.91cm	
Wall Condition:	No visible damage					
Height:	4133mm	Thickness:	353mm	h/t:	11.7	
		Width:	1501mm	Density:	2024kg/m ³	
Header Location:	H3:	1368mm	H6:	2744mm	H8:	3655mm

Crack Acceleration vs. Relative Crack Displacement	Total Force vs. Relative Crack Displacement
Initial Period: 0.095s	Initial Stiffness: 44.3kN/cm

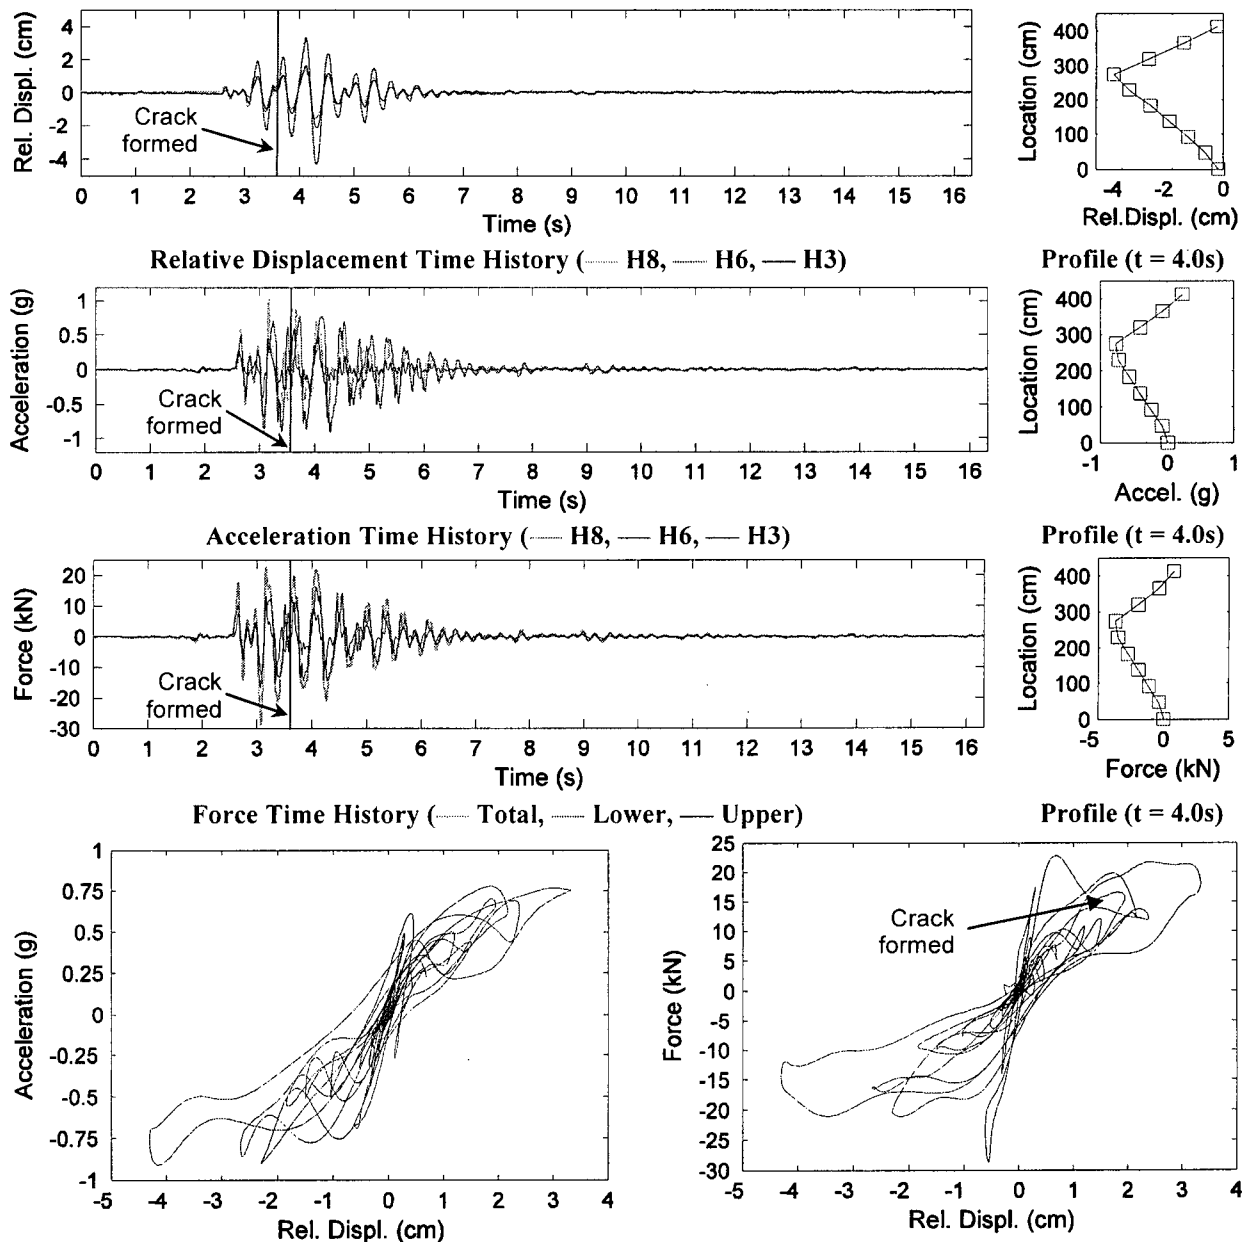
Wall:	Good Quality Collar Joint	Test Sequence:	2	Test Number:	GC2-1.32	
Earthquake Record:	Gilroy	Scale:	1.32*	Site Class:	C	
		PGA:	0.63g	PGD:	3.90cm	
Wall Condition:	Crack formed at H6					
Height:	4133mm	Thickness:	353mm	h/t:	11.7	
		Width:	1501mm	Density:	2024kg/m ³	
Header Location:	H3:	1368mm	H6:	2744mm	H8:	3655mm

Crack Acceleration vs. Relative Crack Displacement

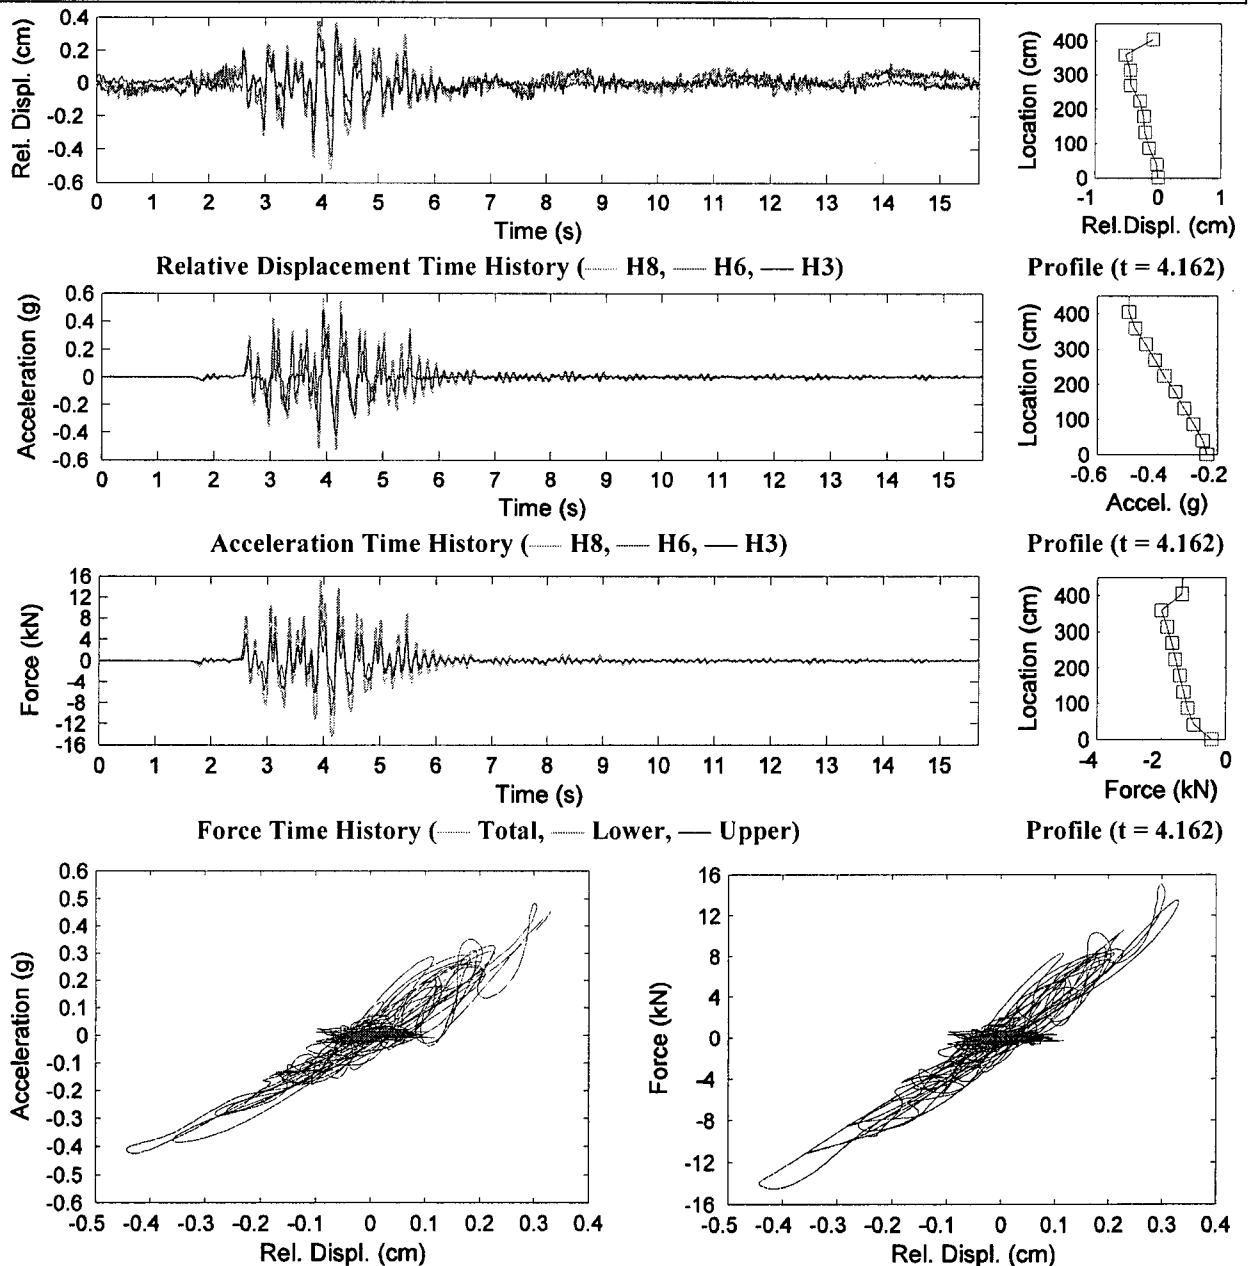
Wall:	Poor Quality Collar Joint	Test Sequence:	1	Test Number:	PC1-0.73
Earthquake Record:	Gilroy	Scale:	0.73*	Site Class:	C
PGA:	0.35g	PGD:	1.89cm		
Wall Condition:	No visible damage				
Height:	4153mm	Thickness:	355mm	h/t:	11.7
Width:	1498mm	Density:	1764.5kg/m ³		
Header Location:	H3:	1317mm	H6:	2682mm	H8: 3586mm

Initial Period:	0.11s	Initial Stiffness:	43.9kN/cm
-----------------	-------	--------------------	-----------

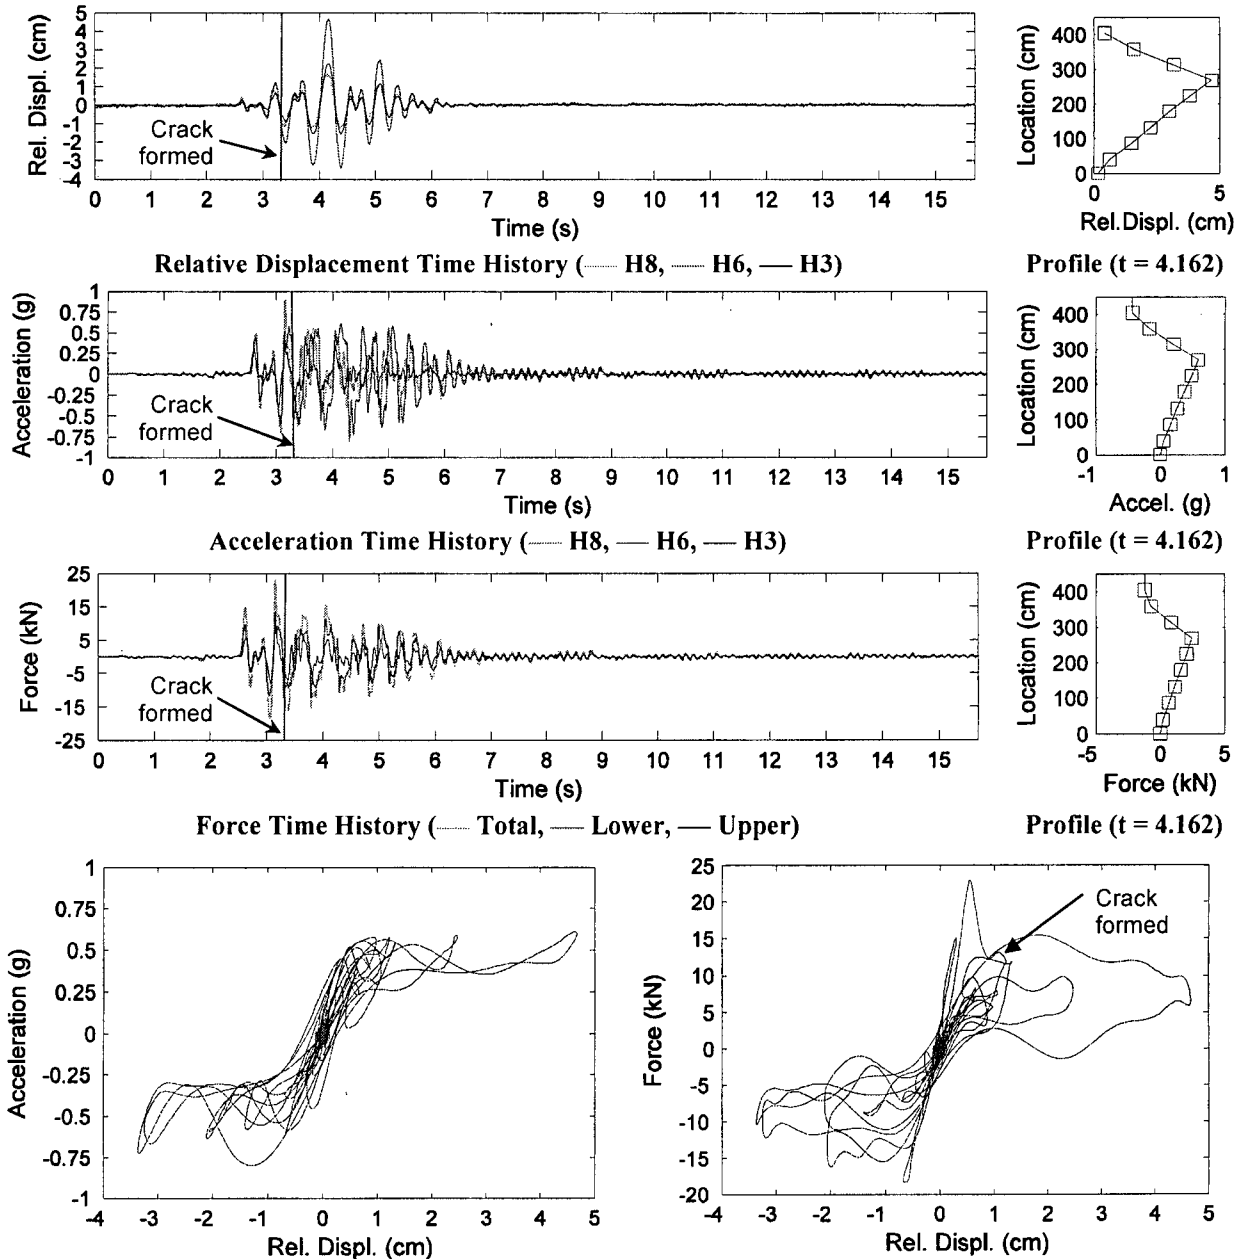
Wall: Poor Quality Collar Joint	Test Sequence: 2	Test Number: PC2-1.10
Earthquake Record: Gilroy	Scale: 1.10*	Site Class: C PGA: 0.53g PGD: 3.84cm
Wall Condition: Crack formed at Header 6 during test		
Height: 4153mm	Thickness: 355mm	h/t: 11.7 Width: 1498mm Density: 1764.5kg/m ³
Header Location: H3: 1317mm	H6: 2682mm	H8: 3586mm

Initial Period: 0.11s	Initial Stiffness: 37.1kN/cm
-----------------------	------------------------------
