Performance of Brick Veneer Ties Under Cyclic Loadings

A THESIS SUBMITTED IN PARTIAL FULFILLMENT OF
THE REQUIREMENTS FOR THE DEGREE OF
MASTER OF APPLIED SCIENCE

THE FACULTY OF GRADUATE STUDIES
Department of Civil Engineering

THE UNIVERSITY OF BRITISH COLUMBIA

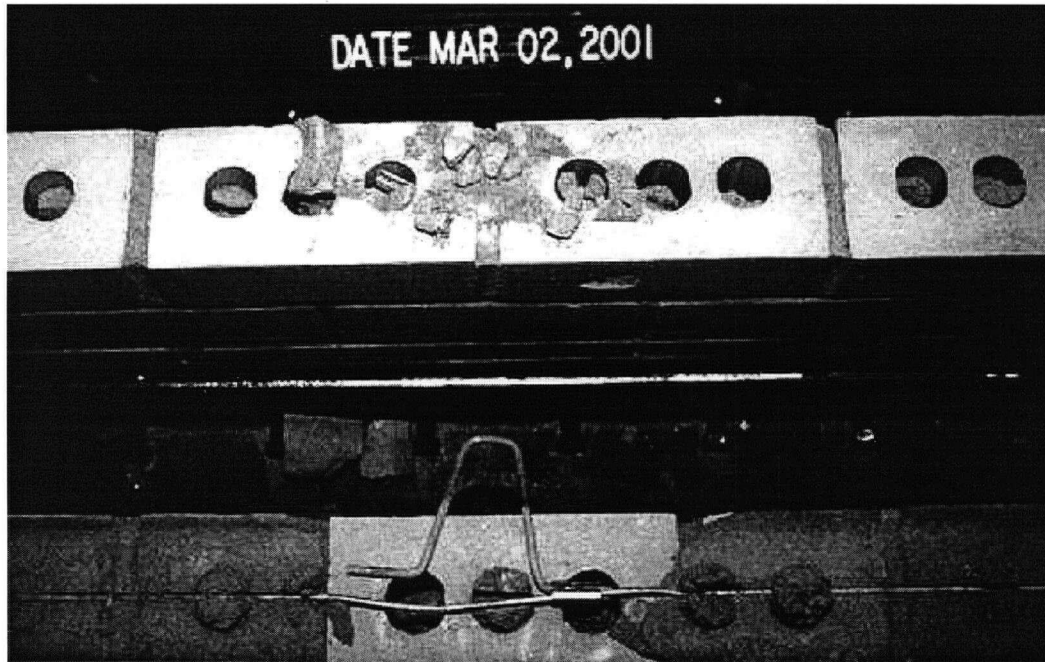
Specimen	TWC4
Characteristics	V-Tie with horizontal wire reinforcement clipped V-Tie length 80 mm Type S mortar
Test Date (age)	February 21 st , 2001 (63 days)
Surcharge Load	60 kPa
Maximum Force	
Tension	4.22 kN
Compression	3.89 kN
Displacement at Maximum Force	
Tension	3.64 mm
Compression	1.53 mm
Failure modes	
Tension	Pull-out from mortar bed joint
Compression	Push-through mortar bed joint

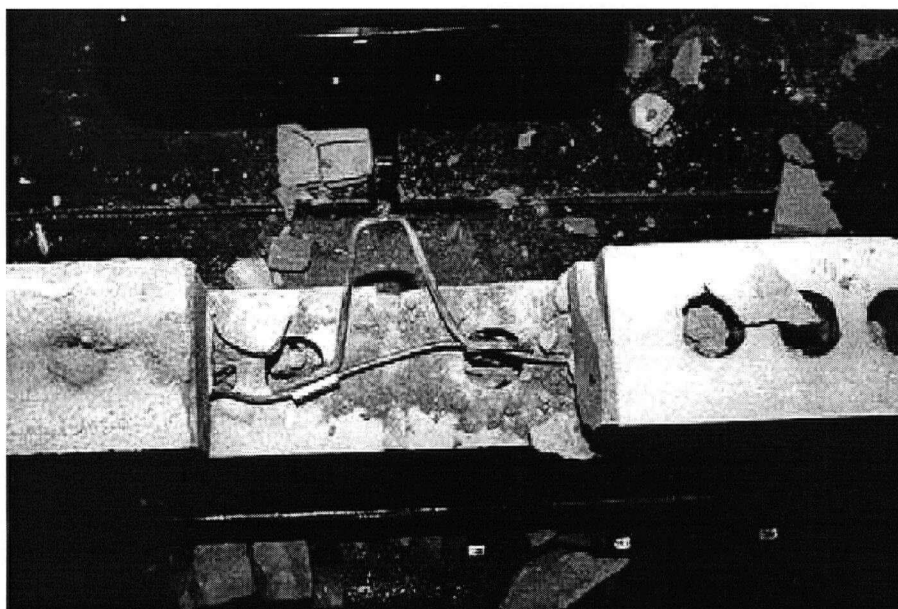
Specimen	TWC5
Characteristics	V-Tie with horizontal wire reinforcement clipped V-Tie length 80 mm Type S mortar
Test Date (age)	February 28 th , 2001 (70 days)
Surcharge Load	60 kPa
Maximum Force	
Tension	3.99 kN
Compression	5.33 kN
Displacement at Maximum Force	
Tension	5.78 mm
Compression	2.74 mm
Failure modes	
Tension	Pull-out from mortar bed joint
Compression	Push-through mortar bed joint
