STRESS CORROSION CRACKING
OF ROTOR STEELS
IN CARBONATE / BICARBONATE
AND SODIUM HYDROXIDE SOLUTIONS

JOHANN RECHBERGER

A THESIS SUBMITTED IN PARTIAL FULFILLMENT OF
THE REQUIREMENTS FOR THE DEGREE OF
MASTER OF APPLIED SCIENCE

THE UNIVERSITY OF BRITISH COLUMBIA

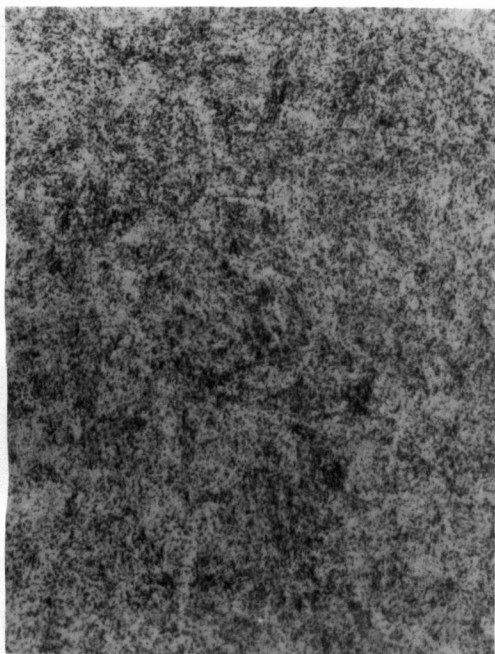
Figure 4:

Microstructure of steel "A",
centre region

Mag.: 600x, etched

The microstructure of the rotor forging was investigated at two locations. One was a few centimeters below the surface and the other one 23 centimeters further towards the centre. Typical microstructures are shown in Figures 4 and 5 below.

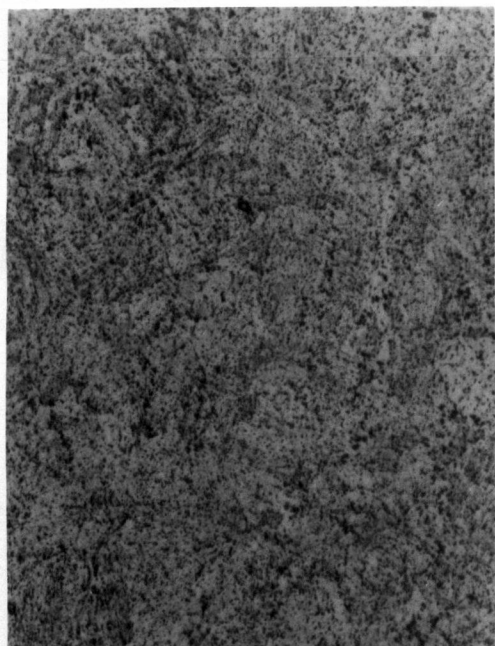
Figure 5:

Microstructure of steel "A",
surface region

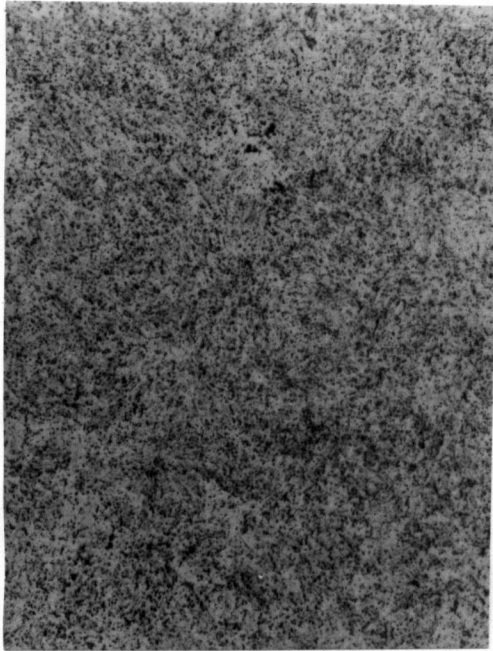
Figure 6:

Microstructure of steel "R",
centre region

Mag.: 600x, etched

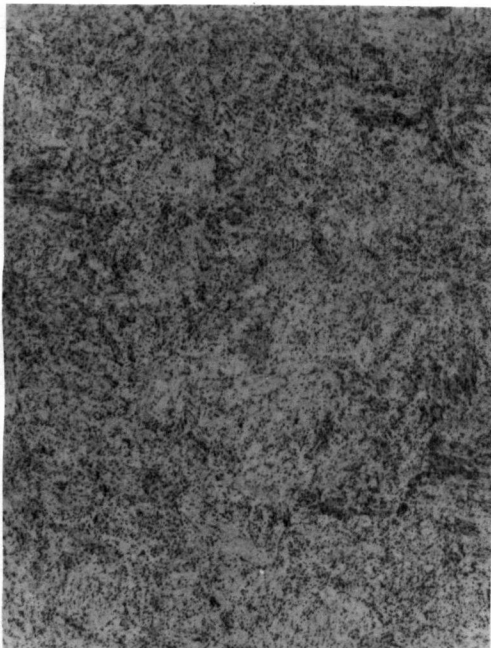
Figure 7:

Microstructure of steel "R",
surface region

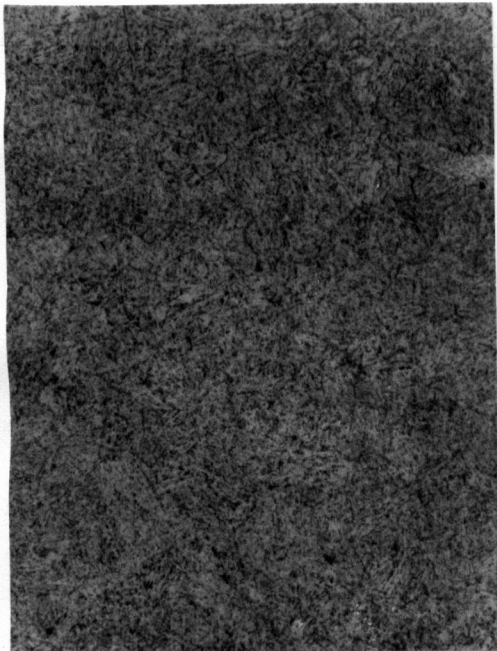
Figure 8:

Microstructure of steel "O",
radial direction with
rolling texture

Mag.: 120x, etched

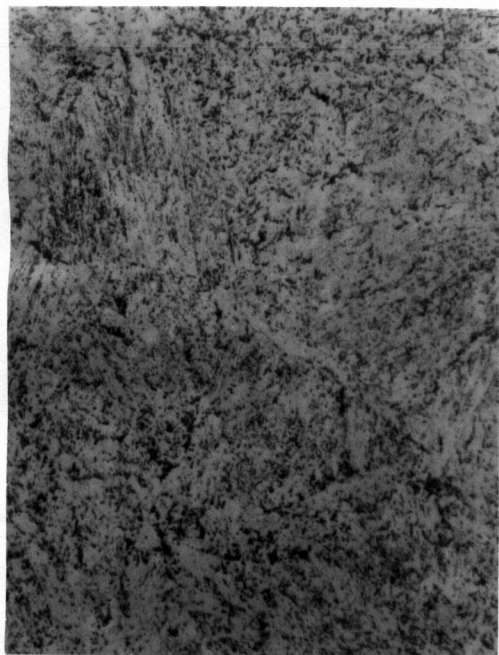
Figure 9:

Microstructure of steel "O"

According to the continuous cooling transformation diagram⁴⁹ of a 1%CrMoV-steel (similar to the one investigated), air cooling of the rotor steel "O" should have resulted in a bainitic microstructure with possibly some ferrite present. Photomicrographs taken at different locations in the material again did not show any major difference in structure between surface and centre regions. However, at low magnification a slight rolling texture could be observed in the longitudinal direction. (See Fig.8) At higher magnification a coarser and less homogeneous carbide distribution is visible compared to the one found in the "A" and "R" steels. (See Fig.9)

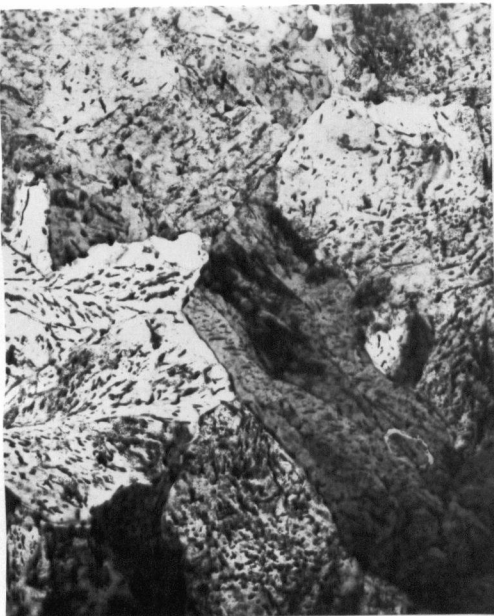
Figure 10:

TEM-picture, microstructure of steel "A" with carbides and subgrains

Bainite, bright areas are ferrite, dark particles carbides
Mag.: 4,000x

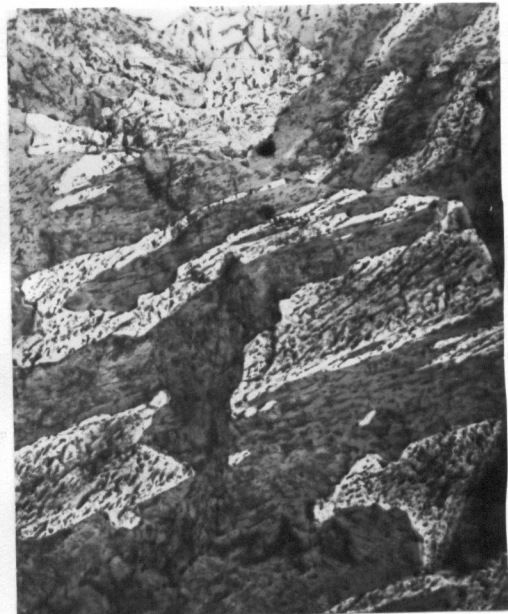
Figure 11:

TEM-picture, microstructure of steel "A" with carbides and subgrains

Mag.: 3,500x

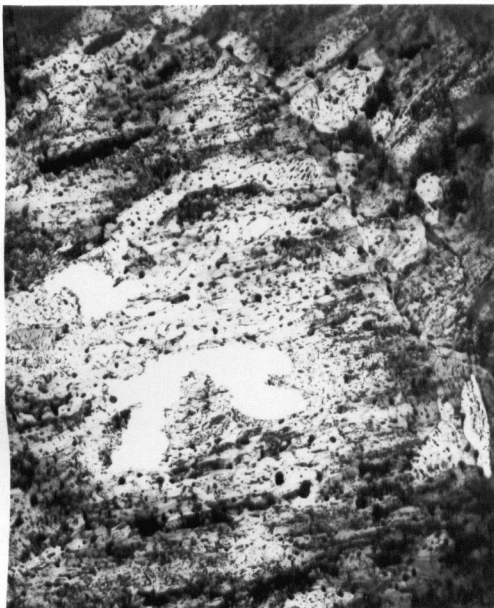
Figure 12:

TEM-picture, microstructure of steel "R" with elongated subgrains

Fine, needle like and round carbides, bright area in the centre is a hole in the sample
Mag.: 4,000x

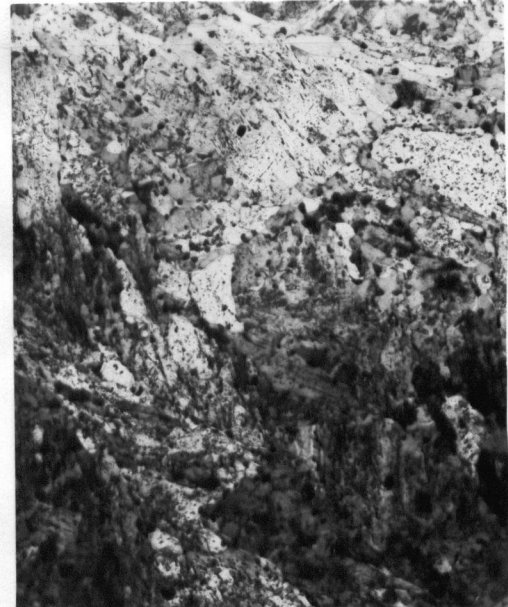
Figure 13:

TEM-picture, microstructure of steel "R" with carbides and subgrains

Mag.: 4,000x

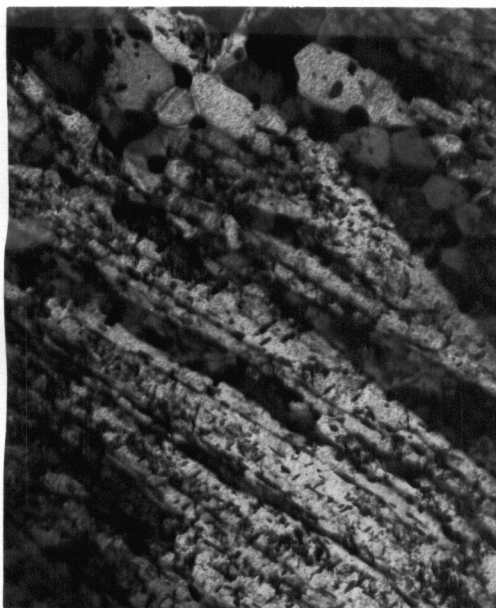
Figure 14:

TEM-picture, steel "R",
elongated carbides inside
subgrains

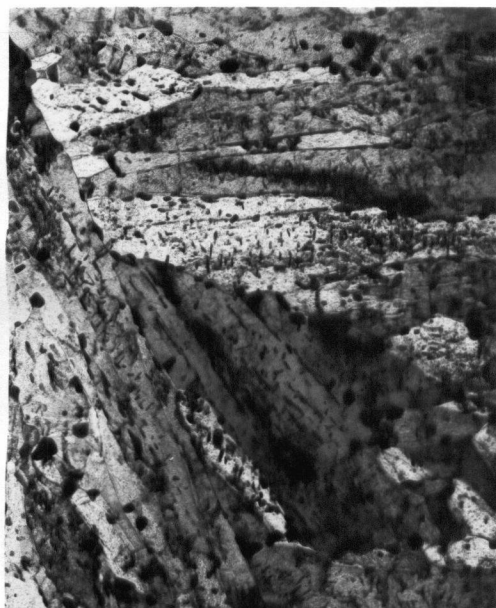
Figure 15:

Small carbides are not aligned
with the long subgrain axis

Mag.: 12,000x

TEM-picture, steel "R", carbides
inside subgrains and at grain
boundaries

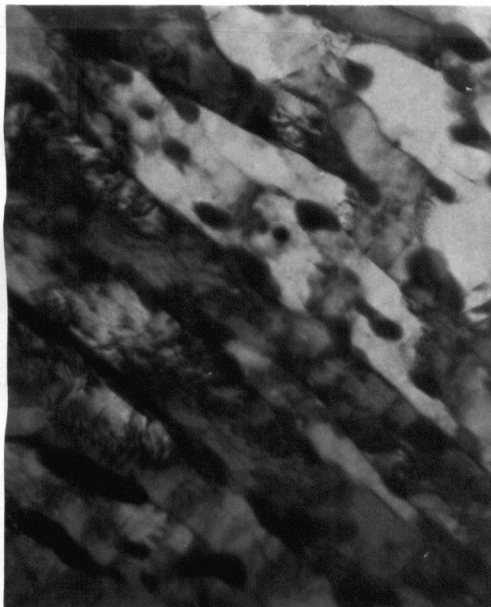
Figure 17:

TEM-picture, steel "A",
elongated carbides at subgrain
boundaries

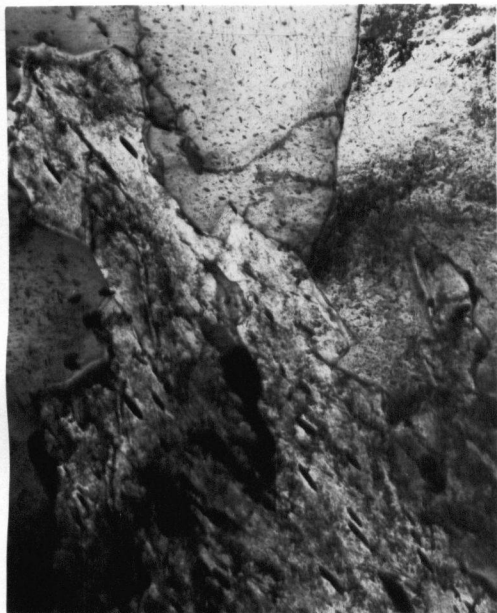
Figure 18:

TEM-picture, steel "O",
microstructure with ferrite
and bainite

This steel had a much less uniform microstructure compared with "R" and "A". On Figure 18 (pg. 32), bainite and ferrite are visible. The very small particles in the ferrite may be carbides or could be some sort of contamination from the polishing solution. The electropolishing of this steel was not as satisfactory as for the other two steels. The structure of the bainite would suggest "upper bainite". On the boundaries between ferrite and bainite rather large, elongated carbides were present. (See Figures 19,20 on page 32)

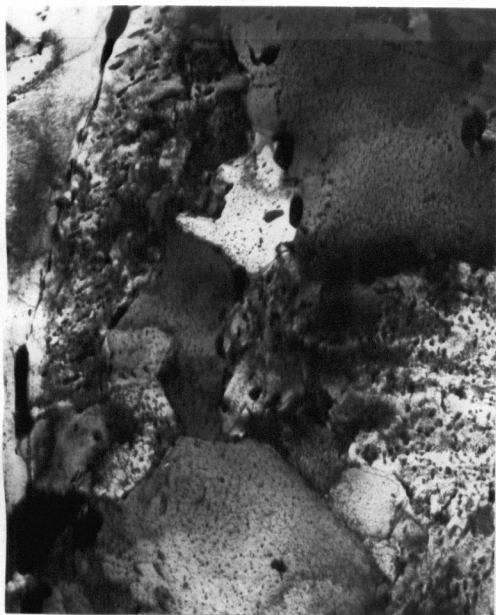
Carbides are aligned in one
direction inside the bainite
grain. Small particles inside
the ferrite grain may not be
carbides, but could be a con-
tamination from the electro-
polishing

Mag.: 8,000x

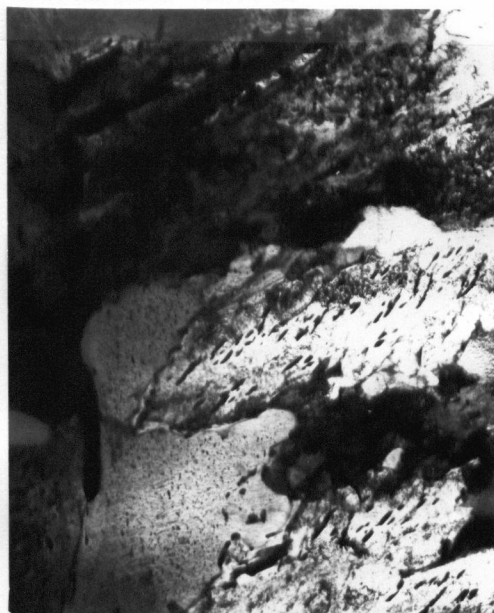
Figure 19:

TEM-picture, steel "O", big
carbides at subgrain boundaries

Ferrite and bainite grains
Mag.: 5,000x

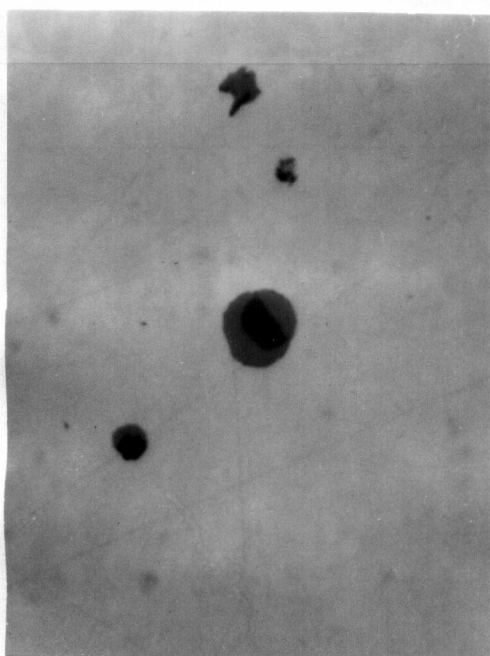
Figure 28:

CaS inclusions in steel "R"

With the EDX analysis, the big round inclusions could be classified as CaS with an alumina / silica core. The irregular shaped particles seemed to be exclusively silica inclusions. (See Figures 28-30)

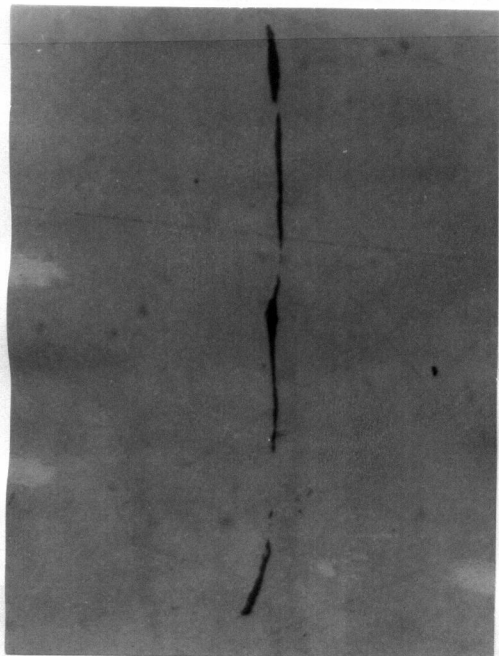
Figure 31:

Elongated MnS inclusions in
steel "O"

Steel O: A completely different inclusion distribution was found in this steel. In the rolling direction long stringers of flattened inclusions were observed. Their length was generally 50 μ m but stringers composed of several aligned inclusions were a few hundred microns long. Their thickness was mostly below 10 μ m. In addition, only a few round inclusions could be found and their size was smaller than a few microns. Irregular shape oxide inclusions could only very rarely be detected. The composition of the elongated inclusions classified them as MnS. In a few MnS stringers, small particles (probably oxides) of Al and Si were found. (See Figures 31 and 32, pg. 42)

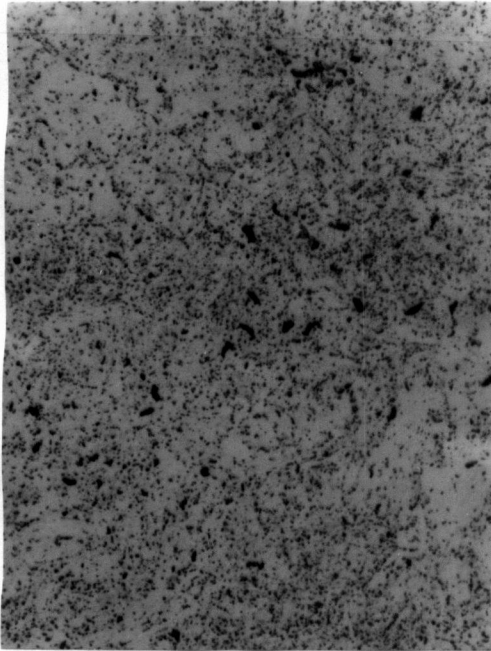
Figure 33:

Microstructure and inclusions
in CaS doped steel "R"

Mag.: 600x

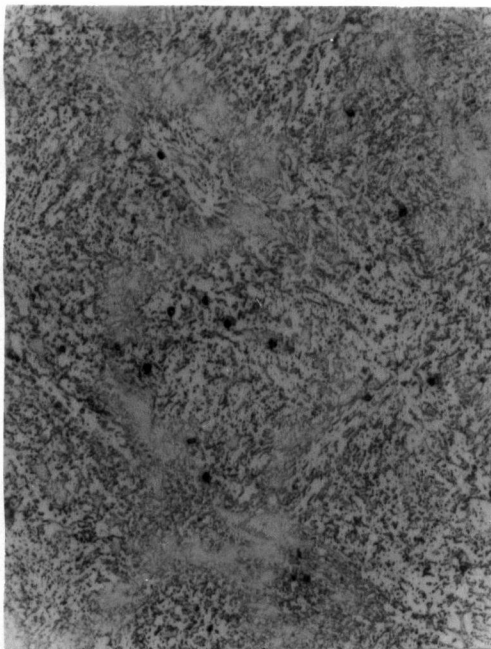
Figure 34:

Microstructure and inclusions
in MnS doped steel "R"

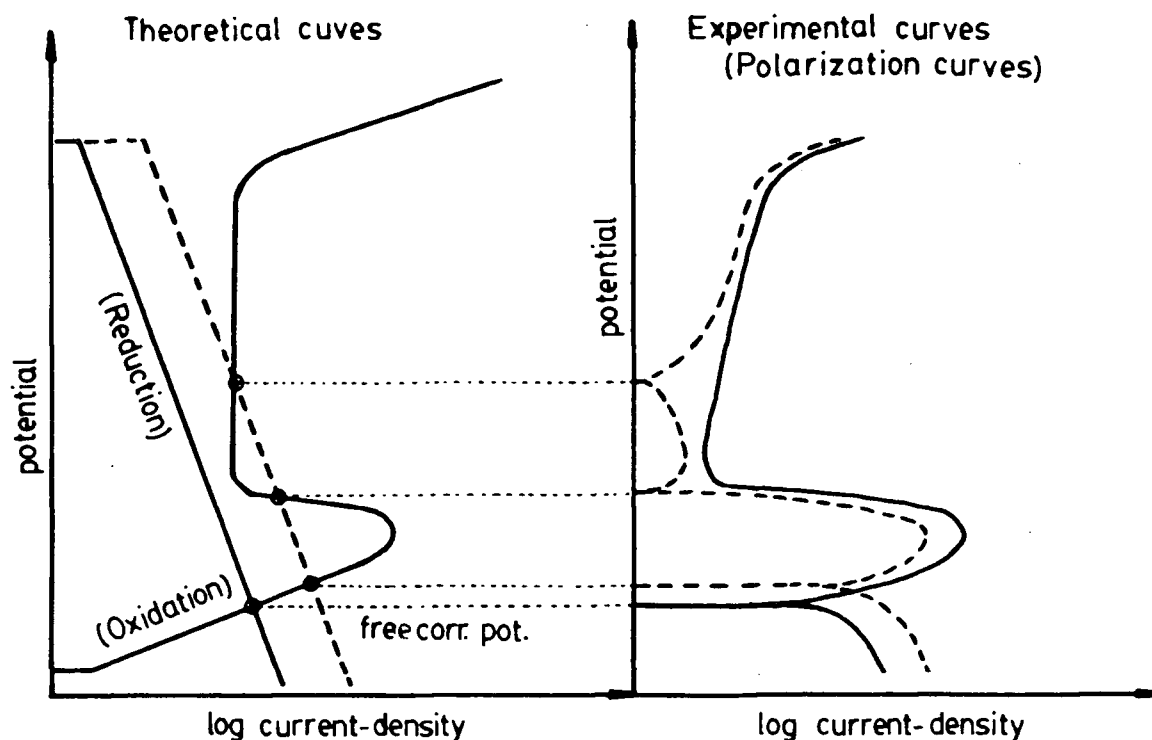
Figure 35 : Illustration of a theoretical and experimental polarization curve

The position of oxidation and reduction curves is dependent on variables like temperature, concentration of species in solution or aeration and agitation of the solution. Therefore, the intersection point(s) of the oxidation curve with the reduction curve change(s) according to these parameters. This means that the free corrosion potential of a certain metal is strongly dependent on the environment conditions. Therefore, by imposing a certain potential onto the metal (in a given environment), one can simulate the free corrosion behavior of the same metal for a different environmental condition.

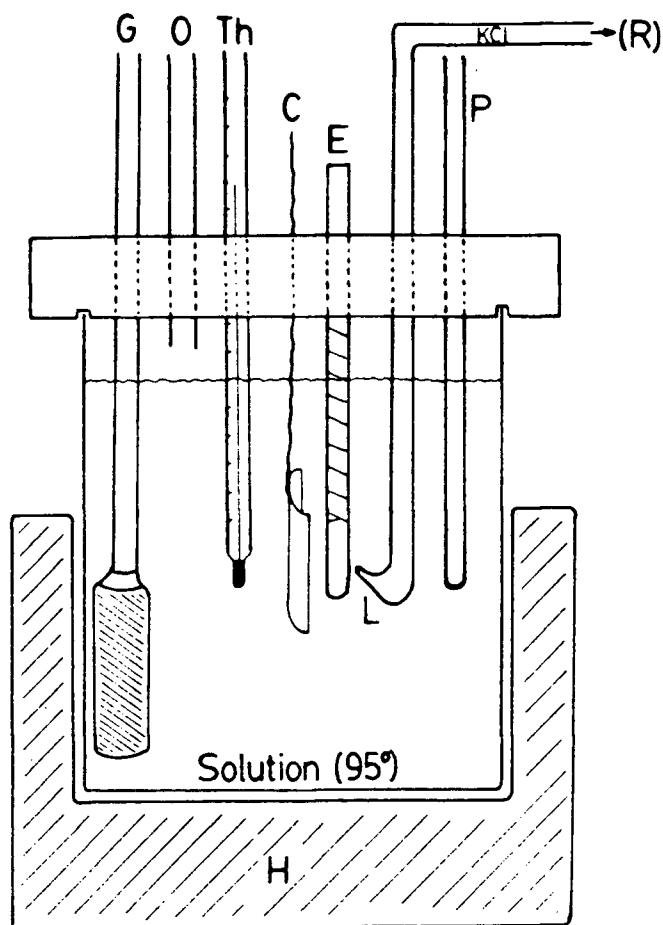
Figure 36 : Test set up for polarization studies

G : Gas inlet

Th: Thermometer

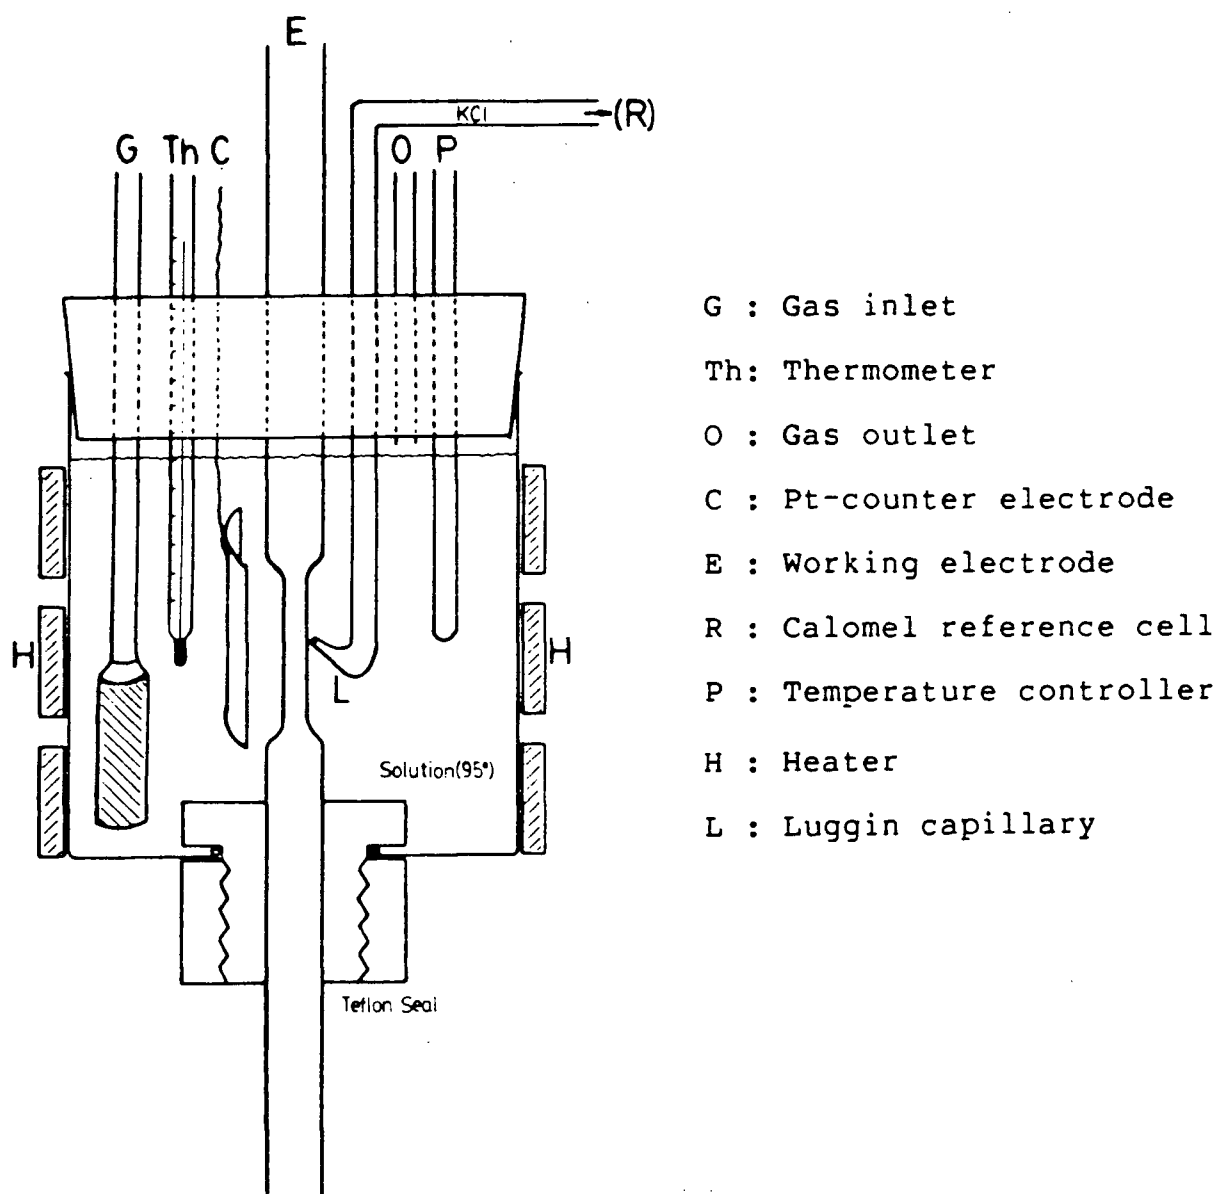
Figure 37 : Set up for slow strain rate tensile tests

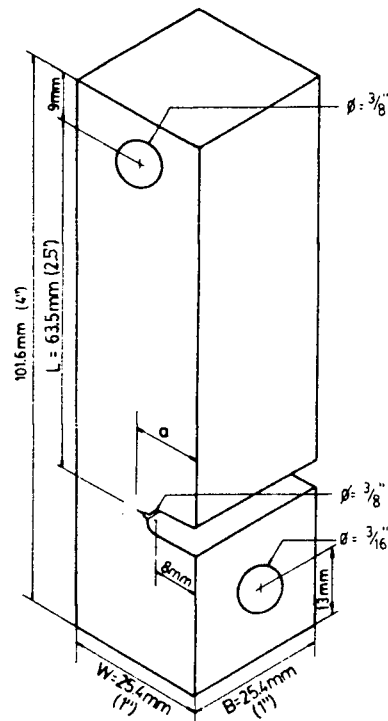
Specimen geometry for fracture-mechanics tests

The specimen were fatigue pre-cracked by cyclic bending on a Sonntag SF-1-U fatigue machine. The applied load was selected so that the stress intensity at the crack tip was at least $5-10 \text{ MNm}^{-3/2}$ below the stress intensity applied during the SCC test.

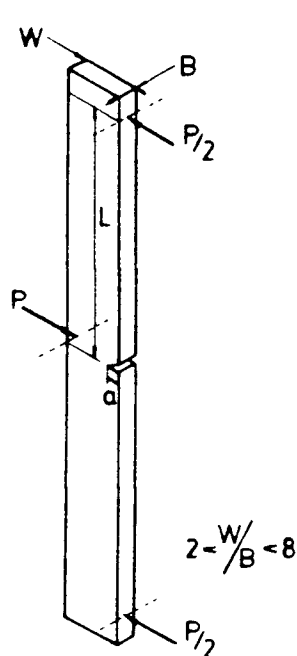
Different specimen geometries for fracture mechanics tests

a) 3-Point Bending
(Brown 58)

The stress intensity for our sample geometry was calculated using a formula described by Brown⁵⁹. (See Fig. 39d, pg. 57) The same relationship was used by Robinson and Scully⁶⁰ to do SCC experiments with a notched cantilever beam. However, this formula assumes pure bending of a cantilever beam which is not fully satisfied in our set up. The maximum bending moment that can be applied is controlled by the maximum tensile fiber bending stress. The analysis is valid only below the yield point of the material.

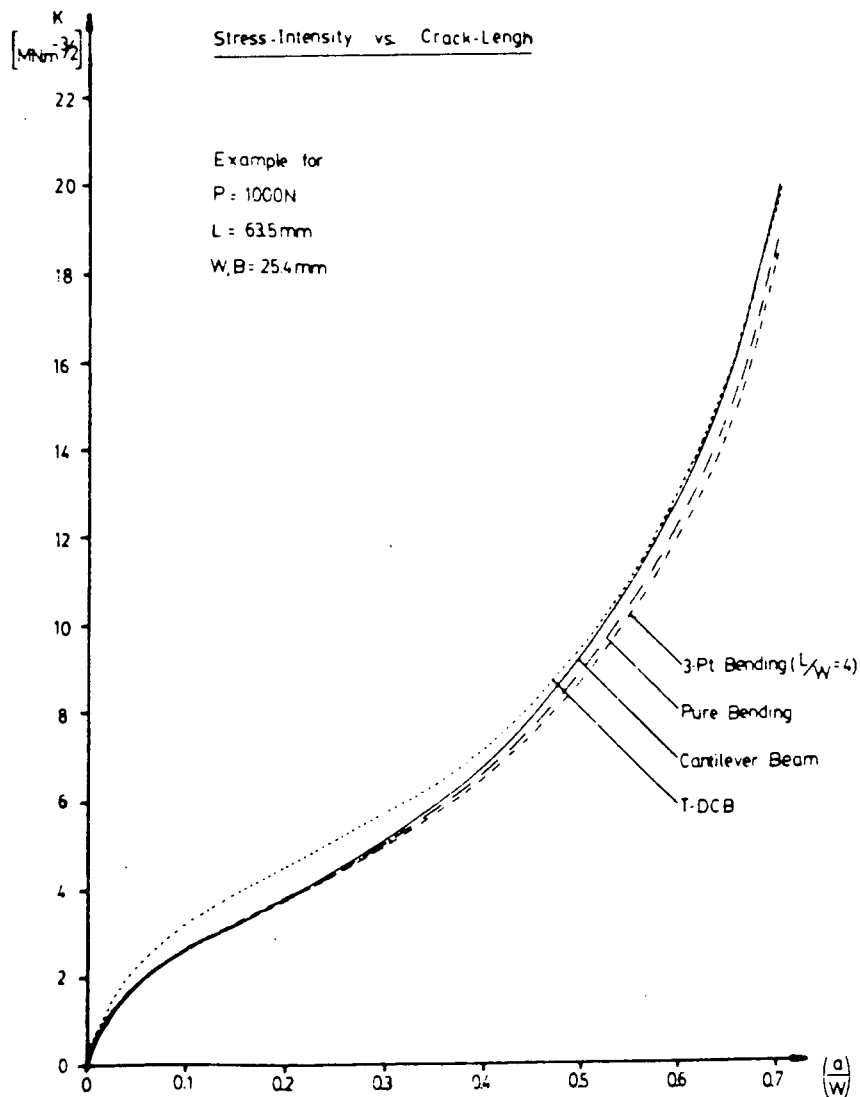
Figure 40 : Stress intensity vs. crack length for different specimen geometries

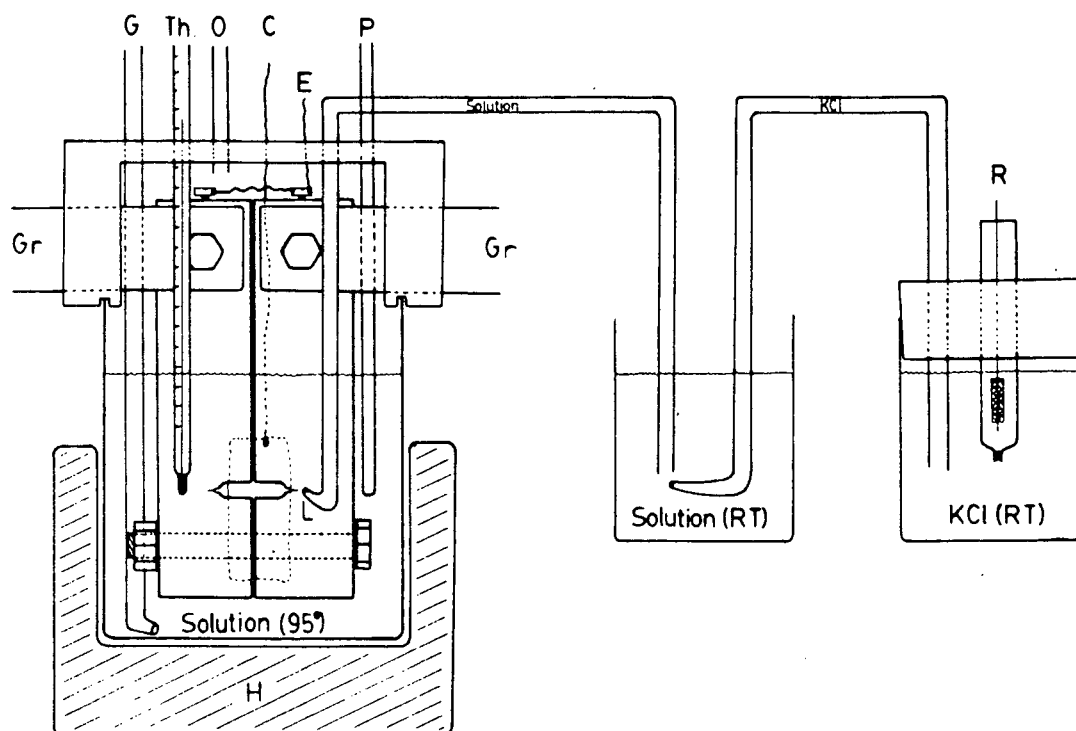
Figure 41 : Test set up for stress corrosion experiments with fracture mechanics specimen

G : Gas inlet

Th: Thermometer

Before the test, the samples were cleaned with acetone and alcohol. Subsequently, the specimens were wrapped with PTFE tape so that only the notch area was exposed to the environment. After tightly bolting the two pieces together (with SAE Grade 5 bolts), the bolt ends were also carefully wrapped with PTFE tape. Copper wires were screwed into each sample and connected to the same potentiostat used for the SSRT studies (see page 51).

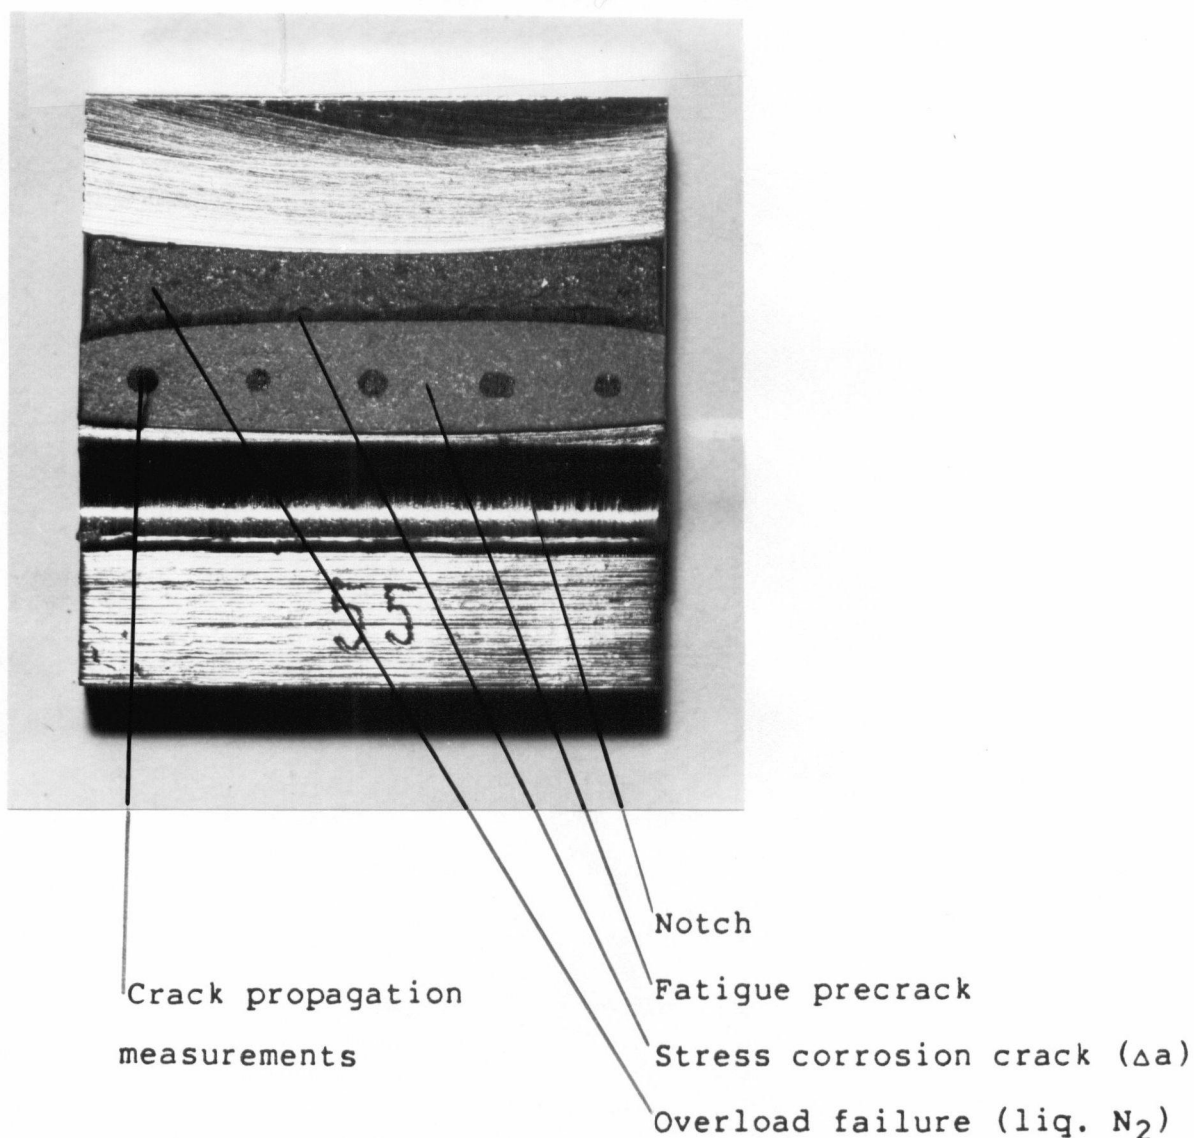
Figure 42 : Illustration of crack propagation measurements

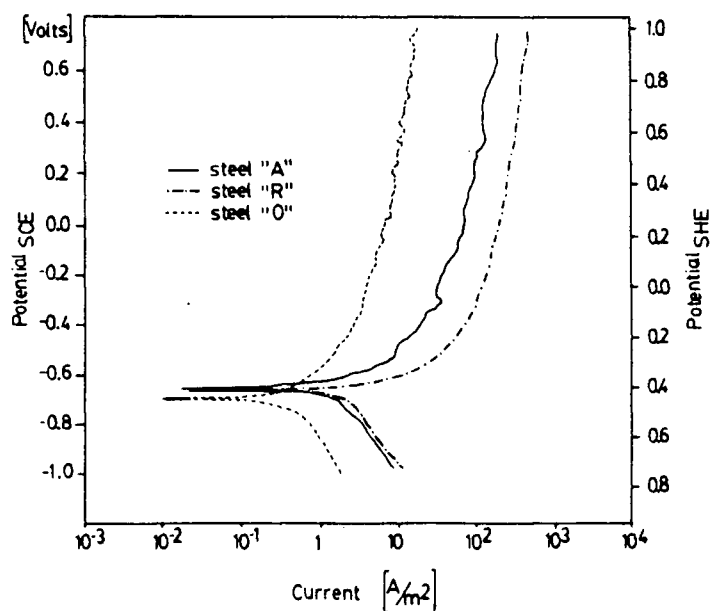
Figure 44:

around $-500\text{mV}_{\text{SCE}}$ appeared, followed by a passive region above $-200\text{mV}_{\text{SCE}}$. The corrosion current density in this passive region was about two orders of magnitude smaller than in the $\text{CO}_2/\text{H}_2\text{O}$ system where no passivation was observed. In the very dilute bicarbonate solutions there was a great tendency for crevice corrosion and with samples mounted in epoxy the passive behavior was overwhelmed by crevicing effects.

Polarization curve for steel "O" in NaHCO_3 ($3.5 \cdot 10^{-3}\text{M}$)

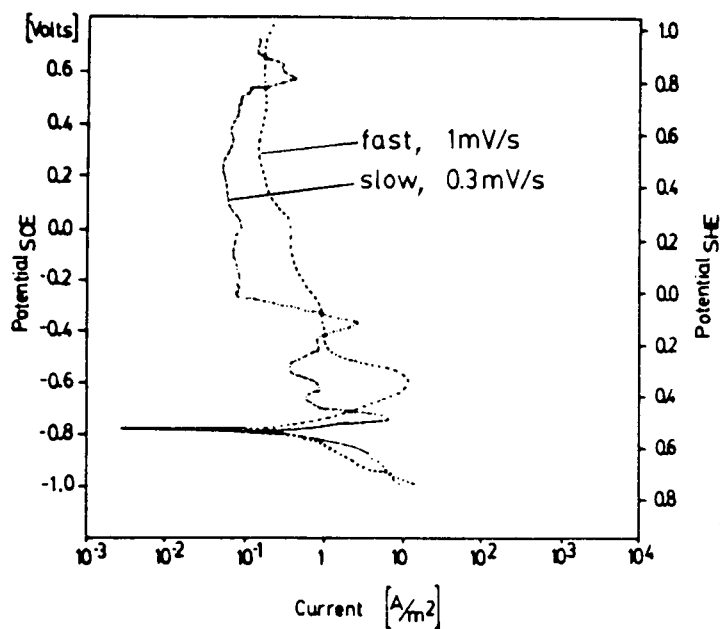
Figure 45:

Upon raising the pH further in the 1M carbonate/bicarbonate solution, only one active peak was observed. But now the behavior in the passive region changed. At about $300\text{mV}_{\text{SCE}}$ a current peak ("transpassive" peak) was observed with current densities nearly ten times higher than in the passive plateau. (See Fig.47, pg. 66) Also in the more dilute solutions, sometimes small peaks were found in the passive region but not as pronounced as in the 1 molar carbonate/bicarbonate solution.

Polarization curves for steel "O" in NaHCO_3 ($3.5 \cdot 10^{-2} \text{M}$), fast and slow scan

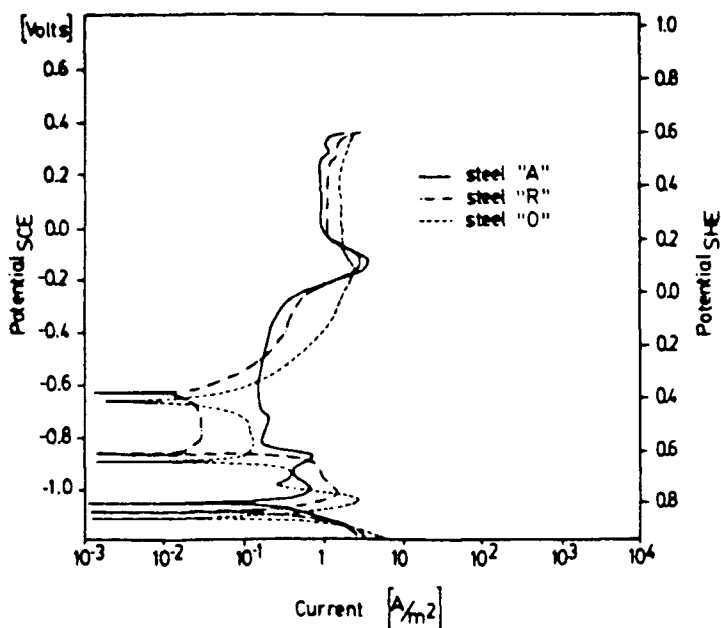
Figure 48:

With a NaOH concentration of 0.35 mole/l, the polarization curves were about identical to the 3.5 molar solutions. However, only a single active peak appeared.

In Fig.48, pg.68, it can be seen that all three steels behaved very similarly in the sodium hydroxide solution. The current densities at the transpassive peak were comparable to the current densities found in the carbonate/bicarbonate solution. However, the peak currents at the active peak were about 10 times lower in the sodium hydroxide solution and both the active and transpassive peaks were displaced 200mV towards more negative potentials. These effects were mainly due to the different pH of the solution. At potentials above and below the transpassive peak, steel "O" seems to show slightly higher current densities compared to "A" and "R", which was also observed in the carbonate/bicarbonate solution. The active peak (double peak) appeared slightly different for steel-"O" as compared to "A" and "R". In steel-"O" the second nose, which is attributed to nickel dissolution was smaller. This may, therefore, be explained by the considerably lower nickel content of steel-"O".

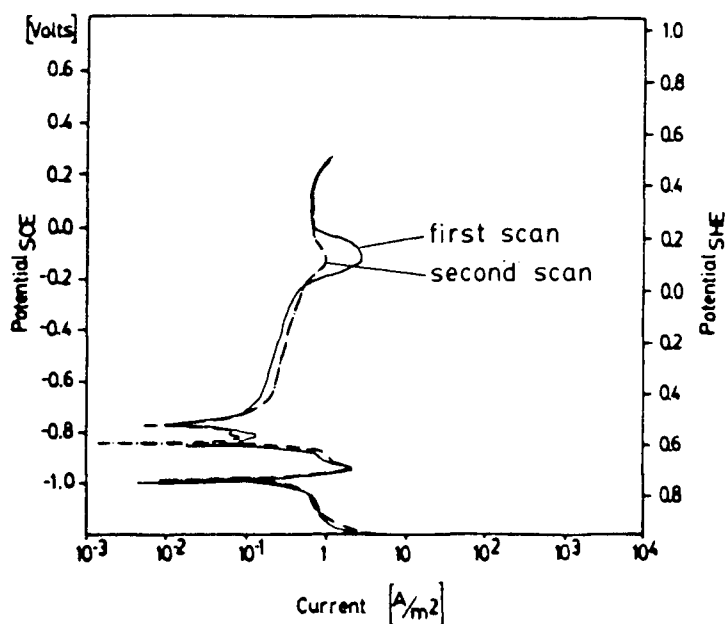
Figure 49:

In Figure 49 a polarization test of the same sample was run twice. It can be seen that the same result is obtained except for the peak in the passive region where a decrease in corrosion current could be seen.

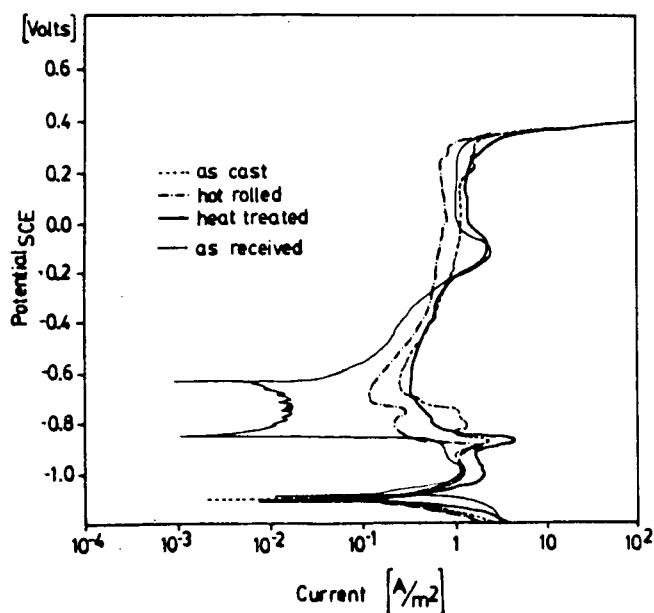
Figure 50:

The results are shown in (Fig.50 and 51). For comparison "R"-steel "as received" (not remelted) is also included. From the microstructure investigation it is known that CaS inclusions were also present in "R" but to a lesser degree than in the CaS doped steel.

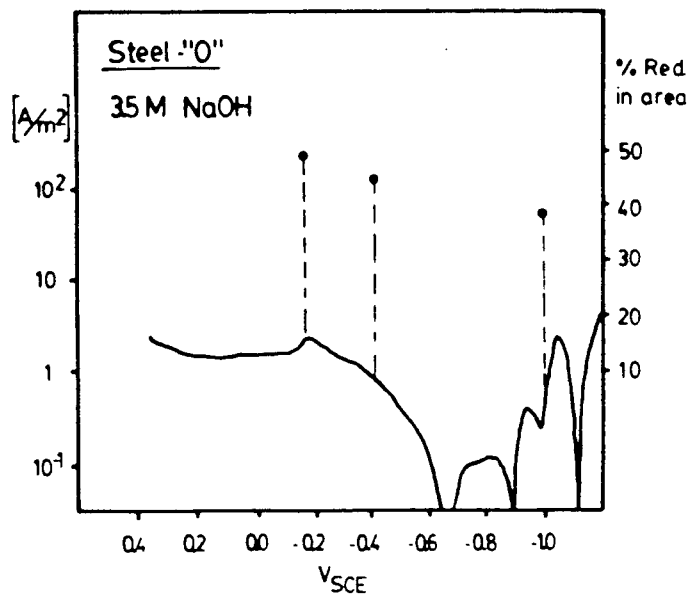
Figure 52:

Influence of potential
on the reduction in area
during SSRT-tests

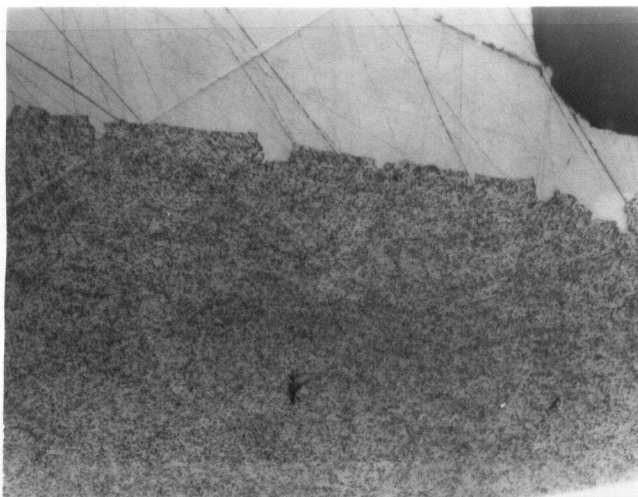
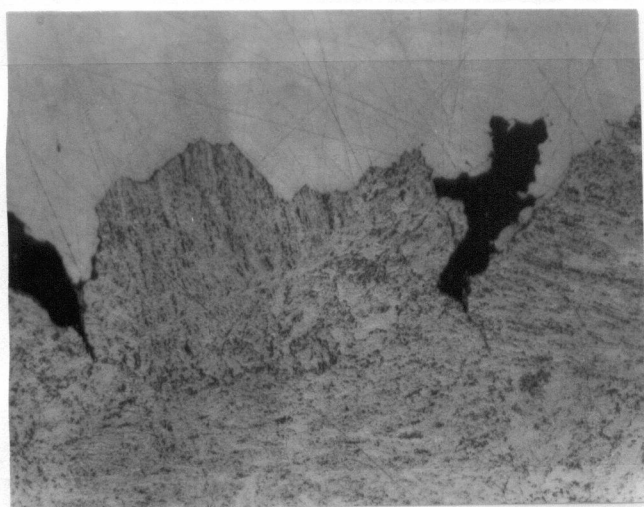
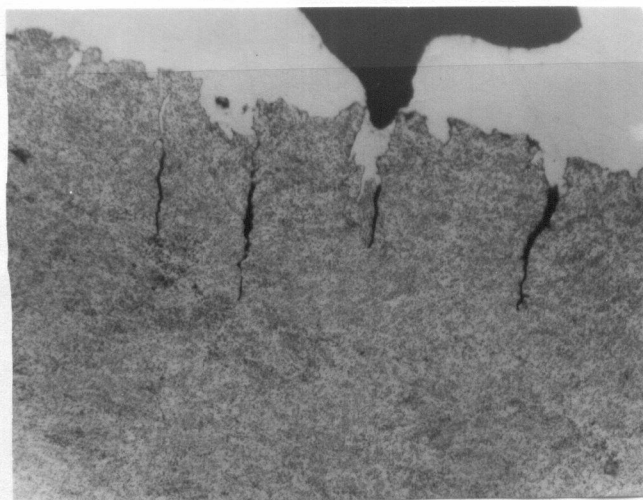
Figure 55 : Surface cracks in SSRT samples after tests in 3.5M NaOH (steel-"R"), CO₂/H₂O (steel-"O") and 1M NaHCO₃ + 1M Na₂CO₃ (steel-"A")

Steel "R", 3.5M NaOH,
-950 mV_{SCE}

Steel "O", CO₂ / H₂O,
-600 mV_{SCE}

Steel "A", 1M NaHCO₃ +
1M Na₂CO₃, -750 mV_{SCE}

The environment and electrochemical potential selected for the fracture mechanics tests were based on micrographs of sectioned SSRT samples. From these, conclusions could be drawn as to whether the corrosive attack during the SSRT experiment was of a general corrosion and pitting nature, or if sharp, penetrating cracks were formed. The latter were assumed to be a sign for sensitivity to SCC. Different types of SSRT-cracks are illustrated in Figure 55 (pg. 77).

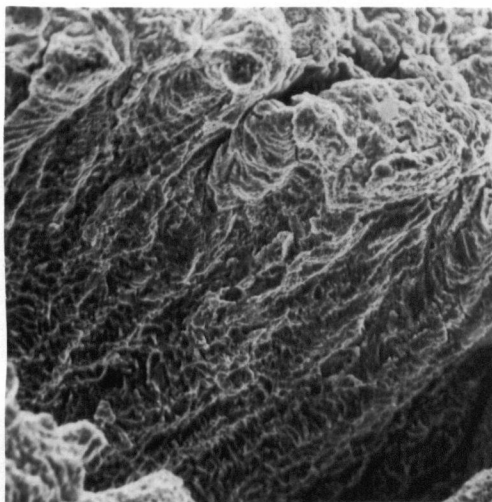
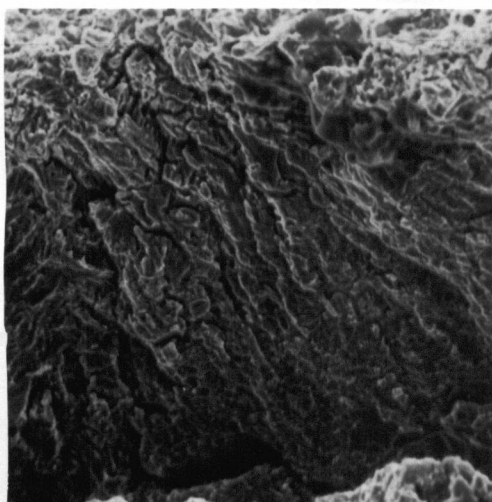
Figure 59:

In Figures 59 and 60, the fracture surface of steel "A" and "O" inside the cracks is compared. No major difference can be seen, which may explain the similar crack velocities observed for both steels in the carbonate/bicarbonate solution.

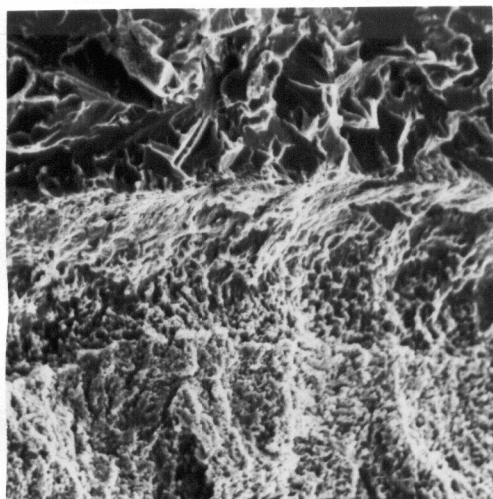
Figure 61:

reduces the tendency for further crack propagation. An illustration of the "rounded" crack tip is given in Fig. 61.

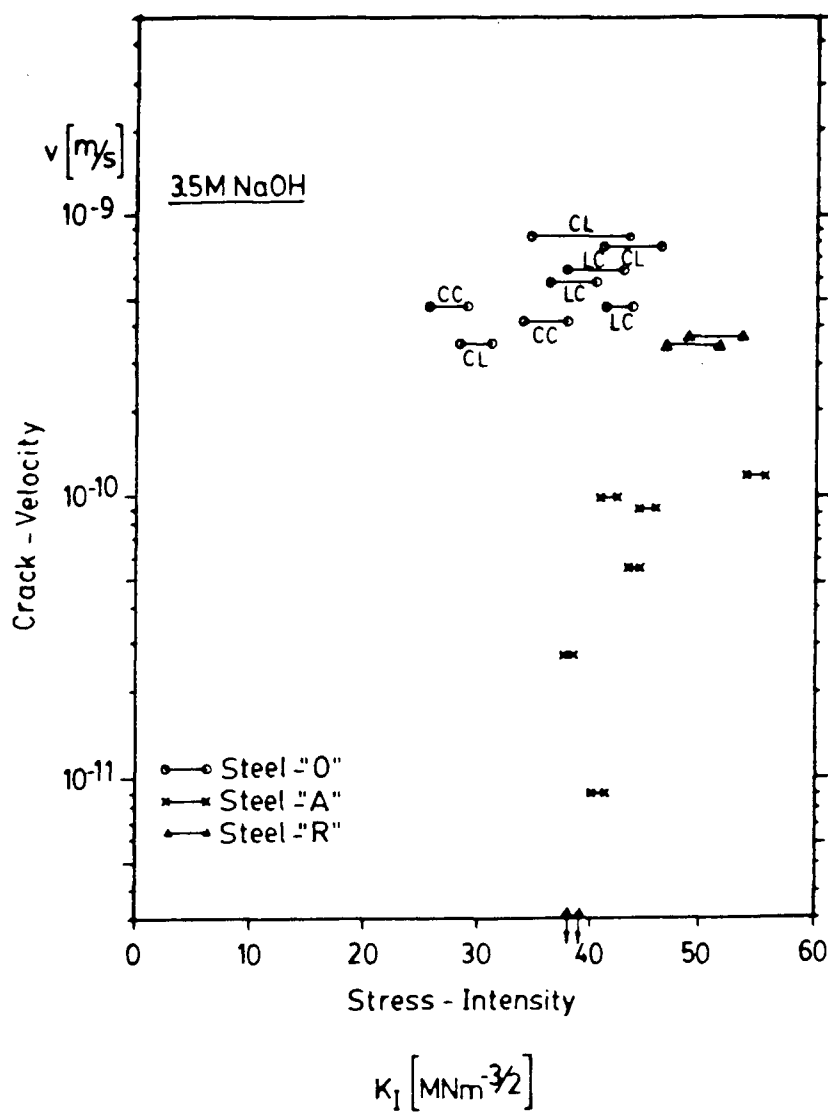
Figure 62 : Stress intensity vs. crack velocity for steels "A", "R" and "O". SCC-tests in 3.5M NaOH at the active peak potential (around $-1000 \text{ mV}_{\text{SCE}}$)

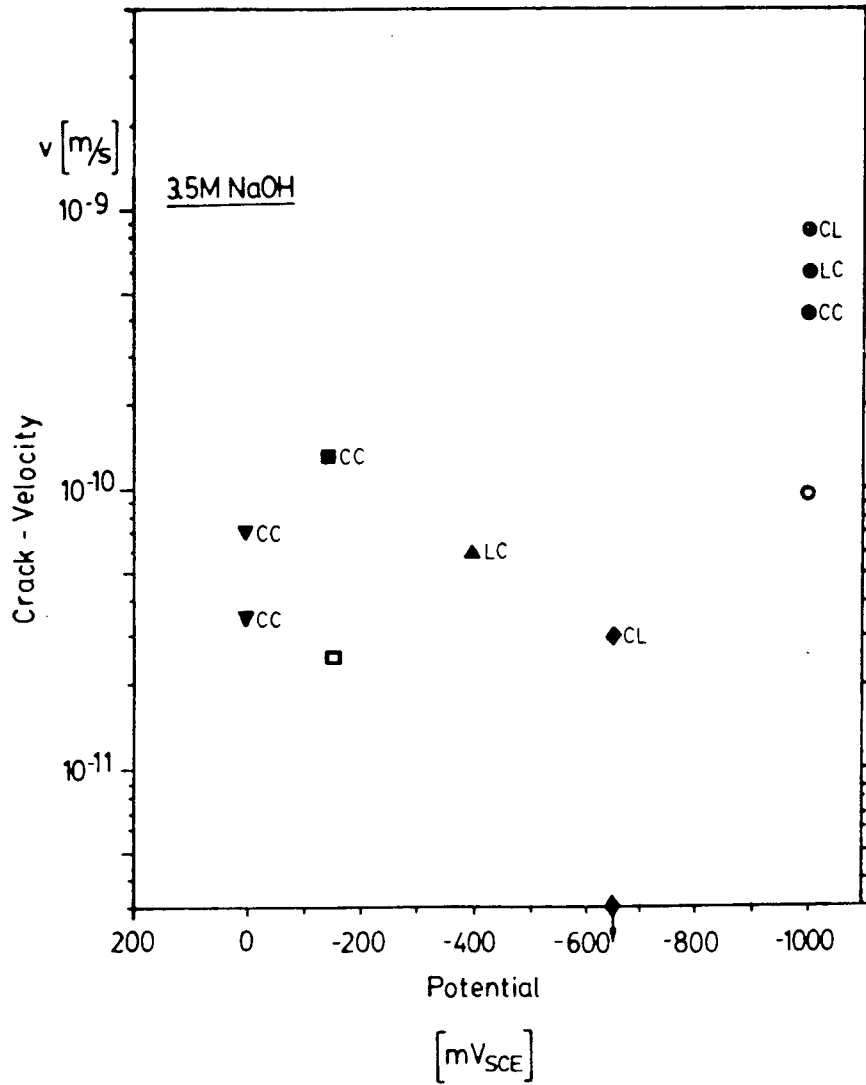
For steel-"O" (and "A"), the influence of test potential on the cracking rate is illustrated in Fig.63, pg. 87. The potential was varied between 0 and $-1000\text{mV}_{\text{SCE}}$. The stress intensity was chosen around $35 \text{ MNm}^{-3/2}$ for steel "O" and around $46 \text{ MNm}^{-3/2}$ for steel "A".

Figure 63 : Potential vs. crack velocity for steels "A" and "O" in 3.5M NaOH, SCC-test

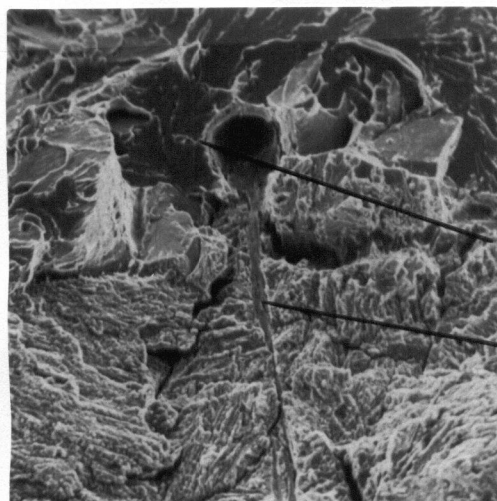
Figure 75:

In Figures 75 (3.5M NaOH, $-1000\text{mV}_{\text{SCE}}$) the crack front seems not to be influenced by the presence of the inclusion. From Figure 76 (1M carbonate/bicarbonate, $-750\text{mV}_{\text{SCE}}$), on the other hand, one could conclude that the crack propagated further in the vicinity of the inclusion. However, this "additional" cracking was only observed very close to the inclusion and may not have markedly influenced the overall cracking behavior. In both examples no change in fractography adjacent to the inclusions was observed.

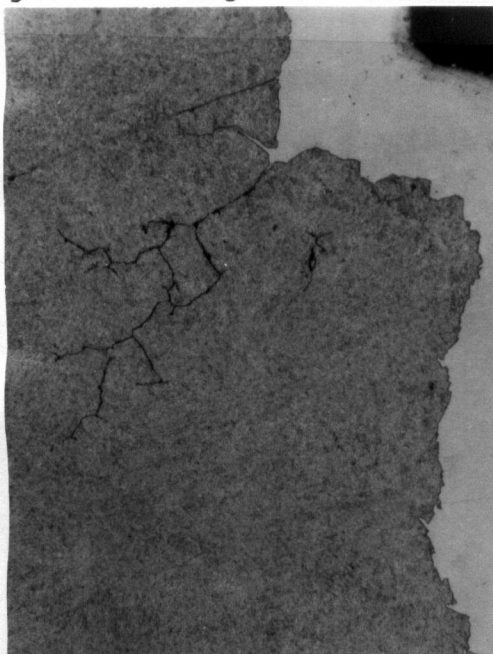
Figure 77:

An example of crack branching observed in steel "A" is given in Figure 77 below.
