STRESS CORROSION CRACKING
OF ROTOR STEELS
IN CARBONATE / BICARBONATE
AND SODIUM HYDROXIDE SOLUTIONS

JOHANN RECHBERGER

A THESIS SUBMITTED IN PARTIAL FULFILLMENT OF
THE REQUIREMENTS FOR THE DEGREE OF
MASTER OF APPLIED SCIENCE

THE UNIVERSITY OF BRITISH COLUMBIA

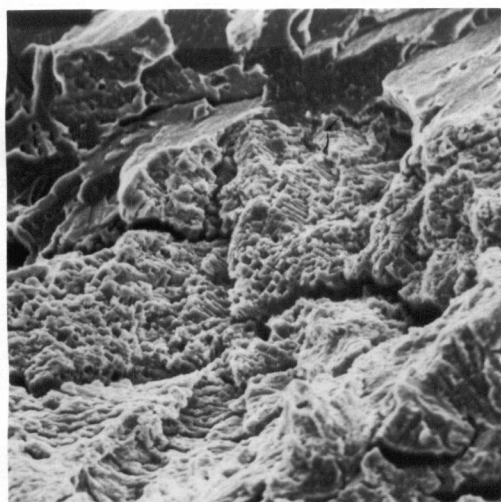
Figure 78:

At the top: overload fracture
Mag.: 1,000x

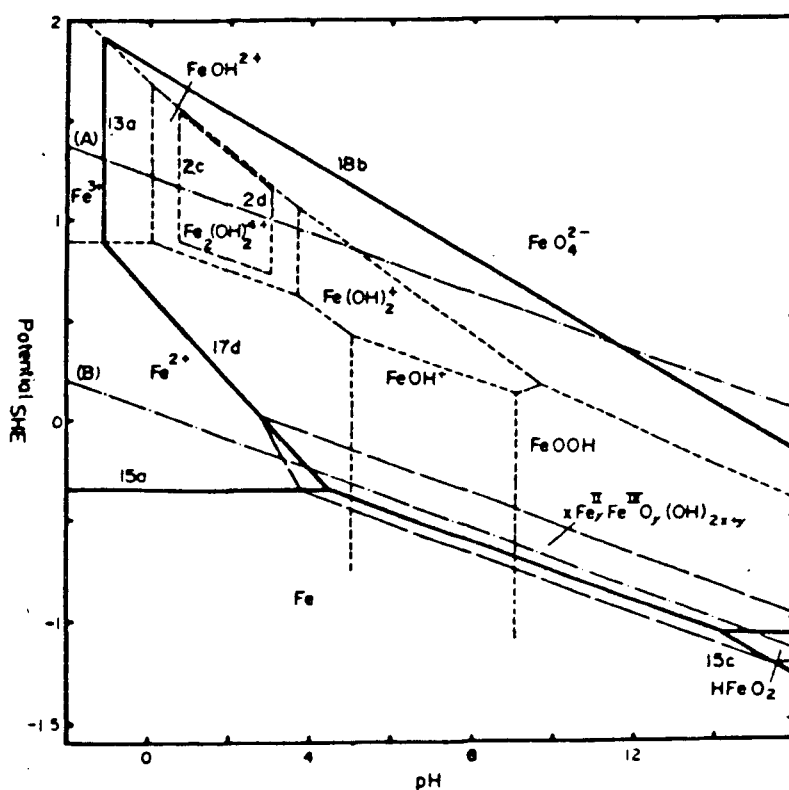
Figure 80 : E-pH diagram of iron in water at 100°C

By adding NaHCO_3 to the solution the pH is raised. Oxide films can now form at much lower potentials which means that passivation behavior is possible. The occurrence of different active peaks (compare Figures 44-47, pg.64,66) suggests that several reactions occurred place and the composition of the passive film changed as the potential was raised from negative (active) to more positive (noble) potentials.

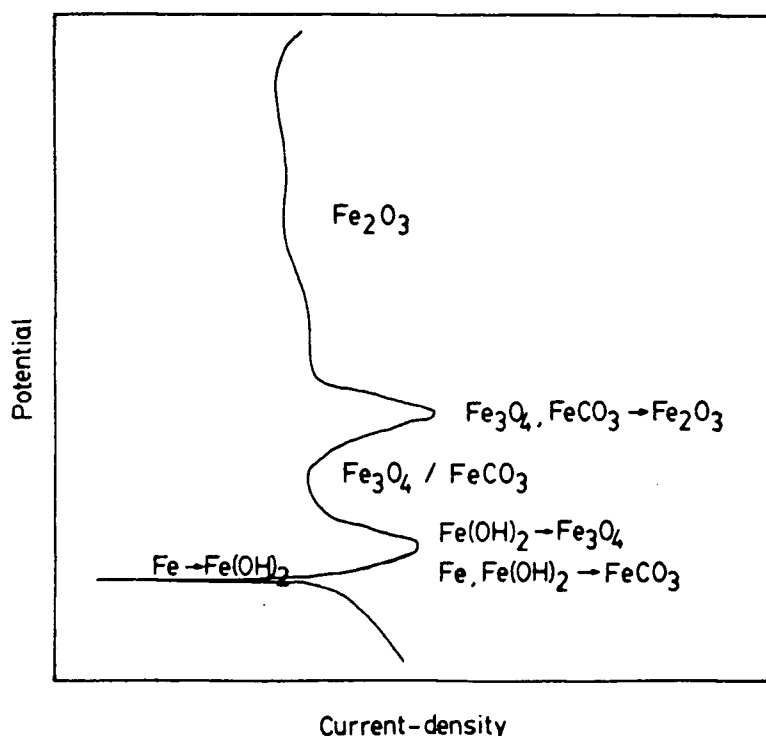
Figure 81: Discussion of the polarization curve in terms of chemical reactions in the Bicarbonate+Carbonate solutions

The occurrence of only the first active peak at low concentration of bicarbonate was explained by Thomas⁶³ as being due to the very slow oxidation of ferrous carbonate at the low pH of these solutions. This could also explain why in the $3.5 \cdot 10^{-2}$ molar bicarbonate solution the second peak was observed only with the slower scan rate.

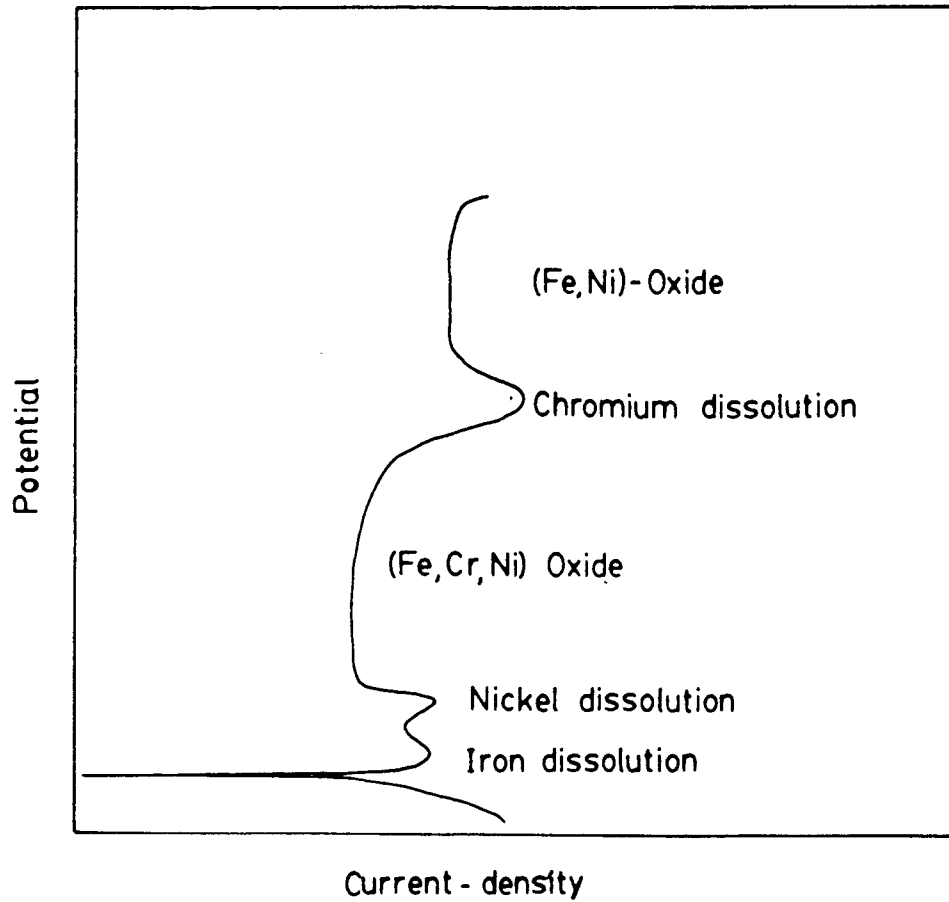
Figure 82: Discussion of the polarization curve in terms of chemical reactions in the sodium hydroxide solutions
