HYDROLOGIC CHARACTERIZATION OF TWO FULL-SCALE  
WASTE ROCK PILES

A THESIS SUBMITTED IN PARTIAL FULFILLMENT OF  
THE REQUIREMENTS FOR THE DEGREE OF  
MASTER OF APPLIED SCIENCE

(Mining Engineering)

THE UNIVERSITY OF BRITISH COLUMBIA  
March 2006

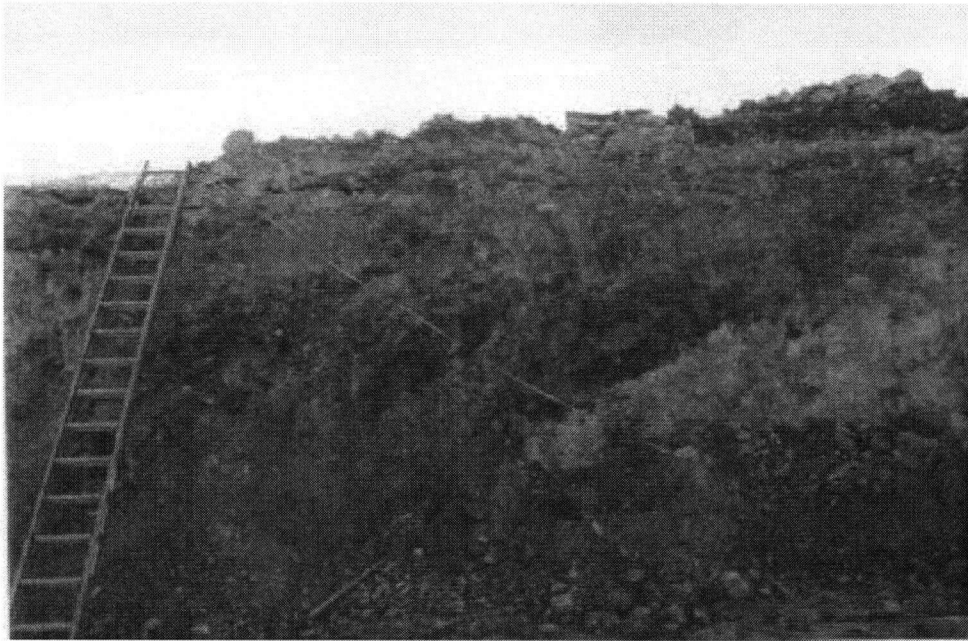
**Figure 4.1 Typical Structure Observed in Site 1 Test Pits**

The waste rock pile at Site 1 was excavated in lifts and the test pits were excavated in each bench of waste rock as it was removed. Each test pit was visually logged and photographed following excavation. Figure 4.1 shows the typical structure observed in the bench. The materials observed in the waste rock dump at Site 1 were highly weathered, fine grained in texture and had a low paste pH. Dipping layers of interbedded materials were observed throughout the profile of the dump. Oxidation products, extremely fine matrix material and traffic surfaces were the dominant features of the dump at Site 1.

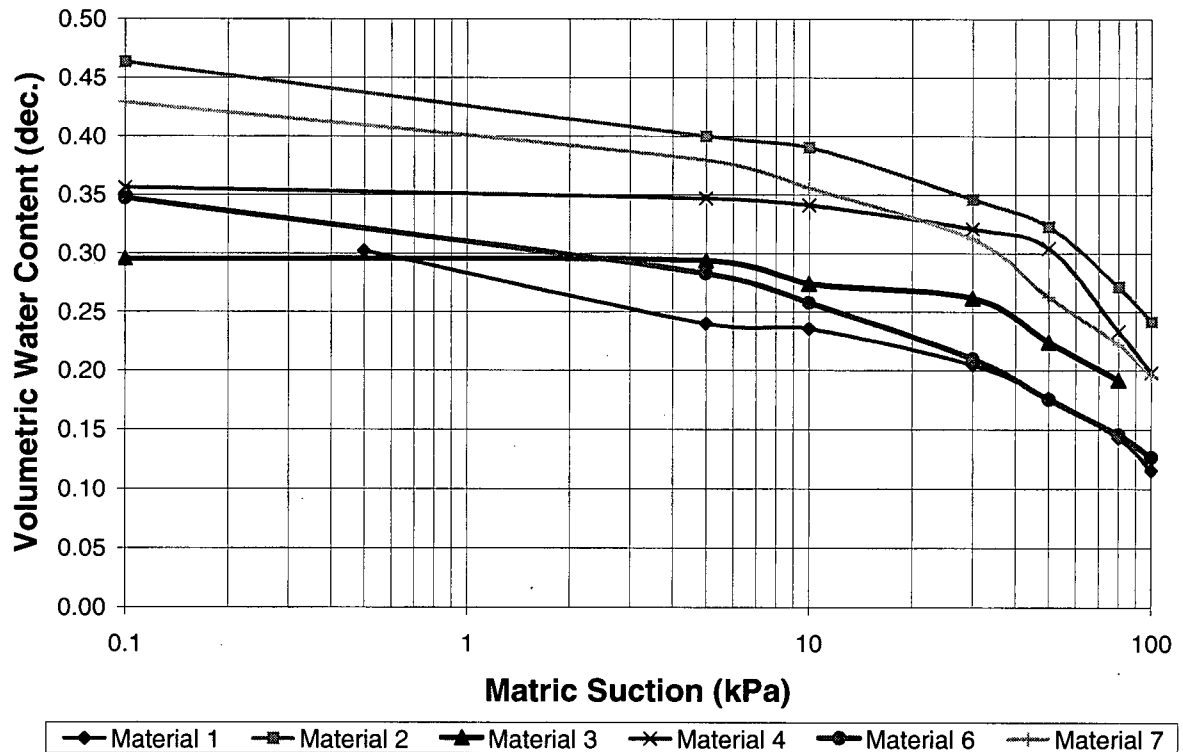
**Figure 4.3** Soil-Water Characteristic Curves for Site 1 Representative Materials.

Site 1 ranged from 20 to 100 kPa. The samples analyzed were remolded from slurried samples and likely resulted in a lower Air Entry Value than would be expected for the intact samples. This reduction in Air Entry Value is attributed to a reduction in density for the slurried samples. Densities in the pressure plates were usually in the range of  $1.3 \text{ g/cm}^3$  versus  $1.5 \text{ g/cm}^3$  to  $2.0 \text{ g/cm}^3$  measured in the field. The Air Entry Values of greater than 10 kPa were indicative of the fine grained texture of the waste rock at Site 1. Yazdani, (2000) showed that the Soil-Water Characteristic Curve could be adjusted to account for the fraction of material greater than 4 mm. However, it was determined that the samples tested from Site 1 did not require this adjustment due to the lack of coarse material in most of the materials encountered in the waste rock pile.

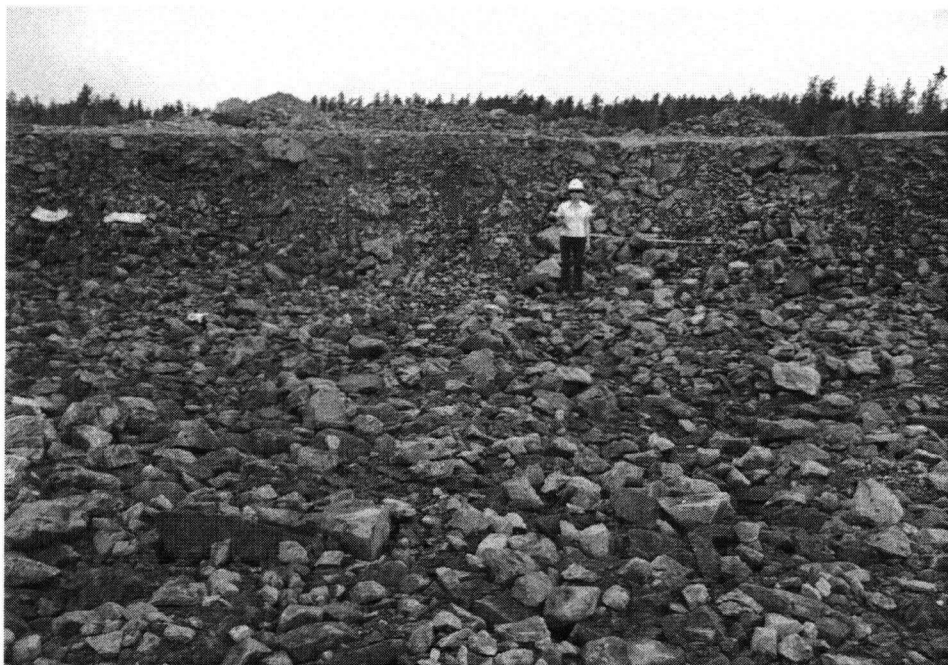
**Figure 4.4** Typical Structure Observed at Site 2

was evidence of layering within some of the test pits that were excavated however, traffic surfaces were not observed. During the excavation of the waste rock dump, gravel had to be added to the surface of the waste rock to limit tire damage to the trucks moving the waste rock. Oxidation was evident on a large fraction of the waste rock and there were indications of fine surface particles on the larger boulders. The waste rock dump was dry until the base of the dump was reached where a large frozen zone was encountered. Figure 4.4 shows the typical structure observed in the waste rock dump at Site 2.

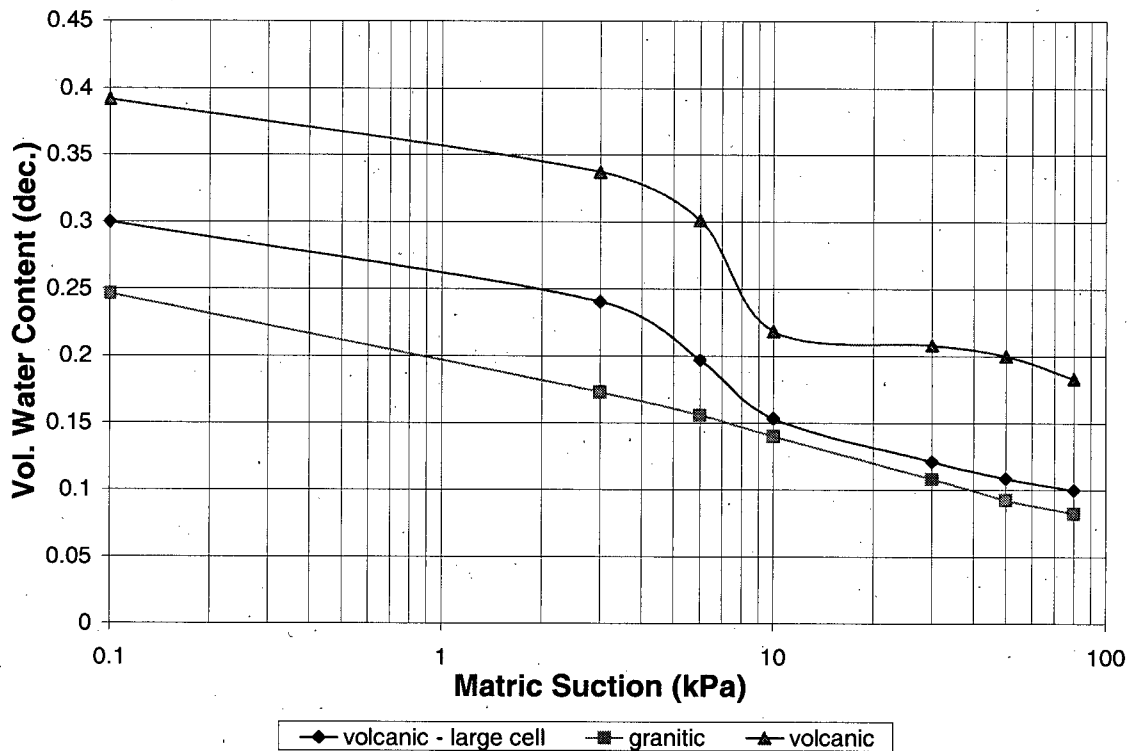
**Figure 4.6 Soil-Water Characteristic Curves Measured on Materials from Site 2:**

pressure plate apparatus (9 cm diameter cell). The third sample was tested using a large pressure plate apparatus (15.5 cm diameter cell) containing a greater fraction of coarse material (25 mm minus) within the cell. These curves are only representative for the materials that had the large void spaces filled with finer than 5 mm material. The overall percentage of the waste rock dump that could be represented by these soil water characteristic curves is likely less than 10%.

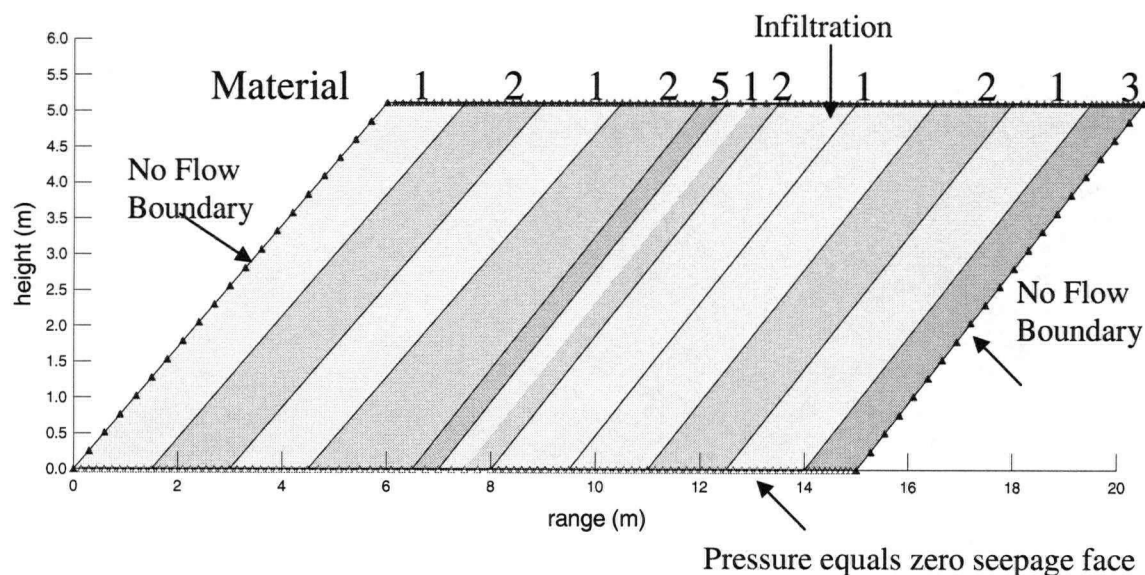
**Figure 5.4** Representative Section 1 for SEEP/W Analyses

Figure 5.4 shows the SEEP/W section constructed to represent the observed cross section in the upper profile of the waste rock dump at Site 1.

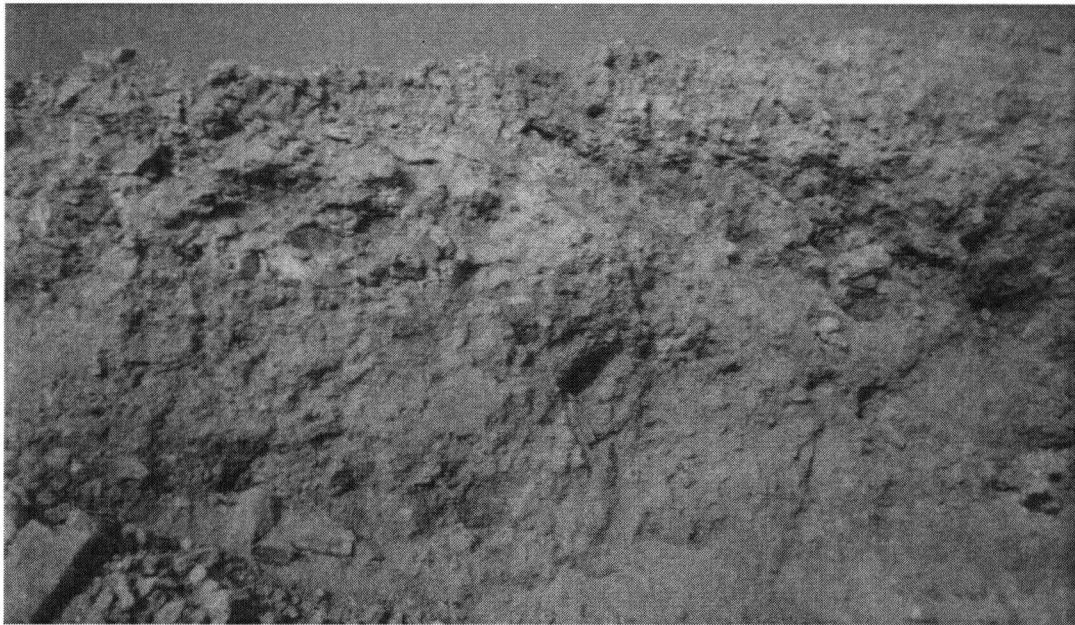
**Figure 5.13** Test Pit 26 Selected to Represent SEEP/W Section 3.
