Proceedings of the 25th Annual British Columbia Mine Reclamation Symposium in Campbell River, BC, 2001. The Technical and Research Committee on Reclamation IDENTIFICATION AND MITIGATION OF HIGH ZINC DISCHARGES TO THE ENVIRONMENT FROM THE WATER DIVERSION SYSTEM AT THE KEMESS SOUTH MINE

Harold Bent, BSc, Scott Frostad, M.A.Sc., P.Geo. and Scott Davidson, M.Sc., P.Geo.,

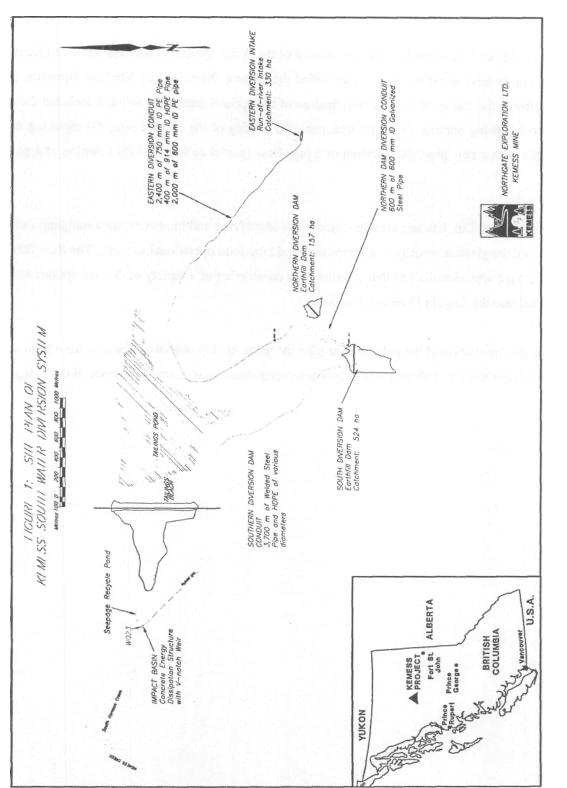
The Environmental Department at Kemess Mine conducts routine monthly water sampling throughout the entire minesite. The Water Quality Objective site (WQO) for South Kemess Creek, WQ-25, is located 150 metres downstream of the Plunge Pool. The peak zinc concentration observed at WQ-25 during 1998 was 0.125 mg/1 on April 28th, exceeding the 0.03 mg/1 WQO. The concentration of zinc was found to drop during the freshet period indicating that fresh water dilution was occurring. High zinc concentrations occurred again in 1999 during low flow conditions with a peak concentration of 0.409 mg/1 at WQ-25 on March 28th.

Proceedings of the 25th Annual British Columbia Mine Reclamation Symposium in Campbell River, BC, 2001. The Technical and Research Committee on Reclamation Proceedings of the 25th Annual British Columbia Mine Reclamation Symposium in Campbell River, BC, 2001. The Technical and Research Committee on Reclamation Figure 2. Zinc Concentrations in Eastern Diversion Conduit (July 24,1999)

Kemess Mines Ltd. has achieved its objective of identifying and implementing a mitigation solution that provided the greatest security of effectiveness and long-term operational success. The Boss 2000 "Big O" HDPE Pipe was identified as that solution after considering of a variety of diverse options and has been inserted into the Eastern Diversion Conduit.

Since the installation of the polyethylene pipe the water quality objectives for zinc have been achieved at WQ-25 consistently, with only a few recorded exceptions (a maximum exceedence of 0.012 mg/1).
